INVENTORY BOOK OF DAM (S1/60)

Name of Dam	Alapan Dam (No.S1)	Drawing(Elevation): Year of Survey : May 2007	Photo (taken on May 22 2007)
Location of Dam	Alapan I-A, Imus

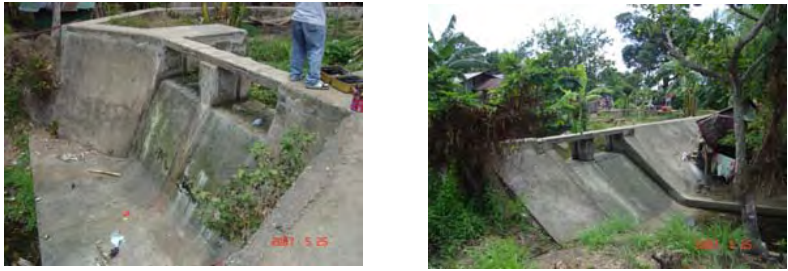
Name of Dam	Balbakin Dam (No.S3)	Drawing(Elevation): Year of Survey : May 2007	Photo (taken on May 22 2007)
Location of Dam	Bucandala V, Imus

General	1	2	3	4	5
Date of Inspection					
Status of Inspection	After Flood*Earthquake / Periodical	After Flood*Earthquake / Periodical	After Flood*Earthquake / Periodical	After Flood*Earthquake / Periodical	After Flood*Earthquake / Periodical
Name of Inspector	SUZUKI, Kazuto (JICA Study Team)				
Administration					
Name of Estate	Imus Estate				
Site					
Dam					
Leakage	None				
Scouring of Footing	None				
Cracking	Both side of the top support				
Stripping of Surface	Minimal part of the surface				
Others	None				
Side Ground					
Leakage	None				
Scouring of Footing	None				
Cracking	None				
Collapse of Slope	None				
Sliding of Slope	None				
Basin Risk in DamBreak	Low / <u>Medium</u> / High				
Necessity of Repair	Low / <u>Medium</u> / High				
Assumed Cost of Repair					
Signature

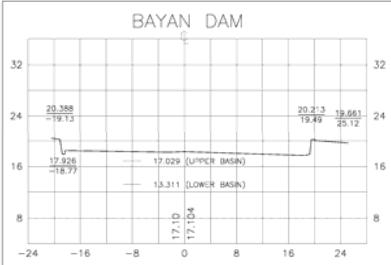
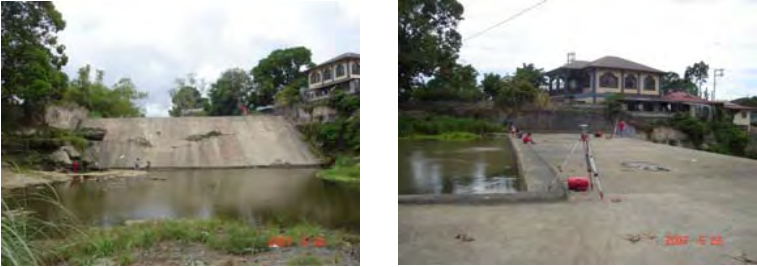
Name of Dam	Bayan Dam (No.S8)	Drawing(Elevation): Year of Survey : May 2007	Photo (taken on May 22 2007)
Location of Dam	Poblacion, General Trias

<i>General</i>	1	2	3	4	5
Date of Inspection					
Status of Inspection	After Flood*Earthquake / <u>Periodical</u>	After Flood*Earthquake / Periodical	After Flood*Earthquake / Periodical	After Flood*Earthquake / Periodical	After Flood*Earthquake / Periodical
Name of Inspector	SUZUKI, Kazuto (JICA Study Team)				
Administration					
Name of Estate	San Francisco De Malabon Estate				
Site					
Dam					
Leakage	None				
Scouring of Footing	0.5m at right side (5m long)				
Cracking	Horizontal Crack (center of slope)				
Stripping of Surface	None				
Others	Broken right side footing				
Side Ground					
Leakage	None				
Scouring of Footing	None				
Cracking	Crack on revetment at right side				
Collapse of Slope	due to collapse of revetment				
Sliding of Slope	None				
Basin Risk in DamBreak	Low <u>Medium</u> High				
Necessity of Repair	Low <u>Medium</u> High				
Assumed Cost of Repair	about 1 million peso				
Signature

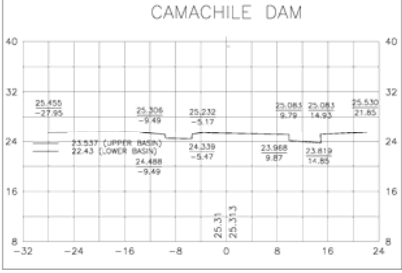
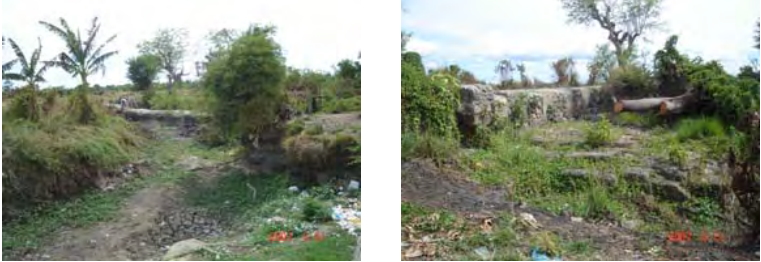
Name of Dam	Camachile Dam (No.S12)	Drawing(Elevation): Year of Survey : May 2007	Photo (taken on May 22 2007)
Location of Dam	Pasong Camachile, General Trias

<i>General</i>	1	2	3	4	5
Date of Inspection					
Status of Inspection	After Flood*Earthquake / Periodical	After Flood*Earthquake / Periodical	After Flood*Earthquake / Periodical	After Flood*Earthquake / Periodical	After Flood*Earthquake / Periodical
Name of Inspector	SUZUKI, Kazuto (JICA Study Team)				
<i>Administration</i>					
Name of Estate	San Francisco De Malabon Estate				
<i>Site</i>					
Dam					
Leakage	None				
Scouring of Footing	Major parts				
Cracking	Most parts				
Stripping of Surface	Major part of the surface				
Others					
Side Ground					
Leakage	Both sides				
Scouring of Footing	on both sides				
Cracking	on both sides				
Collapse of Slope	caused by scouring				
Sliding of Slope	lack of support				
Basin Risk in DamBreak	Low <u>Medium</u> / High				
Necessity of Repair	Low <u>Medium</u> / High				
Assumed Cost of Repair					
Signature

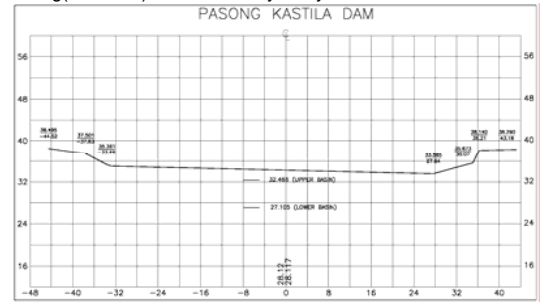
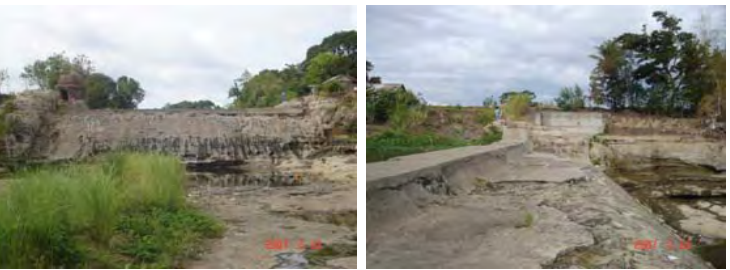
Name of Dam	Pasong Kastila Dam (No.S16)	Drawing(Elevation): Year of Survey : May 2007	Photo (taken on May 22 2007)
Location of Dam	Malagasang II-D, Imus

<i>General</i>	1	2	3	4	5
Date of Inspection					
Status of Inspection	After Flood*Earthquake / Periodical	After Flood*Earthquake / Periodical	After Flood*Earthquake / Periodical	After Flood*Earthquake / Periodical	After Flood*Earthquake / Periodical
Name of Inspector	SUZUKI, Kazuto (JICA Study Team)				
<i>Administration</i>					
Name of Estate	Imus Estate				
<i>Site</i>					
Dam					
Leakage	None				
Scouring of Footing	Most part of the footing				
Cracking	None				
Stripping of Surface	Major part of the surface				
Others	Broken side of the dam				
Side Ground					
Leakage	None				
Scouring of Footing	None				
Cracking	None				
Collapse of Slope	None				
Sliding of Slope	none				
Basin Risk in DamBreak	Low / Medium / <u>High</u>				
Necessity of Repair	Low / Medium / <u>High</u>				
Assumed Cost of Repair					
Signature
