Supporting Report N

Study on Sediment Disaster

N.1 Classification of Sediment Disasters

N.2 Past Sediment Disasters and Rainfall

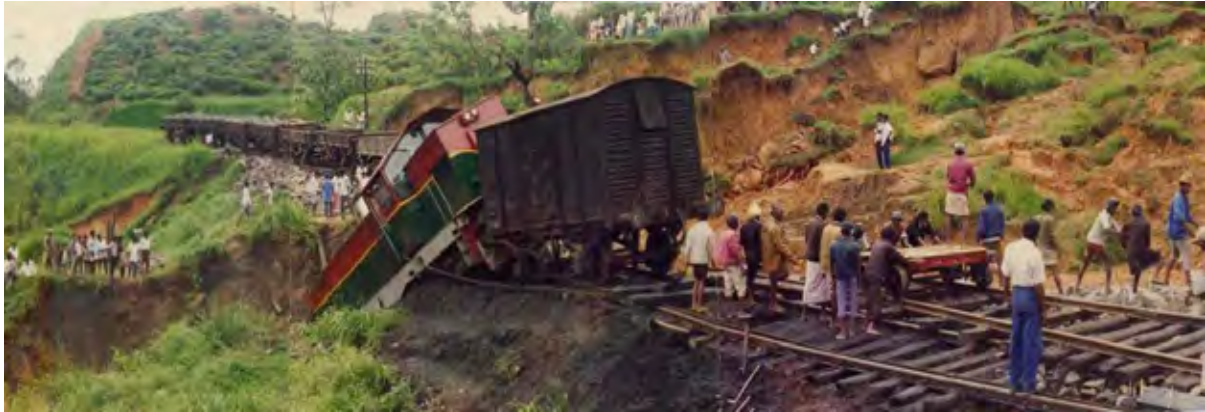
The landslide occurred on the southern slope of the Watawala ridge in the Nuwara Eliya district, where the Colombo-Badulla railroad runs. The slope was creeping for about 50 years, and it finally failed on June 3, 1992. The total area of the moving mass was about 33,120m². The Colombo-Badulla railroad was heavily damaged, and thousands of passengers who use the train daily as well as tourists were in the train. The landslide caused a severe impact on the people and economy of the country.

Figure N.2.2 Watawala Landslide and the Damage of Train (photo by NBRO)

The time of the landslide could not be confirmed by witnesses, but is clarified by the train schedule and the accident. The Colombo-Badulla night mail train with couple of thousand passengers passed the location at 4 AM on June 3, 1993. About one hour later, the Hatton-Colombo train passed and sunk into the landslide. That means that a large landslide was activated between 4 AM and 5 AM.

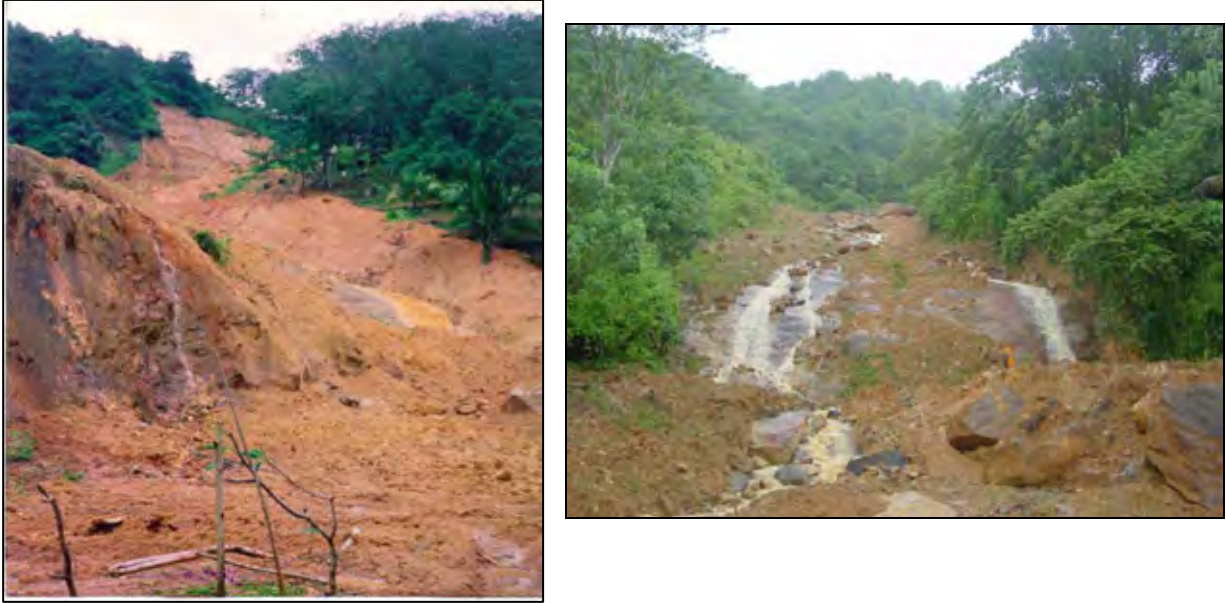
On 8 October 1993, at around 7:30 AM, an earth flow occurred on a slope approximately 3km north of the heart of Ratnapura city. The road and houses below the slope, which ran parallel with the road, were instantly swallowed, resulting in the death of 31 inhabitants.

The collapsed part, on a steep incline with an angle of approximately 40 degrees, was a weathered layer of red clay which collapsed with a depth of 2 or 3 m. The collapsed earth and sand became saturated when it was mixed with water flowing in from the channel to the west of the collapsed part, transforming into an earth flow, which slid and fell from the top of the cliff catching up boulders of 2 to 3 meters in size. The channel of water, accumulated from a table mountain behind, carried the collapsed earth and sand. Because unstable earth and sand had previously accumulated in the middle of the hillside of the collapsed part, following that, torrential rains, as mentioned below (17 May, 2003), caused a small-scale earth flow in the same place on 24 August 2006.

Figure N.2.5 Earthflow at Helauda (left: photos by NBRO in 1994, right: in 2006)

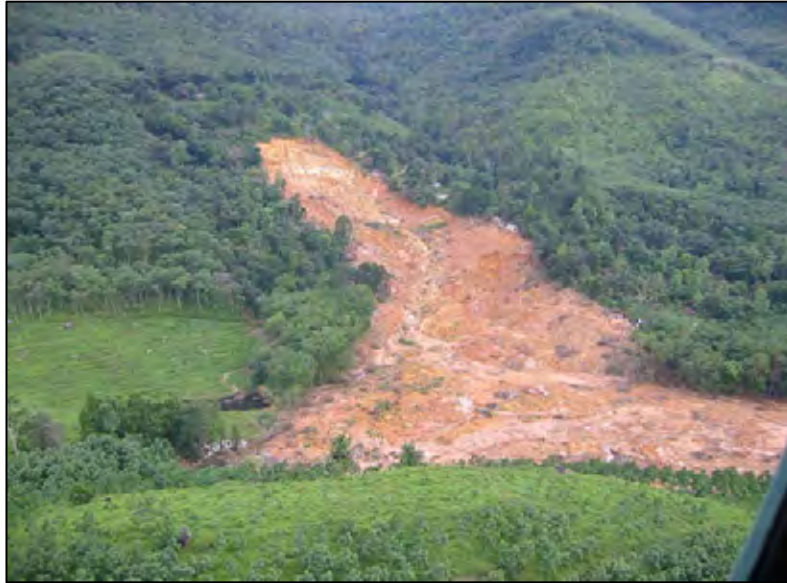
There were also large-scale earth flows, such as in Palawale, where the gentle slope of a mountain base slid down, crossing the valley floor and ran up against the slope on the opposite side. The tail end of the earth flow combined in the small rivers and became a debris flow. The overall length of the debris flow was nearly 1km from the collapsed section. In this way, the primary factor of the long distance flow is presumed to be the loose debris in the lower part of the collapsed slope, with the gentle angle of the colluvial slope, which made it difficult to stop. Furthermore, it is presumed that the participation of ground water and sub-surface water were also a large factor.

According to the NBRO, and also described in the investigation sketch after the disaster, there were streams recorded in the earth flow trail. Also, as the JICA Study Team were able to observe surface water in the collapsed slope during their field survey despite the fair weather, it was clear that there were water channels in the surface layer of the earth. It is presumed that at the time of the torrential rains, the abundant amount of water furthermore increased the current.

Figure N.2.8 Earthflow at Palawela (2003, photo by NBRO)

The feature of this earth flow is a steep slope consisting of a weathered layer of clay soil in the rear, beneath which the advancing slope of a relatively gentle slope consisting of residual soil, water from the rear slope water channel joined the weathered layer of residual soil and slid together. In other places where earth flows have occurred, it is often that the upper part where concentrated low-level weatherized bedrock is exposed. As for the slip surface, it is often the place where the bedrock and weathered layer interface.

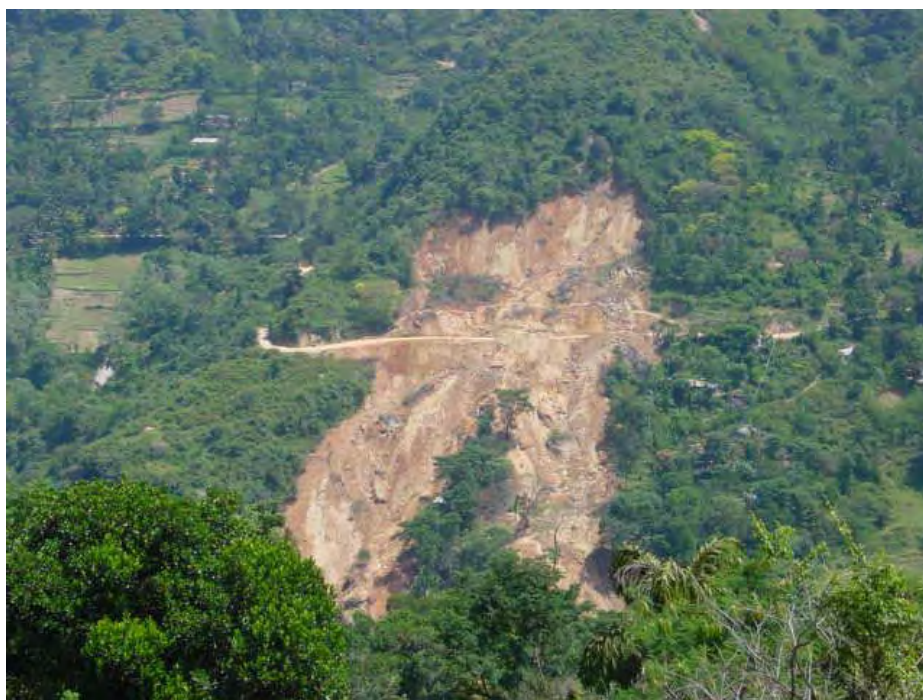
Figure N.2.10 Landslide at Walapane

Walapane National Highway B413 saw multiple episodes of cutting failure, landslide and debris flow. Among places along the national highway where landslide disasters occur frequently, one occurrence reached 100m. In the tracks left behind a landslide which resulted in the deaths of 10 people, traces of piping and the water channel were confirmed and it is thought that the permeation of groundwater caused the deep landslide.

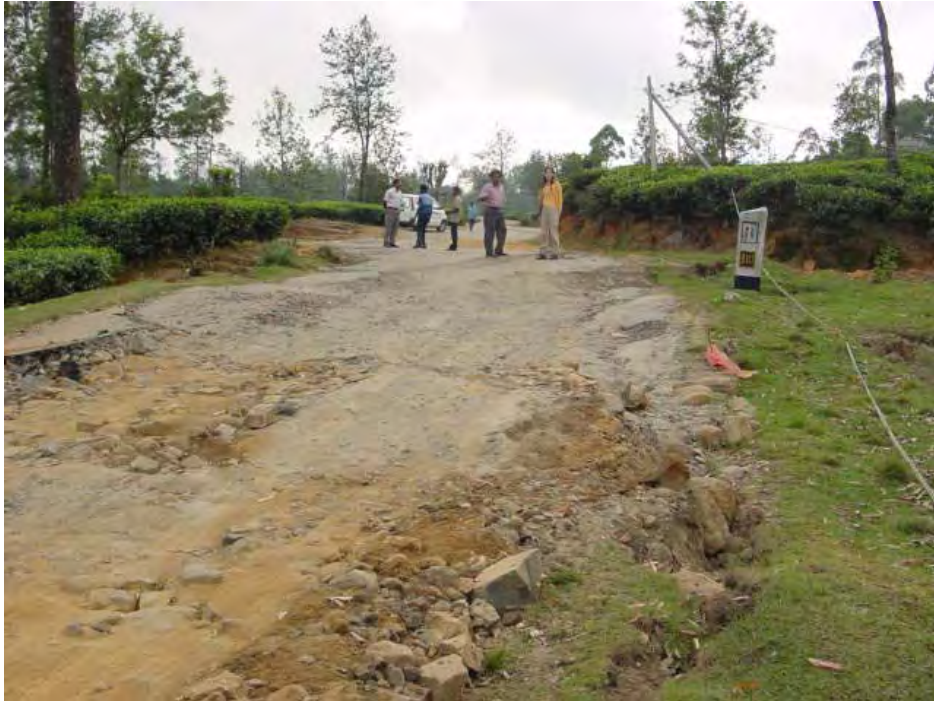
The RDA performed the job of removing debris from along National Highway B413 and ensured temporary transit, but the large quantities of debris along the sides of the road were left in unstable condition, and the danger of a secondary collapse was high. Slow-moving landslides were also observed in two places. When the movement of the Marigold Watta landslide began on 18 December 2006, the inhabitants then evacuated. On 11 January 2007, when serious landslide activity took place, the homes, road and farmland were all completely destroyed. In addition, the landslide which occurred at the Estate in Diyan Hawatta (Figure N.2.11) continues at present to move slowly and destruction of the tea garden and the road is advancing.

Figure N.2.11 Landslide at the Estate in Diyan Hawatta

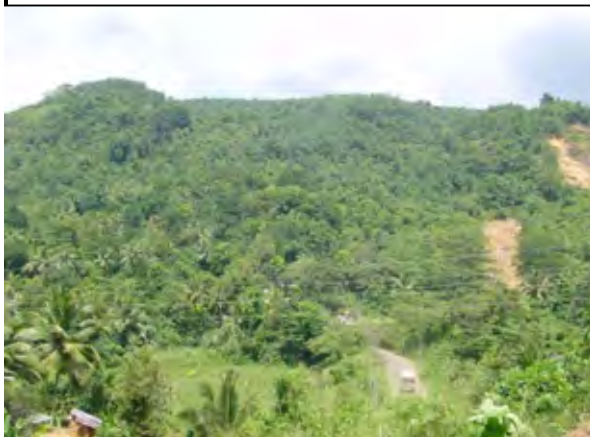
Slope beside Helauda landslide

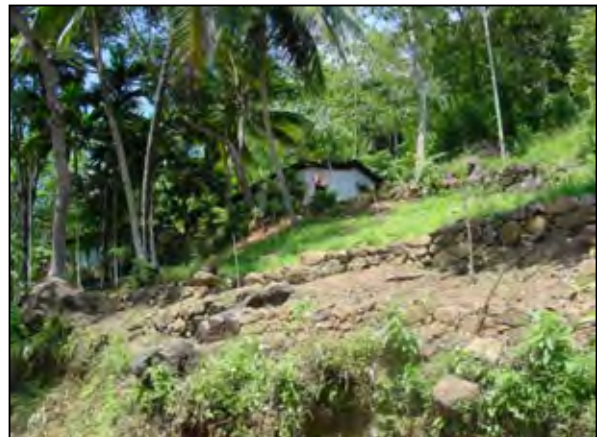
House on the colluvial slope

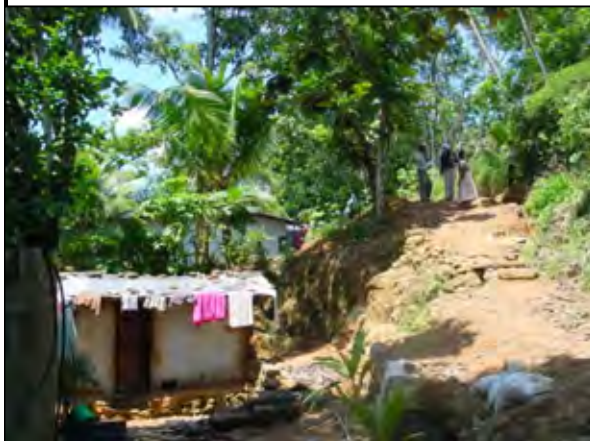
House and cutting slope

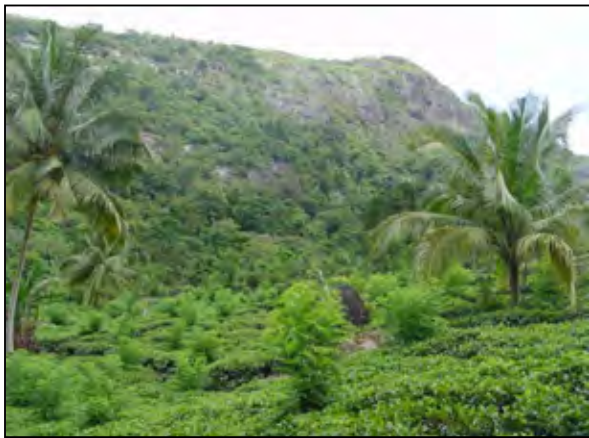
top of the landslide and cliff

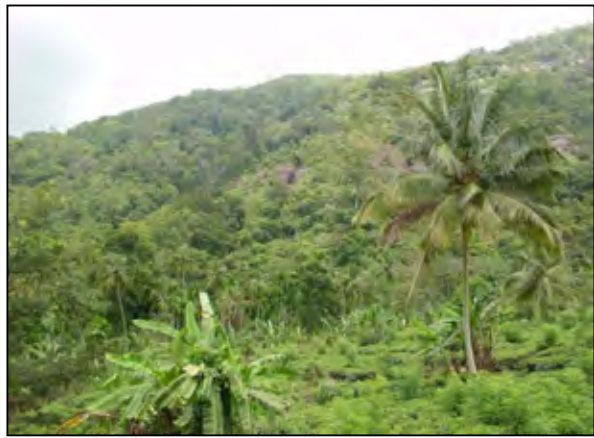
an overall view of landslide slope

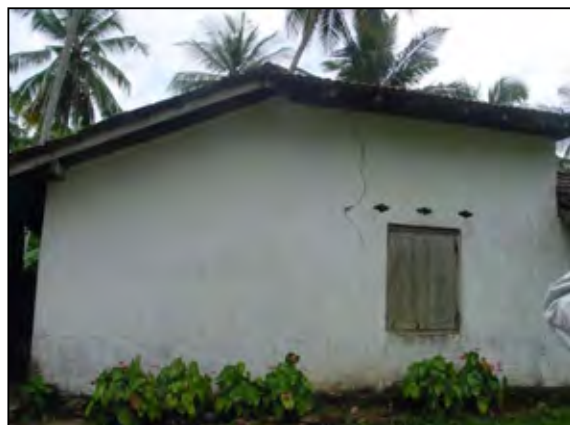
crack on the wall

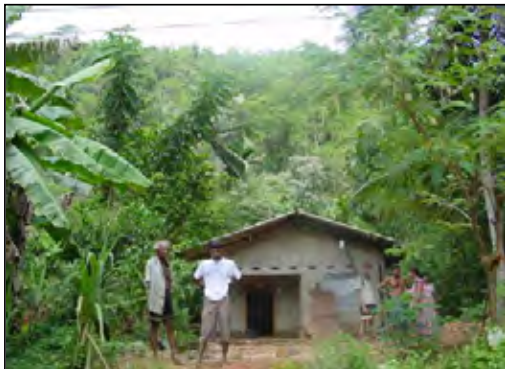
steep slope and torrent

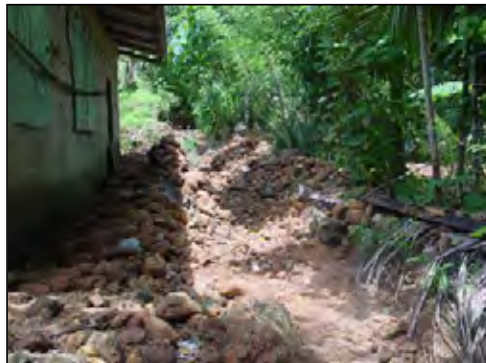
debris flow deposits

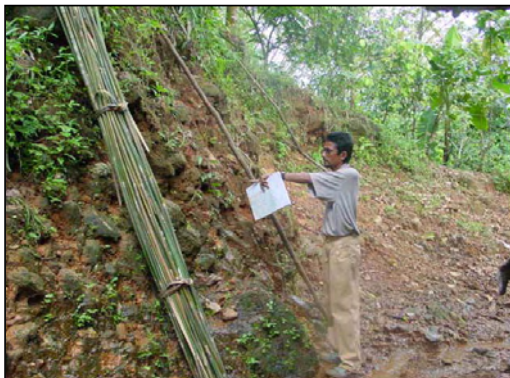
alluvial cone deposit behind house

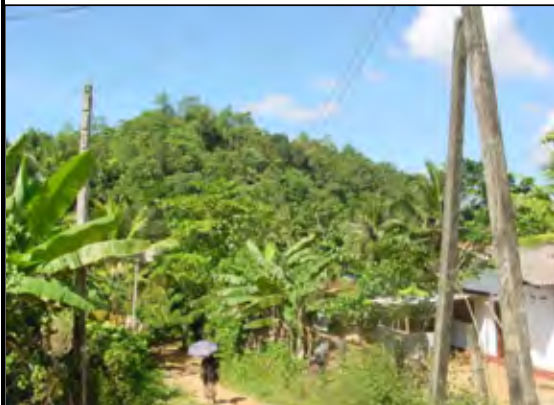
landslide prone slope

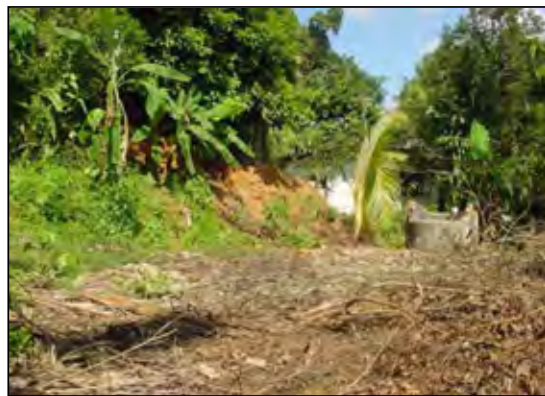
ruin of evacuee's house

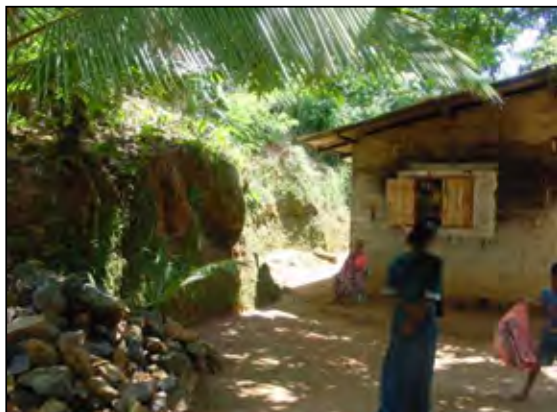
cutting slope behind the house
