付録-6 橋梁目視調査票

Inspection sheet of visual survey

Bridge No. 1

Bridge name		Patum Thani Bridge		Route name		3110, 346		Authority		DOH		Code of authority		-		
Place		from Amphue Lat Lun Kaeo		Distance		from km+ 0						No.		-		
		to Amphoe Mueang Pathum Thani				to km+ 0						Survey date		2009/10/28		
Bridge properties	Bridge type(1)	main road · side road · ramp														
	Bridge type(2)	bridge · viaduct · plank pass														
	Bridge type(3)	4-span continuous PC box girder														
	Total length	240.00 (m)														
	Span	47 + 73 + 73 + 47 (m)														
	Nos. of span	4 span														
	Width	32.21 (m) / 10.6-original (m)														
	Completion	1984 original, 2006 additional														
Road information	Horizontal	Straight · incli ($\theta = 1.5^\circ$) · Curve (R m)														
	Gradient	One way (\nearrow · \searrow) parabo (\square · \square)														
	Nearby tunnel	yes · no (m)														
	Nearby crossing	yes · no (m)

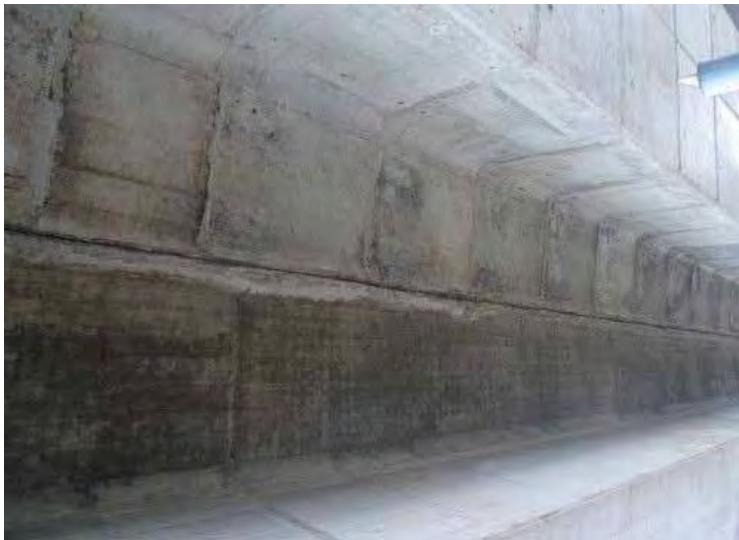
Picture No.	4
	Span	1
	Member	Longitudinal joint
	Longitudinal joint between girder	
	Leakage from joint

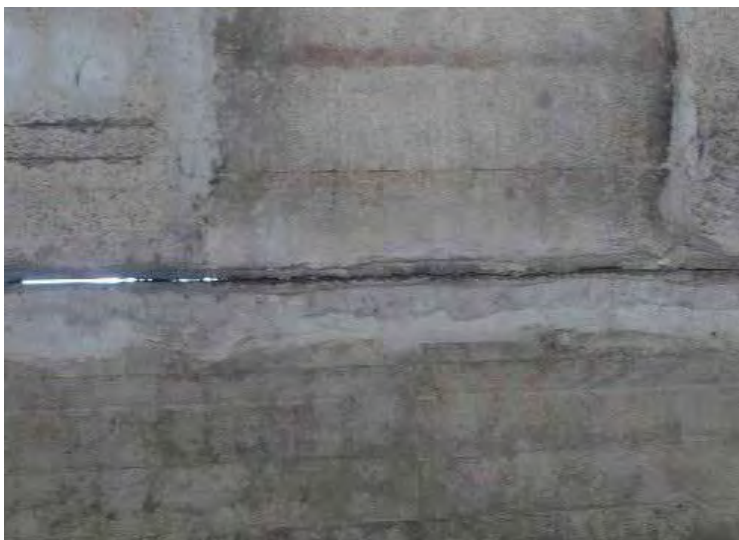
Picture No.	5
	Span	1
	Member	Longitudinal joint
	Longitudinal joint between girder	
	Exfoliation of concrete

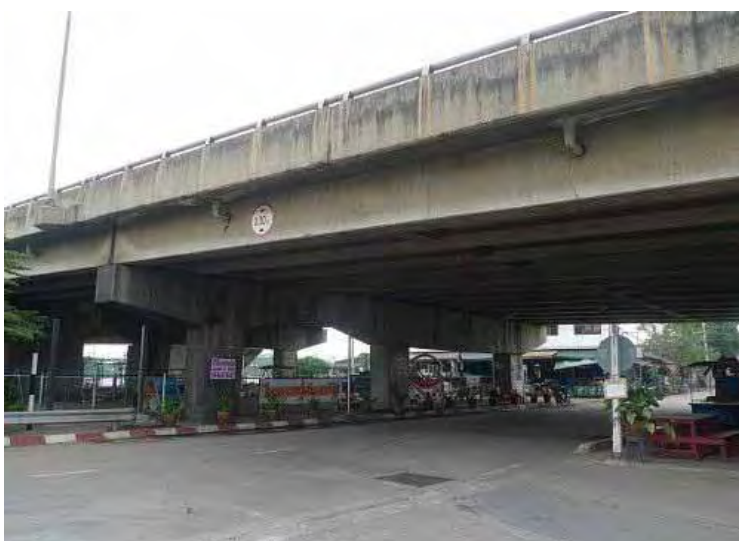
Picture No.	6
	Span	1
	Member	Approach bridge
	Limit of vehicle height, 3.5m

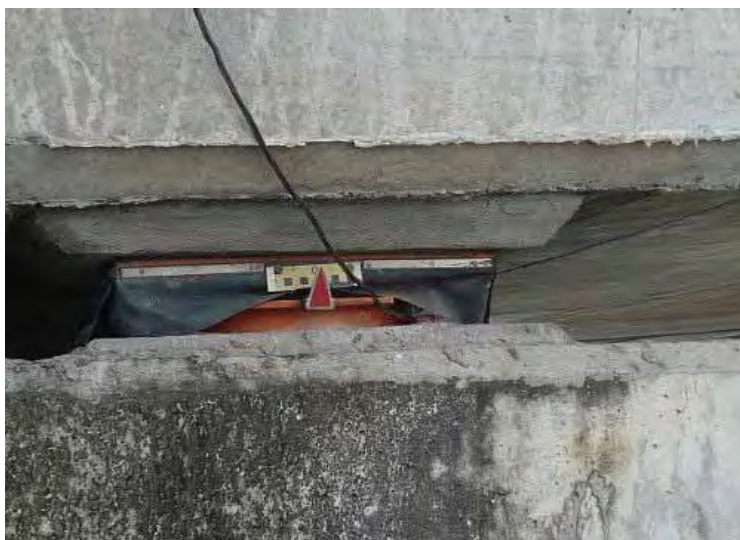
Picture No.	11
Span	1
Member	bearing
Spacing of side block	
<i>*Survey on board, 31-oct</i>

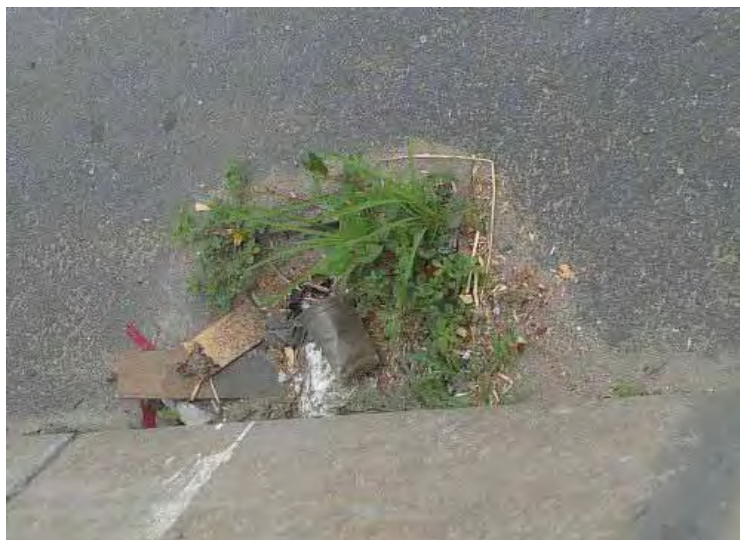
Picture No.	8
Span	1
Member	Catch basin
Blocking of catch basin

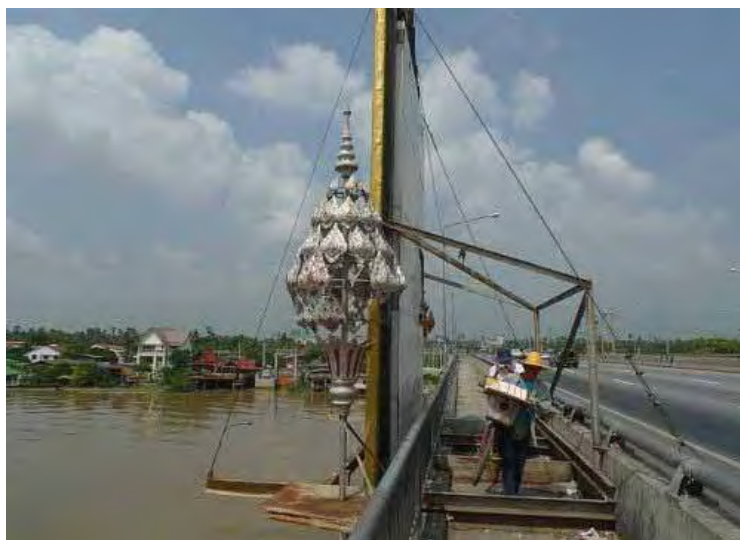
Picture No.	9
Span	1
Member	Walkway
Obstacle of bicycle

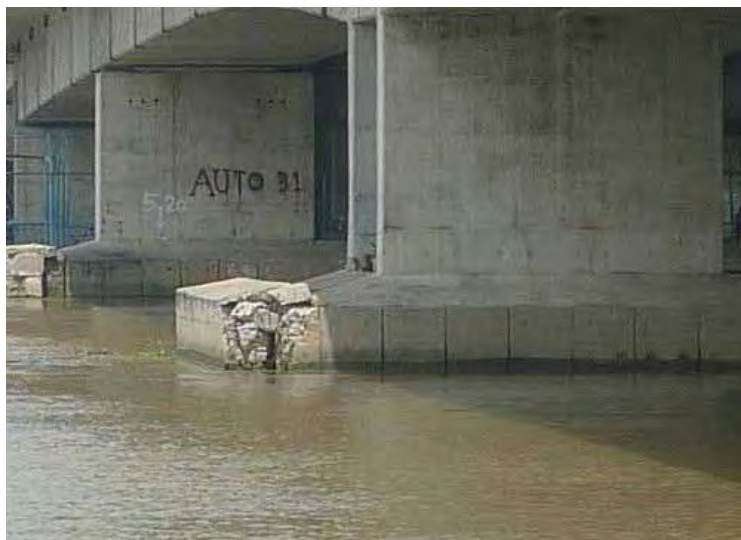
Picture No.	11
Span	1
Member	Footing
Ship collision to protection

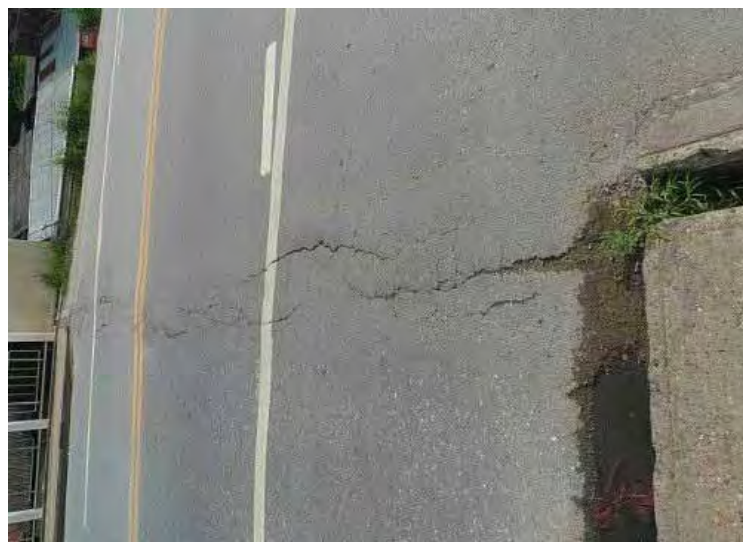
Picture No.	6
Span	1
Member	Expansion joint

Expansion joint was filled by asphalt

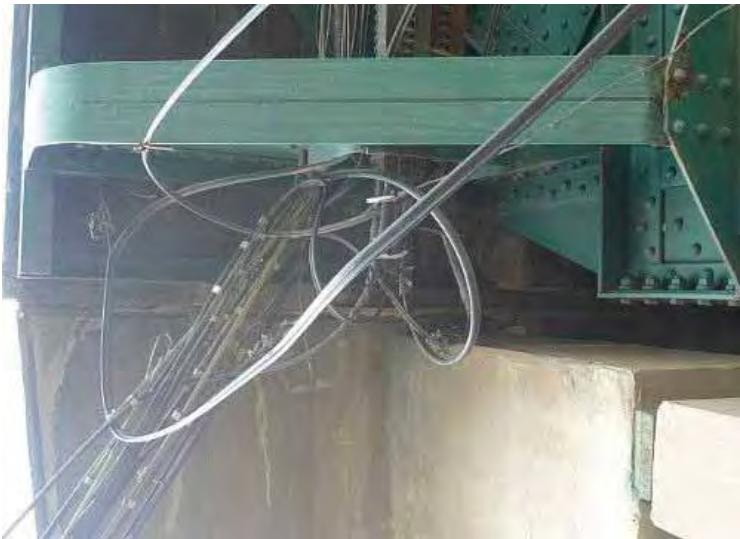
Picture No.	7
	Span	1
	Member	Expansion joint
	Leakage from expansion joint

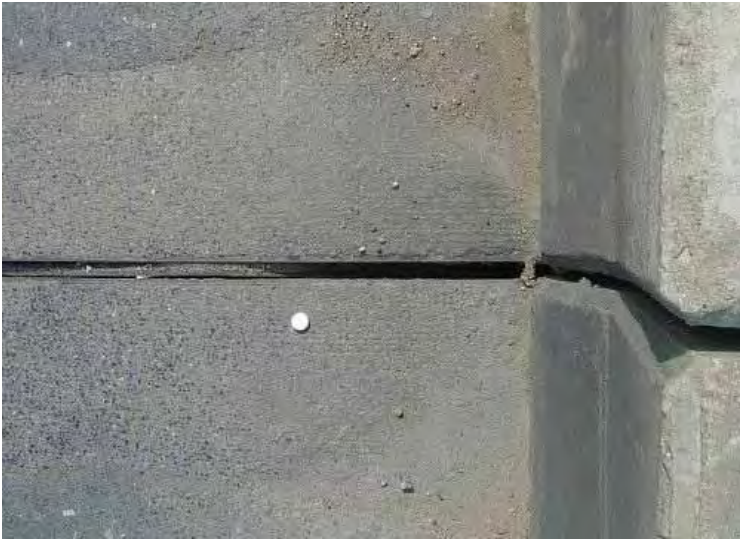
Picture No.	9
	Span	1
	Member	
	Lack of rubber at end	
	Thon Buri side

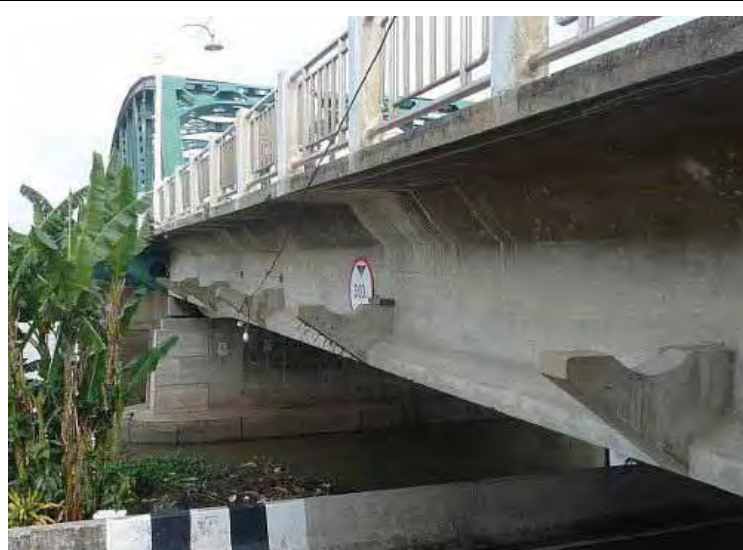
Picture No.	10
Span	1
Member	Water supply
Water supply was removed	
Limit of vehicle height, 3.0m

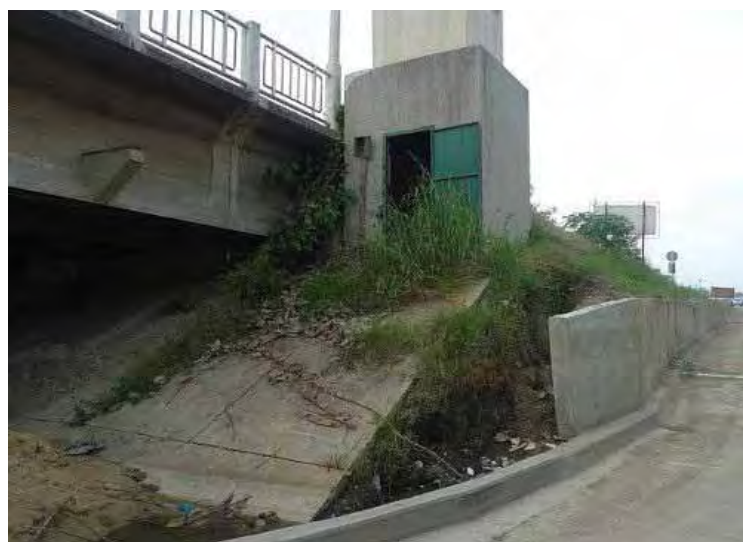
Picture No.	12
Span	1
Member	Newel
Opening of door	
Erosion of abutment

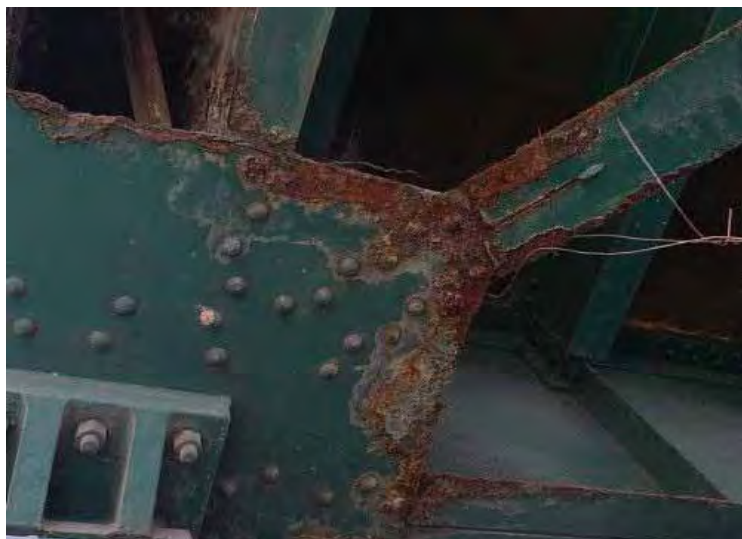
Picture No.	9
	Span	1
	Member	Approach bridge
	Corrosion on bearing	
	Deterioration of corrosion proofing

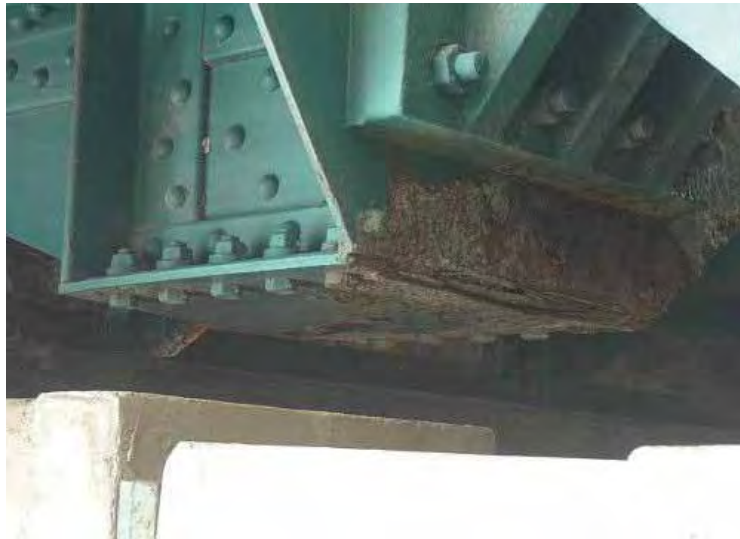
Picture No.	10
Span	1
Member	Bearing
Expansion of steel by corrosion	
Deterioration of corrosion proofing

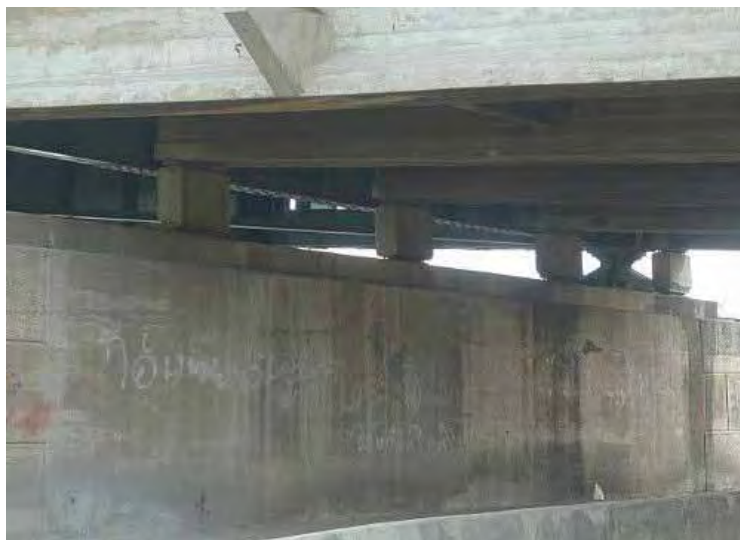
Picture No.	11
Span	1
Member	Bearing
Inclination of locker bearing of Approach bridge

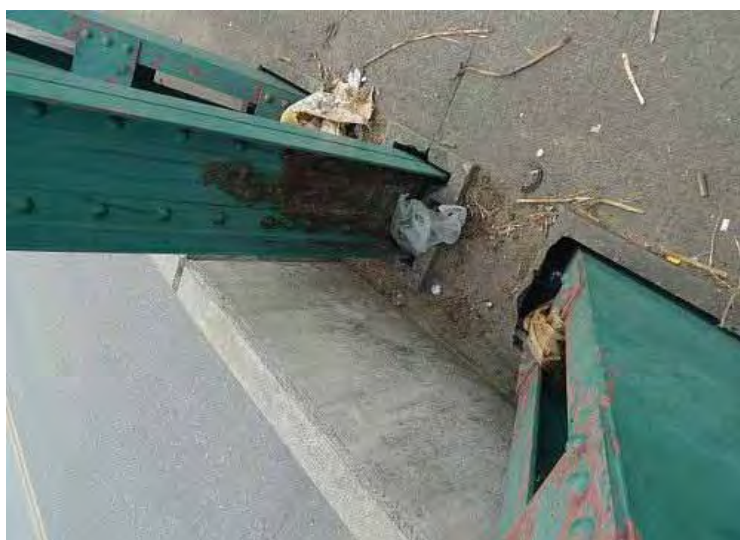
Picture No.	12
Span	1
Member	Vertical member
Gap between steel and slab	
Mount up around steel member	
It's good countermeasure for corrosion proofing by water

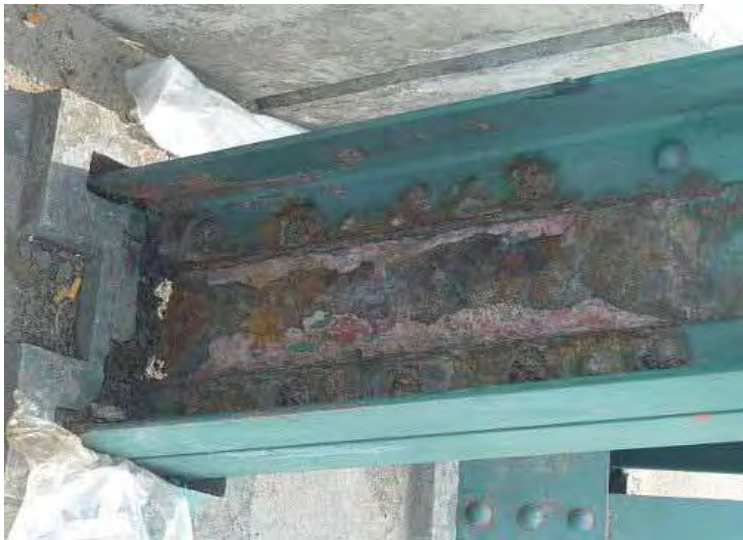
Picture No.	13
	Span	1
	Member	Vertical member
	Remarkable reducing of thickness of plate	
	Opening at bottom end

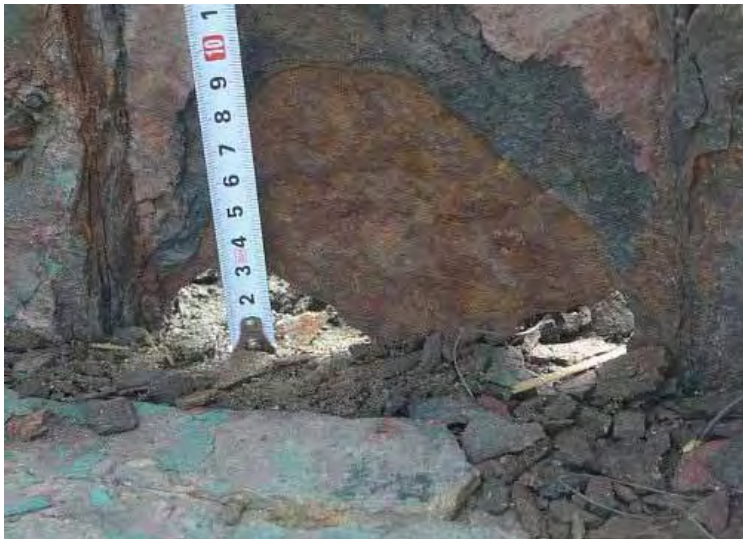
Picture No.	14
	Span	1
	Member	Vertical member
	Enlarged photo	
	Opening at bottom end

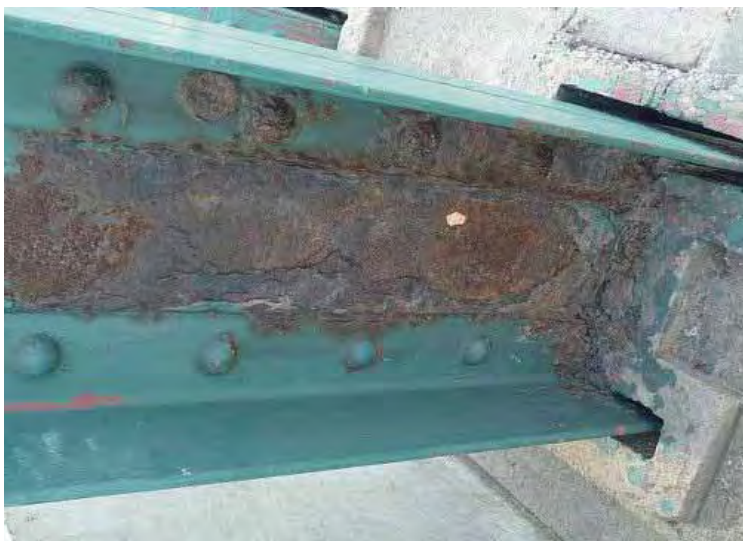
Picture No.	15
	Span	1
	Member	Vertical member
	Remarkable reducing of thickness of plate	
	Hole position is higher than contact section with concrete

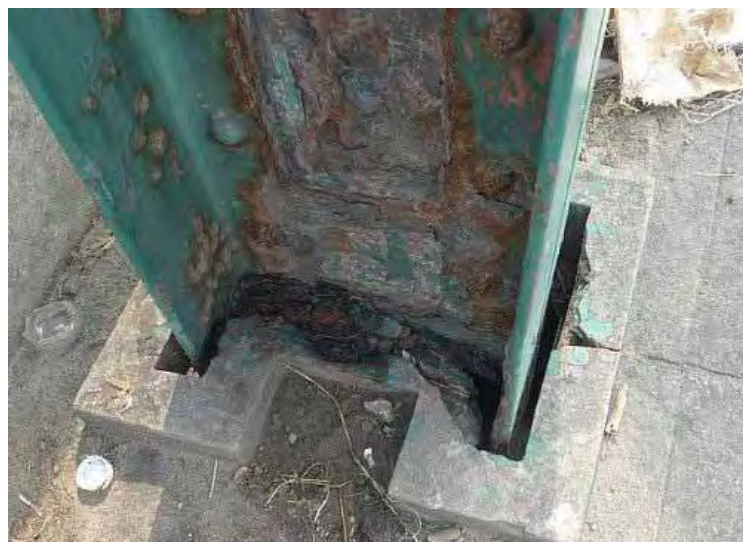
Picture No.	16
Span	1
Member	Bearing
Remarkable reducing of thickness of plate

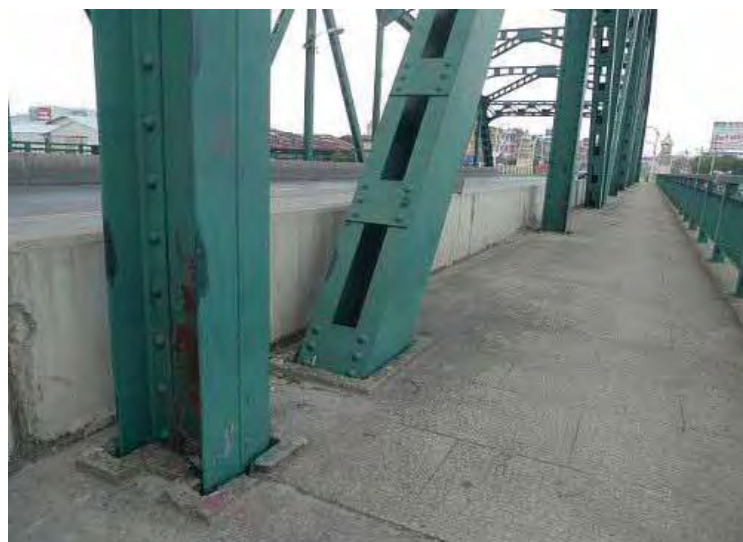
Picture No.	17
Span	1
Member	Vertical member
Proceeding of corrosion is different between each member

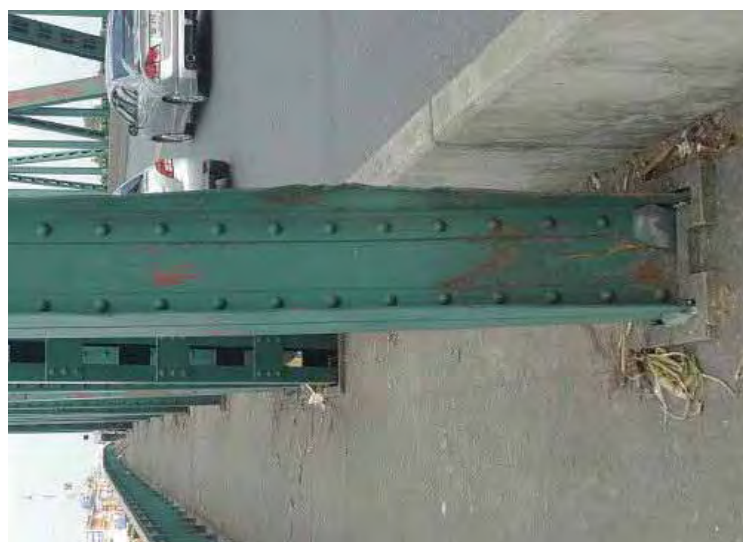
Picture No.	18
Span	1
Member	Vertical member
Deformation by vehicle collision

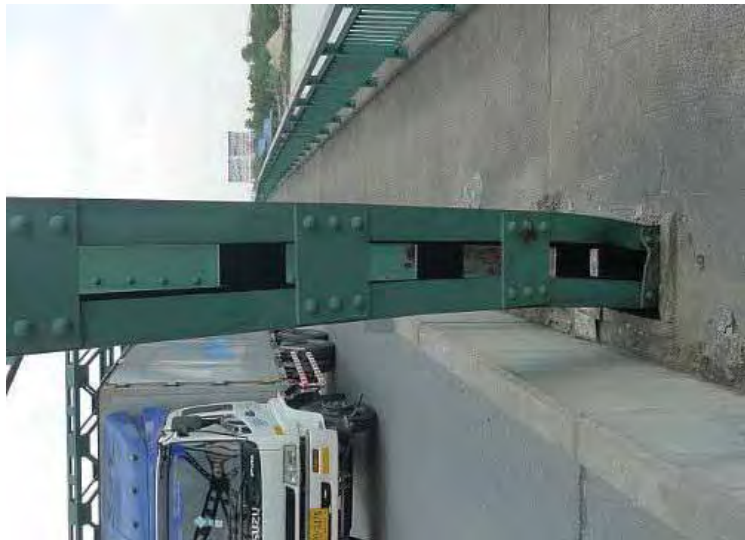
Picture No.	19
Span	1
Member	Vertical member
Deformation by vehicle collision

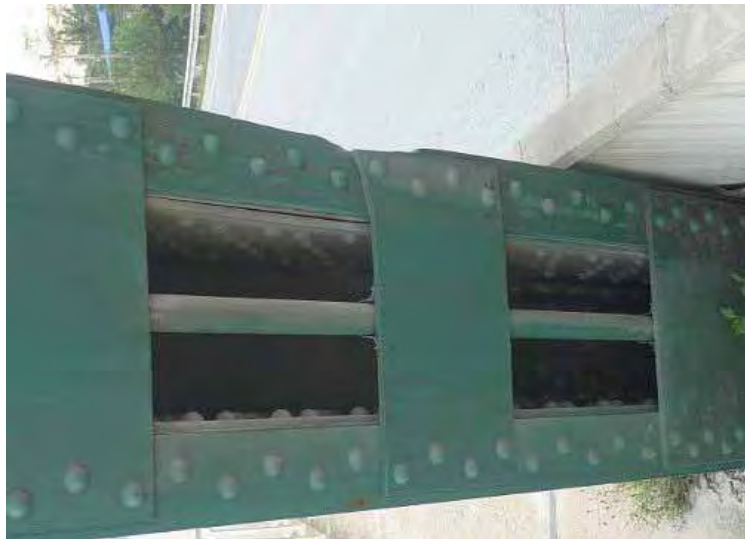
Picture No.	20
Span	1
Member	Bracket
Deformation by vehicle collision

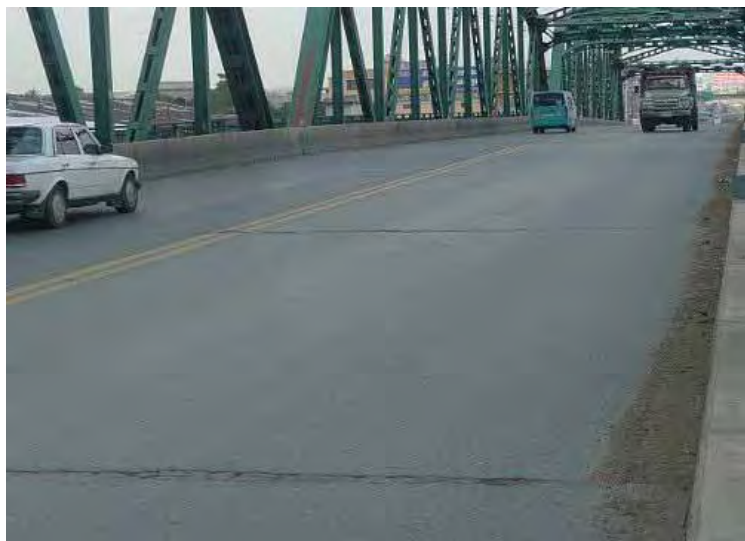
Picture No.	21
Span	1
Member	Pavement
Breaking of pavement on cross beam

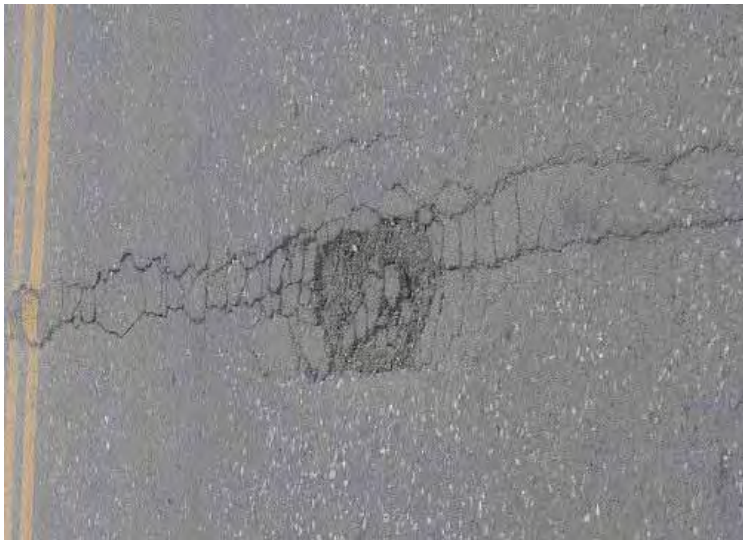
Picture No.	22
	Span	1
	Member	Pavement
	Breaking of pavement on cross beam	
	Severe leakage is found on bottom slab.	
	It is estimated that this breaking go through slab.

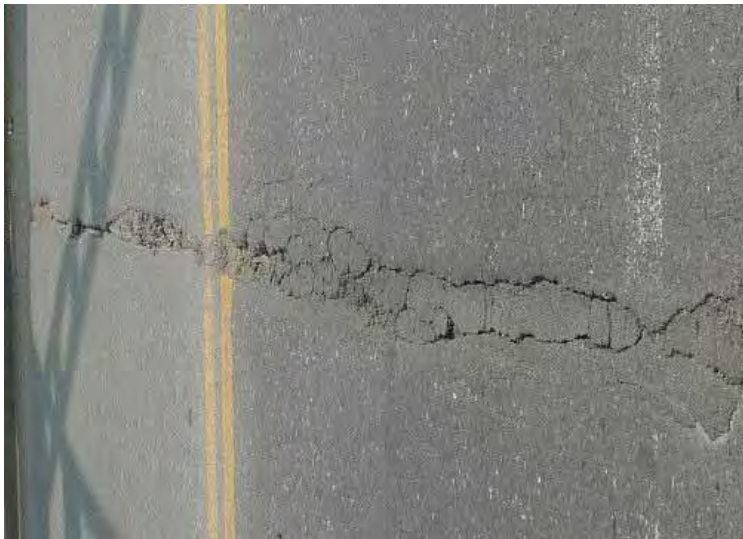
Picture No.	23
	Span	1
	Member	Pavement
	Breaking of pavement on cross beam

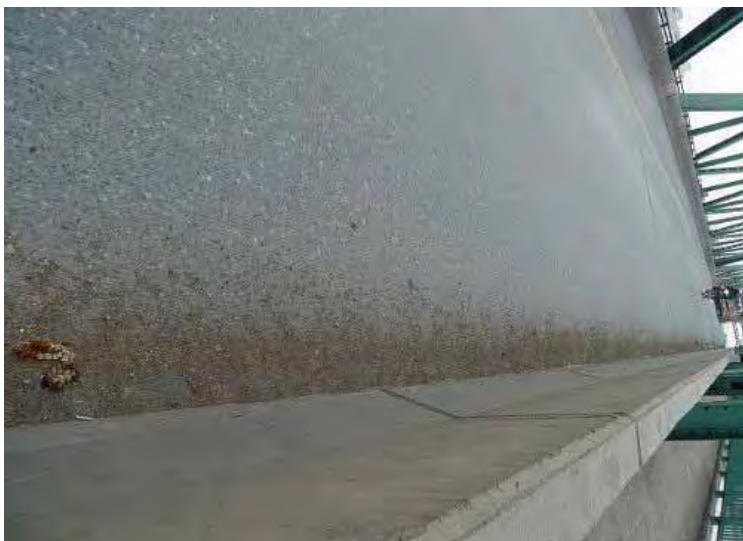
Picture No.	24
	Span	1
	Member	Drainage
	Catch basin may exist under barrier	
	Deterioration of drain function

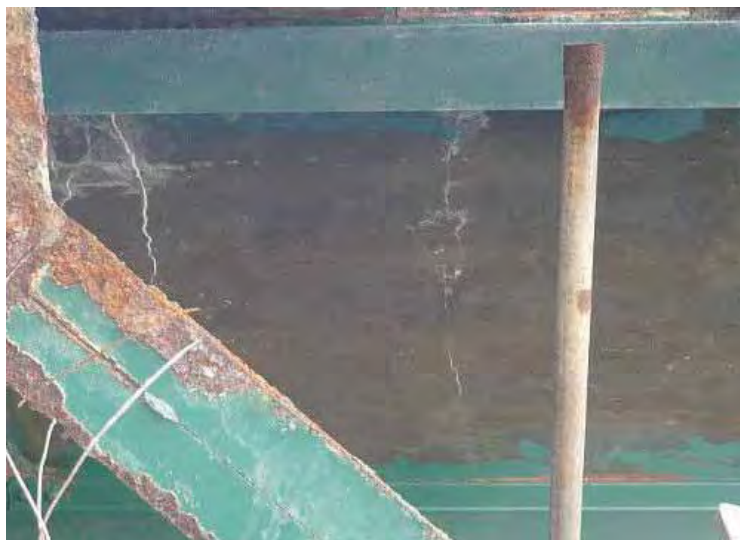
Picture No.	26
Span	1
Member	slab
Crack	
Free lime

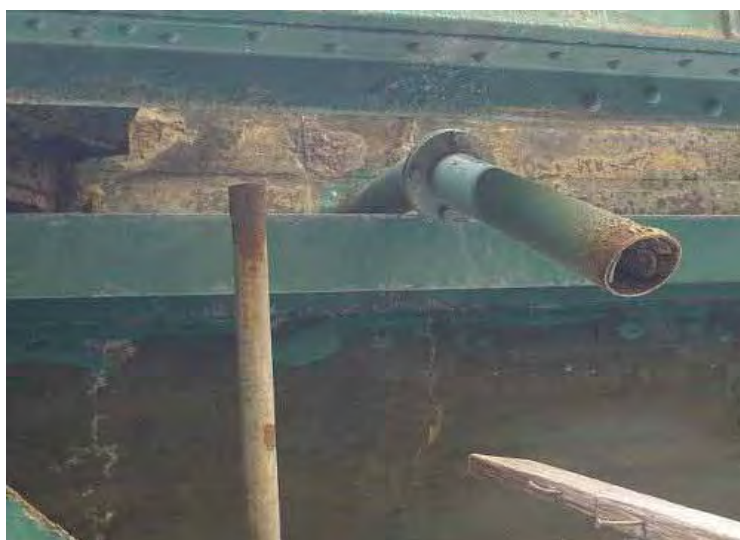
Picture No.	27
Span	1
Member	Slab
Deterioration of corrosion proofi	
Fracture of concrete surface	
Free lime

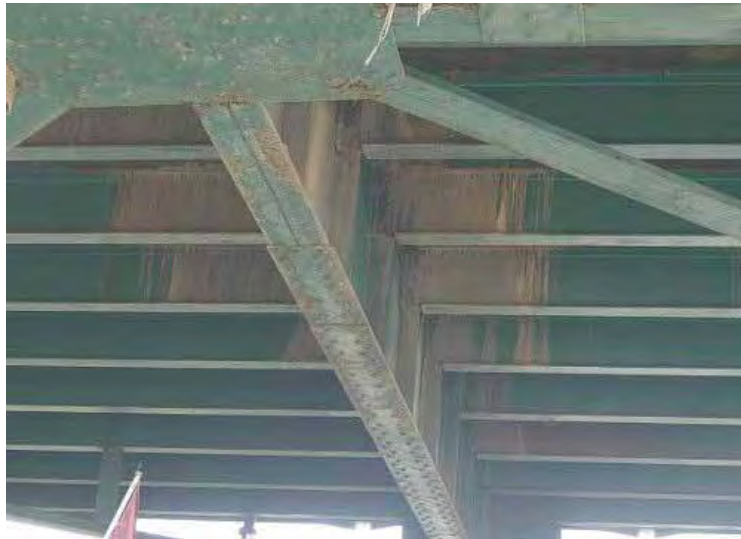
Picture No.	28
Span	1
Member	Slab
Leakage from slab on cross beam

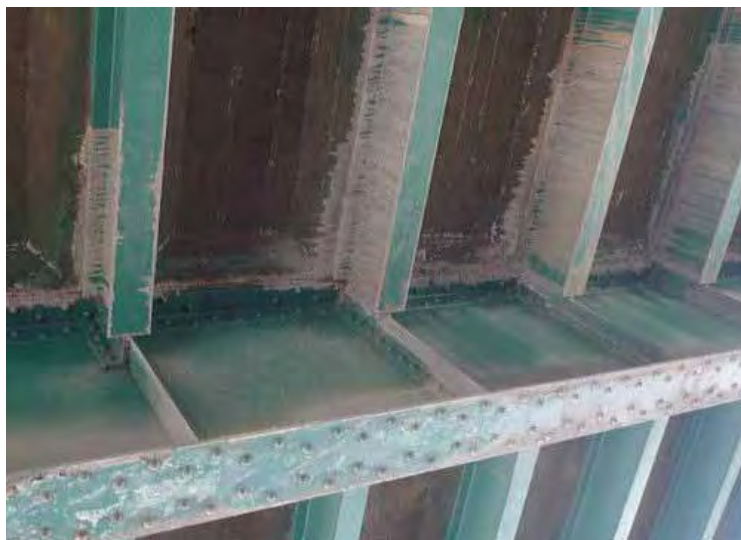
Picture No.	29
Span	1
Member	Slab
Leakage from slab on cross beam

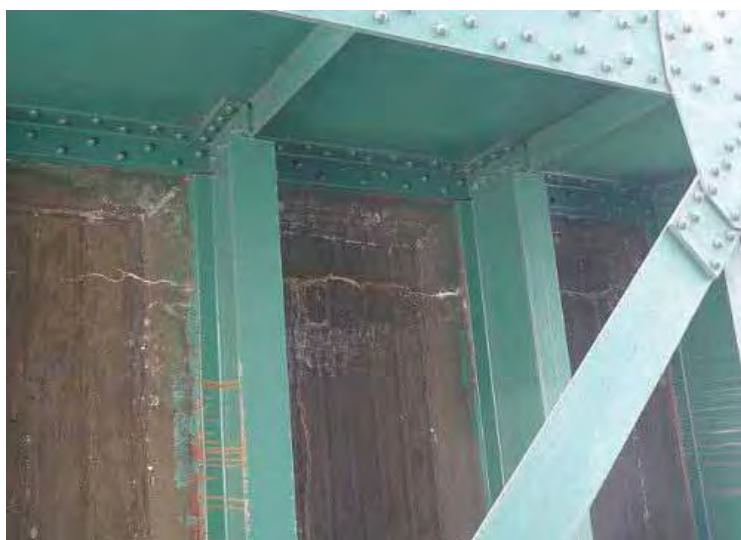
Picture No.	30
Span	1
Member	slab
Crack	
Free lime

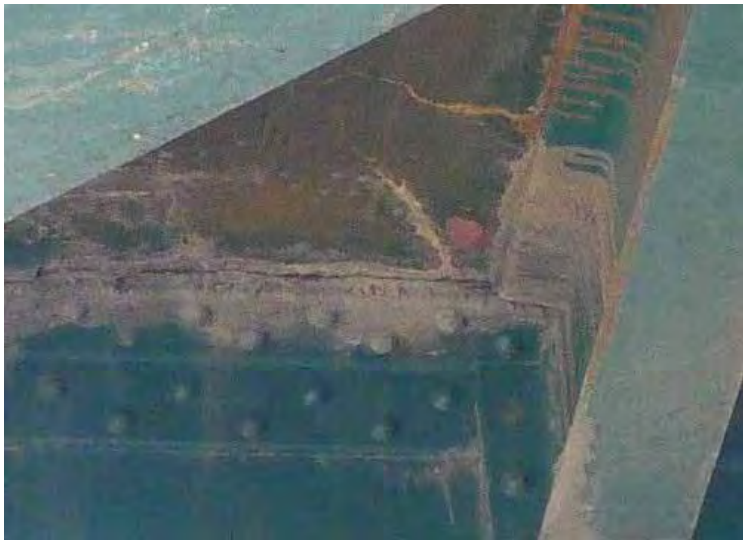
Picture No.	31
	Span	1
	Member	Slab
	Leakage from slab on cross beam	
	Crack, free lime	
	Concrete slab was changed to dirt	
	<i>*Survey on board, 31-oct</i>

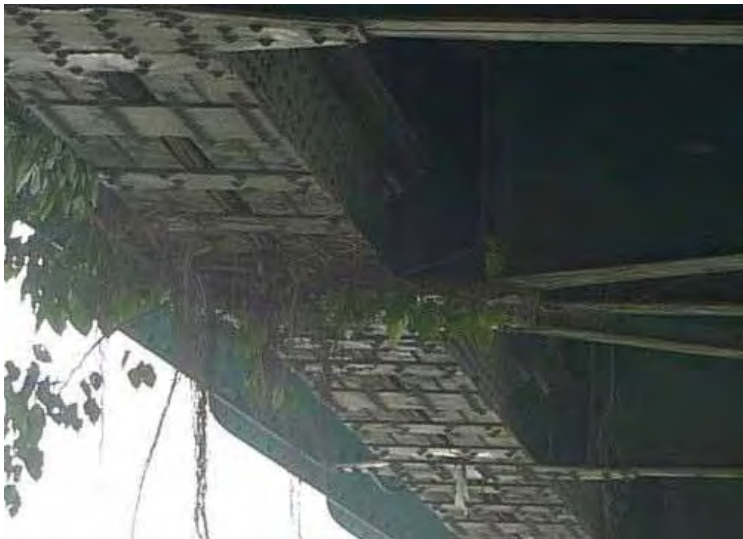
Picture No.
Span		1
Member		slab
Plant		
Possibility of soil dump

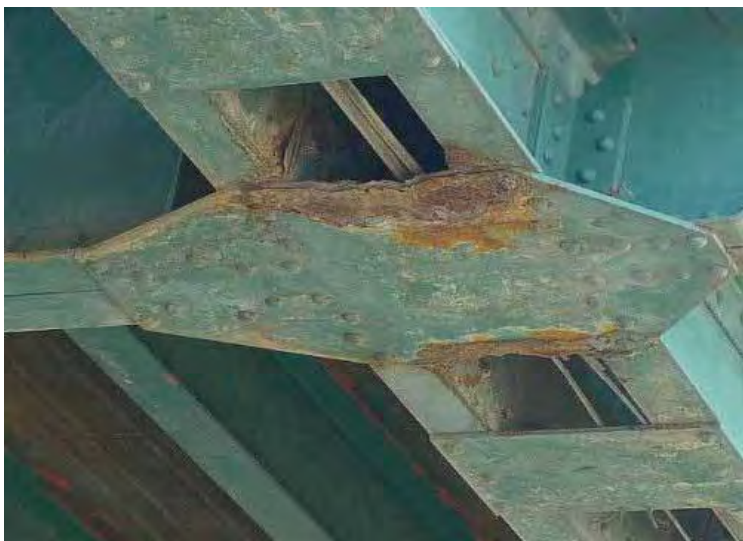
Picture No.
	Span	1
	Member	Slab
	Reduce of thickness by corrosion	
	<i>*Survey on board, 31-oct</i>

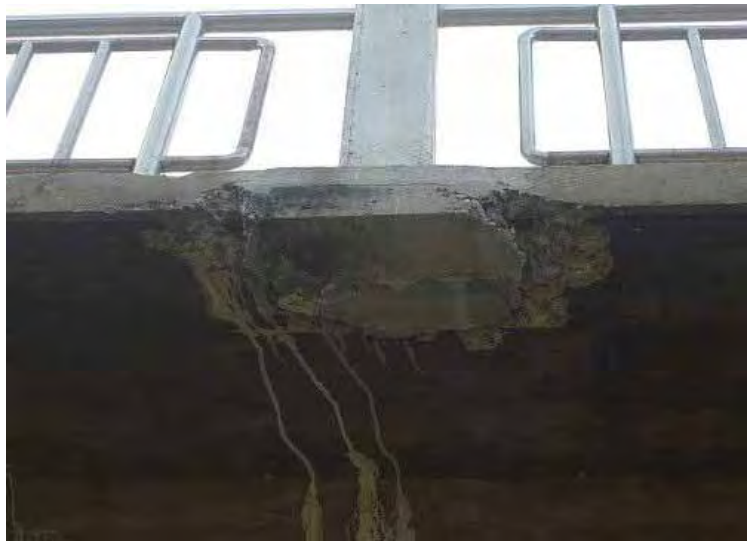
Picture No.	34
Span	1
Member	Approach bridge
コンクリートの剥離と補修

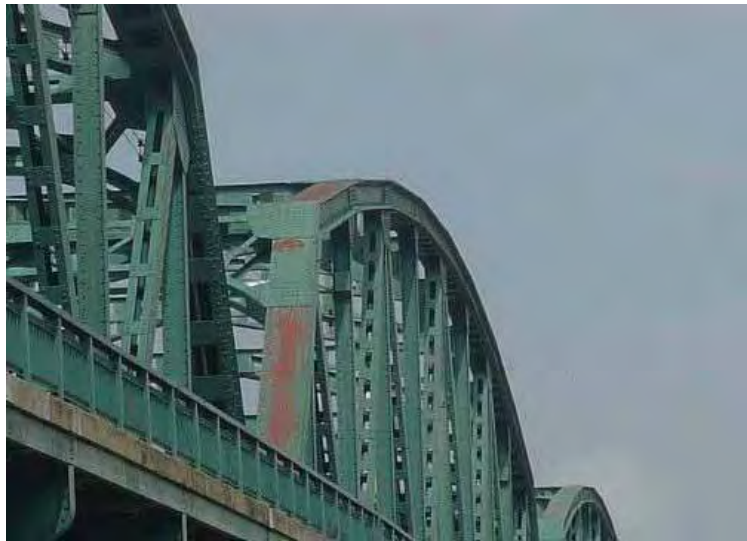
Picture No.	35
Span	1
Member	Chord member
防蝕性能の劣化

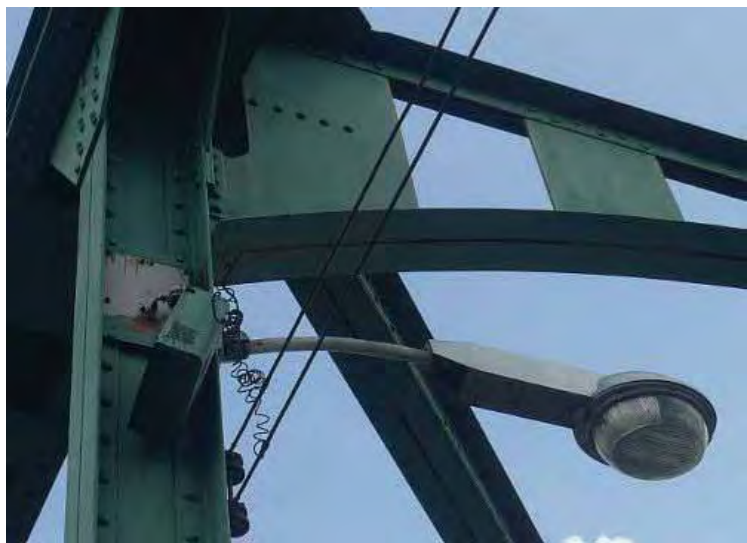
Picture No.	36
Span	1
Member	Lighting pole
破損

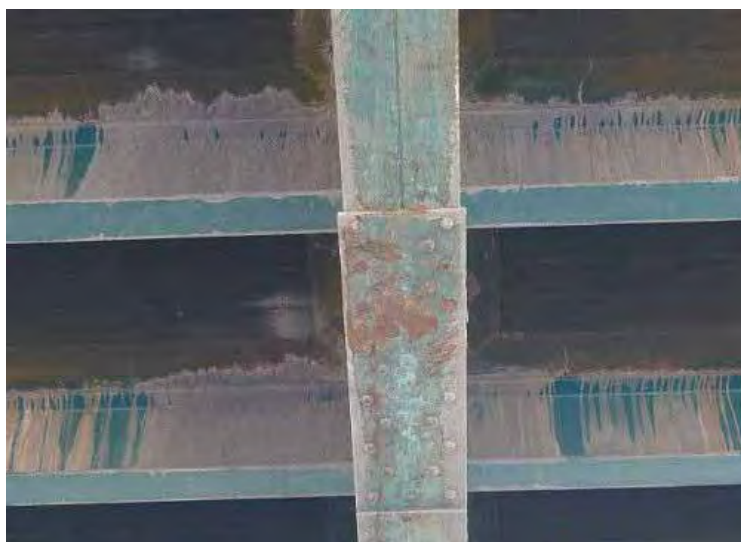
Picture No.	38
Span	1
Member	Transverse beam
Corrosion and fall of rivet	
<i>*Survey on board, 31-oct</i>

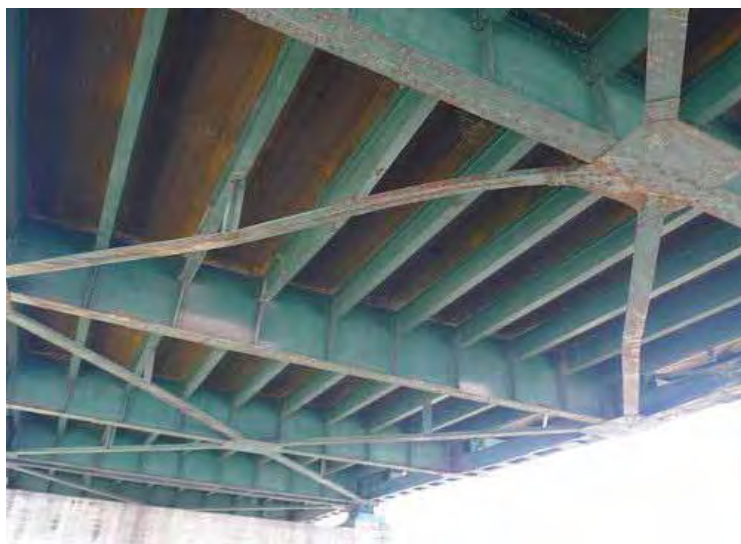
Picture No.	39
Span	1
Member	Cross frame
Deformation by ship collision	
2nd span from Bangkok side	
<i>*Survey on board, 31-oct</i>

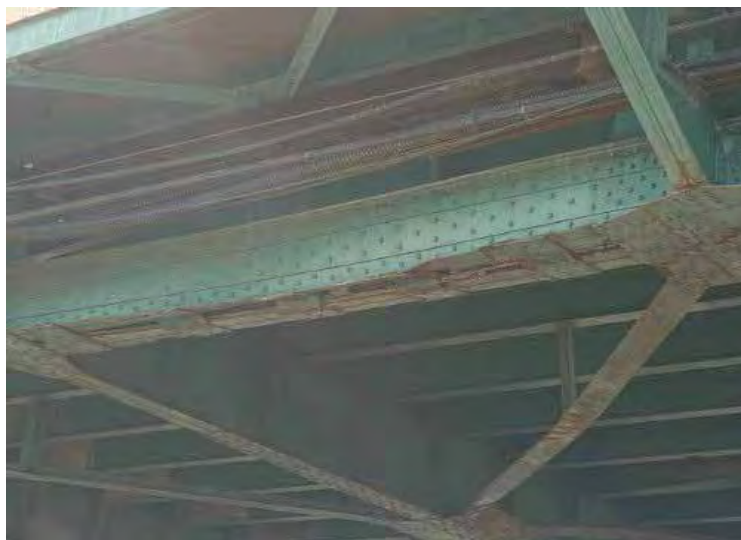
Picture No.	41
Span	1
Member	Bottom chord
Deformation by ship collision	
<i>*Survey on board, 31-oct</i>

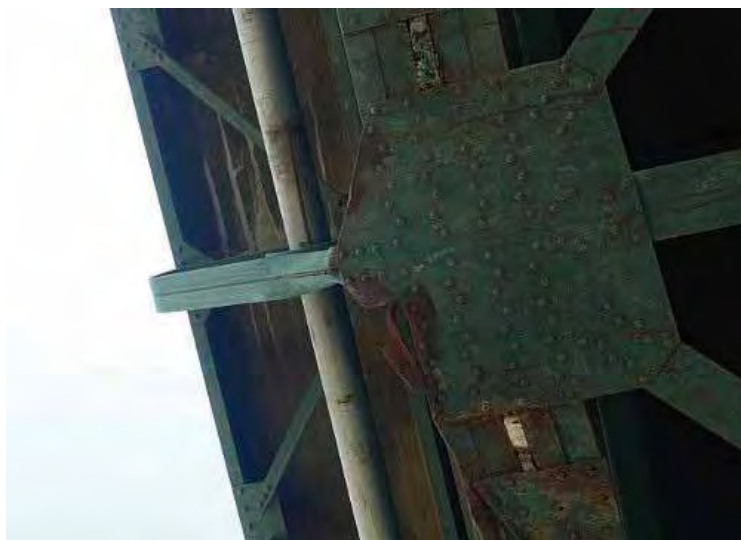
Picture No.	42
Span	1
Member	Bottom chord
Deformation by ship collision	
<i>*Survey on board, 31-oct</i>

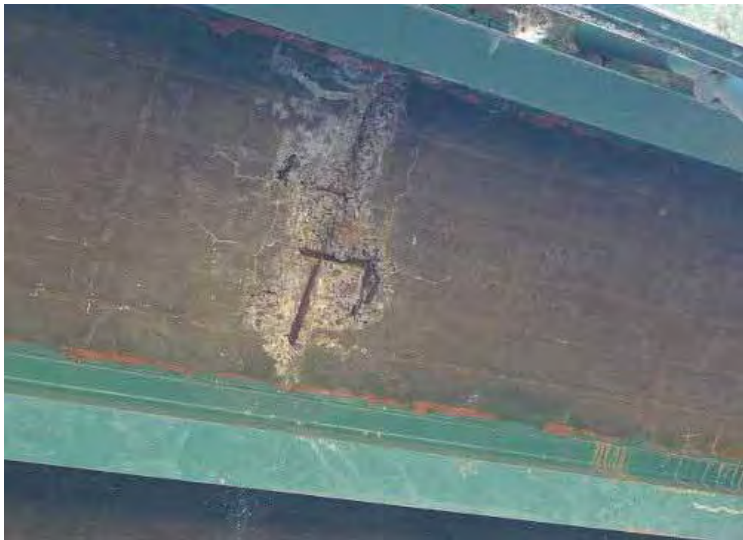
Picture No.	43	
	Span	1	
	Member	Slab	
	Fracture of concrete surface		
	Rock pocket		
	Crack		
	<i>*Survey on board, 31-oct</i>		
		Picture No.	44
		Span	1
Member			
<i>*Survey on board, 31-oct</i>			
		Picture No.	45
		Span	1
	Member

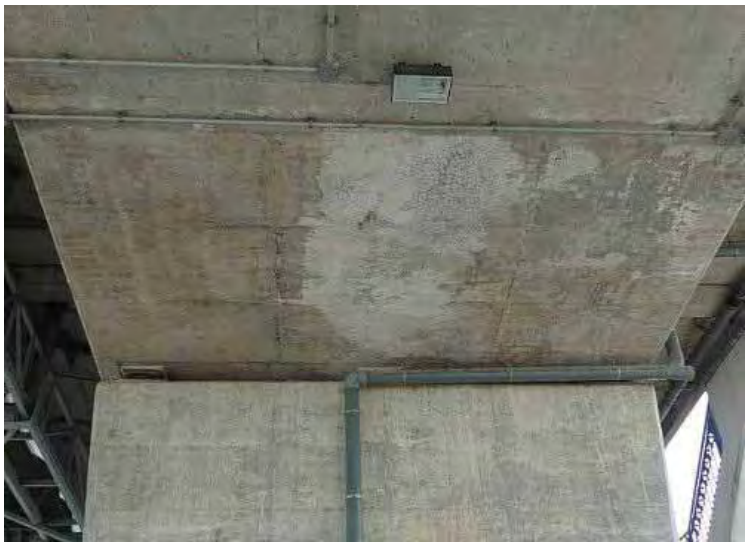
Picture No.	5
	Span	1
	Member	Box-girder
	Insufficiency of cover concrete	
	Repairing work was finished

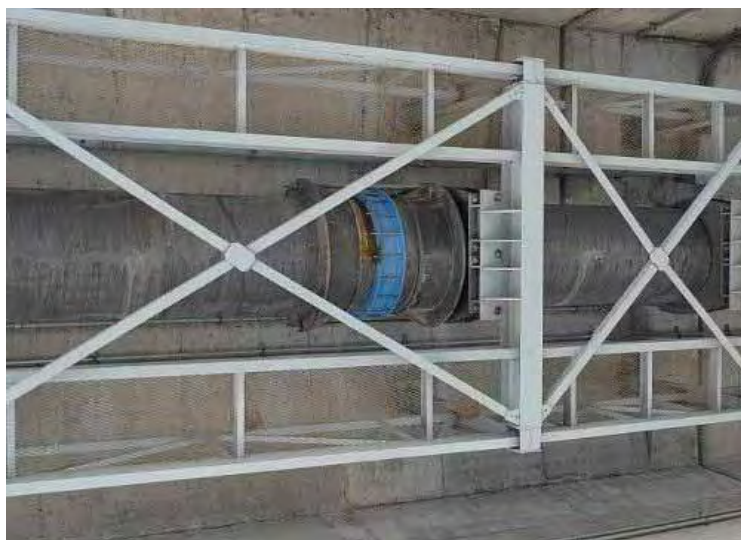
Picture No.	7
Span	1
Member	桁下全景

No expanded metal plate.

It's not suitable for inspection.

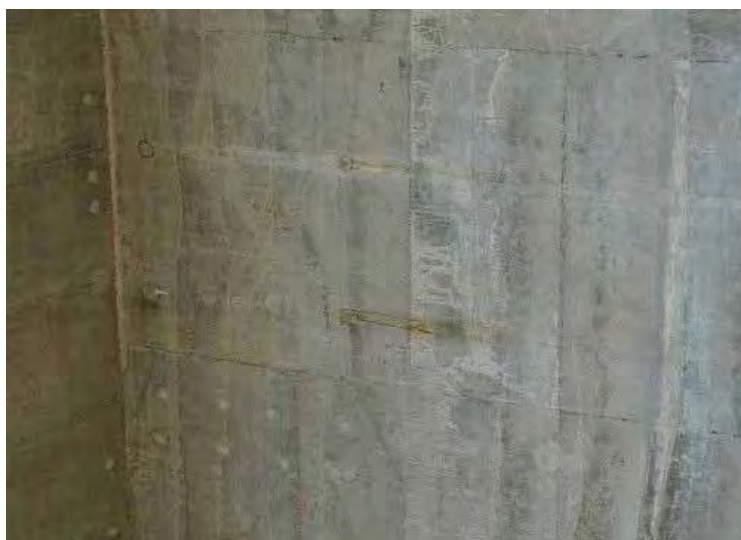
Picture No.	8
Span	1
Member	slab (walkway, roadway)

Ooze out of rust

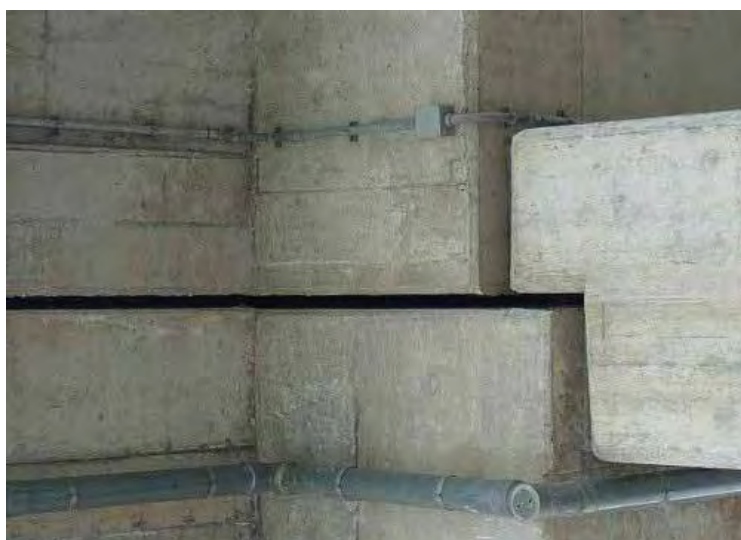
Picture No.	9
Span	1
Member	Bearing

Drainage function of joint is good.

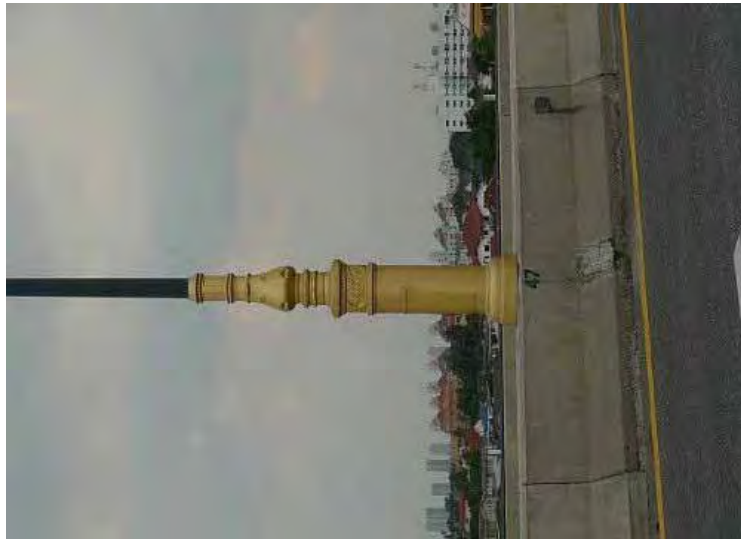
Picture No.	10
Span	1
Member	Lighting pole
Mark of filling concrete at bottom of lighting pole	
Possibility of fracturing in future

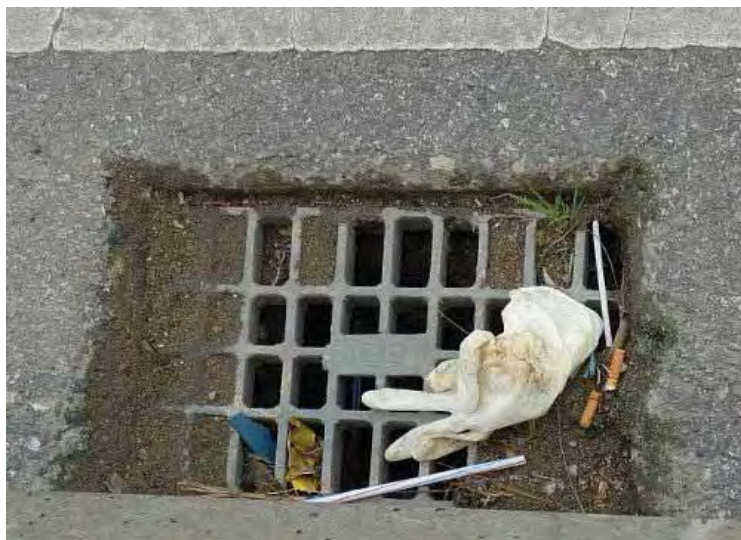
Picture No.	11
Span	1
Member	Catch basin
Partly blocked

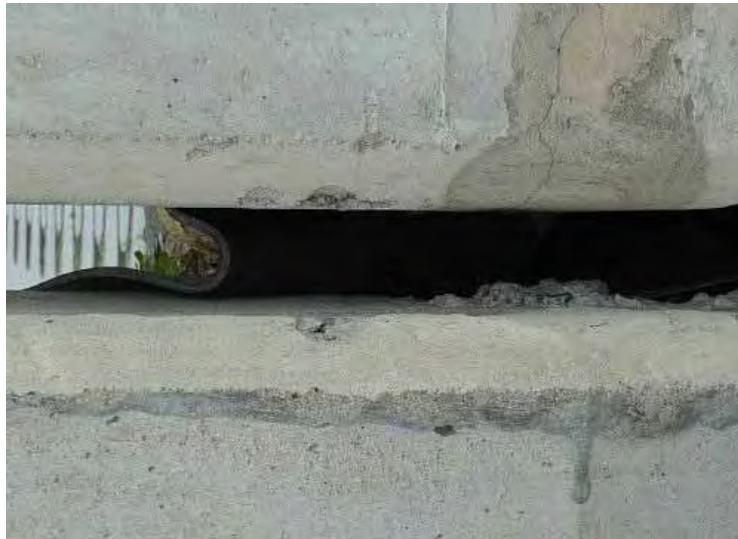
Picture No.	13
Span	1
Member	Barrier
Crack.	
Repariring material with permeability?

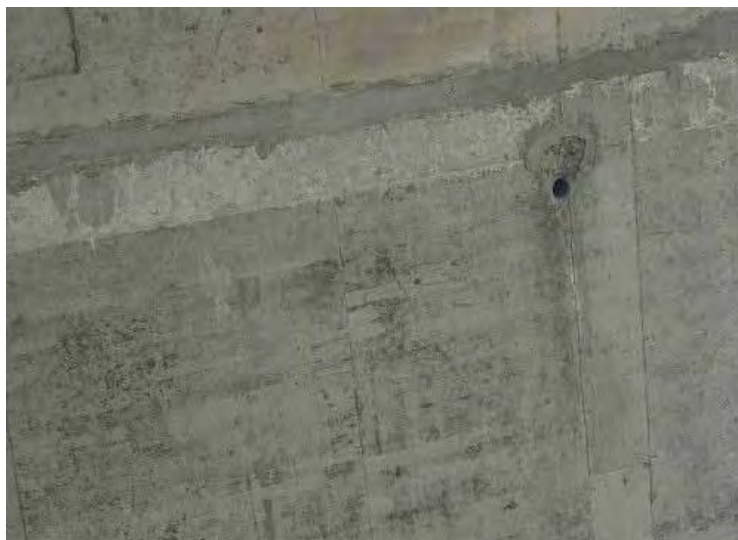
Picture No.	14
Span	1
Member	
Chipped concrete around drainage	
<i>*Survey on board, 31-oct</i>

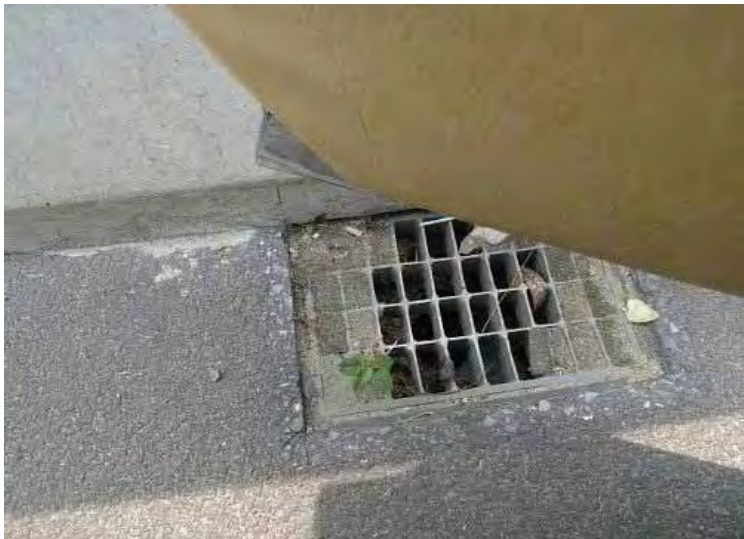
Picture No.	7
	Span	1
	Member	Drainage
	Partly blocked	
	Picture No.	8
	Span	1
	Member	
	Picture No.	9
	Span	1
	Member	
	Thon Buri side
