# Inspection sheet of visual survey

Bridge No. 6

Bridge name		Pra Nangklao Bridge		Route name		-		Authority		DOH		Code of authority		-		
Place		from Anphoe Bang Bua Thong		Distance		from km+ 0						No.		-		
		to Anphoe mueang Nonthaburi				to km+ 0						Survey date		24-oct-2009		
Bridge properties	Bridge type(1)	main road · side road · ramp														
	Bridge type(2)	bridge · viaduct · plank pass														
	Bridge type(3)	5-span continuous PC box girder														
	Total length	330.00 (m)														
	Span	51 + 72 + 84 + 72 + 51 (m)														
	Nos. of span	5 span														
	Width	21.80 (m) / (m)														
	Completion	1985														
Road information	Horizontal	Straight · incli ( $\theta = 1.5^\circ$ ) · Curve ( R m )														
	Gradient	One way ( $\nearrow$ · $\searrow$ ) parabo ( $\square$ · $\square$ )														
	Nearby tunnel	yes · no ( m )														
	Nearby crossing	yes · no ( m )														
	Traffic	Much · Medium · Little

Present state ( 1 / 10 )					
Authority	DOH	Address	Bangkok	Data	24-Oct-09
Bridge	Phra NangKlao Bridge

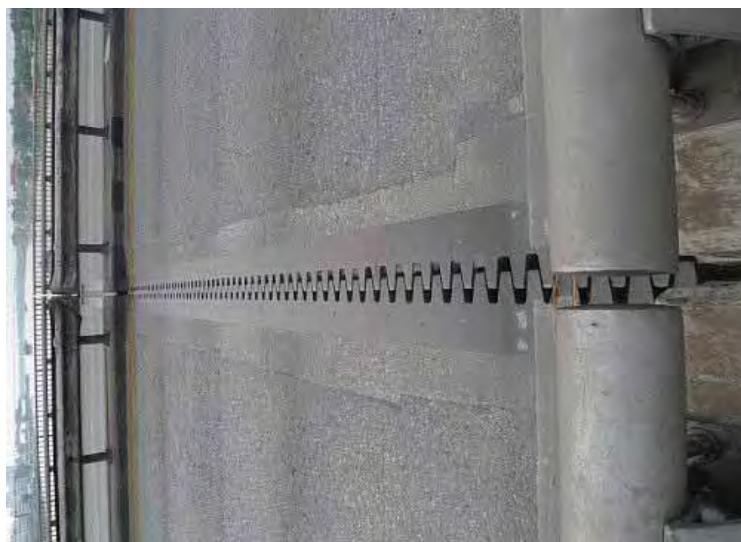
Picture No.	4
Span	1
Member	Hinge
Joint on hinge part	
Vertical movement independently especially in upstream girder

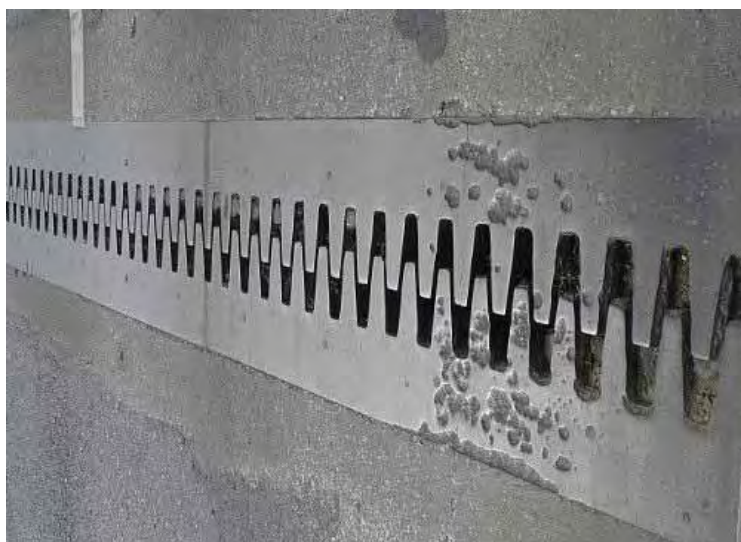
Picture No.	5
Span	1
Member	Expansion joint
Spacing is widen	
Bangkok side

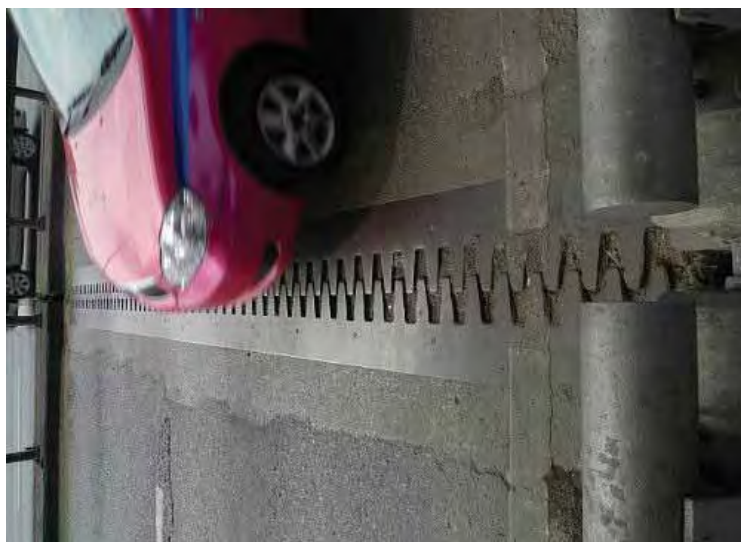
Picture No.	6
Span	1
Member	Expansion joint
Spacing is widen	
Thon Buri side

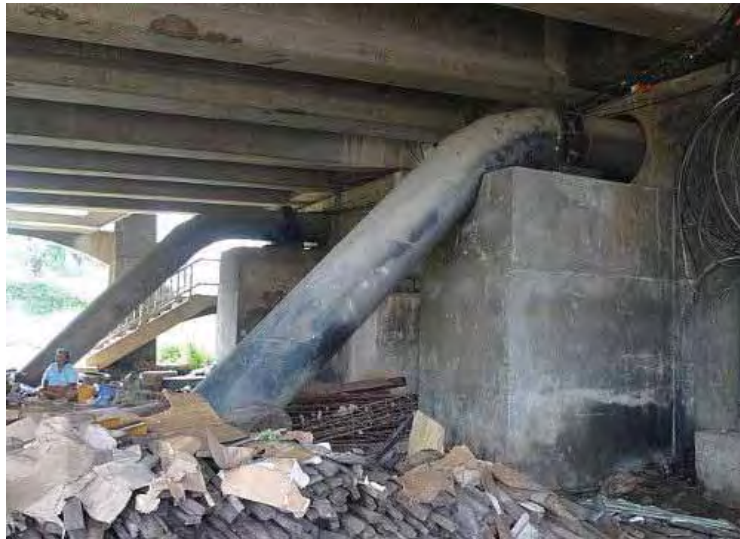
Picture No.	7
Span	1
Member	Water supply
Leakage inside of PC-box girder

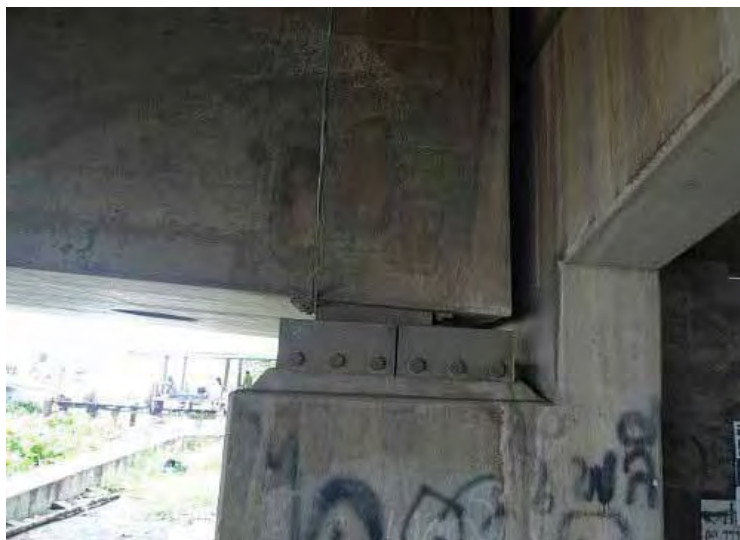
Picture No.	8
Span	1
Member	Bearing
Movement of girder	
Thon Buri side	
effect of shrinkage and creep

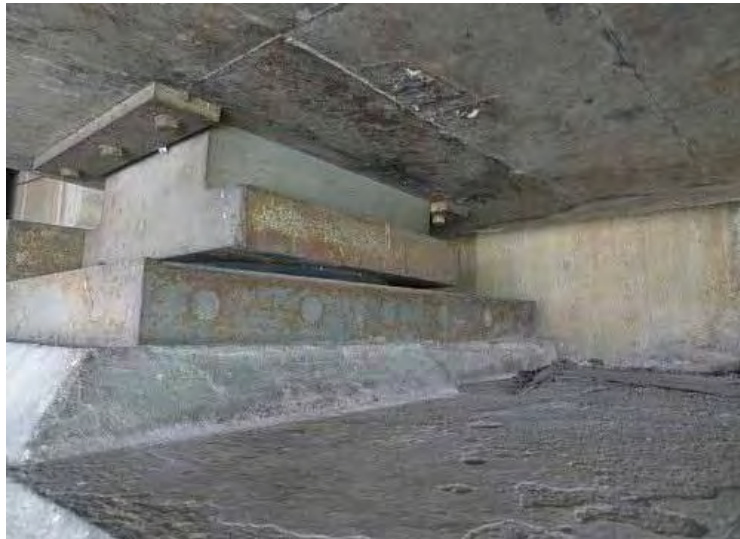
Picture No.	10
Span	1
Member	Bearing
Deterioration of corrosion proofi

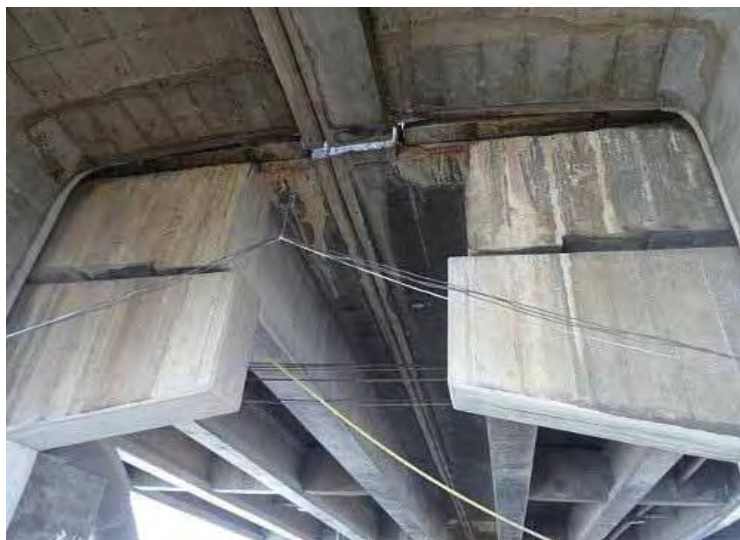
Picture No.	11
Span	1
Member	Expansion joint
Deterioration of drain function	
Leakage from medium

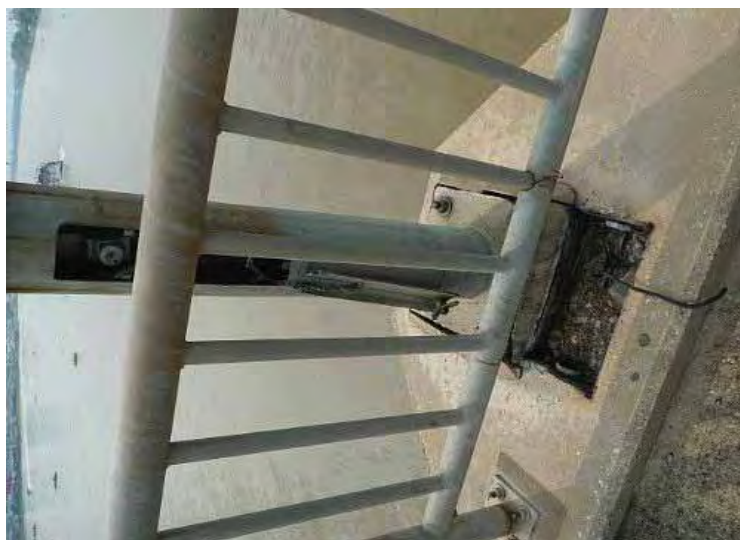
Picture No.	12
Span	1
Member	Lighting pole
Damaged

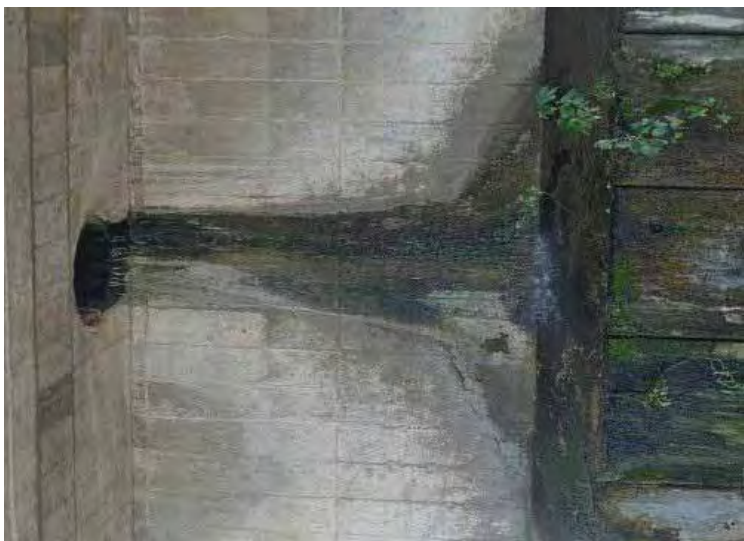
Picture No.	18
	Span	1
	Member	Water supply
	Much water from manhole due to leakage of water supply	
	<i>*Survey on board, 31-oct</i>

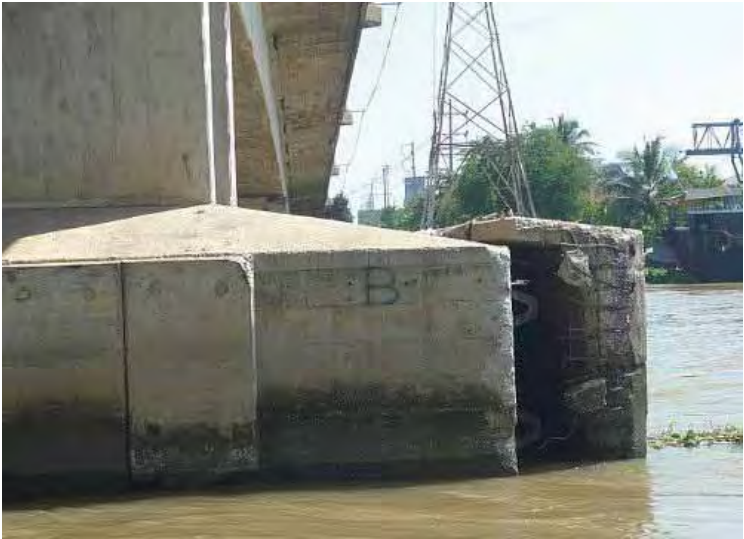
Picture No.	10
	Span	1
	Member	Footing
	Breaking and movement	
	<i>*Survey on board, 31-oct</i>	
	Picture No.	11
	Span	1
	Member	
	Picture No.	12
	Span	1
	Member

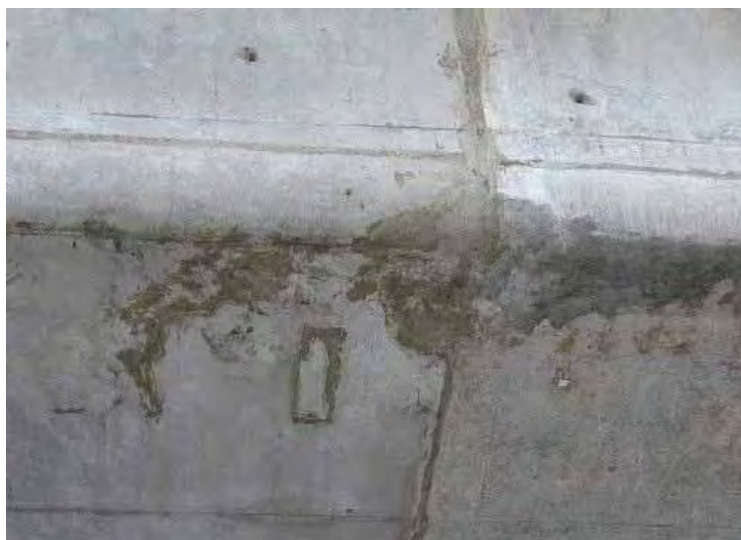
Picture No.	9
Span	1
Member	Girder
Defect of construction?

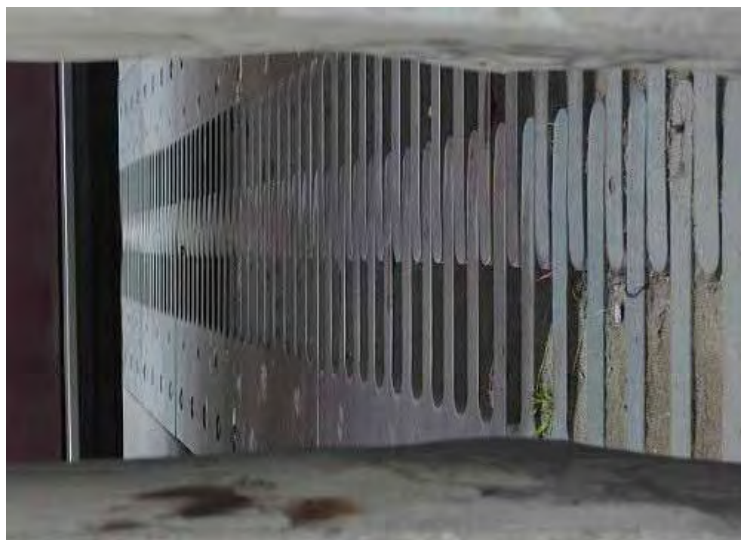
Picture No.	11
Span	1
Member	Expansion joint
Spacing is expanded 5cm

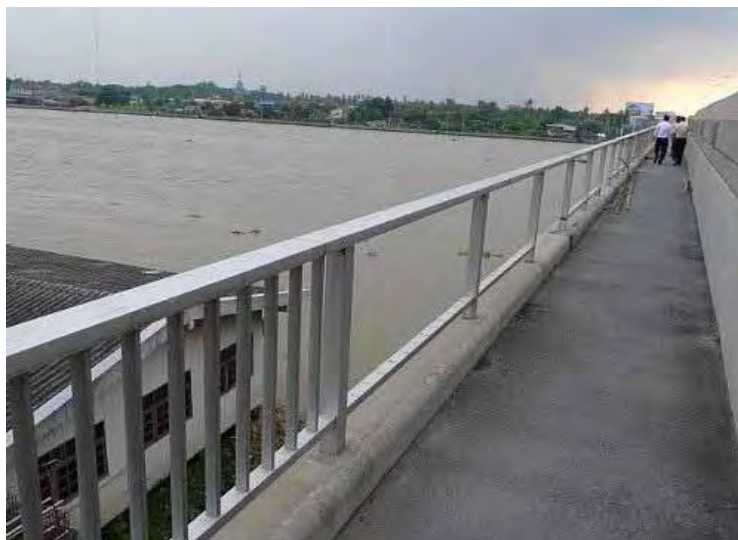
Picture No.	8
Span	1
Member	Handrail
Stolen of stainless handrail

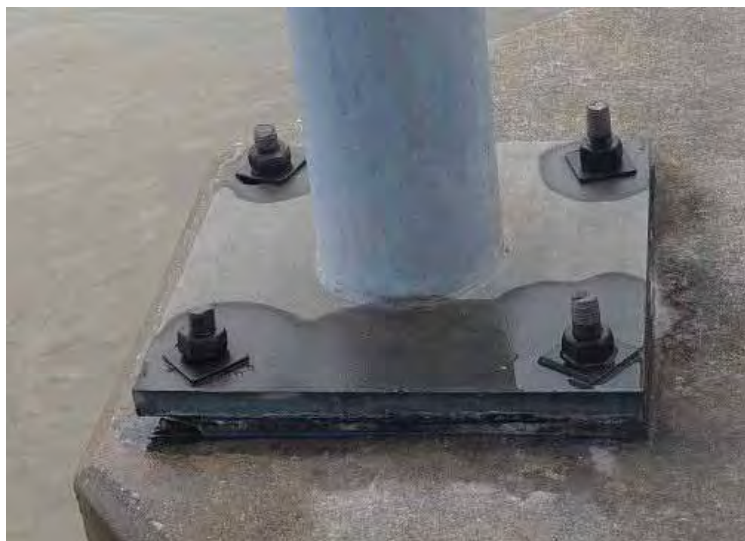
Picture No.	6
Span	1
Member	Lighting pole
Deformation of bolt

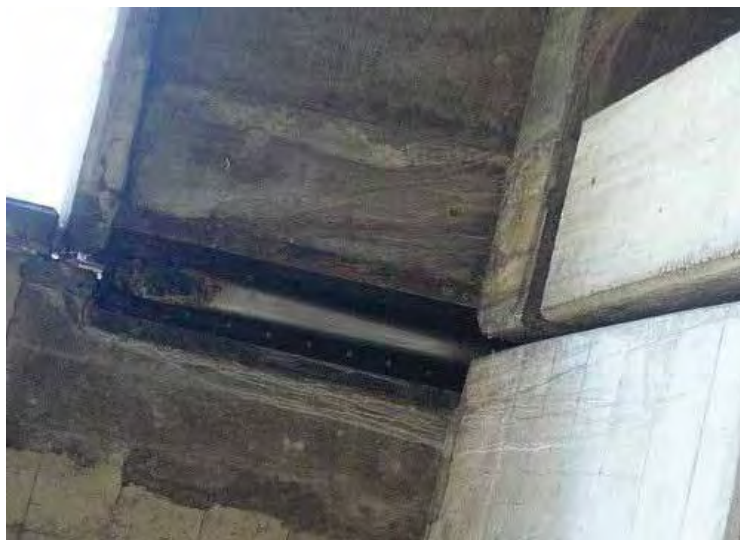
Picture No.	8
Span	1
Member	Expansion joint
Deterioration of drain function

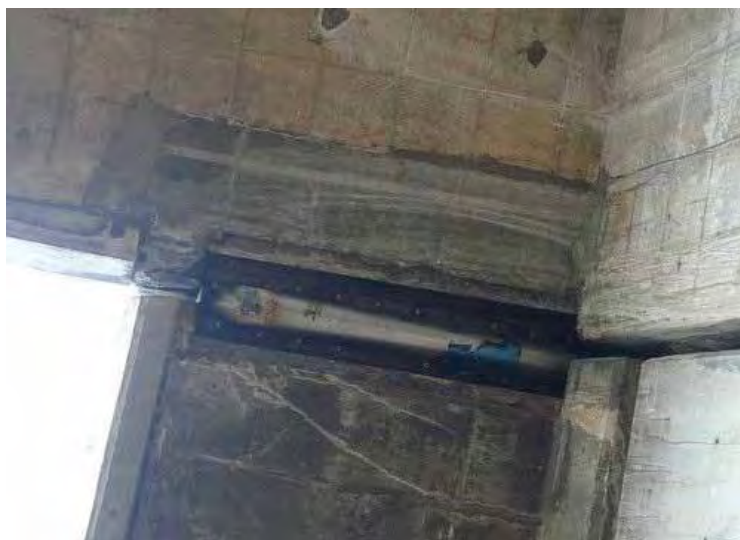
Picture No.	9
Span	1
Member	Expansion joint
Deterioration of drain function

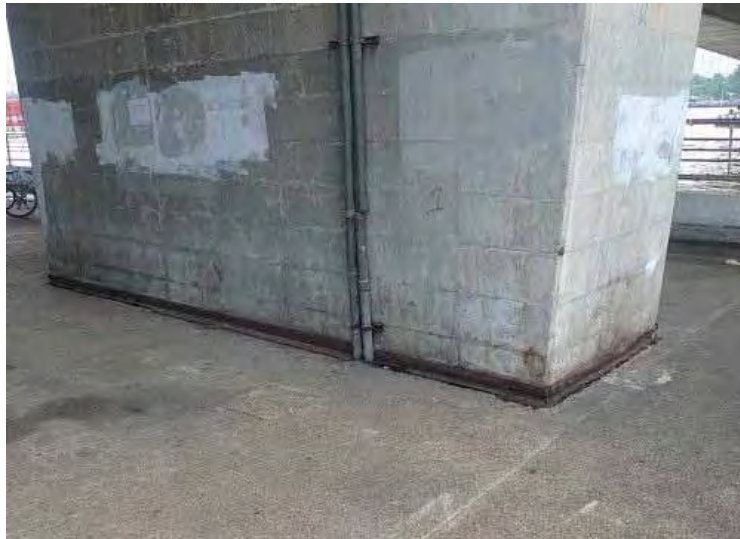
Picture No.	10
Span	1
Member	End pier
Corrosion of steel plate at base

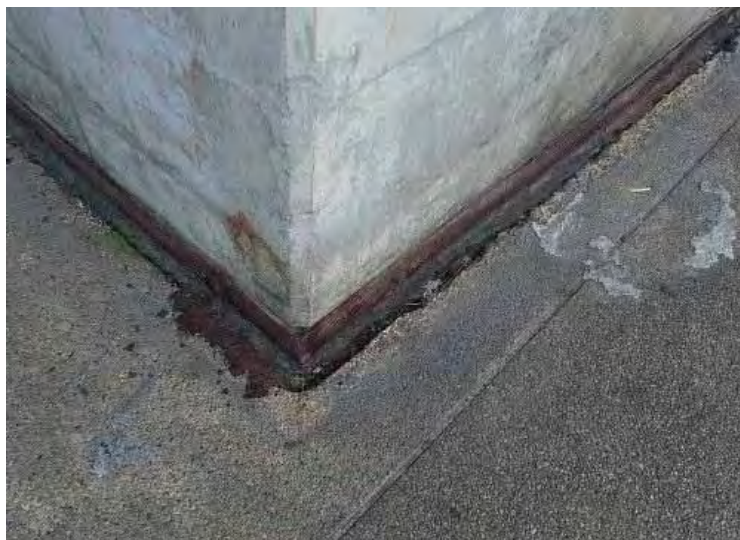
Picture No.	11
Span	1
Member	End pier
Corrosion of steel plate at base

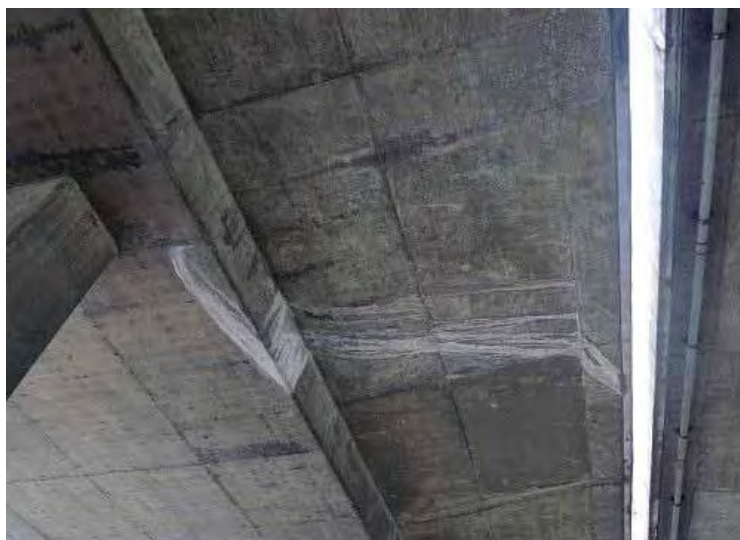
Picture No.	12
Span	1
Member	Approach bridge
Free lime

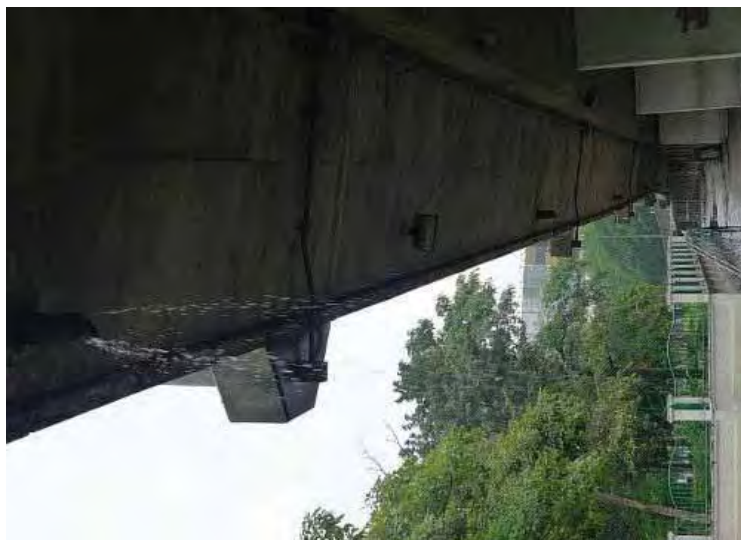
Picture No.	8
Span	1
Member	Approach bridge

Deterioration of drain function

First one is good. 2nd, 3rd drain is blocked

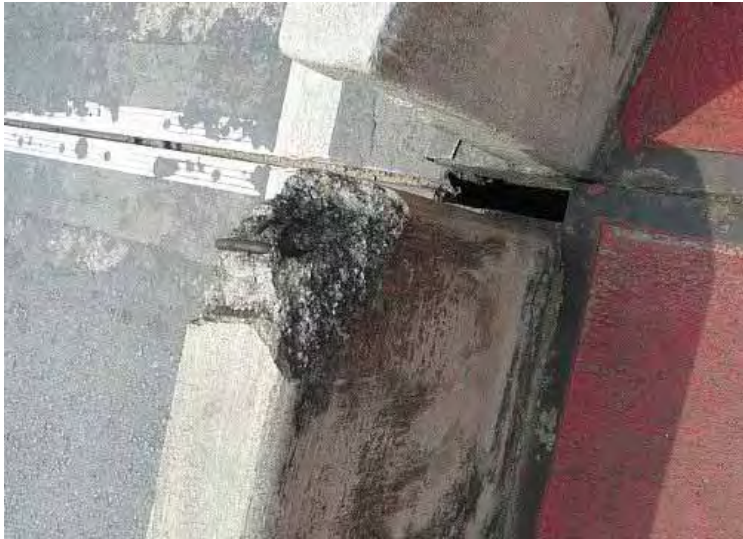
Picture No.	7
	Span	1
	Member	Expansion joint
	Thon Buri end	
	Fracture of side barrier

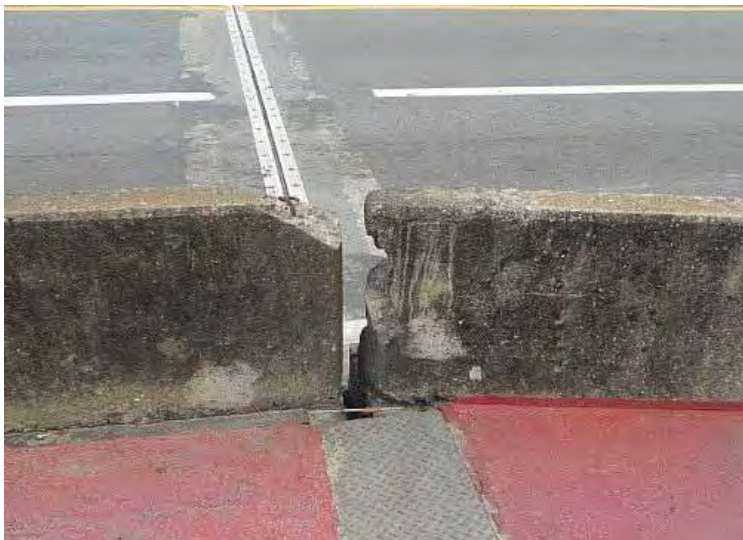
Picture No.	8
	Span	1
	Member	Side barrier
	Fracture of side barrier

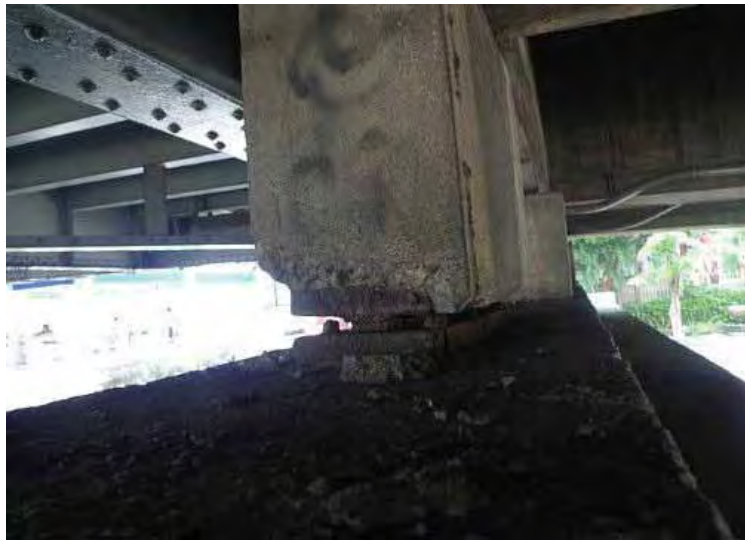
Picture No.	19
Span	1
Member	Bearing
Deterioration of corrosion proofi	
Fracture of edge	
Approach bridge

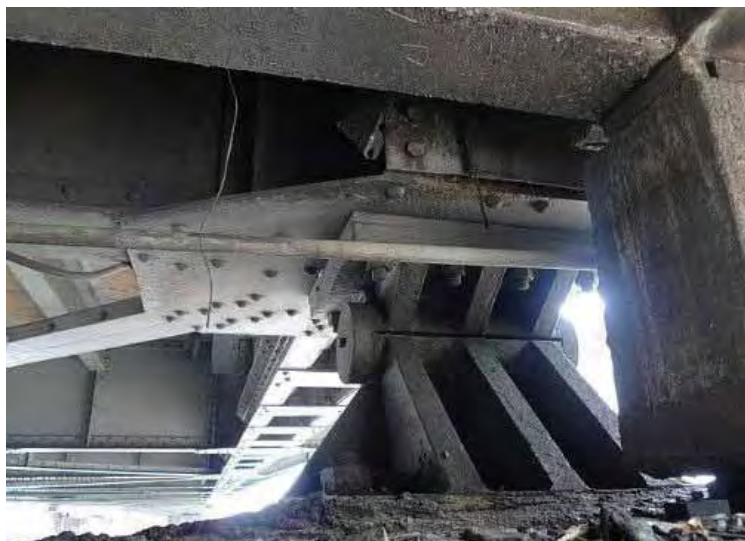
Picture No.	21
Span	1
Member	Bearing
Deterioration of corrosion proofi

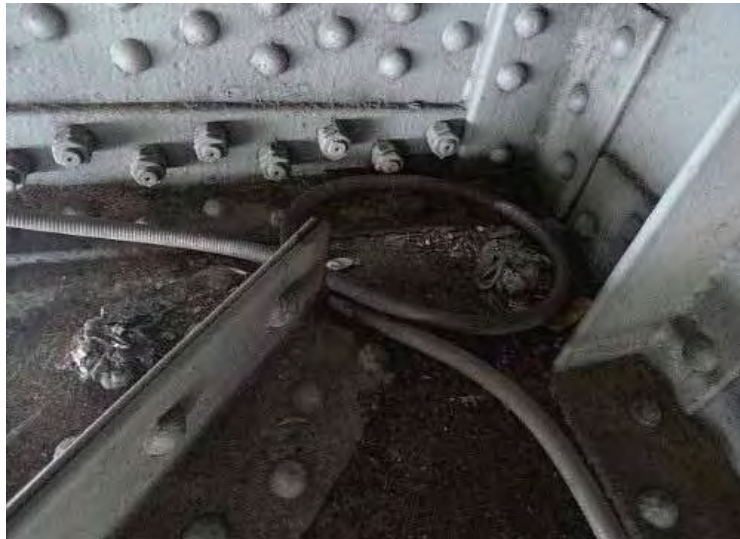
Picture No.	25
Span	1
Member	Bearing
Rivet at bottom side is replaced by bolt	
It might be corroded before

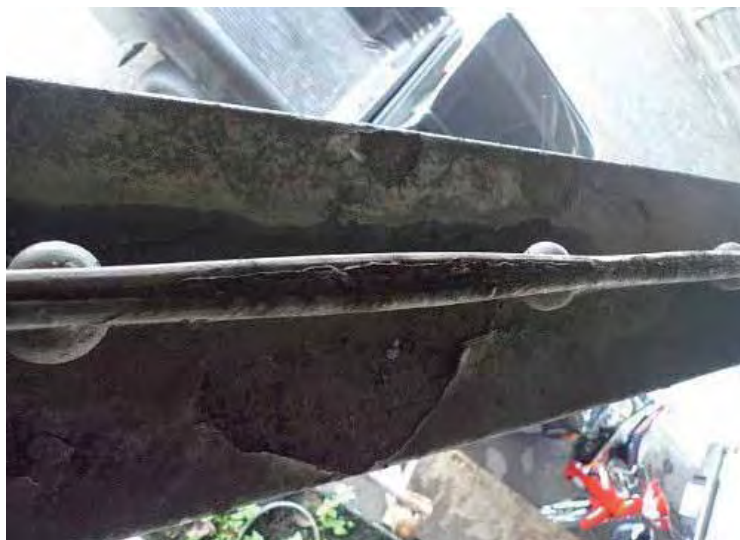
Picture No.	26
Span	1
Member	Cross frame
Peeling of paint	
Expansion of steel by corrosion

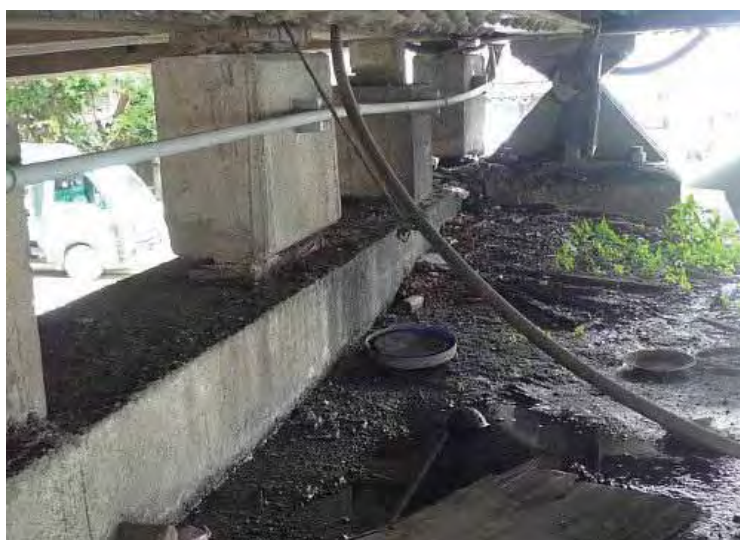
Picture No.	27
Span	1
Member	Bearing
Accumulation of soil

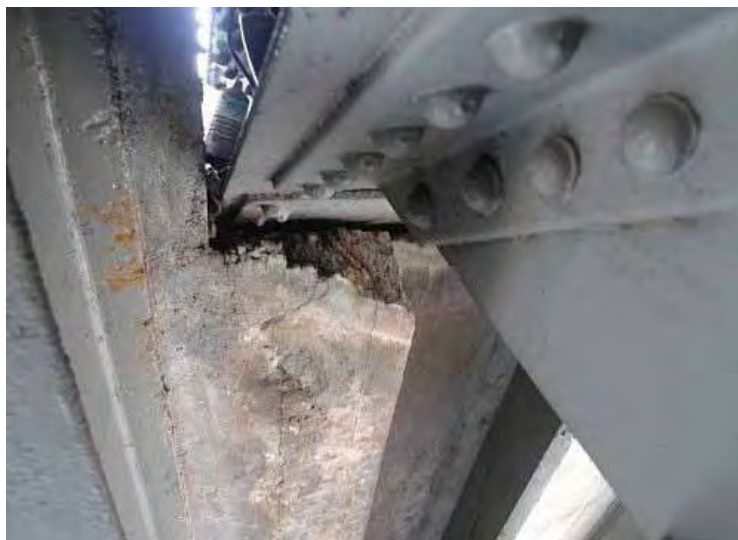
Picture No.	32
Span	1
Member	Chord member
Fracture of concrete

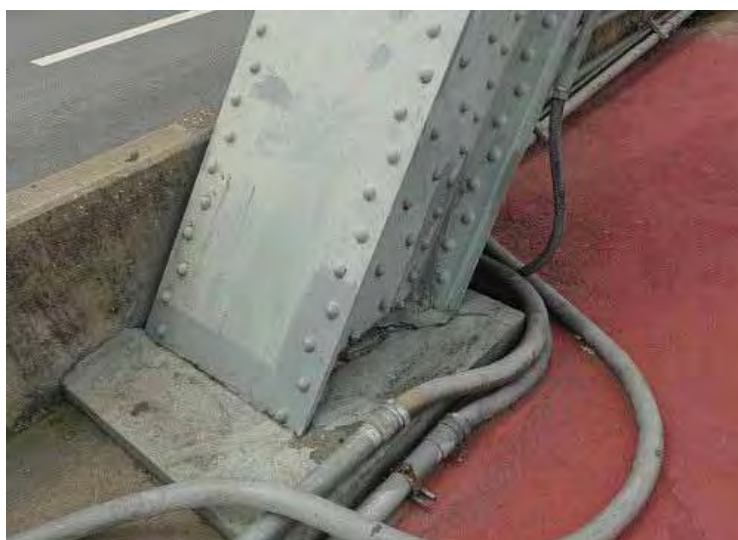
Picture No.	33
Span	1
Member	Chord member
Mount up to prevent remaining water	
Possibility of corrosion inside of concrete slab

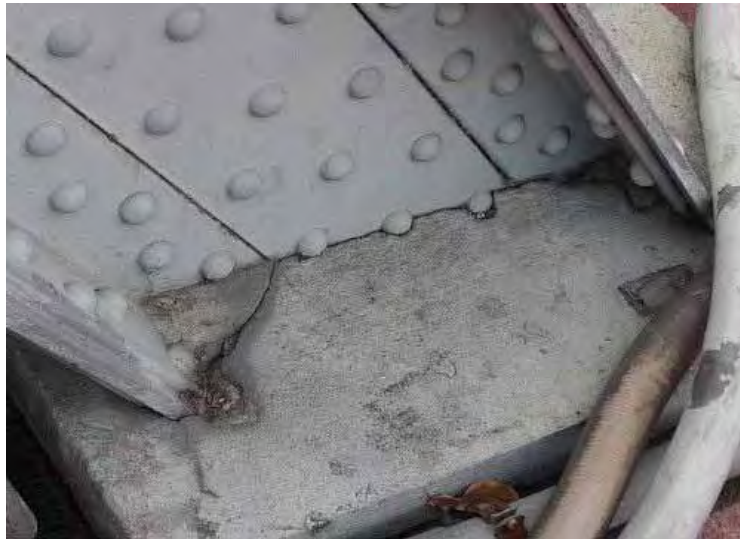
Picture No.	34
Span	1
Member	Chord member
Crack and mark of water

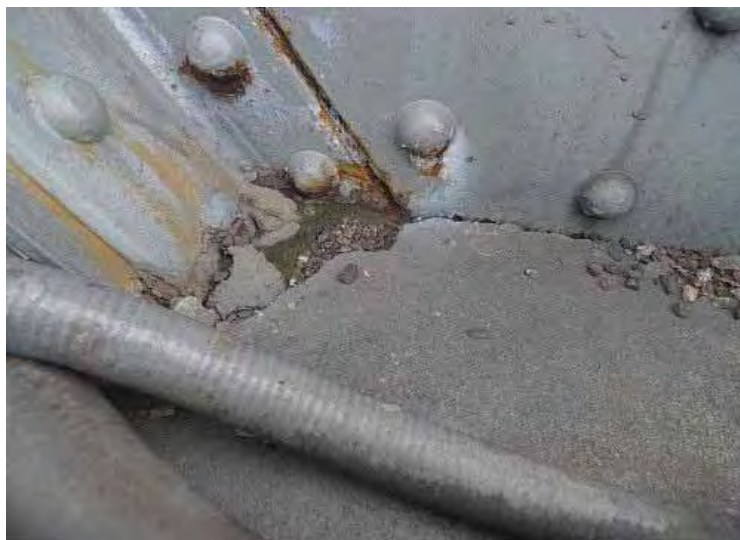
Picture No.	35
Span	1
Member	Chord member
Corrosion

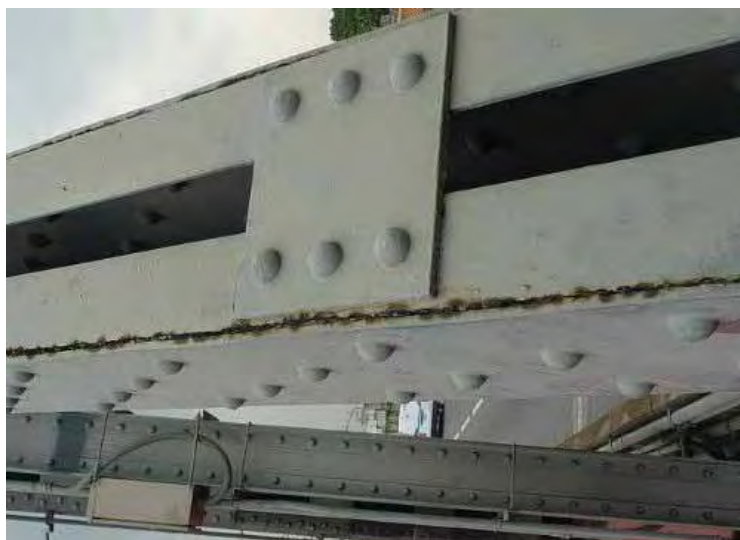
Picture No.	36
Span	1
Member	Bottom chord
Deterioration of corrosion proofing

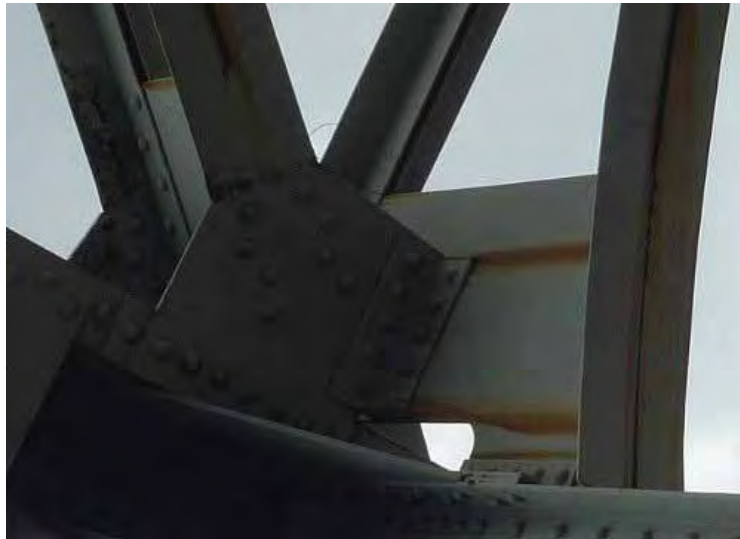
Picture No.	37
Span	1
Member	Upper chord
Deterioration of corrosion proofing

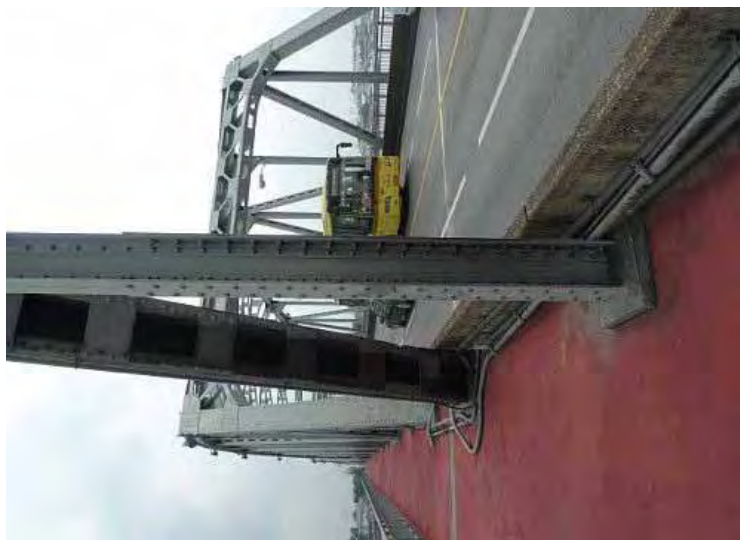
Picture No.	38
Span	1
Member	Vertical member
Reinforcement by additional plate	
4-vertical member was reinforced

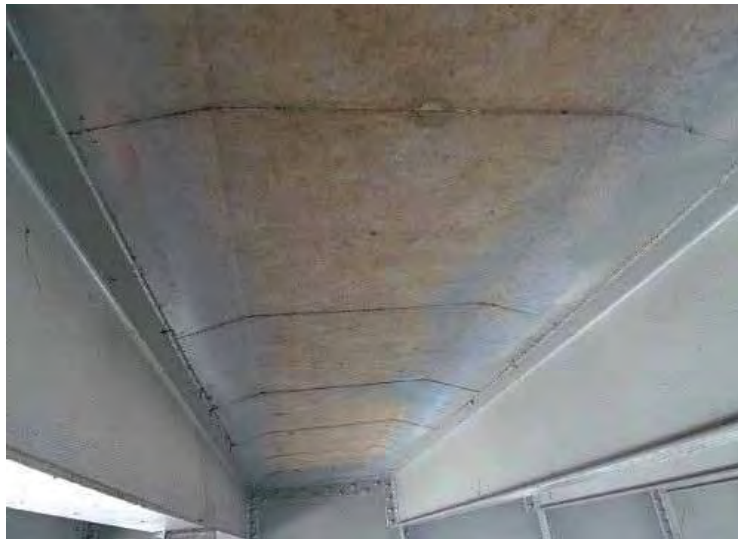
Picture No.	41
Span	1
Member	slab
Replaced slab under roadway

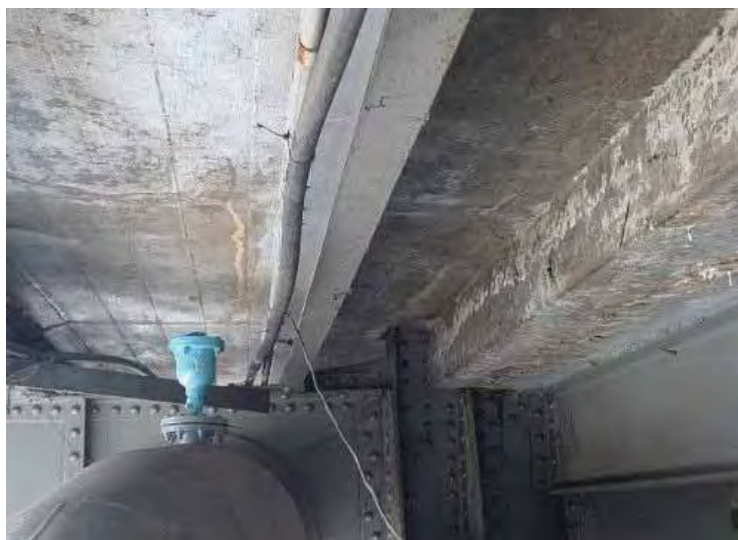
Picture No.	42
Span	1
Member	Slab
Slab under walkway	
Crack and free lime

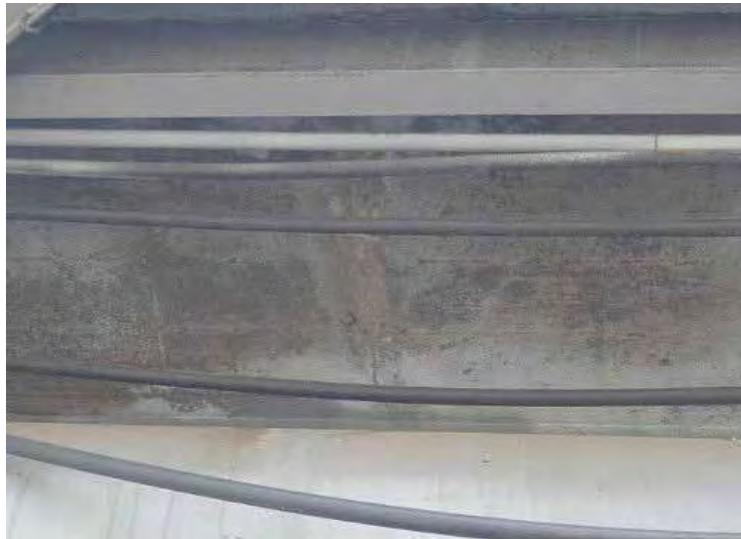
Picture No.	43
Span	1
Member	Slab
Slab under walkway	
Crack and free lime

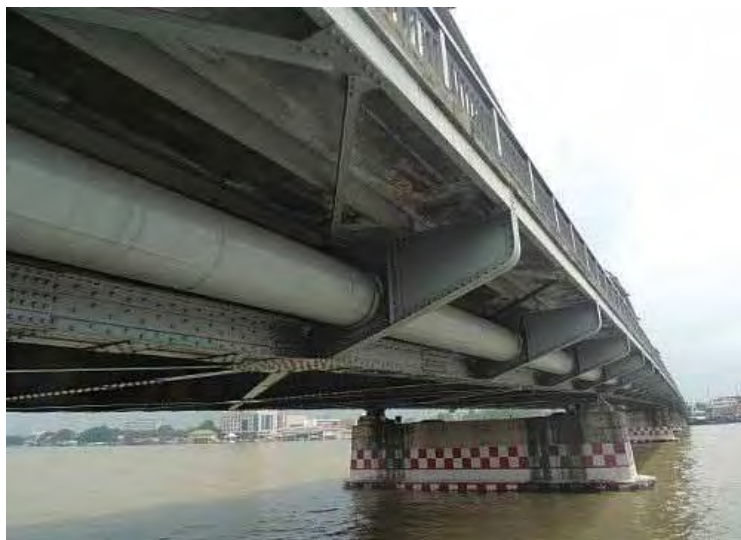
Picture No.	44
Span	1
Member	Slab
Exposure of rebar	
Crack above bracket

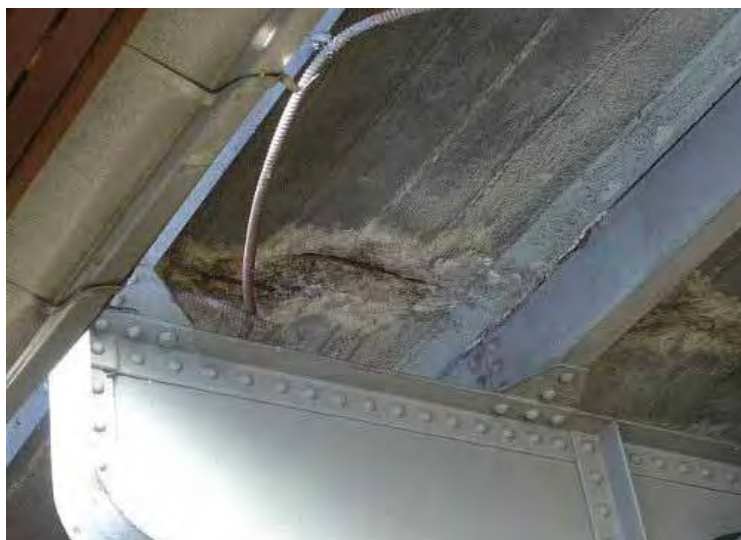
Picture No.	45
Span	1
Member	slab
Exposure of rebar

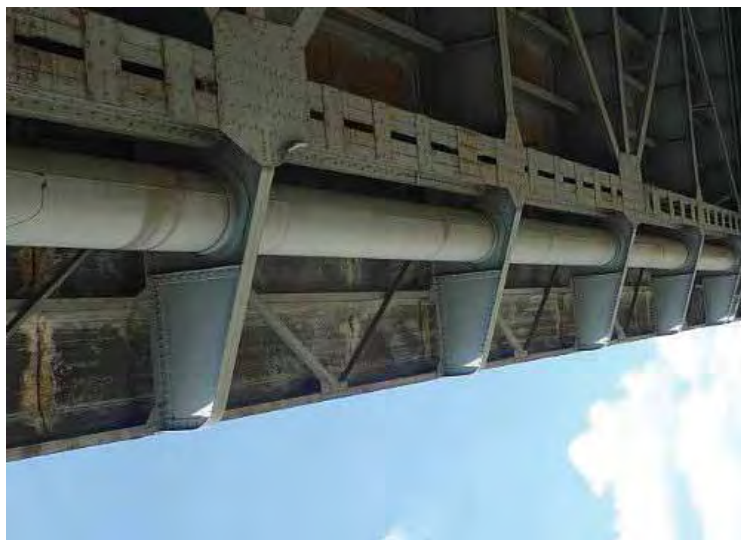
Picture No.	53
Span	1
Member	slab
Crack and free lime under walkway	
<i>*Survey on board, 31-oct</i>

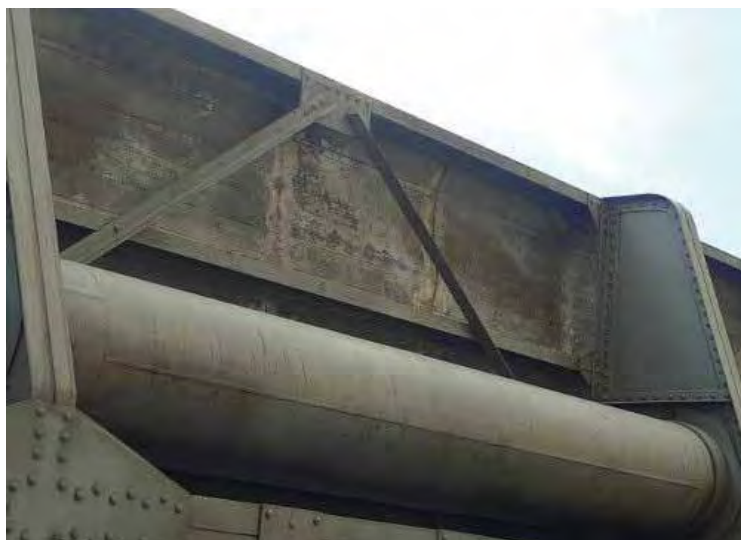
Picture No.	54
Span	1
Member	Slab
Crack and free lime under walkway	
<i>*Survey on board, 31-oct</i>

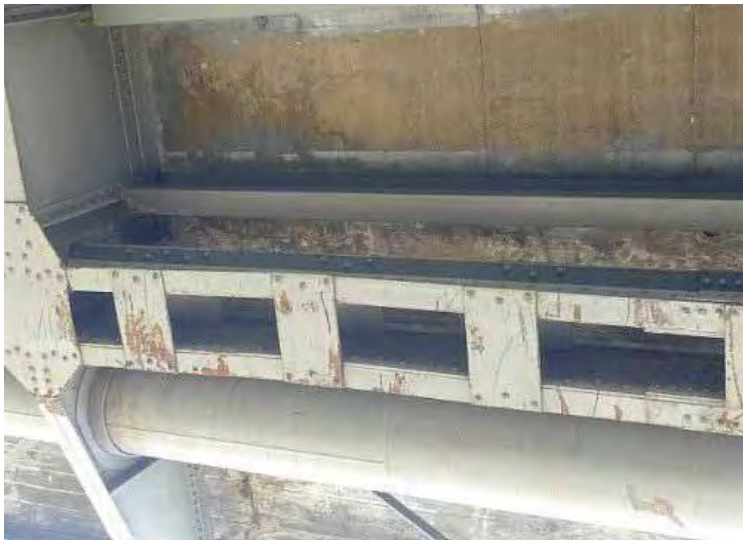
Picture No.	55
	Span	1
	Member	Slab
	Deformation by ship collision	
*Survey on board, 31-oct

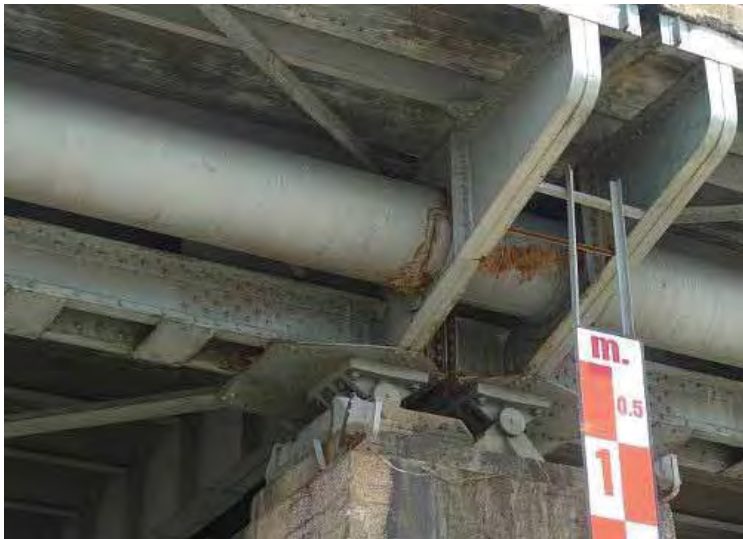
Picture No.	56
	Span	1
	Member	Water supply
	Deterioration of corrosion proofi	
*Survey on board, 31-oct		
	Picture No.	57
	Span	1
	Member
