Inspection sheet of visual survey

Bridge No. 11

Bridge name		RAMA VIII Bridge		Route name		-		Authority		BMA		Code of authority		-		
Place		from Khat Bang Phlat to Khet Phra Nakhon		Distance		from km+ 0 to km+ 0						No.		-		
												Survey date		23-Oct-2009		
Bridge properties	Bridge type(1)	main road · side road · ramp														
	Bridge type(2)	bridge · viaduct · plank pass														
	Bridge type(3)	4-span composite 2 l girder cable stayed bridge														
	Total length	475.00 (m)														
	Span	75 + 50 + 50 + 300 (m)														
	Nos. of span	4 span														
	Width	29.20 (m) / (m)														
	Completion	2002														
Road information	Horizontal	Straight · incli (θ = 2 %) · Curve (R m)														
	Gradient	One way (↗ · ↘) parabo (▽ · ▹)														
	Nearby tunnel	yes · no (m)														
	Nearby crossing	yes · no (ramp way)														
	Traffic	Much · Medium · Little														
	Commercial traffic	Much · Medium · Little

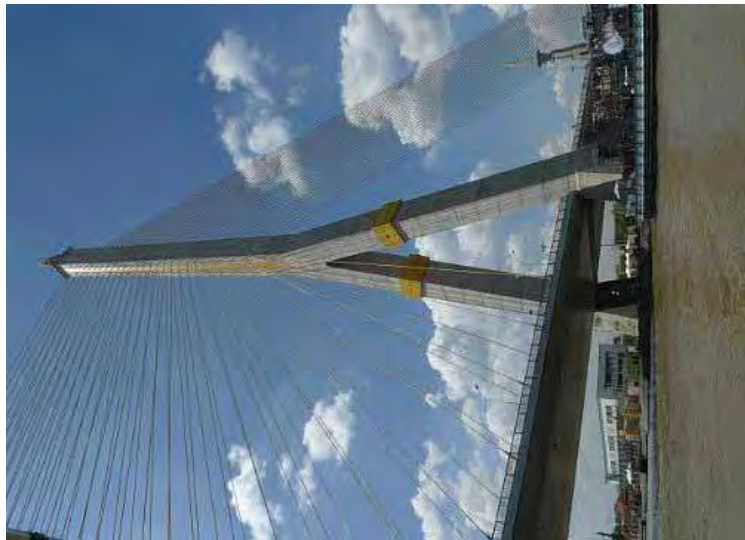
Picture No.	4
	Span	1
	Member	Pylon
	<i>*Survey on board, 31-oct</i>

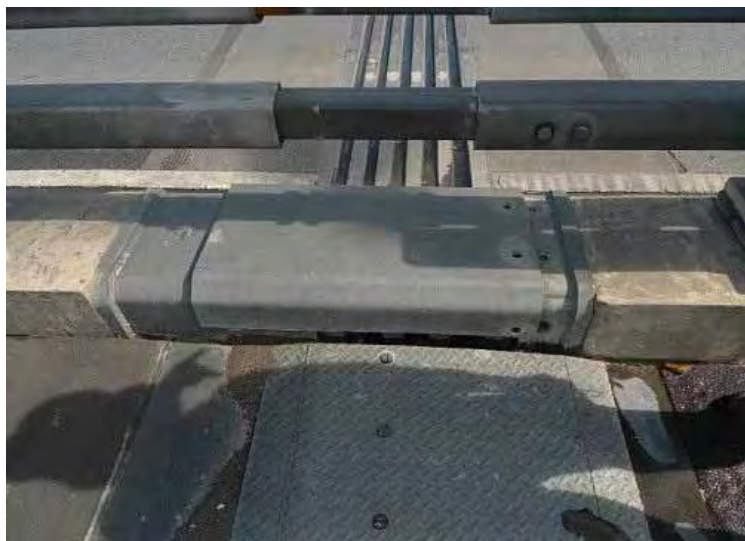
Picture No.	6
	Span	1
	Member	Expansion joint
	Lack of bolt	
	Soil dump

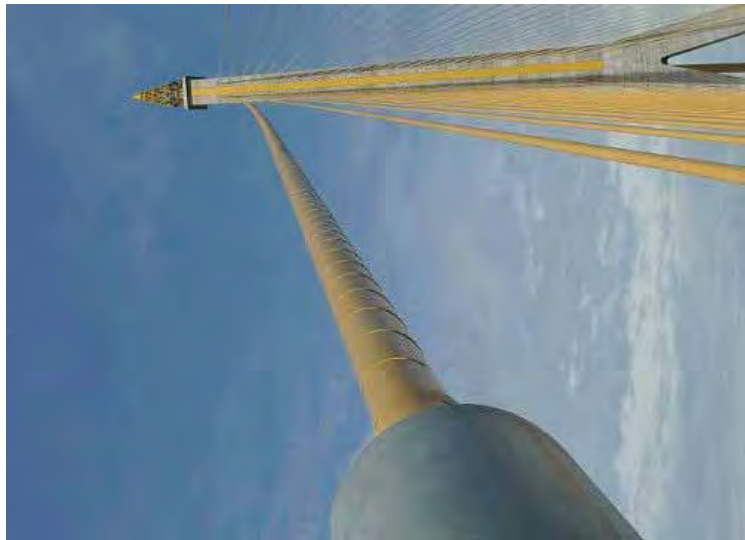
Picture No.	7
Span	1
Member	View of cable
Helical type wind resistance

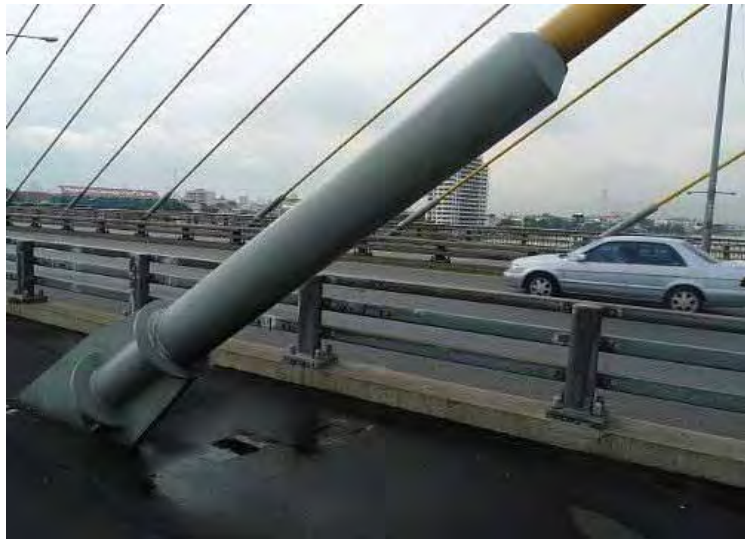
Picture No.	8
Span	1
Member	Cable
Leakage from cable

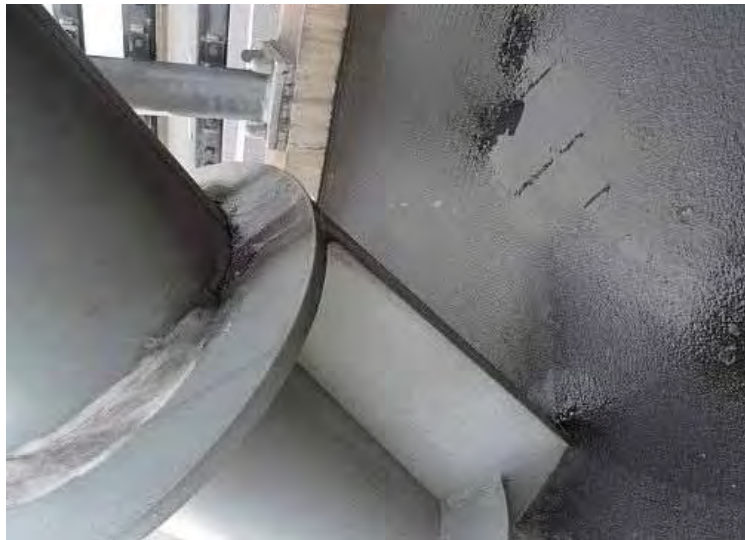
Picture No.	9
Span	1
Member	Cable
Leakage from cable	
Opening under side of cable cover for drainage

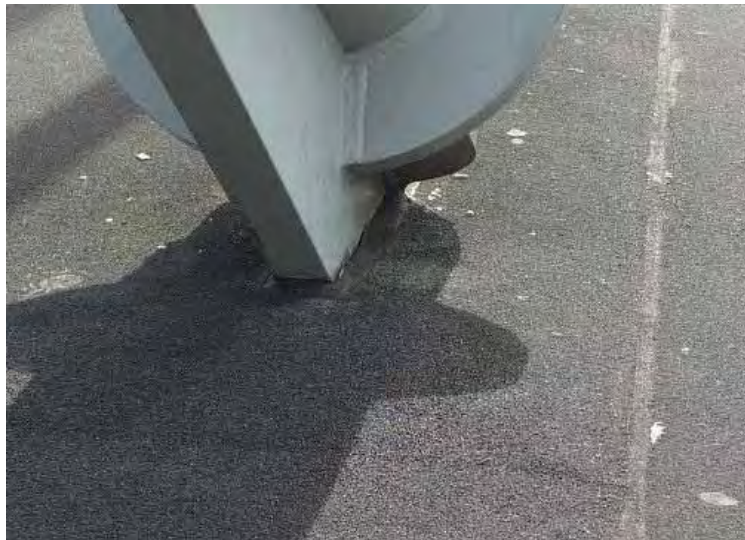
Picture No.	10
Span	1
Member	Cable fixing structure
Gap and calking between cable and slab. And mounted up around cable to prevent remaining water.

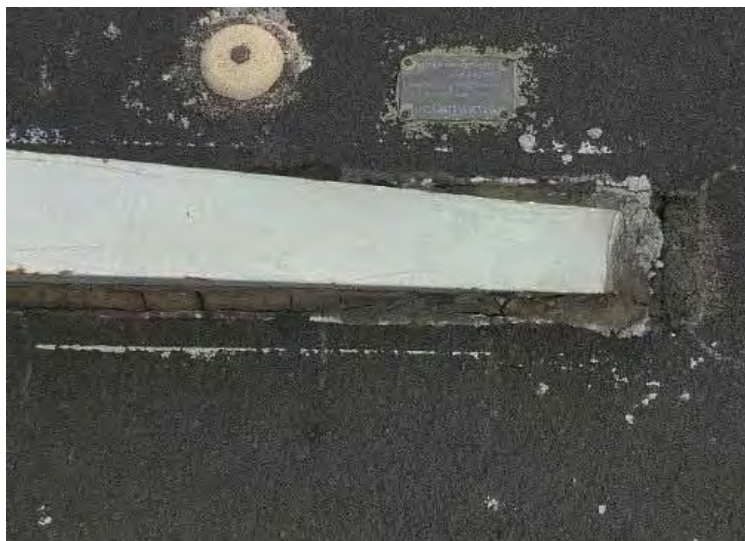
Picture No.	12
Span	1
Member	Cable fixing structure
Calking and name plate of cable	
well maintained but aging

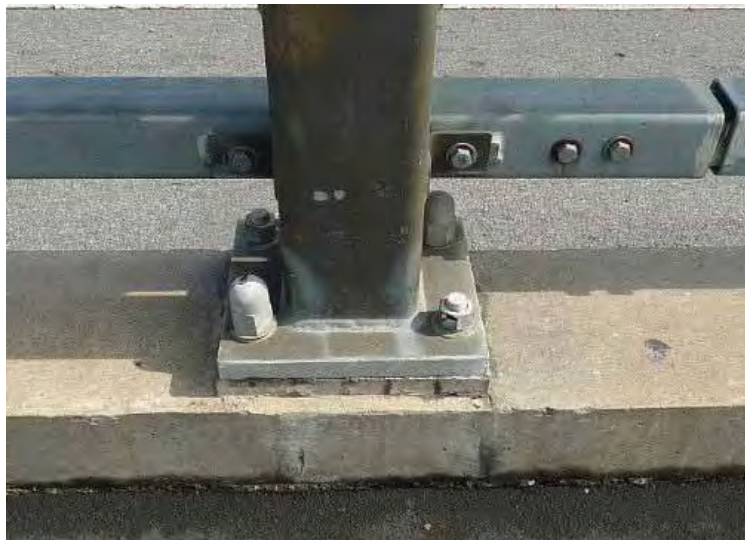
Picture No.	7
	Span	1
	Member	Barrier
	Lack of bolt cap

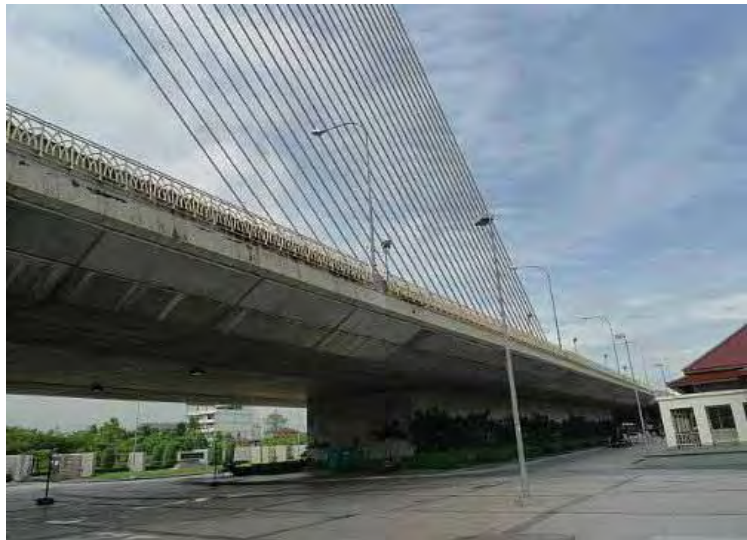
Picture No.	10
	Span	1
	Member	Decorative plate
	leakage line

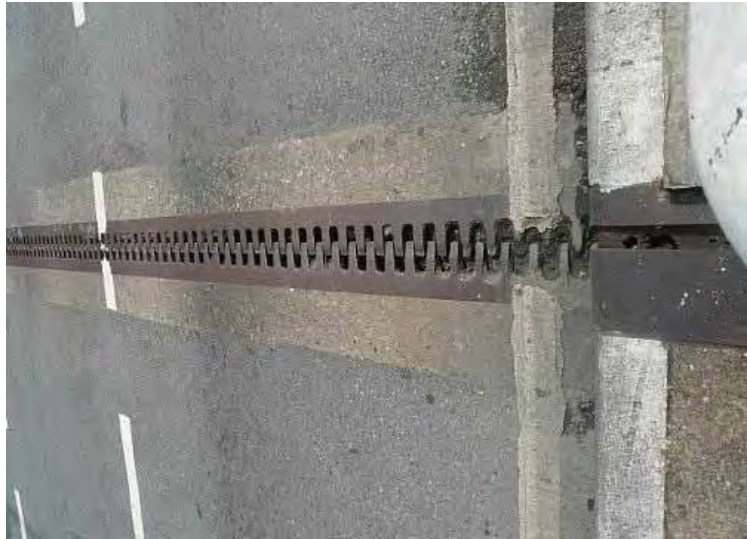
Picture No.	5
Span	1
Member	Expansion joint
Corrosion at end

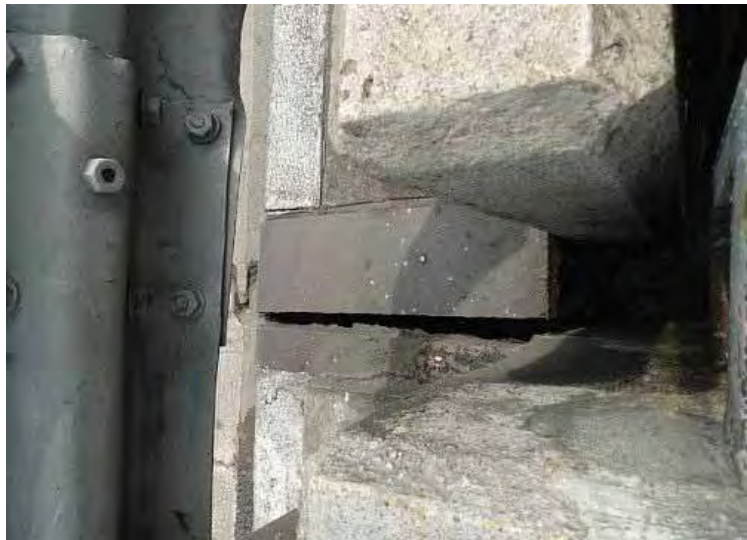
Picture No.	6
Span	1
Member	Expansion joint
Corrosion

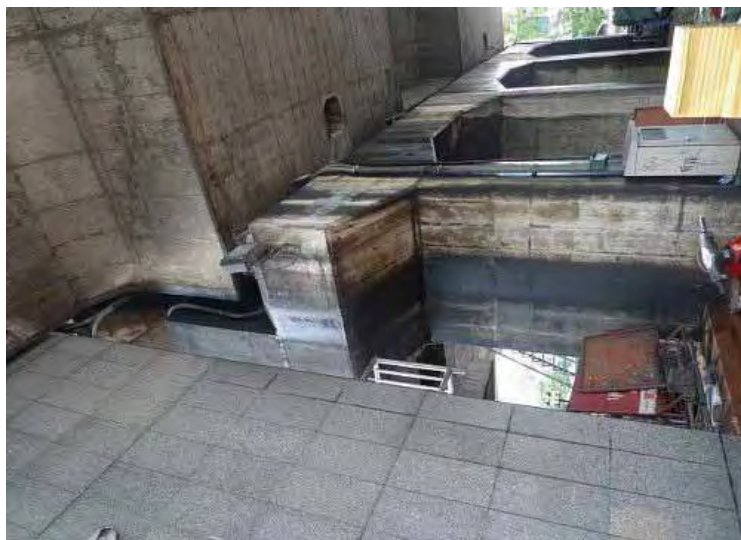
Picture No.	8
Span	1
Member	Expansion joint
Deterioration of drain function	
Bangkok side	
No door in manhole

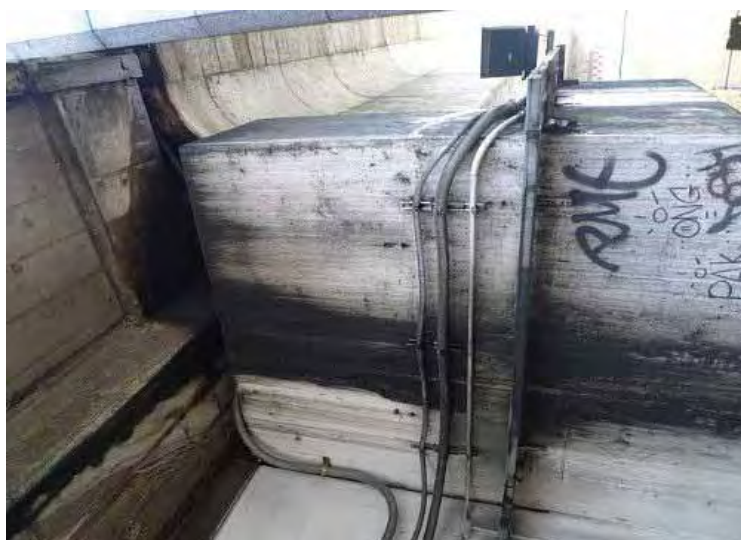
Picture No.	9
Span	1
Member	bottom slab
Deterioration of drain function	
Thon Buri side

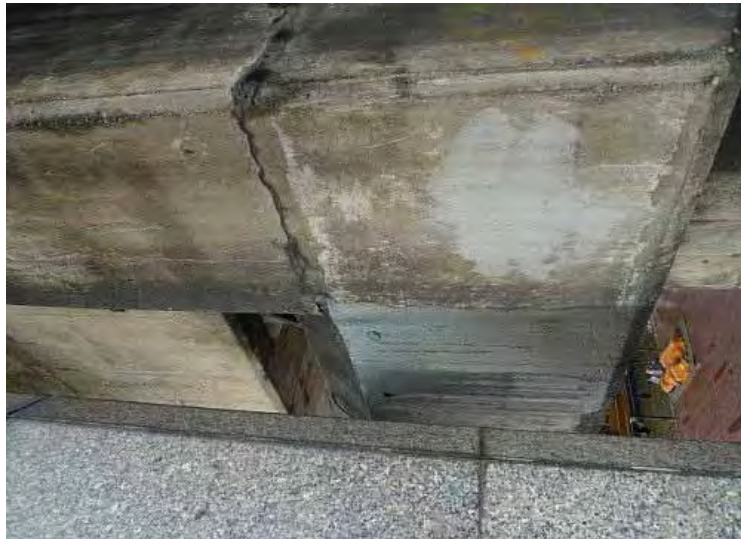
Picture No.	10
Span	1
Member	Approach bridge
Crack

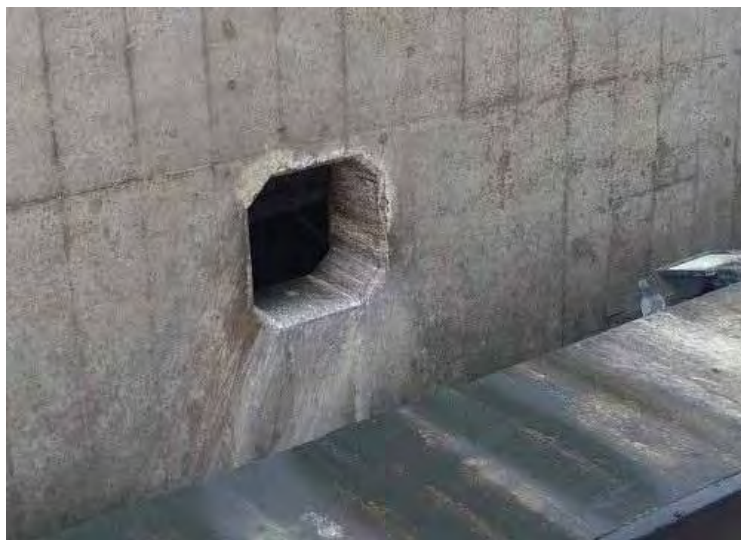
Picture No.	11
Span	1
Member	Man hole
Leakage from manhole	
Leakage from water supply?

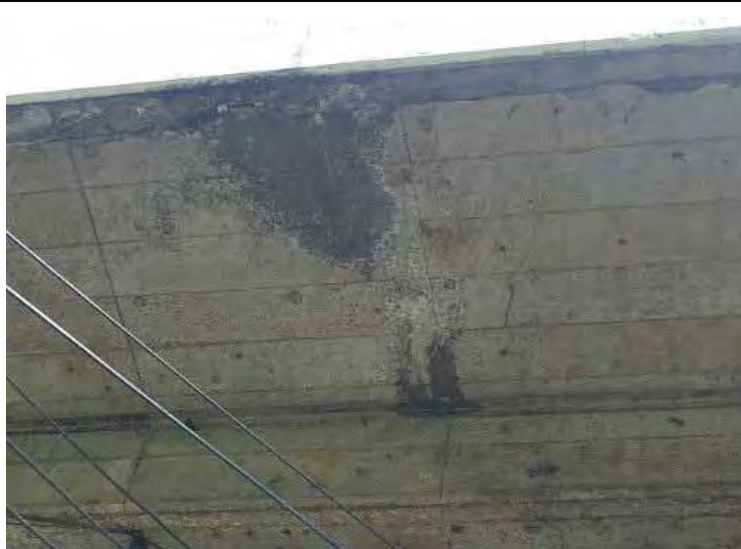
Picture No.	12
Span	1
Member	Pylon
Mark of leakage from joint of barrier

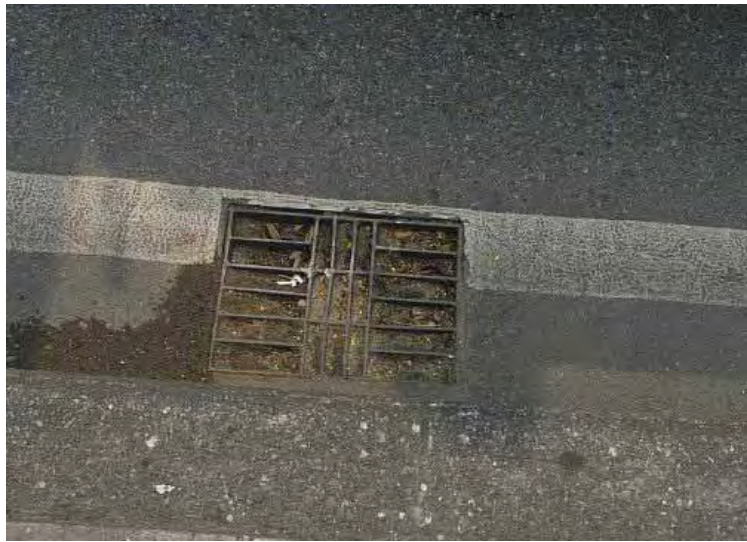
Picture No.	13
	Span	1
	Member	Drainage
	Blocking

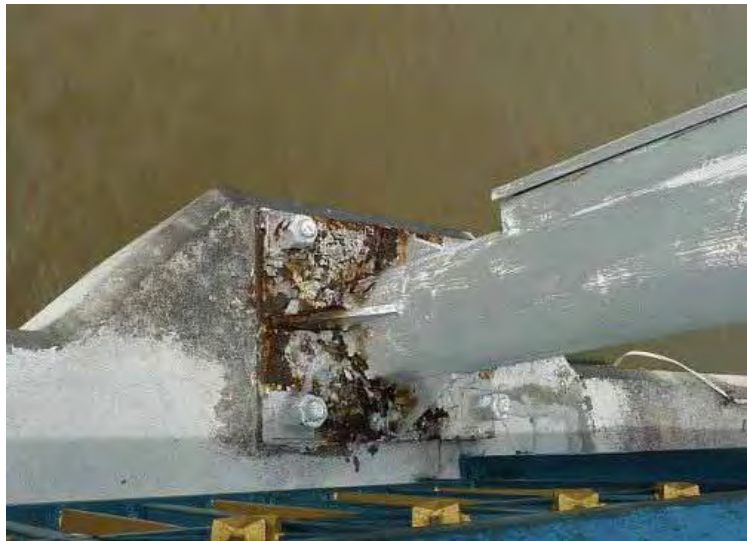
Picture No.	14
	Span	1
	Member	Lighting pole
	Deterioration of corrosion proofi

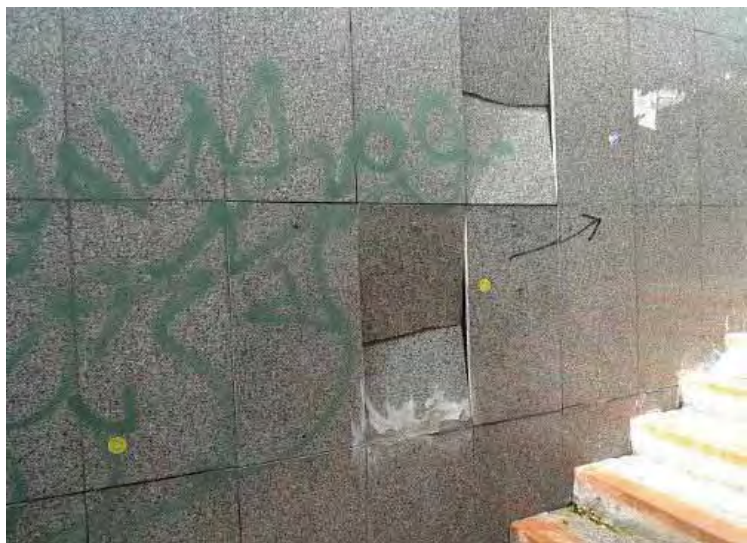
Picture No.	15
	Span	1
	Member	Walkway
	Graffiti	
	Fracture of decorative plate

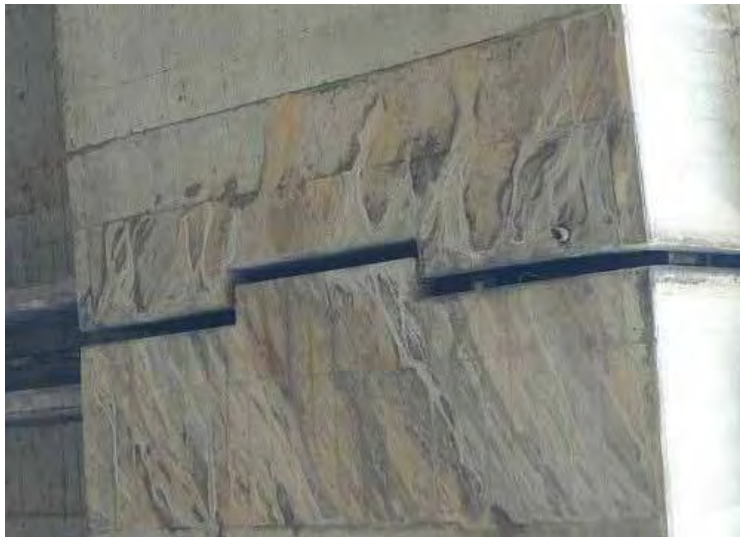
Picture No.	17
Span	1
Member	Hinge
Leakage	
<i>*Survey on board, 31-oct</i>

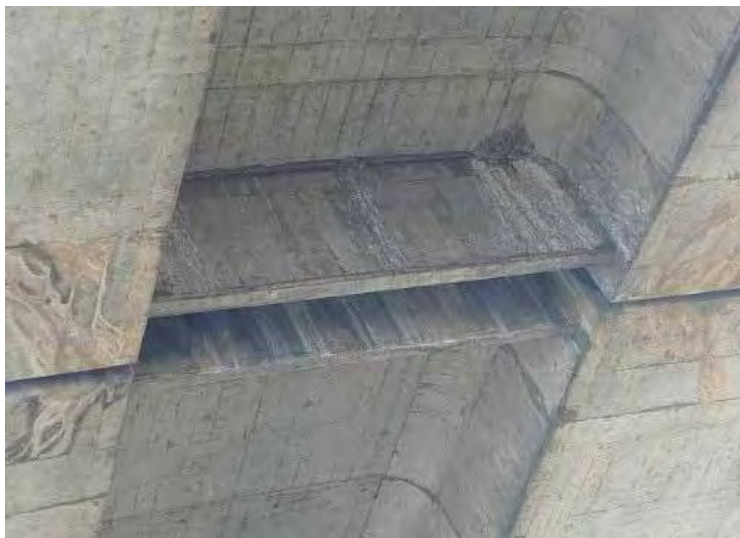
Picture No.	18
Span	1
Member	Slab
Nest harm	
<i>*Survey on board, 31-oct</i>

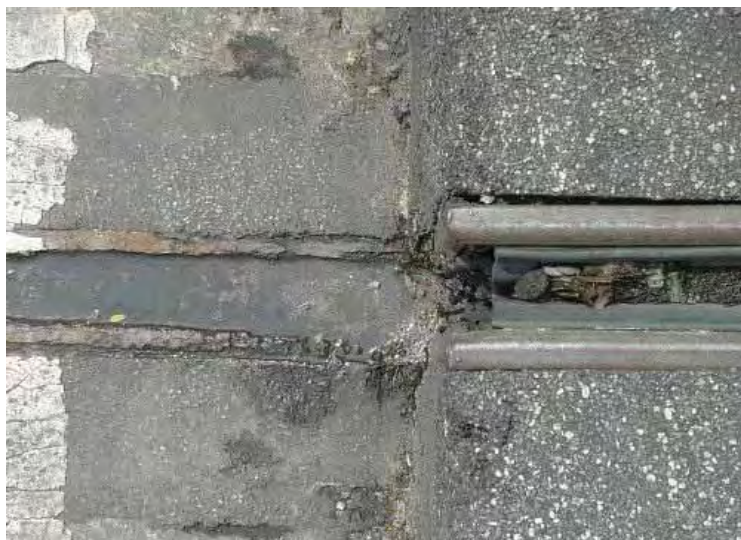
Picture No.	11
Span	1
Member	Expansion joint
Bangkok side	
Deterioration of corrosion proofi

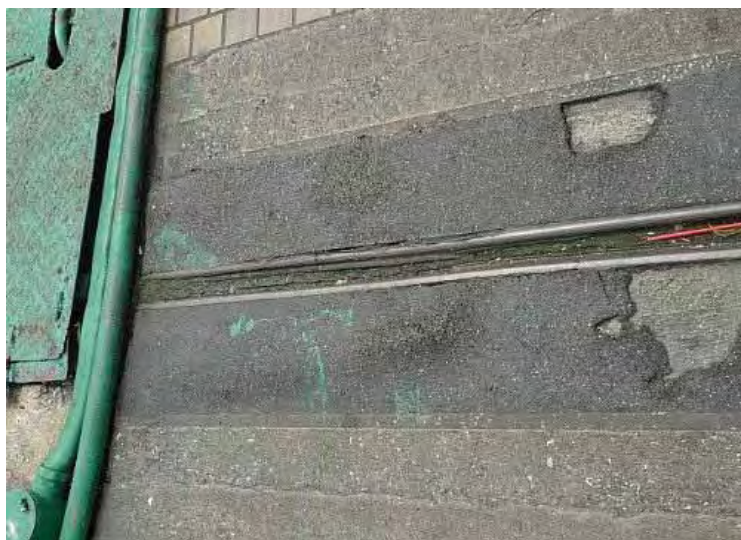
Picture No.	12
Span	1
Member	Expansion joint
between side span and center span	
Peeling of surface layer

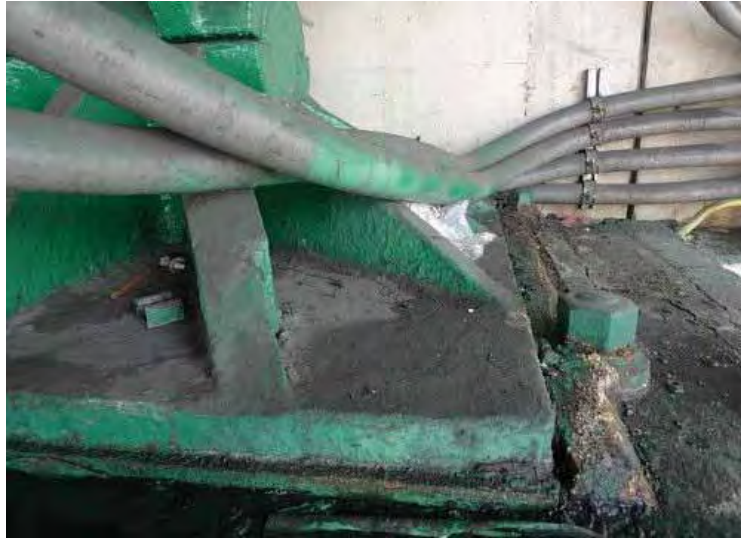
Picture No.	7
Span	1
Member	Bearing
Deterioration of corrosion proofi

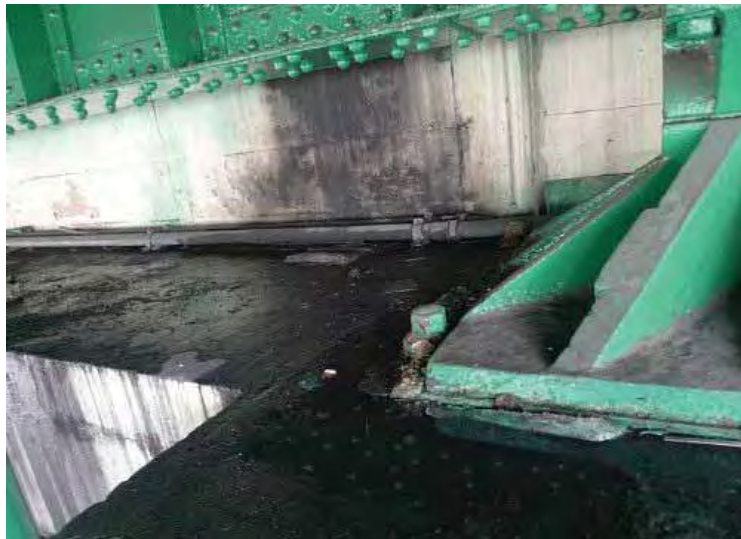
Picture No.	8
Span	1
Member	Bearing
Remaining water

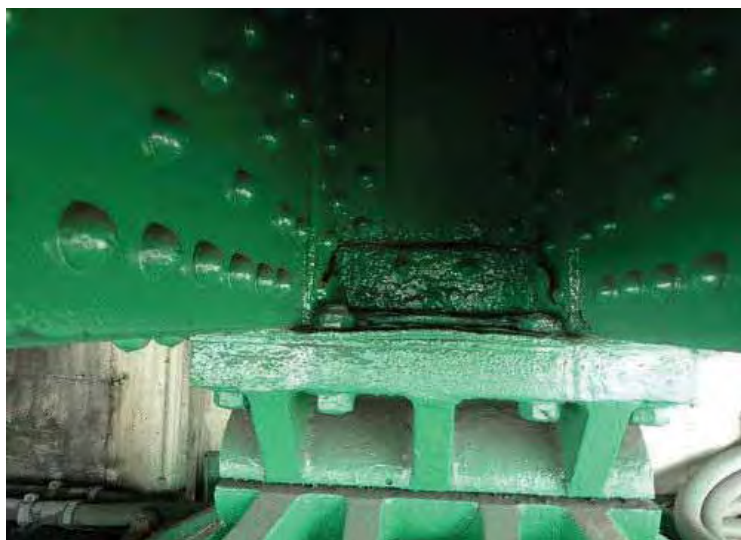
Picture No.	9
Span	1
Member	Bearing
Mark of remarkable corrosion	
There is no remaining water at survey. Improved?

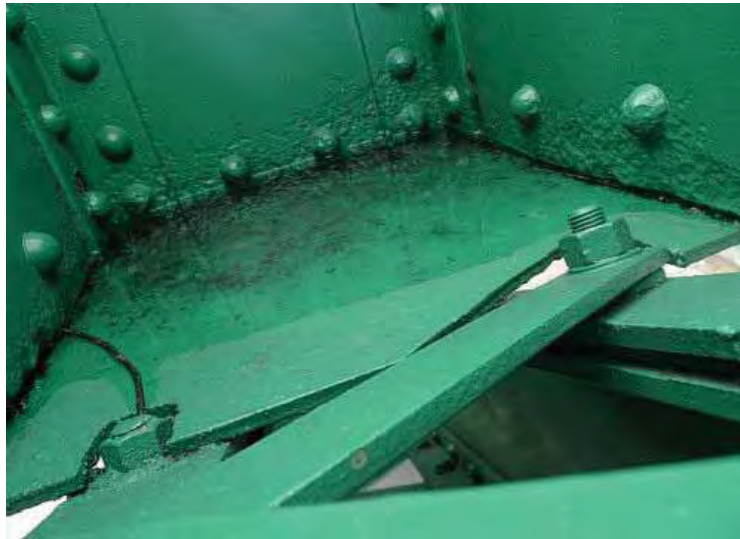
Picture No.	16
Span	1
Member	slab
Remaining water It will make corrosion

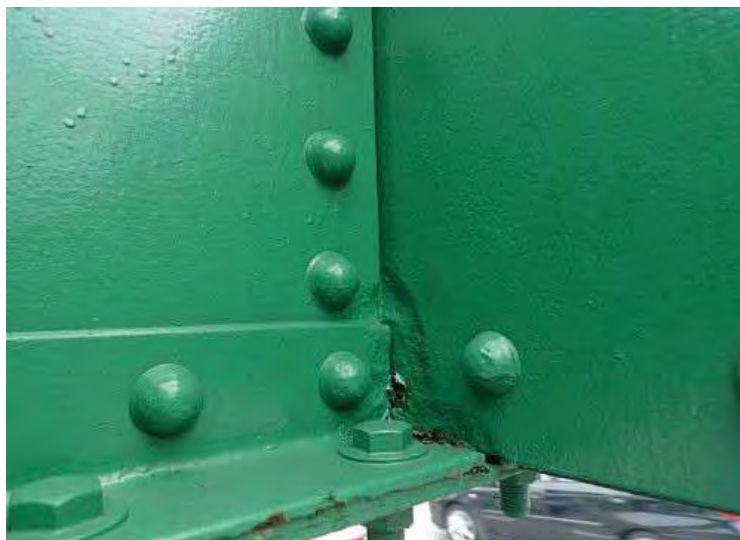
Picture No.	17
Span	1
Member	slab
Remarkable reduced section

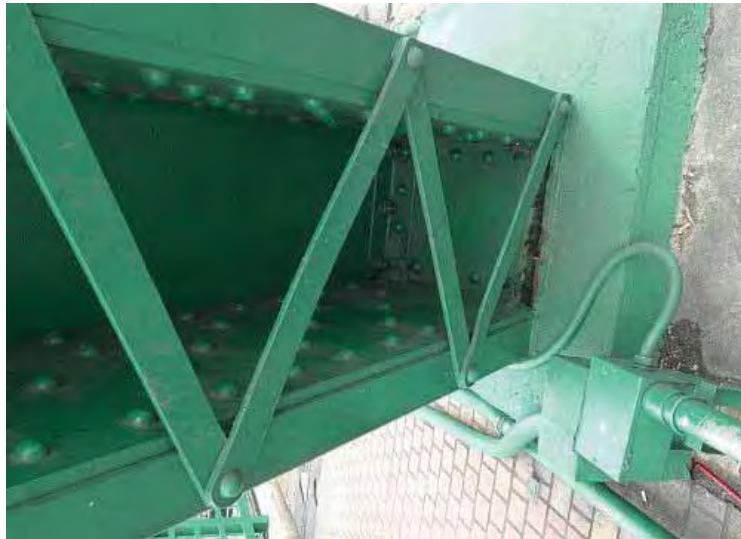
Picture No.	13
Span	1
Member	slab
Deterioration of corrosion proofi

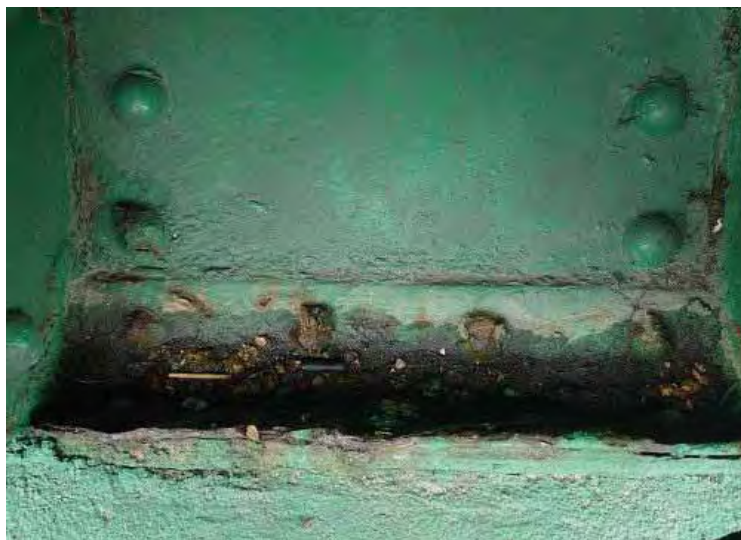
Picture No.	14
Span	1
Member	slab
Corrosion of diaphragm	
Accumulation of soil

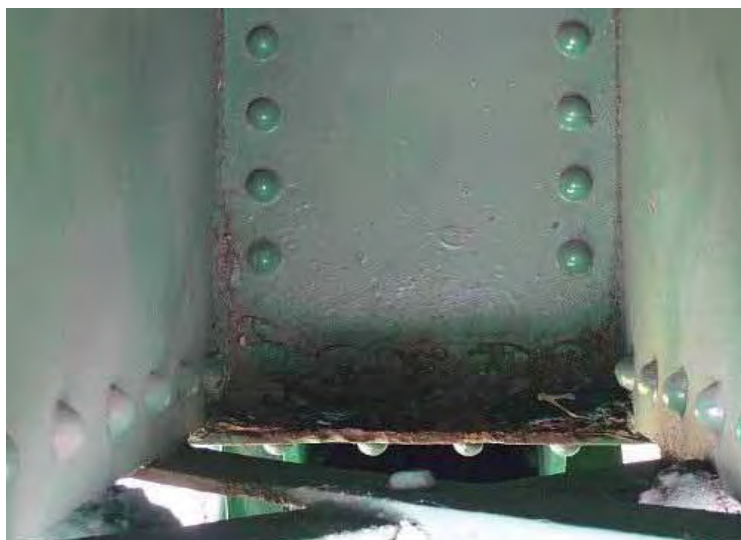
Picture No.	15
Span	1
Member	Lighting pole
Corrosion of diaphragm

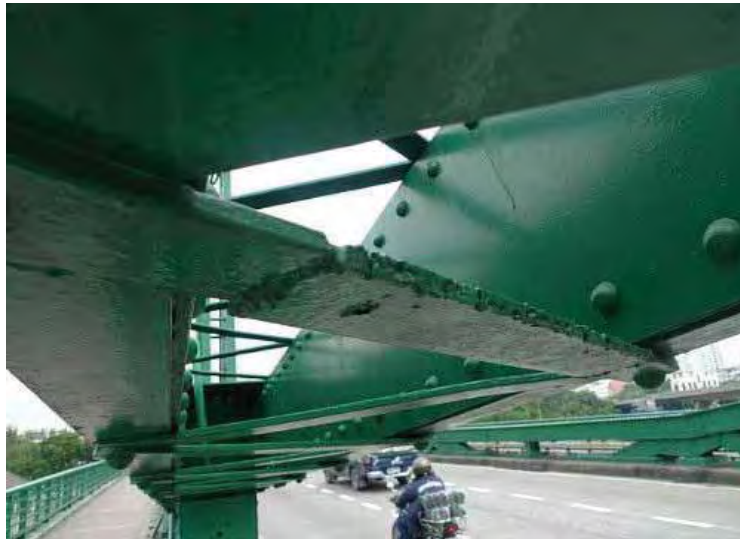
Picture No.	16
Span	1
Member	Chord member
Repaired member

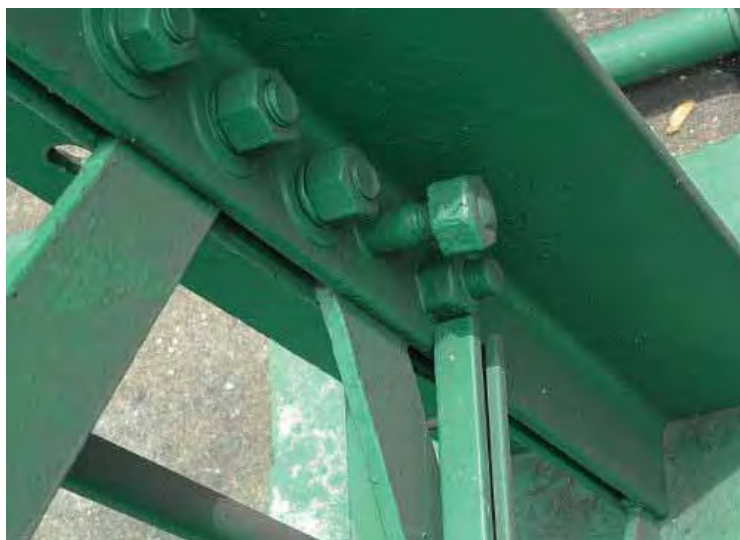
Picture No.	18
Span	1
Member	Bolt
Looseness of bolt

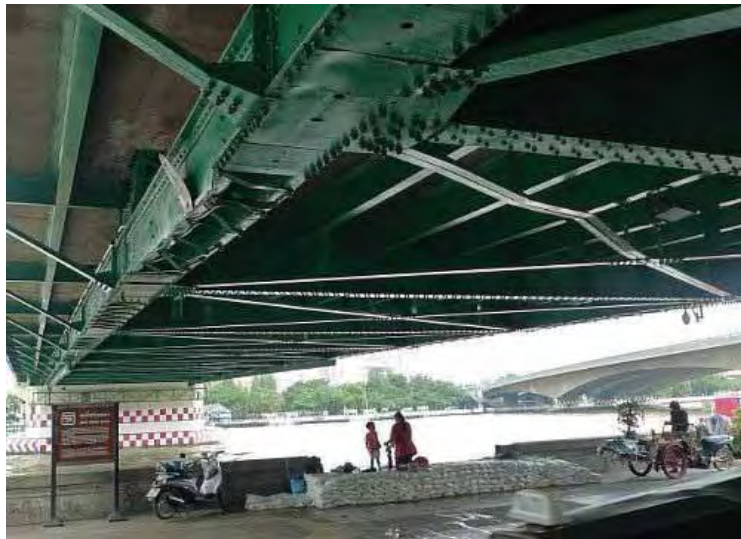
Picture No.	23
Span	1
Member	Bottom chord
Deformation by vehicle collision	
Limit of vehicle height is 3.5m	
No warning frame is set before bridge at Thon Buri side

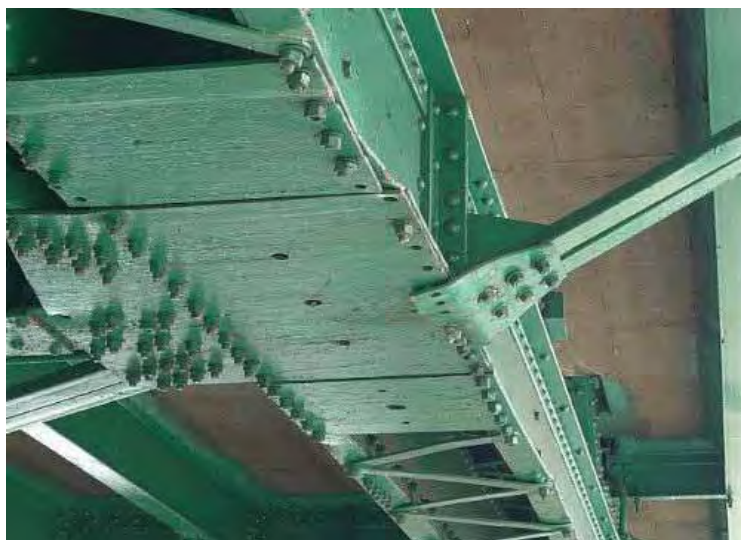
Picture No.	27
Span	1
Member	Bottom chord
Rupture of rivet by vehicle collision

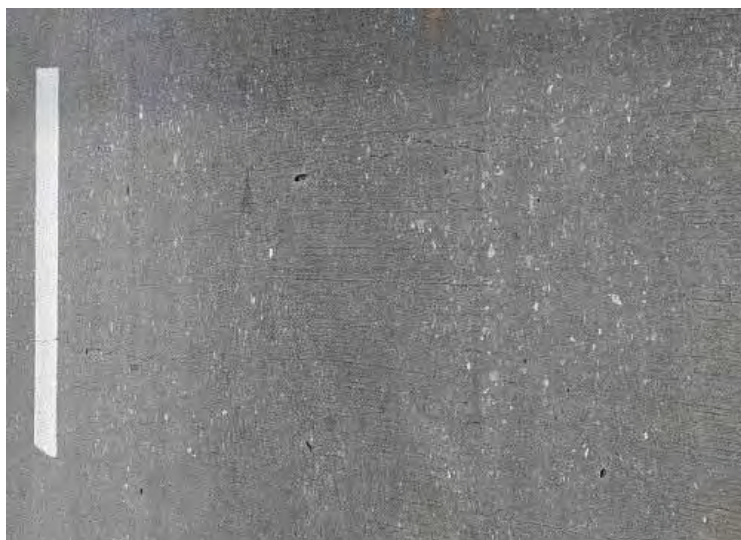
Picture No.	30
Span	1
Member	slab

Crack on slab

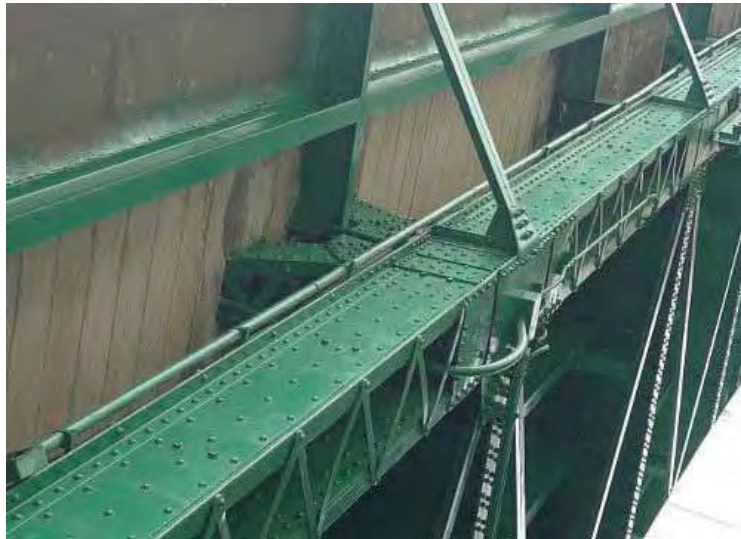
Picture No.	31
Span	1
Member	slab
Replaced slab	
Free lime is seen on slab of center span and walkway

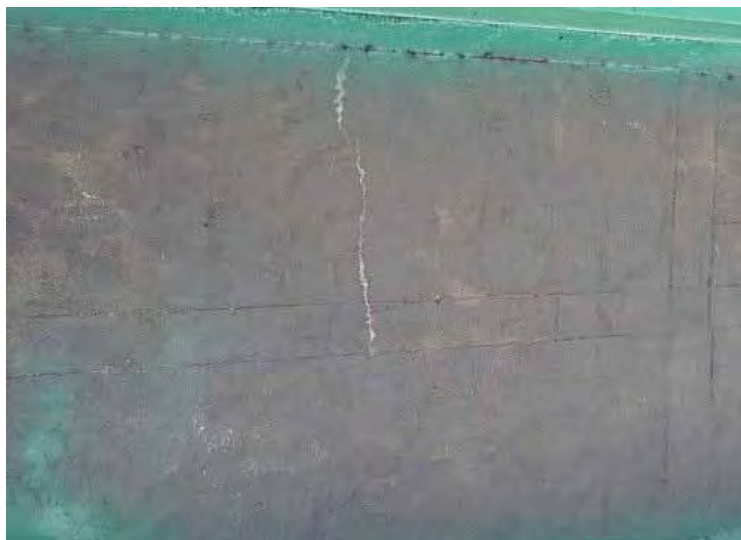
Picture No.	32
Span	1
Member	slab
Crack and free lime

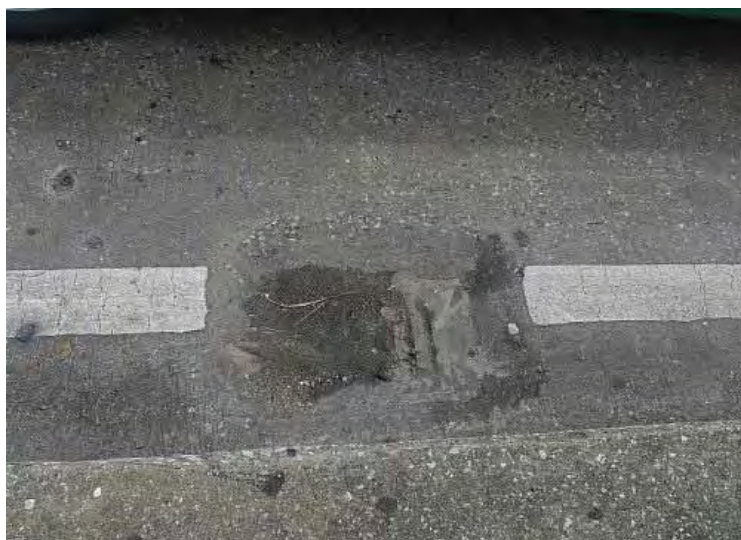
Picture No.	33
Span	1
Member	Drainage
Blocked

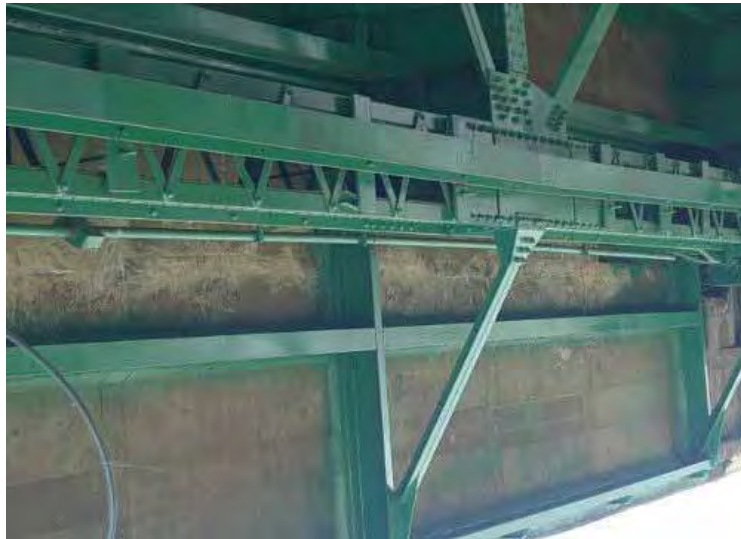
Picture No.	34
Span	1
Member	Slab
Longitudinal crack between road and walkway	
Insufficiency of rigidity of bracket member of walkway?	
*Survey on board, 31-oct

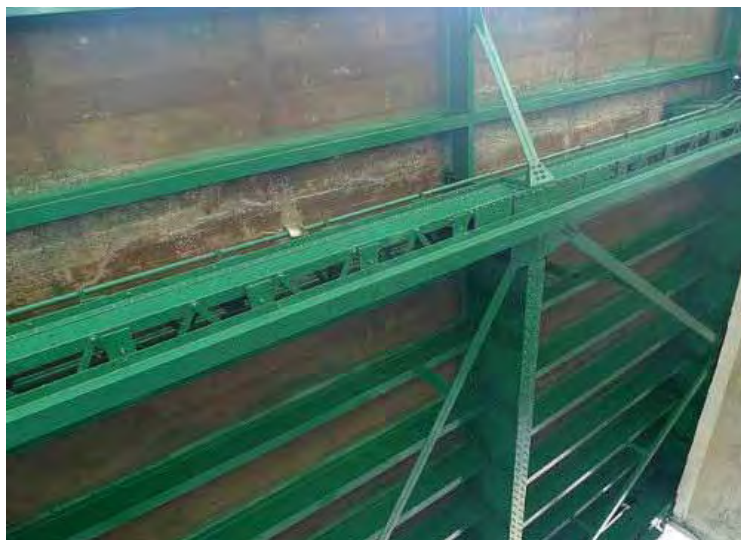
Picture No.	35
Span	1
Member	Slab
Longitudinal crack between road and walkway	
*Survey on board, 31-oct

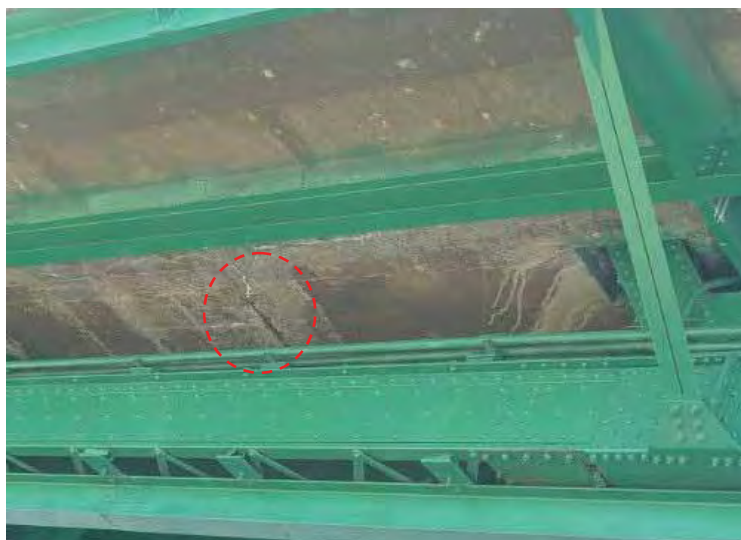
Picture No.	36
Span	1
Member	Slab
Longitudinal crack between road and walkway	
Fracture of surface	
*Survey on board, 31-oct

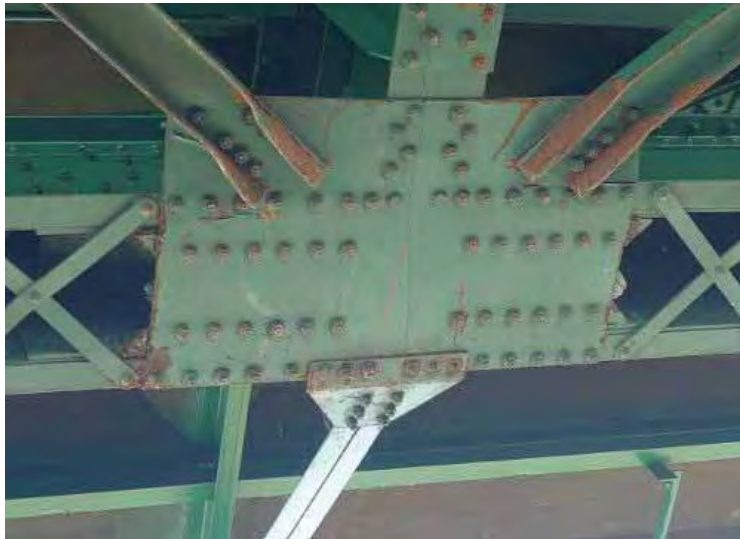
Picture No.	40
Span	1
Member	Gusset plate
Damage by ship collision	
<i>*Survey on board, 31-oct</i>

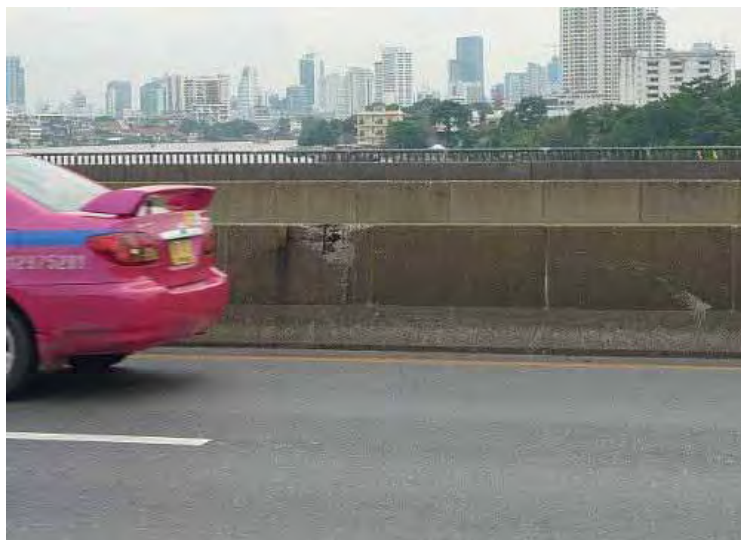
Picture No.	8
Span	1
Member	Center barrier
Fracture of concrete surface

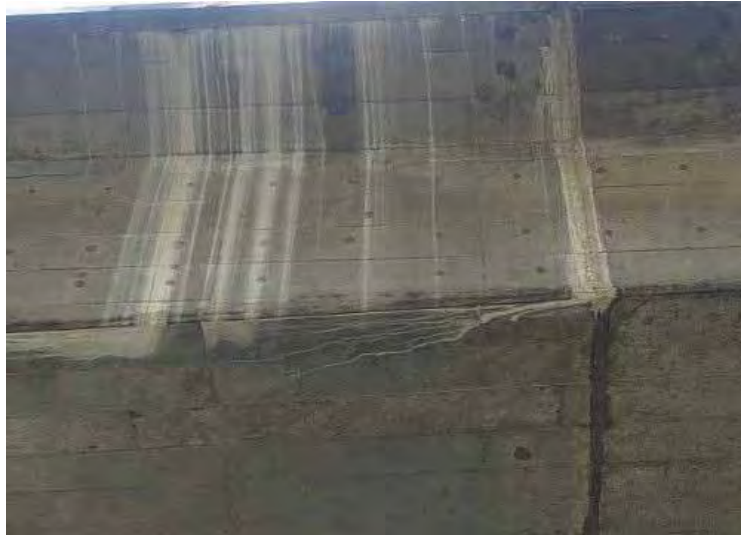
Picture No.	9
Span	1
Member	
Free lime	
Deterioration of drain function	
<i>*Survey on board, 31-oct</i>

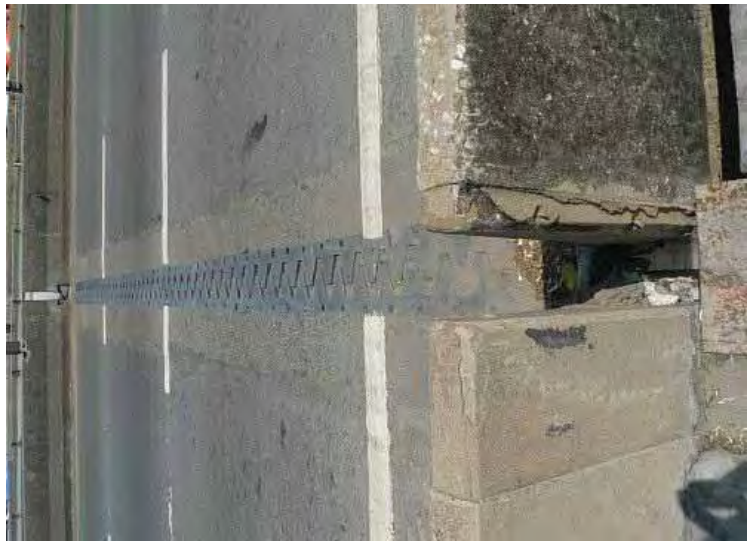
Picture No.	4
Span	1
Member	Expansion Joint
Replaced expansion joint

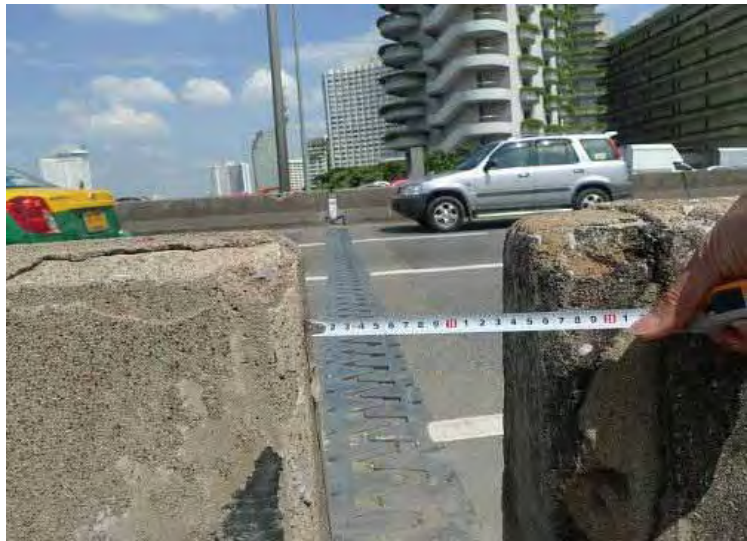
Picture No.	5
Span	1
Member	Expansion joint
Spacing is wider than 3cm than other joint	
Bangkok side, down stream

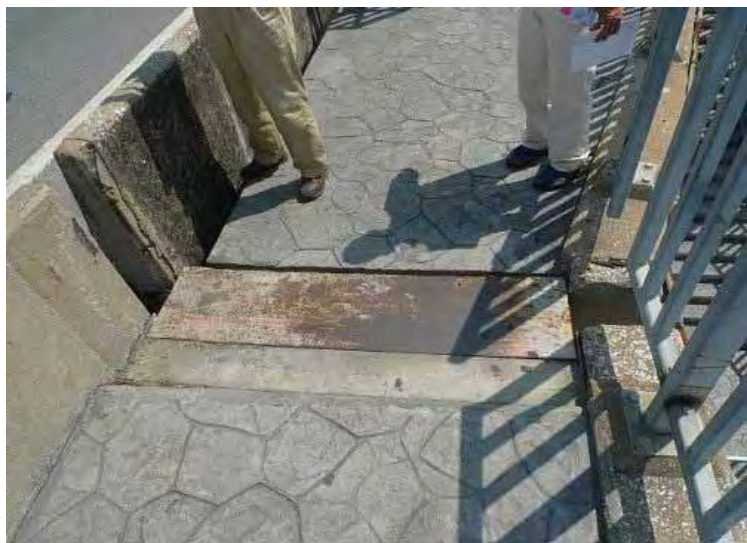
Picture No.	6
Span	1
Member	Expansion joint
Lack of cover of barrier and curv

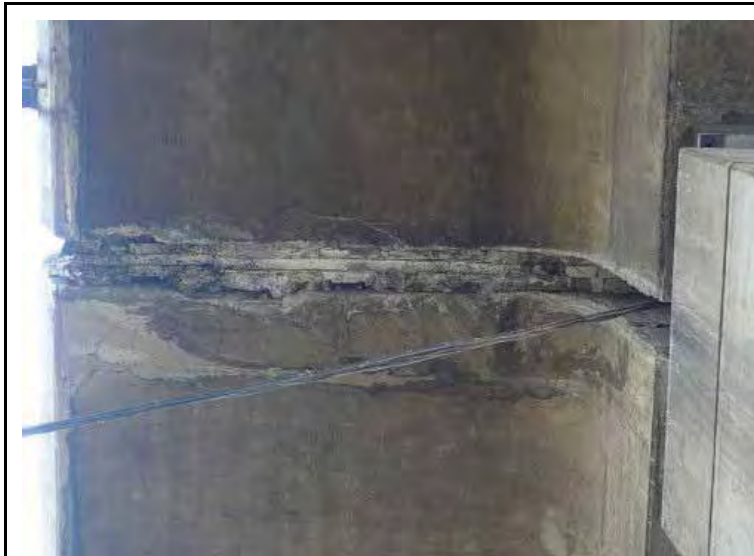
Picture No.	10
Span	1
Member	Expansion joint
Deterioration of drain function	
Mark of leakage

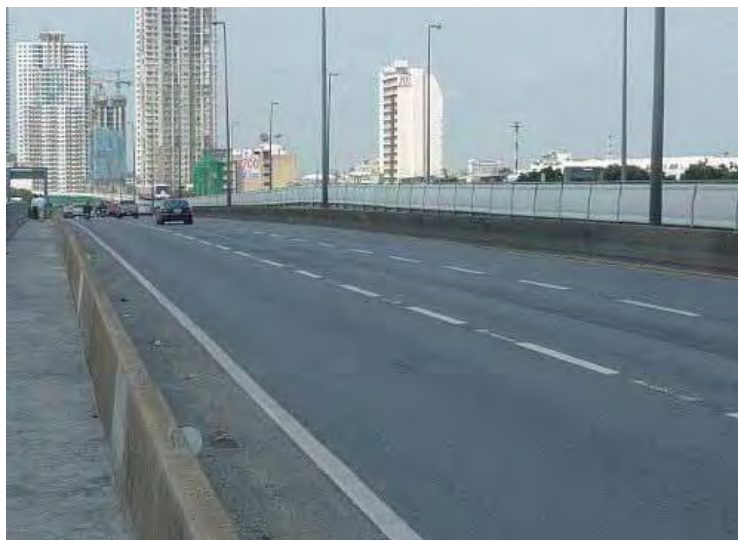
Picture No.	11
Span	1
Member	Vertical alignment
Bent angle between main bridge and approach bridge

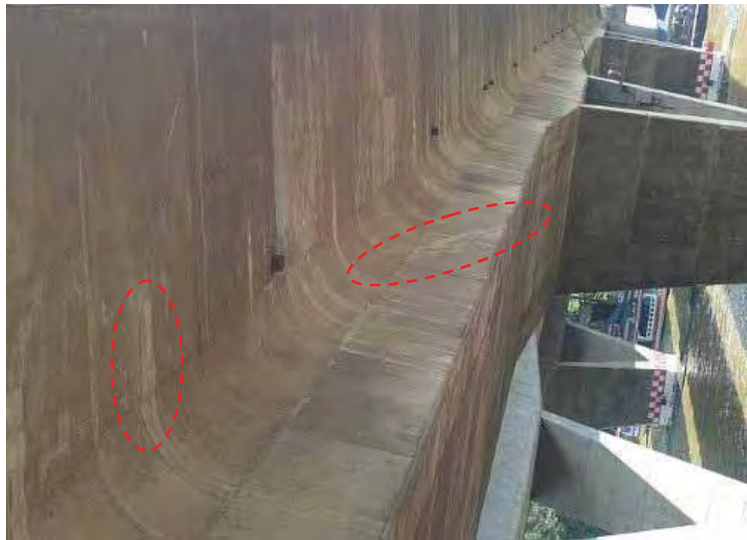
Picture No.	7
Span	1
Member	Box girder
Shear crack or severe cold joint Detailed study is recommended	
Free lime from filled hole Without waterproofing?

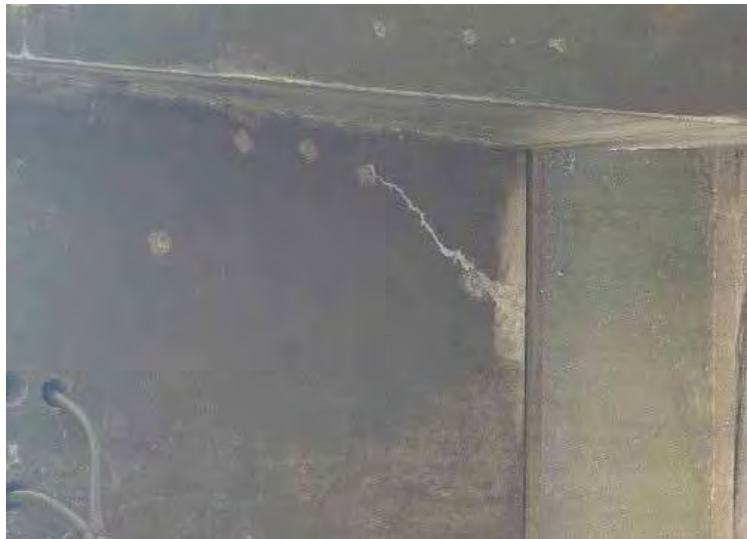
Picture No.	8
Span	1
Member	Catch basin
Free lime from filled hole Without waterproofing?

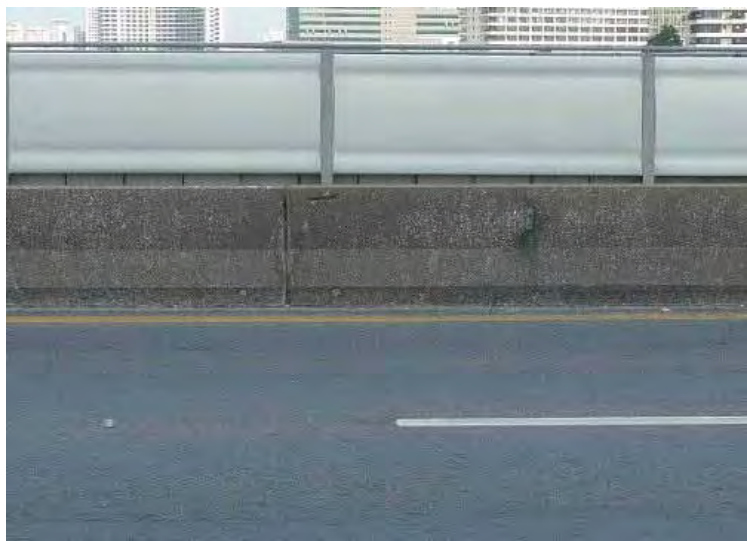
Picture No.	9
Span	1
Member	Barrier
Exposure of rebar

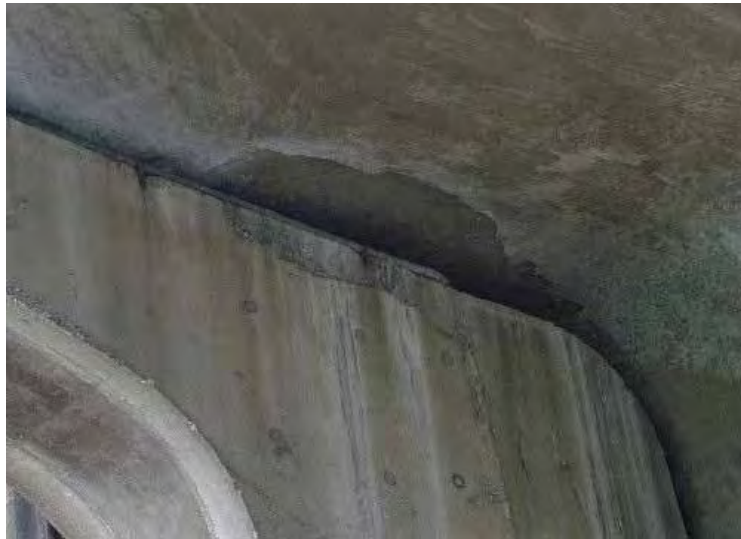
Picture No.	10
Span	1
Member	Slab
Mark of repair
