Inspection sheet of visual survey

Bridge No. 11

Bridge name		RAMA VIII Bridge		Route name		-		Authority		BMA		Code of authority		-		
Place		from Khat Bang Phlat to Khet Phra Nakhon		Distance		from km+ 0 to km+ 0						No.		-		
												Survey date		23-Oct-2009		
Bridge properties	Bridge type(1)	main road · side road · ramp														
	Bridge type(2)	bridge · viaduct · plank pass														
	Bridge type(3)	4-span composite 2 l girder cable stayed bridge														
	Total length	475.00 (m)														
	Span	75 + 50 + 50 + 300 (m)														
	Nos. of span	4 span														
	Width	29.20 (m) / (m)														
	Completion	2002														
Road information	Horizontal	Straight · incli (θ = 2 %) · Curve (R m)														
	Gradient	One way (↗ · ↘) parabo (▽ · ▹)														
	Nearby tunnel	yes · no (m)														
	Nearby crossing	yes · no (ramp way)														
	Traffic	Much · Medium · Little														
	Commercial traffic	Much · Medium · Little

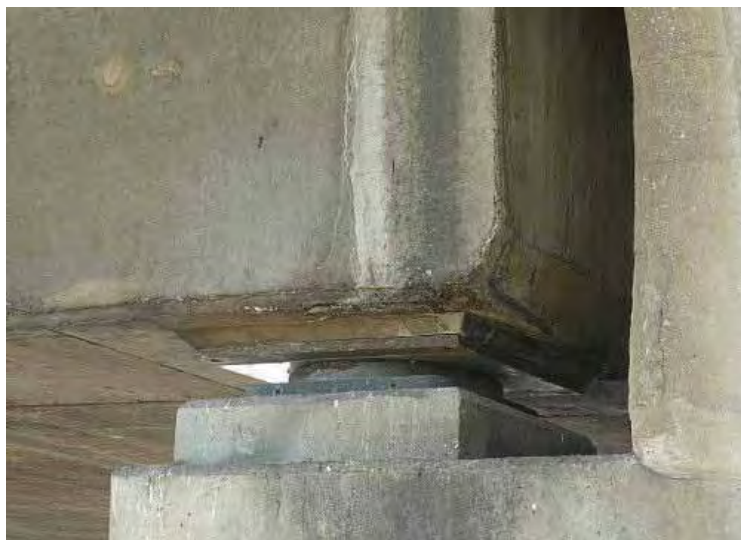
Picture No.	11
Span	1
Member	Bearing
Leakage from joint	
Upstream, Thon Buri side

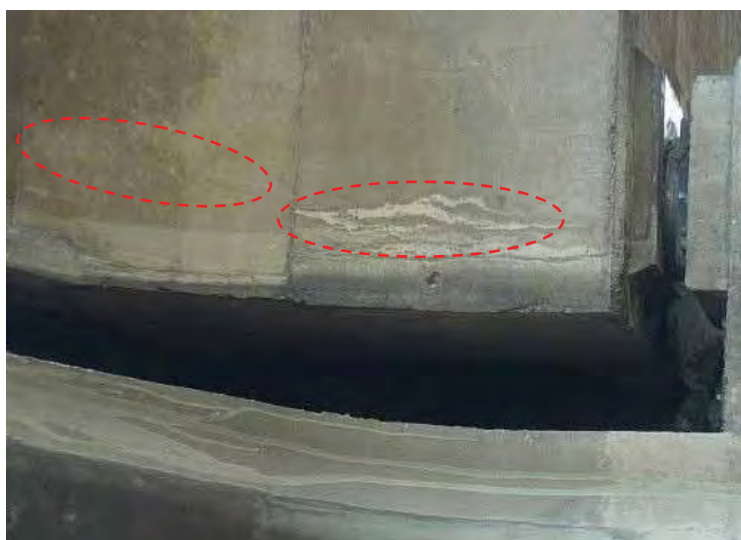
Picture No.	12
Span	1
Member	Lighting pole
Free lime (lower)	
Crack (upper)	
Upstream, Bangkok side

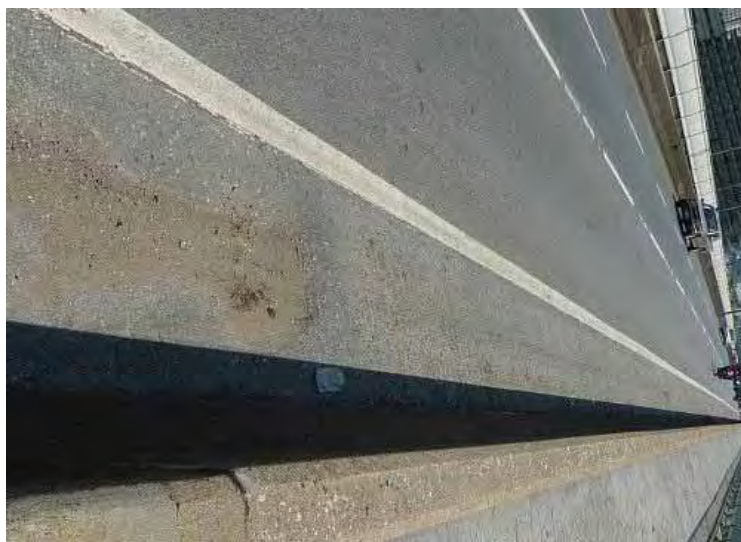
Picture No.	7
Span	1
Member	Catch basin
Blocking
