# Inspection sheet of visual survey

Bridge No. 16

Bridge name		RAMA III Bridge		Route name		-		Authority		DRR		Code of authority		-			
Place		from Khet Thon Buri to Khet Bang Kho Leam		Distance		from km+ 0 to km+ 0						No.		-			
												Survey date		2009/10/23			
Bridge properties	Bridge type(1)	main road · side road · ramp															
	Bridge type(2)	bridge · viaduct · plank pass															
	Bridge type(3)	3-span continuous PC box girder															
	Total length	476.00 (m)															
	Span	125 + 226 + 125 (m)															
	Nos. of span	3 span															
	Width	23.00 (m) / (m)															
	Completion	2000															
Road information	Horizontal	Straight · incli ( $\theta =$ ° ) · Curve ( R m )															
	Gradient	One way ( ↗ · ↘ ) parabo ( $\frac{1}{4}$ · $\frac{3}{4}$ )															
	Nearby tunnel	yes · no ( m )															
	Nearby crossing	yes · no ( m )															
	Traffic	Much · Medium · Little

Bridge name		Krung Thep Bridge		Route name		-		Authority		DRR		Code of authority		-			
Place		from Khet Thon Buri to Khet Bang Kho Leam		Distance		from km+ 0 to km+ 0						No.		-			
												Survey date		2009/10/23			
Bridge properties

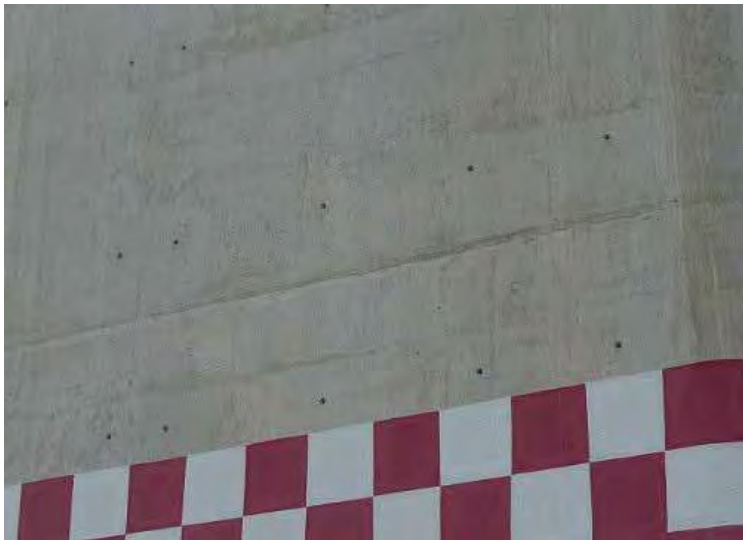
Picture No.	4
	Span	1
	Member	Pier
	Unfilled hole

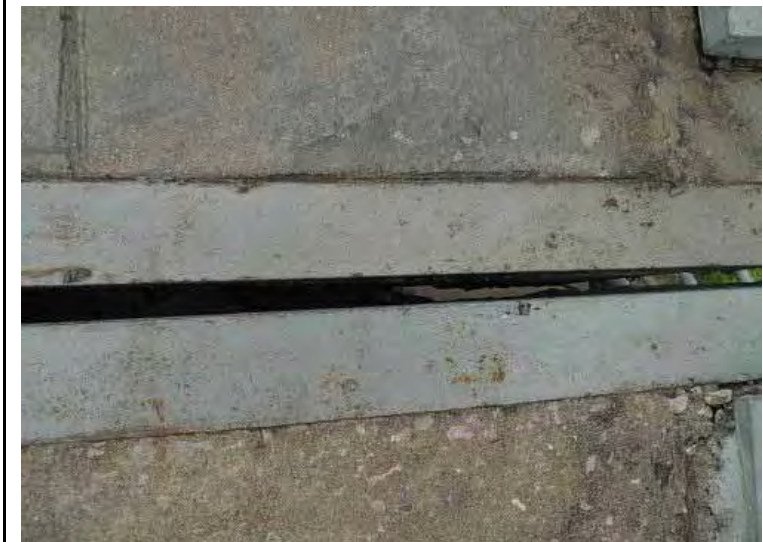
Picture No.	9
Span	1
Member	Expansion joint
Deterioration of drainage function

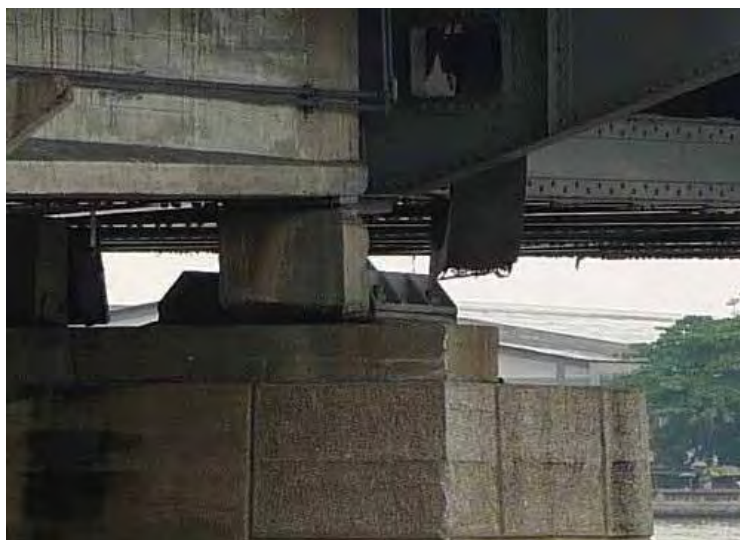
Picture No.	12
Span	1
Member	Expansion joint
Fracture of concrete edge of locker bearing	
Falling of water proofing material

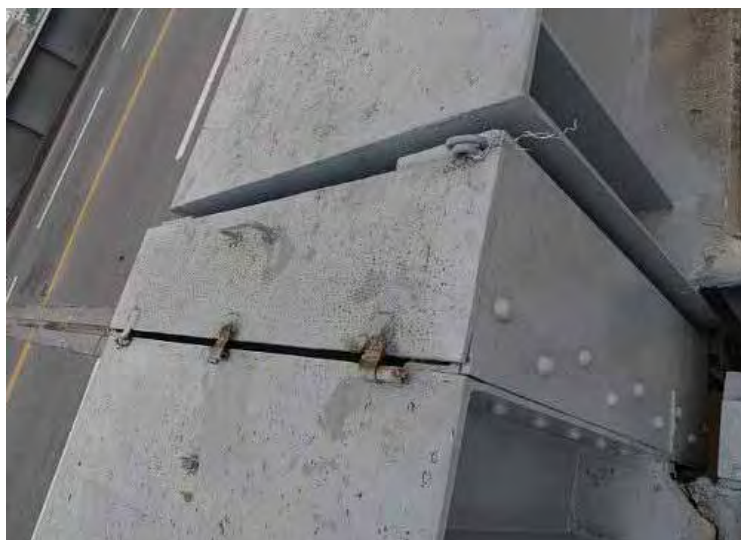
Picture No.	15
Span	1
Member	Center span
Hinge part	
Continuous vibration	
It is important to check fatigue crack around rotation center.

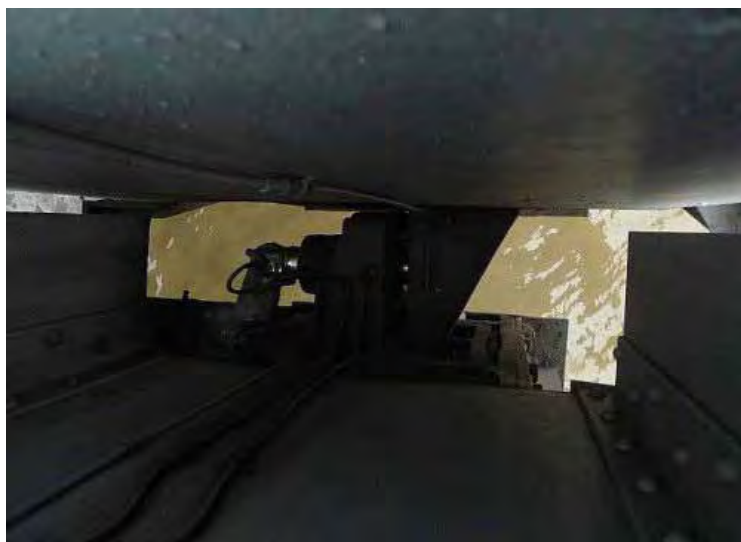
Picture No.	16
Span	1
Member	Stay cable
Hinge of drawbridge	
Mechanical parts is replaced every 2 years.

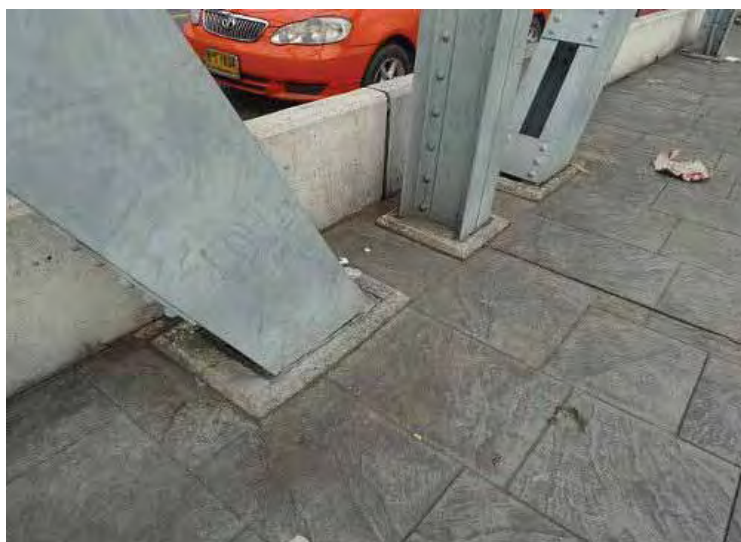
Picture No.	17
Span	1
Member	Vertical member
Mount up around vertical member to prevent remaining water.

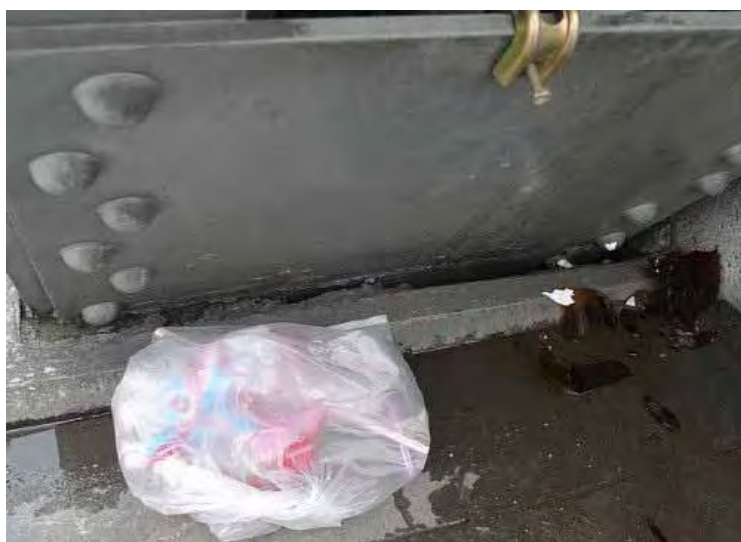
Picture No.	18
Span	1
Member	Vertical member
Deterioration of calking in gap

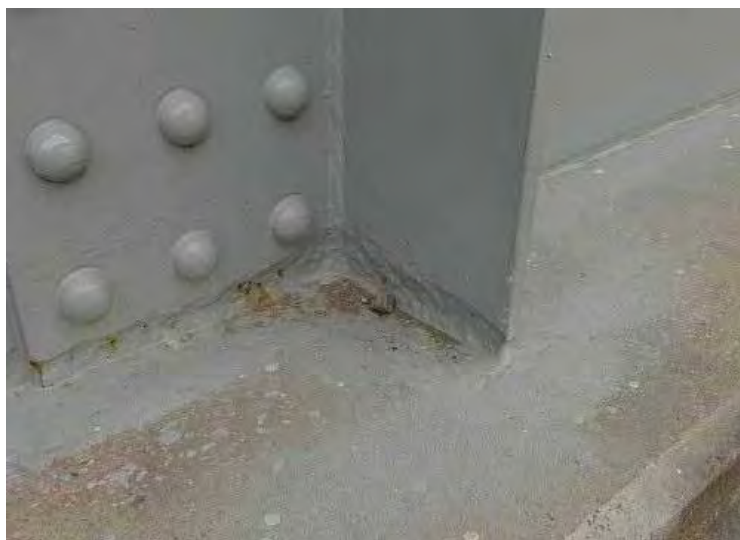
Picture No.	33
Span	1
Member	Center span
Rust from painting part	
Possibility of insuficient of scraping before painting

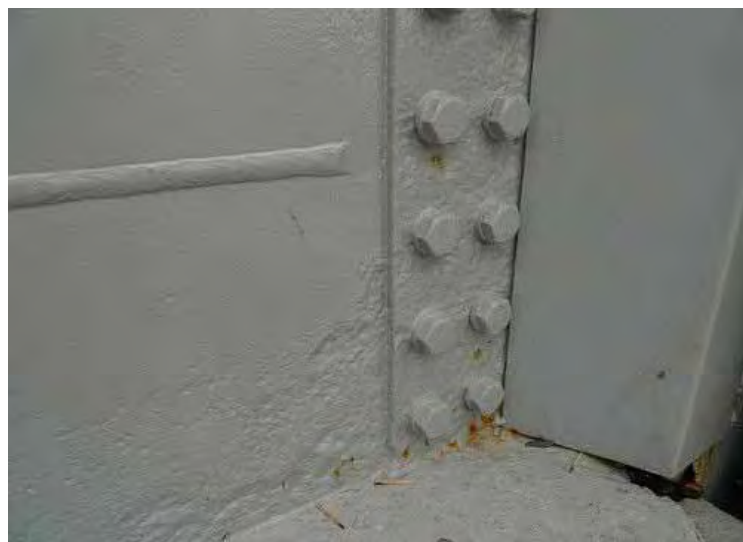
Picture No.	34
Span	1
Member	Center span
Around center joint	
Change from revet to bolt	
Mark of remarkable corrosion	
Rust from painting part	
Possibility of insuficient of scraping before painting

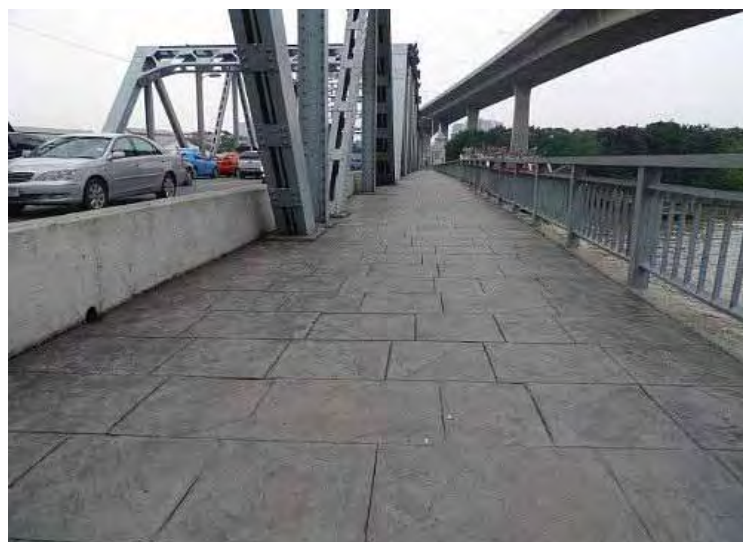
Picture No.	35
Span	1
Member	Center span
Deflection between vertical member?

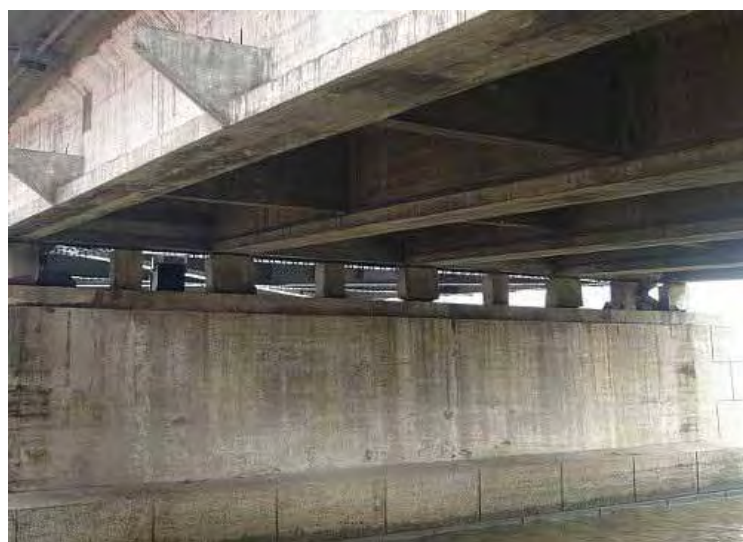
Picture No.	36
Span	1
Member	Center span
Inclination of locker bearing Bangkok side

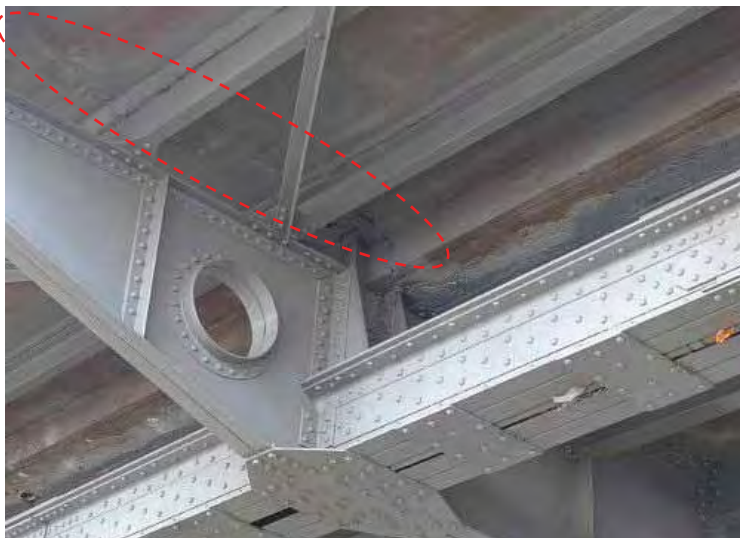
Picture No.	42
Span	1
Member	
Crack above bracket	
<i>*Survey on board, 31-oct</i>

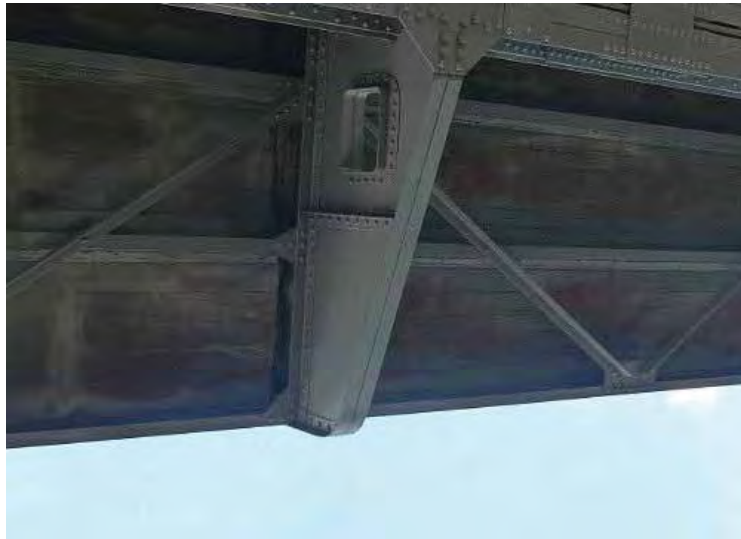
Picture No.	43
Span	1
Member	Slab
Fracture of slab on bracket	
<i>*Survey on board, 31-oct</i>

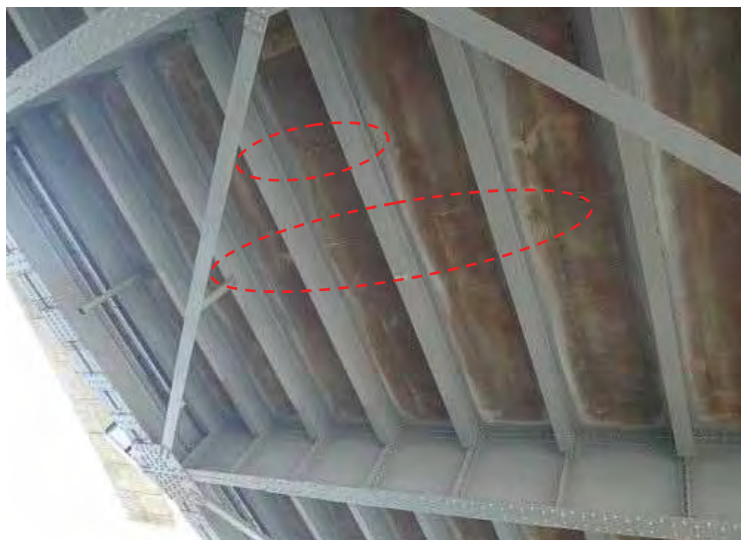
Picture No.	44
Span	4
Member	Slab
Crack	
Free lime	
*Survey on board, 31-oct

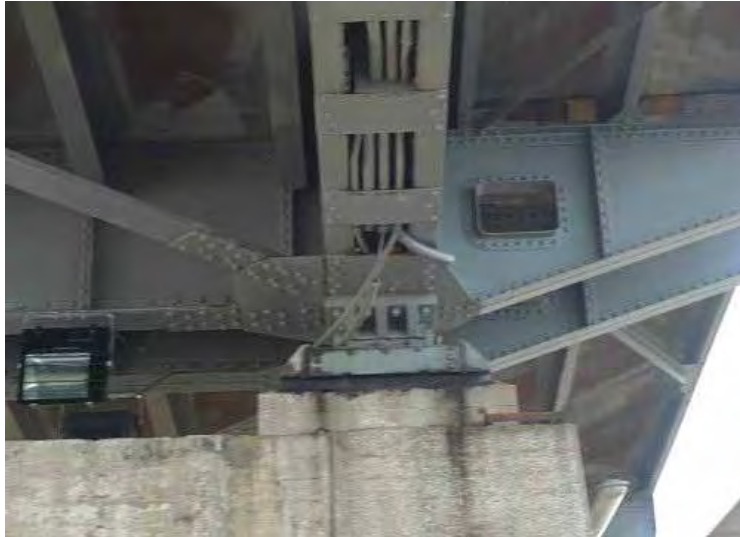
Picture No.	46
Span	1
Member	Bearing

Deterioration of corrosion proofi

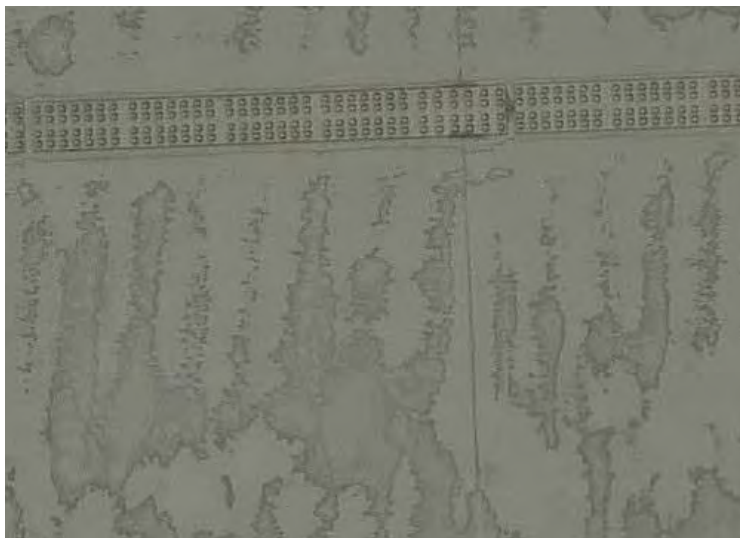
Picture No.	9
Span	1
Member	Bottom flange

Deterioration of corrosion proofing

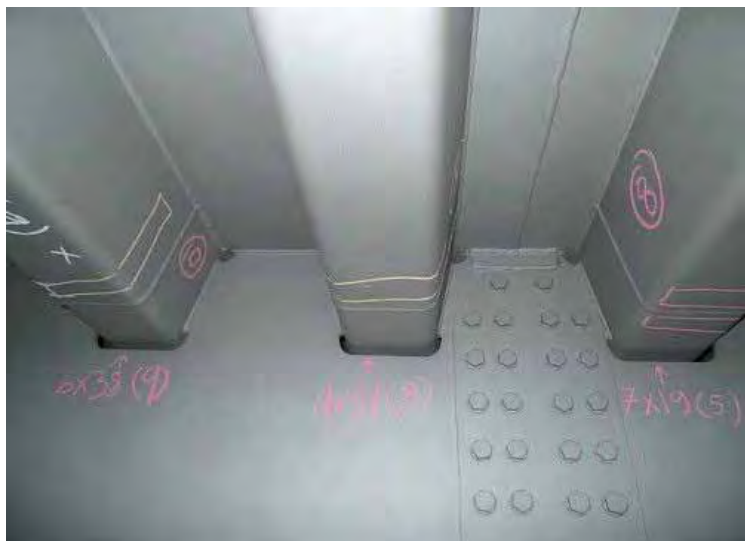
Picture No.	12
Span	1
Member	slab
Mark of deformation of member	
Axial stress is small at span cer	
Normaly, far from yield stress.	
It's not clear the deformation	
and reinforcement at this survev.

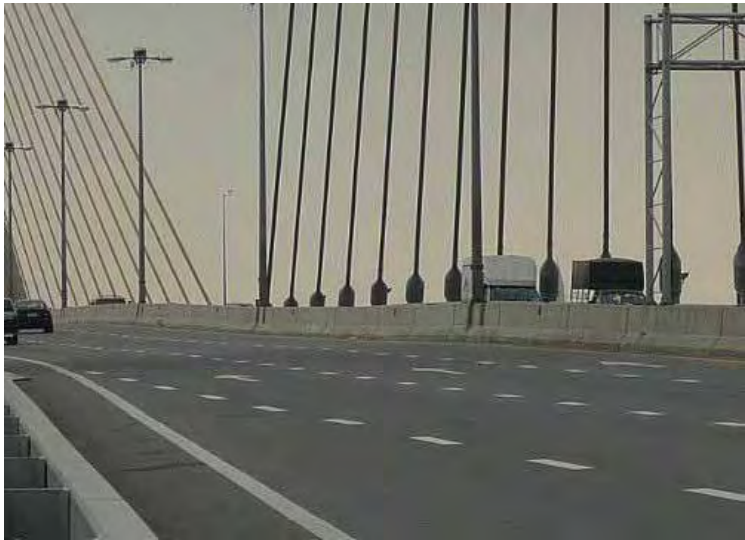
Picture No.	8
	Span	1
	Member	Vertical alignment
	Saged vertical alignment

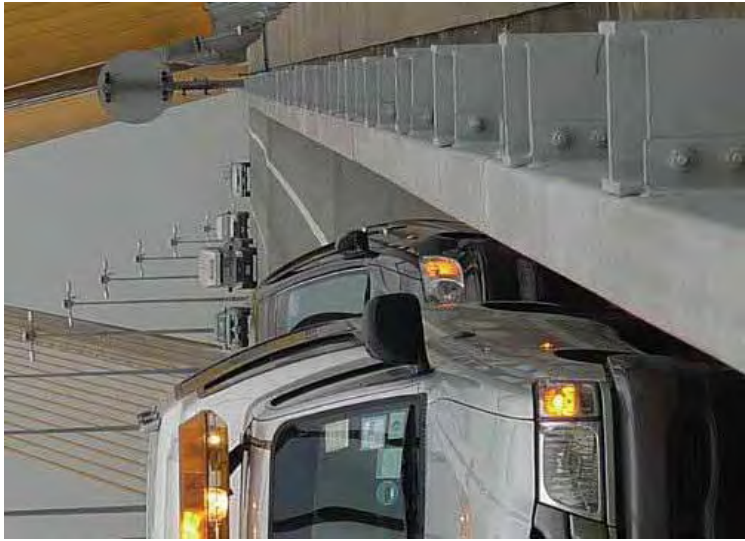
Picture No.	9
	Span	1
	Member	Vertical alignment
	Saged vertical alignment

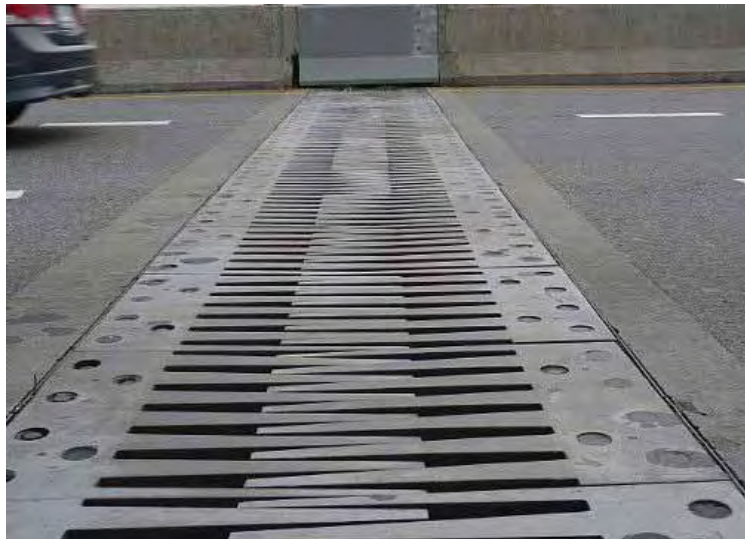
Picture No.	11
Span	1
Member	Expansion joint
North side.	
Occurrence of sound of impact	
Jumping by heavy vehicle

Railing	Stainless		Generally healthy																
	Curb	-		-																
	Pavement	asphalt · concrete		-																
	Joint	drained · undrained		Occurrence of sound of impact																
	Drainage	yes · no																		
History of repair	· Occurrence of sound of impact and jumping by heavy vehicle at at expansion joint · Crack is seen in pylon around cross beam end. It is required detailed investigation. especially in the case of increasing the defect after completion. · Improvement around fixing structure is recommended.																			
Surveyor ;	Mr. Chujo, Mr. Kudo										Repaint ;					- yy - mm

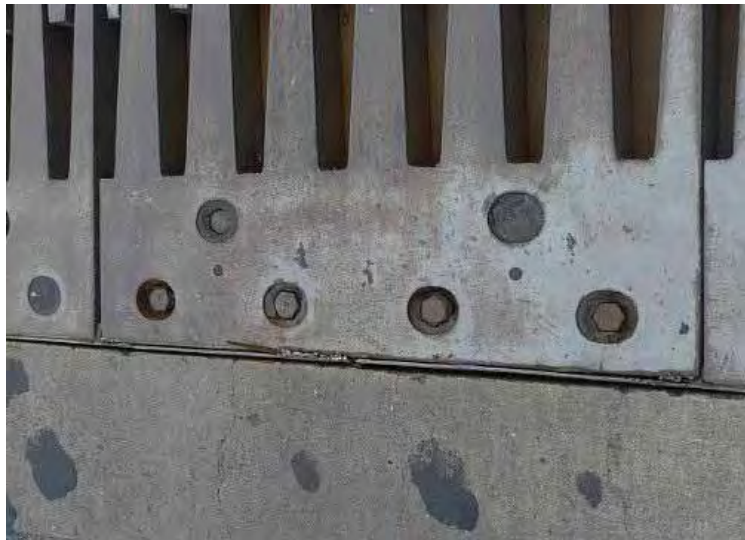
Picture No.	12
Span	1
Member	Expansion joint
Looseness of bolt

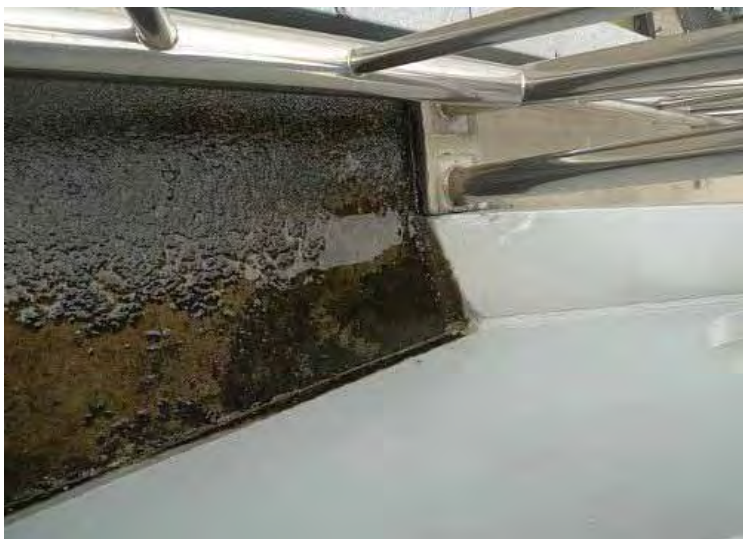
Picture No.	18	
			Span	1	
			Member	slab	
			Remaining water and deterioration of corrosion proofi

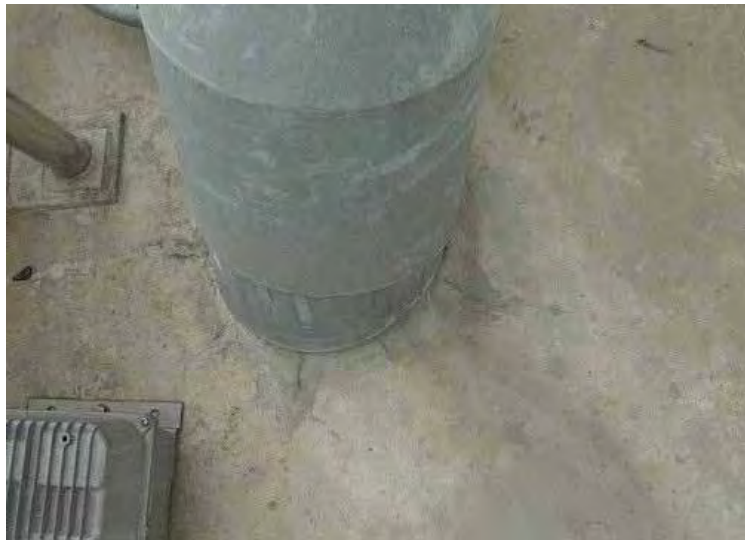
Picture No.	13
	Span	1
	Member	slab
	Crack from cable fixing structure	
	PC girder part

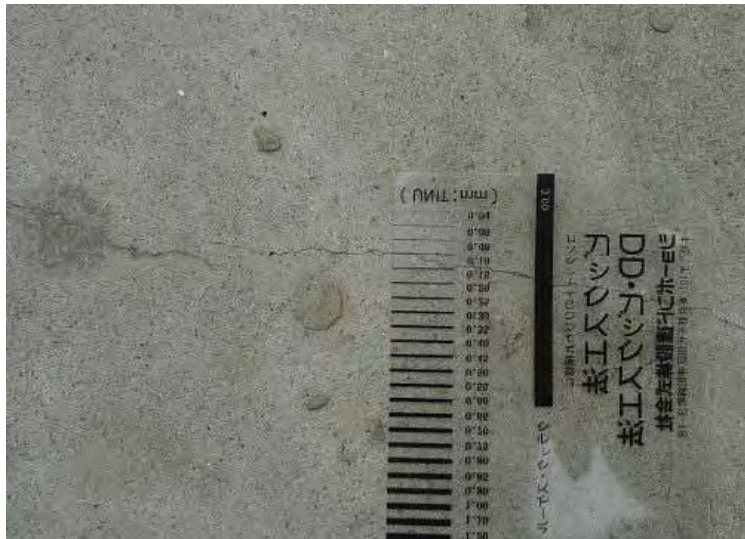
Picture No.	14
	Span	1
	Member	slab
	Crack from cable fixing structure	
	0.1mm~0.15mm	
	PC girder part

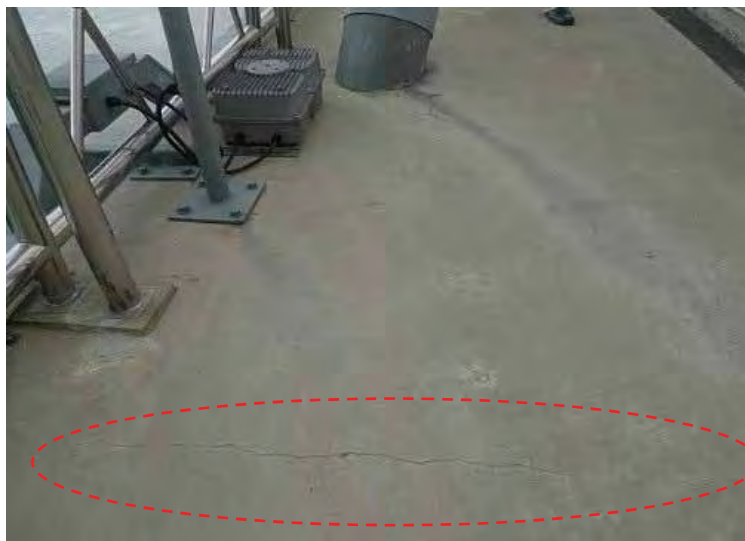
Picture No.	15
	Span	1
	Member	slab
	crack	
	PC girder part

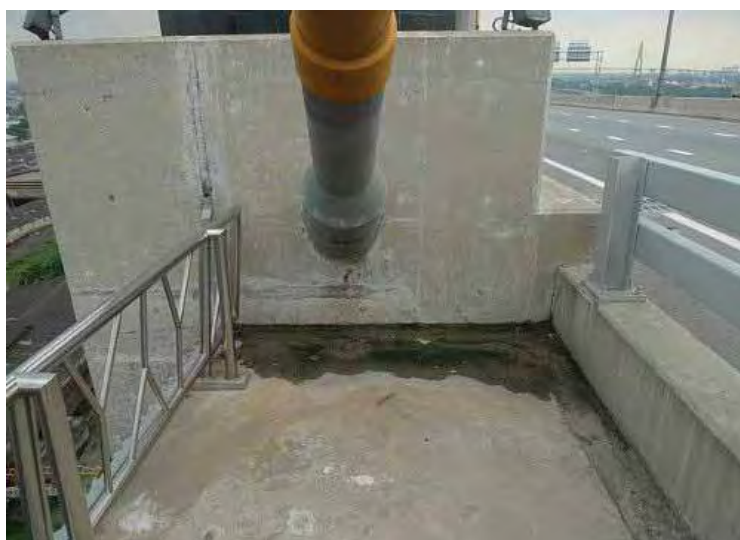
Picture No.	18
Span	1
Member	slab
Remaining water

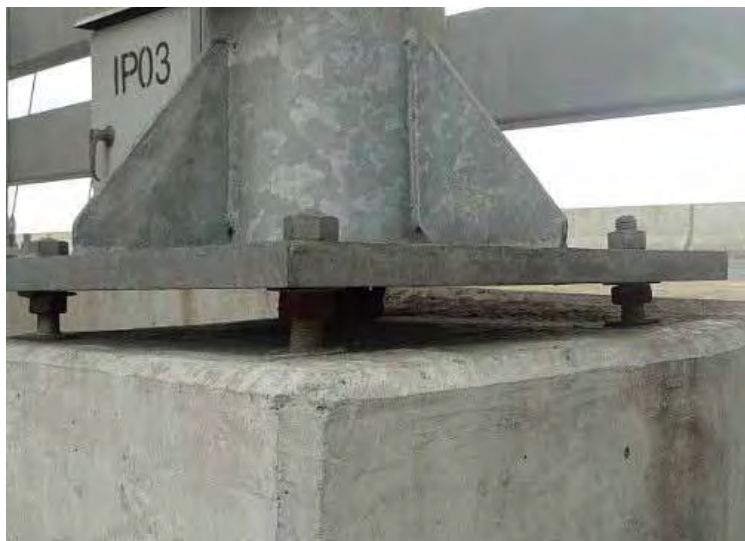
Picture No.	24
Span	1
Member	Lighting pole
Gap between base plate and foundation

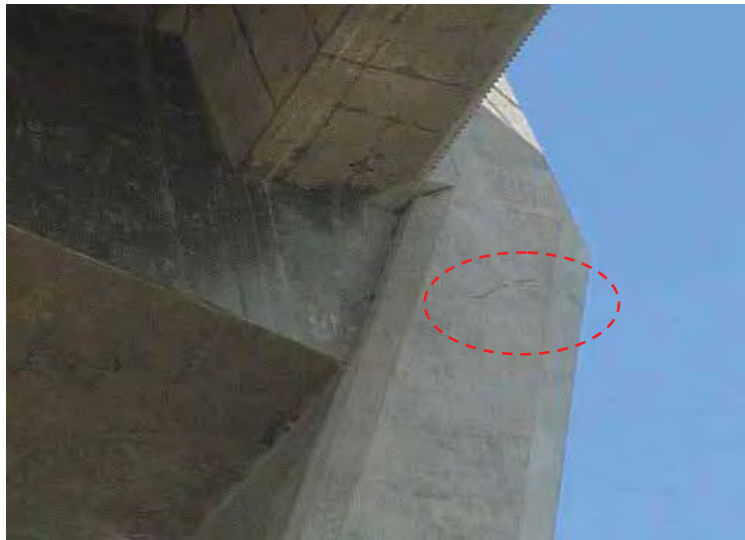
Picture No.	28
Span	1
Member	
North bridge- South pylon - cente	
crack	
*Survey on board, 31-oct

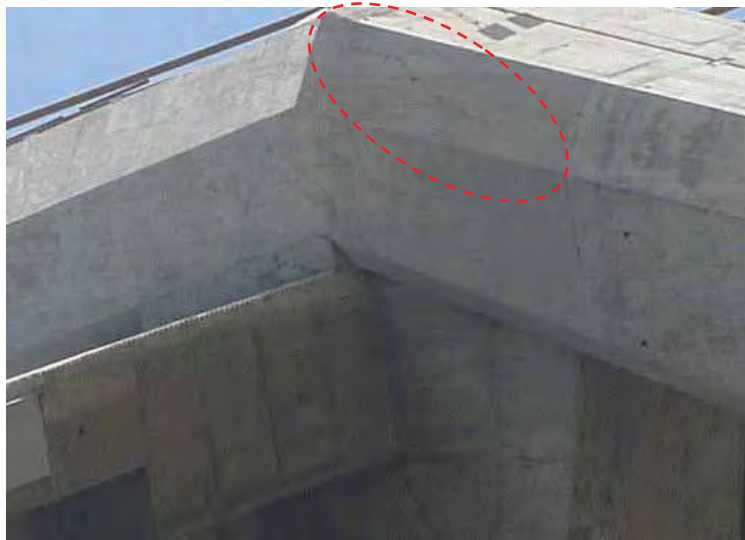
Picture No.	29
Span	1
Member	
North bridge - North pylon - cent	
crack	
*Survey on board, 31-oct

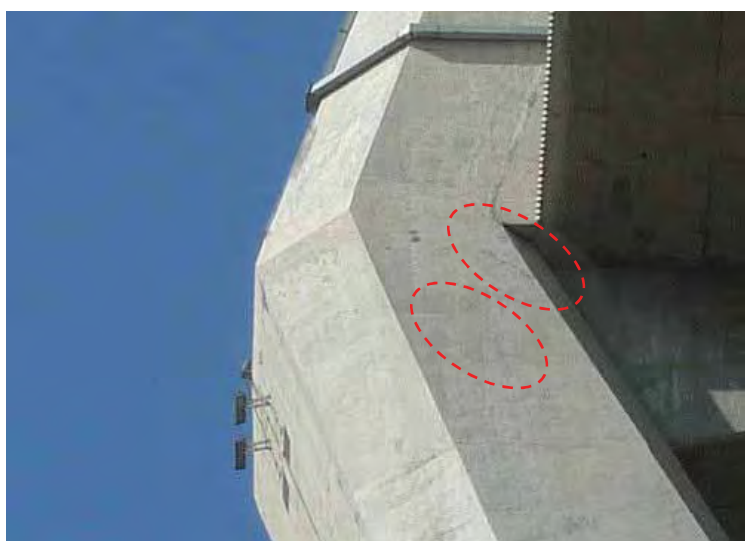
Picture No.	30
Span	1
Member	
North bridge - North pylon - cent	
crack	
*Survey on board, 31-oct

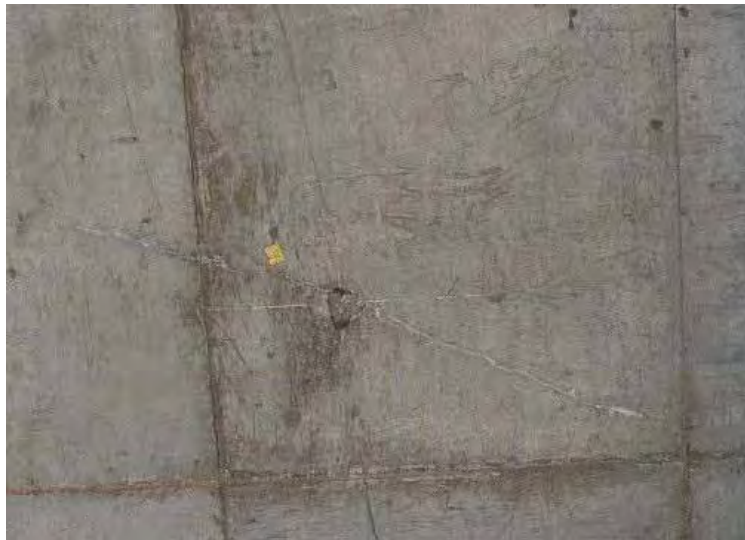
Picture No.	7
Span	1
Member	slab bottom surface
Free lime from filled hole

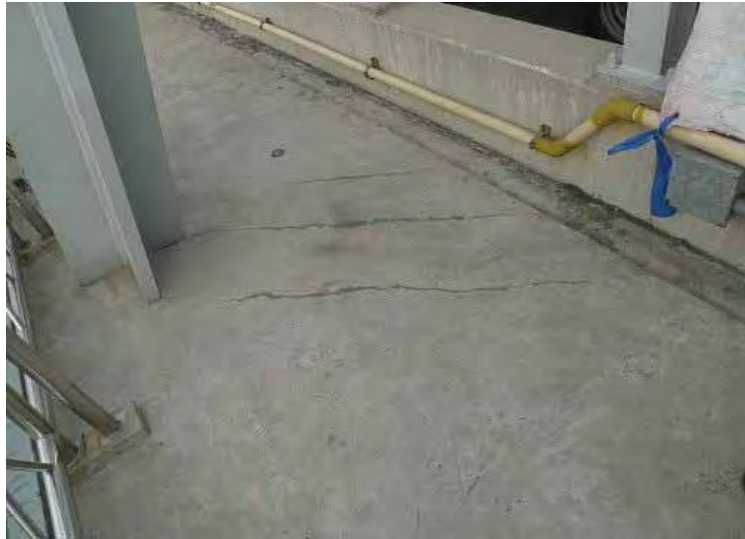
Picture No.	8
Span	1
Member	slab
Crack from cable fixing structure

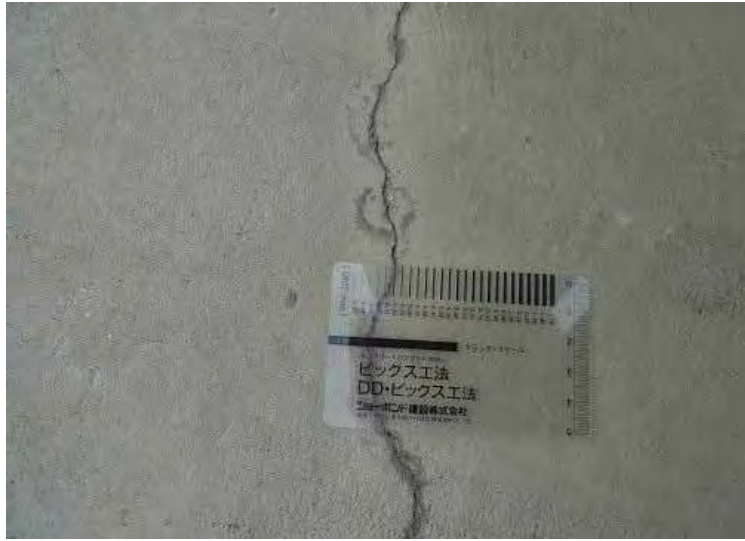
Picture No.	9
Span	1
Member	bottom slab
Crack from cable fixing structure	
0.15mm - 0.3mm

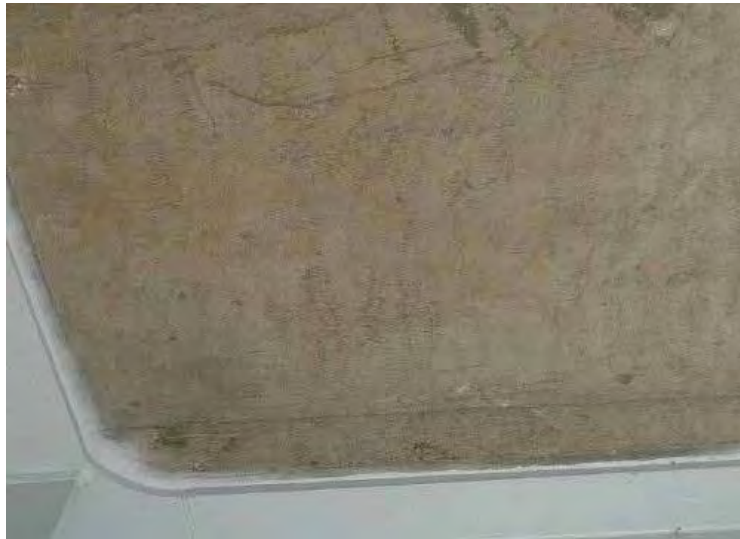
Picture No.	10
Span	1
Member	bottom slab
Back surface of crack around fixed	
Crack cannot find from inspection vehicle (about 2m from eye height)

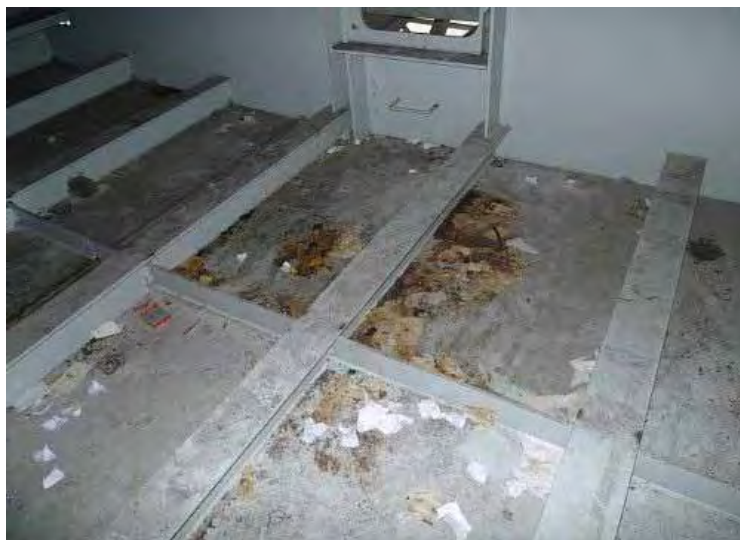
Picture No.	11
Span	1
Member	Connection girder
Inside of connection girder	
Harm of bird

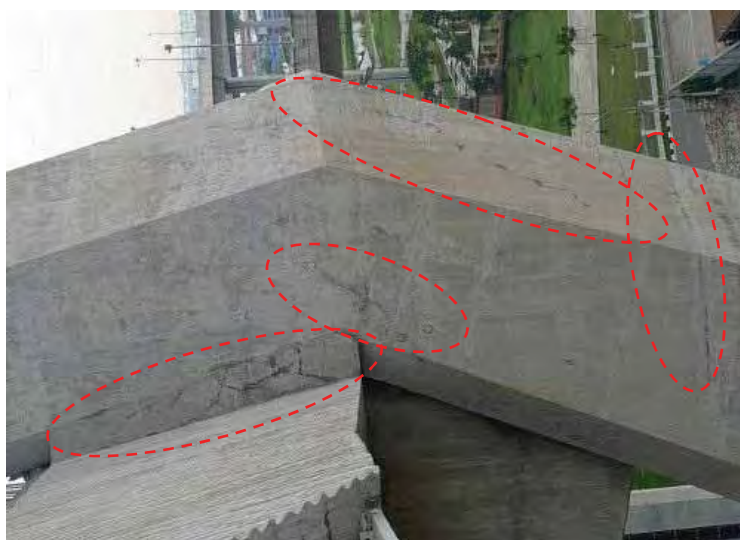
Picture No.	12
Span	1
Member	Pylon
Vertical crack at cross beam end	
Inclined crack of pylon shaft	
Opening construction joint

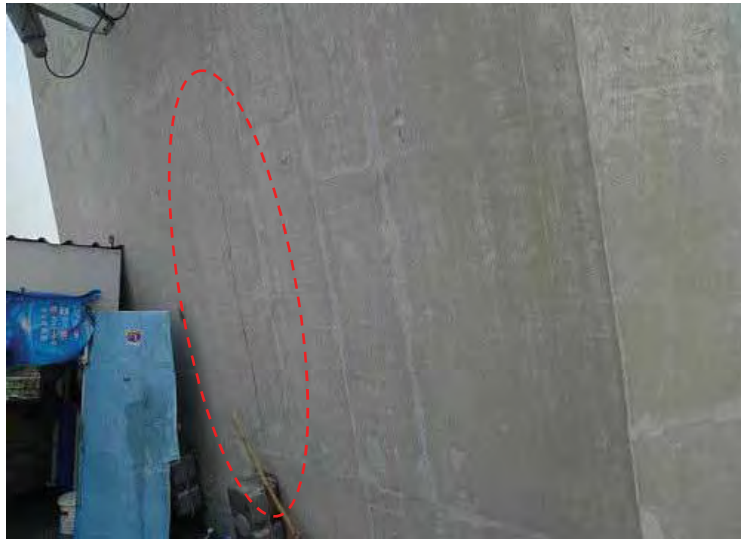
Picture No.	7
Span	1
Member	Pylon

Vertical crack of pylon shaft

Possibility of shirincage crack during construction is high.
--

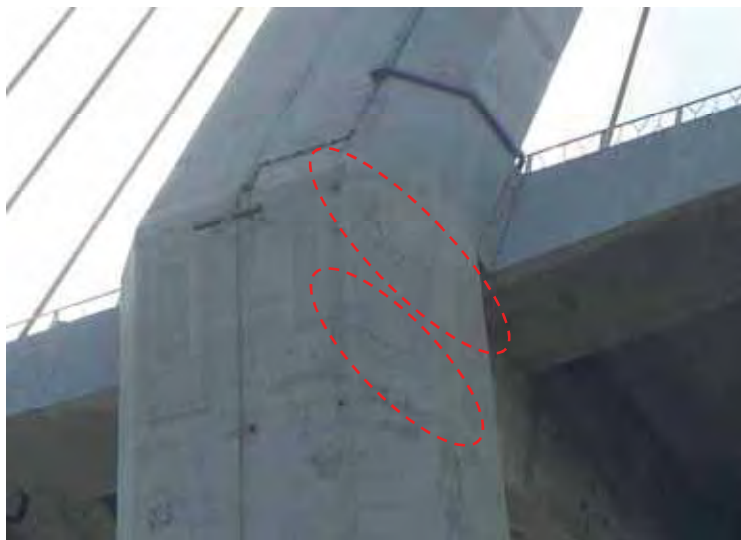
Picture No.	8
Span	1
Member	Pylon

Crack
-------
