Appendix-6

Bridge Inspection Sheets of Visual Survey

Inspection sheet of visual survey

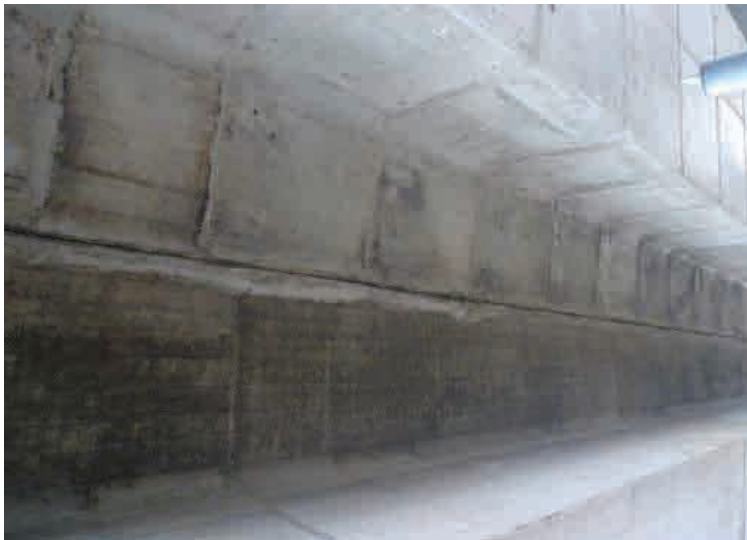
Picture No.	4
	Span	1
	Member	Longitudinal joint
	Longitudinal joint between girder	
	Leakage from joint

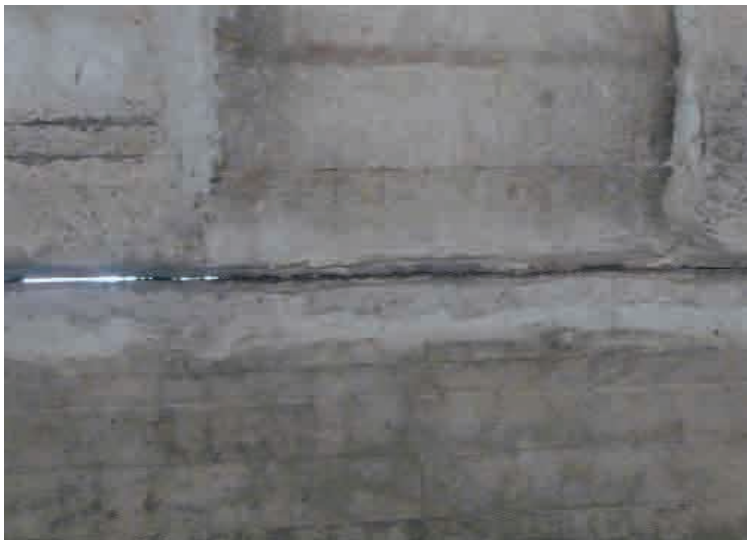
Picture No.	5
	Span	1
	Member	Longitudinal joint
	Longitudinal joint between girder	
	Exfoliation of concrete

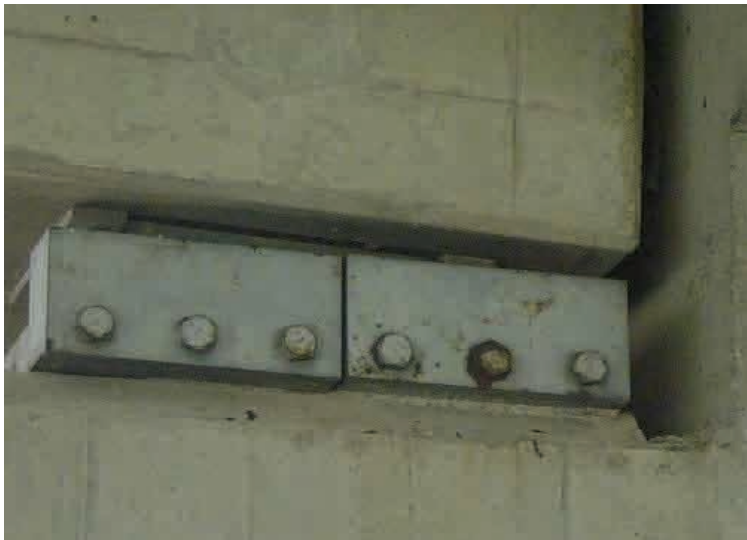
Picture No.	10
	Span	1
	Member	Bearing
	Deterioration of corrosion proofing

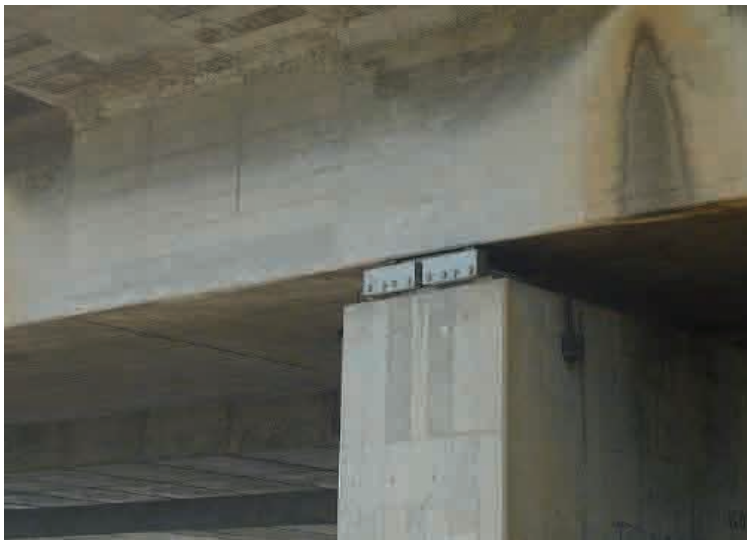
Picture No.	11
	Span	1
	Member	bearing
	Spacing of side block	
<i>*Survey on board, 31-oct</i>

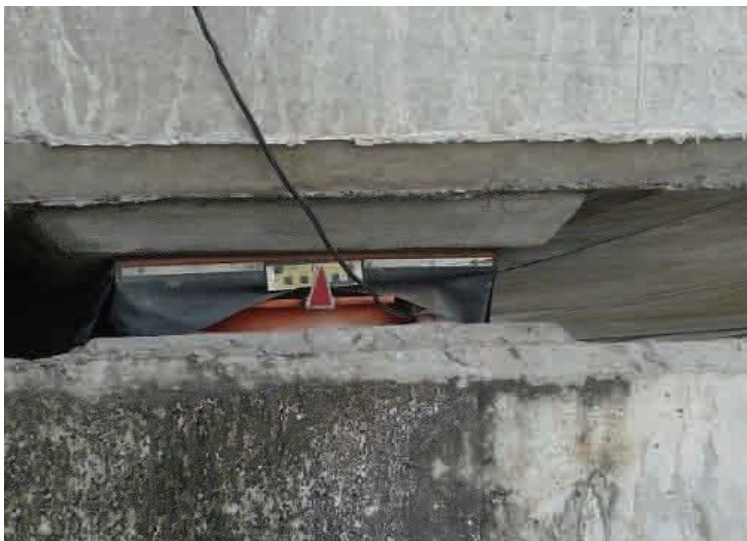
Picture No.	12
	Span	1
	Member	Bearing
	Additional bridge, no movement

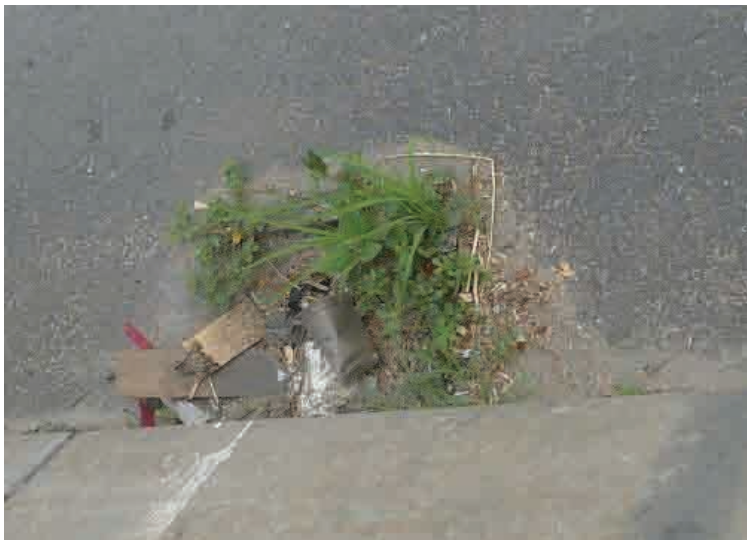
Picture No.	8
	Span	1
	Member	Catch basin
	Blocking of catch basin

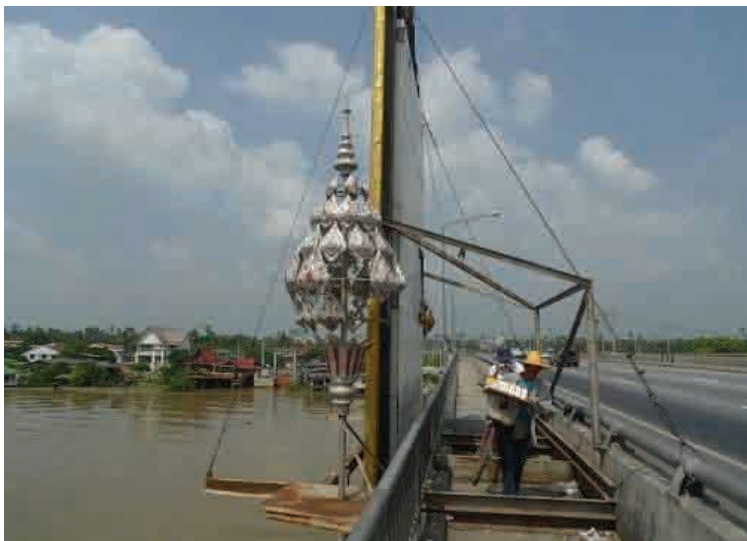
Picture No.	9
	Span	1
	Member	Walkway
	Obstacle of bicycle

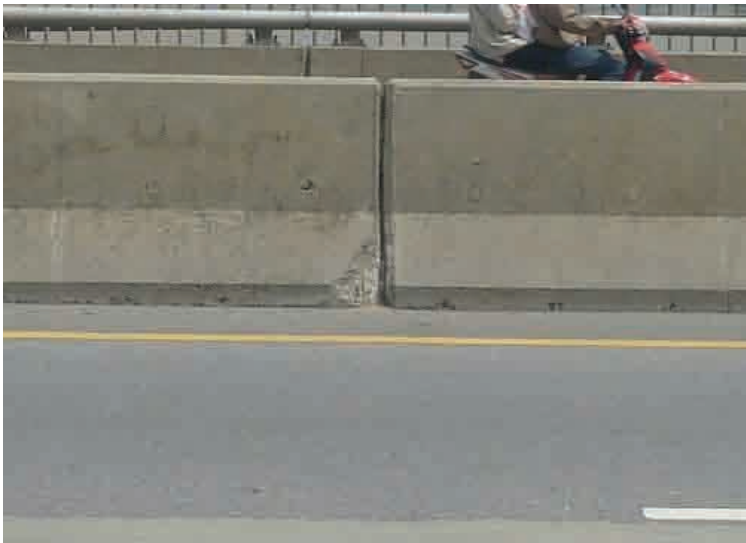
Picture No.	10
	Span	1
	Member	Barrier
	Chipping of barrier

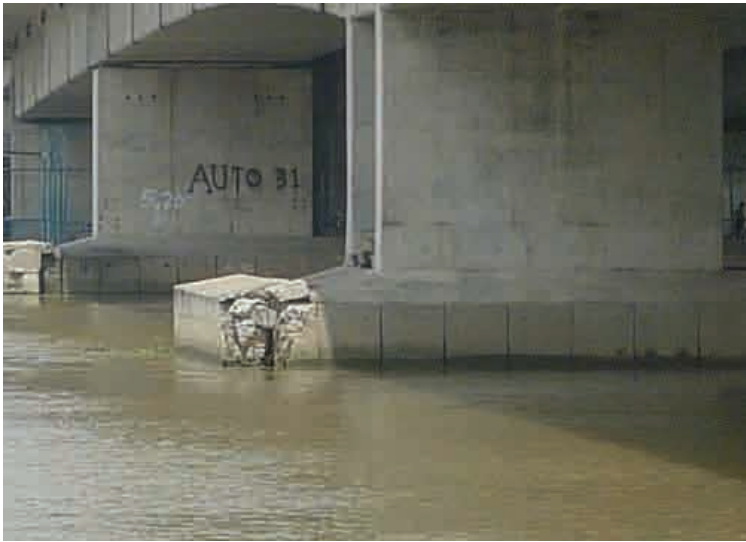
Picture No.	11
	Span	1
	Member	Footing
	Ship collision to protection	
	Picture No.	12
	Span	1
	Member

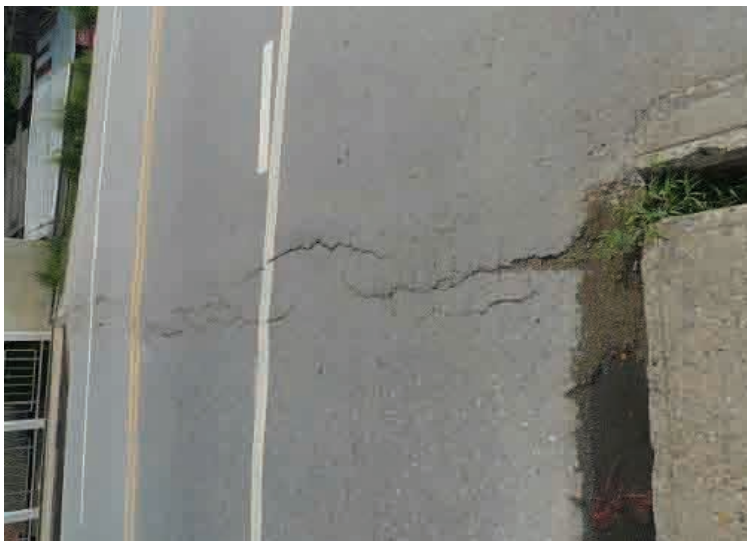
Picture No.	6
	Span	1
	Member	Expansion joint
	Expansion joint was filled by asphalt	
	Bangkok side

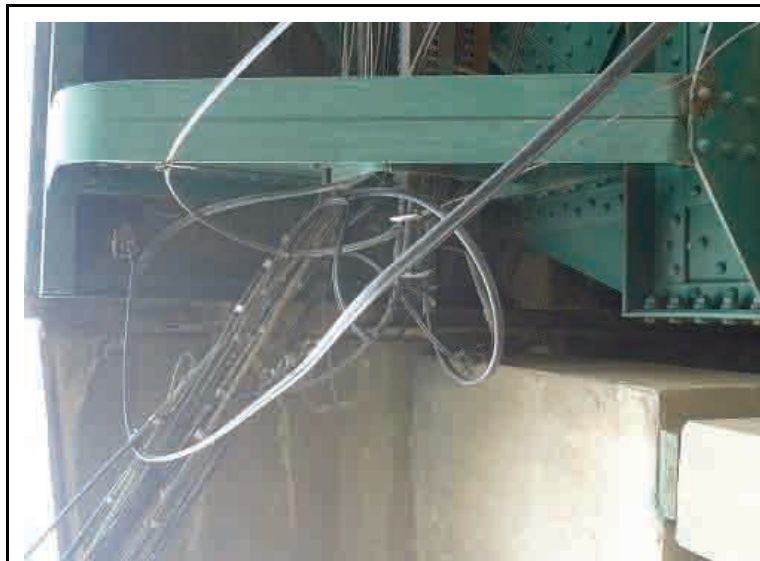
Picture No.	7
Span	1
Member	Expansion joint
Leakage from expansion joint

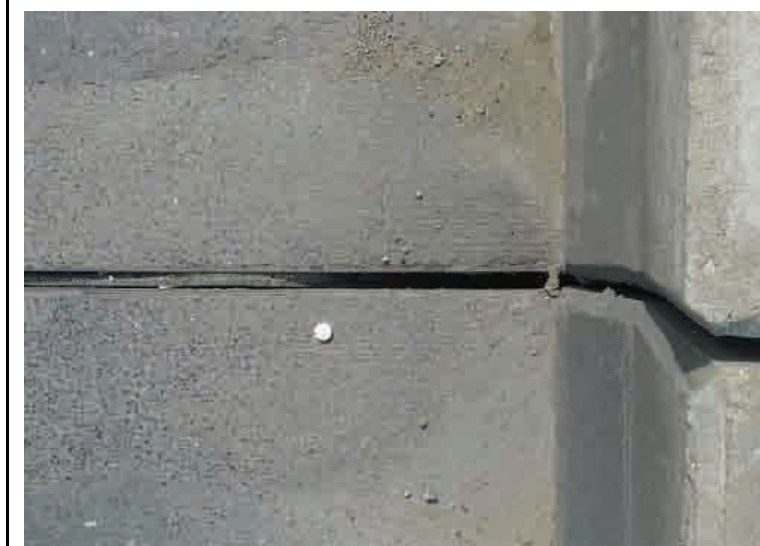
Picture No.	9
Span	1
Member	
Lack of rubber at end	
Thon Buri side

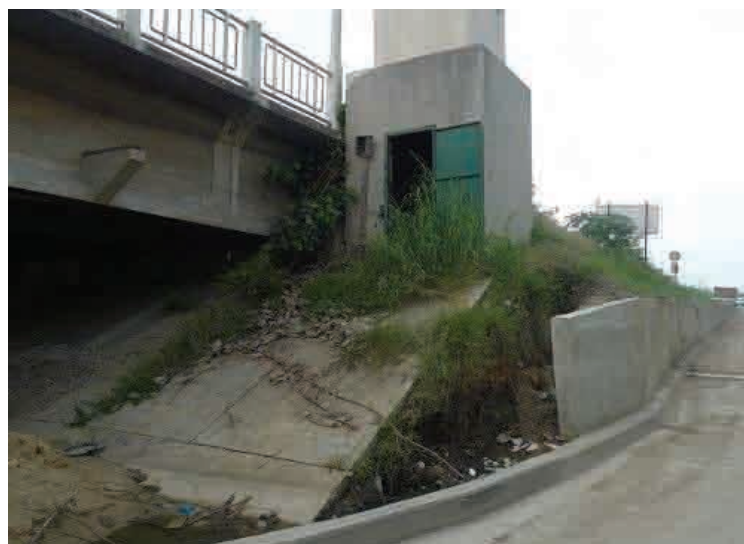
Picture No.	12
Span	1
Member	Newel
Opening of door	
Erosion of abutment

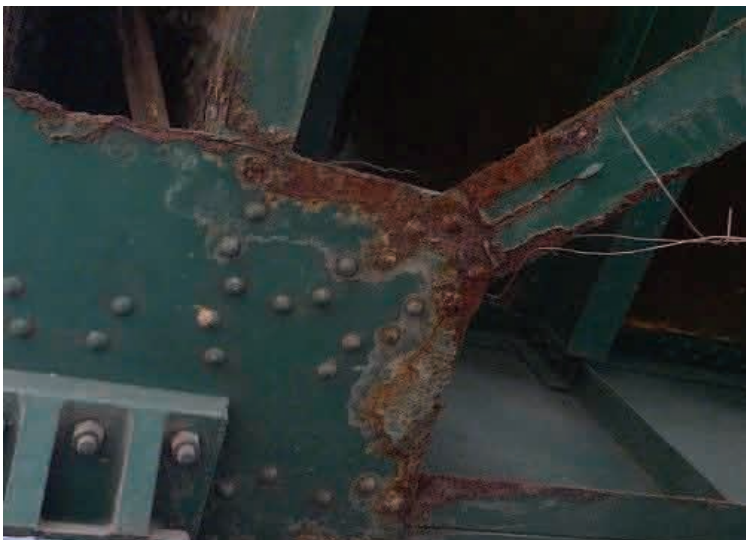
Picture No.	9
	Span	1
	Member	Approach bridge
	Corrosion on bearing	
	Deterioration of corrosion proofing

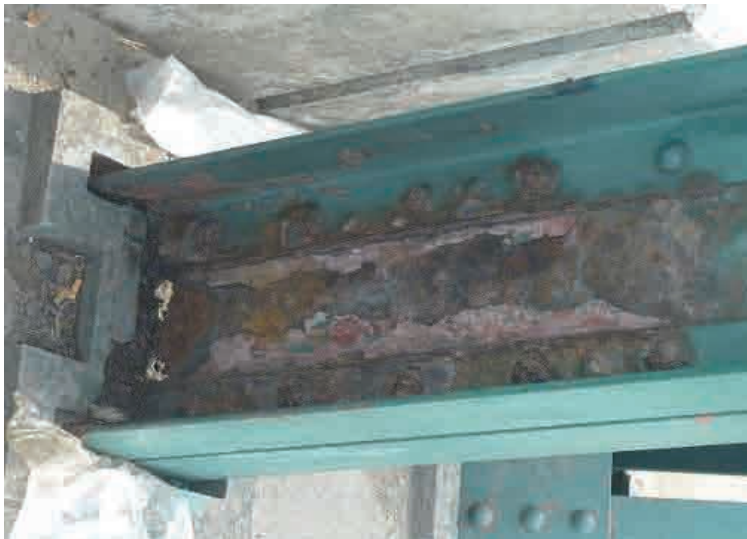
Picture No.	13
	Span	1
	Member	Vertical member
	Remarkable reducing of thickness of plate	
	Opening at bottom end

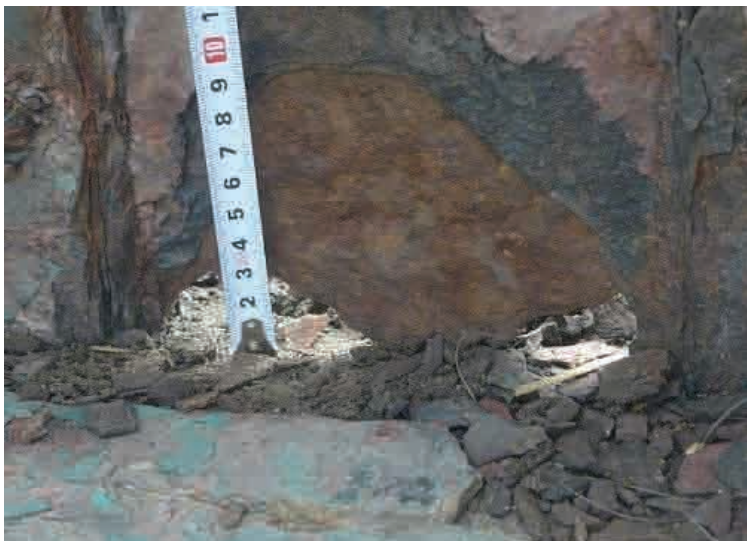
Picture No.	14
	Span	1
	Member	Vertical member
	Enlarged photo	
	Opening at bottom end

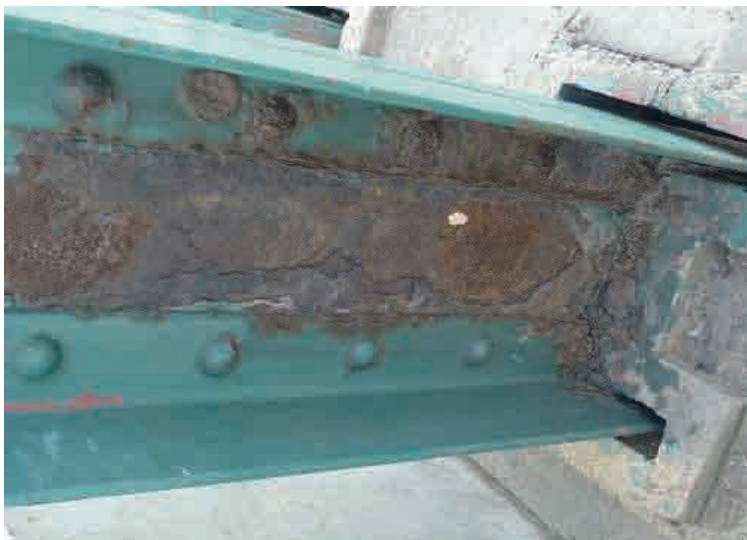
Picture No.	15
	Span	1
	Member	Vertical member
	Remarkable reducing of thickness of plate	
	Hole position is higher than contact section with concrete

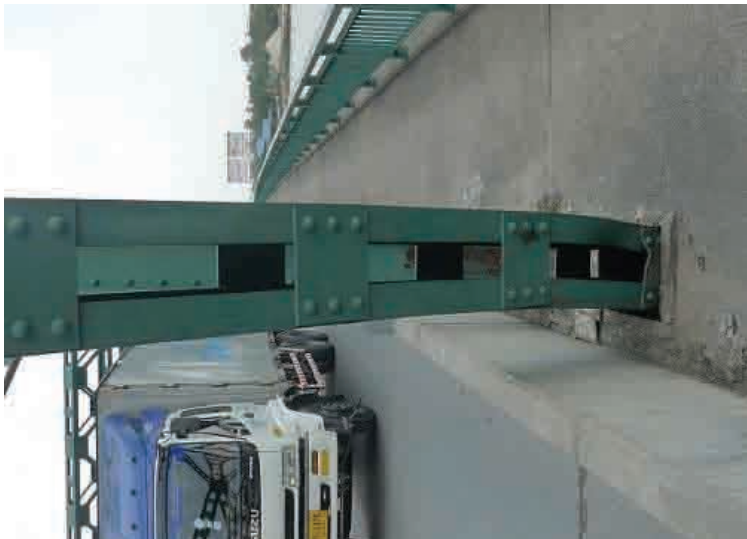
Picture No.	19
	Span	1
	Member	Vertical member
	Deformation by vehicle collision

Crack of pavement	yes · no													
		Damage of lighting	yes · no													
		Damage of sign	-													
Impressions	Damage of handrail	yes · no														
		Possibility of scour	yes · no													
		Walkway yes · no														
		Vehicle yes · no														
Diagnosis	Height of girde	about 7m														
		Deterioration of bridge														
		deficien · fair · good														
		Noticeable point														
History of repair	Surveyor ;	Mr.Chujo, Mr.Kudo														
		Setting of barrier to protect vehicle collision to vertical member														
		Repaint ; - yy - mm

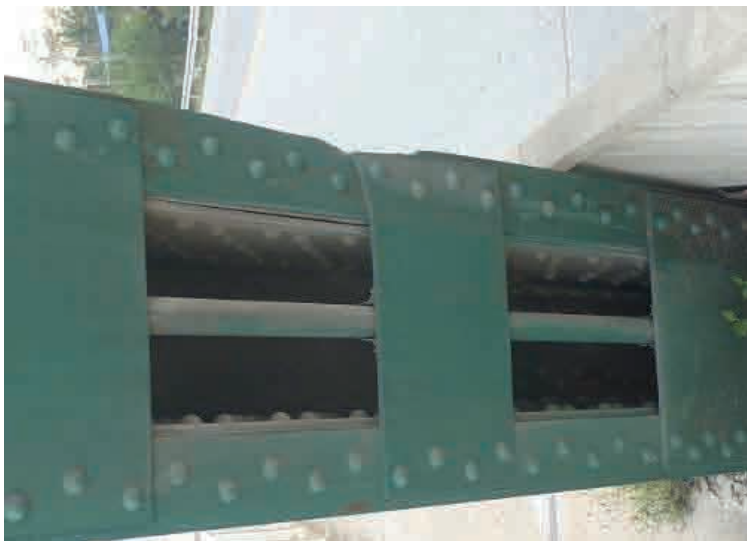
Picture No.	20
	Span	1
	Member	Bracket
	Deformation by vehicle collision

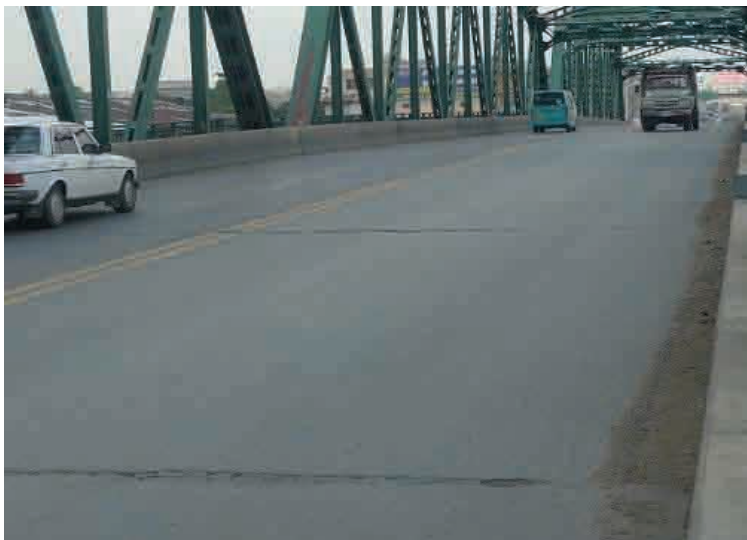
Picture No.	21
	Span	1
	Member	Pavement
	Breaking of pavement on cross beam

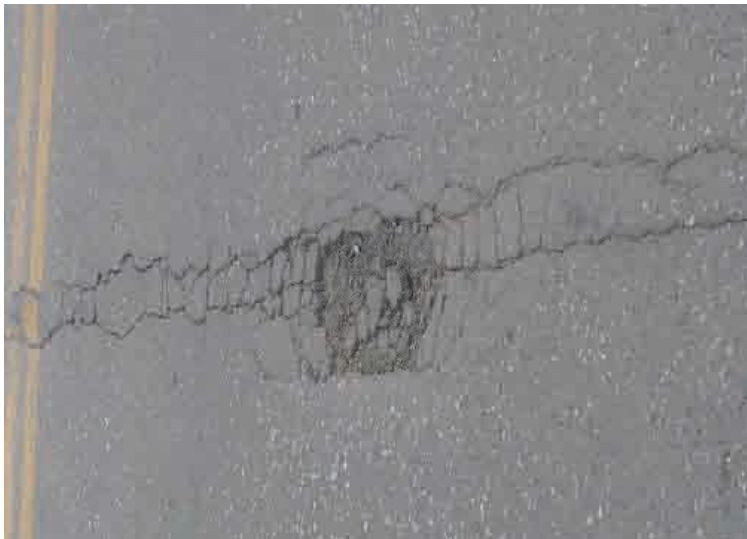
Picture No.	22
	Span	1
	Member	Pavement
	Breaking of pavement on cross beam	
	Severe leakage is found on bottom slab.	
	It is estimated that this breaking go through slab.

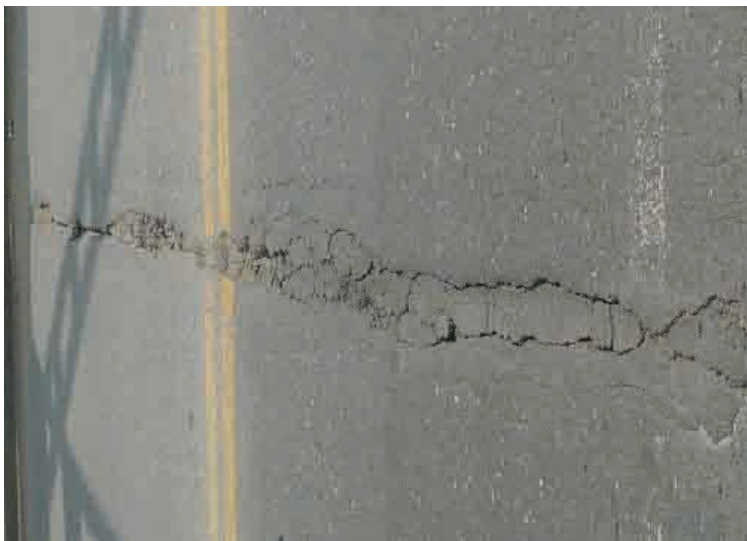
Picture No.	23
	Span	1
	Member	Pavement
	Breaking of pavement on cross beam

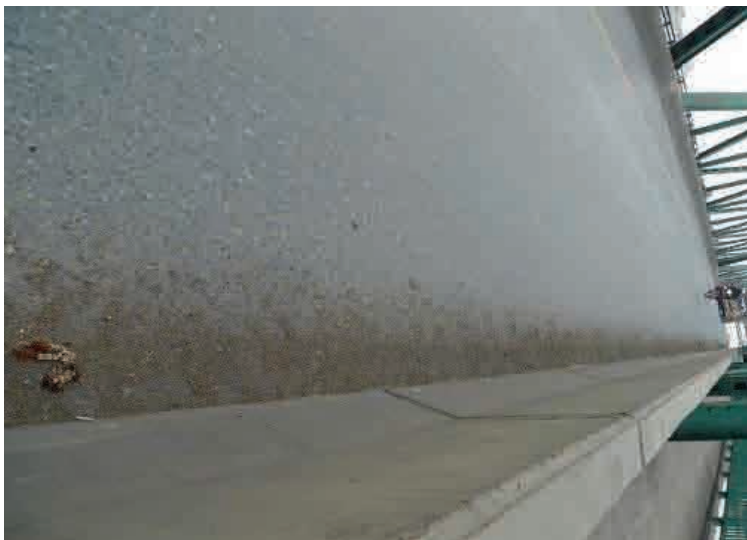
Picture No.	24
	Span	1
	Member	Drainage
	Catch basin may exist under barrier	
	Deterioration of drain function

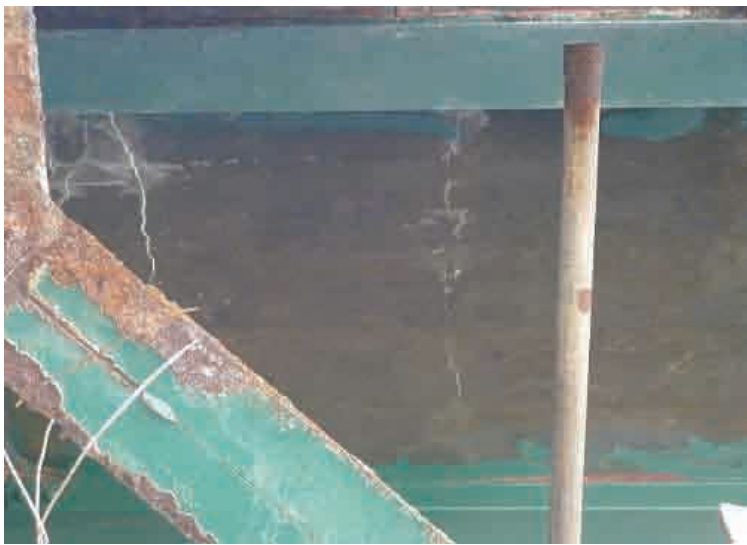
Picture No.	26
	Span	1
	Member	slab
	Crack	
	Free lime

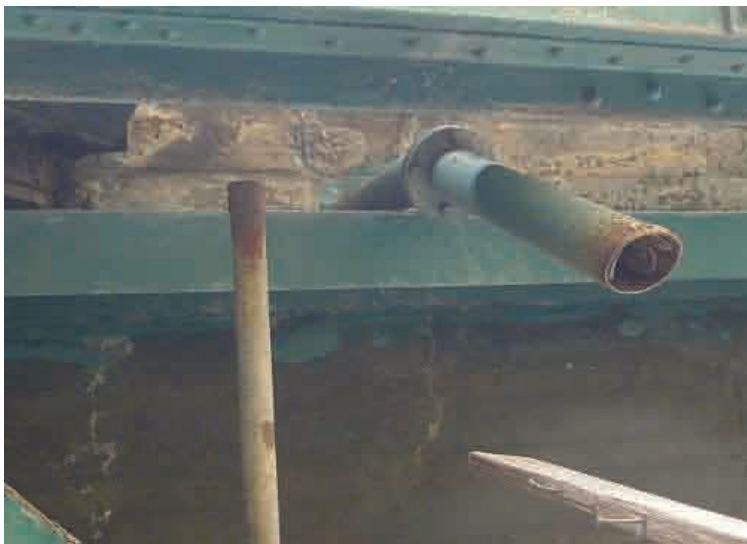
Picture No.	27
	Span	1
	Member	Slab
	Deterioration of corrosion proofing	
	Fracture of concrete surface	
	Free lime

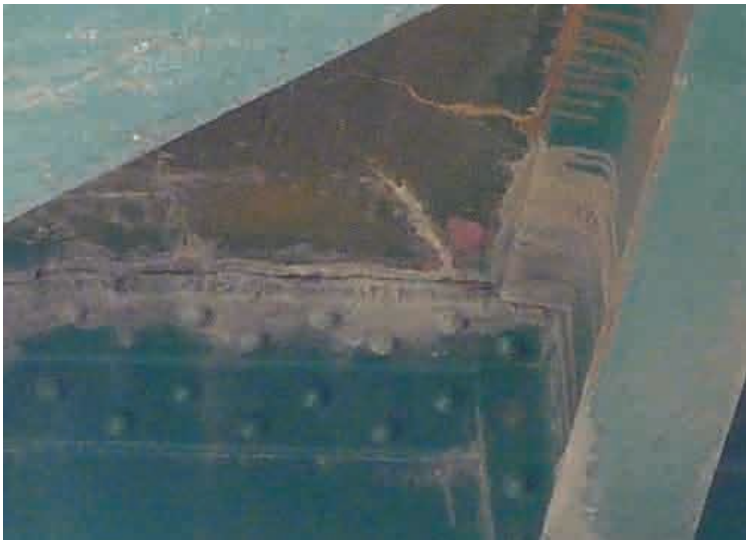
Picture No.	31
	Span	1
	Member	Slab
	Leakage from slab on cross beam	
	Crack, free lime	
	Concrete slab was changed to dirt	
	<i>*Survey on board, 31-oct</i>

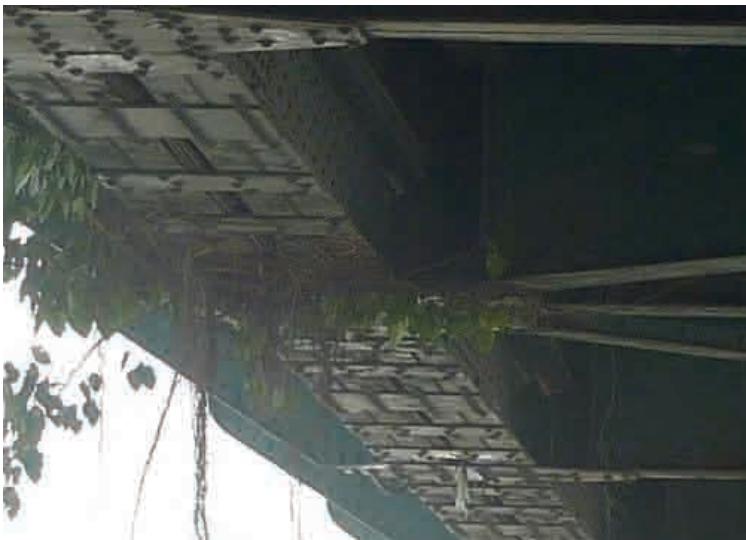
Picture No.	32
	Span	1
	Member	slab
	Plant	
	Possibility of soil dump

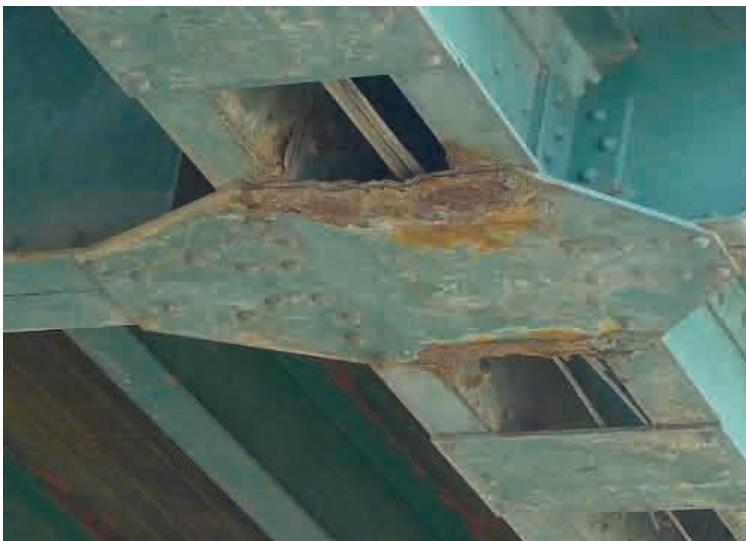
Picture No.	33
	Span	1
	Member	Slab
	Reduce of thickness by corrosion	
	<i>*Survey on board, 31-oct</i>

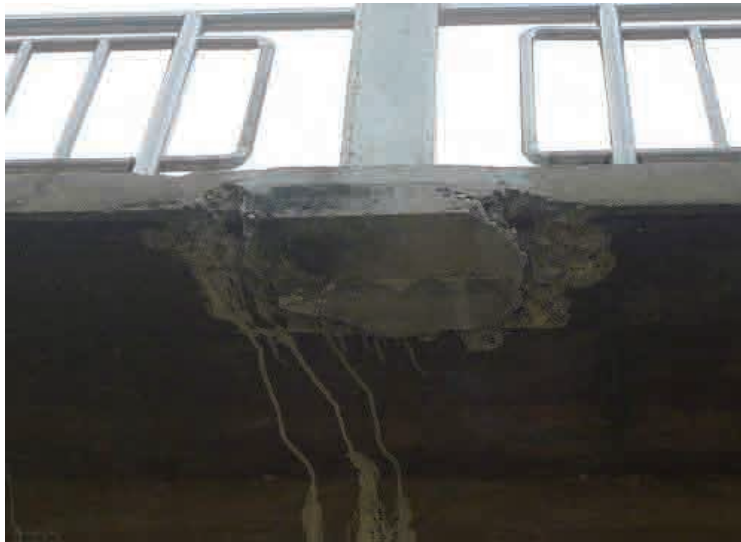
Picture No.	34
Span	1
Member	Approach bridge

コンクリートの剥離と補修

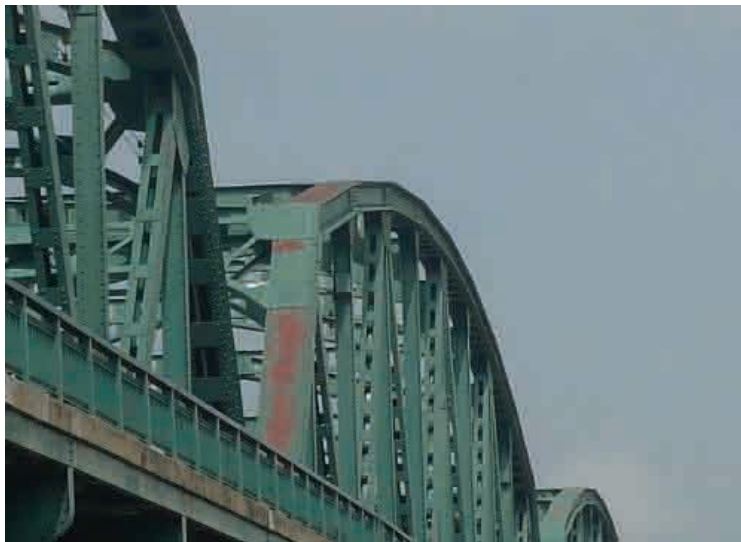
Picture No.	35
Span	1
Member	Chord member

防蝕性能の劣化

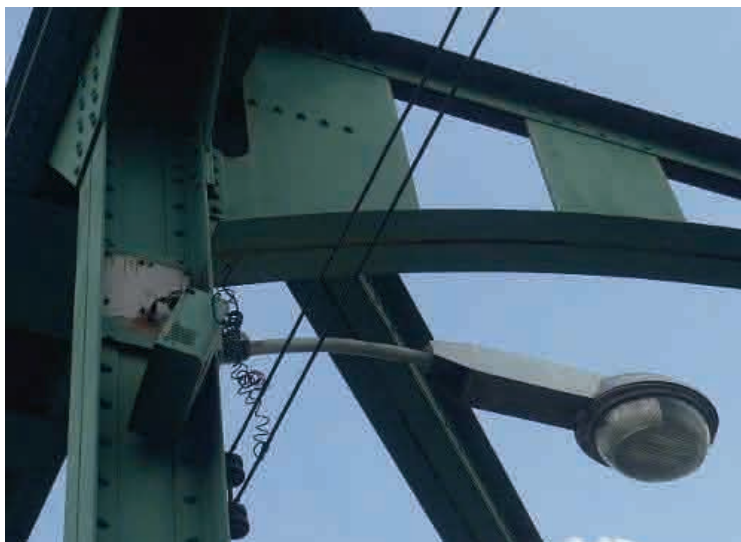
Picture No.	36
Span	1
Member	Lighting pole

破損

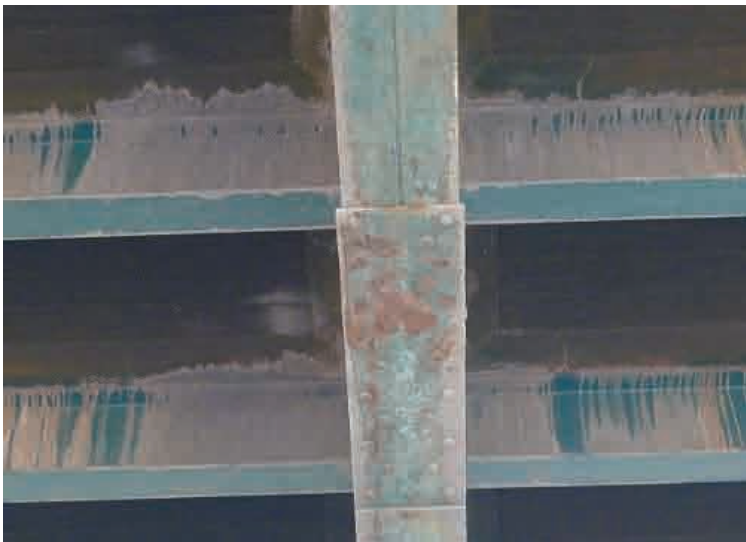
Picture No.	38
	Span	1
	Member	Transverse beam
	Corrosion and fall of rivet	
	<i>*Survey on board, 31-oct</i>

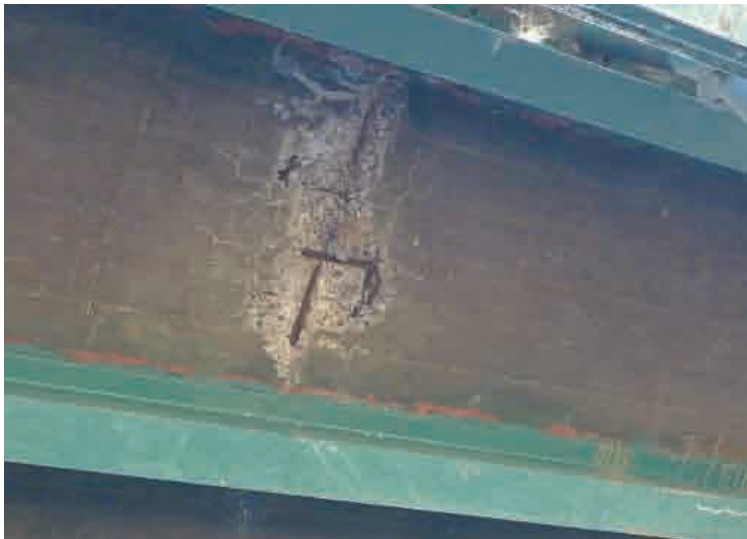
Picture No.	43
	Span	1
	Member	Slab
	Fracture of concrete surface	
	Rock pocket	
	Crack	
	<i>*Survey on board, 31-oct</i>	
	Picture No.	44
	Span	1
	Member	
	<i>*Survey on board, 31-oct</i>	
	Picture No.	45
	Span	1
	Member

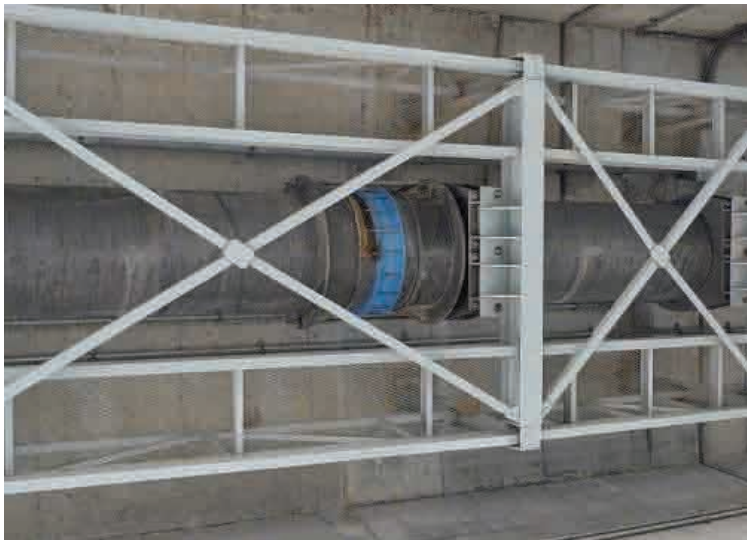
Picture No.	7
	Span	1
	Member	桁下全景
	water supply	
	No expanded metal plate.	
	It's not suitable for inspection.

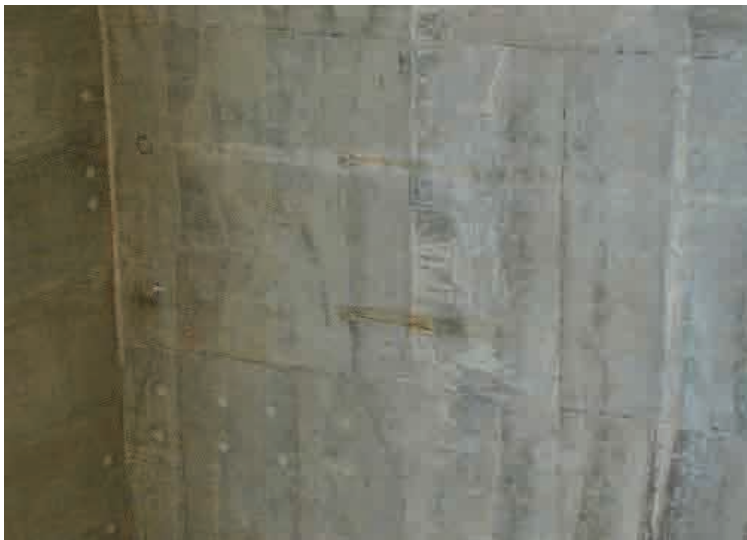
Picture No.	8
	Span	1
	Member	slab (walkway, roadway)
	Ooze out of rust

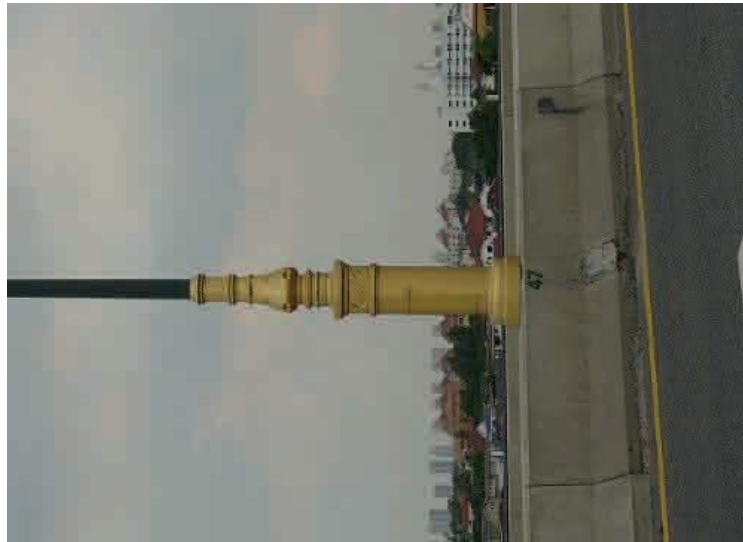
Picture No.	10
Span	1
Member	Lighting pole

Mark of filling concrete at bottom of lighting pole

Possibility of fracturing in future

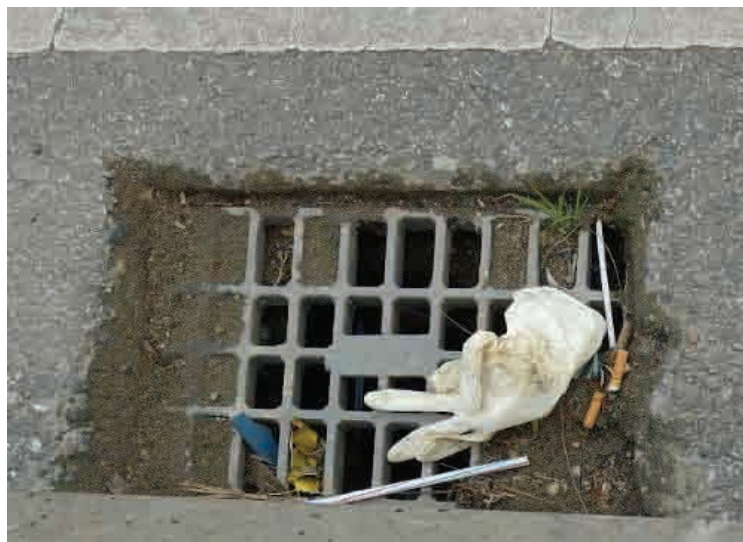
Picture No.	11
Span	1
Member	Catch basin

Partly blocked

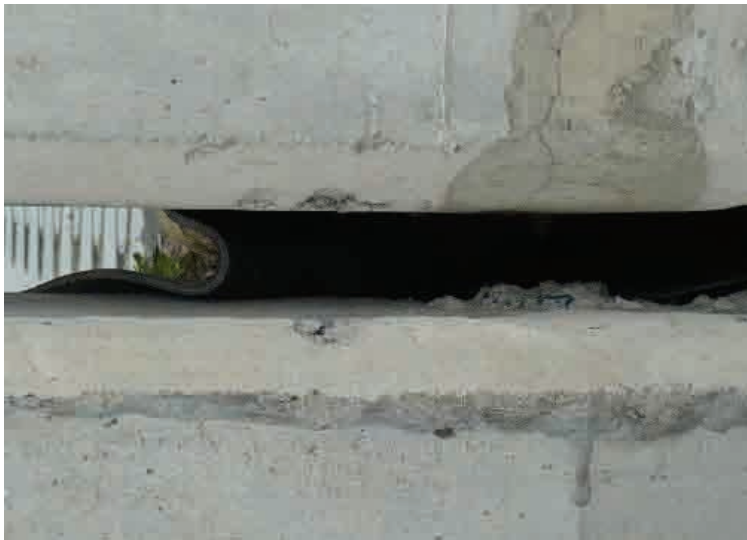
Picture No.	13
	Span	1
	Member	Barrier
	Crack.	
	Repariring material with permeability?

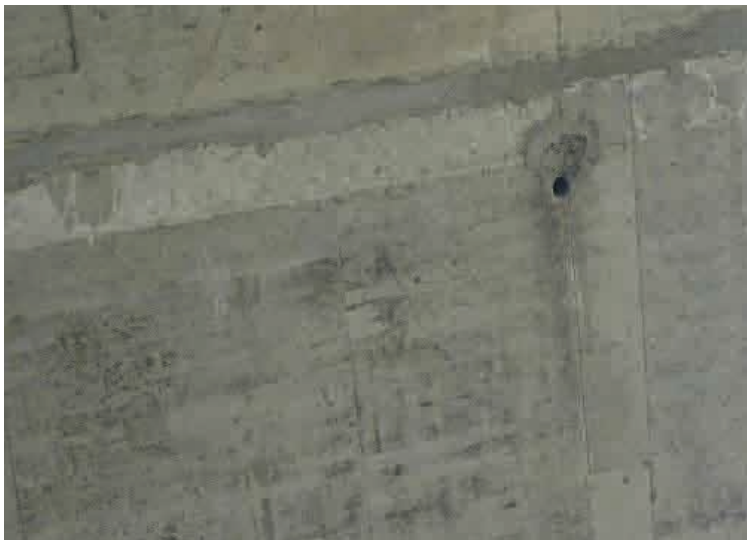
Picture No.	14
	Span	1
	Member	
	Chipped concrete around drainage

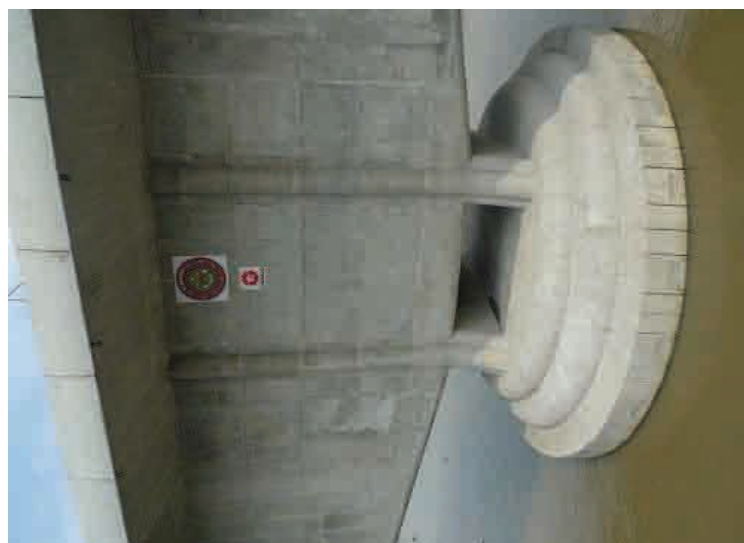
Picture No.	4
Span	1
Member	Pier
Pier height is low The structure may occur large moment after shrinkage, creep and temperature.	
Continuous careful checking is required.

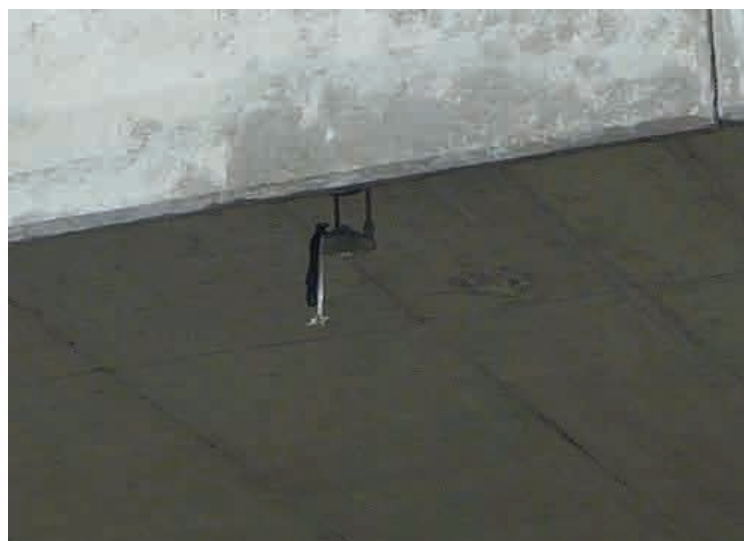
Picture No.	5
Span	1
Member	Drainage
Parts for water sprinkling Garbage
