Inspection sheet of visual survey

Bridge No. 6

Bridge name		Pra Nangklaio Bridge		Route name		-		Authority		DOH		Code of authority		-	
Place		from Anphoe Bang Bua Thong		Distance		from km+ 0						No.		-	
		to Anphoe mueang Nonthaburi				to km+ 0						Survey date		24-oct-2009	
Bridge properties	Bridge type(1)	main road · side road · ramp													
	Bridge type(2)	bridge · viaduct · plank pass													
	Bridge type(3)	5-span continuous PC box girder													
	Total length	330.00 (m)													
	Span	51 + 72 + 84 + 72 + 51 (m)													
	Nos. of span	5 span													
	Width	21.80 (m) / (m)													
	Completion	1985													
Road information	Horizontal	Straight · incli(= 1.5 °) · Curve (R m)													
	Gradient	One way (·) parabo (▽ · ▽)													
	Nearby tunnel	yes · no (m)													
	Nearby crossing	yes · no (m)													
	Traffic	Much · Medium · Little													
	Commercial traffic	Much · Medium · Little

Authority	DOH	Address	Bangkok	Data	24-Oct-09
Bridge	Phra NangKlao Bridge

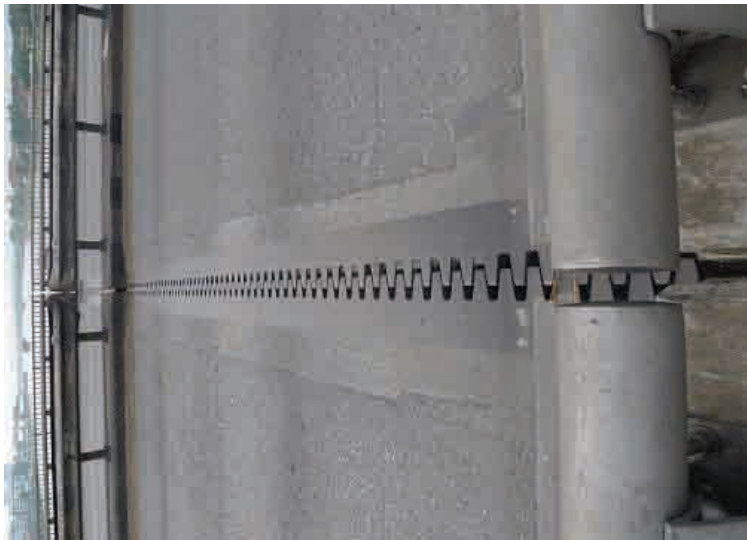
Picture No.	4
	Span	1
	Member	Hinge
	Joint on hinge part	
	Vertical movement independently especially in upstream girder

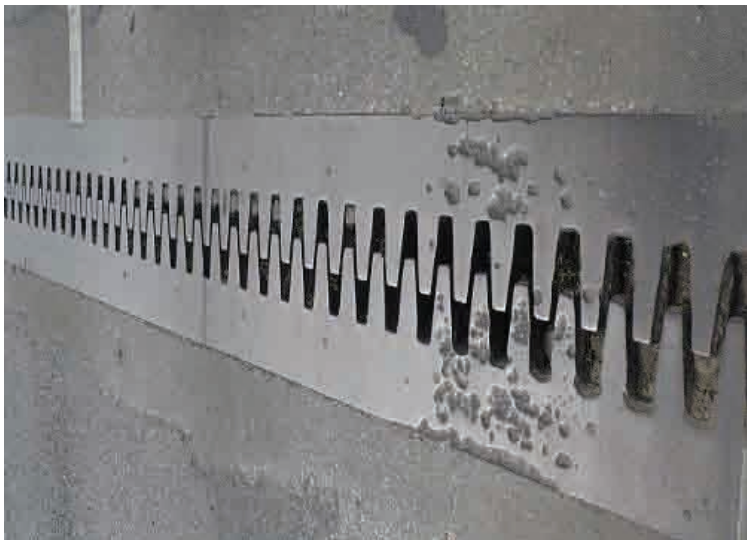
Picture No.	5
	Span	1
	Member	Expansion joint
	Spacing is widen	
	Bangkok side

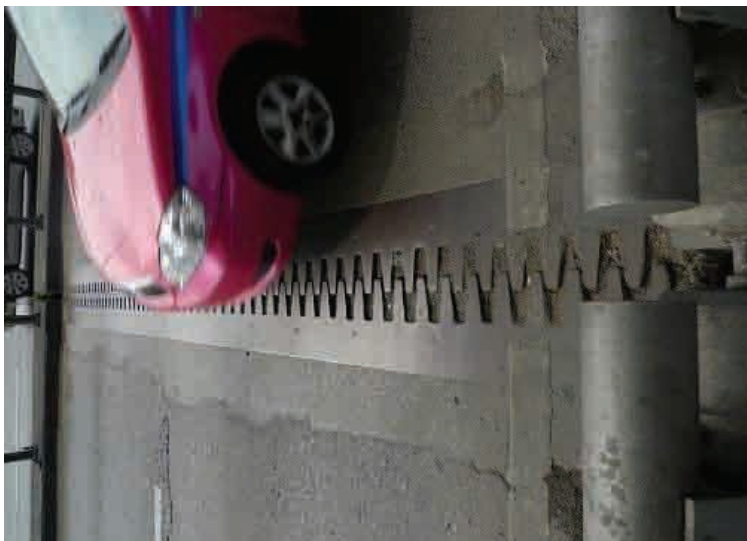
Picture No.	6
	Span	1
	Member	Expansion joint
	Spacing is widen	
	Thon Buri side

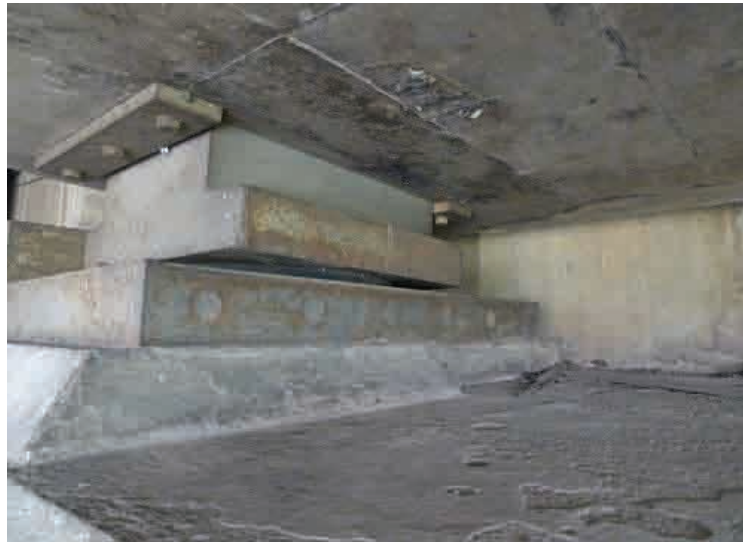
Picture No.	10
Span	1
Member	Bearing
Deterioration of corrosion proofing

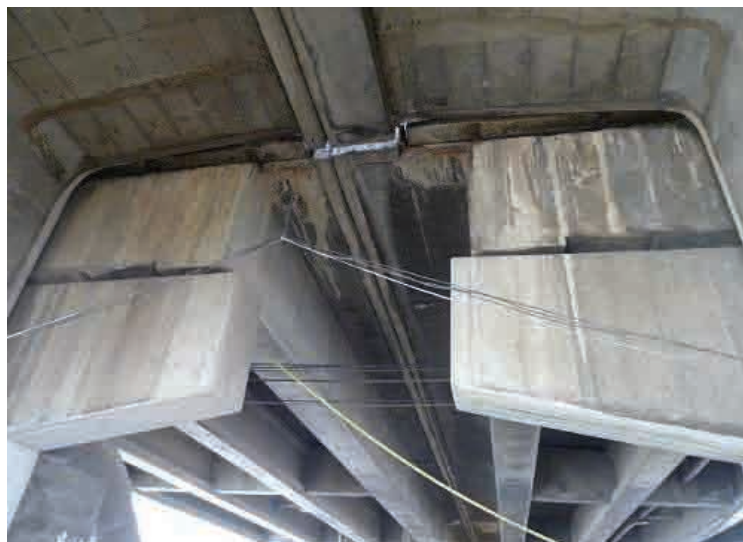
Picture No.	11
Span	1
Member	Expansion joint
Deterioration of drain function	
Leakage from medium

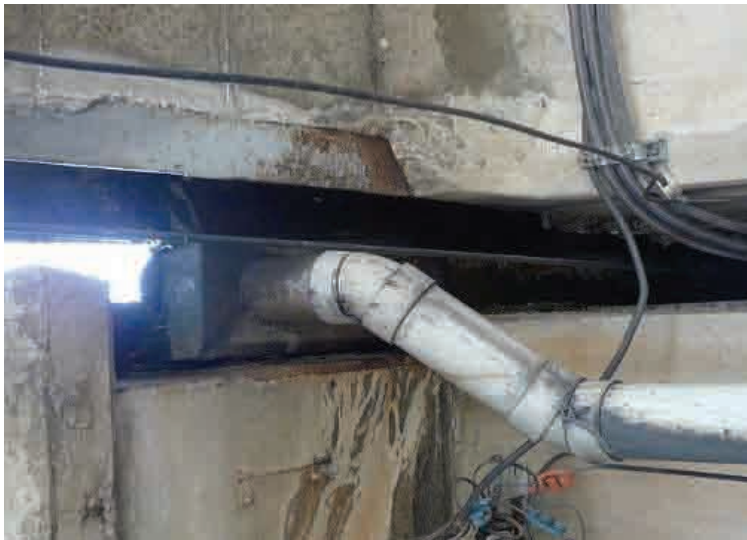
Picture No.	7
	Span	1
	Member	Expansion joint
	Deterioration of drain function

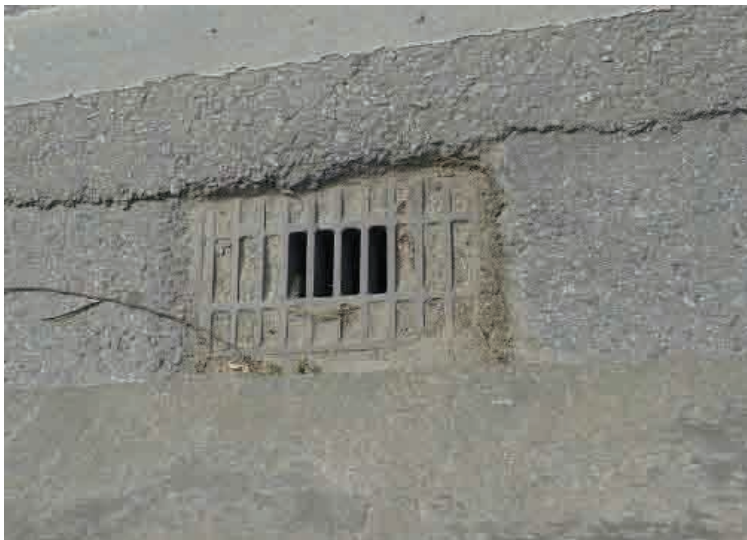
Picture No.	8
	Span	1
	Member	Drainage
	Blocking of catch basin

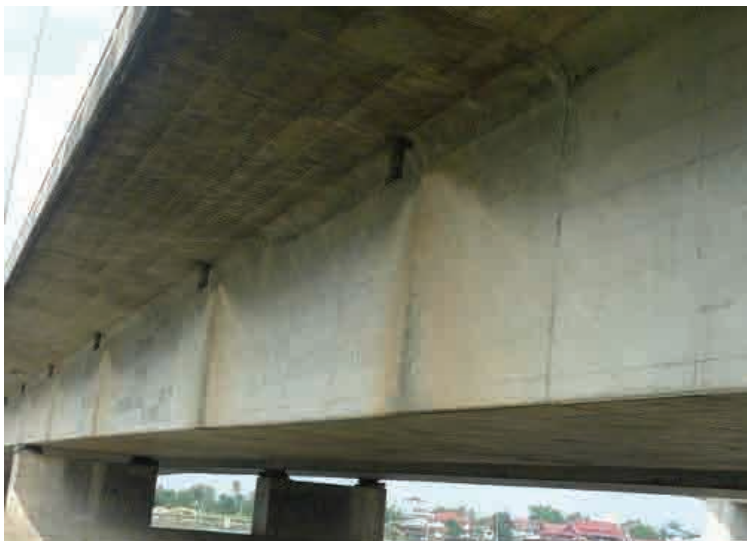
Picture No.	9
	Span	1
	Member	Drainage
	dirt

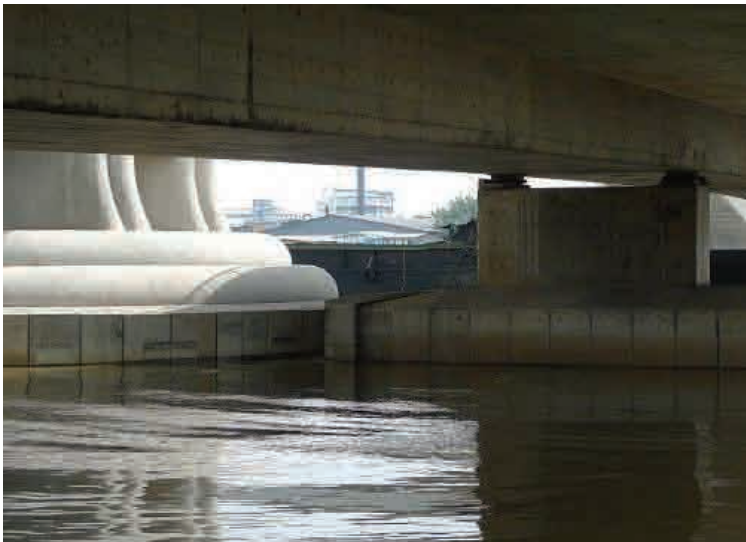
Picture No.	16
	Span	1
	Member	Footing
	Footing is close to new pra nangklao bridge at Thonburi side

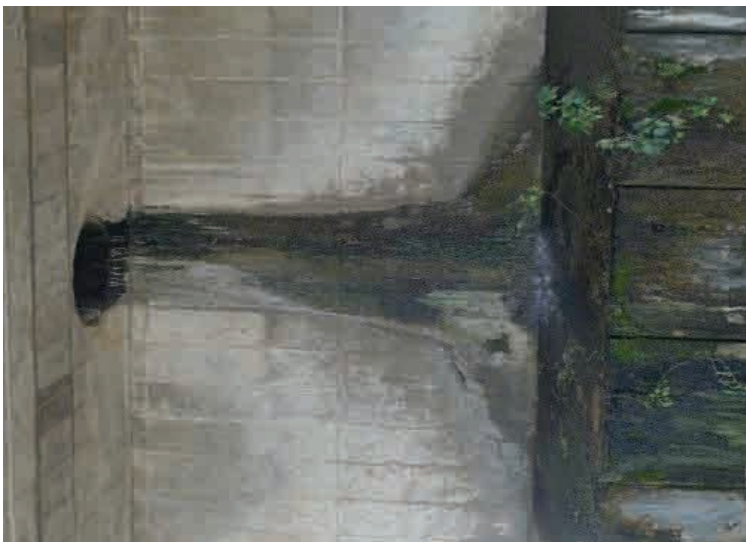
Picture No.	18
	Span	1
	Member	Water supply
	Much water from manhole due to leakage of water supply

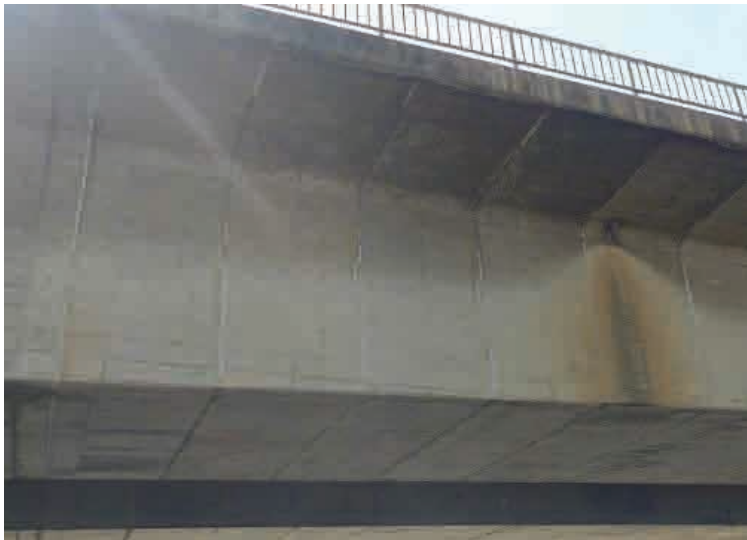
Picture No.	7
	Span	1
	Member	PC-box
	Free lime from construction joint	
<i>*Survey on board, 31-oct</i>

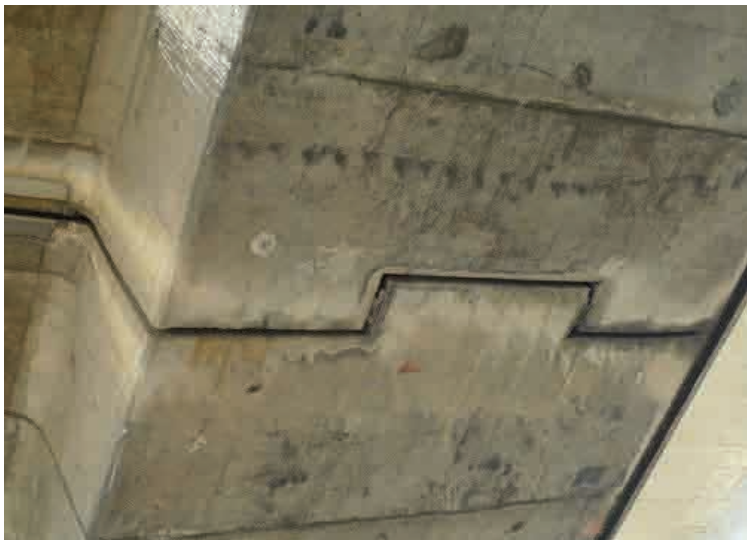
Picture No.	8
	Span	1
	Member	Hinge
	Lack of pin	
	Vertical movement is occurred independently	
<i>*Survey on board, 31-oct</i>

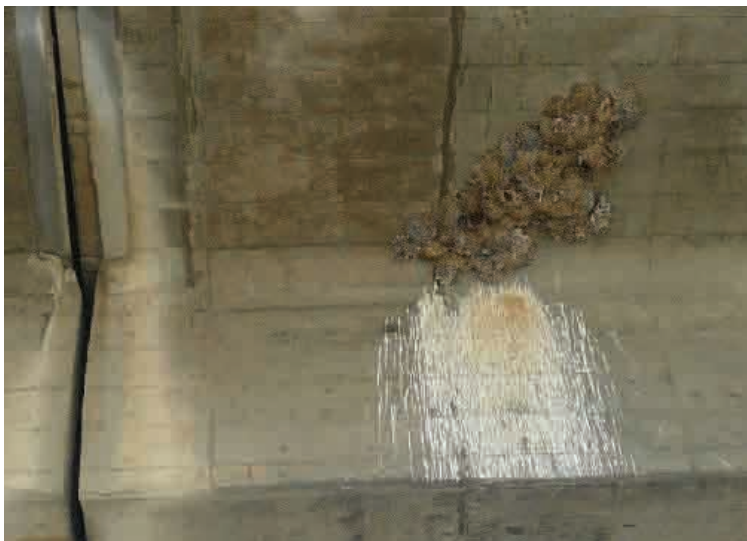
Picture No.	9
	Span	1
	Member	PC-box
	Nest and droppings	
<i>*Survey on board, 31-oct</i>

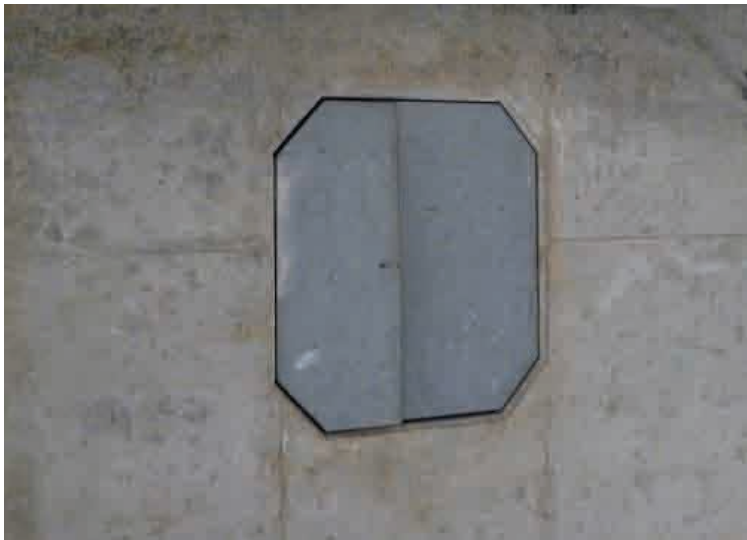
Picture No.	4
	Span	1
	Member	Manhole
	No key

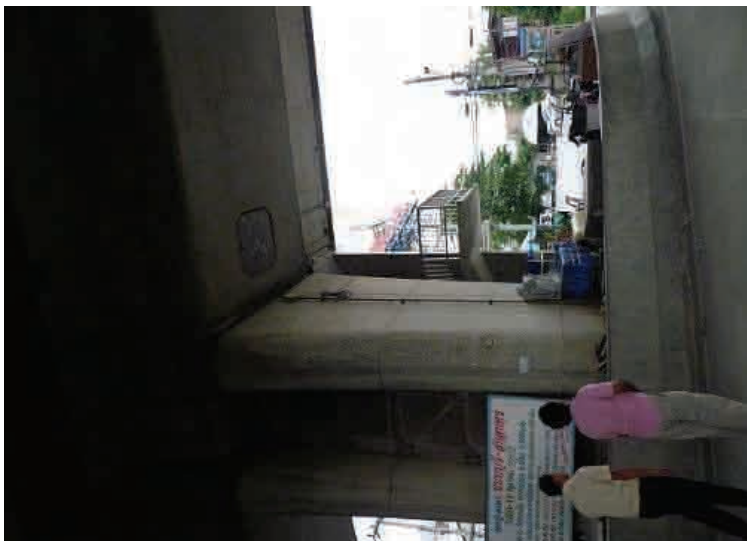
Picture No.	6
	Span	1
	Member	Manhole
	About 6m height	
	Lift car or ladder is needed to access

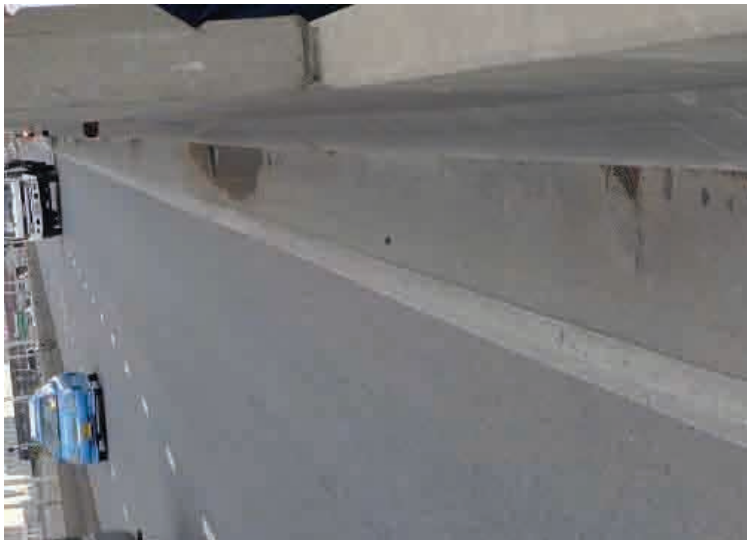
Picture No.	7
	Span	1
	Member	Catch basin
	Blocking	
	Part without noise barrier is cleaned and has no blocking

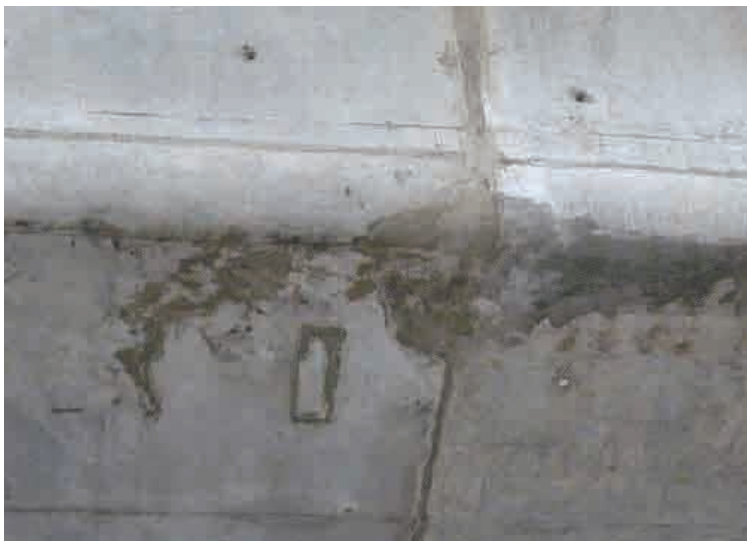
Picture No.	9
	Span	1
	Member	Girder
	Defect of construction?

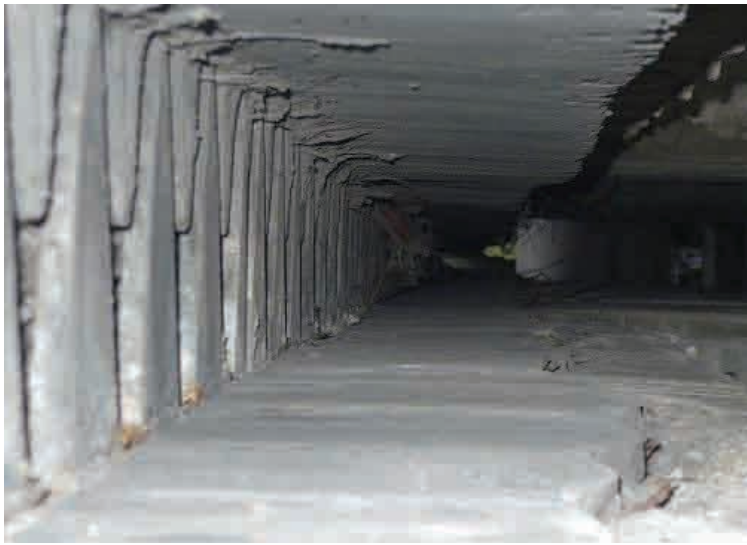
Picture No.	10
	Span	1
	Member	Expansion joint
	Leaving of form work

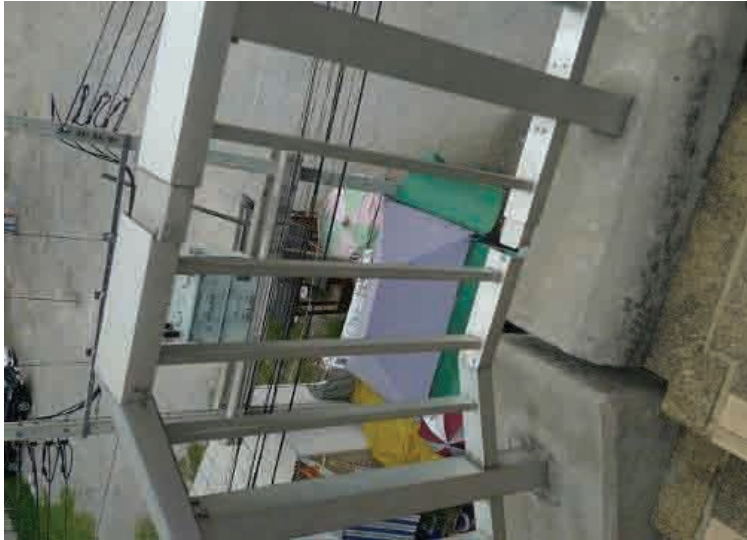
Picture No.	12
	Span	1
	Member	Handrail
	Joint is off by unusual movement

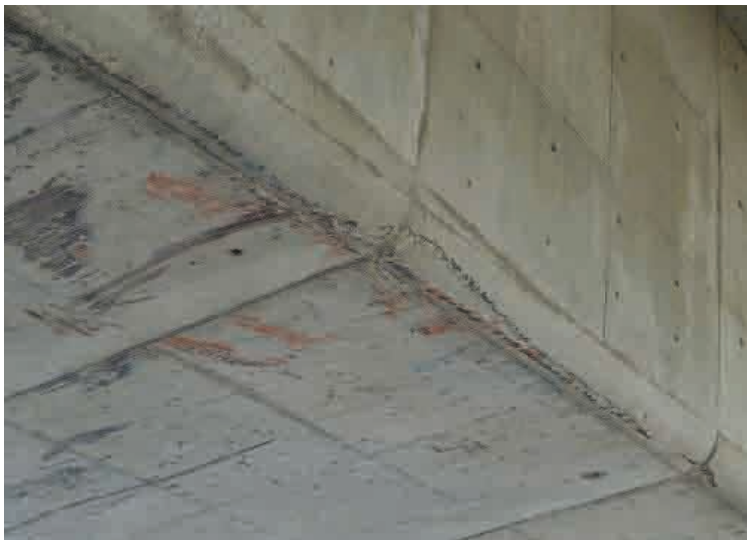
Picture No.	11
	Span	1
	Member	Girder
	Scorch by ship collision

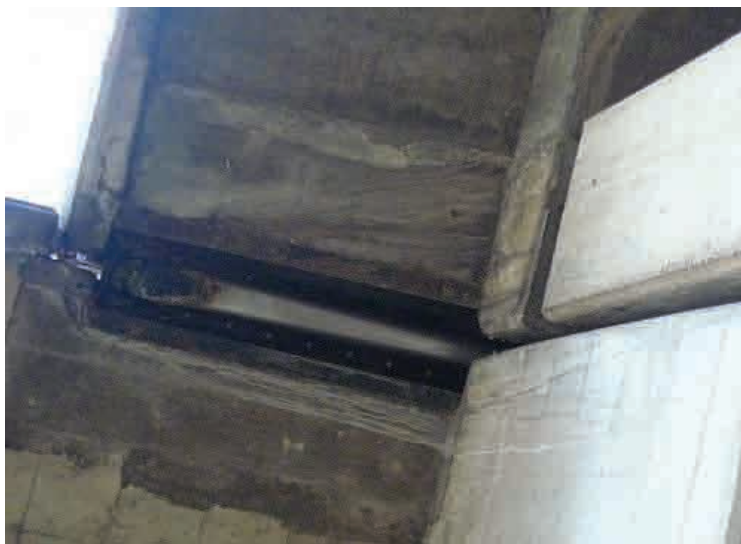
Picture No.	8
Span	1
Member	Expansion joint
Deterioration of drain function

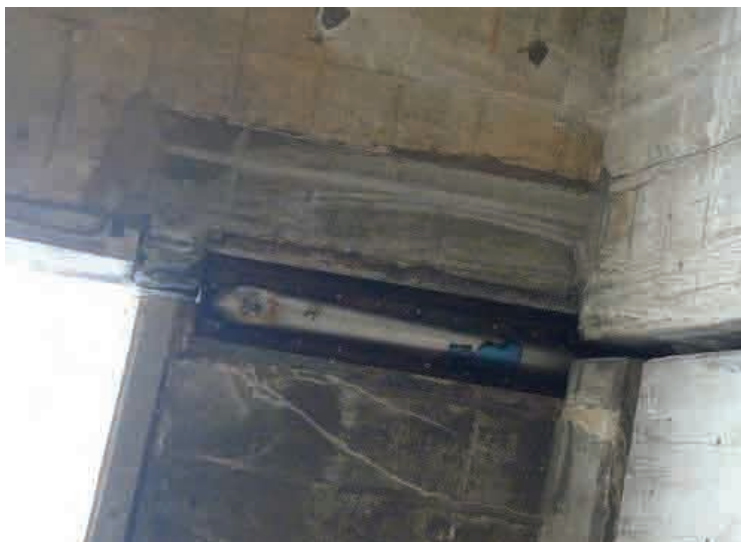
Picture No.	9
Span	1
Member	Expansion joint
Deterioration of drain function

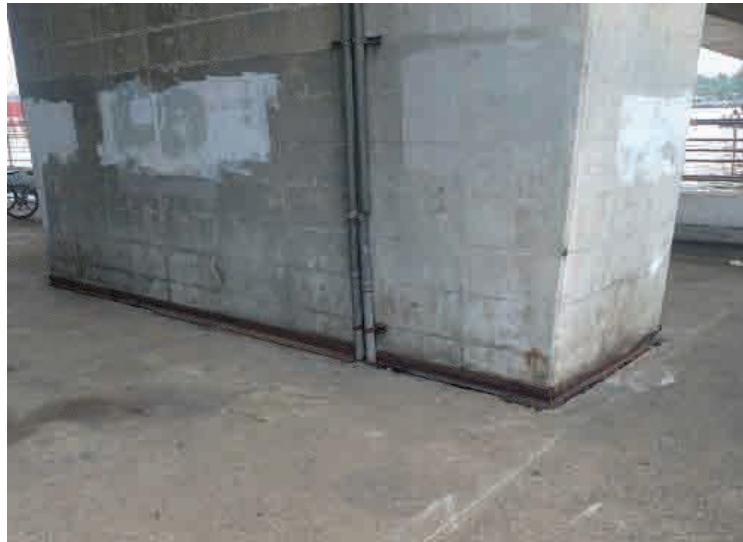
Picture No.	10
Span	1
Member	End pier
Corrosion of steel plate at base

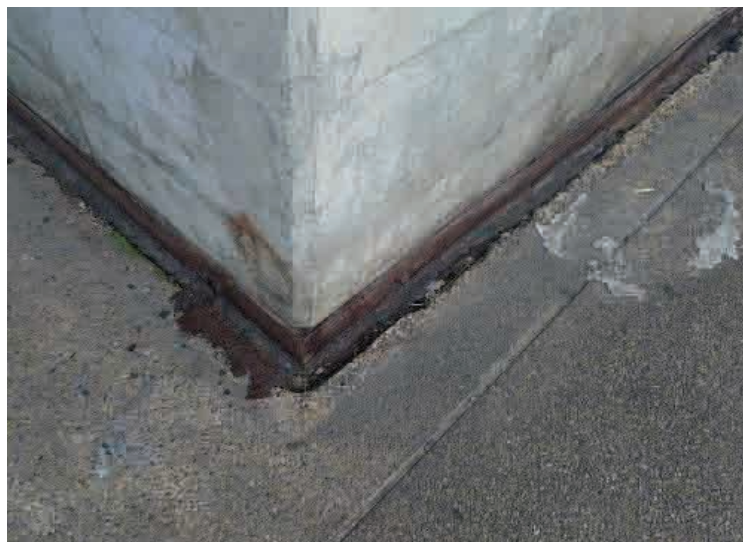
Picture No.	11
Span	1
Member	End pier
Corrosion of steel plate at base

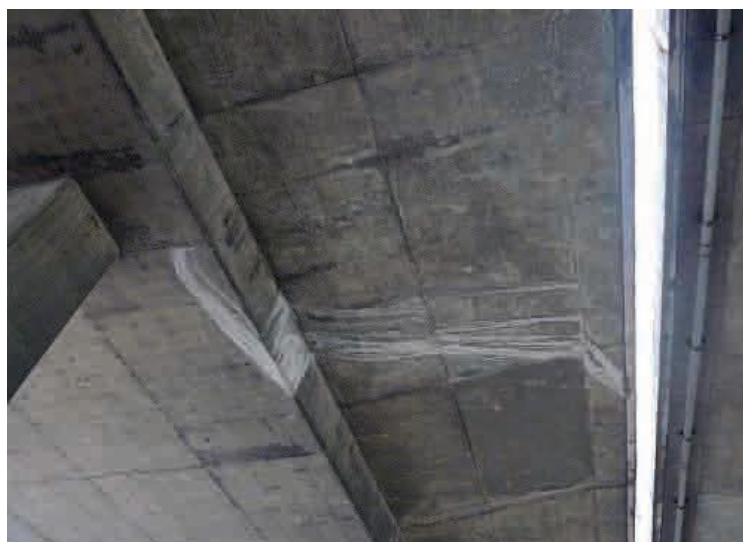
Picture No.	12
Span	1
Member	Approach bridge
Free lme

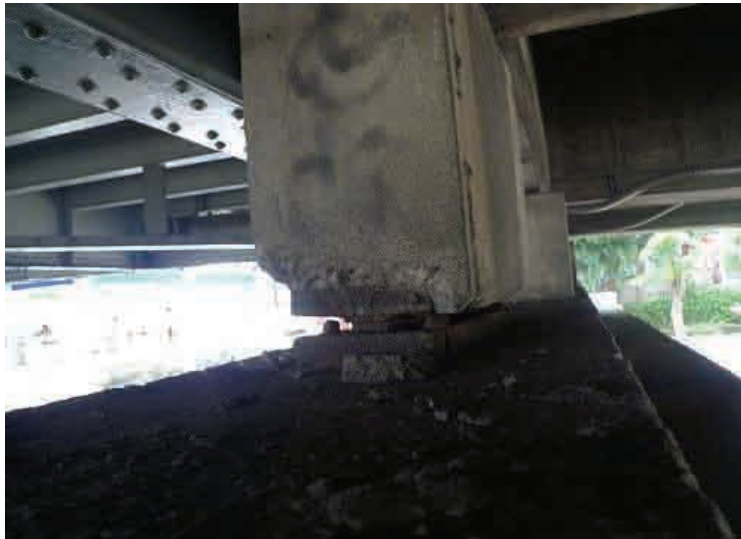
Picture No.	19
Span	1
Member	Bearing
Deterioration of corrosion proofing	
Fracture of edge	
Approach bridge

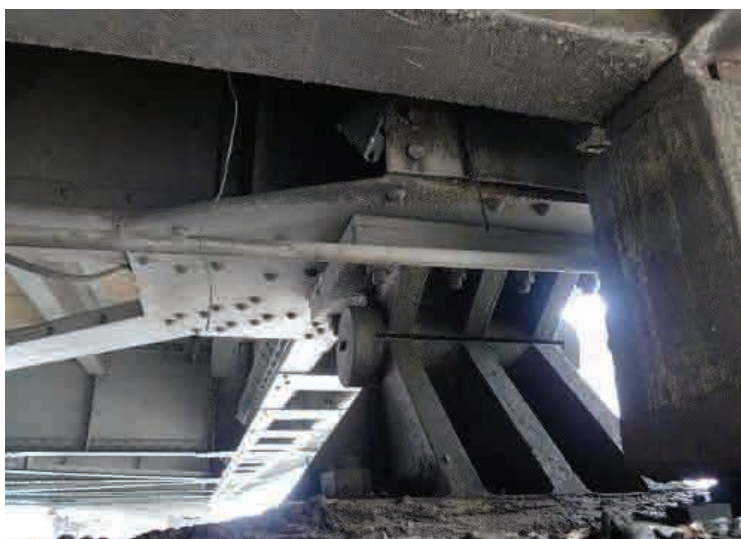
Picture No.	21
Span	1
Member	Bearing
Deterioration of corrosion proofing

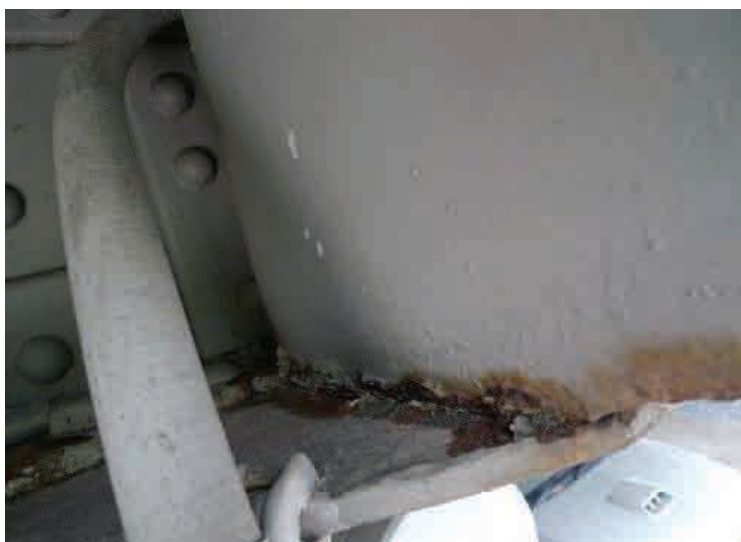
Picture No.	24
Span	1
Member	Bearing
Deterioration of corrosion proofi

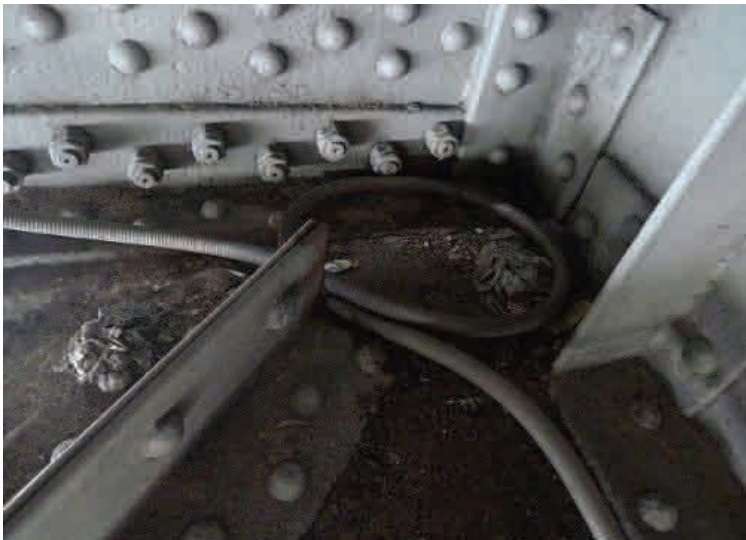
Picture No.	25
	Span	1
	Member	Bearing
	Rivet at bottom side is replaced by bolt	
	It might be corroded before

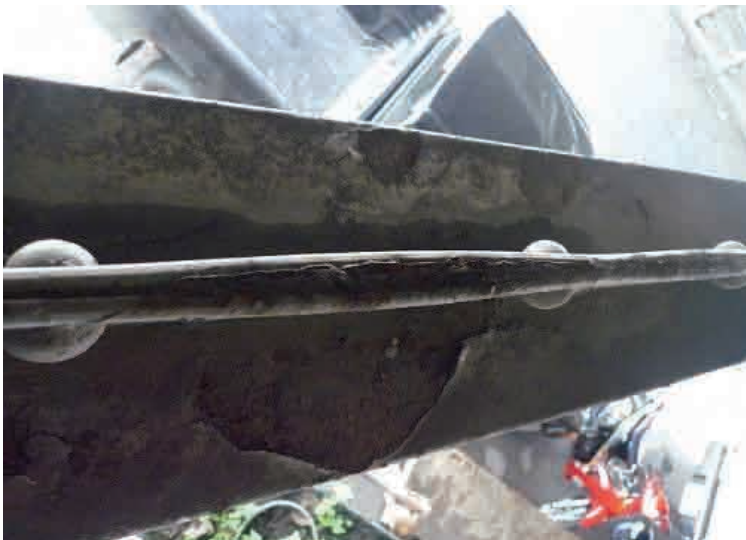
Picture No.	26
	Span	1
	Member	Cross frame
	Peeling of paint	
	Expansion of steel by corrosion

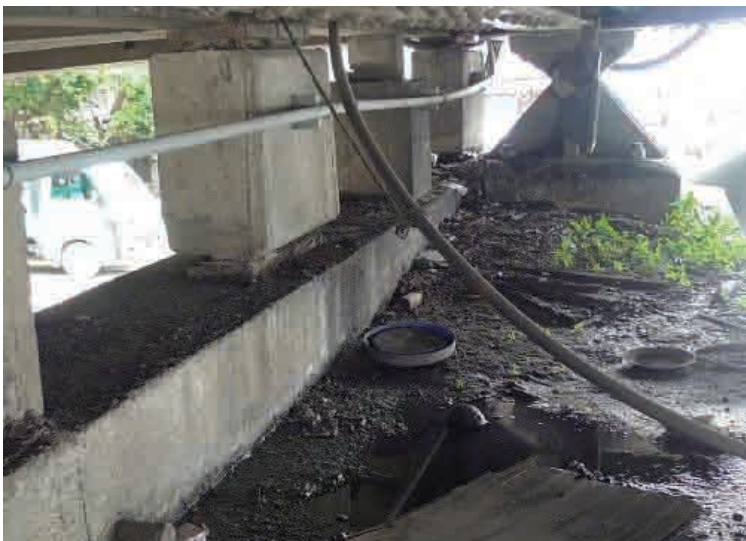
Picture No.	27
	Span	1
	Member	Bearing
	Accumulation of soil

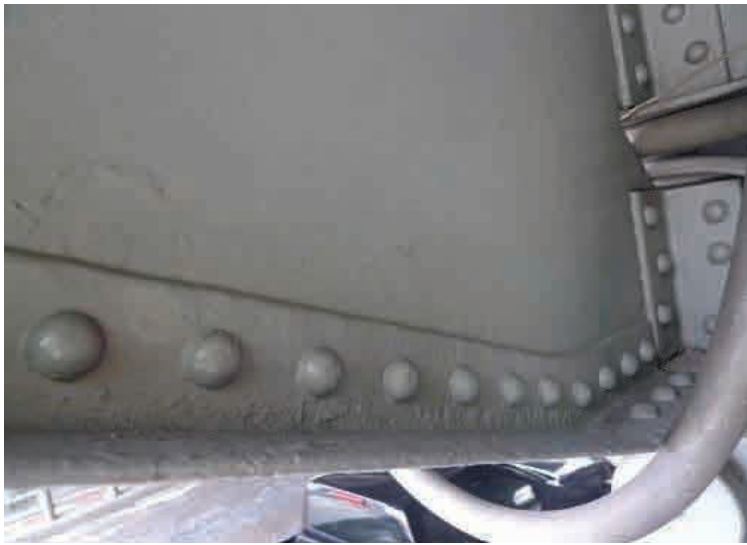
Picture No.	28
	Span	1
	Member	Bracket
	Reduction of plate thickness

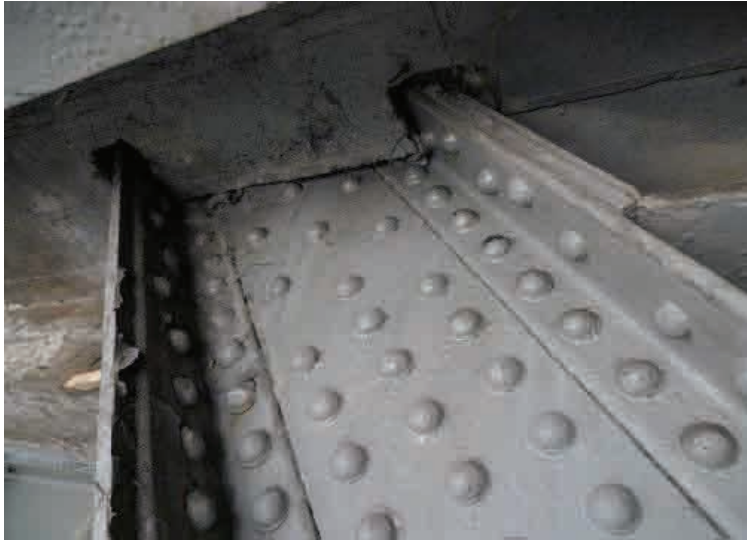
Picture No.	30
	Span	1
	Member	Chord member
	It's not clear the concept of gap Gap width is small.

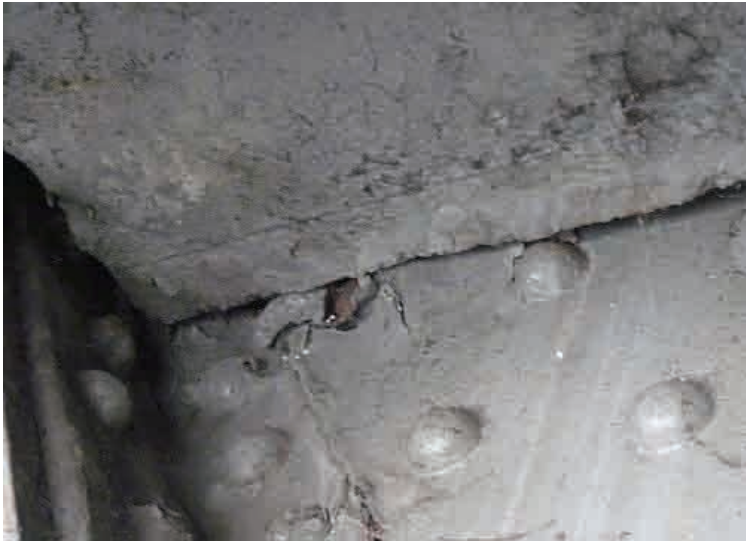
Picture No.	31
	Span	1
	Member	Stringer
	Peeling of paint

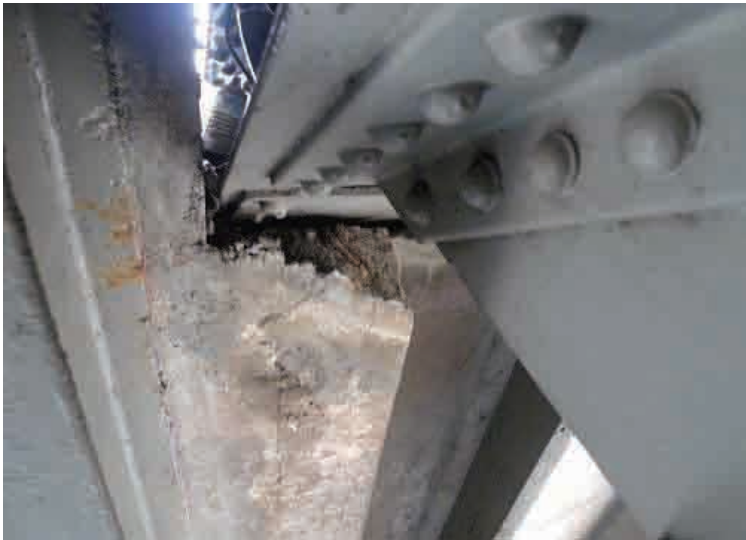
Picture No.	32
	Span	1
	Member	Chord member
	Fracture of concrete

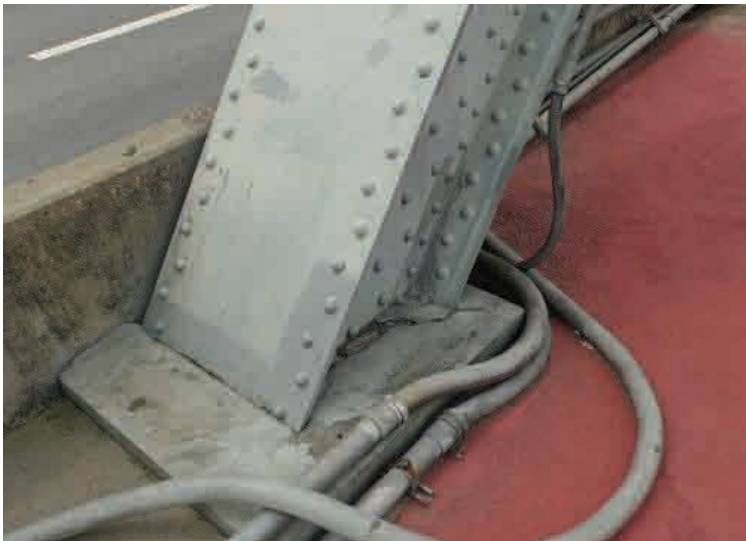
Picture No.	33
	Span	1
	Member	Chord member
	Mount up to prevent remaining water	
	Possibility of corrosion inside of concrete slab

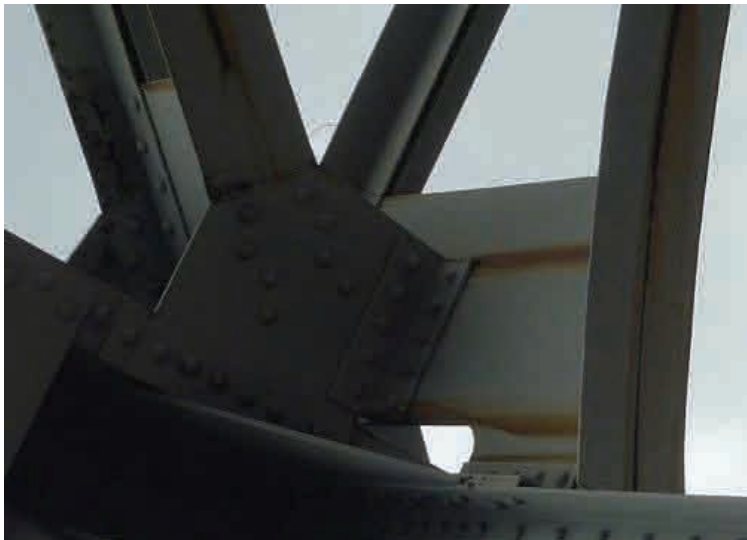
Picture No.	37
	Span	1
	Member	Upper chord
	Deterioration of corrosion proofing

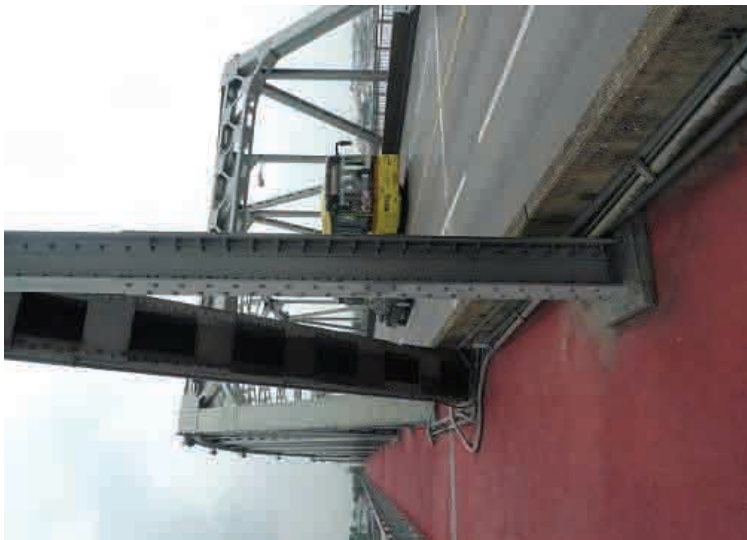
Picture No.	38
	Span	1
	Member	Vertical member
	Reinforcement by additional plate	
	4-vertical member was reinforced

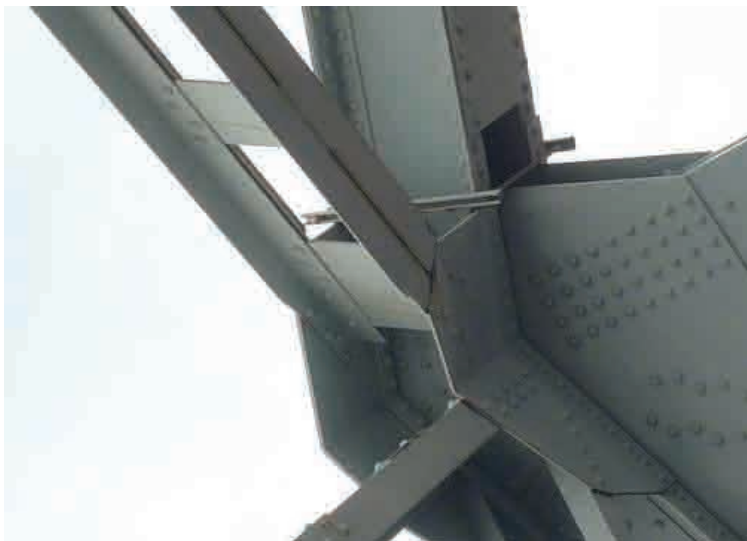
Picture No.	39
	Span	1
	Member	Cross frame
	Deformation at the end of cross frame	
	Adjustment of height?

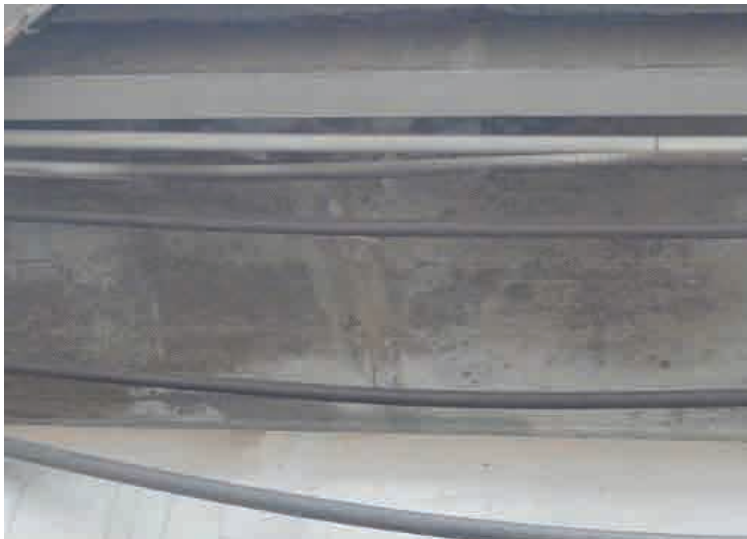
Picture No.	43
	Span	1
	Member	Slab
	Slab under walkway	
	Crack and free lime

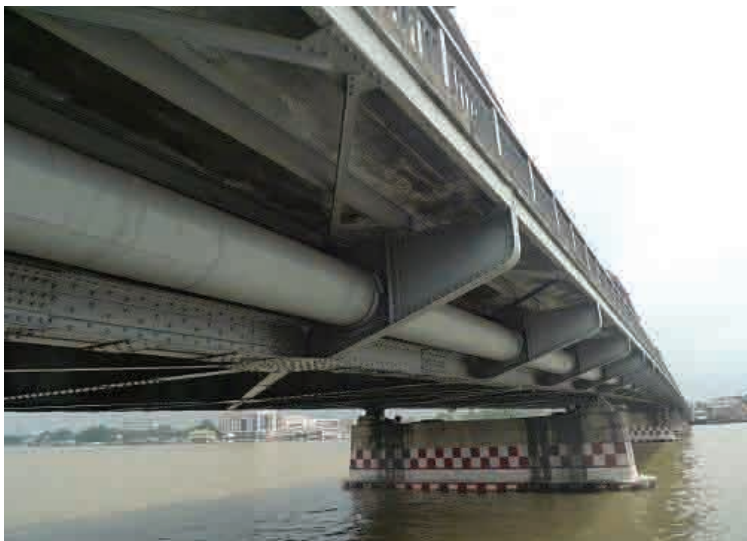
Picture No.	44
	Span	1
	Member	Slab
	Exposure of rebar	
	Crack above bracket

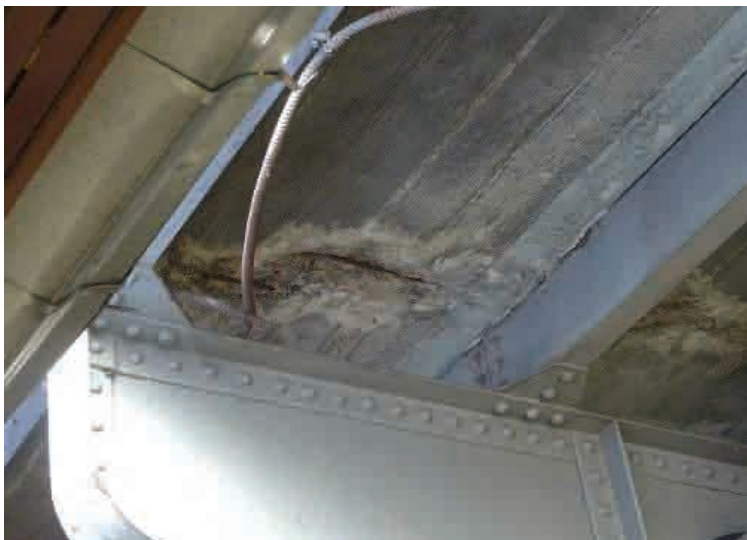
Picture No.	45
	Span	1
	Member	slab
	Exposure of rebar

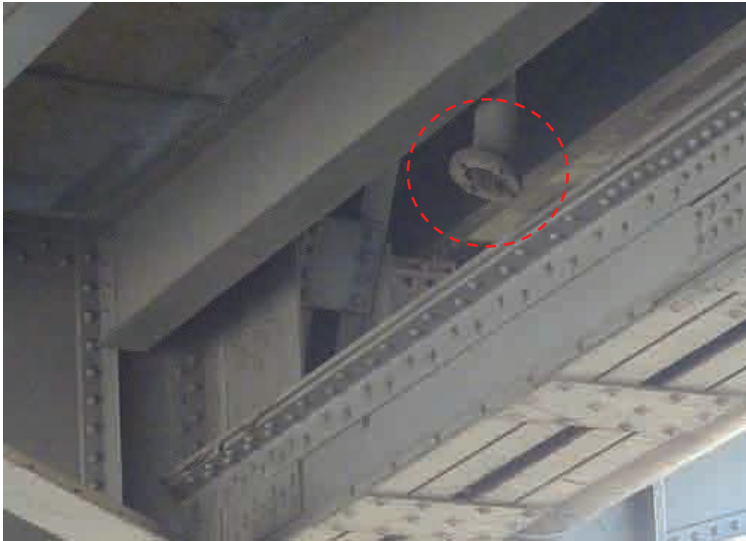
Picture No.	52
	Span	1
	Member	Slab
	Falling of drainage pipe	
	<i>*Survey on board, 31-oct</i>

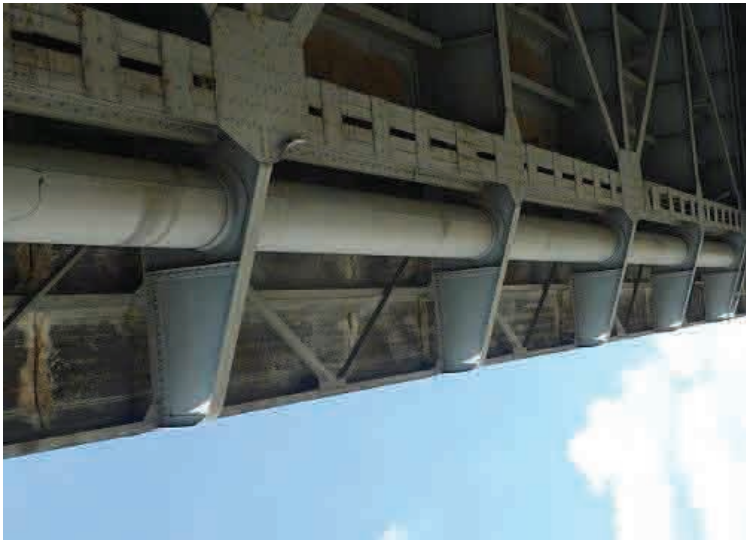
Picture No.	53
	Span	1
	Member	slab
	Crack and free lime under walkway	
	<i>*Survey on board, 31-oct</i>

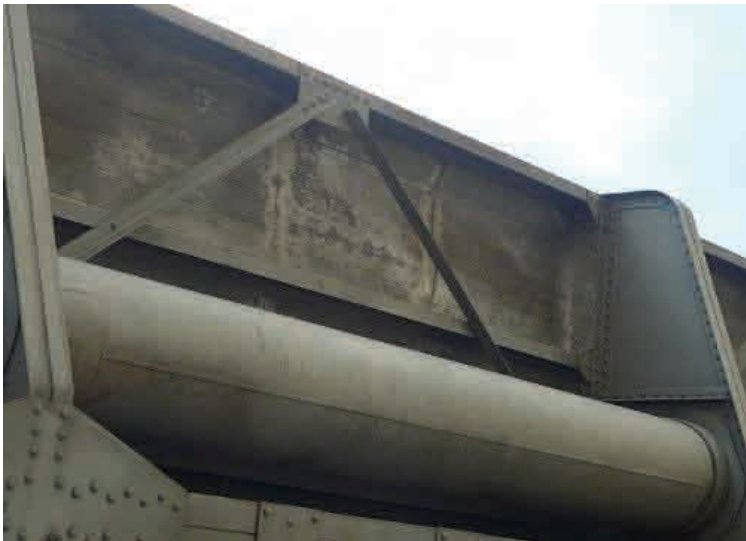
Picture No.	54
	Span	1
	Member	Slab
	Crack and free lime under walkway	
	<i>*Survey on board, 31-oct</i>

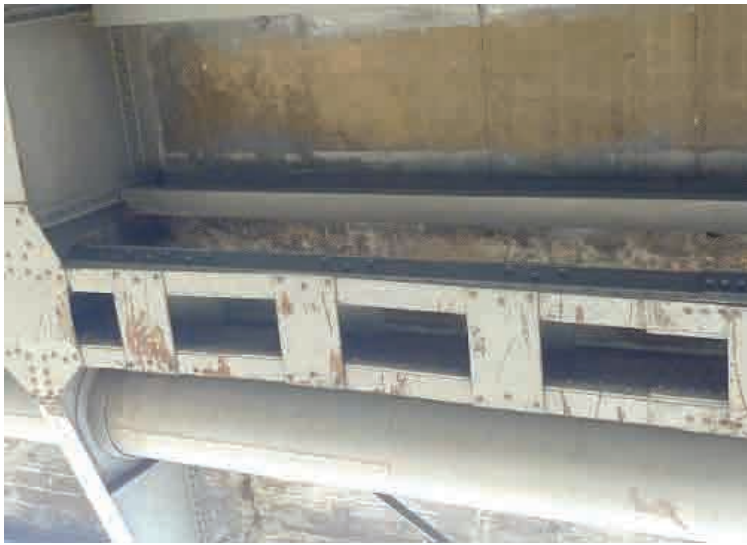
Picture No.	55
	Span	1
	Member	Slab
	Deformation by ship collision	
*Survey on board, 31-oct

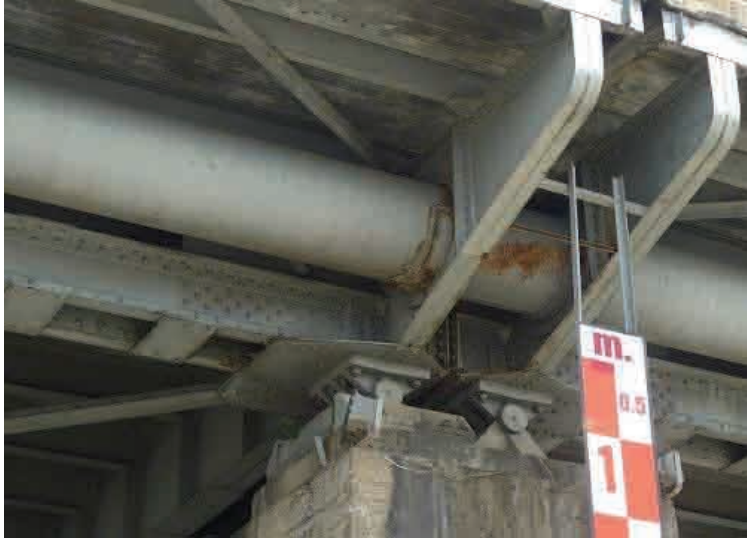
Picture No.	56
	Span	1
	Member	Water supply
	Deterioration of corrosion proofi	
*Survey on board, 31-oct
