Inspection sheet of visual survey

Bridge name		RAMA VIII Bridge		Route name		-		Authority		BMA		Code of authority		-		
Place		from Khat Bang Phlat to Khet Phra Nakhon		Distance		from km+ 0 to km+ 0						No.		-		
												Survey date		23-Oct-2009		
Bridge properties	Bridge type(1)	main road · side road · ramp														
	Bridge type(2)	bridge · viaduct · plank pass														
	Bridge type(3)	4-span composite 2 l girder cable stayed bridge														
	Total length	475.00 (m)														
	Span	75 + 50 + 50 + 300 (m)														
	Nos. of span	4 span														
	Width	29.20 (m) / (m)														
	Completion	2002														
Road information	Horizontal	Straight · incli(= 2 %) · Curve (R m)														
	Gradient	One way (·) parab (▽ · ▽)														
	Nearby tunnel	yes · no (m)														
	Nearby crossing	yes · no (ramp way)														
	Traffic	Much · Medium · Little														
	Commercial traffic	Much · Medium · Little

Appendices

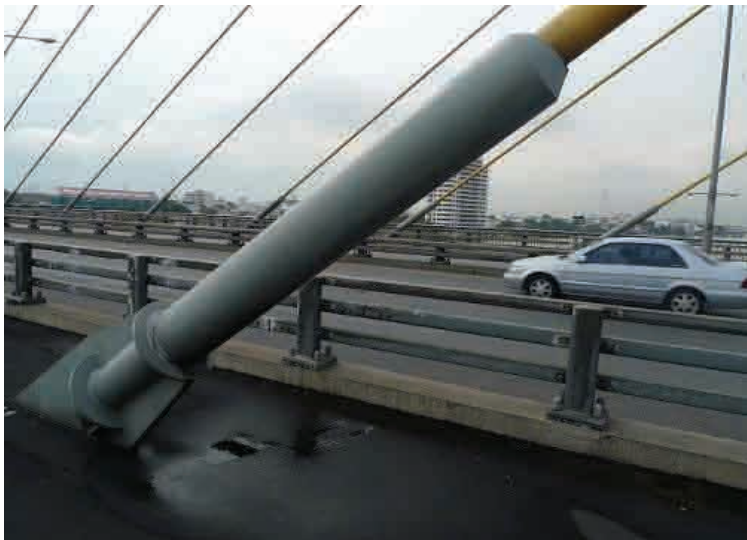
Picture No.	7
	Span	1
	Member	View of cable
	Helical type wind resistance

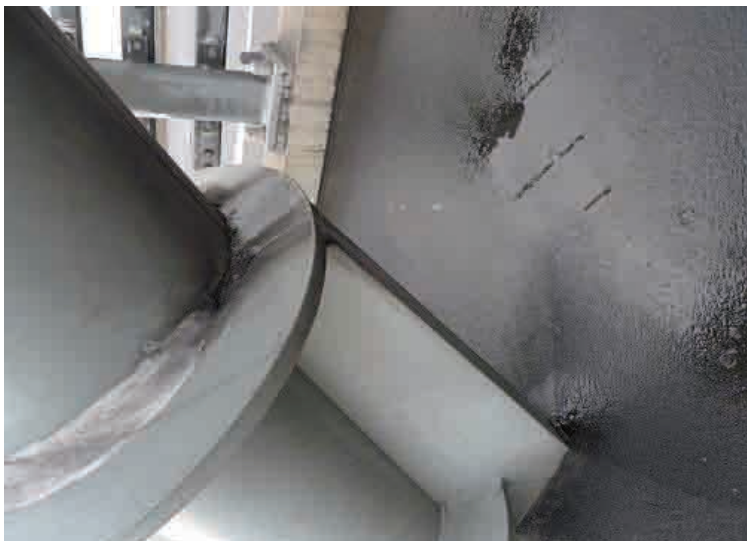
Picture No.	8
	Span	1
	Member	Cable
	Leakage from cable

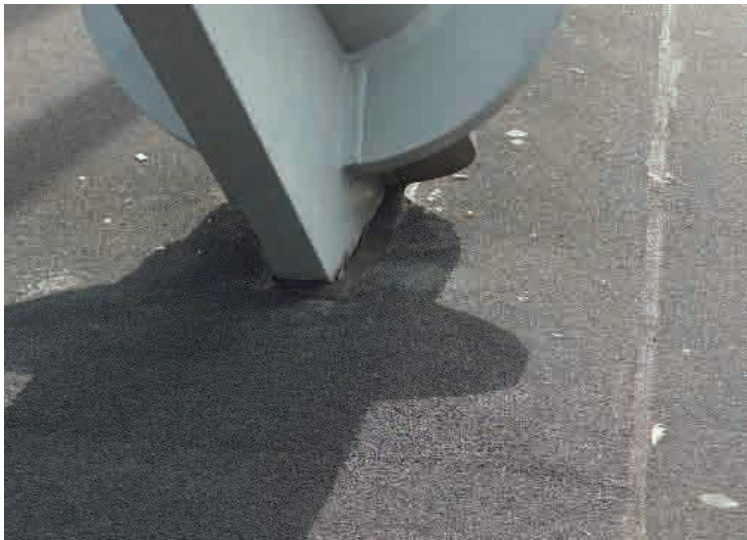
Picture No.	10
	Span	1
	Member	Cable fixing structure
	Gap and calking between cable and slab. And mounted up around cable to prevent remaining water.

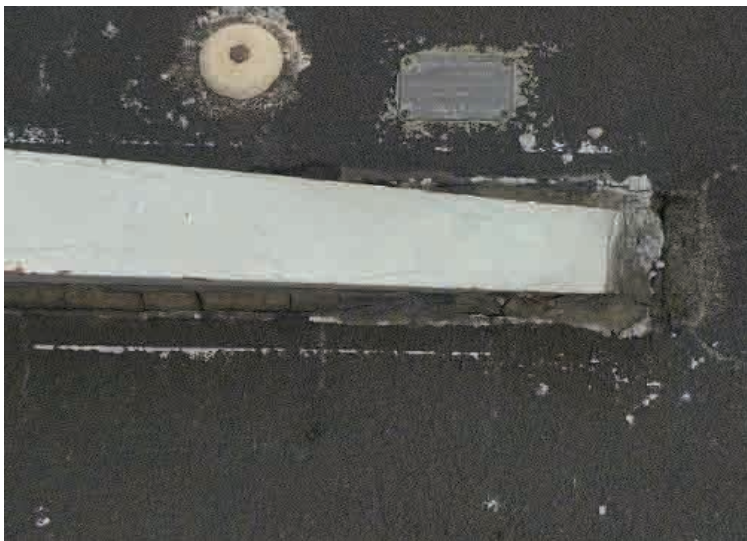
Picture No.	12
	Span	1
	Member	Cable fixing structure
	Calking and name plate of cable	
	well maintained but aging

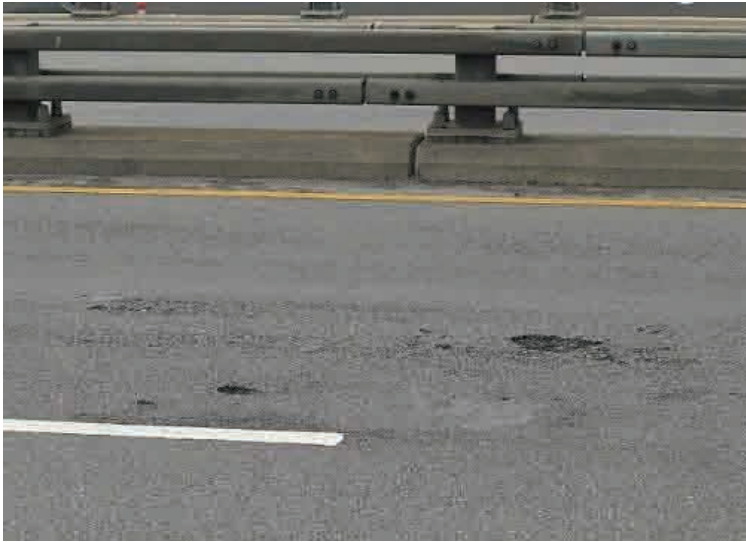
Picture No.	10
	Span	1
	Member	Pavement
	Pot-hole

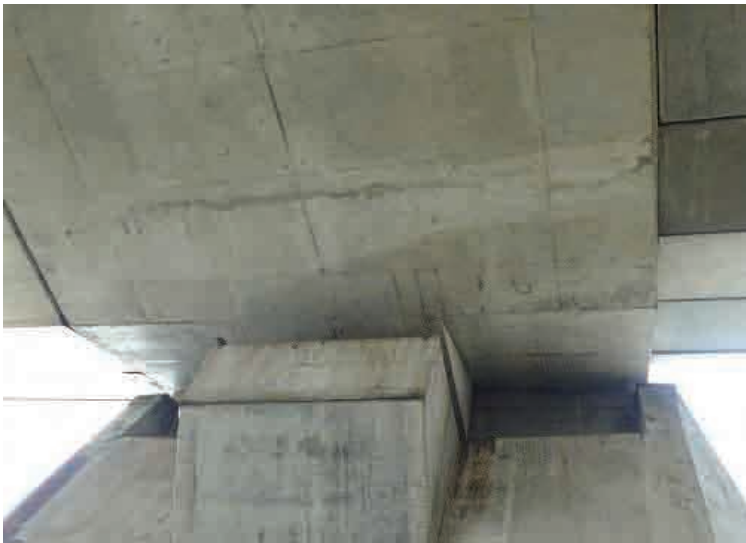
Picture No.	12
	Span	1
	Member	Cross beam
	Leakage and small fracture of concrete surface

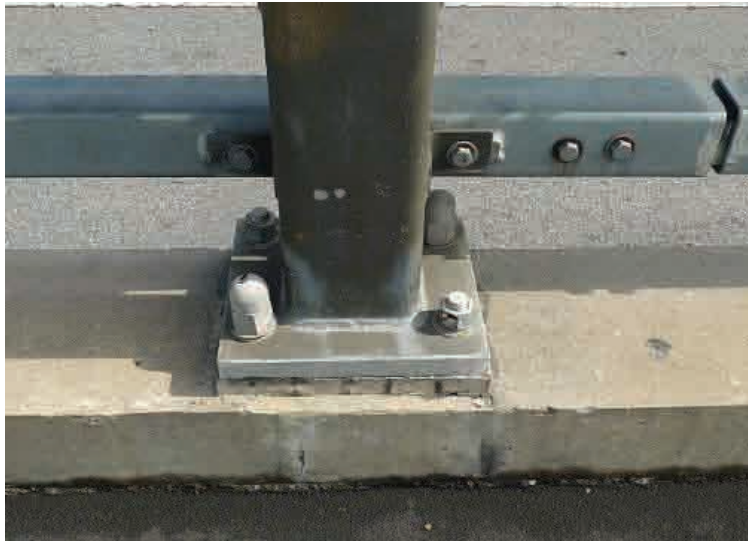
Picture No.	7
Span	1
Member	Barrier
Lack of bolt cap

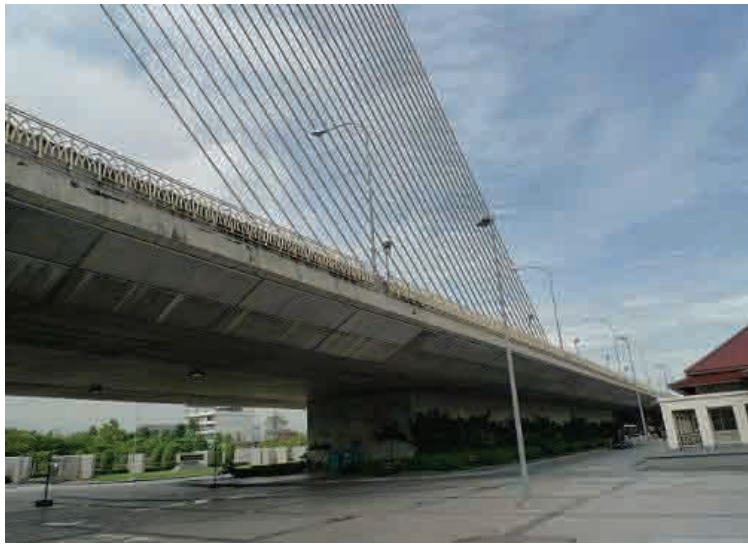
Picture No.	10
	Span	1
	Member	Decorative plate
	leakage line

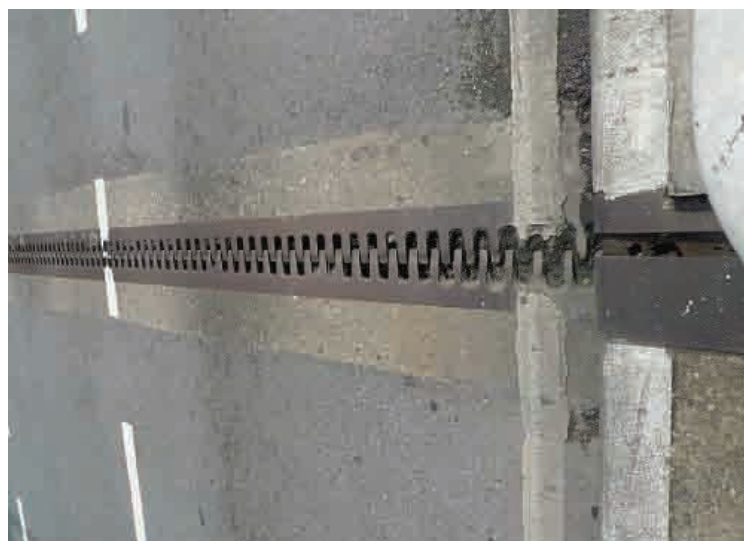
Picture No.	5
Span	1
Member	Expansion joint
Corrosion at end

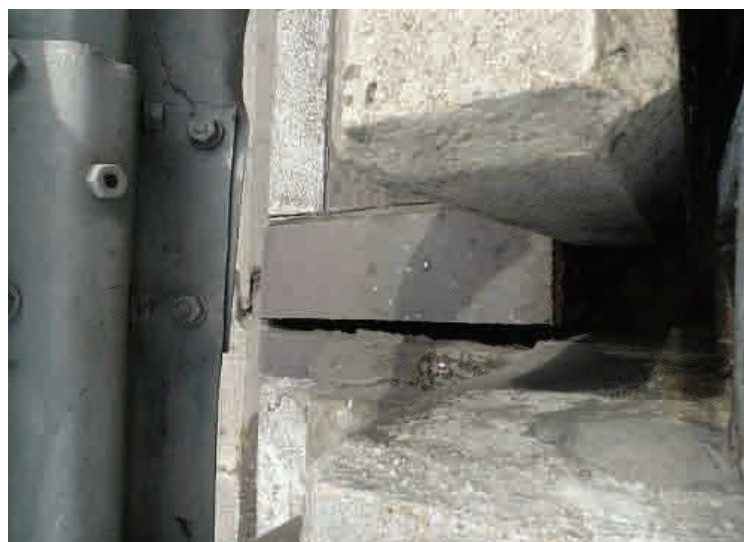
Picture No.	6
Span	1
Member	Expansion joint
Corrosion

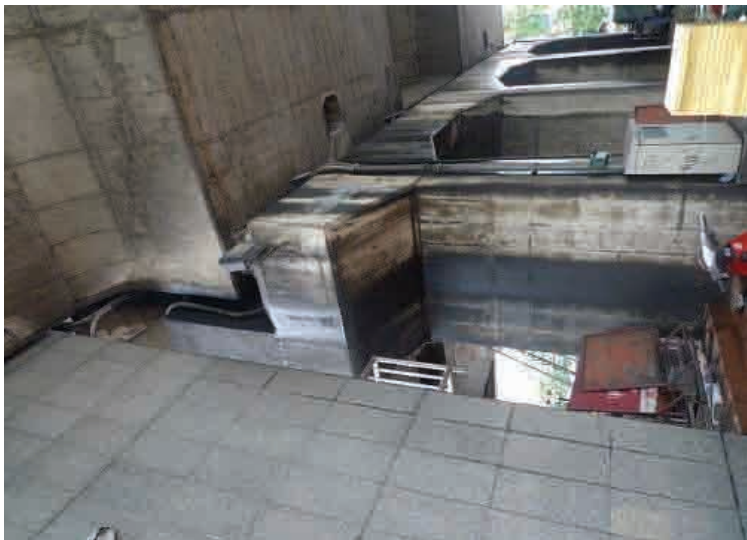
Picture No.	8
	Span	1
	Member	Expansion joint
	Deterioration of drain function	
	Bangkok side	
	No door in manhole

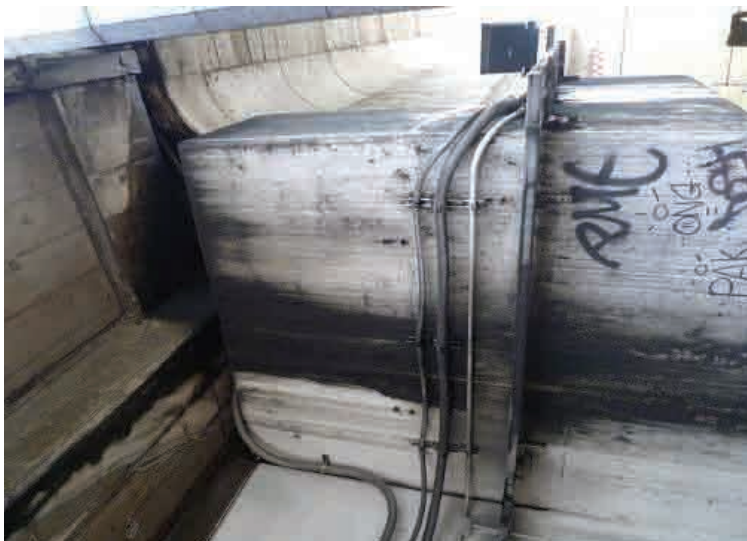
Picture No.	9
	Span	1
	Member	bottom slab
	Deterioration of drain function	
	Thon Buri side

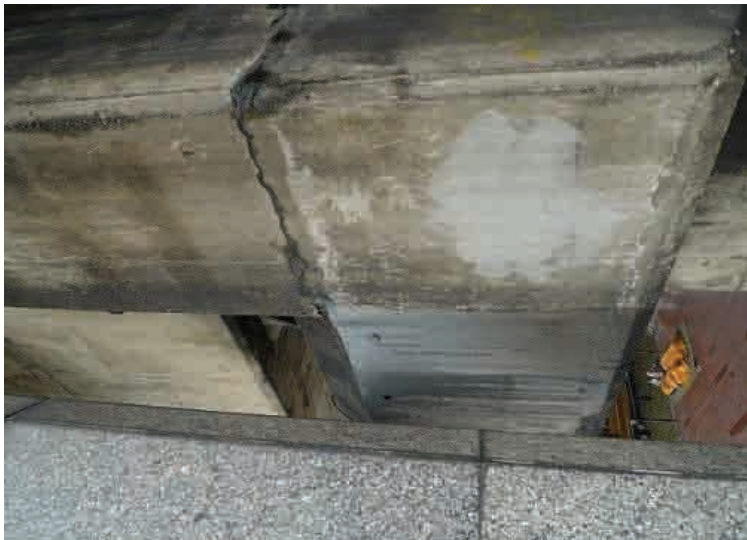
Picture No.	10
	Span	1
	Member	Approach bridge
	Crack

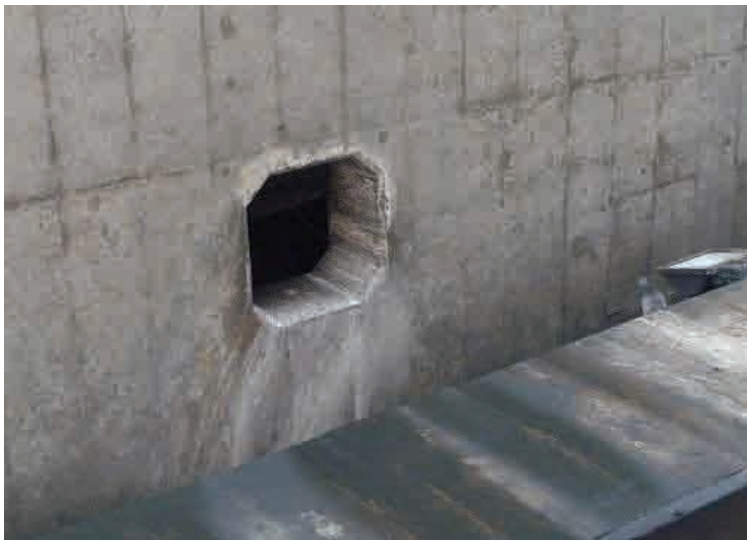
Picture No.	11
	Span	1
	Member	Man hole
	Leakage from manhole	
	Leakage from water supply?

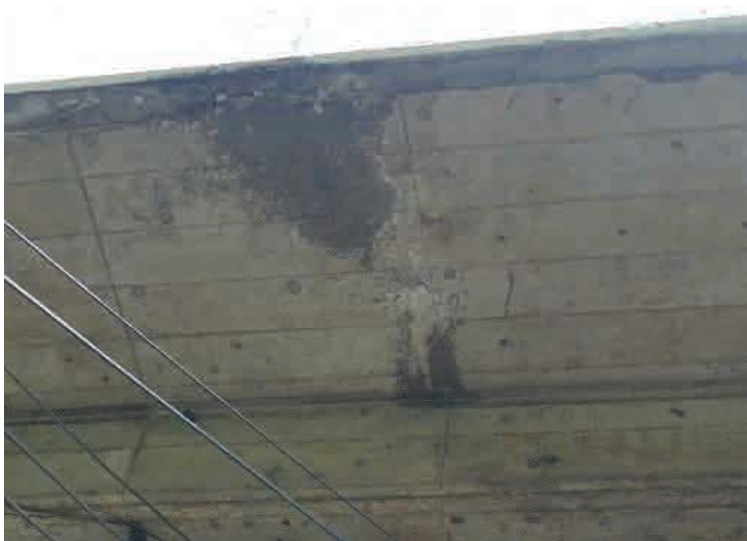
Picture No.	12
	Span	1
	Member	Pylon
	Mark of leakage from joint of barrier

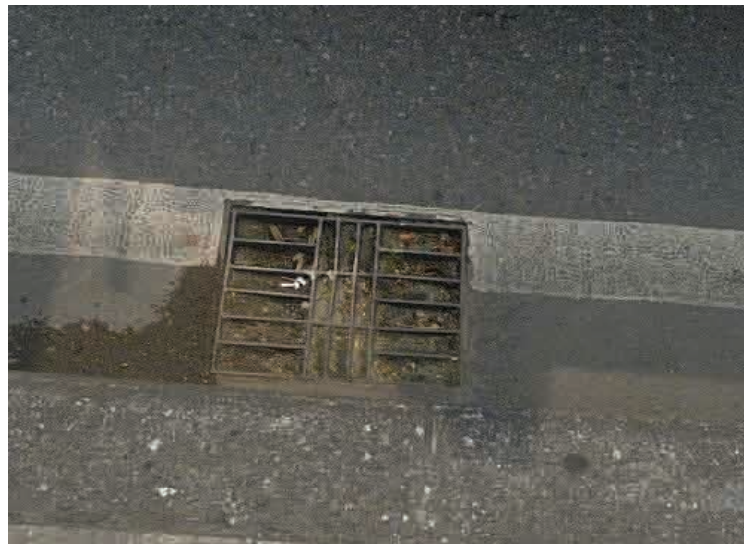
Picture No.	13
Span	1
Member	Drainage
Blocking

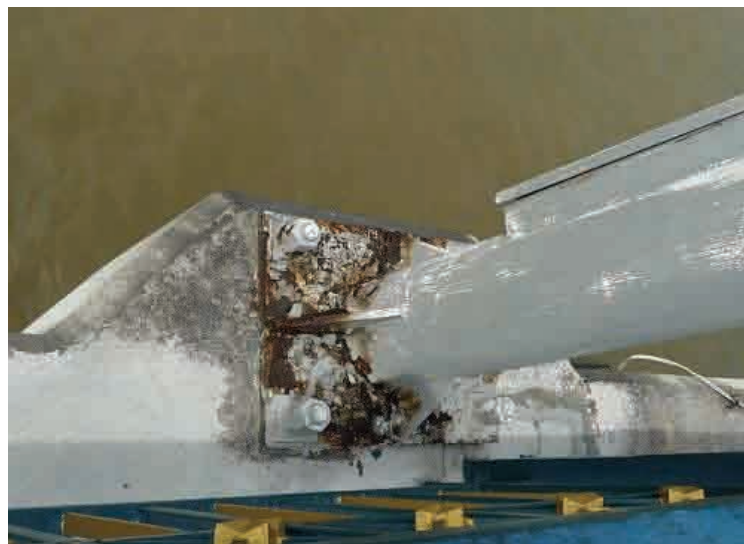
Picture No.	14
Span	1
Member	Lighting pole
Deterioration of corrosion proofi

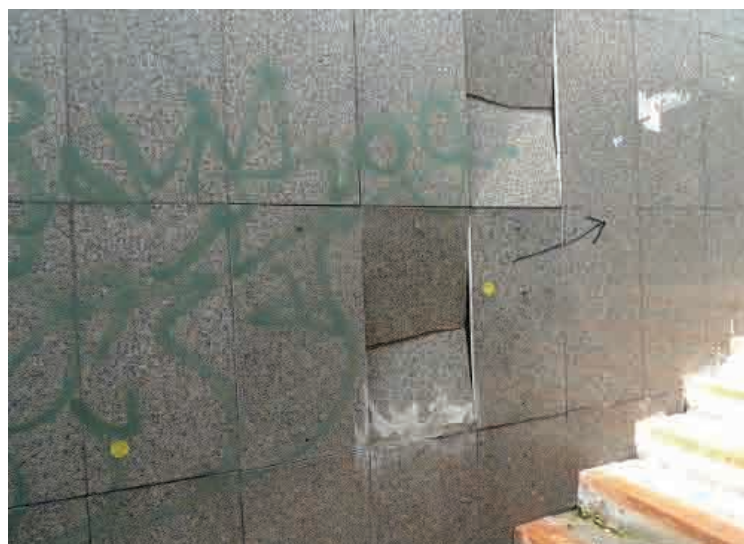
Picture No.	15
Span	1
Member	Walkway
Graffiti	
Fracture of decorative plate

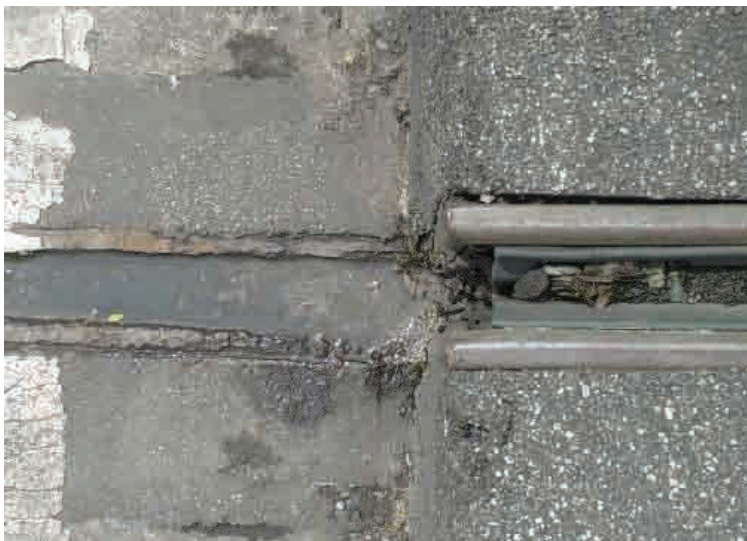
Picture No.	11
	Span	1
	Member	Expansion joint
	Bangkok side	
	Deterioration of corrosion proofi

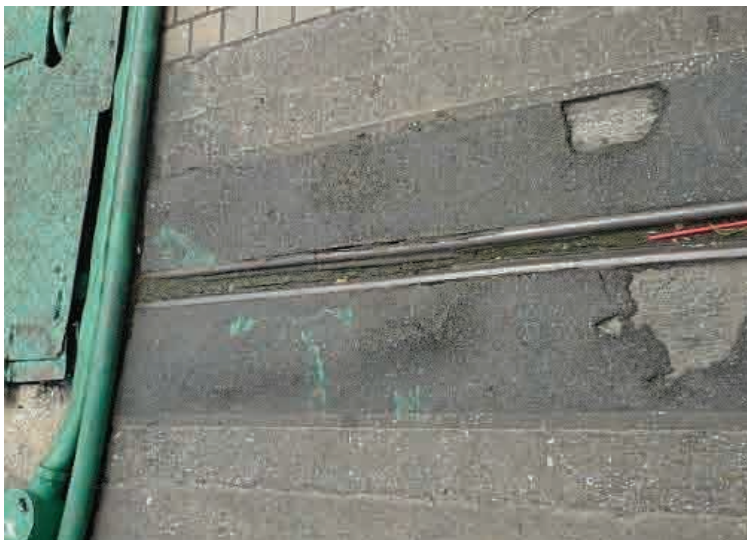
Picture No.	12
	Span	1
	Member	Expansion joint
	between side span and center span	
	Peeling of surface layer

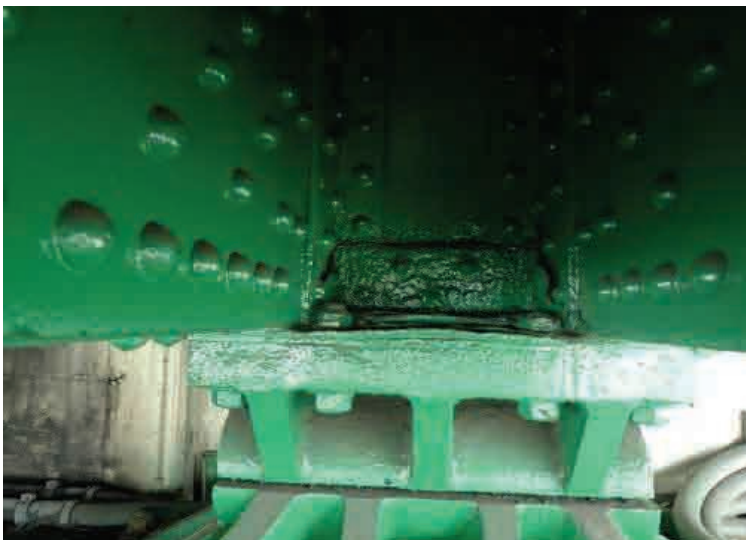
Picture No.	9
	Span	1
	Member	Bearing
	Mark of remarkable corrosion	
	There is no remaining water at survey. Improved?

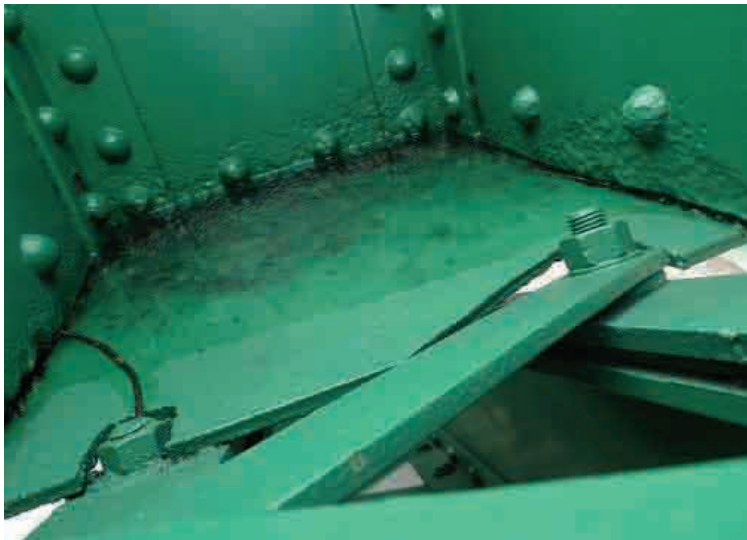
Picture No.	16
	Span	1
	Member	slab
	Remaining water It will make corrosion

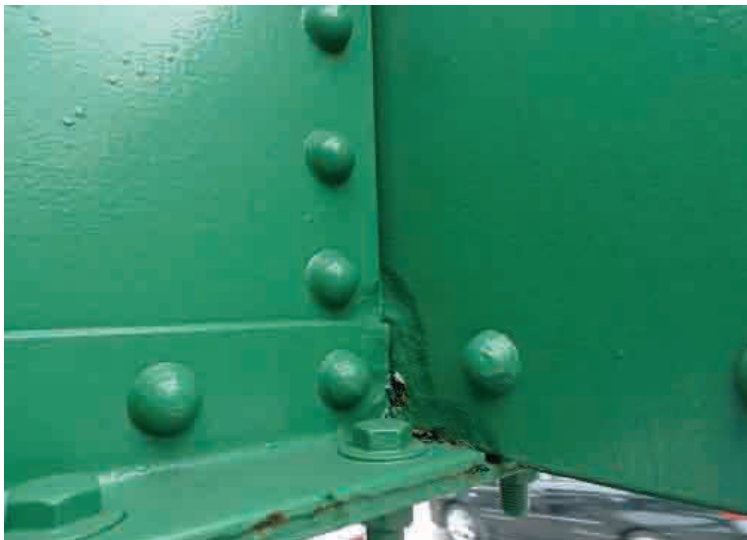
Picture No.	17
	Span	1
	Member	slab
	Remarkable reduced section

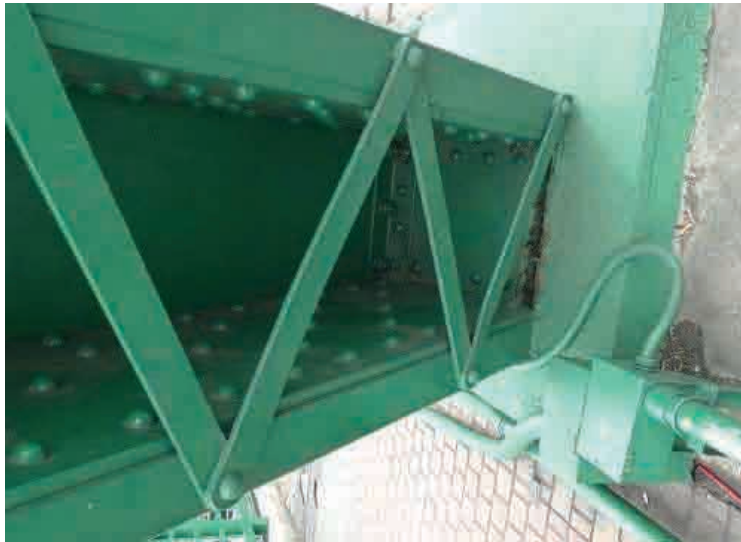
Picture No.	13
Span	1
Member	slab
Deterioration of corrosion proofing

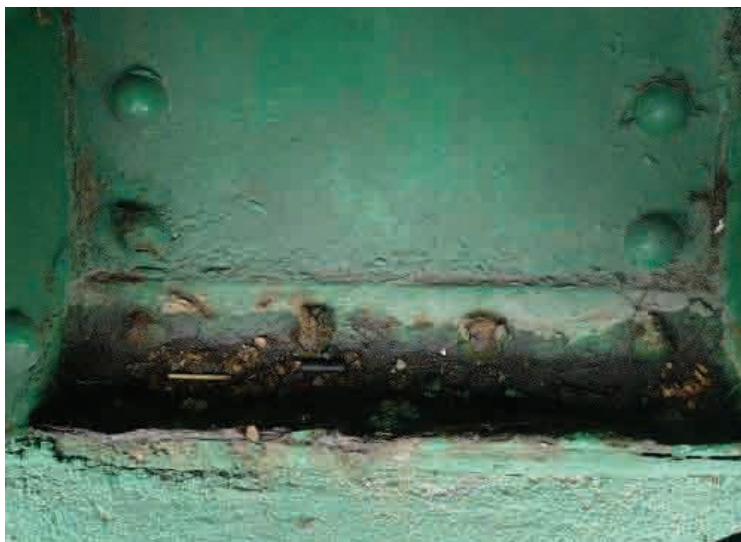
Picture No.	14
Span	1
Member	slab
Corrosion of diaphragm	
Accumulation of soil

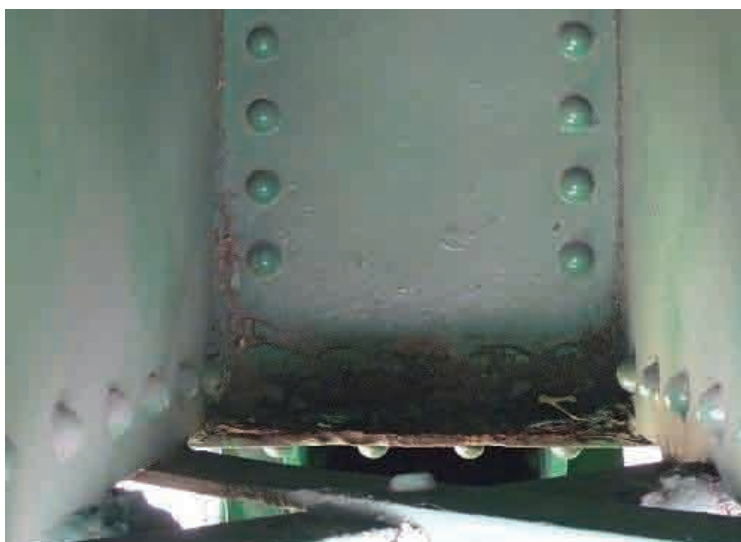
Picture No.	15
Span	1
Member	Lighting pole
Corrosion of diaphragm

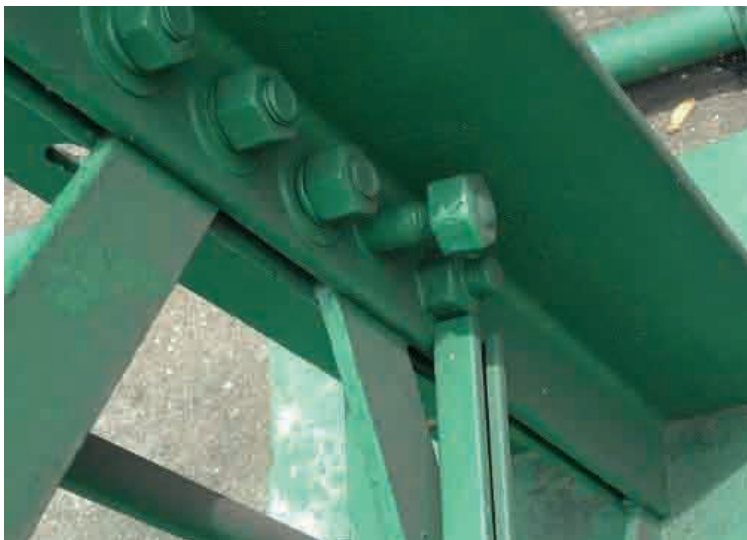
Picture No.	18
	Span	1
	Member	Bolt
	Looseness of bolt

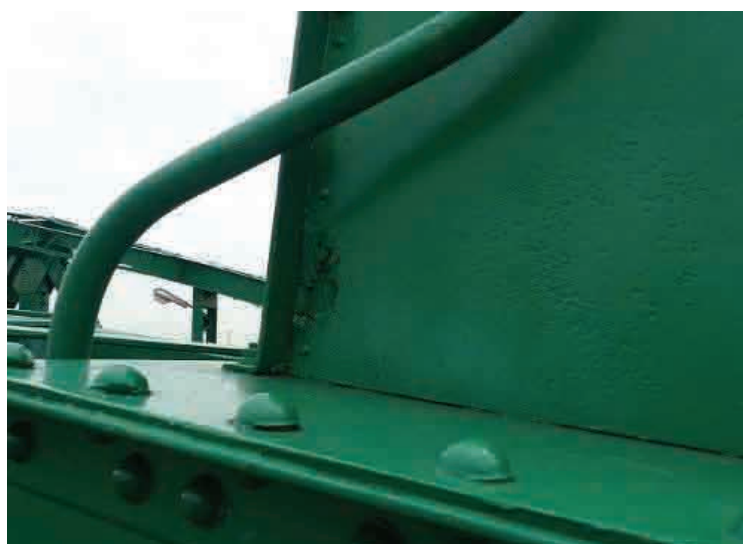
Picture No.	21
Span	1
Member	Lighting pole
Corrosion

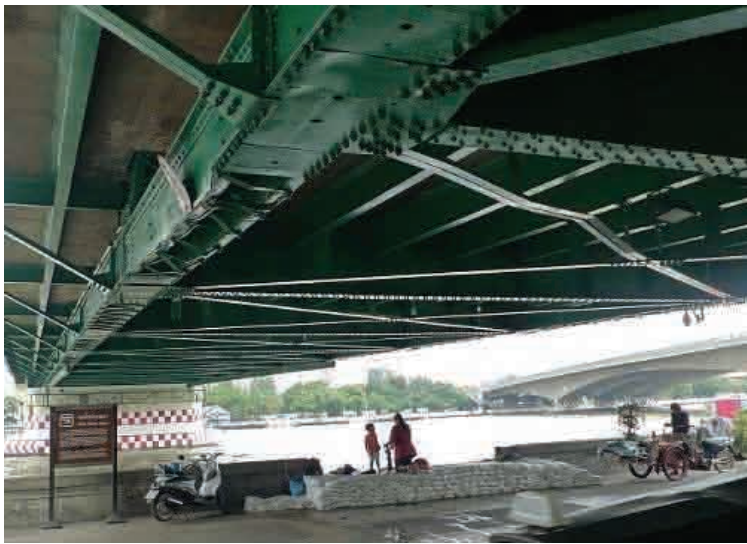
Picture No.	23
	Span	1
	Member	Bottom chord
	Deformation by vehicle collision	
	Limit of vehicle height is 3.5m	
	No warning frame is set before bridge at Thon Buri side

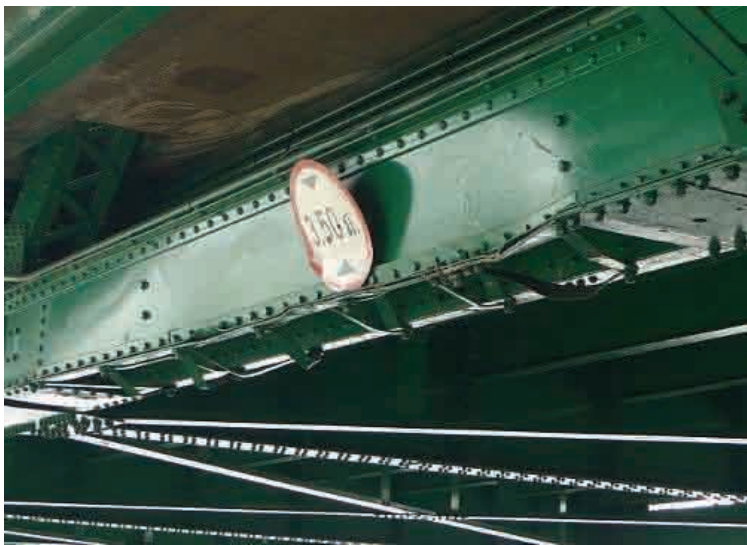
Picture No.	24
	Span	1
	Member	Bottom chord
	Deformation by vehicle collision	
	Thon Buri side

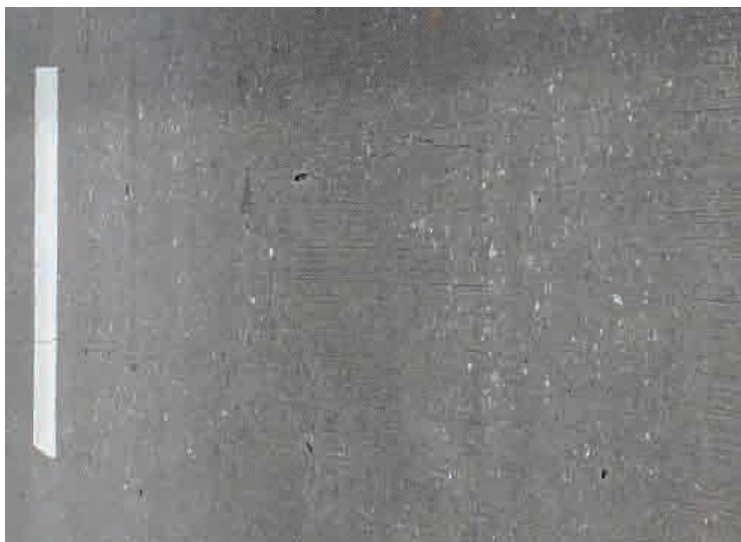
Picture No.	30
Span	1
Member	slab

Crack on slab

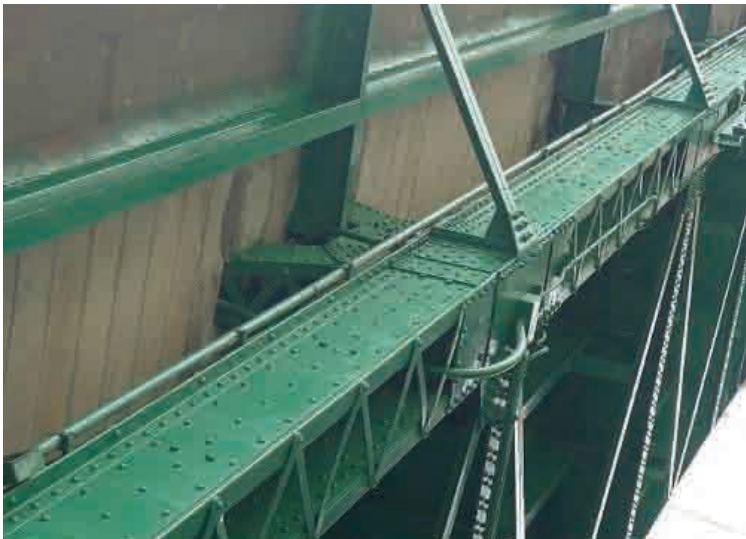
Picture No.	31
	Span	1
	Member	slab
	Replaced slab	
	Free lime is seen on slab of center span and walkway

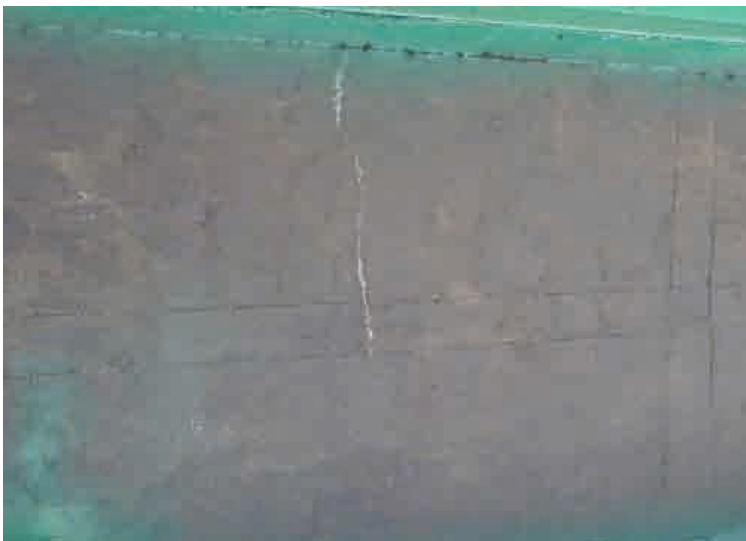
Picture No.	32
	Span	1
	Member	slab
	Crack and free lime

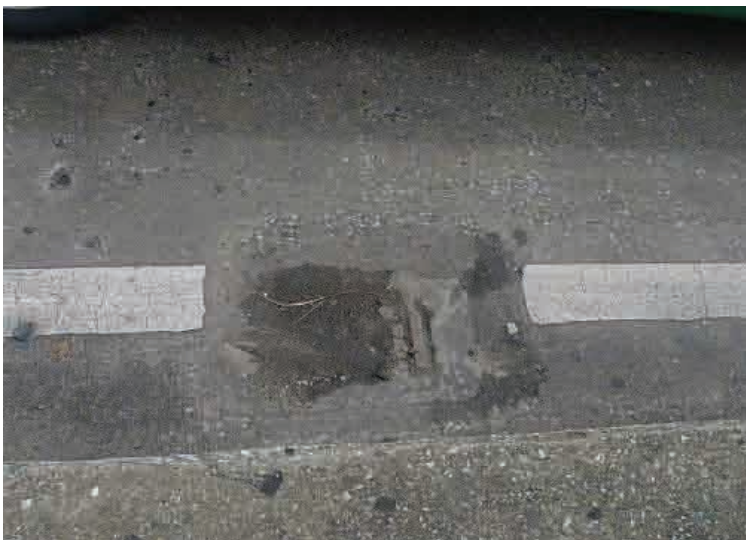
Picture No.	33
	Span	1
	Member	Drainage
	Blocked

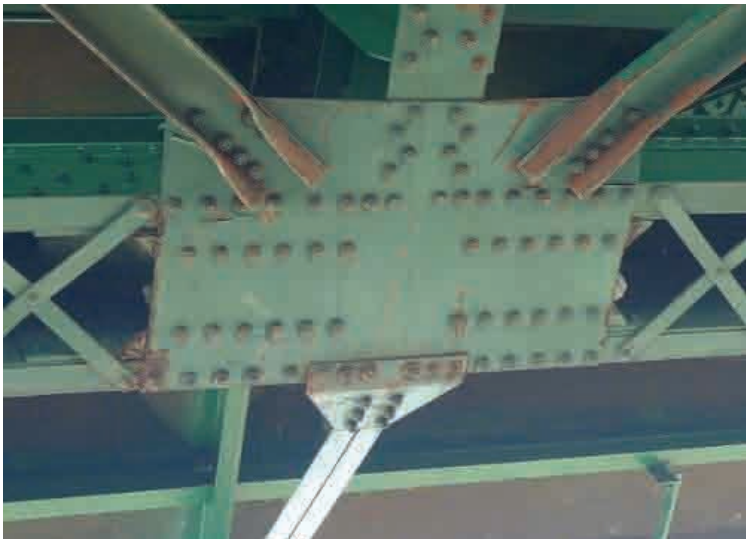
Picture No.	40
	Span	1
	Member	Gusset plate
	Damage by ship collision	
	<i>*Survey on board, 31-oct</i>	
	Picture No.	41
	Span	1
	Member	
	Picture No.	42
	Span	1
	Member

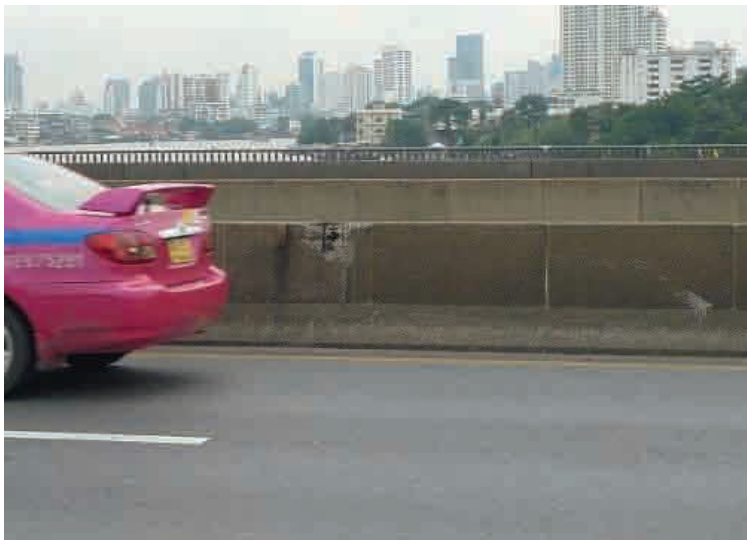
Picture No.	8
	Span	1
	Member	Center barrier
	Fracture of concrete surface

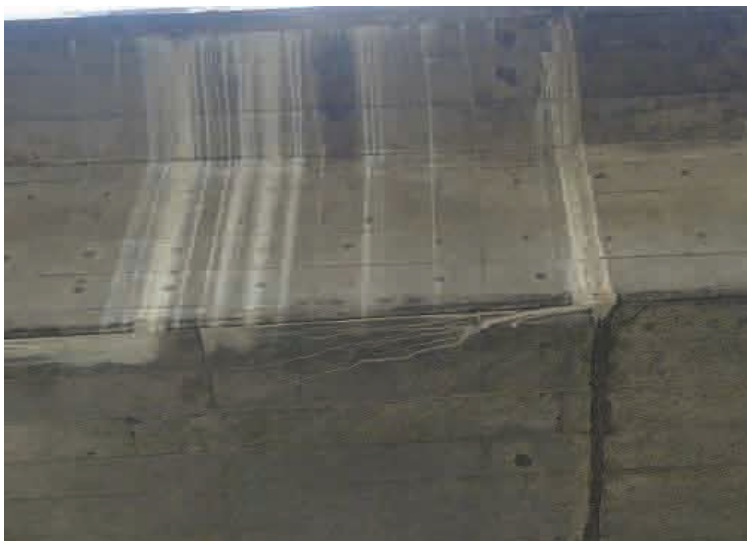
Picture No.	9
	Span	1
	Member	
	Free lime	
	Deterioration of drain function	
<i>*Survey on board, 31-oct</i>

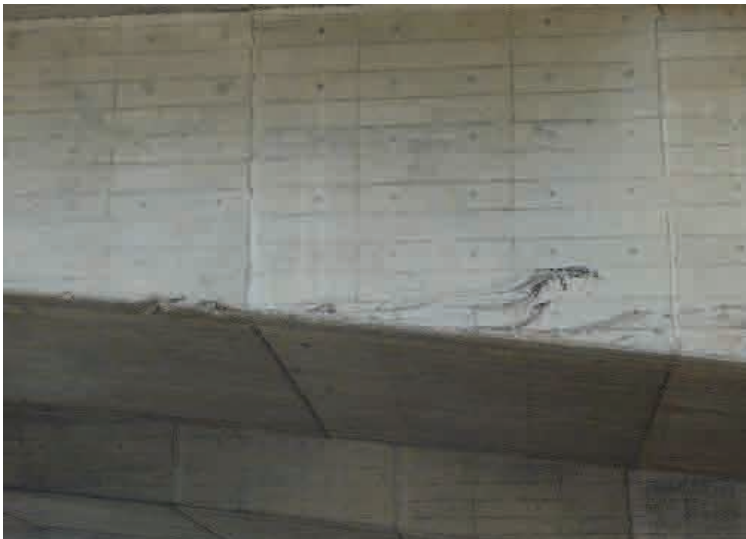
Picture No.	10
	Span	1
	Member	Drainage
	Scratch by ship collision

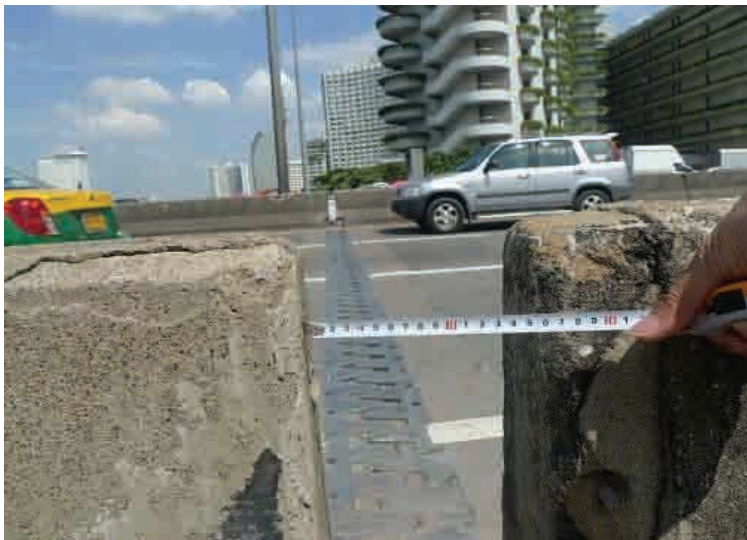
Picture No.	5
	Span	1
	Member	Expansion joint
	Spacing is wider than 3cm than other joint	
	Bangkok side, down stream

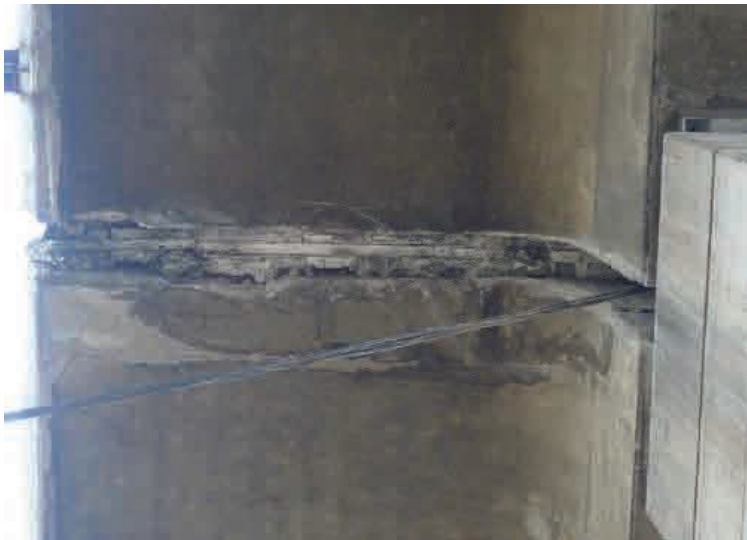
Picture No.	10
	Span	1
	Member	Expansion joint
	Deterioration of drain function	
	Mark of leakage

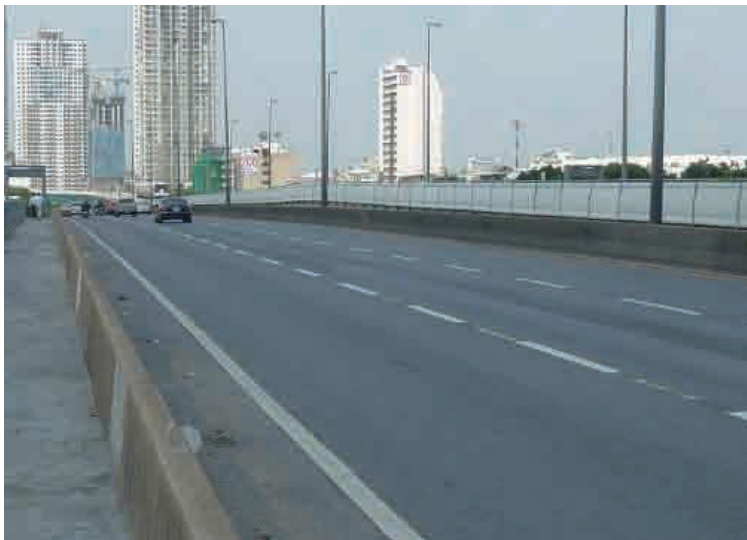
Picture No.	11
	Span	1
	Member	Vertical alignment
	Bent angle between main bridge and approach bridge

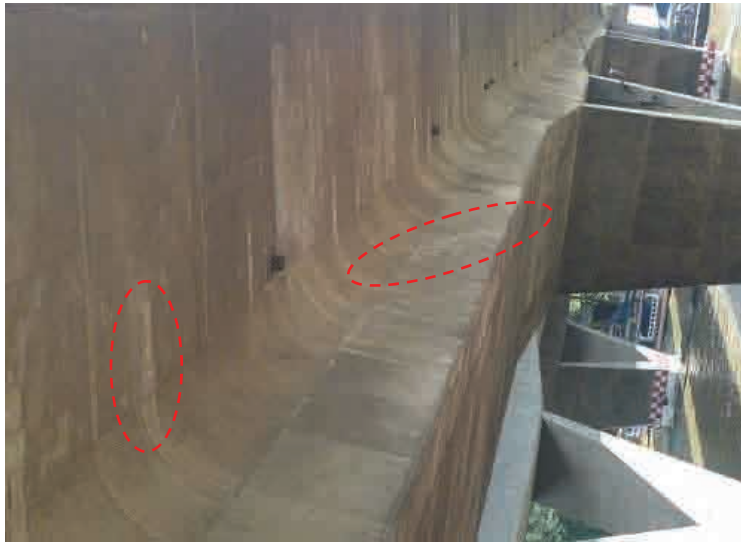
Picture No.	7
Span	1
Member	Box girder
Shear crack or severe cold joint	
Detailed study is recommended	
Free lime from filled hole	
Without waterproofing?

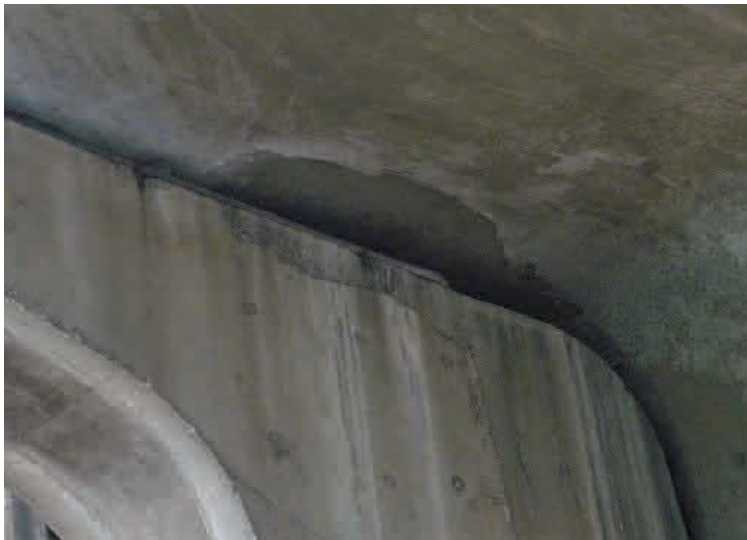
Picture No.	10
	Span	1
	Member	Slab
	Mark of repair

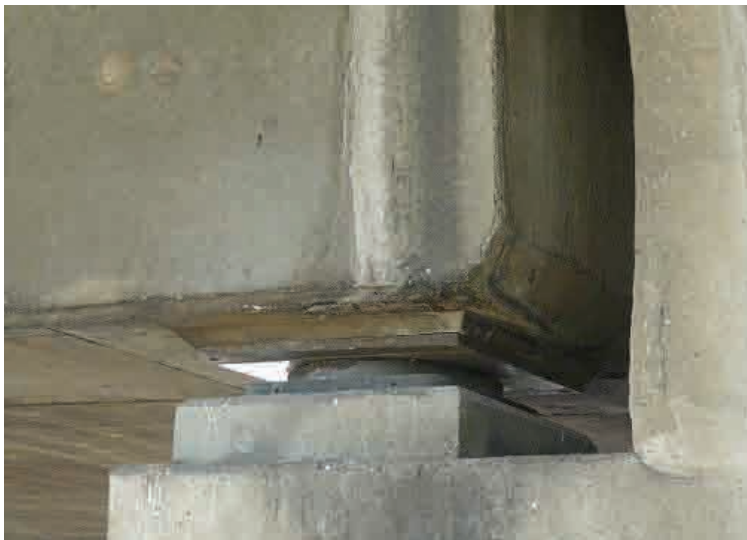
Picture No.	11
	Span	1
	Member	Bearing
	Leakage from joint	
	Upstream, Thon Buri side

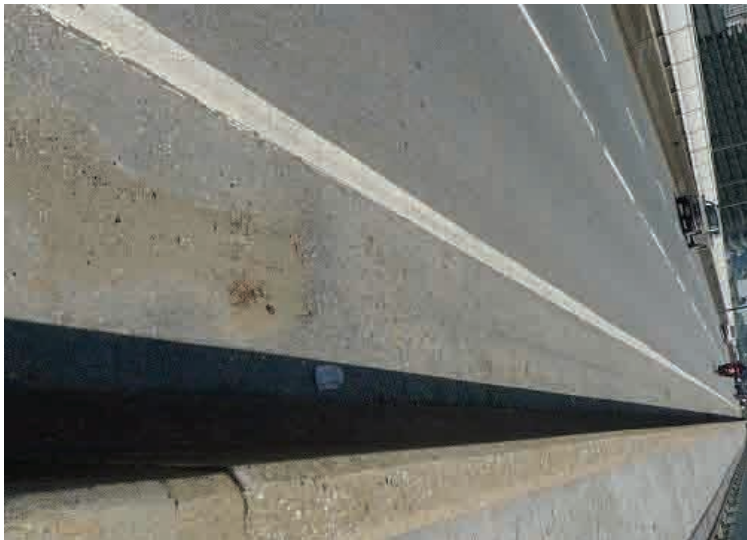
Picture No.	7
	Span	1
	Member	Catch basin
	Blocking
