Inspection sheet of visual survey

Bridge No. 10

Bridge name		Krung Thon Bridge		Route name	-		Authority	Code of authority	-		
Place		from Khat Bang Phlat to Khet Dusit		Distance	from	km+	0	No.	-		
					to	km+	0	Survey date	2009/10/24		
Bridge properties	Bridge type(1)	<input checked="" type="checkbox"/> main road · <input type="checkbox"/> side road · <input type="checkbox"/> ramp		Camber deform	yes · <input checked="" type="checkbox"/> no		Outline of damage	Item	Type	State	
	Bridge type(2)	<input checked="" type="checkbox"/> bridge · <input type="checkbox"/> viaduct · <input type="checkbox"/> plank pass		Difference in grade	yes · <input checked="" type="checkbox"/> no			Main girder	Truss	Corrosion, Deterioration of proofing, deformation by collision	
	Bridge type(3)	6-span steel truss		Continuous of barrier	<input checked="" type="checkbox"/> yes · <input type="checkbox"/> no			Cross beam	I section steel	-	
	Total length	360.00 (m)		Continuous of curve	<input checked="" type="checkbox"/> yes · <input type="checkbox"/> no			Stringer	I section steel	Deterioration of proofing

Present state (7 / 19)					
Authority	DRR	Address	Bangkok	Data	24-Oct-09
Bridge	Krung Thon Bridge

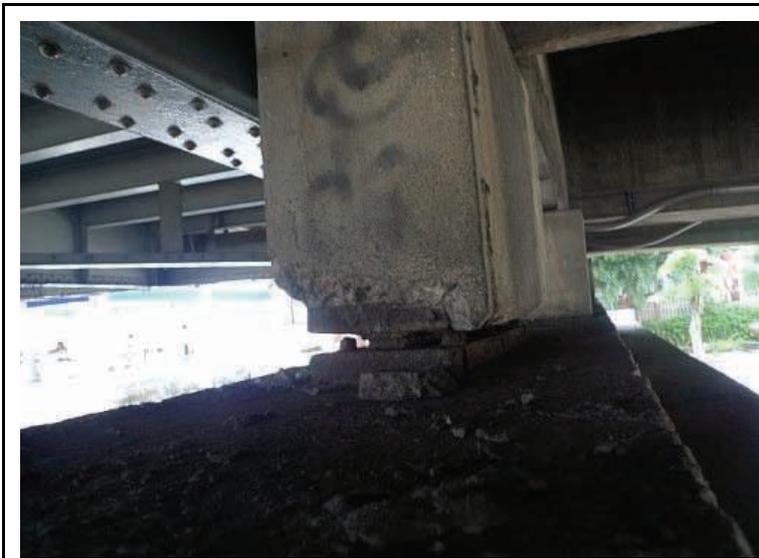
Picture No.	19
Span	1
Member	Bearing
Deterioration of corrosion proof i	
Fracture of edge	
Approach bridge

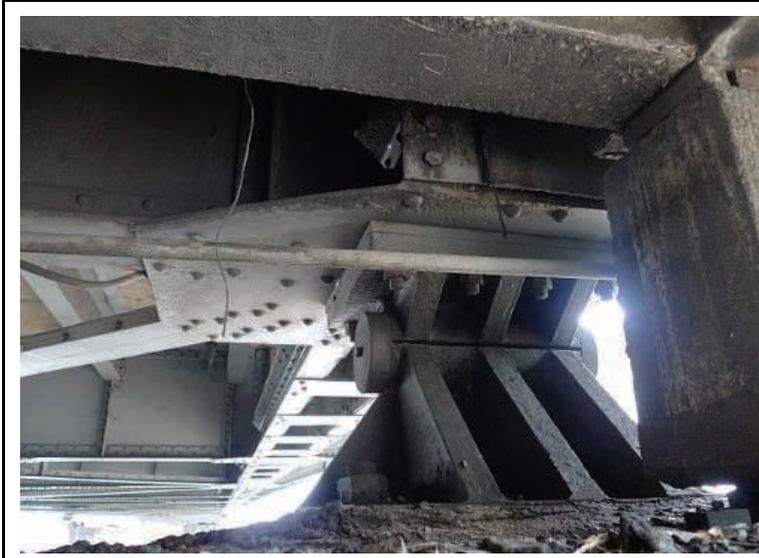
Picture No.	21
Span	1
Member	Bearing
Deterioration of corrosion proof i

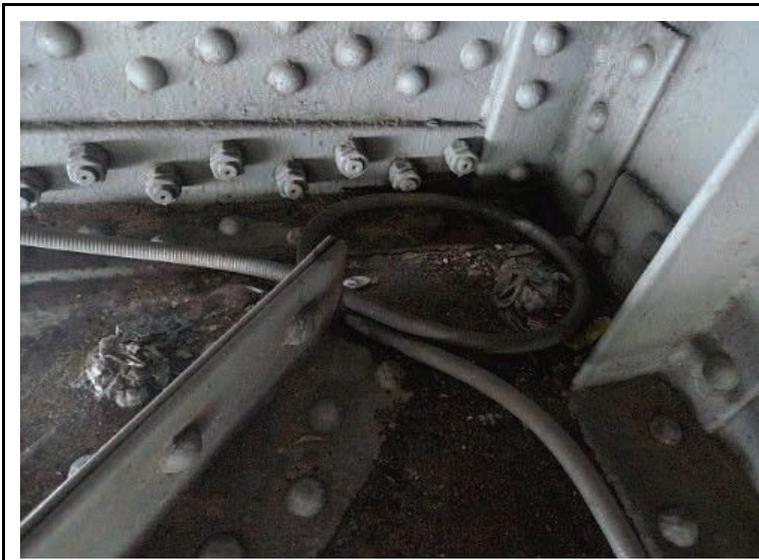
Picture No.	25
Span	1
Member	Bearing
Rivet at bottom side is replaced by bolt	
It might be corroded before

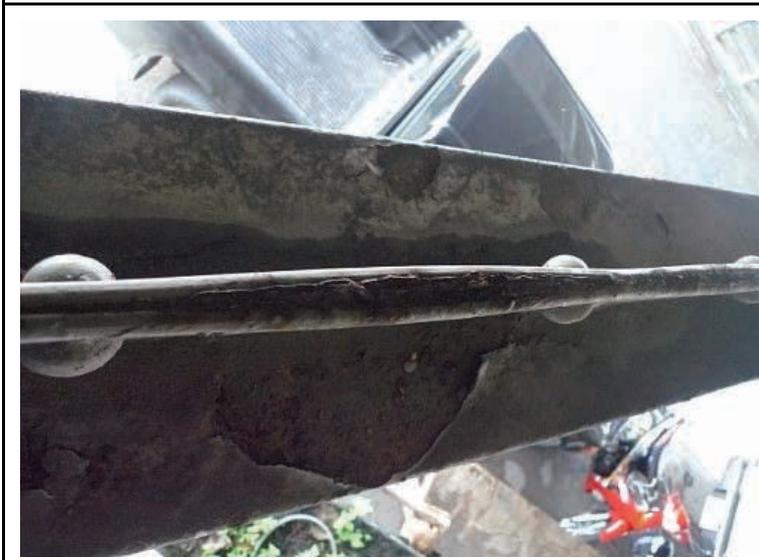
Picture No.	26
Span	1
Member	Cross frame
Peeling of paint	
Expansion of steel by corrosion

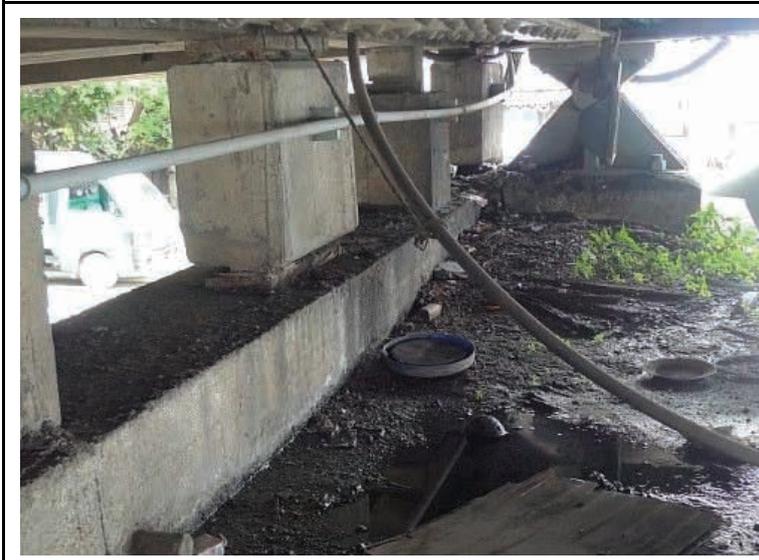
Picture No.	27
Span	1
Member	Bearing
Accumulation of soil

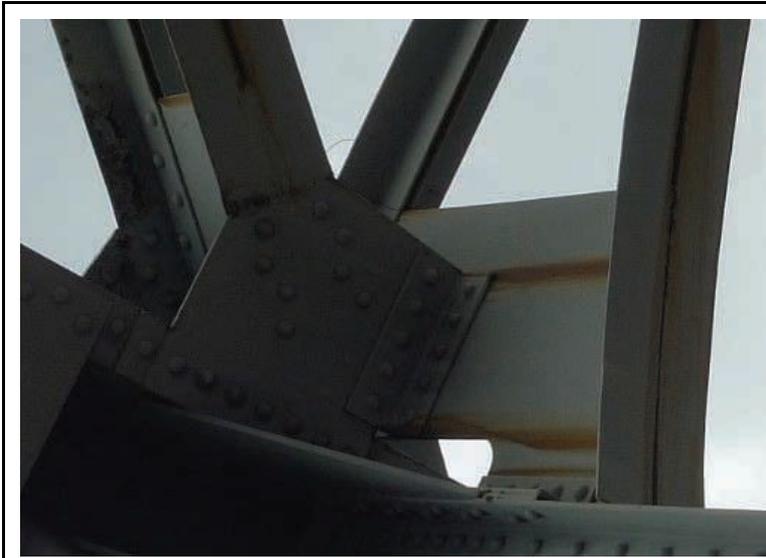
Picture No.	37
Span	1
Member	Upper chord
Deterioration of corrosion proof

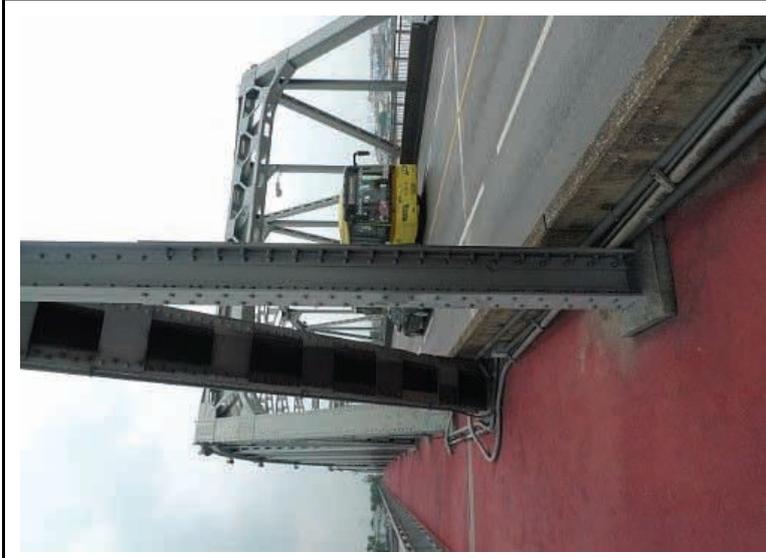
Picture No.	38
Span	1
Member	Vertical member
Reinforcement by additional plate	
4-vertical member was reinforced

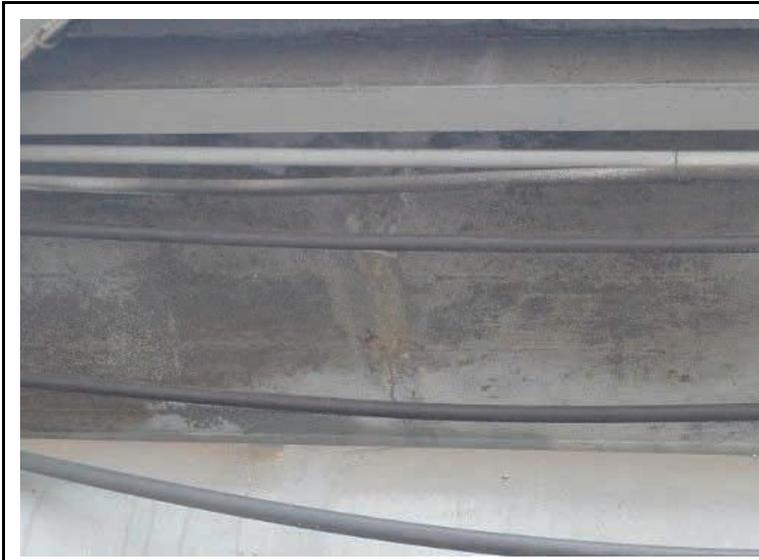
Picture No.	43
Span	1
Member	Slab
Slab under walkway	
Crack and free lime

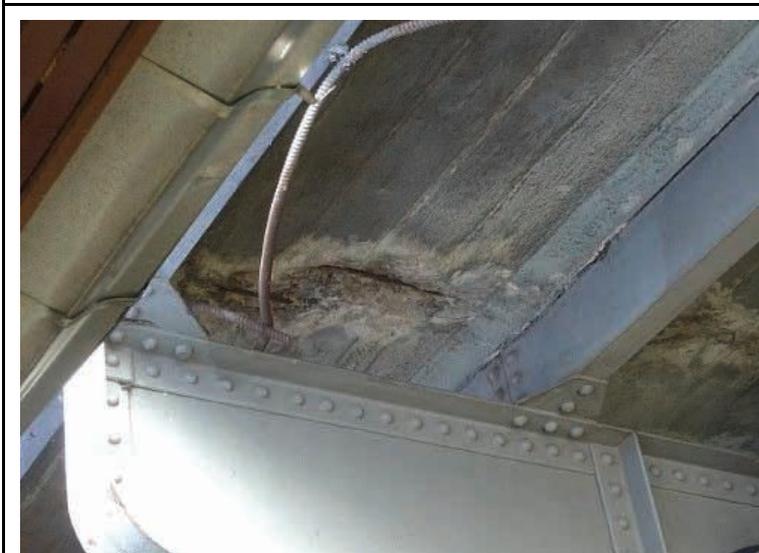
Picture No.	45
Span	1
Member	slab
Exposure of rebar

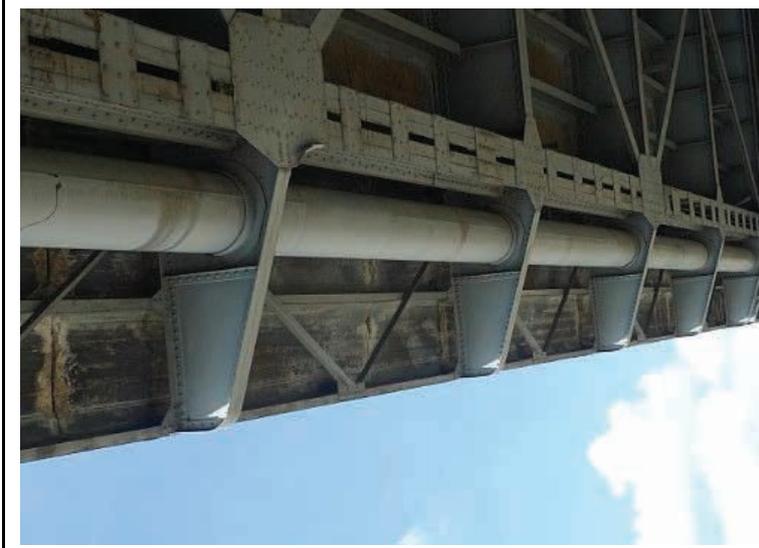
Picture No.	53
Span	1
Member	slab
Crack and free lime under walkway	
*Survey on board, 31-oct

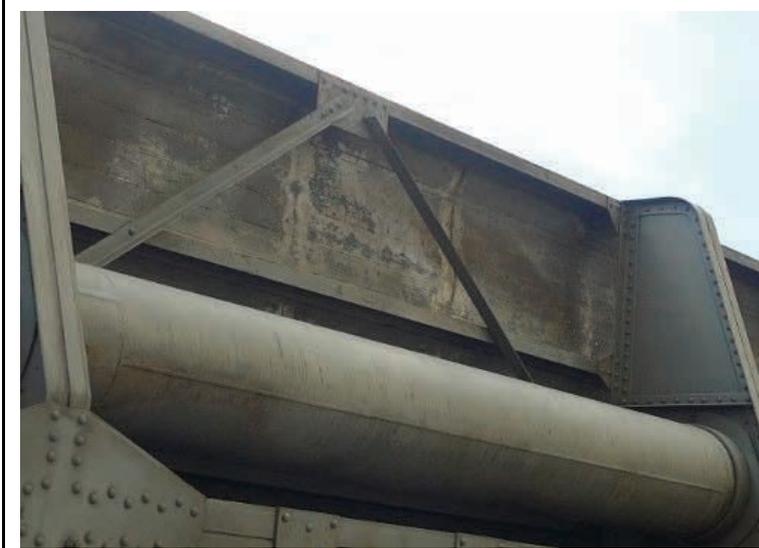
Picture No.	54
Span	1
Member	Slab
Crack and free lime under walkway	
*Survey on board, 31-oct

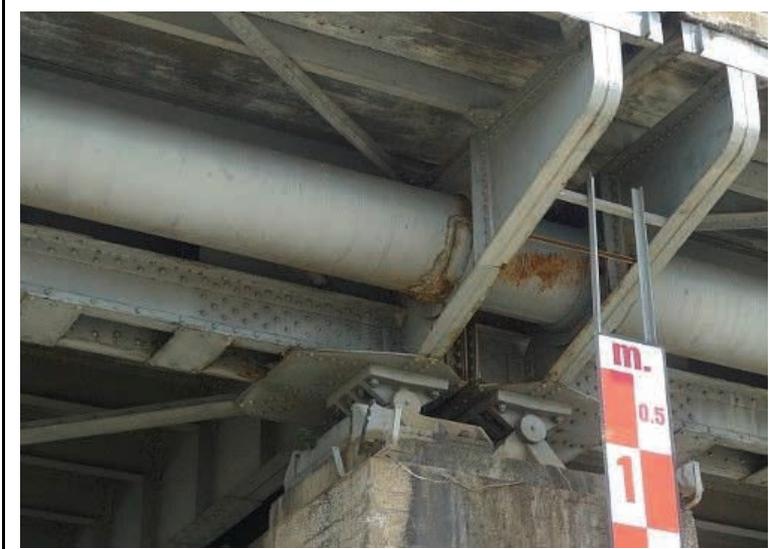
Picture No.	56
Span	1
Member	Water supply
Deterioration of corrosion proofing	
*Survey on board, 31-oct

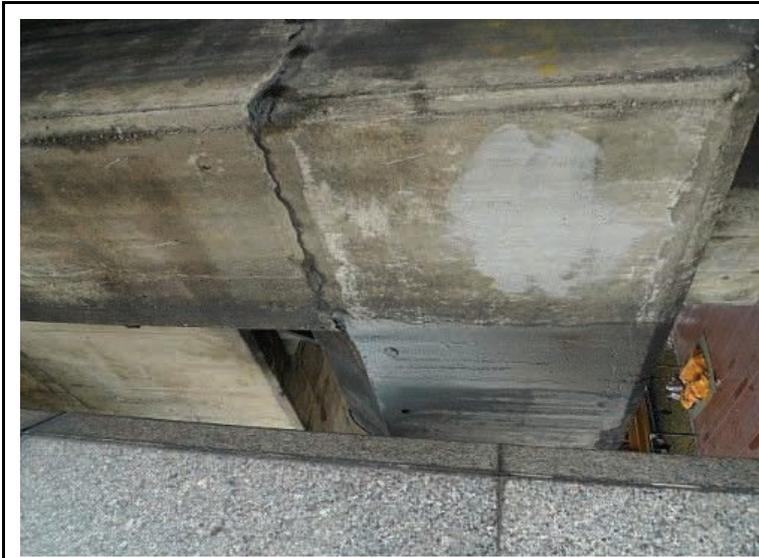
Picture No.	10
Span	1
Member	Approach bridge
Crack

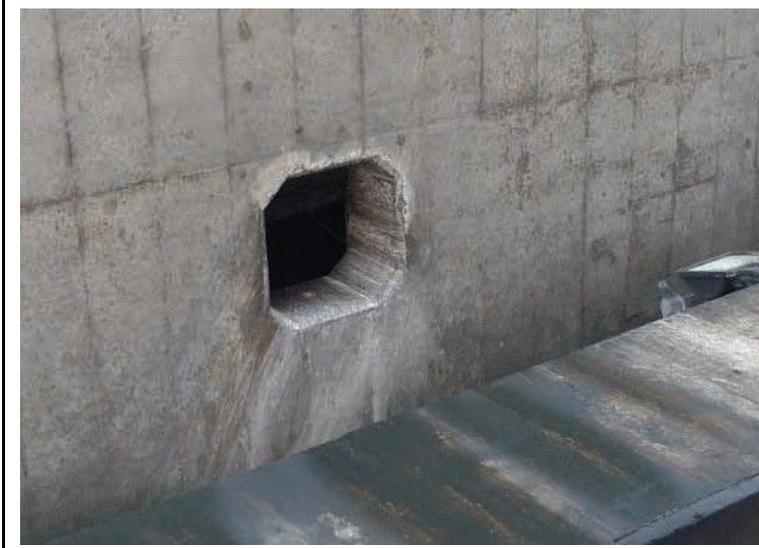
Picture No.	11
Span	1
Member	Man hole
Leakage from manhole	
Leakage from water supply?

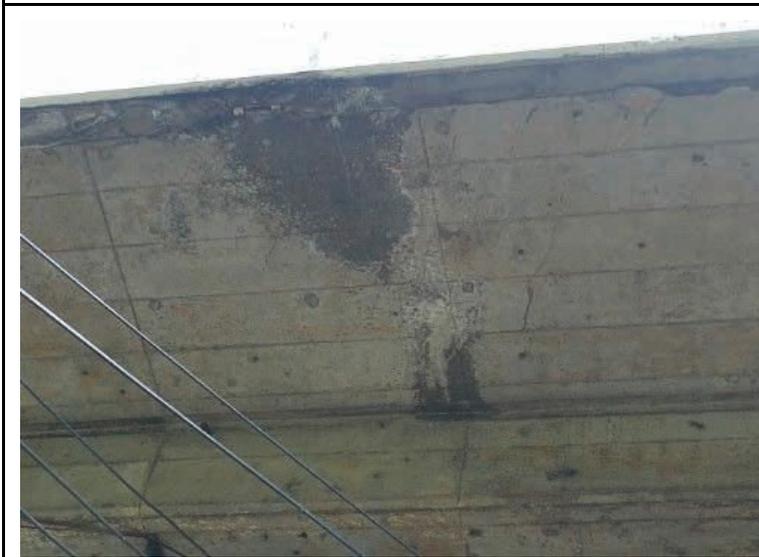
Picture No.	12
Span	1
Member	Pylon
Mark of leakage from joint of barrier

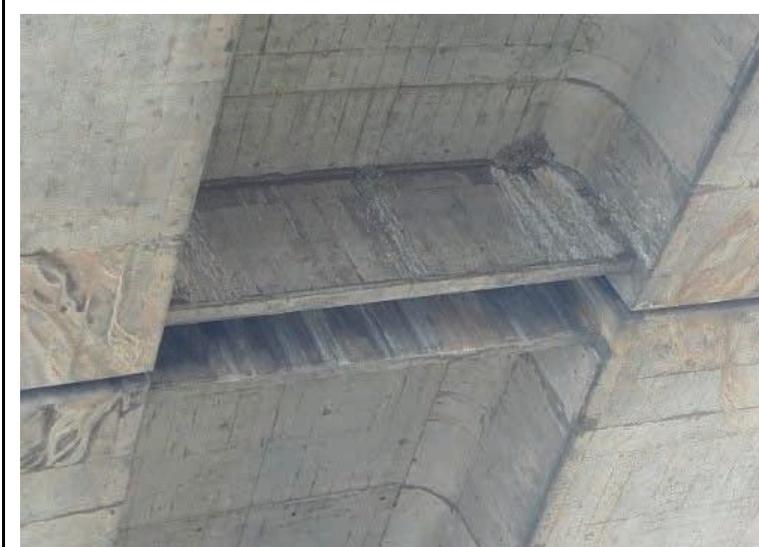
Picture No.	18
Span	1
Member	Slab
Nest harm	
*Survey on board, 31-oct

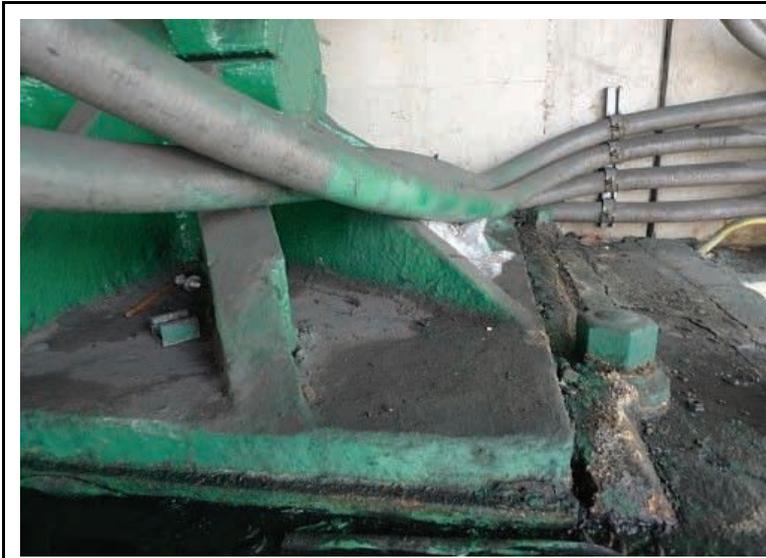
Picture No.	7
Span	1
Member	Bearing
Deterioration of corrosion protection

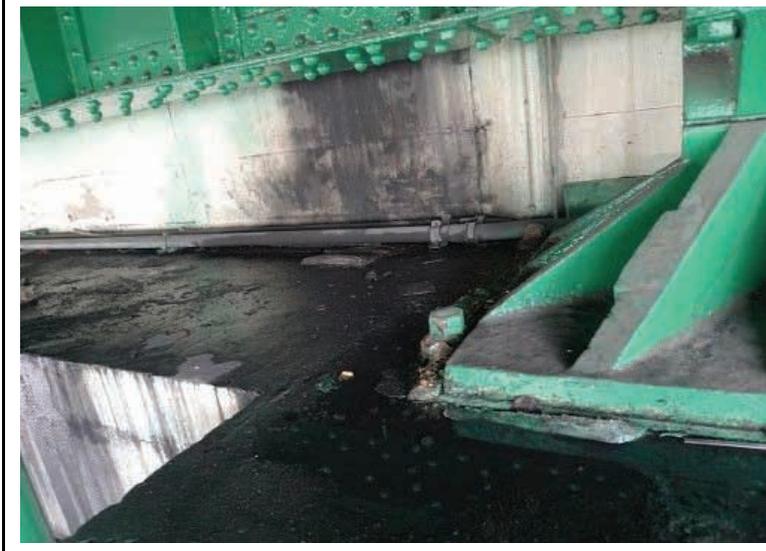
Picture No.	8
Span	1
Member	Bearing
Remaining water

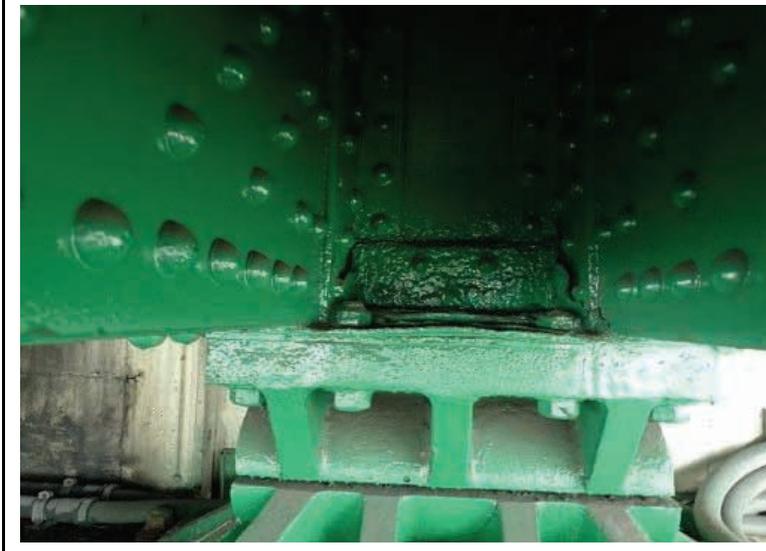
Picture No.	9
Span	1
Member	Bearing
Mark of remarkable corrosion	
There is no remaining water at survey. Improved?

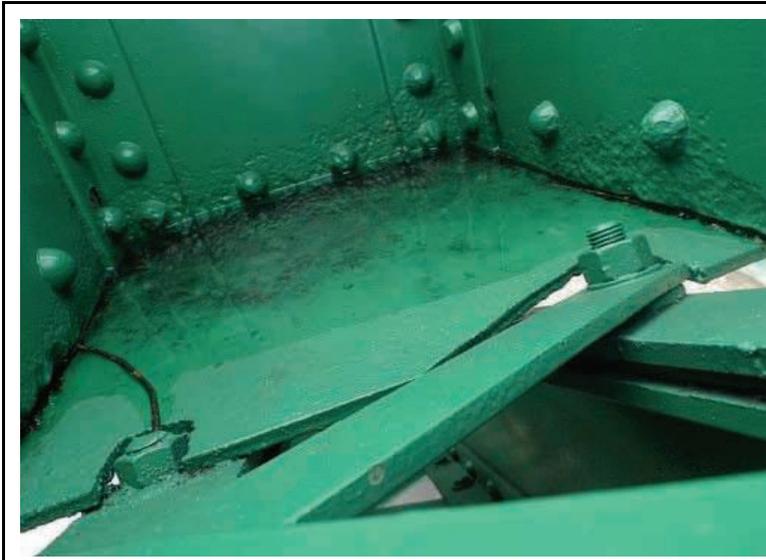
Picture No.	16
Span	1
Member	slab
Remaining water It will make corrosion

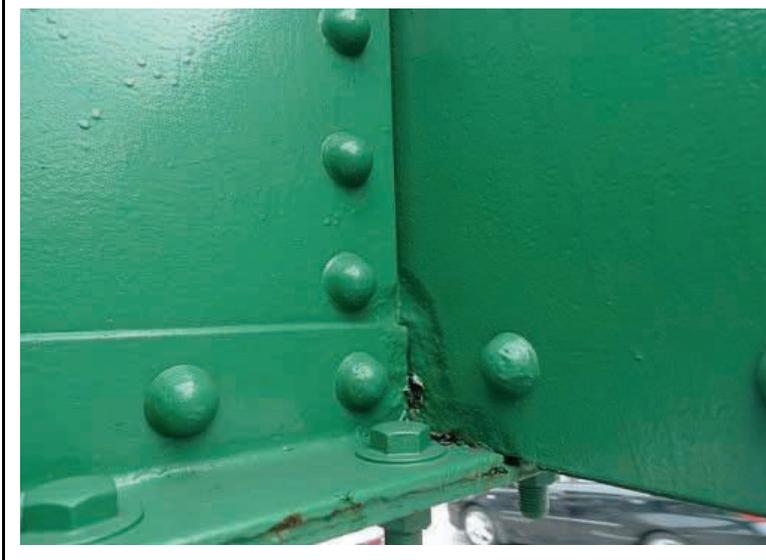
Picture No.	17
Span	1
Member	slab
Remarkable reduced section

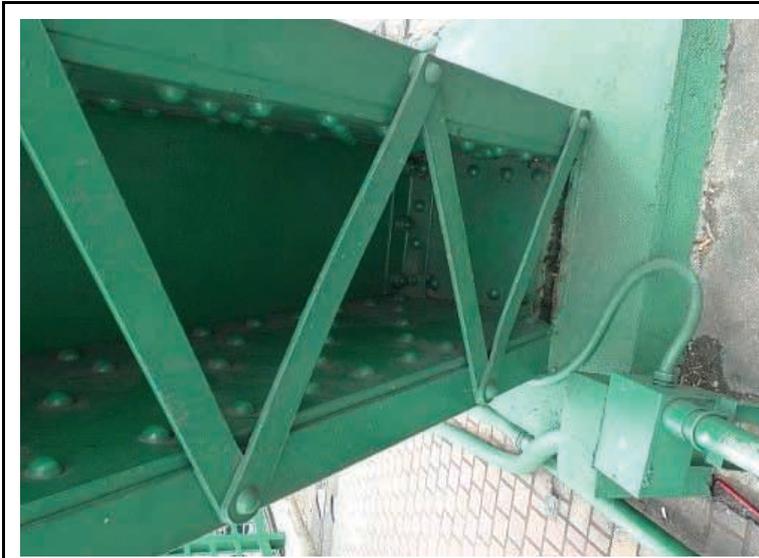
Picture No.	13
Span	1
Member	slab
Deterioration of corrosion proof

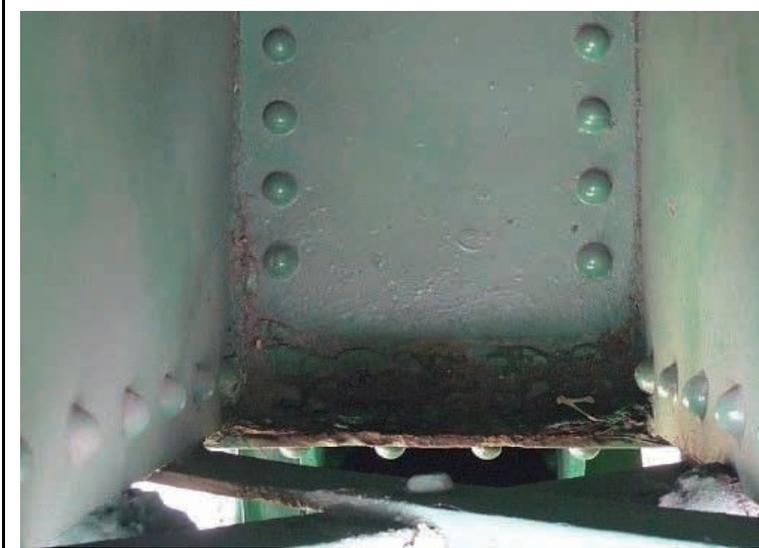
Picture No.	15
Span	1
Member	Lighting pole
Corrosion of diaphragm

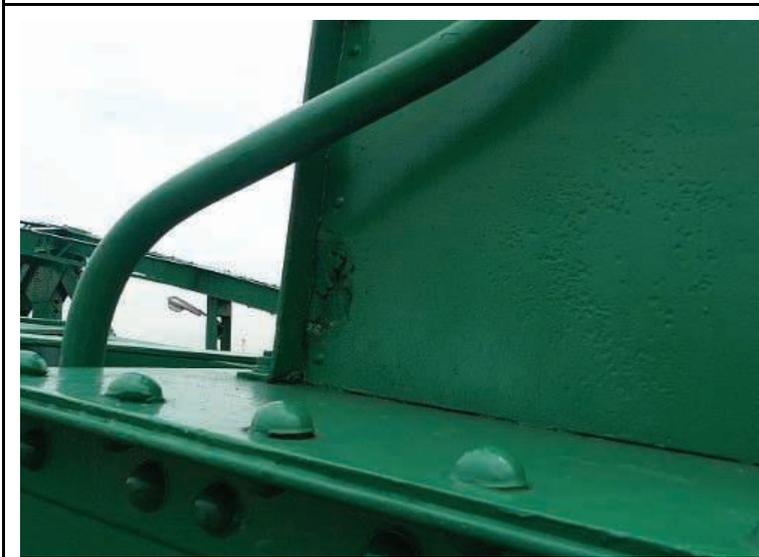
Picture No.	21
Span	1
Member	Lighting pole
Corrosion

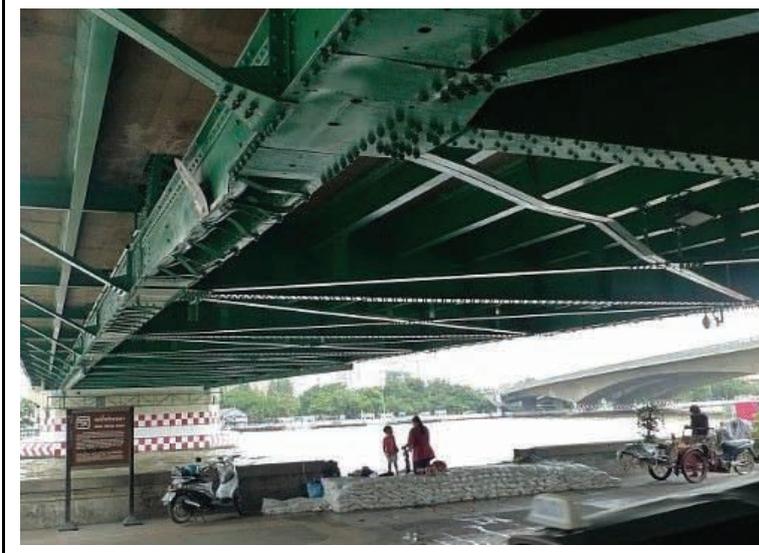
Picture No.	23
Span	1
Member	Bottom chord
Deformation by vehicle collision	
Limit of vehicle height is 3.5m	
No warning frame is set before bridge at Thon Buri side

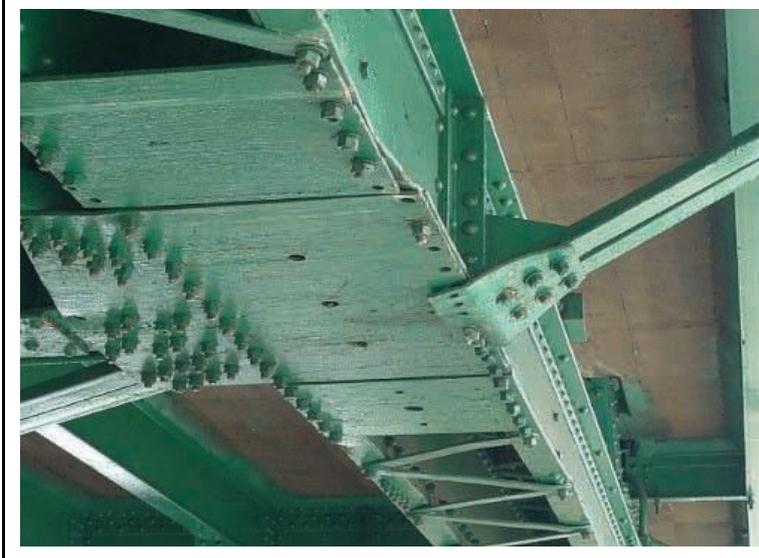
Picture No.	27
Span	1
Member	Bottom chord
Rupture of rivet by vehicle collision

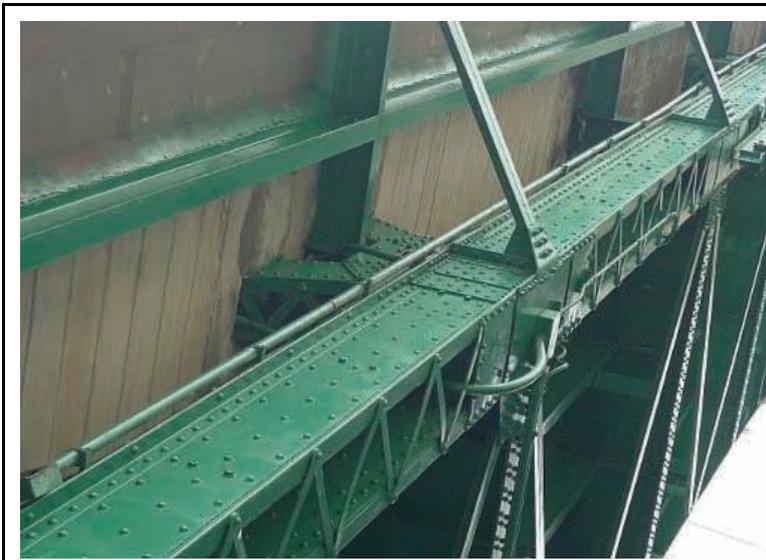
Picture No.	31
Span	1
Member	slab
Replaced slab	
Free lime is seen on slab of center span and walkway

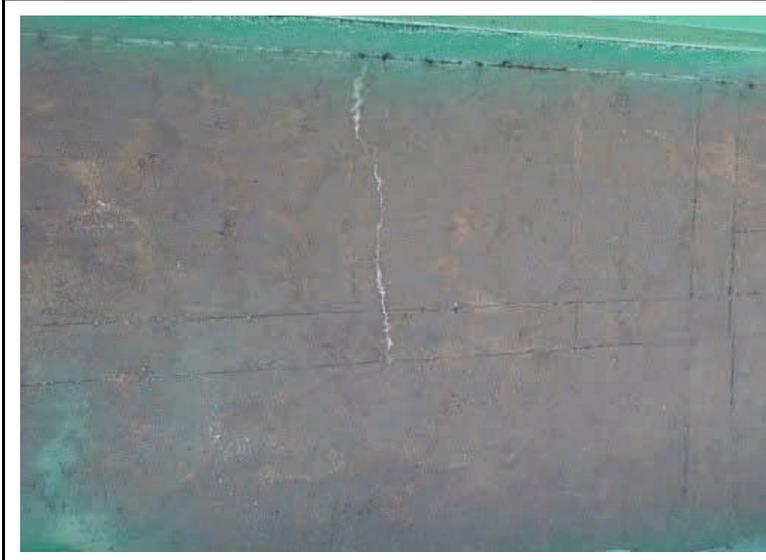
Picture No.	32
Span	1
Member	slab
Crack and free lime

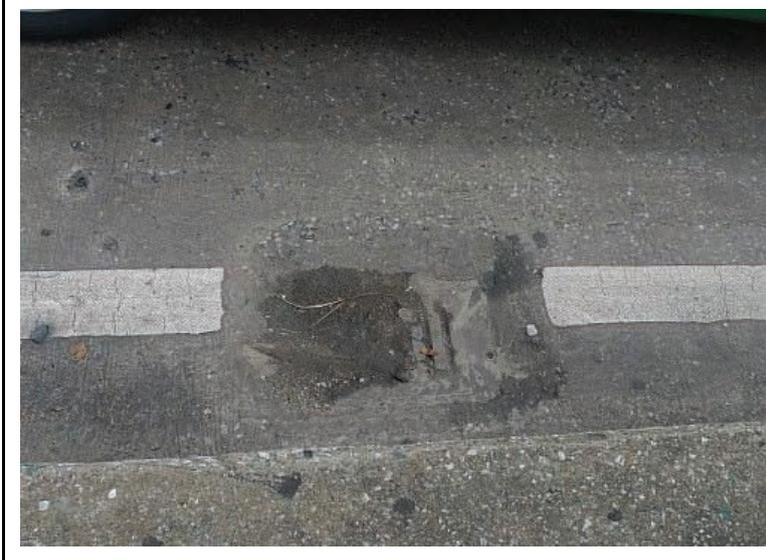
Picture No.	33
Span	1
Member	Drainage
Blocked

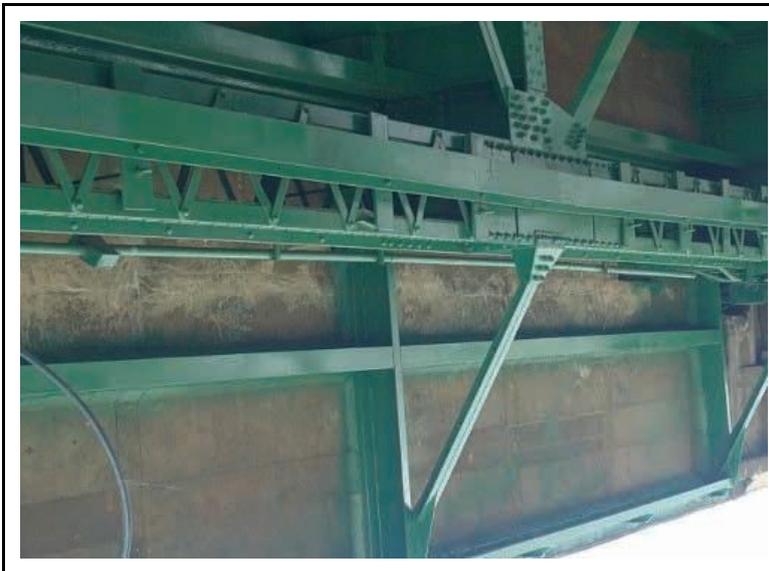
Picture No.	34
Span	1
Member	Slab
Longitudinal crack between road and walkway	
Insufficiency of rigidity of bracket member of walkway?	
*Survey on board, 31-oct

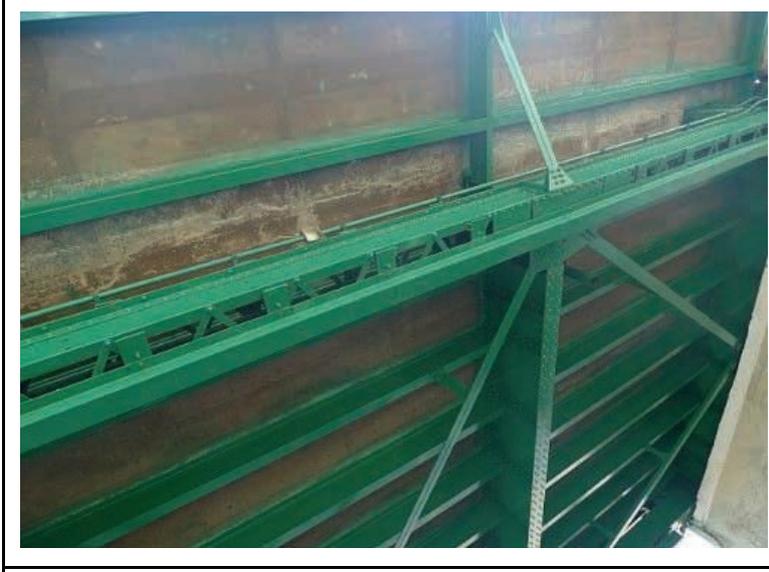
Picture No.	35
Span	1
Member	Slab
Longitudinal crack between road and walkway	
*Survey on board, 31-oct

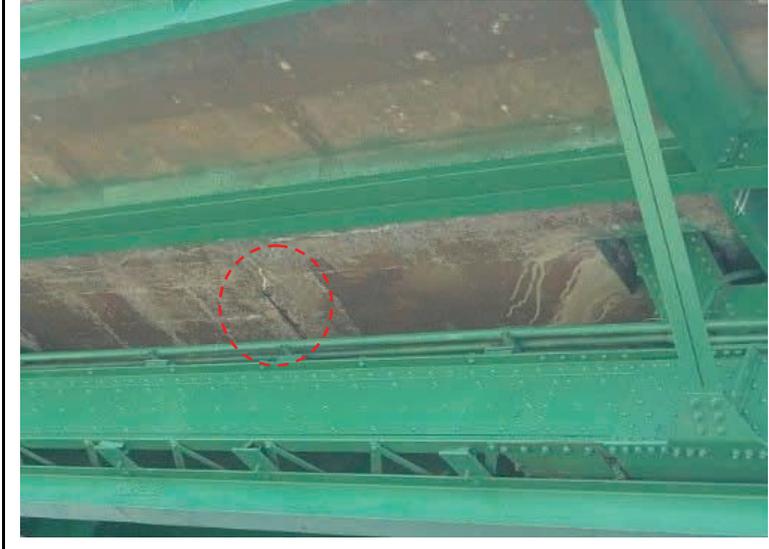
Picture No.	36
Span	1
Member	Slab
Longitudinal crack between road and walkway	
Fracture of surface	
*Survey on board, 31-oct

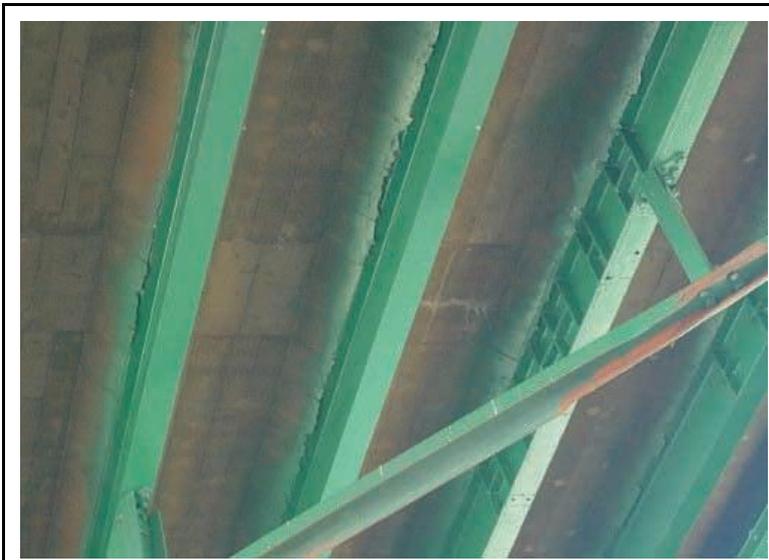
Picture No.	37
Span	1
Member	slab
Crack and free lime on bottom surface of slab	
Deformation of cross frame by ship collision	
*Survey on board, 31-oct

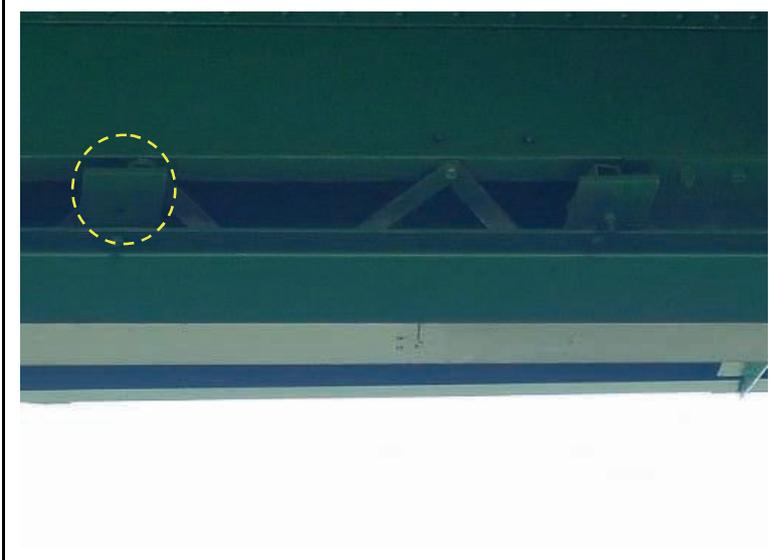
Picture No.	38
Span	1
Member	Inspection car rail
Lack of bolt	
*Survey on board, 31-oct

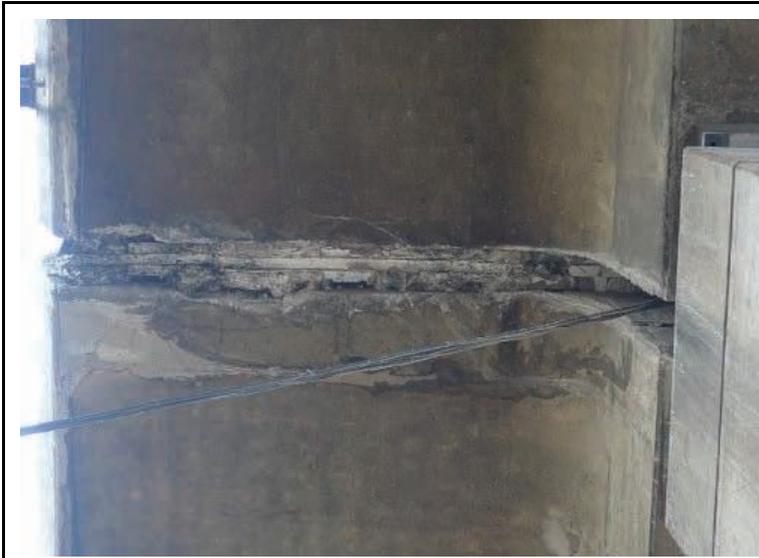
Picture No.	10
Span	1
Member	Expansion joint
Deterioration of drain function	
Mark of leakage

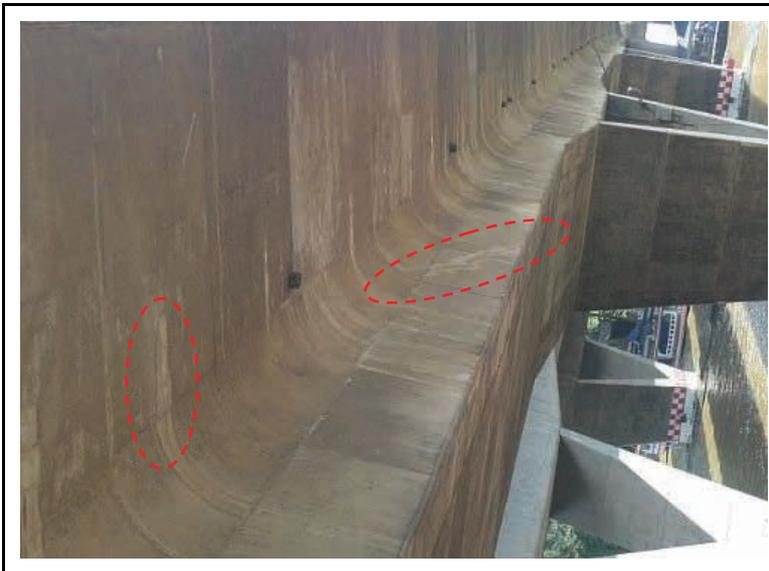
Picture No.	7
Span	1
Member	Box girder
Shear crack or severe cold joint Detailed study is recommended	
Free lime from filled hole Without waterproofing?

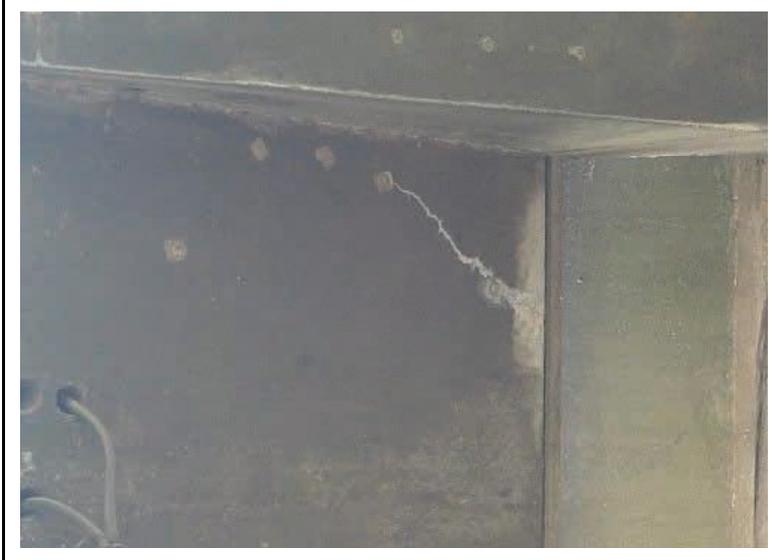
Picture No.	8
Span	1
Member	Catch basin
Free lime from filled hole Without waterproofing?

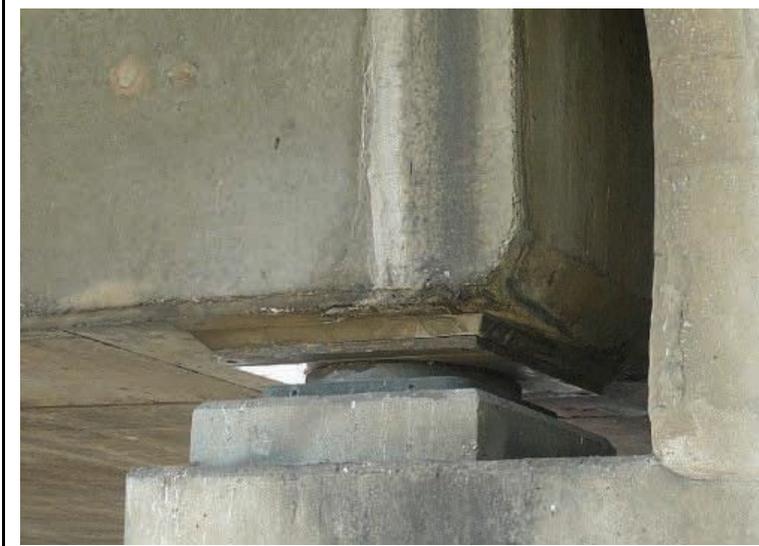
Picture No.	11
Span	1
Member	Bearing
Leakage from joint	
Upstream, Thon Buri side

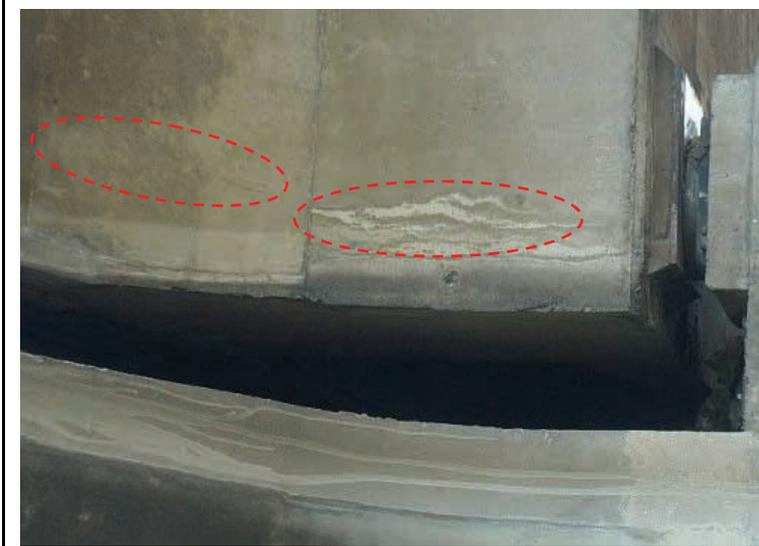
Picture No.	12
Span	1
Member	Lighting pole
Free lime (lower)	
Crack (upper)	
Upstream, Bangkok side

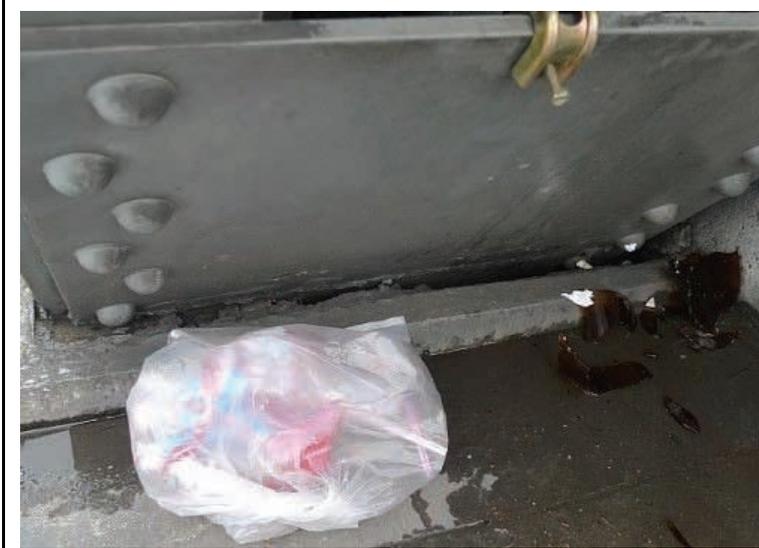
Picture No.	18
Span	1
Member	Vertical member
Deterioration of caulking in gap

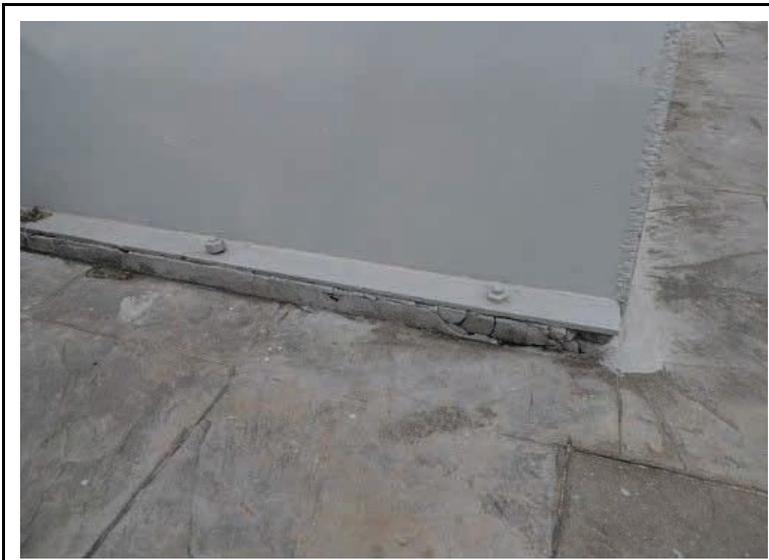
Picture No.	22
Span	1
Member	Center span
Fracture of mortar for height adjustment

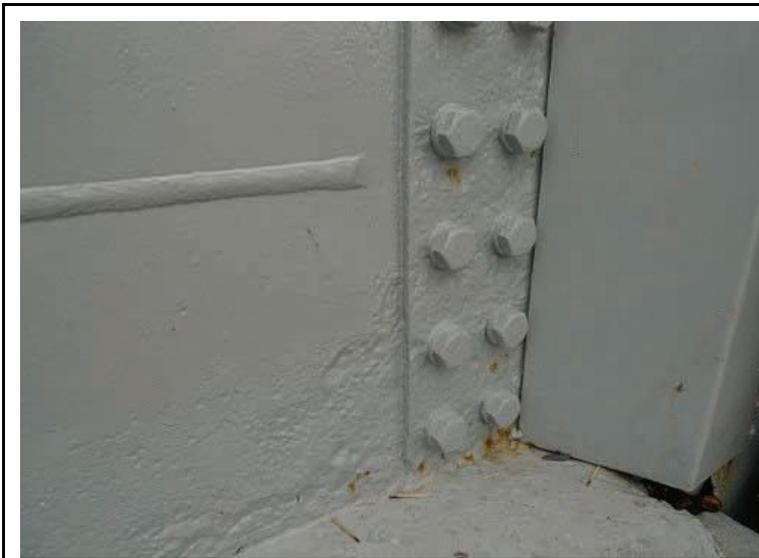
Picture No.	34
Span	1
Member	Center span
Around center joint	
Change from rivet to bolt	
Mark of remarkable corrosion	
Rust from painting part	
Possibility of insufficient of scraping before painting

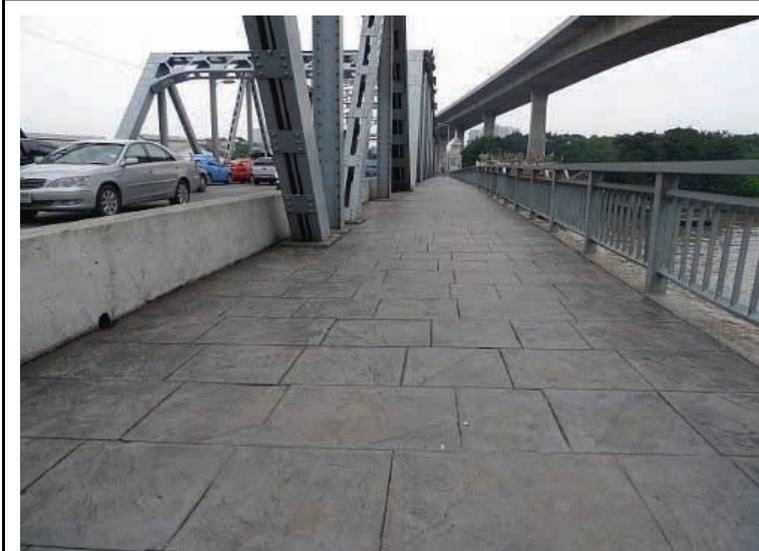
Picture No.	35
Span	1
Member	Center span
Deflection between vertical member?

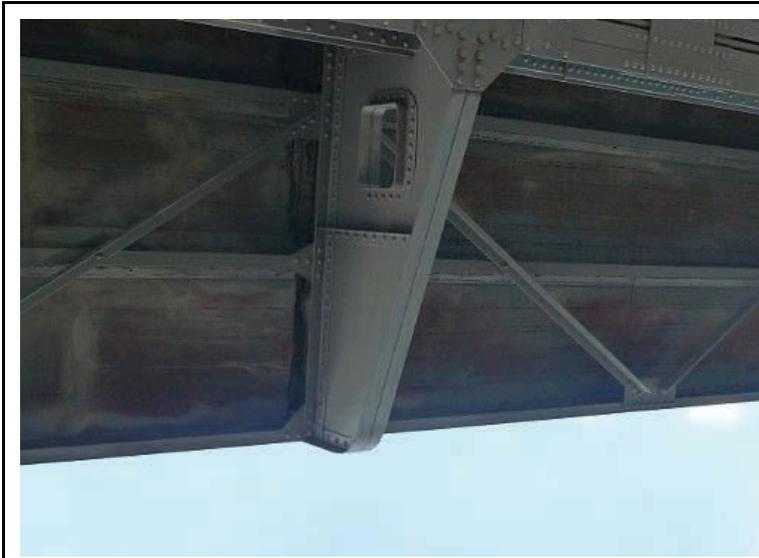
Picture No.	43
Span	1
Member	Slab
Fracture of slab on bracket	
*Survey on board, 31-oct

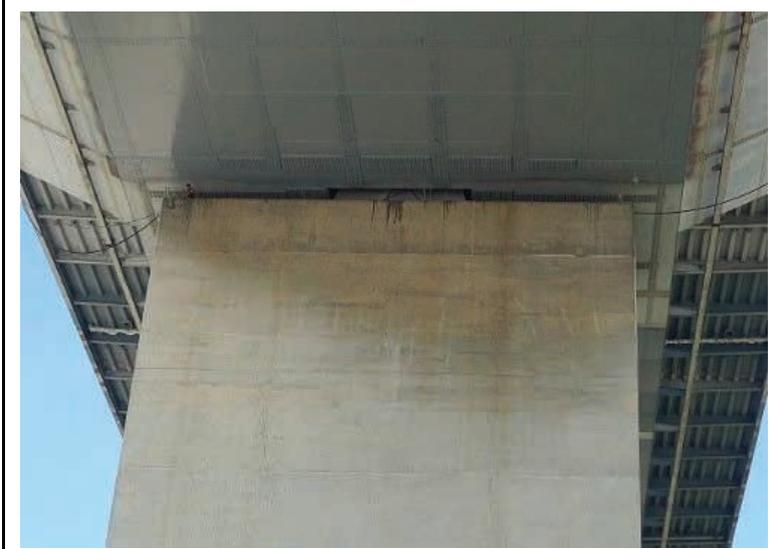
Picture No.	8
Span	1
Member	Pylon
Bottom flange is repainted.	
Shrinkage crack is seen in pier.

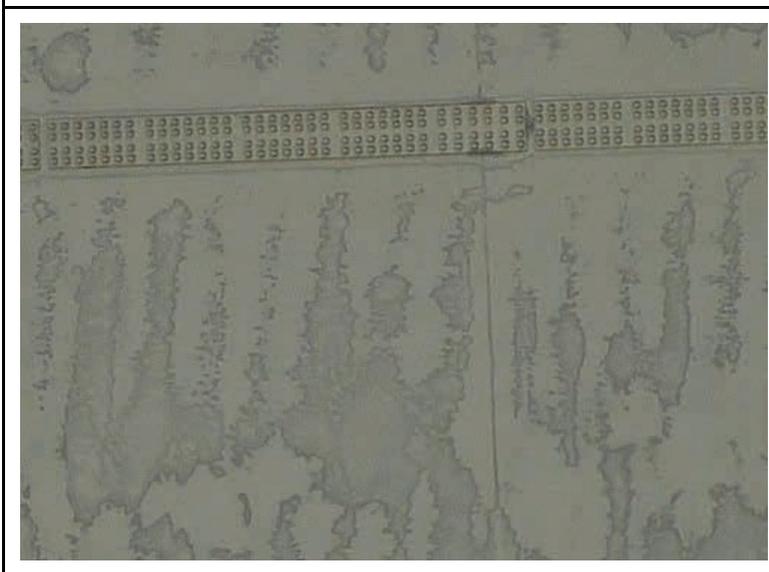
Picture No.	9
Span	1
Member	Bottom flange
Deterioration of corrosion proofi

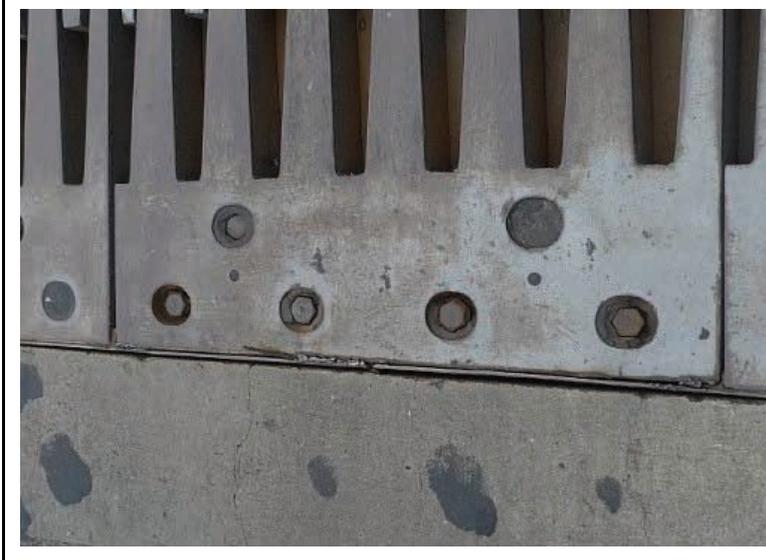
Picture No.	12
Span	1
Member	Expansion joint
Looseness of bolt

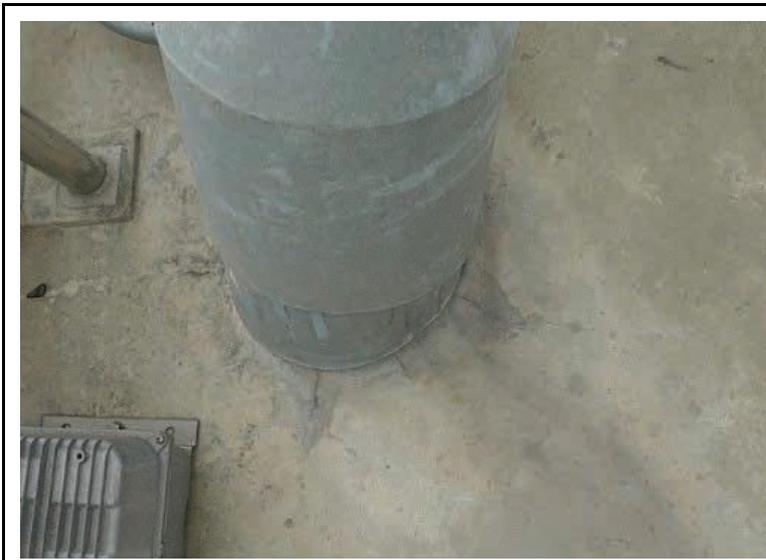
Picture No.	13
Span	1
Member	slab
Crack from cable fixing structure	
PC girder part

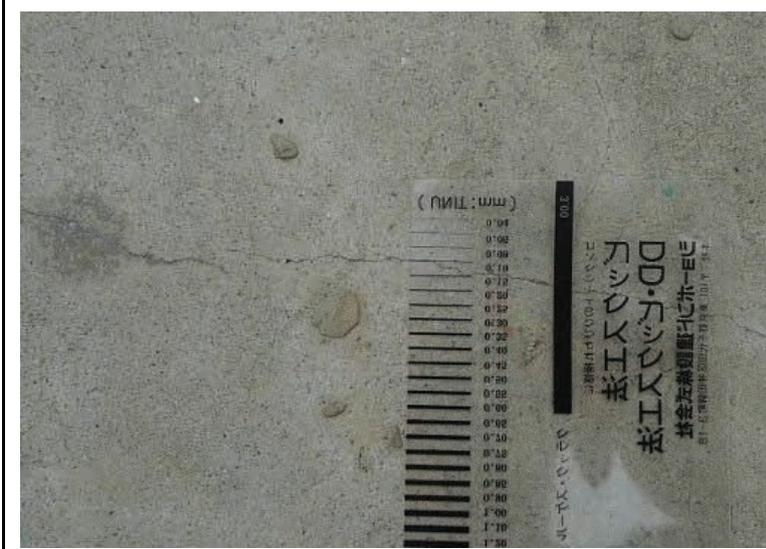
Picture No.	14
Span	1
Member	slab
Crack from cable fixing structure	
0.1mm ~ 0.15mm	
PC girder part

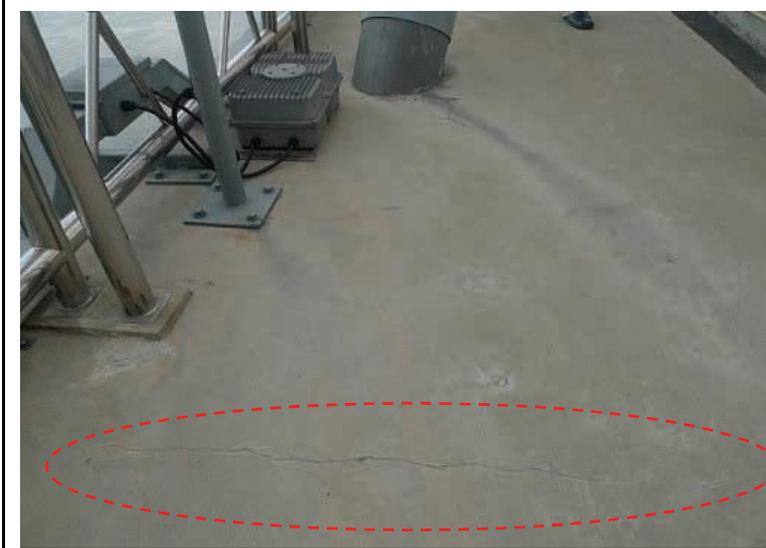
Picture No.	15
Span	1
Member	slab
crack	
PC girder part

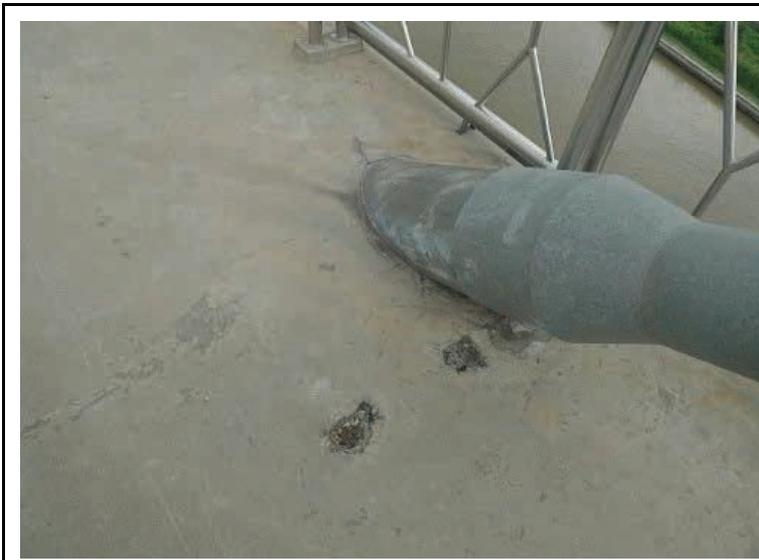
Picture No.	16
Span	1
Member	slab
Peeling of concrete
