Inspection sheet of visual survey

Bridge No. 10

Bridge name		Krung Thon Bridge		Route name	-		Authority	Code of authority	-		
Place		from Khat Bang Phlat to Khet Dusit		Distance	from	km+	0	No.	-		
					to	km+	0	Survey date	2009/10/24		
Bridge properties	Bridge type(1)	<input checked="" type="checkbox"/> main road · <input type="checkbox"/> side road · <input type="checkbox"/> ramp		Camber deform	yes · <input checked="" type="checkbox"/> no		Outline of damage	Item	Type	State	
	Bridge type(2)	<input checked="" type="checkbox"/> bridge · <input type="checkbox"/> viaduct · <input type="checkbox"/> plank pass		Difference in grade	yes · <input checked="" type="checkbox"/> no			Main girder	Truss	Corrosion, Deterioration of proofing, deformation by collision	
	Bridge type(3)	6-span steel truss		Continuous of barrier	<input checked="" type="checkbox"/> yes · <input type="checkbox"/> no			Cross beam	I section steel	-	
	Total length	360.00 (m)		Continuous of curve	<input checked="" type="checkbox"/> yes · <input type="checkbox"/> no			Stringer	I section steel	Deterioration of proofing

Present state (7 / 19)					
Authority	DRR	Address	Bangkok	Data	24-Oct-09
Bridge	Krung Thon Bridge

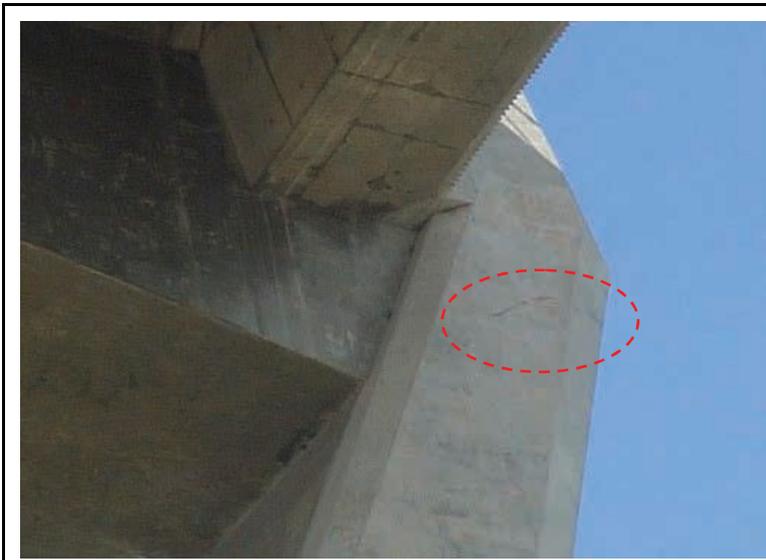
Picture No.	28
Span	1
Member	
North bridge- South pylon - center	
crack	
*Survey on board, 31-oct

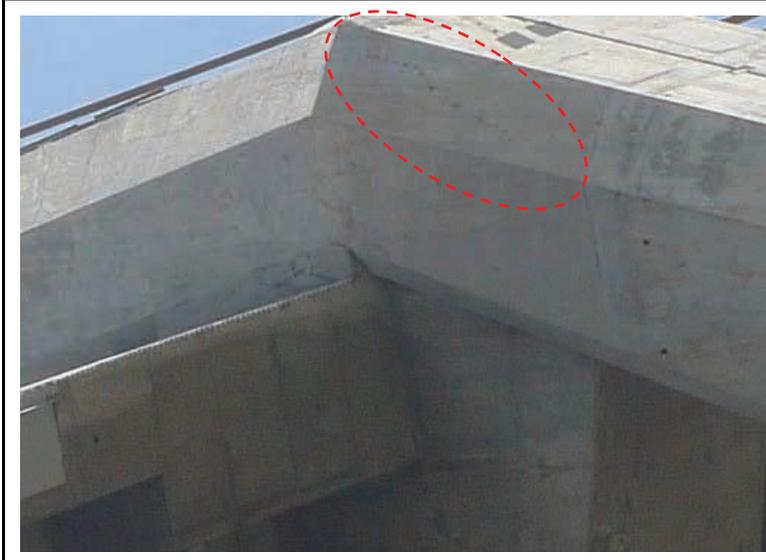
Picture No.	29
Span	1
Member	
North bridge - North pylon - center	
crack	
*Survey on board, 31-oct

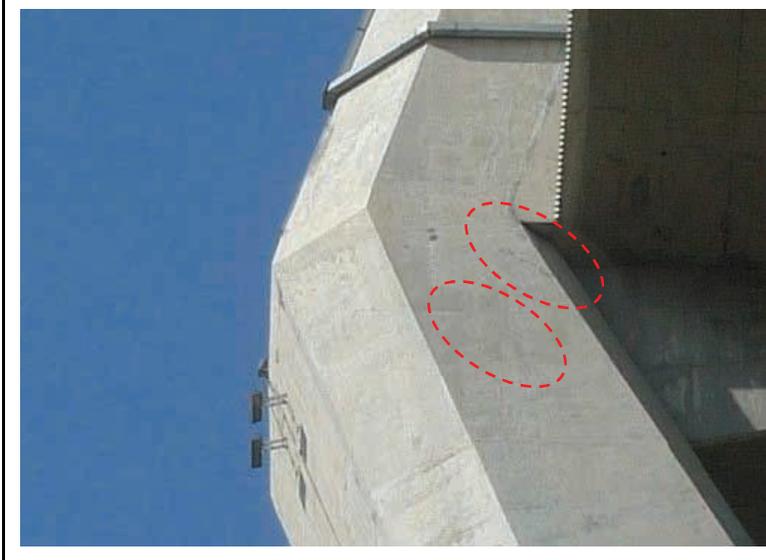
Picture No.	30
Span	1
Member	
North bridge - North pylon - center	
crack	
*Survey on board, 31-oct

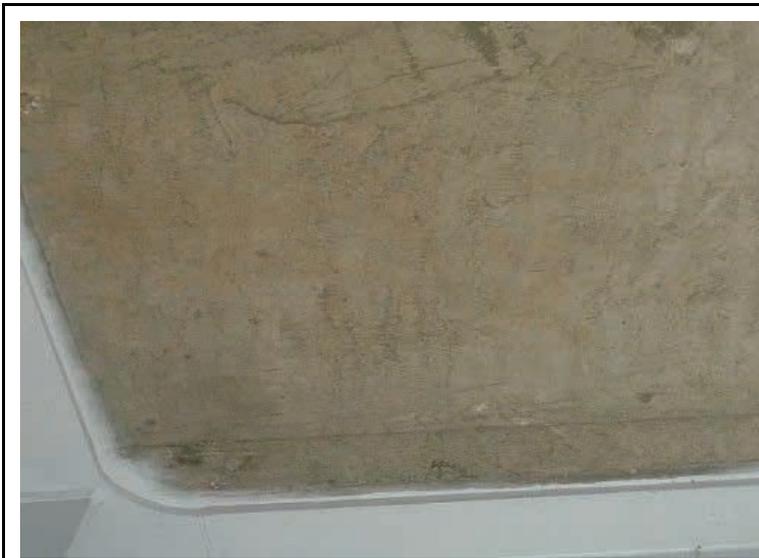
Picture No.	10
Span	1
Member	bottom slab
Back surface of crack around fixed	
Crack cannot find from inspection vehicle (about 2m from eye height)

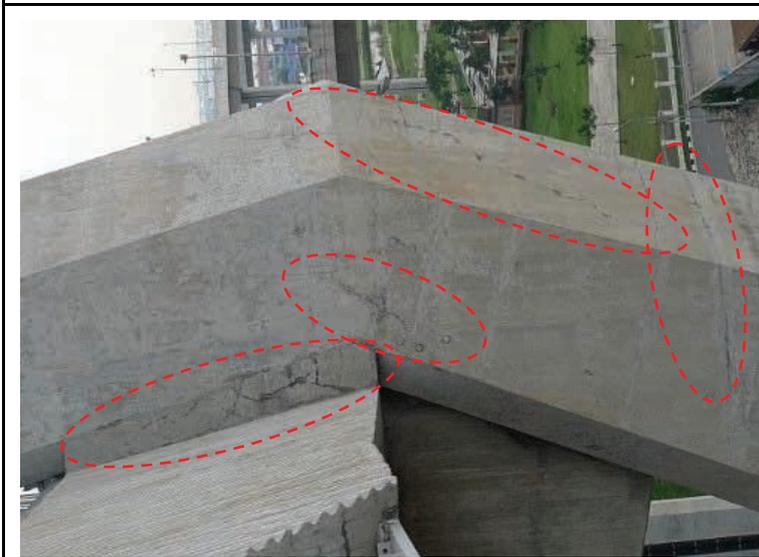
Picture No.	12
Span	1
Member	Pylon
Vertical crack at cross beam end	
Inclined crack of pylon shaft	
Opening construction joint

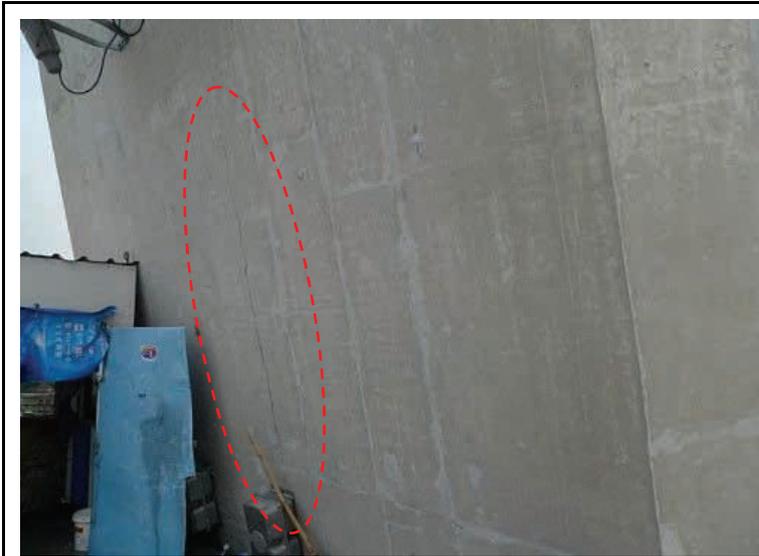
Picture No.	7
Span	1
Member	Pylon
Vertical crack of pylon shaft	
Possibility of shirincage crack during construction is high.

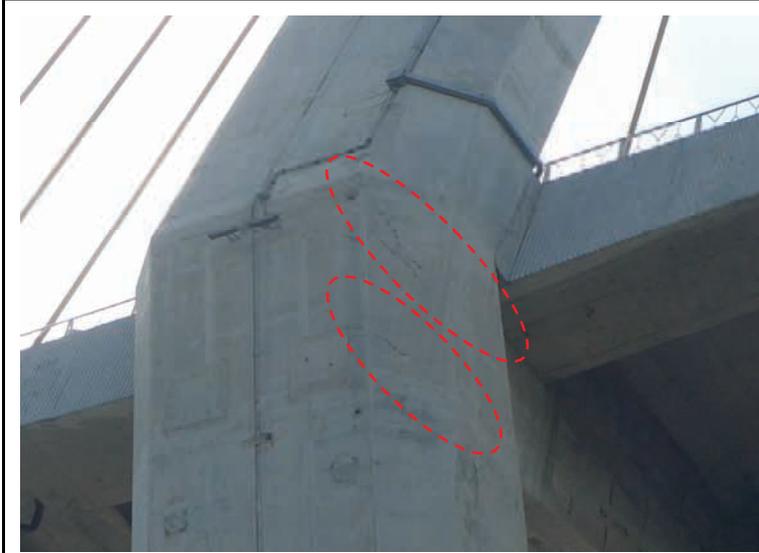
Picture No.	8
Span	1
Member	Pylon
Crack	
<i>*Survey on board, 31-oct</i>
