## **CHAPTER 3    LARGE-SCALE RC BUILDING DAMAGE SURVEY**

### **3.1    Outline**

### **3.2    Features of Major Damage to RC Building Structures**

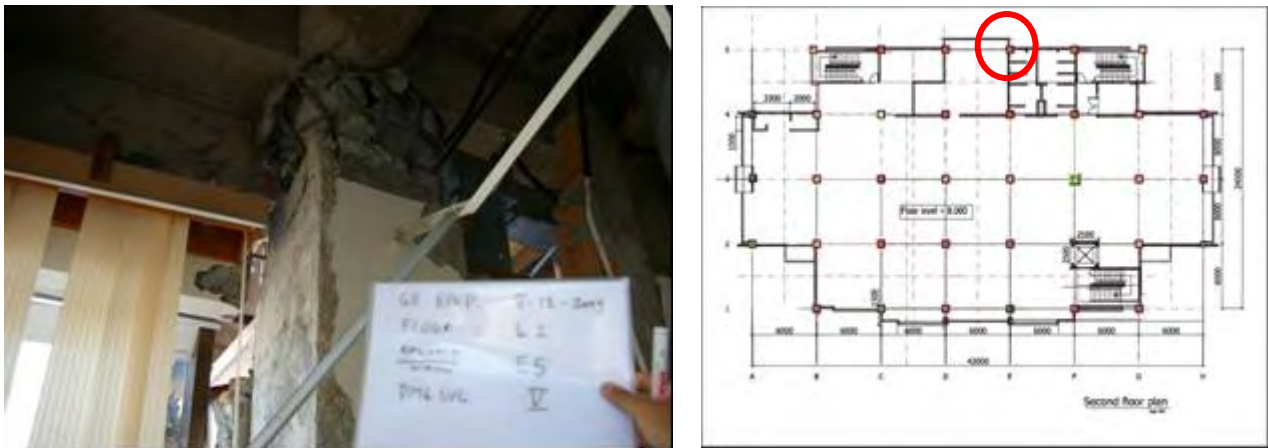
The most intense destruction of the structure is buckling of the top column of the 2F floor of the northwest side of the building as shown in Figure 3.2.7.

**Figure 3.2.7 Buckling of the Top of the Column**

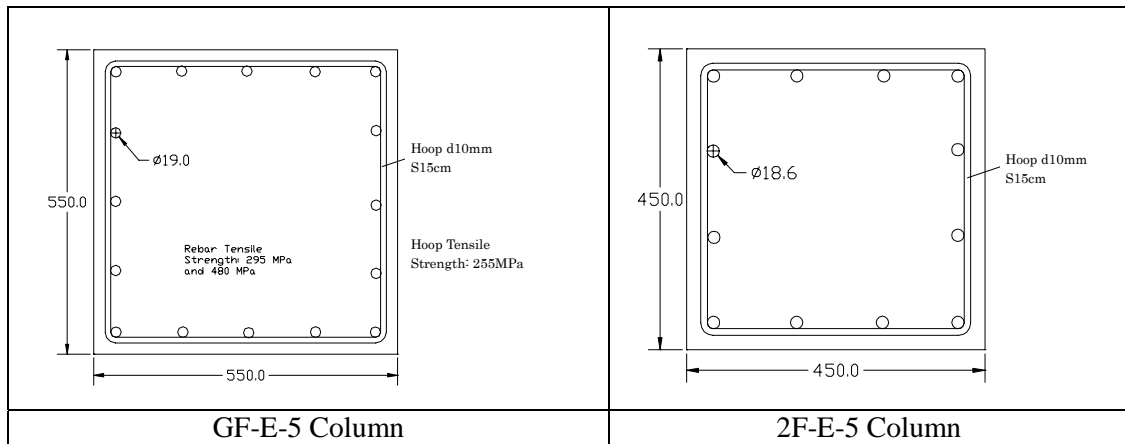
The reason for the destruction of the second floor is due to compression of the column section as shown in Figure 3.2.8 It is noted in this connection that the section of the column was not adequately designed to resist dead loads of the second floor combined with seismic load..

**Figure 3.2.8 Column Section**

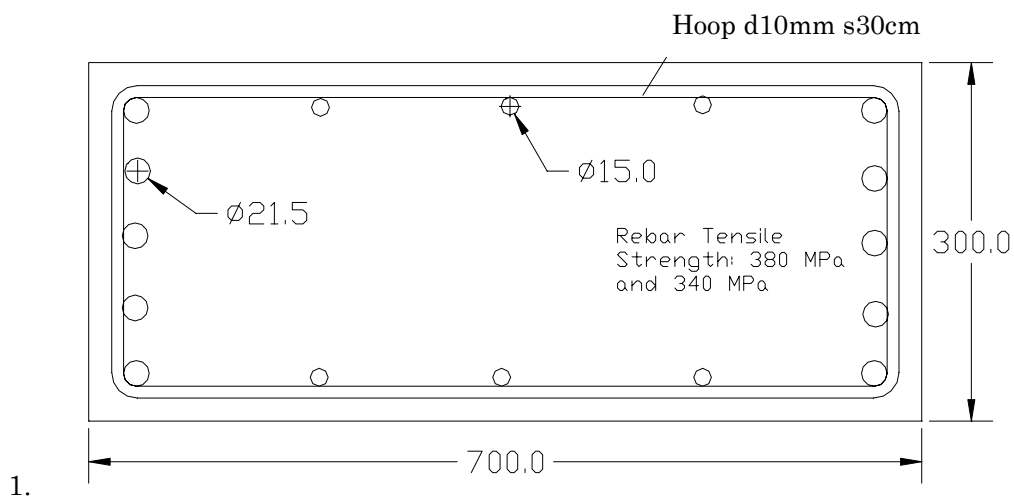
This building was completed in 1970. As can be seen, the entire first floor incurred severe damage and is almost in the state of collapsed and therefore is no longer usable because of its detrimental condition. All the column were distorted as shown in Figure 3.2.11 and the inadequacy of hardness in this direction appears to be overwhelmingly large considering the low resistance to secondary moment at the crossbeam area direction. Therefore, the building is about to collapse like a domino as shown in Figure 3.2.12.

**Figure 3.2.11 1<sup>st</sup> Floor Column Section**

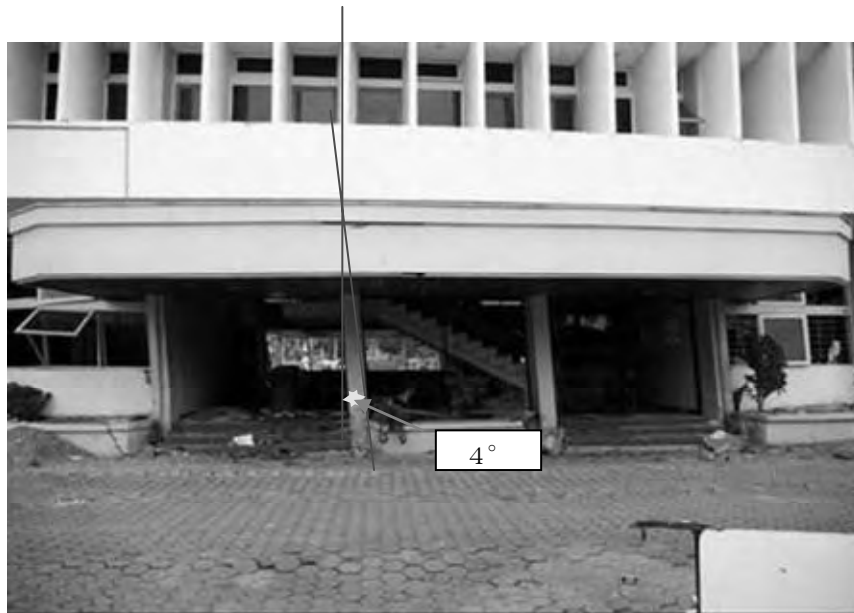
**Figure 3.2.12 State of Transformation(Structure is inclined at 4 degrees from vertical direction)**

Due to the higher height of the second floor, more walls were provided than the first floor, and as a result hardness has risen, and the resultant is a reversal of layer hardness. Due to this development, the first floor became a soft layer of the building segment and with the inertial force, the concentrated between the two layers, had caused the transformation.

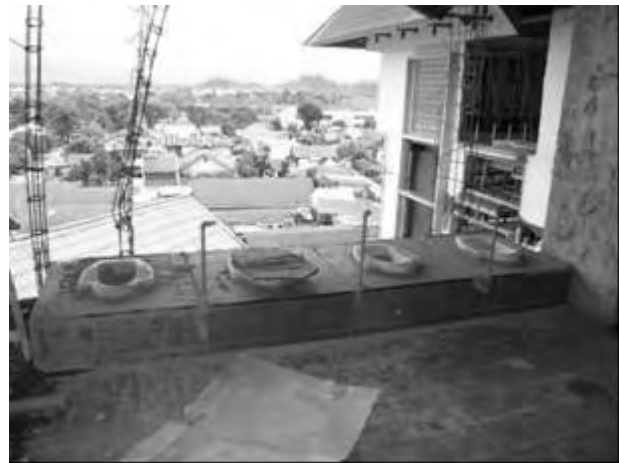
**Figure 3.2.14 Collapsed Brick Wall of the rest room for females at the fifth floor**

earthquake that occurred in 2007. The primary structural components of the building, however, were totally undamaged (Damage Level at 0). However, the tremors that occurred in the upper floors of the building, had displaced the exterior brick wall due to inertial force acting towards the right angle direction, had distorted the exterior appearance/ aesthetics of the building. .

In a sense, the horizontal direction inertial force of the earthquake caused the disintegration of the brick wall but could have prevented damage to the structural frames of the building. This phenomenon appears to be a contributory factor to quake resistance of buildings but falling of debris is hazardous to pedestrians below.

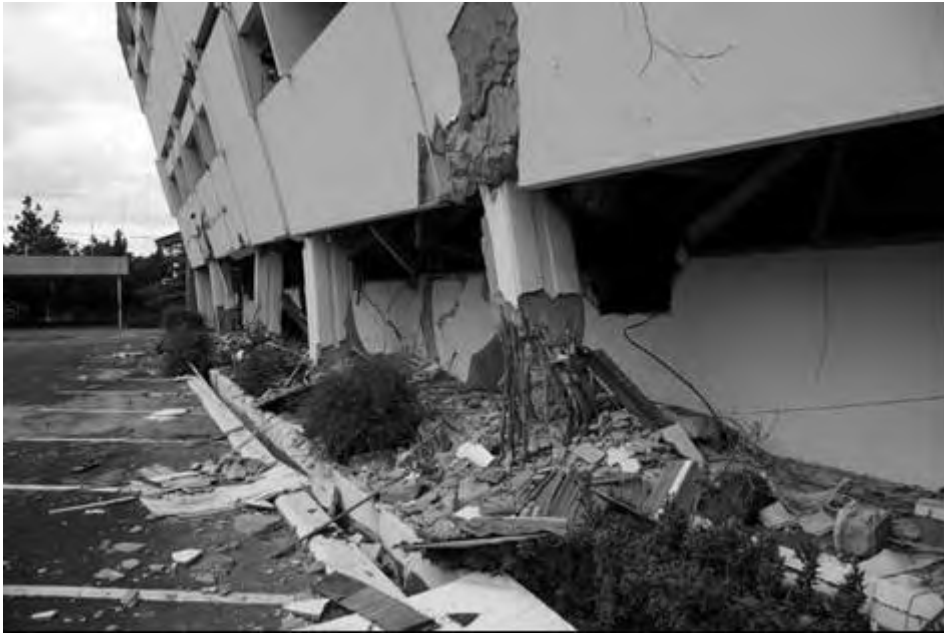
The first floor of this 3 stories high building completely had collapsed. The brick wall of the first floor with the top not connected to the upper structure had collapsed inwards as shown in Figure 3.2.15 above. As a result, most of the brick walls of the first floor did not contribute to the hardness of the structure. On the one hand, the hardness of the floors on the 2<sup>nd</sup> and 3<sup>rd</sup> floors rose because of the presence of RC walls. Consequently, the first floor became a Soft segment. It is noted in this connection that the inertial force acting on irregular shaped buildings of this type, particularly at the transformation area of the center of the layers between the soft segment and the hard segment has tendencies to amplify thus facilitating the collapsed.

**Figure 3.2.16** Photo Showing the Collapsed Brick Wall of the first floor

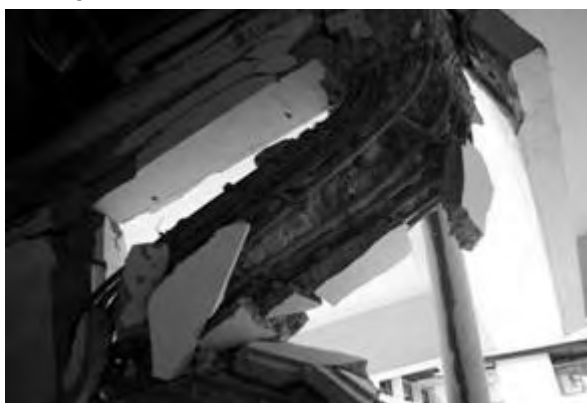
Destruction of the left side ridge is particularly intense in addition to the destruction incurred to the right side ridge as shown in the photos hereunder. The building is irregularly shaped, but considering the segments to have been separated by expansion joints, it is difficult to imagine the cause to be due to asymmetrical form. Rather, the inadequate sectional dimensions, and insufficiency of Re-bars coupled with deficient Re-bar arrangement particularly at the column / beam joint could most likely be the causes of the destruction as shown in Figure 3.2.19, and Figure 3.2.20 hereunder.

**Figure 3.2.19 Inadequate Column Size and Inadequacy of Re-bars**

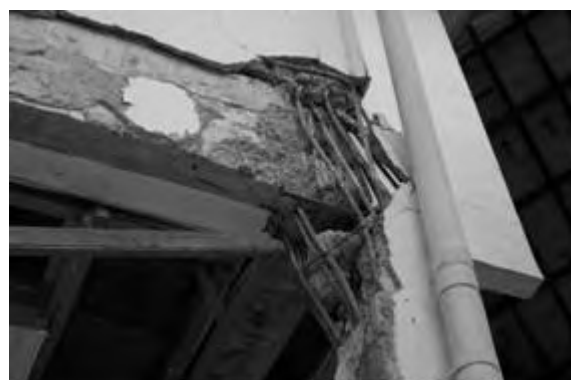
**Figure 3.2.20 Deficient Re-bar Arrangement at the Column / Beam Joint**

Figure 3.2.20 shows the deficiencies of the column / beam joint. As shown, axial re-bars were excessively placed at the small column section. The re-bars to resist axial forces have also been extended upto the bottom of the floor slab of the 1<sup>st</sup> floor even surpassing the beam, but the shear re-bars which should be placed in position with ties is not absent. Moreover, the hoop bars placed for the column are short.

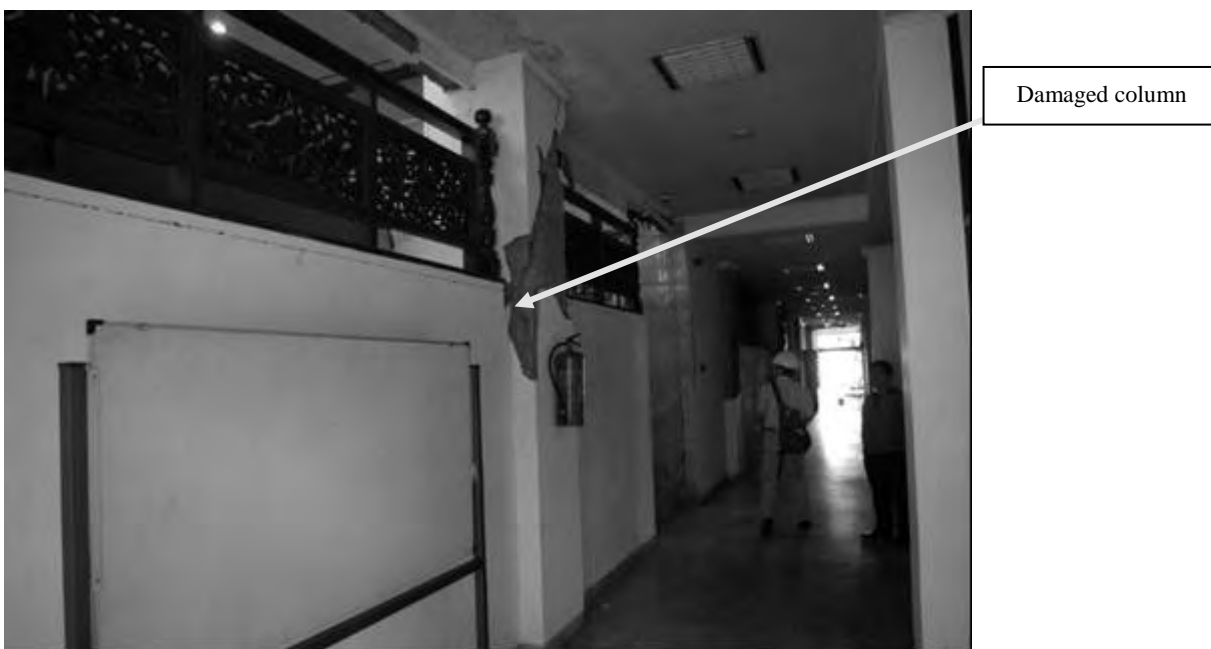
**Figure 3.2.23 Level IV Damage to the Columns**

The caused level IV damage is due to the provision of "Short columns" without supports at the sides. Moreover, the other columns with crossbeams are provided only with brick walls.

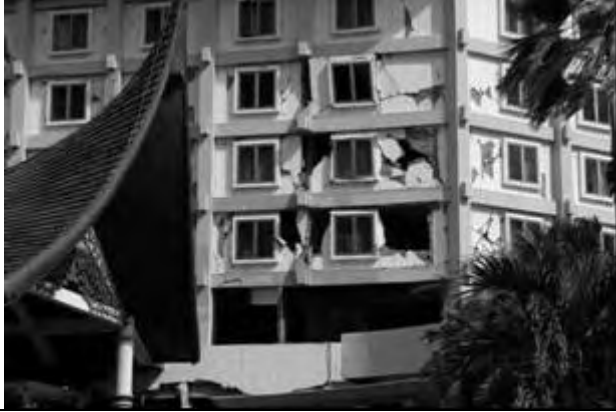
<p><b>Hotel BUMIMINANG</b></p>

<p>As shown, the columns and the walls made of bricks sustained heavy damages but those constructed with RC frames appears to have almost not incurred damages.</p>
<p><b>INNA MUARA Hotel</b></p>

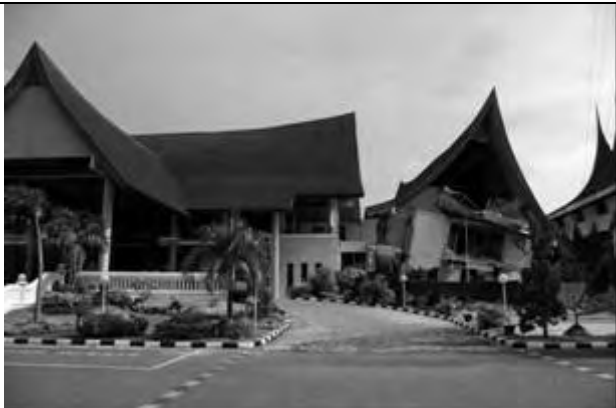
<p>As shown, damage to the adjoining buildings varied greatly.</p> <p>As can be seen, the size of the column and the beam are quite small. Re-bar arrangement appears deficient for the damage building.</p>
