**THE PREPARATORY STUDY  
ON  
DISASTER MANAGEMENT PROGRAM  
FOR  
INDONESIA**

**SUPPLEMENT REPORT**

**- FINDINGS FROM WEST SUMATRA EARTHQUAKE -  
- 30 SEPTEMBER 2009 -**

## **Appendix-1**

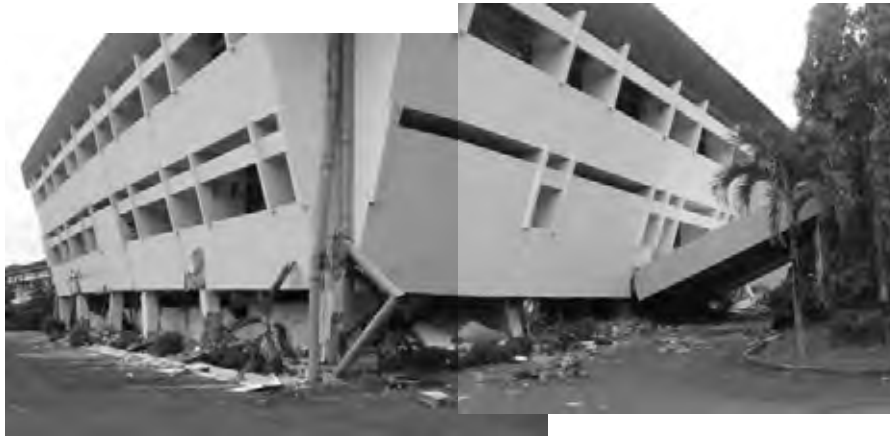
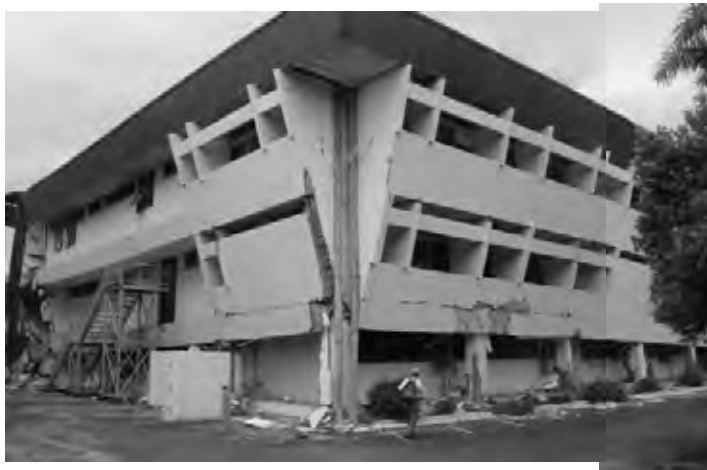
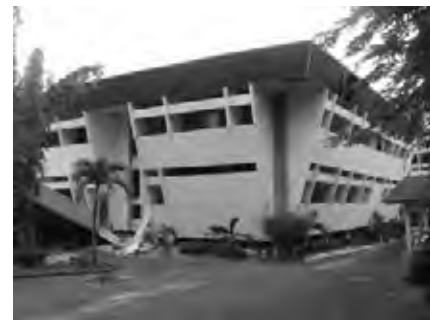
In 2009 earthquake, damage was so severe that the first story (front part) was practically disappeared. The back part dropped as well but not as severe as the front part.

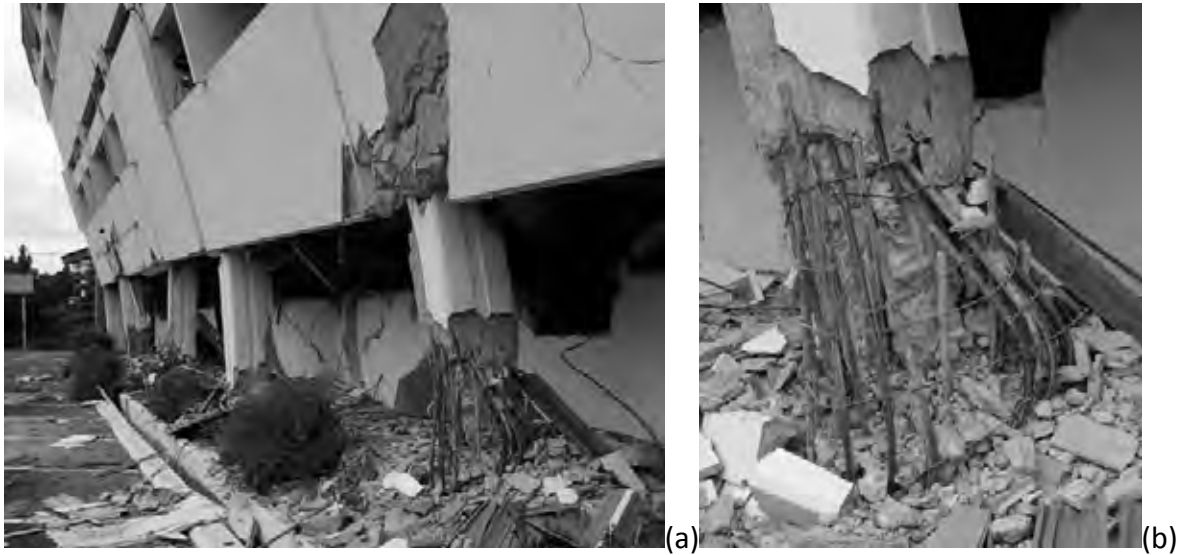
Photo of column damage at Floor-1.

The demand of 206 kN.m at the base at one column under seismic static loading is still below the moment capacity of column at Floor-1 (400 kN.m). From the survey, the column shows heavy damage at the first floor so that soft-story mechanism occurred.

Damaged Columns (a) building side view (b) zoom view

The results show that the damage of columns at Floor-1 is due to column rebars were overlapped at maximum moment region, smooth type of rebars, and too-small stirrups. Therefore real capacity is lower than the calculated capacity.

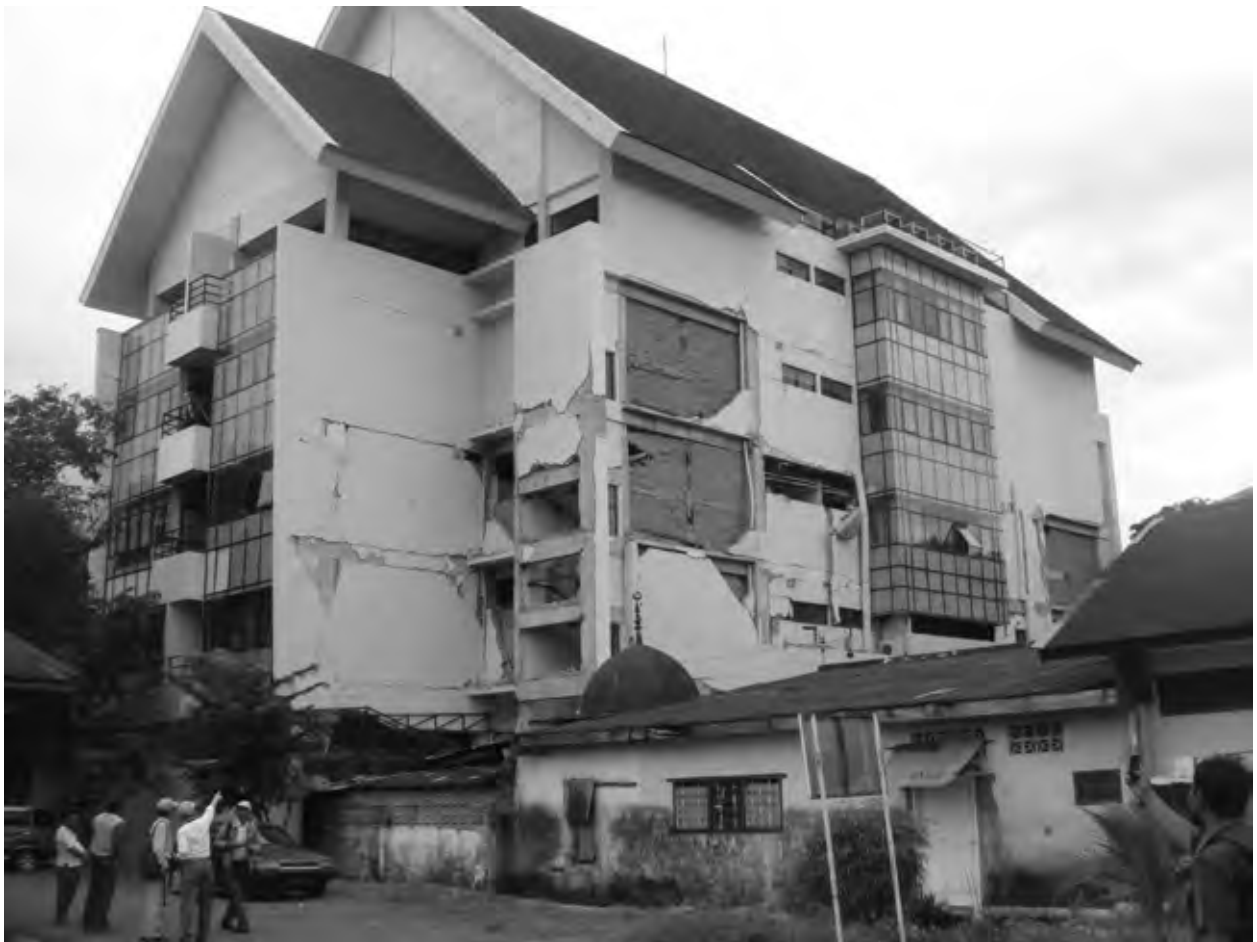
BPKP Building (Photo shows damage at the back side of the building)

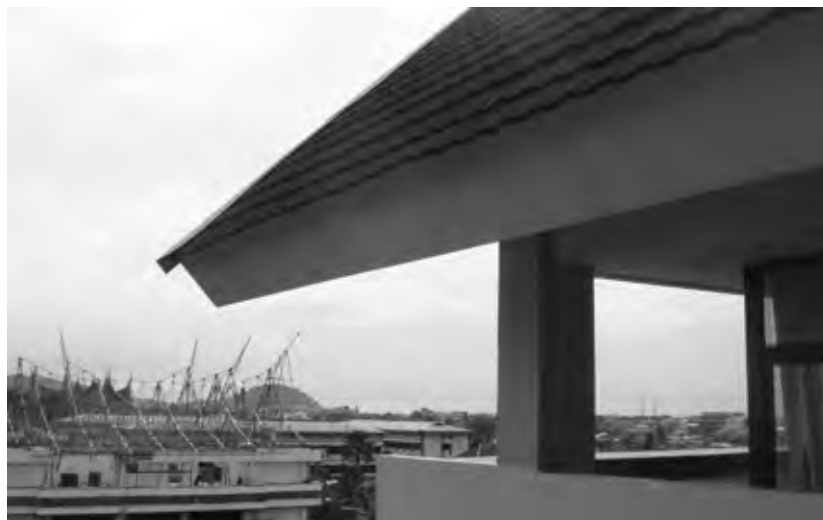
In 2007 earthquake (two years before the 2009 earthquake), the roof top was falling down. Therefore, the roof was altered from terracotta roof to lighter thin-steel roof (see Figure below).

Roof of BPKP Building

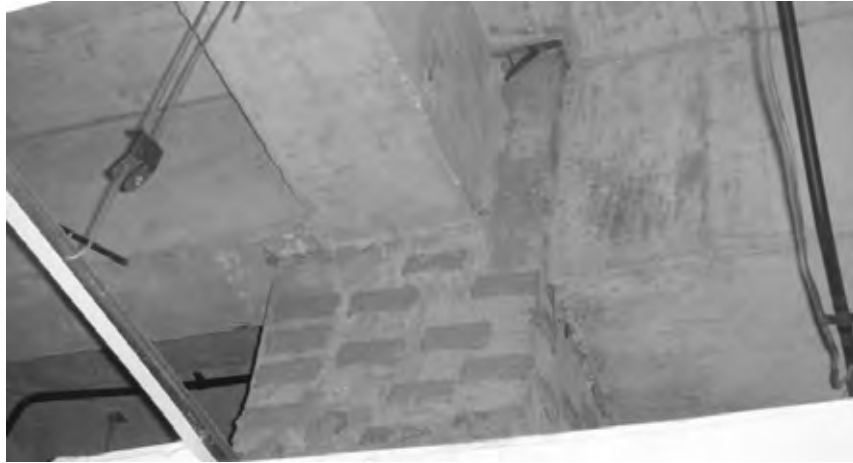
Also in 2007 earthquake, there were some minor damage at the column at Floor-3 (Floor-4 at Japanese floor-numbering system: No ground floor). The column was repaired. There were some marks of repair on column when the team inspected the column (see figure below).

Photo of repaired column at Floor-3.

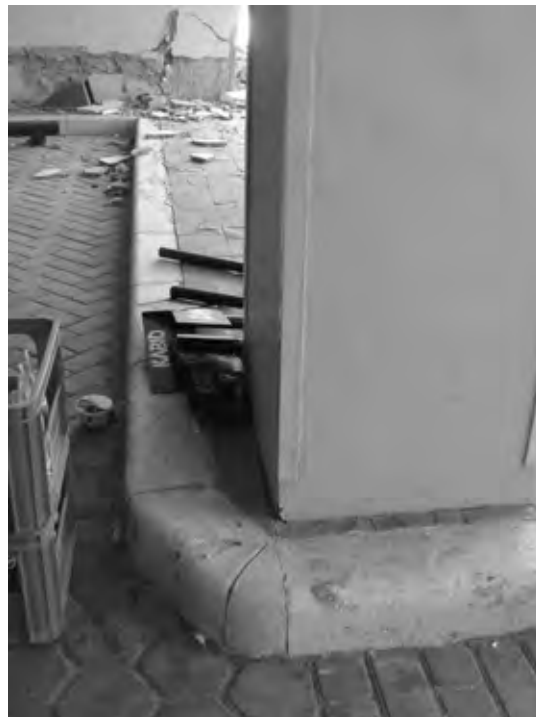
Therefore the demand of 792 kN.m at the base at one column by the seismic static loading is beyond the moment capacity of 515 kN.m at the base column. From the survey, the column shows little damage at the base floor (see figure below).

Photo of Column at Floor-G

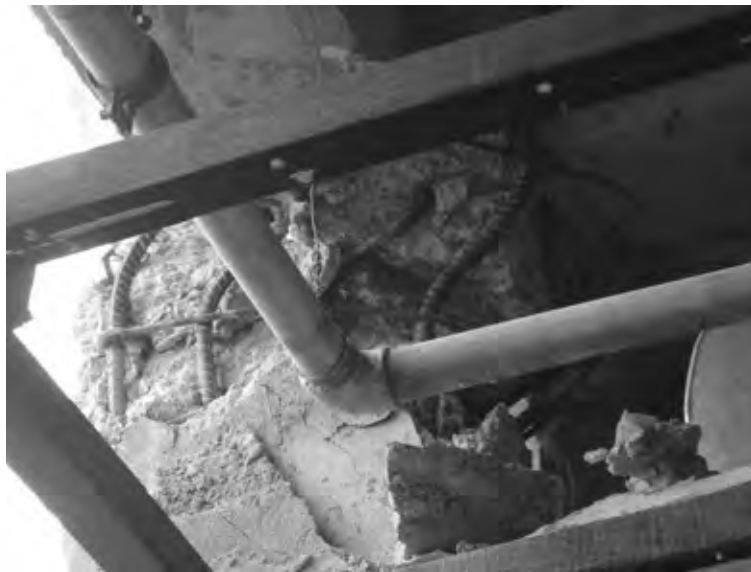
Therefore the demand of 504 kN.m at upper part of columns at Floor-2 by the seismic static loading is beyond the moment capacity (230 kN.m) of the column at Floor-2. From the survey, the column shows severe damage at upper part of column.

Photo of upper part column damage at Floor-2.

The results show that the damage of columns at Floor-2 is due to the “too early” reduction of column size at Floor-2. The seismic moment demand is higher than the capacity of columns at Floor-2.

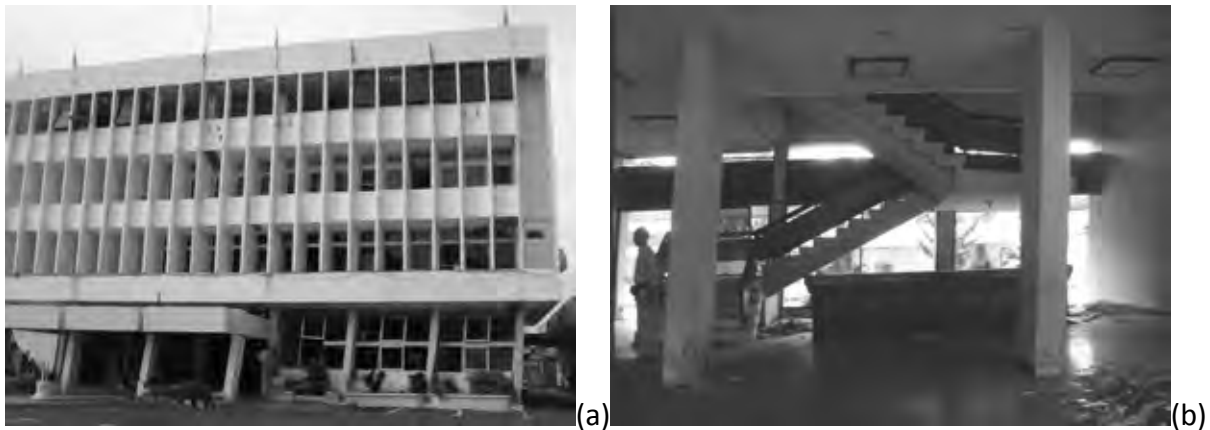
Photo of damage at Floor-1.

Therefore the demand of 198 kN.m at the base at one column under seismic static loading is beyond the moment capacity of column at Floor-1 (180 kN.m). From the survey, the column shows heavy damage at the first floor so that soft-story mechanism occurred.

Damaged Columns (a) Outside View (b) Inside View

The inclination of inner columns is 4 degree (longitudinal direction)

With the column height of 4.4 meter and column inclination of  $4^\circ$  (0.07 radian), the moment caused by the weight of building is  $10341 \times 0.07 \times 4.4 = 3185$  kN.m.

Therefore, the building can stand at this tilting position because the demand moment (caused by P-delta effect) is half the capacity of the columns.
