インド国 火力発電所運用改善計画調査

ファイナルレポート Volume II

平成 22 年 11 月 (2010 年)

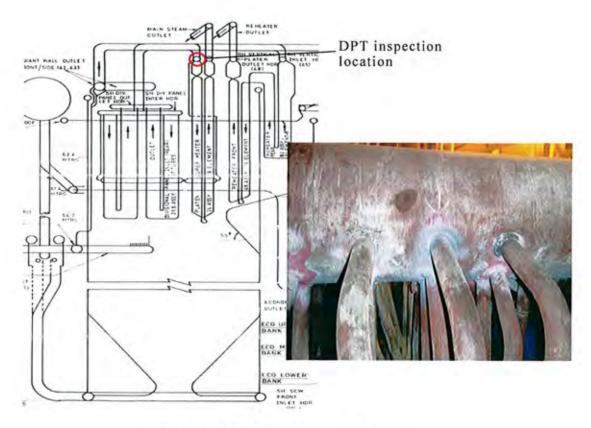
Fig. I -5 DPT inspection location

An indication with 2mm in length was found in 3rd stub weld portion from front. The indication disappeared after grinding off the tube 1mm in depth.

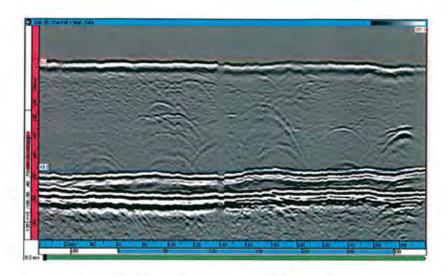
Fig. I -7 X=0~300mm TOFD detection results

No flaw echo judged as a crack was detected, although a number of flaw echoes from subtle blow holes and slag inclusions by welding were detected.

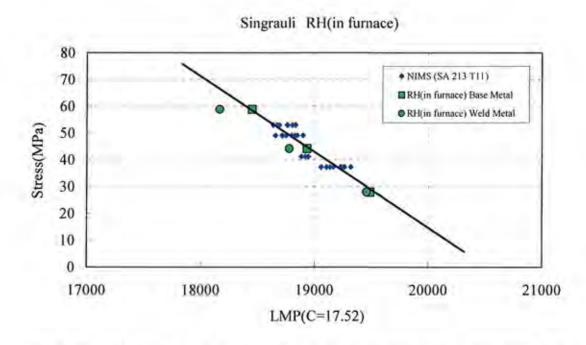
Fig I -27 The comparison of the test results with the creep rupture data of virgin materials by NIMS (National Institute for Materials science)
