Client	J-Power (Electric Power Development Co. Ltd.,)
	Project	Turbine and System Assessment for NTPC-Korba Unit #4
	Order No.	CGP10028C
	Contractor	ALSTOM K.K. NASL Ltd. (Nominated subcontractor in India)

Document	<b>FINAL REPORT VOL. I B(RLA OF TURBINE)</b>

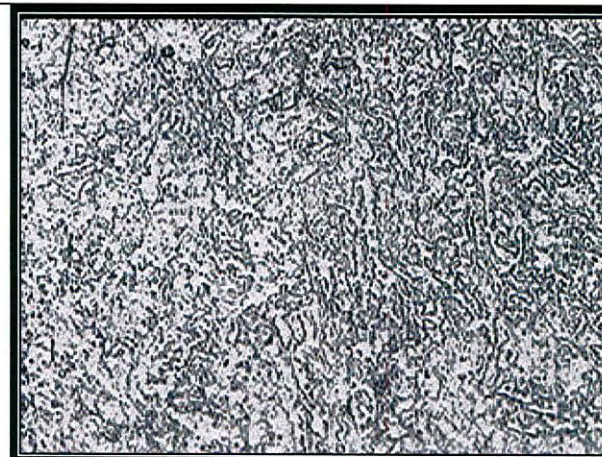
Fig: 84

**Name of Component:** IP Steam Inlet  
**Location:** IP Steam Inlet T joint \_ Weld Metal \_ Replica No. 13  
 Hardness: 180-186HB.

**Observation:** Microstructure shows tempered Bainite with spheroidisation carbides.

Degradation Level- IIL

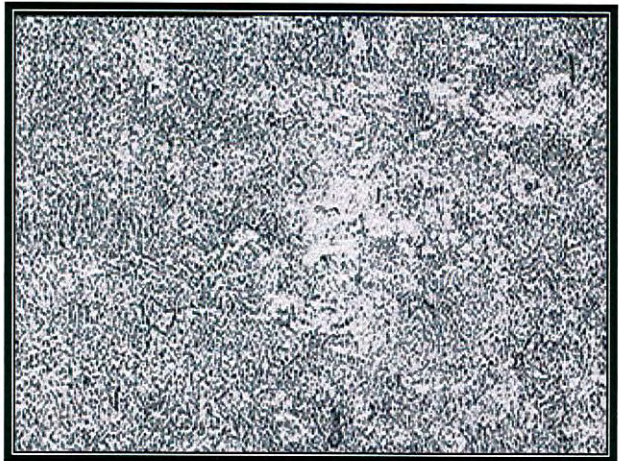
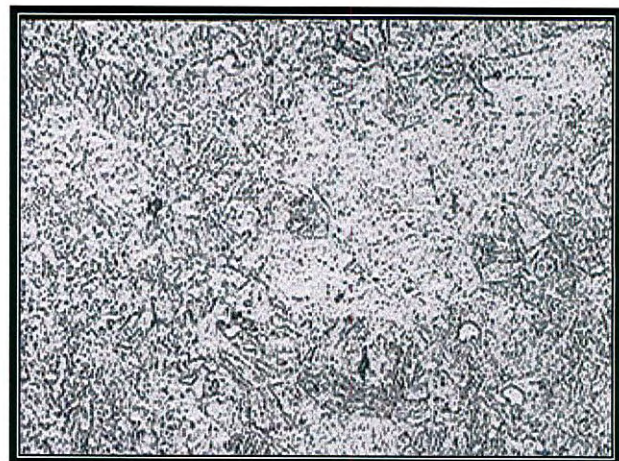
<p><b>Name of Component:</b> IP Steam Inlet  <b>Location:</b> IP Steam Inlet T joint _ Heat affected zone _ Replica No. 13  Hardness: 181-185HB.</p>

200X	400X
<p><b>Observation:</b> Microstructure shows tempered Bainite with spheroidisation carbides.</p>	<p>Degradation Level- IIL</p>
Fig: 85

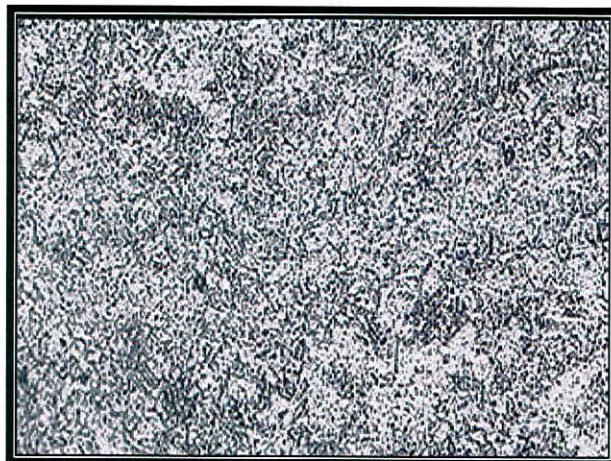
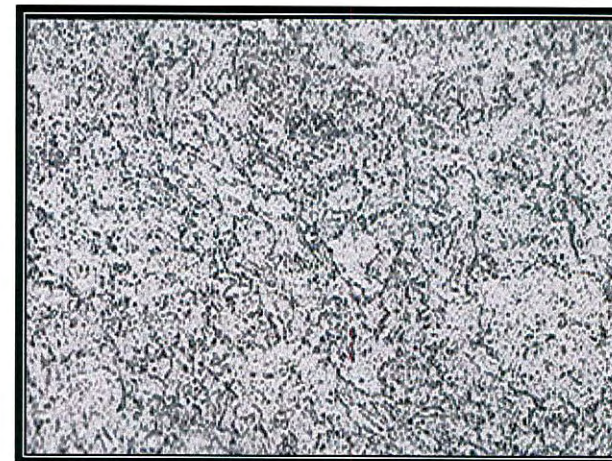
Fig: 86

**Name of Component:** IP Steam Inlet  
**Location:** IP Steam Inlet T joint \_ Parent Metal \_ Replica No. 13  
 Hardness: 158-162HB

**Observation:** Microstructure shows ferrite and Bainite with precipitation of carbides at grain boundary.

Degradation Level- IVL

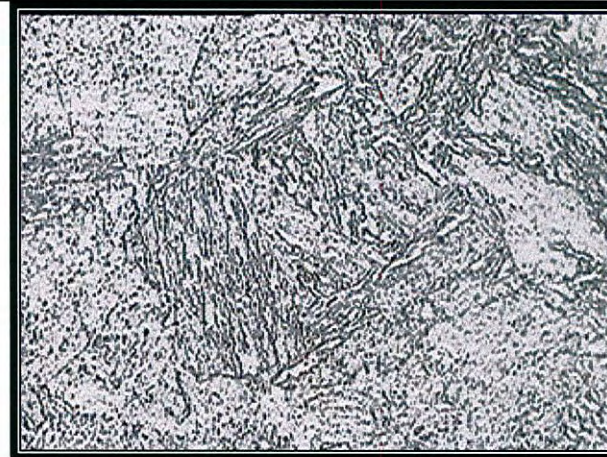
Fig: 87

**Name of Component:** IP Steam Inlet  
**Location:** IP Steam Inlet \_ Parent Metal \_ Replica No. 12  
 Hardness: 203-209HB.

**Observation:** Microstructure shows tempered Bainite with spheroidisation carbides.

Degradation Level- IIL

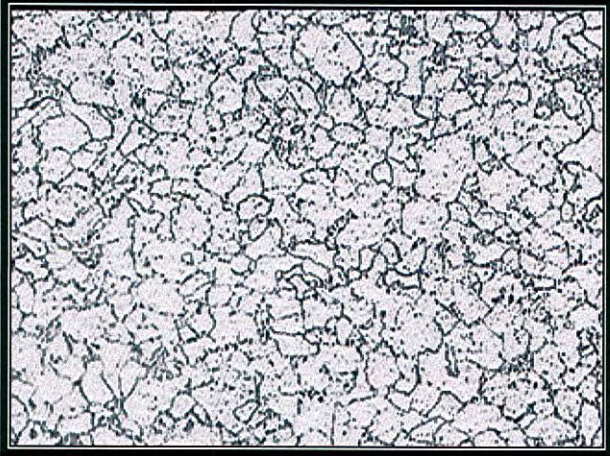
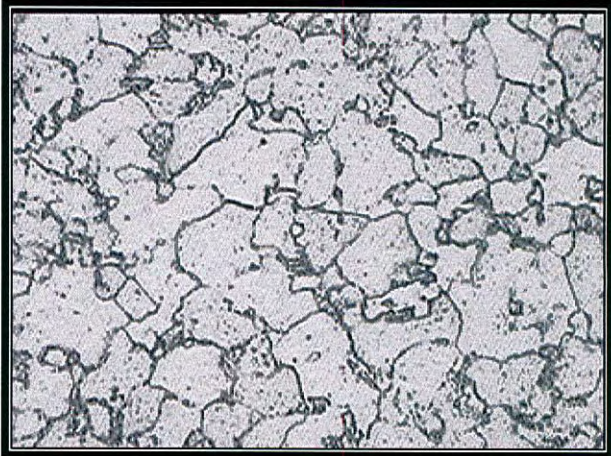
<p><b>Name of Component:</b> Main Steam Line  <b>Location:</b> Main Steam Line RHS on Bend_ Parent Metal _ Replica No. 10          Hardness: 128-138HB.</p>

200X	400X
<p><b>Observation:</b> Microstructure shows ferrite and Bainite with precipitation of carbides at grain boundary.</p>	
<p>Fig: 88</p>	
<p>Degradation Level- IVL</p>

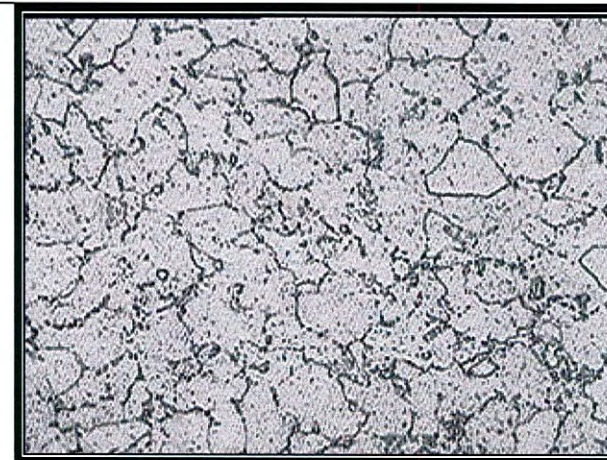
Fig: 89

**Name of Component:** Main Steam Line  
**Location:** Main Steam Line LHS on Bend\_ Parent Metal \_ Replica No. 11  
 Hardness: 130-134HB.

**Observation:** Microstructure shows ferrite and Bainite with precipitation of carbides at grain boundary. Degradation Level- IVL

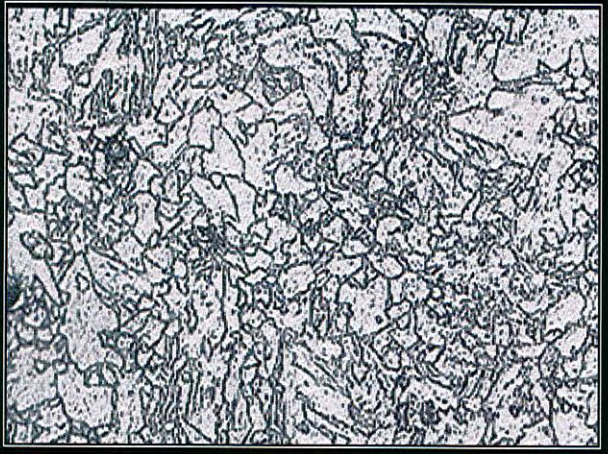
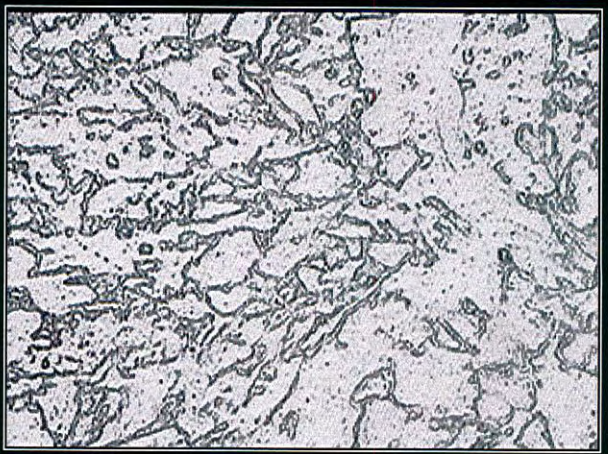
<p><b>Name of Component:</b> HPCV-1 Body  <b>Location:</b> HPCV-1 Body outer _ Parent Metal _ Replica No. 17          Hardness: 181-198HB.</p>

200X	400X
<p><b>Observation:</b> Microstructure shows tempered Bainite with spherodisation carbides.          Fig: 90</p>	<p>Degradation Level- IIL</p>

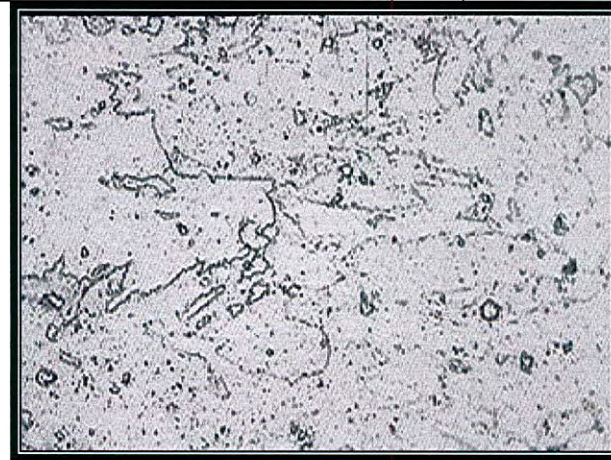
Fig: 91

**Name of Component:** HPCV-2 Body  
**Location:** HPCV-2 Body outer \_ Parent Metal \_ Replica No. 18  
 Hardness: 171-187HB.

**Observation:** Microstructure shows tempered bainite and carbides precipitation at grain boundary is observed.

Degradation Level- IVL

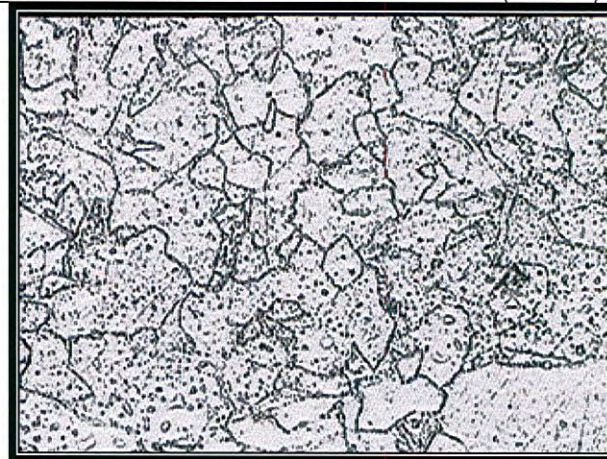
Fig: 92

**Name of Component:** IPCV-1 Body  
**Location:** IPCV-1 Body Inner\_ Parent Metal \_ Replica No. 19  
 Hardness: 175-178HB.

**Observation:** Microstructure shows ferrite and bainite and carbides at grain boundaries. Degradation Level- IVL

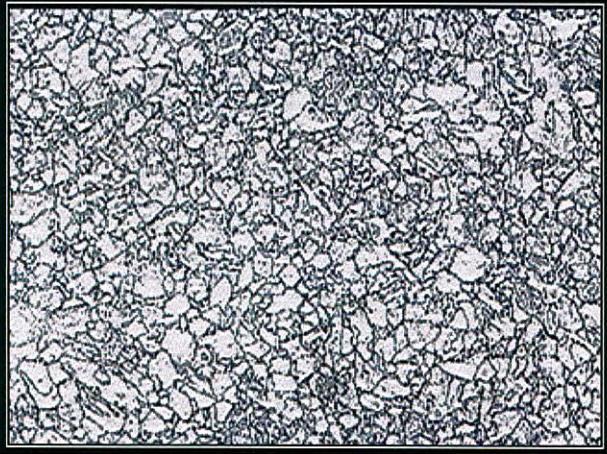
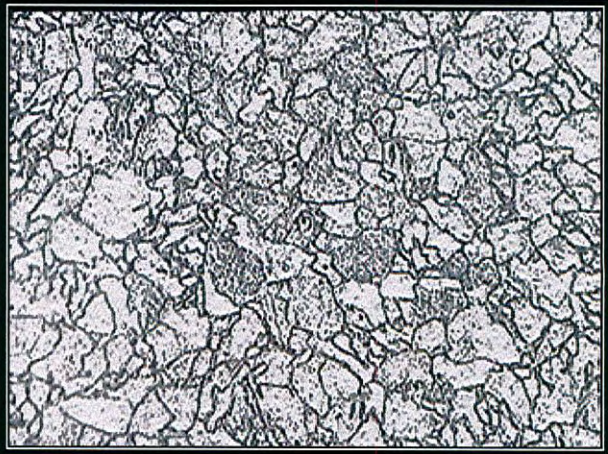
<p><b>Name of Component:</b> IPCV-2 Body  <b>Location:</b> IPCV-2 Body Inner_ Parent Metal _ Replica No. 20  Hardness: 171-179HB.</p>

200X	400X
<p><b>Observation:</b> Microstructure shows ferrite and bainite and carbides at grain boundaries. Degradation Level- IVL</p>	
Fig: 93

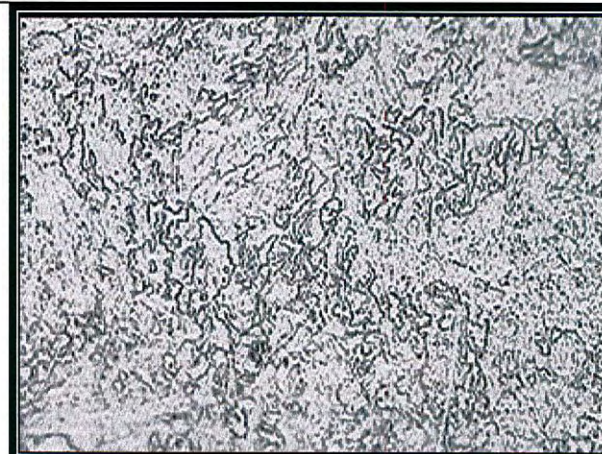
Fig: 94

**Name of Component:** LP Bypass  
**Location:** LP Bypass con \_ Parent Metal \_ Replica No. 38  
 Hardness: 171-181HB.

**Observation:** Microstructure shows tempered Bainite with spherodisation carbides. Degradation Level- IIL

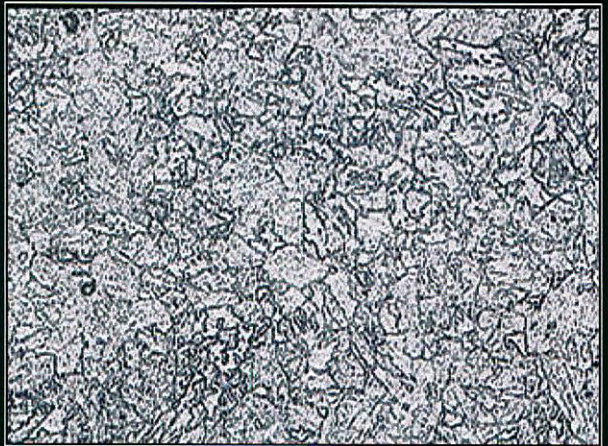
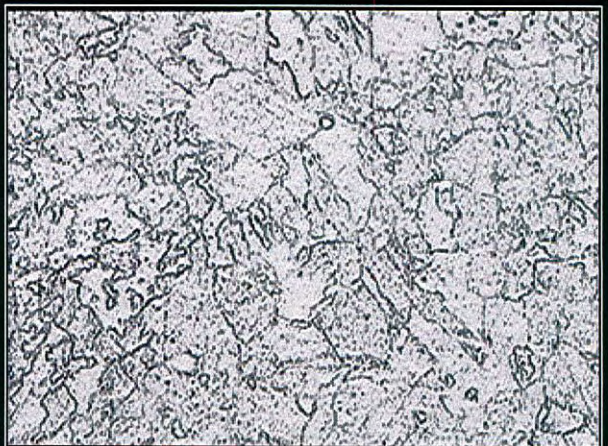
<p><b>Name of Component:</b> LP Bypass  <b>Location:</b> LP Bypass con _ Parent Metal _ Replica No. 39  Hardness: 191-201HB.</p>

200X	400X
<p><b>Observation:</b> Microstructure shows tempered Bainite with spheroidisation of carbides.</p>	
<p>Degradation Level- IIL</p>	
<p>Fig: 95</p>

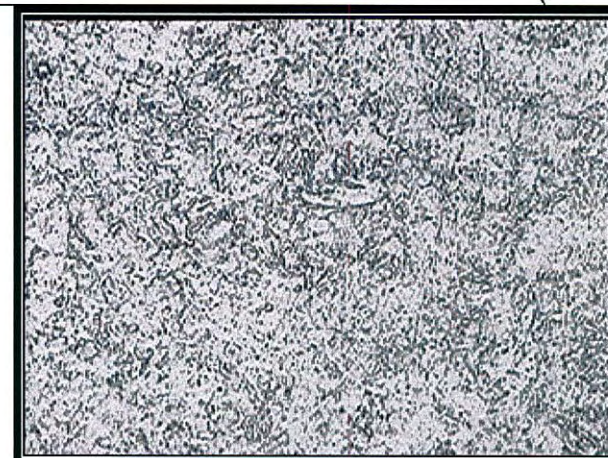
Fig: 96

**Name of Component:** LP Bypass valve  
**Location:** LP Bypass Body\_ Parent Metal \_ Replica No. 51  
 Hardness: 185-196HB.

**Observation:** Microstructure shows tempered Bainite with spheroidisation carbides.

Degradation Level- IIL

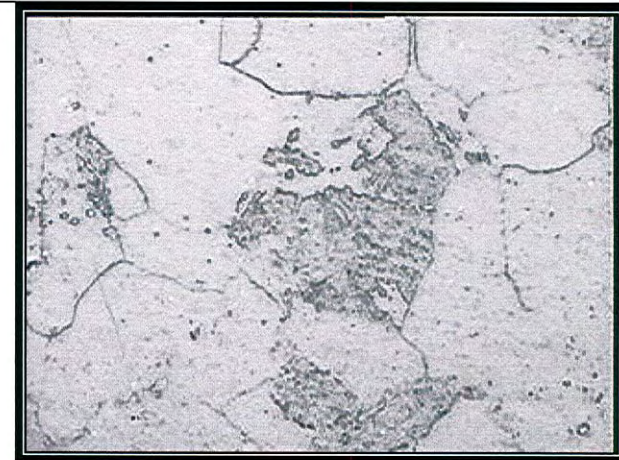
Fig: 97

**Name of Component:** HP Bypass valve  
**Location:** HP Bypass Body\_ Parent Metal \_ Replica No. 52  
 Hardness: 122-138HB.

**Observation:** Microstructure shows tempered Bainite with spheroidisation carbides. Degradation Level- IIL

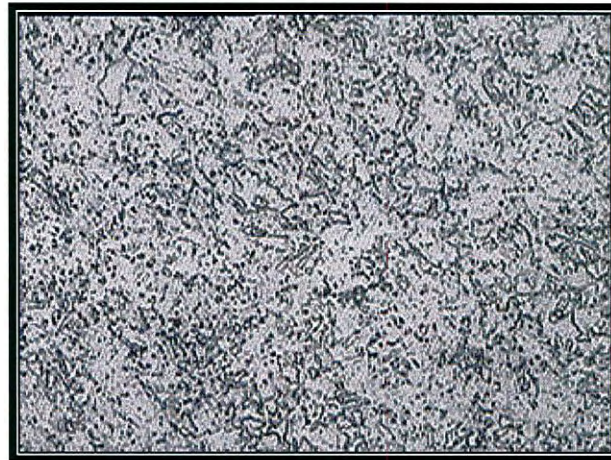
Fig: 98

**Name of Component:** IPCV-3  
**Location:** IPCV-3 Inner body\_ Parent Metal \_ Replica No. 54  
 Hardness: 181-187HB

**Observation:** Microstructure shows ferrite and Bainite with precipitation of carbides at grain boundary.

Degradation Level- IVL

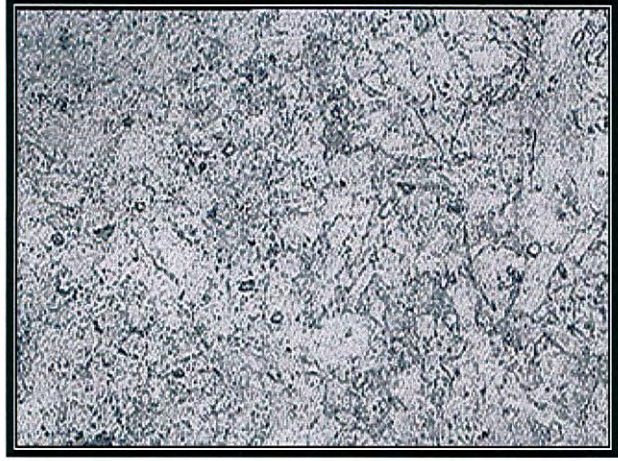
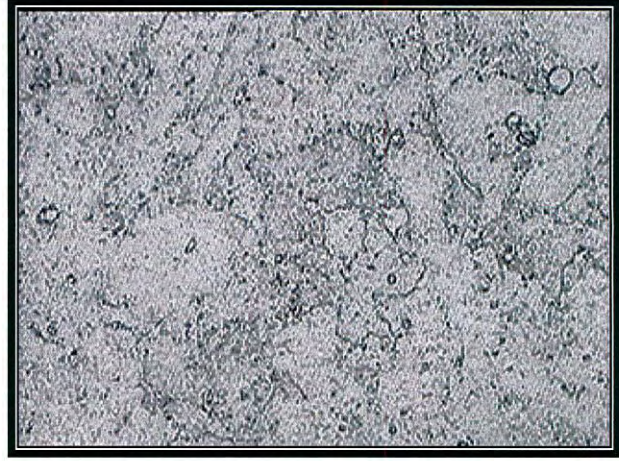
Fig: 99

**Name of Component:** IPCV-4  
**Location:** IPCV-4 Inner body\_ Parent Metal \_ Replica No. 55  
 Hardness: 171-178HB

**Observation:** Microstructure shows ferrite and Bainite with precipitation of carbides at grain boundary. Degradation Level- IVL

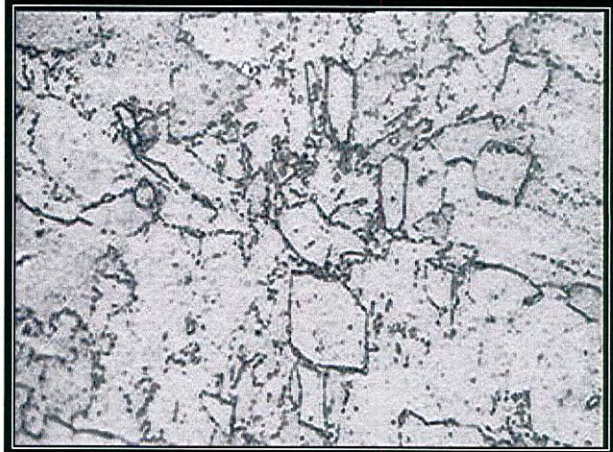
Fig: 100

**Name of Component:** HPCV-3  
**Location:** HPCV-3 outer body\_ Parent Metal \_ Replica No. 56  
**Hardness:** 186-196HB

**Observation:** Microstructure shows ferrite and Bainite with precipitation of carbides at grain boundary.

Degradation Level- IVL

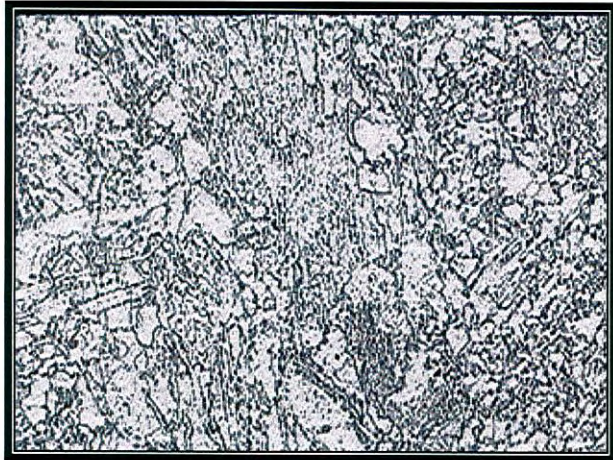
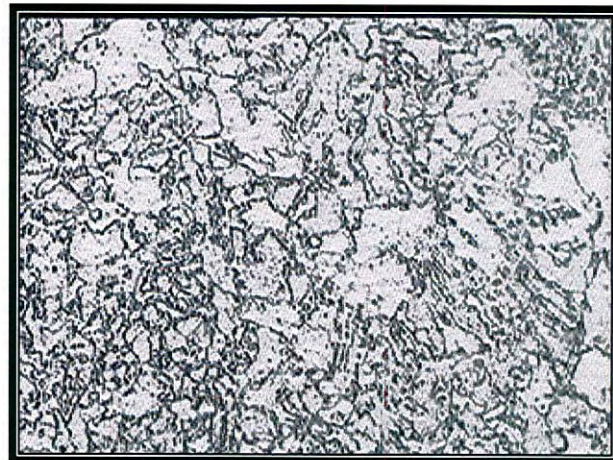
Fig: 101

**Name of Component:** HPSV -1  
**Location:** HPSV bush-1 \_ Parent Metal \_ Replica No. 57  
 Hardness: 150-164HB

**Observation:** Microstructure shows ferrite and Bainite with precipitation of carbides at grain boundary.

Degradation Level- IVL

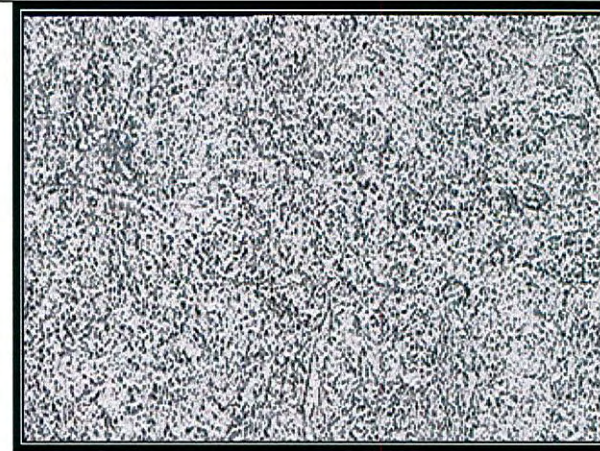
Fig: 102

**Name of Component:** HPSV-2  
**Location:** HPSV con-2 \_ Parent Metal \_ Replica No. 58  
 Hardness: 180-192HB

**Observation:** Microstructure shows ferrite and Bainite with precipitation of carbides at grain boundary.

Degradation Level- IVL

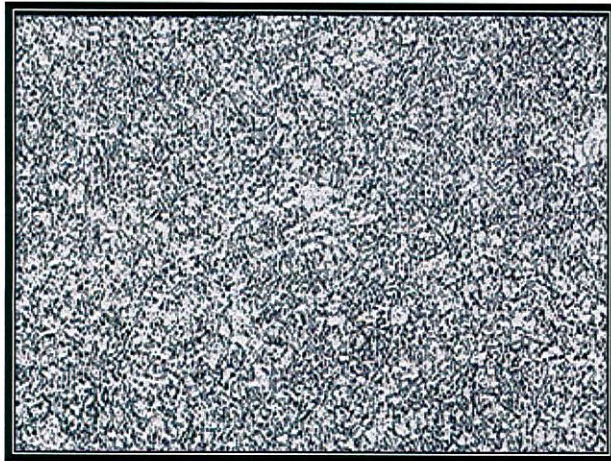
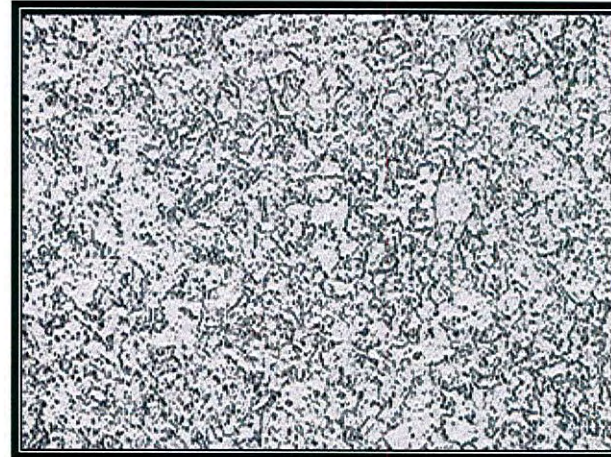
Fig: 103

**Name of Component:** HPSV-3  
**Location:** HPSV bush-3 \_ Parent Metal \_ Replica No. 59  
 Hardness: 191-200HB

**Observation:** Microstructure shows tempered Bainite precipitation of carbides at grain boundary. Degradation Level- IVL

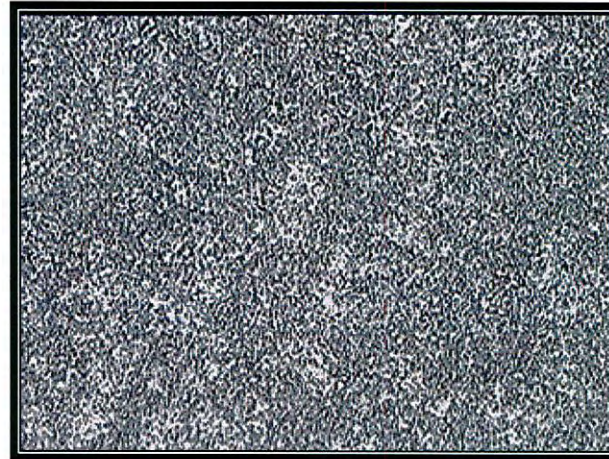
Fig: 104

**Name of Component:** HPSV-4  
**Location:** HPSV con-4 \_ Parent Metal \_ Replica No. 60  
 Hardness: 199-201HB

**Observation:** Microstructure shows tempered Bainite with spherodisation carbides.

Degradation Level- IIL

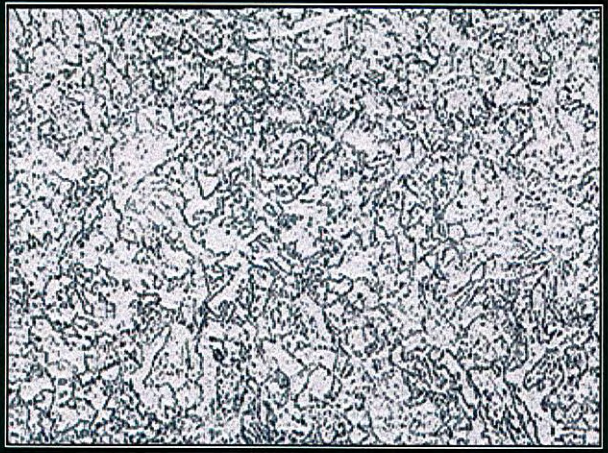
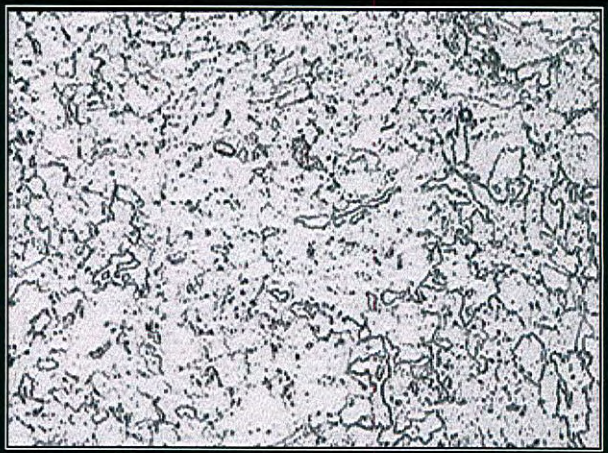
<p><b>Name of Component:</b> IPSV-1  <b>Location:</b> IPSV-1Bush _ Parent Metal _ Replica No. 1  Hardness: 156-161HB</p>

200X	400X	
<p><b>Observation:</b> Microstructure shows tempered Bainite precipitation of carbides at grain boundary.</p>		Degradation Level- IVL
Fig: 105

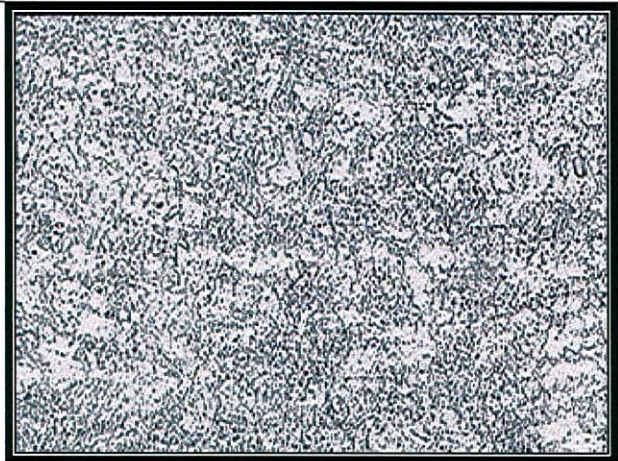
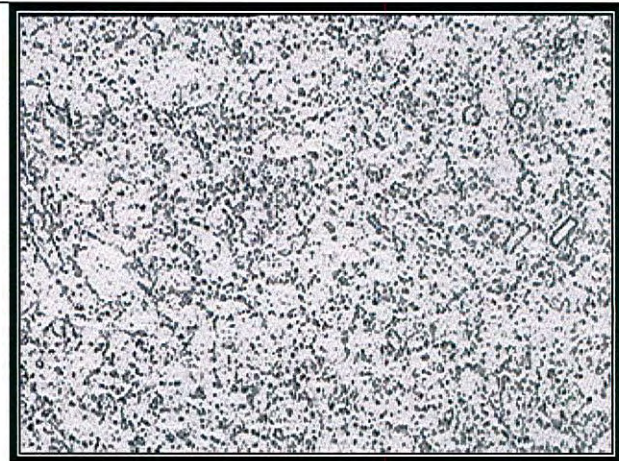
Fig: 106

**Name of Component:** IPSV-3  
**Location:** IPSV-3Bush \_ Parent Metal \_ Replica No. 2  
 Hardness: 157-164HB

**Observation:** Microstructure shows tempered Bainite Degradation Level- IVL  
 precipitation of carbides at grain boundary.

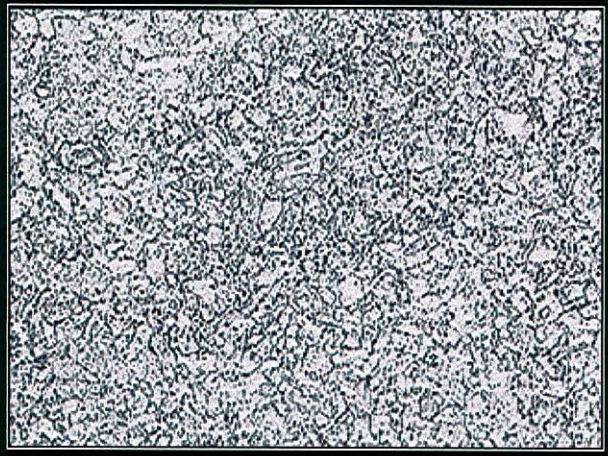
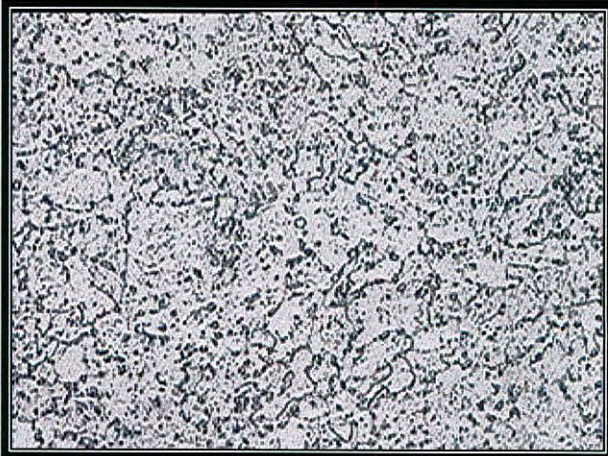
<p><b>Name of Component:</b> IPSV-2  <b>Location:</b> IPSV-2 con _ Parent Metal _ Replica No. 3  Hardness: 140-148HB</p>

200X	400X
<p><b>Observation:</b> Microstructure shows tempered Bainite precipitation of carbides at grain boundary.</p>	Degradation Level- IVL
Fig: 107

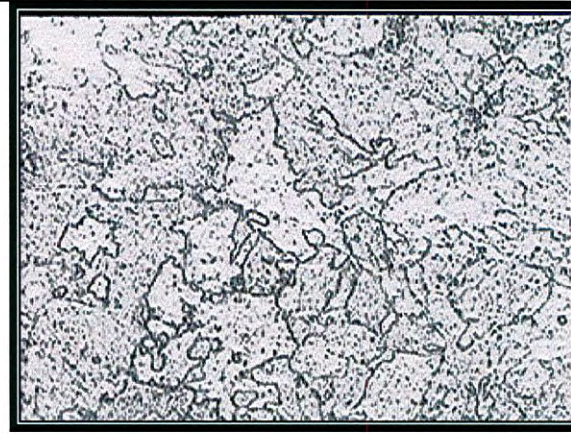
Fig: 108

**Name of Component:** IPSV-4  
**Location:** IPSV-4 con \_ Parent Metal \_ Replica No. 4  
 Hardness: 148-151HB

**Observation:** Microstructure shows ferrite and Bainite with precipitation of carbides at grain boundary..

Degradation Level- IVL

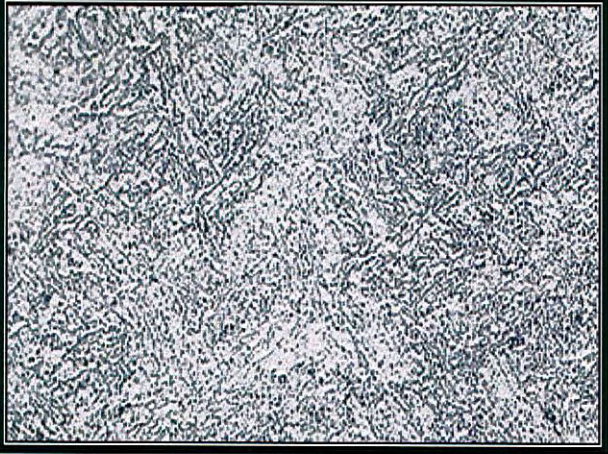
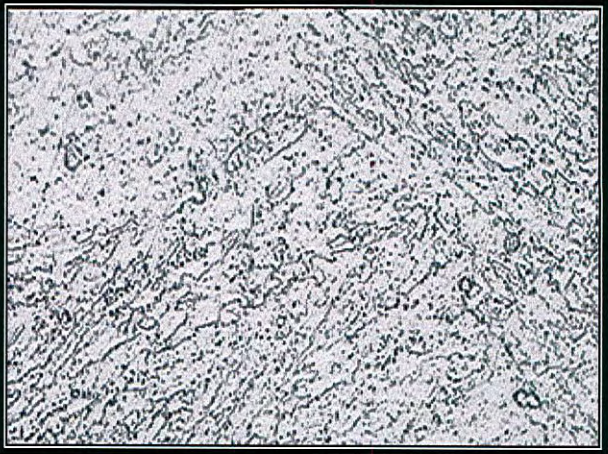
<p><b>Name of Component:</b> IPCV-2  <b>Location:</b> IPCV-2 bush _ Parent Metal _ Replica No. 5  Hardness: 155-157HB.</p>

200X	400X	
<p><b>Observation:</b> Microstructure shows ferrite and Bainite with precipitation of carbides at grain boundary.</p>		Degradation Level- IVL
Fig: 109

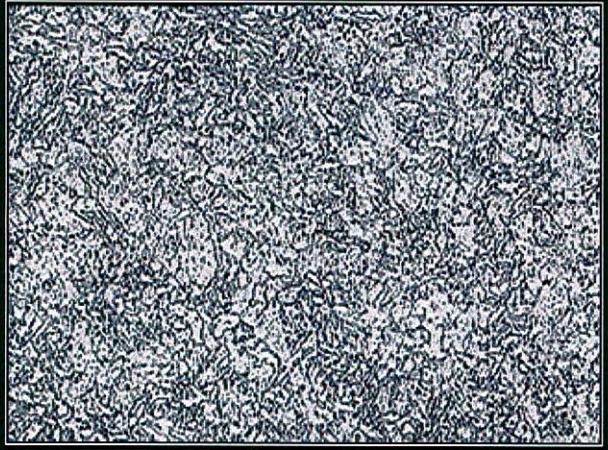
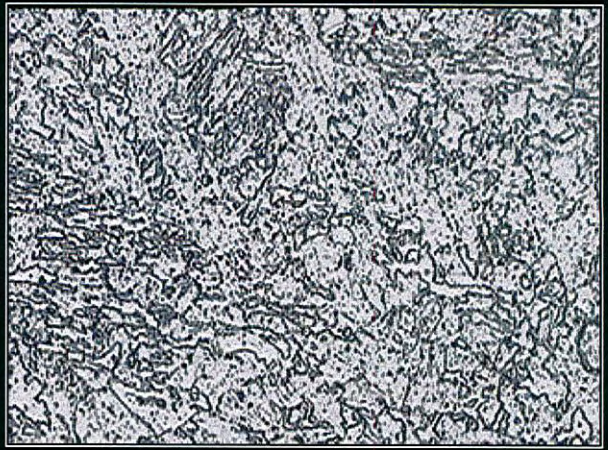
**Name of Component:** IPCV-4  
**Location:** IPCV-4 bush \_ Parent Metal \_ Replica No. 6  
 Hardness: 158-161HB

200X	400X
<b>Observation:</b> Microstructure shows tempered Bainite with precipitation of carbides.	
Degradation Level- IIL	
Fig: 110

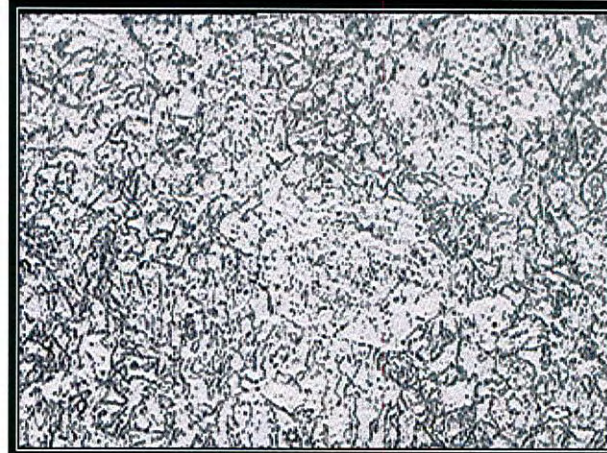
Fig: 111

**Name of Component:** IPCV-3  
**Location:** IPCV-3 con \_ Parent Metal \_ Replica No. 7  
 Hardness: 168-171HB.

**Observation:** Microstructure shows tempered Bainite with spheroidisation carbides. Degradation Level- III

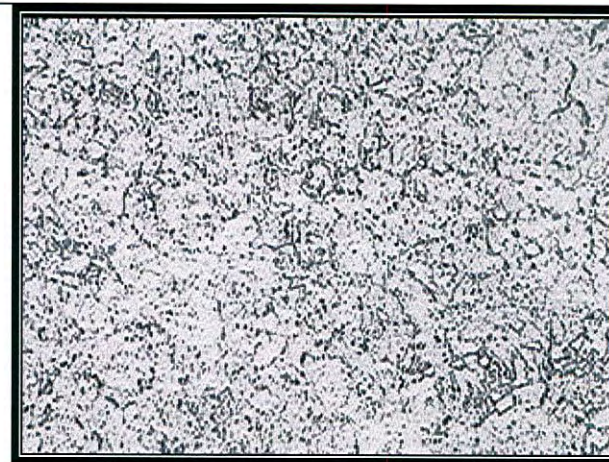
Fig: 112

**Name of Component:** IPCV-1  
**Location:** IPCV-1 con \_ Parent Metal \_ Replica No. 8  
 Hardness: 171-178HB.

**Observation:** Microstructure shows tempered Bainite  
 precipitation of carbides at grain boundary. Degradation Level- IVL

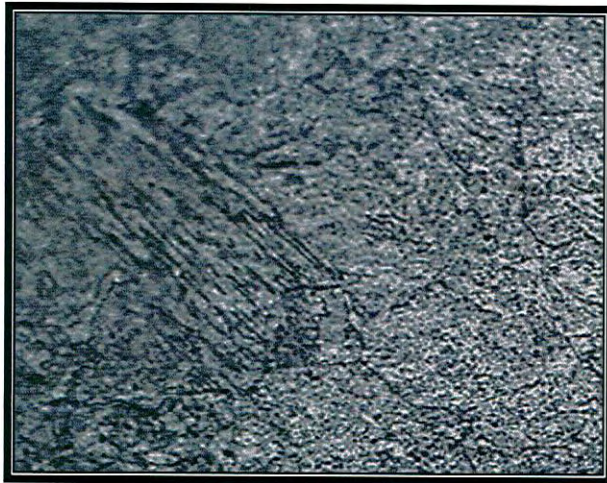
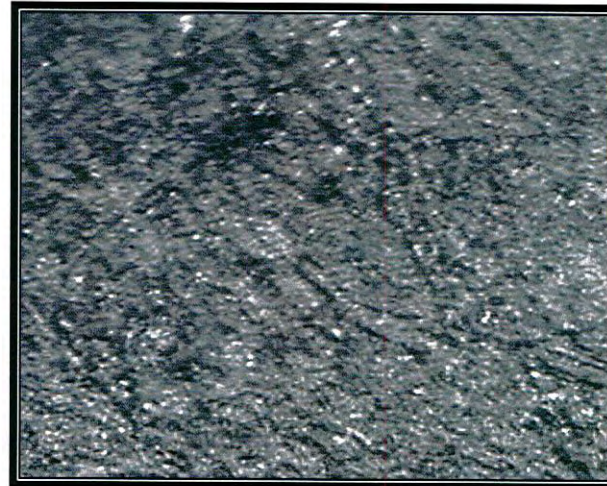
Fig: 113

**Name of Component:** HP CV-1  
**Location:** HP CV-1\_CONE  
Hardness: 160-162HB.

**Observation:** Microstructure shows tempered Bainite with precipitation of carbides..

Degradation Level- IIL

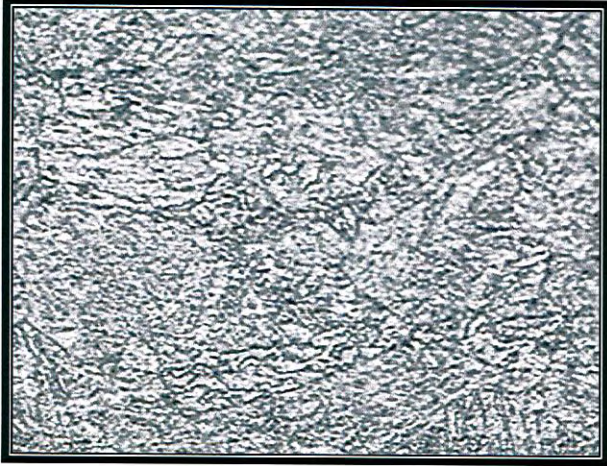
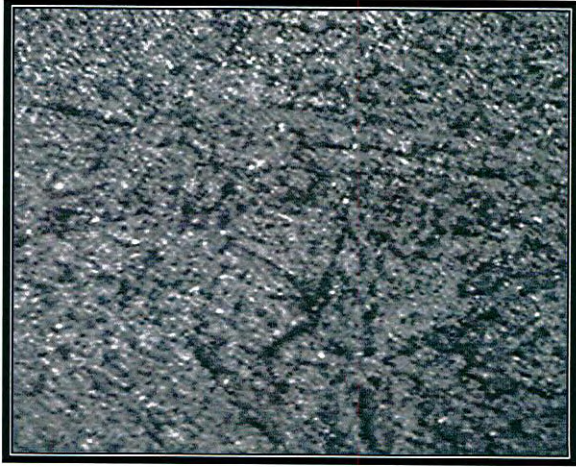
<b>Name of Component:</b> HP CV-1 <b>Location:</b> HP CV-1_BUSH Hardness: 162-165HB

200X	400X
<b>Observation:</b> Microstructure shows tempered Bainite with precipitation of carbides. Degradation Level- IIL	
Fig: 114

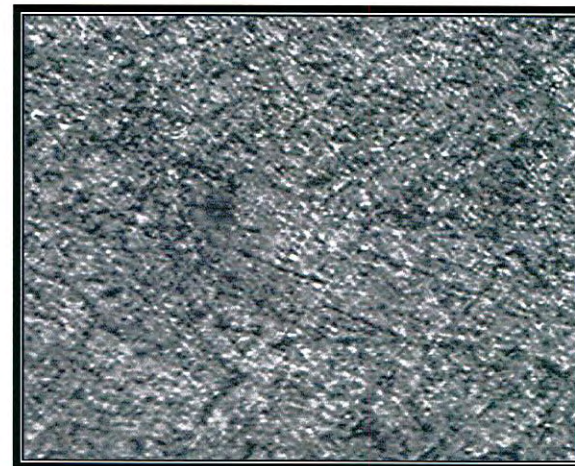
Fig: 115

**Name of Component:** HP CV-1

**Location:** HP CV-1\_BUSH

Hardness: 165-168HB

**Observation:** Microstructure shows tempered Bainite with precipitation of carbides.

Degradation Level- IIL

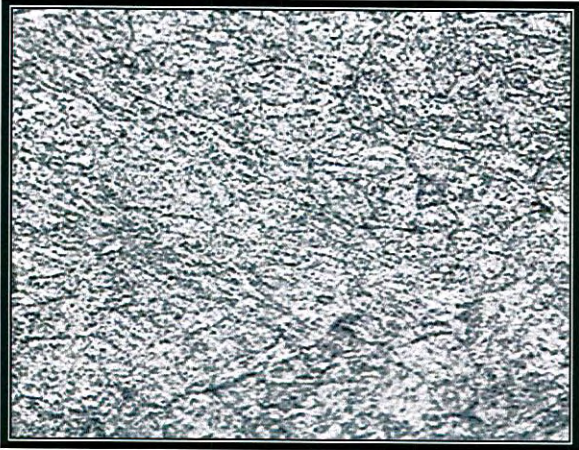
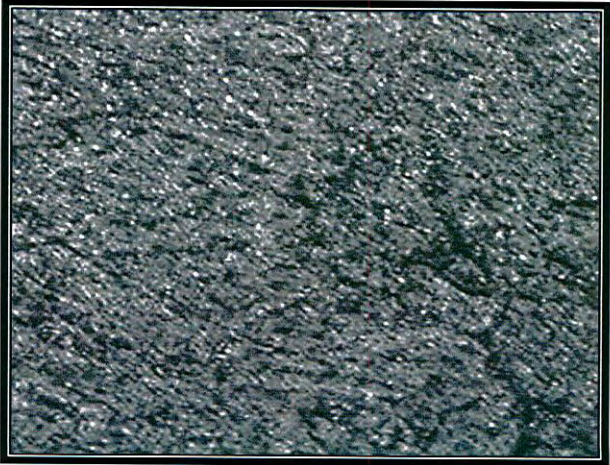
<b>Name of Component:</b> HP CV-2 <b>Location:</b> HP CV-2_CONE Hardness: 160-163HB

200X	400X
<b>Observation:</b> Microstructure shows tempered Bainite with precipitation of carbides.	Degradation Level- IIL
Fig: 116

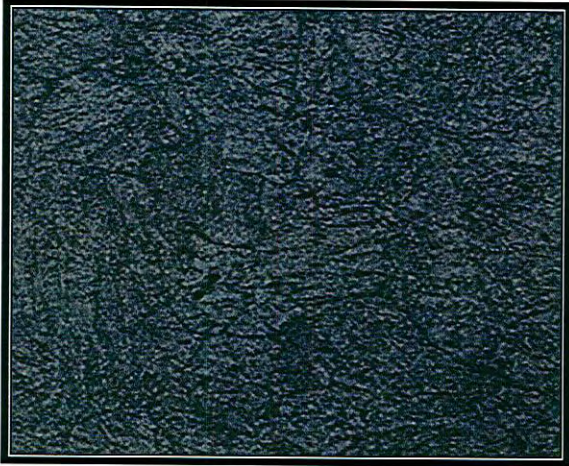
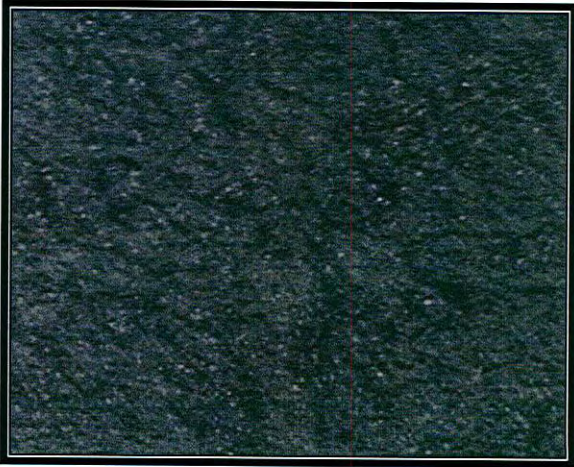
<b>Name of Component:</b> HP CV-2 <b>Location:</b> HP CV-2_BUSH Hardness: 158-160HB

200X	400X
<b>Observation:</b> Microstructure shows tempered Bainite precipitation of carbides at grain boundary. Degradation Level- IVL	
Fig: 117

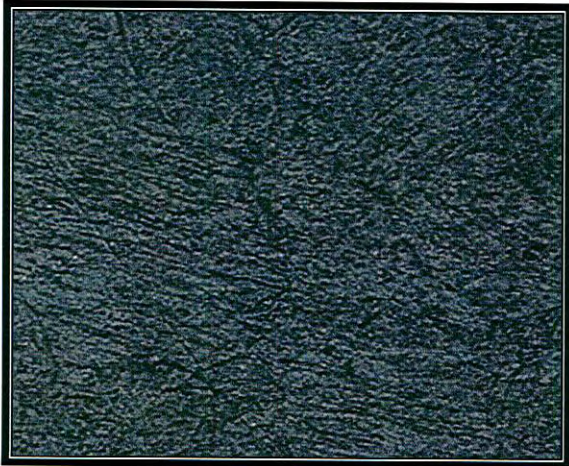
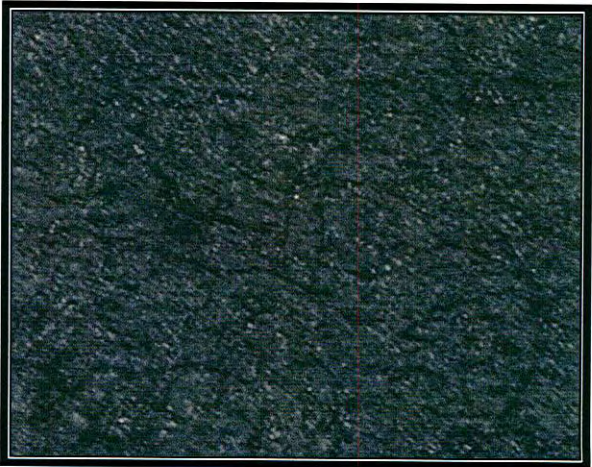
<b>Name of Component:</b> HP CV-2 <b>Location:</b> HP CV-2_BUSH Hardness: 160-163HB

200X	400X
<b>Observation:</b> Microstructure shows tempered Bainite precipitation of carbides at grain boundary. Degradation Level- IVL	
Fig: 118

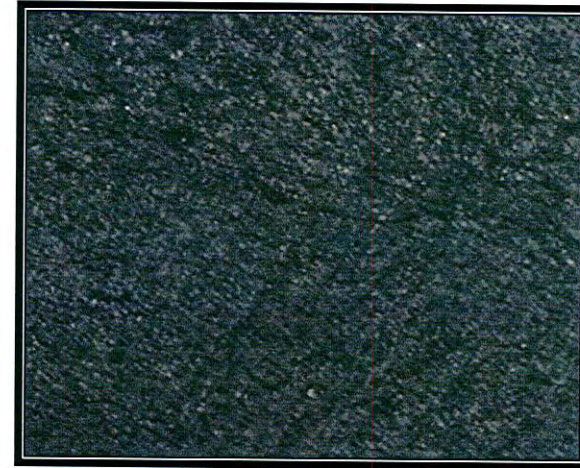
Fig: 119

**Name of Component:** HP CV-3  
**Location:** HP CV-3\_CONE  
 Hardness: 161-162HB

**Observation:** Microstructure shows tempered Bainite with precipitation of carbides.

Degradation Level- IIL

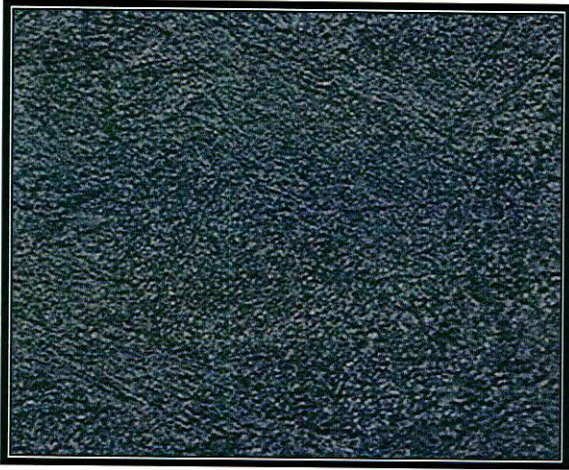
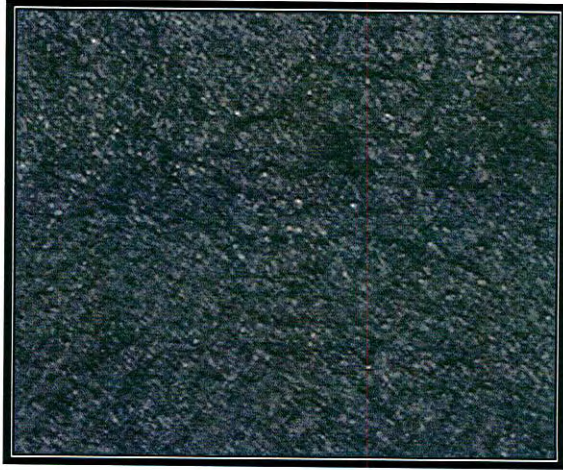
<b>Name of Component:</b> HP CV-3 <b>Location:</b> HP CV-3_BUSH Hardness: 160-162HB

200X	400X
<b>Observation:</b> Microstructure shows tempered Bainite with precipitation of carbides..	Degradation Level- IIL
Fig: 120

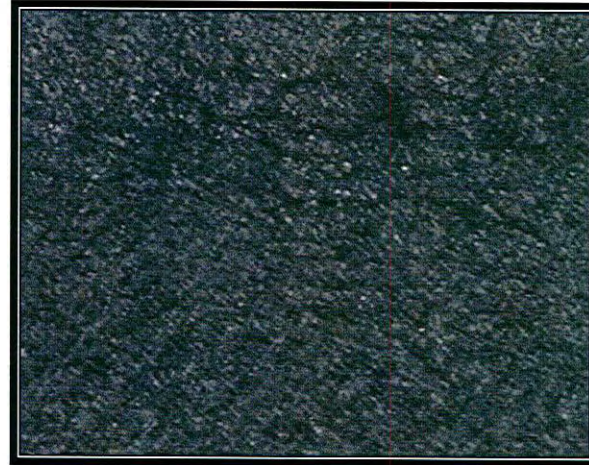
Fig: 121

**Name of Component:** HP CV-4  
**Location:** HP CV-4\_CONE  
Hardness: 163-165HB

**Observation:** Microstructure shows tempered Bainite precipitation of carbides at grain boundary. Degradation Level- IVL

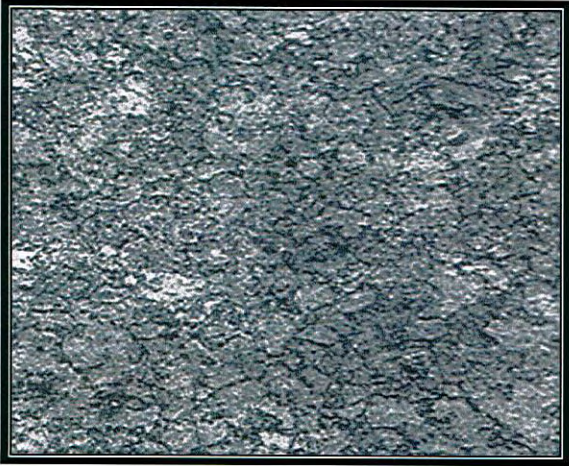
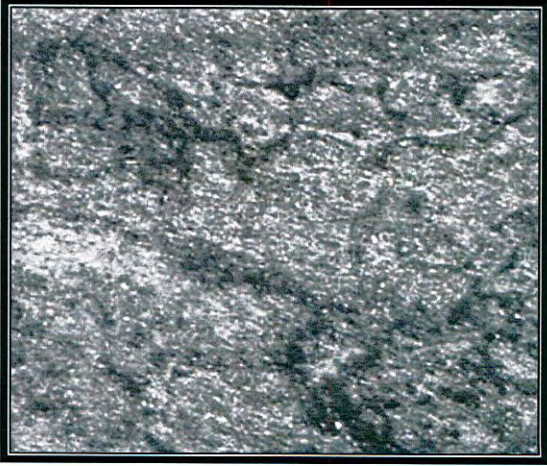
<b>Name of Component:</b> HP CV-4 <b>Location:</b> HP CV-4_BUSH Hardness: 155-158HB

200X	400X
<b>Observation:</b> Microstructure shows tempered Bainite with precipitation of carbides.	Degradation Level- IIL
Fig: 122

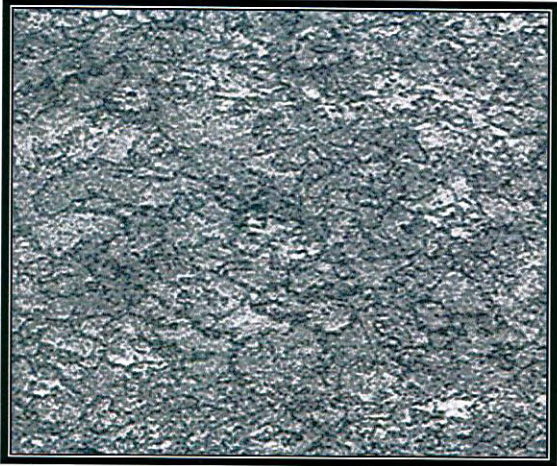
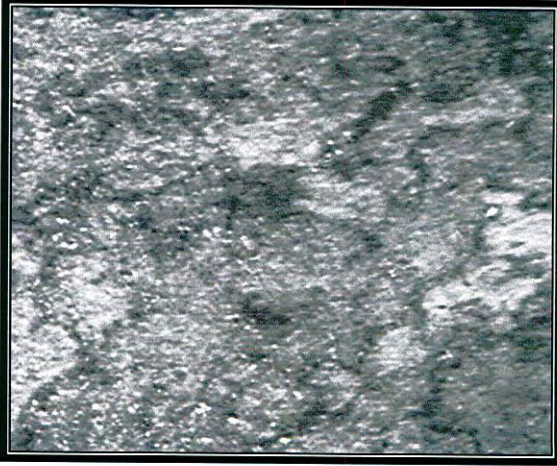
<b>Name of Component:</b> HP CV-4 <b>Location:</b> HP CV-4_BUSH Hardness: 140-145HB

200X	400X
<b>Observation:</b>	No significant degradation observed
Fig: 123

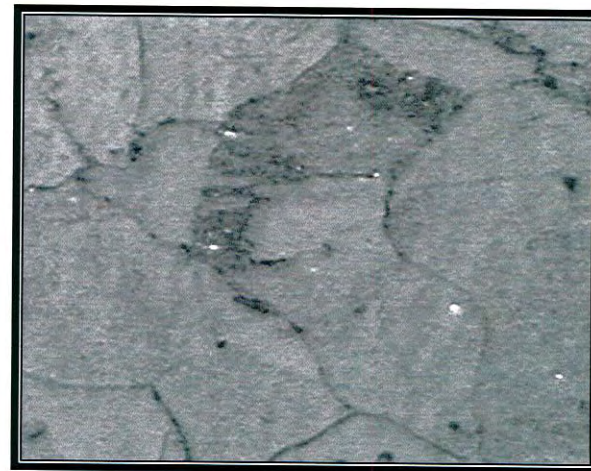
Fig: 124

**Observation:** Microstructure shows tempered Bainite precipitation of carbides at grain boundary.

Degradation Level- IVL

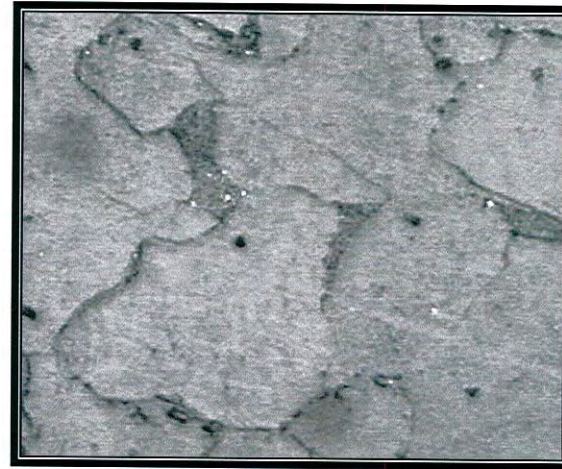
Fig: 125

**Observation:** Microstructure shows tempered Bainite precipitation of carbides at grain boundary. Degradation Level- IVL

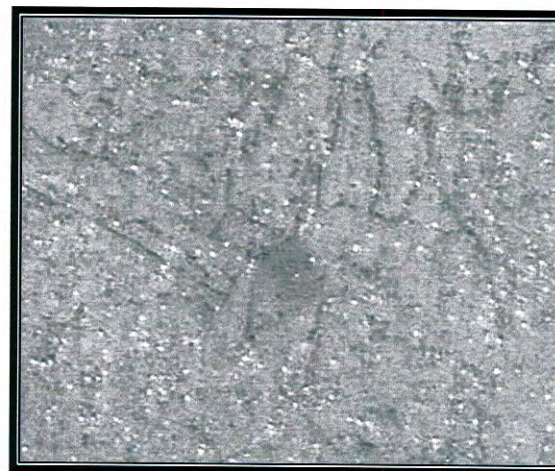
**Observation:** Microstructure shows ferrite and Bainite with precipitation of carbides at grain boundary.

Degradation Level- IVL

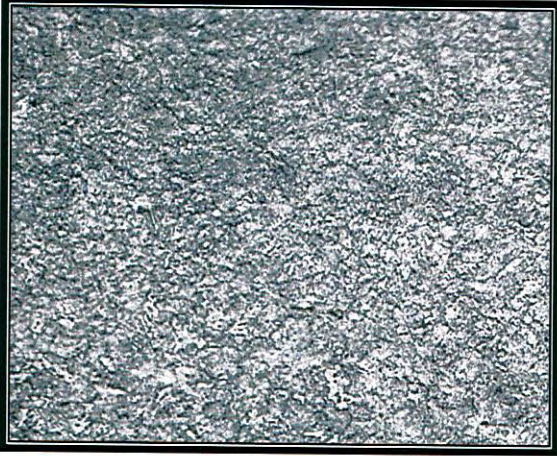
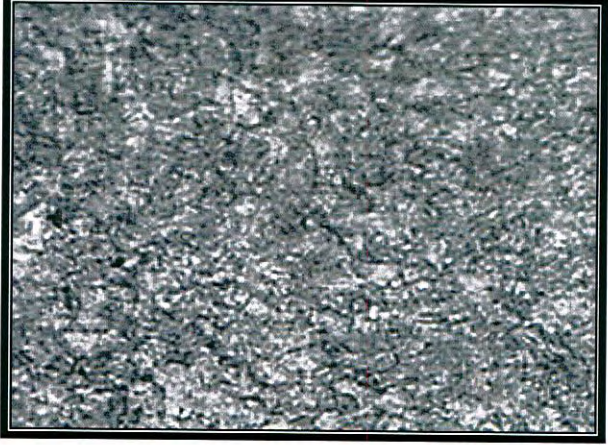
<b>Name of Component:</b> IP CV-2 <b>Location:</b> IP CV-2_BUSH Hardness: 160-165HB

200X	400X
<b>Observation:</b> Microstructure shows ferrite and Bainite with precipitation of carbides at grain boundary.	
Degradation Level- IVL	
Fig: 127

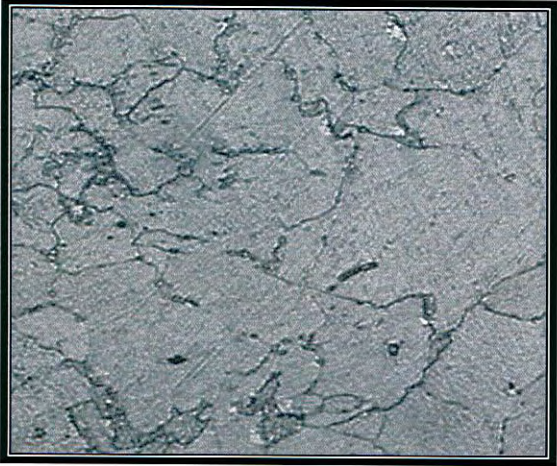
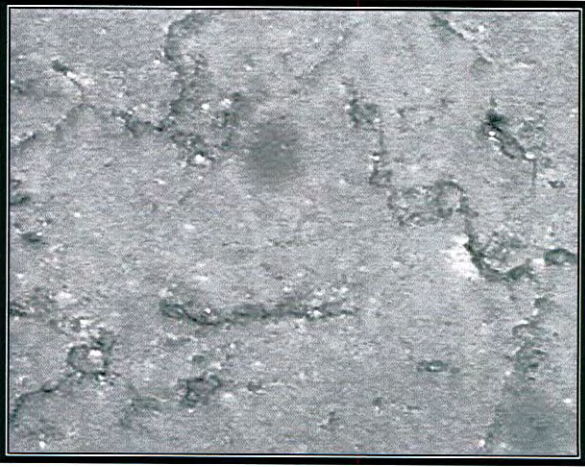
<b>Name of Component:</b> IP CV-3 <b>Location:</b> IP CV-3_BUSH Hardness: 140-145HB

200X	400X
<b>Observation:</b> Microstructure shows tempered Bainite precipitation of carbides at grain boundary. Degradation Level- IVL	
Fig: 128

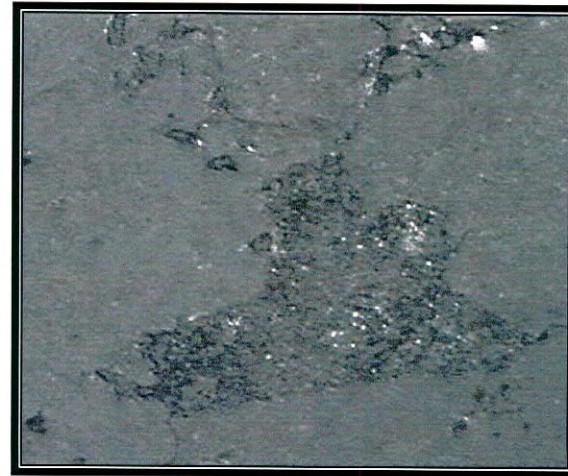
**Observation:** Microstructure shows tempered Bainite with precipitation of carbides..

Degradation Level- IIL
