7. Results of each observation and quantitative evaluation

8. Residual life assessment results

9. The other inspection results

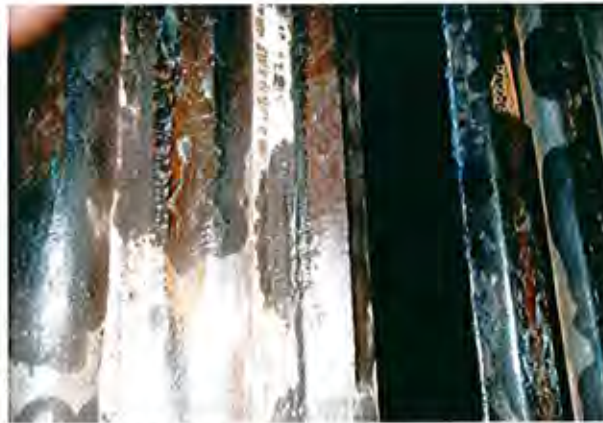
(Erosion of water wall around short soot blower)

- Erosion by soot blower was observed at a number of Water wall tubes around short soot blower.
- The thickness measurement was carried out at the representative eroded portion (2nd short soot blower level) as shown in Table I -13~16.
- Min.thickness was 3.7mm at a front wall tube around #1 short soot blower from right, that was less than tsr (thickness required) 5.5mm calculated with designed OD, pressure and allowable stress at the designed temperature.

Erosion of front wall tube
[extracted from Table I -12]

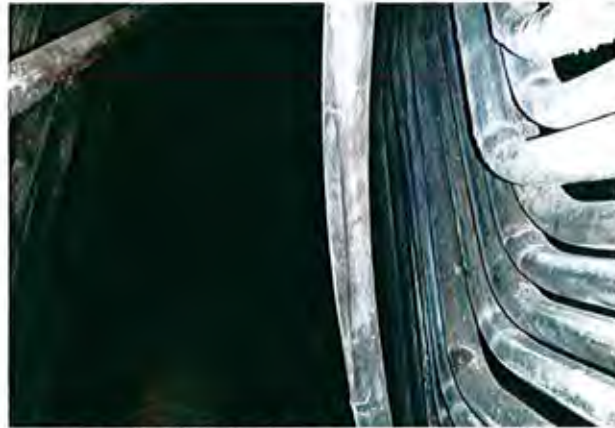
(Attrition of Platen-SH binding tube #4 and #5

- Attrition of binding tube #4 and #5 with each other was found.
- The thickness measurement results are shown in Table I -17.
- Min.thickness was 2.8mm, that was far less than the designed value 6.5mm.

Attrition of binding tube [extracted from Table I -12]

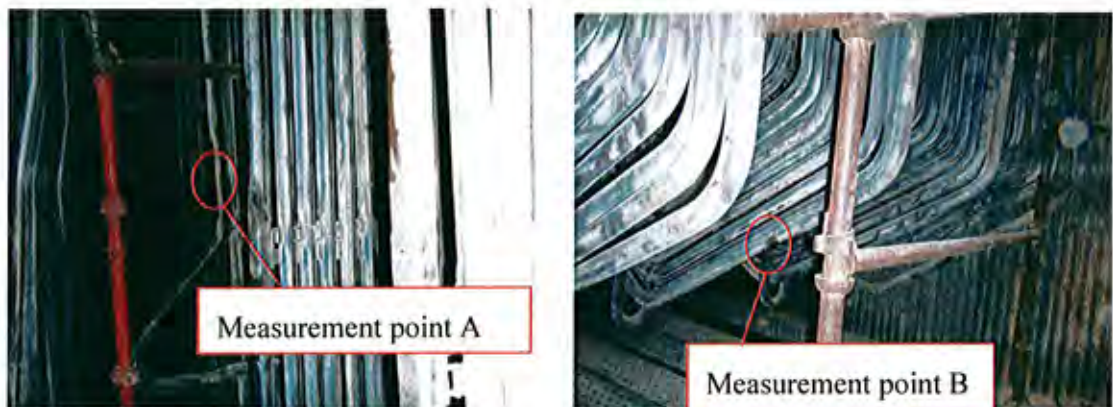
Thickness measurement portion of Platen-SH [extracted Table I -18]

(Thickness measurement of Platen-SH)

- Thickness was measured mainly for outer tubes of rear side portion at soot blower level and outer bottom tubes as shown in Table I -18.
- Min.thickness at soot blower level (measurement point A) was 6.3mm, that was not less than the designed value 6.3mm.
- Min.thickness at outer bottom tubes (measurement point B) was 9.8mm, that was larger than the designed value 9.5mm.

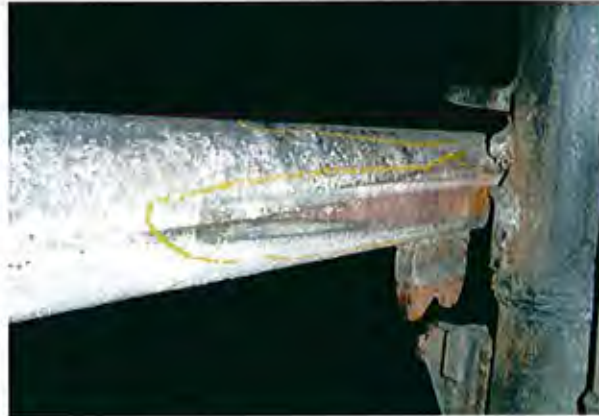
(Attrition of cooling spacer tube with Platen-SH front tube of #14 panel)

- Attrition of a cooling spacer tube with Platen-SH front tube of #14 panel.
- The thickness measurement results are shown in Table I -17.
- Min.thickness was 5.0mm.

Attrition of cooling spacer tube [extracted Table I -12]

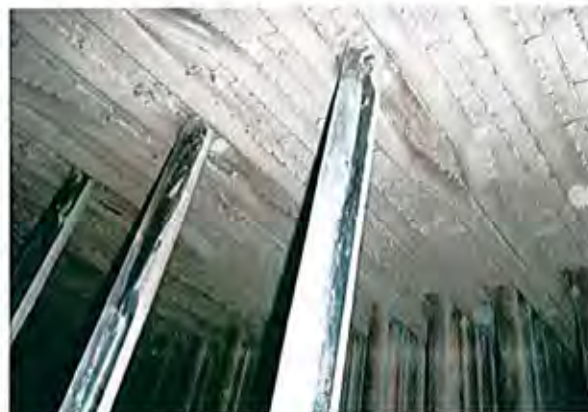
(Erosion of screen tubes near the ceiling between front RH panel and rear RH panel)

- Erosion of screen tubes at front side near the ceiling was found at left side of boiler.

Erosion of rear wall screen tubes [extracted Table I -12]

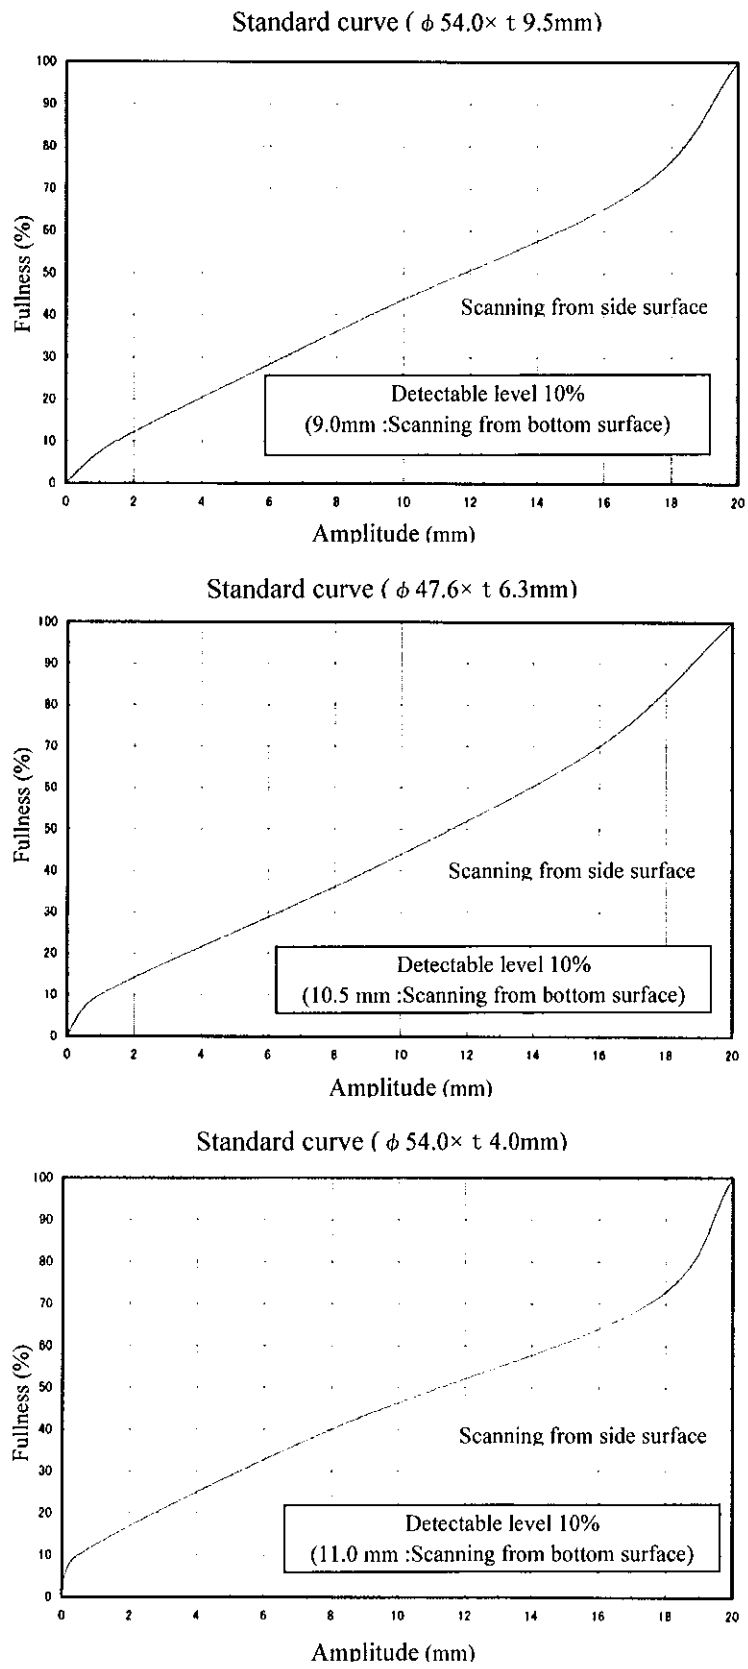
- 15% fullness of SUS scale deposition was detected at 4 outermost tubes of Platen-SH and 1 outermost tube of RH.
- 10% % fullness of SUS scale deposition was detected at 3 outermost tubes of Platen-SH.
- The others were less than 10% fullness of SUS scale deposition.

The representative deposition signal for this inspection is shown in Fig. I -3. The standard curve used is shown in Fig. I -4.

Scanning from bottom surface	Scanning from side surface
Platen SH outermost tube front bend portion # 14 panel Fullness 15%		
Platen SH binding tube bottom bend portion #18 panel Fullness 0%		
RH outermost tube front bend portion # 3 panel Fullness 15%		
RH binding tube bottom bend portion #5 panel- a Fullness 0%

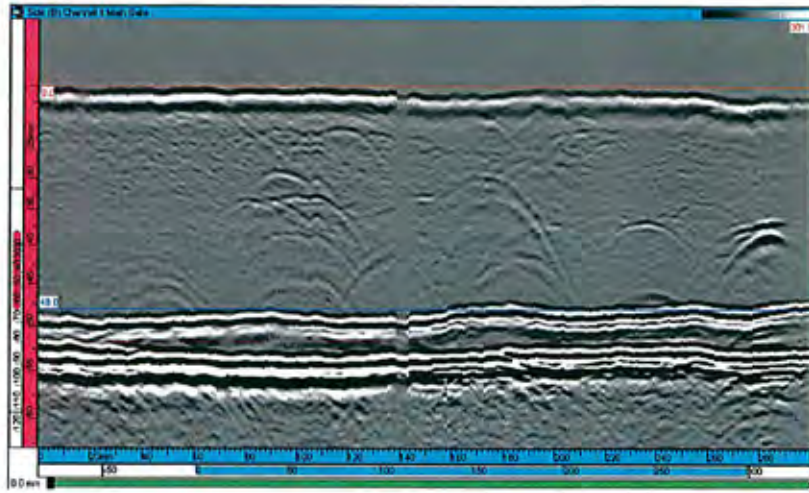
Fig. I -7 X=0~300mm TOFD detection results

No flaw echo judged as a crack was detected, although a number of flaw echoes from subtle blow holes and slag inclusions by welding were detected.
