## Inspection at Unchahar #2

Boiler residual life assessment was carried out as one of the activities to improve the efficiency of coal-fired thermal power plants in NTPC-India and transfer to counterpart the technology.

Feroze Gandhi Unchahar Thermal Power Station #2 unit

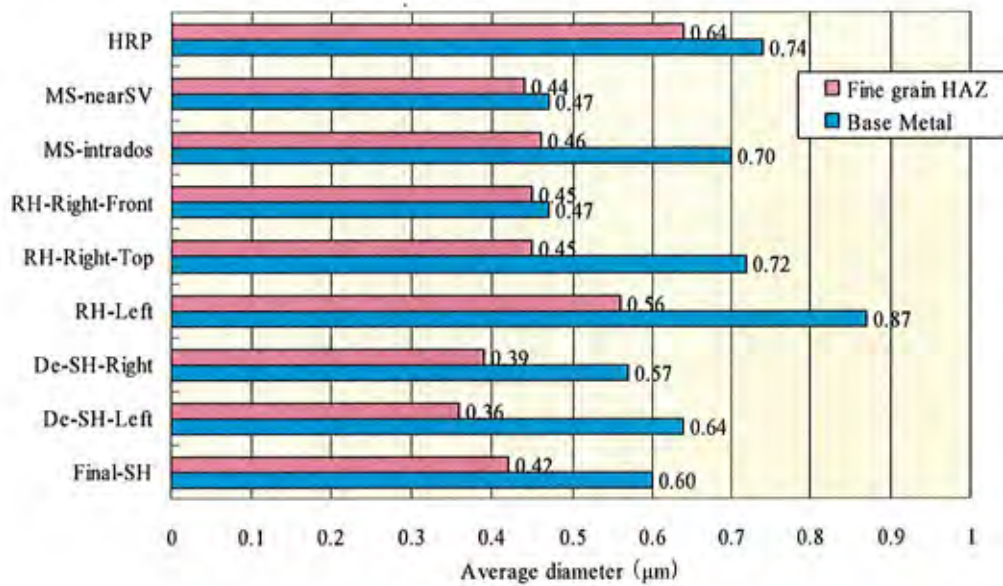
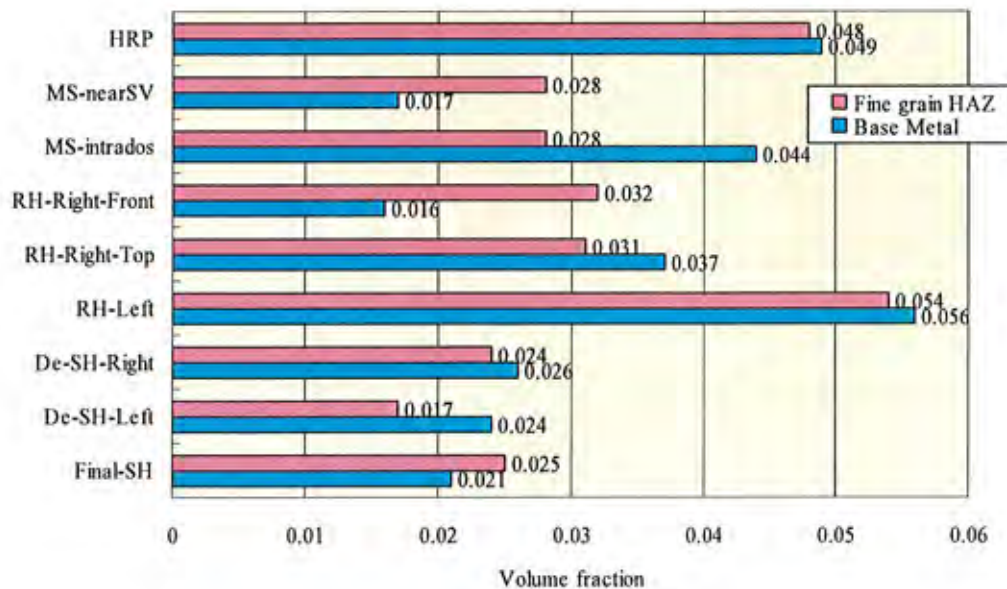
Quantitative evaluation of grain boundary precipitates [extracted Table II -7]

- The max. value of average diameter of grain boundary precipitates was  $0.87 \mu\text{m}$  in base metal at RH Outlet Header-Left,  $0.64 \mu\text{m}$  in fine grain HAZ at Hot Reheat Pipe-Right.
- The max. value of volume fraction of grain boundary precipitates was 0.056 in base metal at RH Outlet Header-Left, 0.054 in fine grain HAZ at RH Outlet Header-Left.

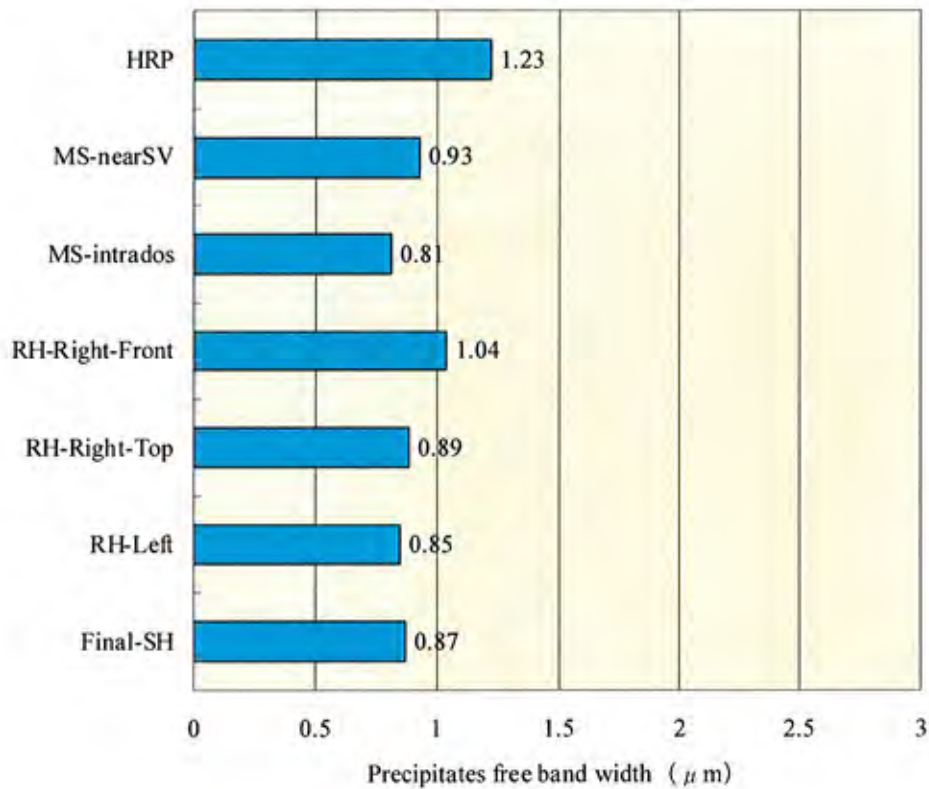
Precipitates free band width along grain boundary [extracted Table II -8]

- The quantitative evaluation was focused on base metal of SA 335 P22.
- The max. value of precipitates free band width along grain boundary was  $1.23 \mu\text{m}$  at Hot Reheat Pipe-Right.
