## 9. The other inspection results

### 9-1 Visual inspection, Thickness measurement

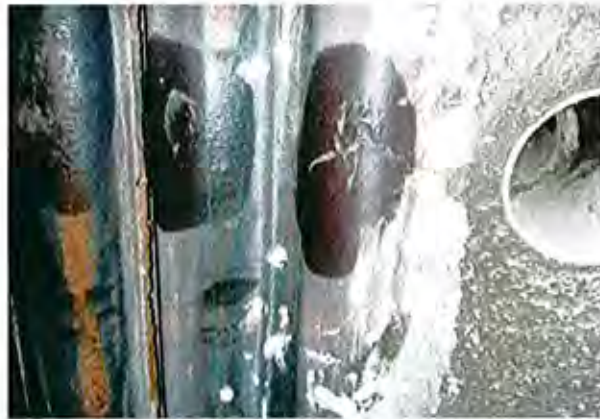
(Erosion of Water Wall tube around short soot blower)

- Erosion by soot blower were observed at a number of Water Wall tubes around short soot blower.
- The thickness measurement was carried out at the representative eroded portion (2<sup>nd</sup> short soot blower level) as shown in Table II -13~16.
- Min.thickness was 5.3mm at a rear wall tube around #1 short soot blower from right, that was less than the designed value tsr (thickness required) 6.1mm calculated with designed OD, pressure and allowable stress at the designed temperature.

Erosion of rear wall tube  
[extracted from Table II -12]

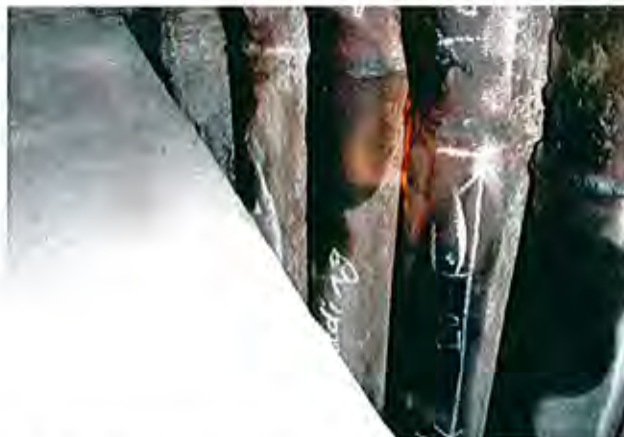
(Erosion of Water Wall tube around burner portion)

- Erosion by soot blower was observed at a number of Water Wall tubes around burner portion.
- The thickness measurement was carried out at the eroded portion as shown in Table II -17.
- Min.thickness was 4.7 mm, that was less than the tsr 6.1mm.

Erosion of Water Wall tube around burner portion [extracted from Table II -12]

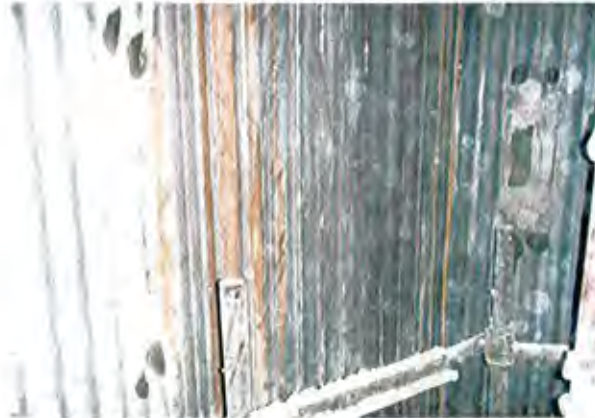
(Erosion of Water Wall tube around corner portion)

- Erosion around corner portion at soot blower level was observed.
- The thickness measurement was carried out at the eroded portion as shown in Table II -18.
- Min.thickness was 4.2 mm, that was less than the tsr 6.1 mm.

Erosion of Water Wall tube around corner portion [extracted from Table II -12]

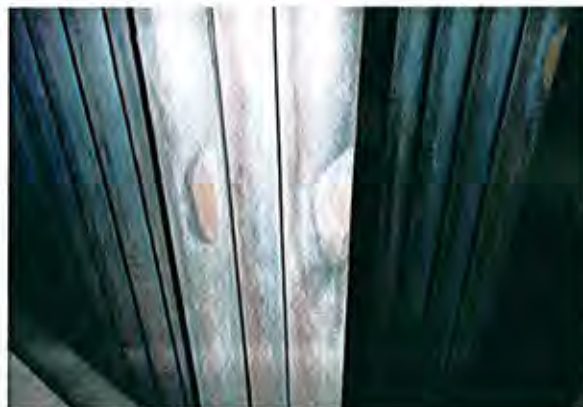
(Erosion of Platen SH tube at the highest level of soot blower)

- Slight erosion of Platen SH tube was observed at the highest level of soot blower.
- The thickness measurement was carried out at the eroded portion as shown in Table II -19.
- Min.thickness was 9.8mm, that was larger than the designed thickness 9.6 mm.

Erosion of Platen SH tube at the highest level of soot blower [extracted from Table II -18]

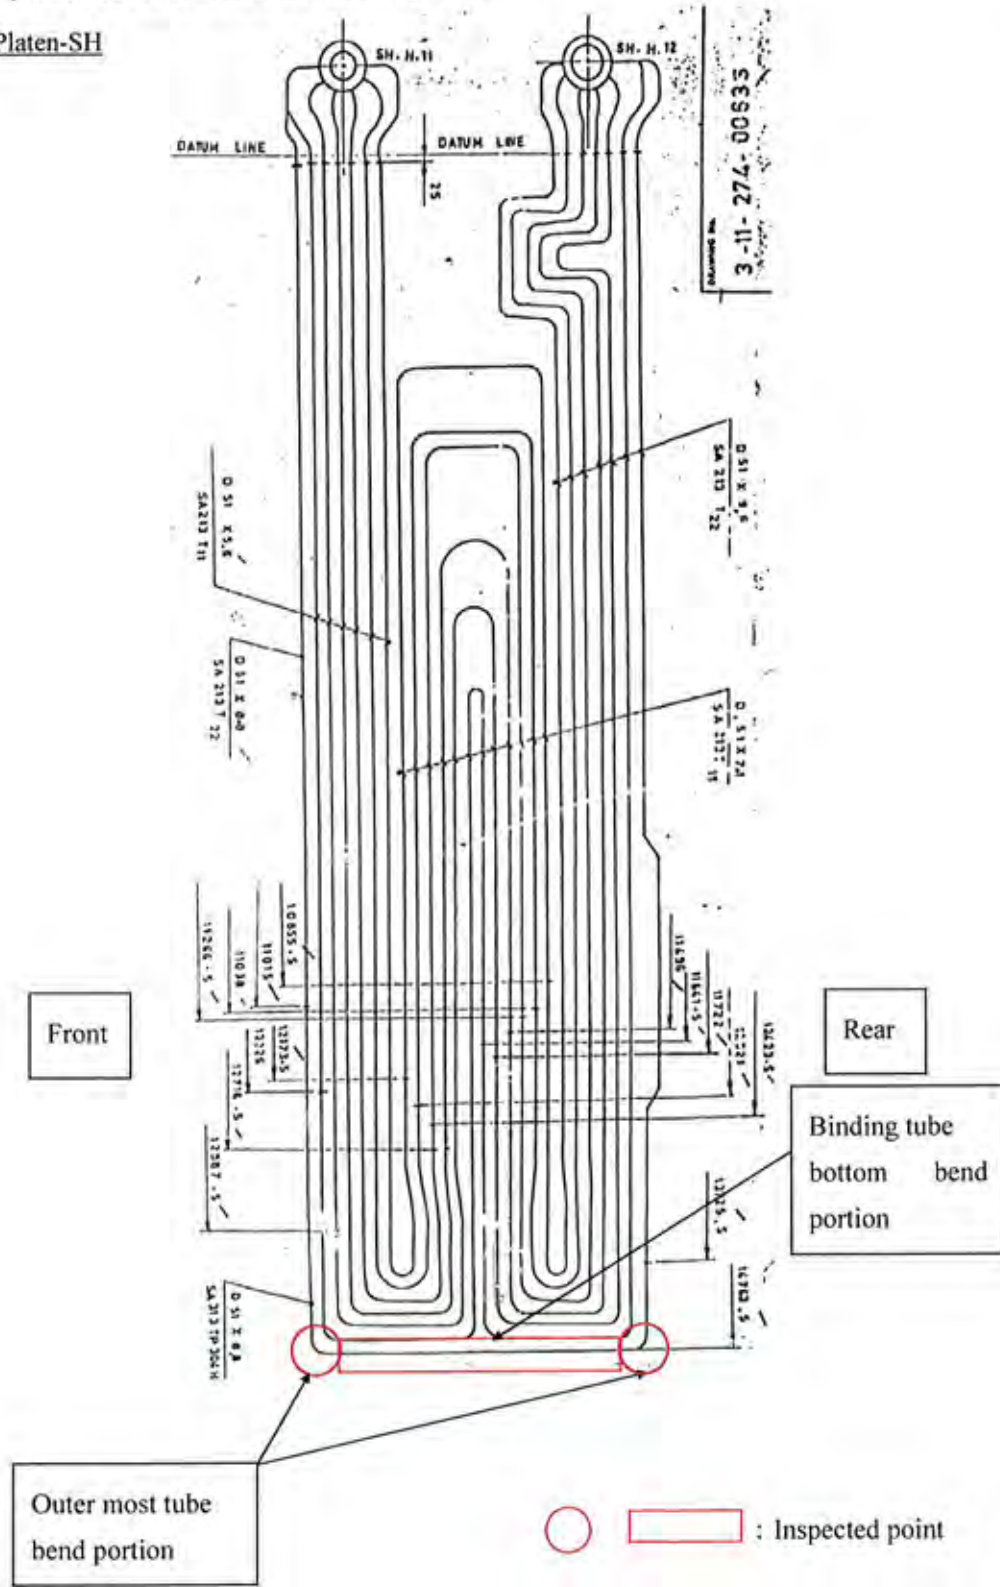
Fig. II -2 Inspection location

SUS scale deposition inspection was carried out at outer most tube bottom bend and horizontal portion of Platen-SH as shown in Fig. II -2.

SUS scale deposition was not significant with 15% fullness for 4 points, 10% fullness for 2 points and less than 10% fullness for the other portions.

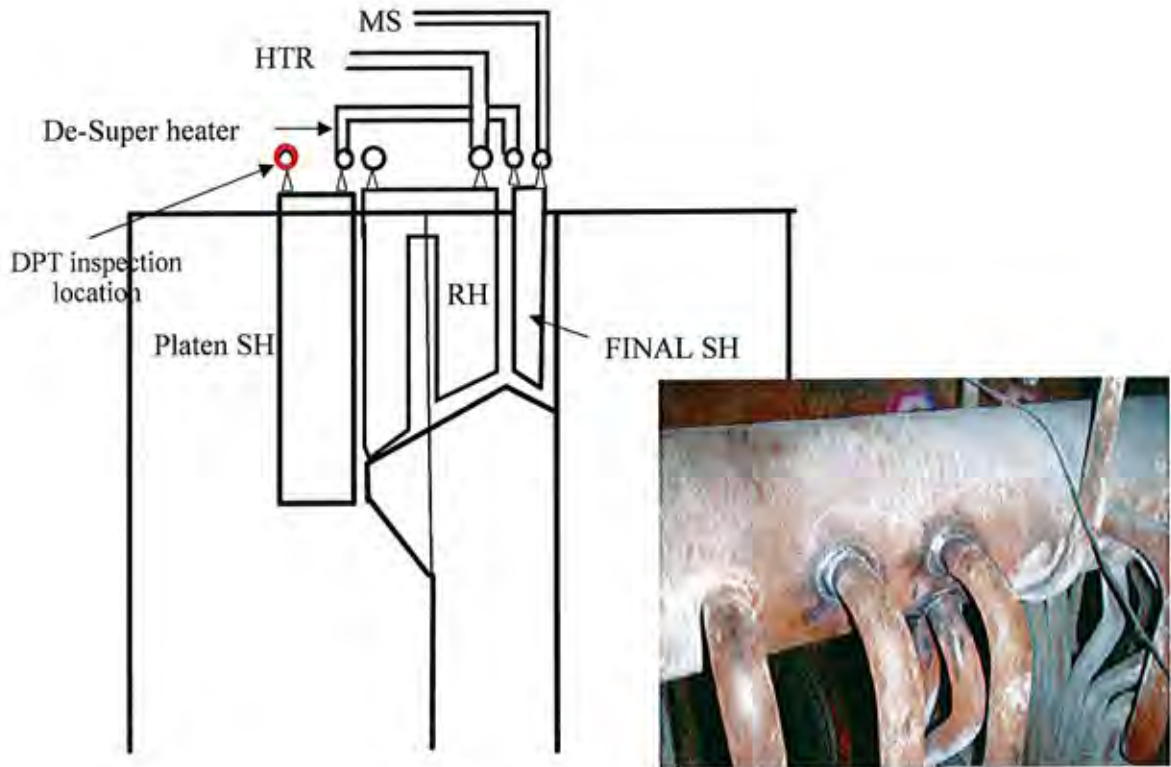
Fig. II -5 DPT inspection location

DPT inspection were carried out at 4 stub weld portions of #3 panel from right in Platen SH inlet header front side.

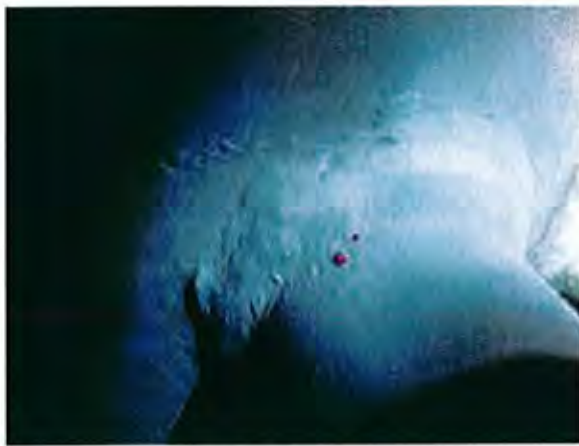
Before grinding off

Two for each of  $\phi 2\text{mm}$  and  $\phi 1\text{mm}$  circular indication pattern were detected at 4th tube from front, although no indication pattern was judged as crack. After grinding off these indications, a new  $\phi 2\text{mm}$  circular indication pattern appeared. The new indication has been left since it was not judged as crack.

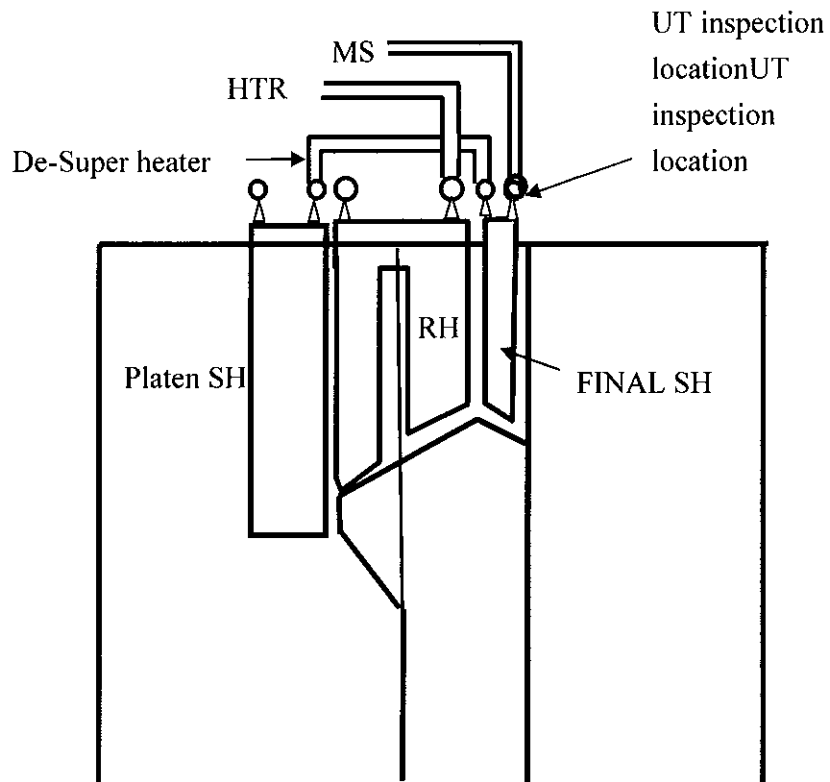
Fig. II -7 Inspected location of UT

UT inspection was carried out at circumferential weld of right side in Final-SH Outlet Header.

As a result of UT inspection, no flaw echo exceeding the criteria was detected.

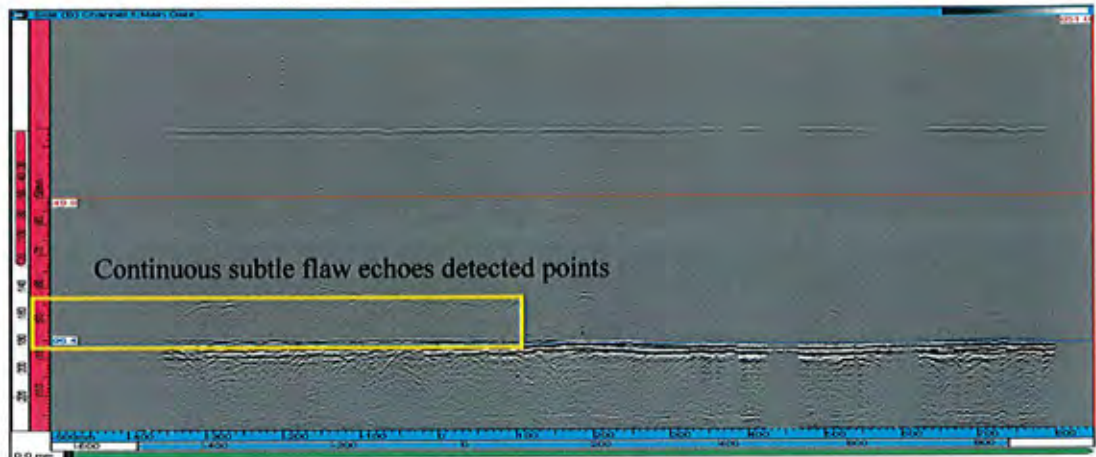
Fig. II-8 Set1 (Monitor range : 50mm~bottom)

No flaw echo judged as a crack was detected, although continuous subtle flaw echoes were detected at about 80mm in depth from surface.
