**THE STUDY
ON
ENHANCING EFFICIENCY
OF
OPERATING
THERMAL POWER PLANTS
IN
NTPC-INDIA**

Final Report

Volume IV

Volume- I-B
RLA of Turbine
(IP & LP)

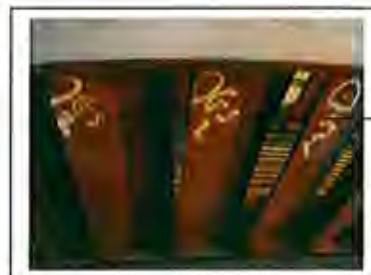
No significant deposits were observed. Integral seals are intact. Blade tips are Ok. No rubbing marks were observed on rotor surfaces. Visual Inspection of the IP casing and diaphragms revealed no significant abnormality. There is minor erosion on the stationary blades of stages. (Refer

Rubbing marks

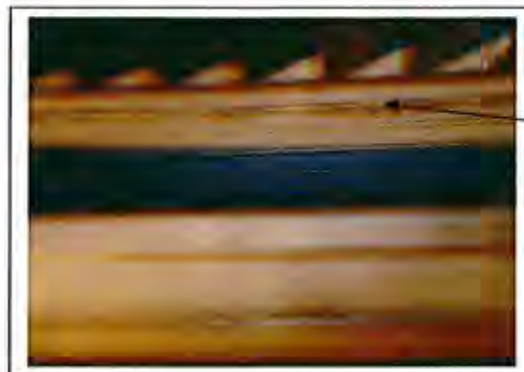
The view of erosion observed on blades.

Distorted
sealing fins

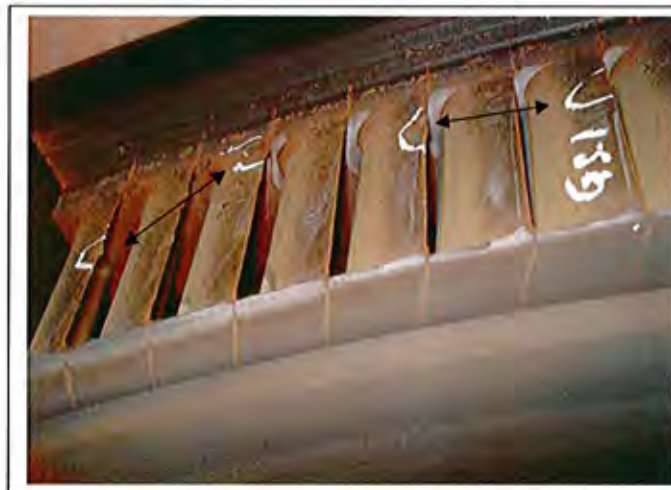
- Erosion on the steam exit side of the last stages i.e. TS-6 & GS-6 of blades.
- Minor erosion observed on blades of second last stages i.e. TS-5 & GS-5.
- Minor pitting is also observed on the blades of stages TS-3 & GS-3.
- Deposits were observed and collected for analysis
- No rubbing marks were observed on rotor surfaces.
- All balancing weights are in position.
- Integral seals are intact.

Arrow indicates the location of erosion marks observed on trailing edge.

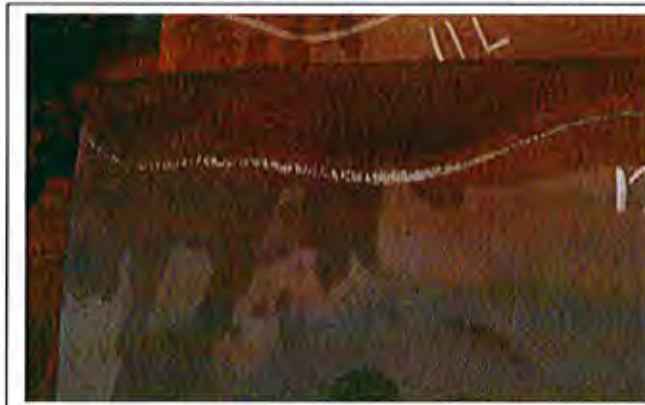
Erosion marks observed on trailing edge of blade.
 NDT (LPI, MPI , UT & ET) of the casing, casing internals (guide blade stages, front sealing housing, rear sealing housing, LP rotor and moving blades of all stages was carried out. No significant defect was observed.

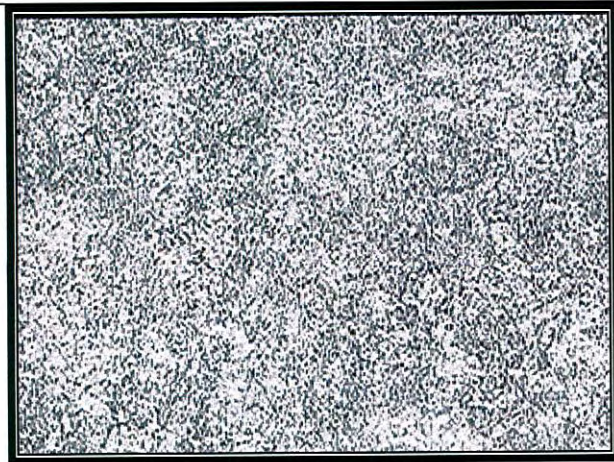
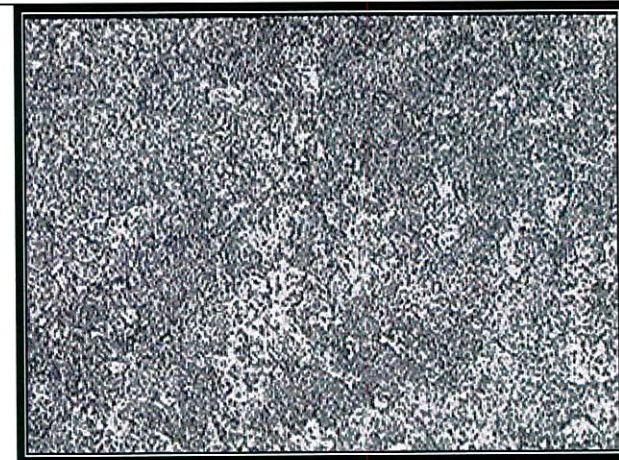
Name of Component: IP Rotor
Location: IP Rotor steam inlet_ Replica No. 25
 Hardness: 204-210HB

Observation: Microstructure shows fine tempered bainite with spheroidisation of the carbides.

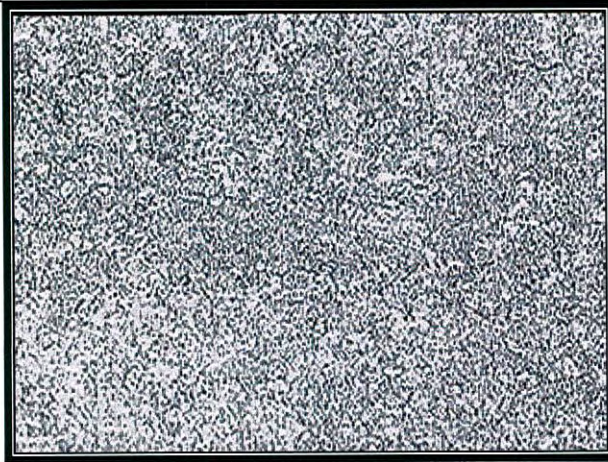
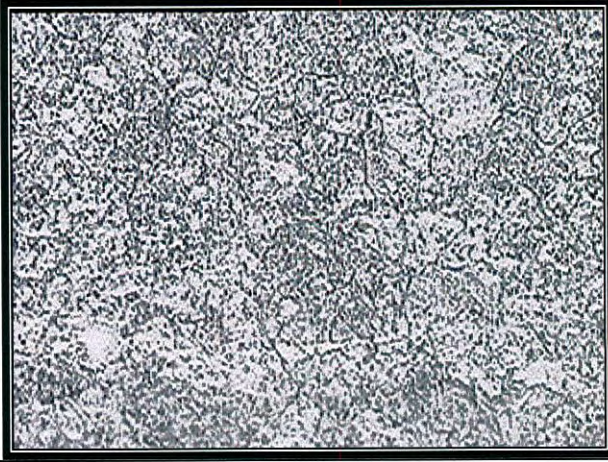
<p>Name of Component: IP Rotor Location: IP Rotor steam inlet at HP side_ Replica No. 26 Hardness: 211-212HB</p>

200X	400X	
<p>Observation: Microstructure shows fine tempered bainite with spherodisation of the carbides.</p>		Degradation level-IIL
<p>Fig: 2</p>

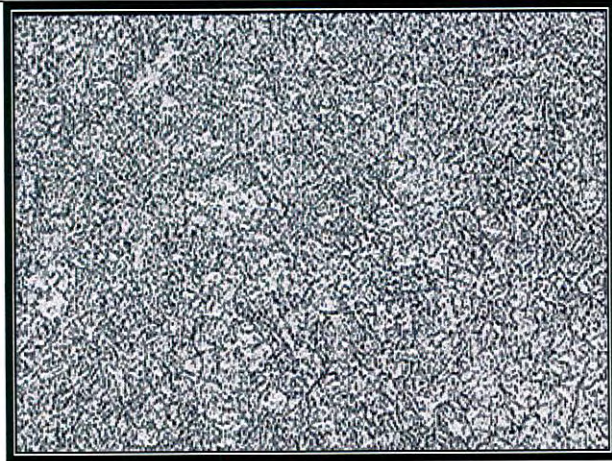
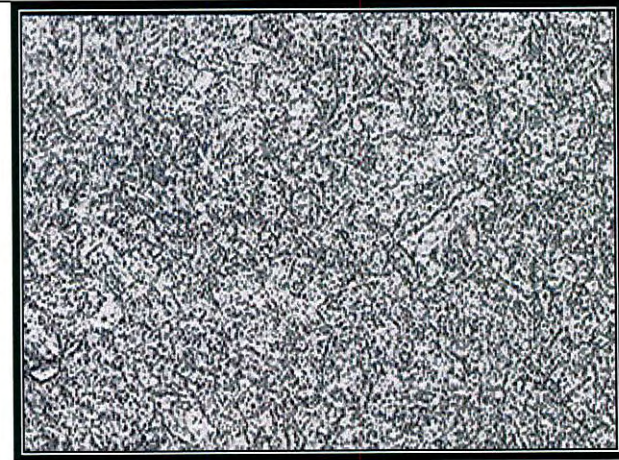
Name of Component: IP Rotor
Location: IP Rotor steam outlet at LP side_ Replica No. 27
 Hardness: 210-218HB

Observation: Microstructure shows fine tempered bainite with spheroidisation of the carbides.

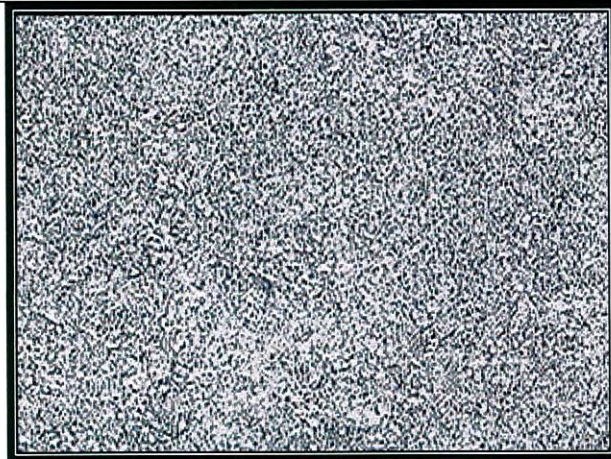
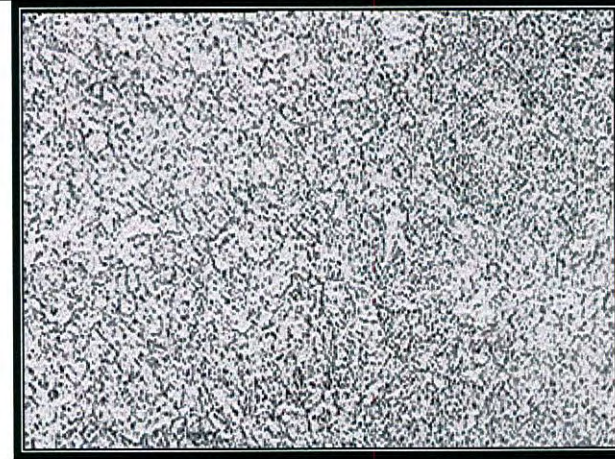
Name of Component: IP Rotor
Location: IP Rotor steam outlet _ Replica No. 28
 Hardness: 221-223HB

Observation: Microstructure shows fine tempered bainite with spheroidisation of the carbides. Degradation level-IIL

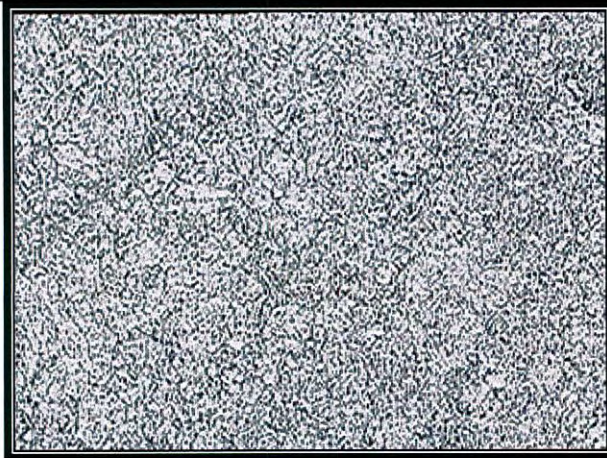
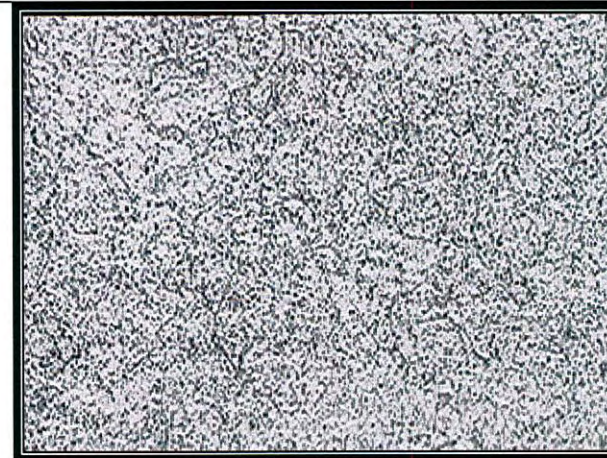
Name of Component: IP Rotor
Location: IP Rotor steam Inlet _ Replica No. 29
Hardness: 204-208HB

Observation: Microstructure shows fine tempered bainite with spheroidisation of the carbides.

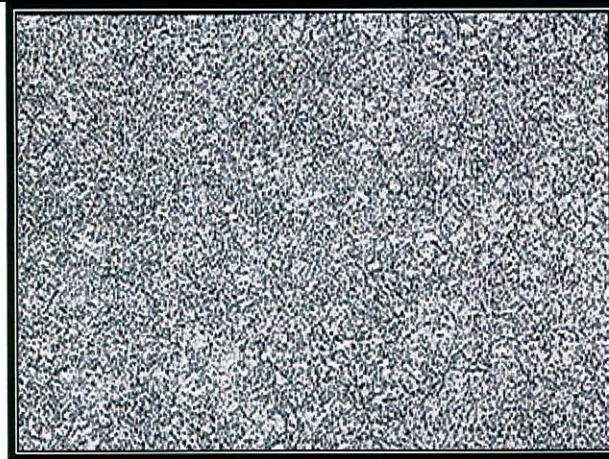
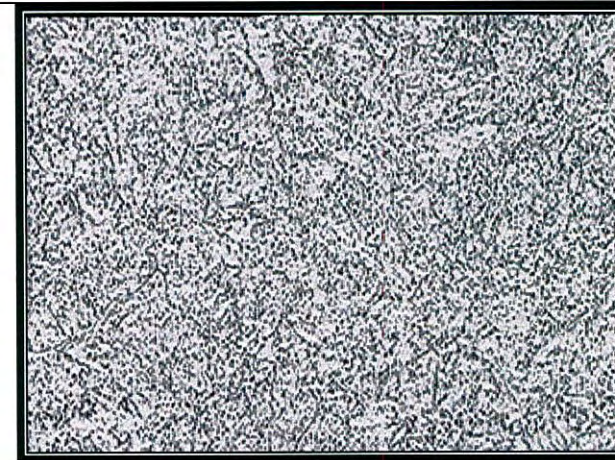
Name of Component: IP Rotor
Location: IP Rotor steam Inlet _ Replica No. 30
 Hardness: 205-208HB

Observation: Microstructure shows fine tempered bainite with spheroidisation of the carbides. Degradation level-IIL

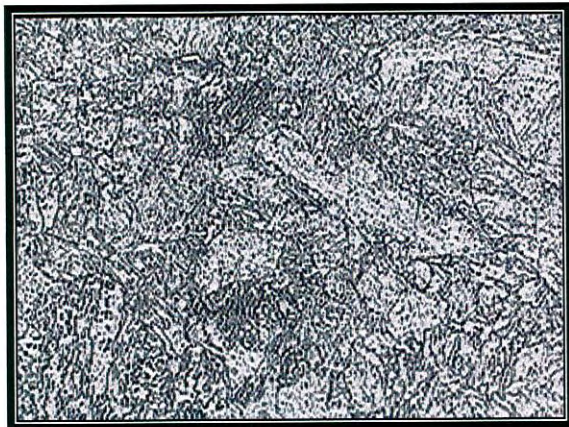
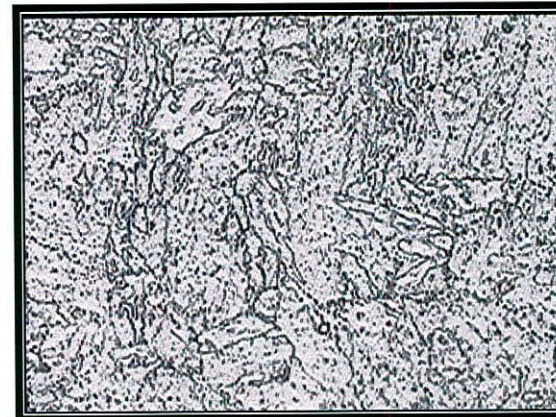
Name of Component: IP Top Casing
Location: IP Top Inner Casing steam inlet Nozzle chamber _ Replica No. 31
Hardness: 168-172HB

Observation: Microstructure shows tempered bainite with spheroidisation of the carbides.

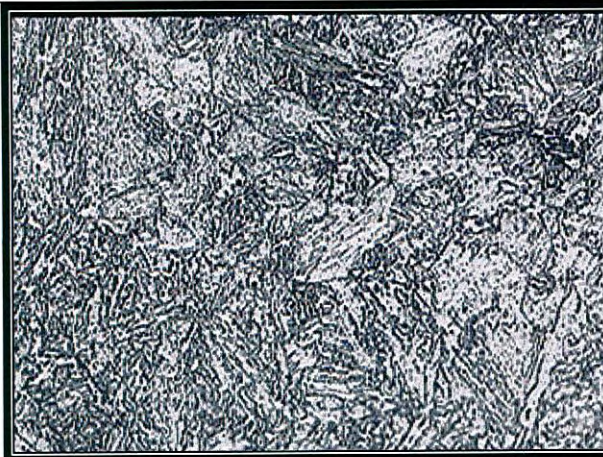
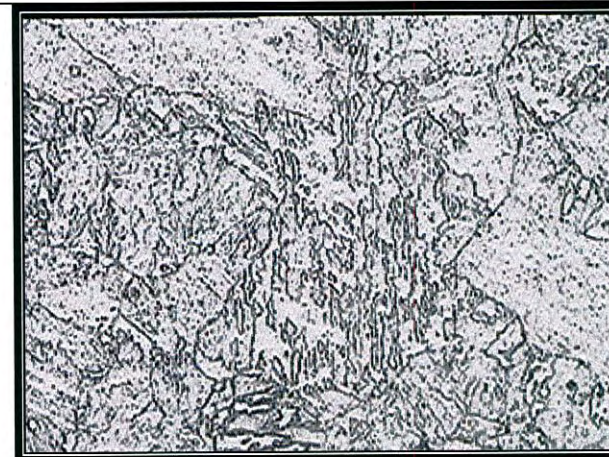
Name of Component: IP Top Casing
Location: IP Top outlet Casing steam _ Replica No. 32
 Hardness: 190-200HB.

Observation: Microstructure shows tempered bainite with spheroidisation of the carbides.

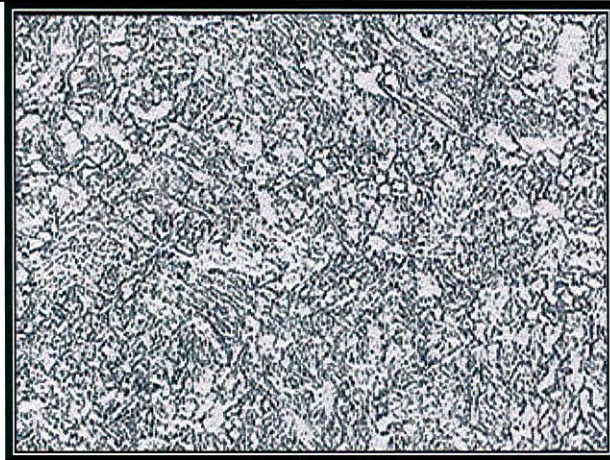
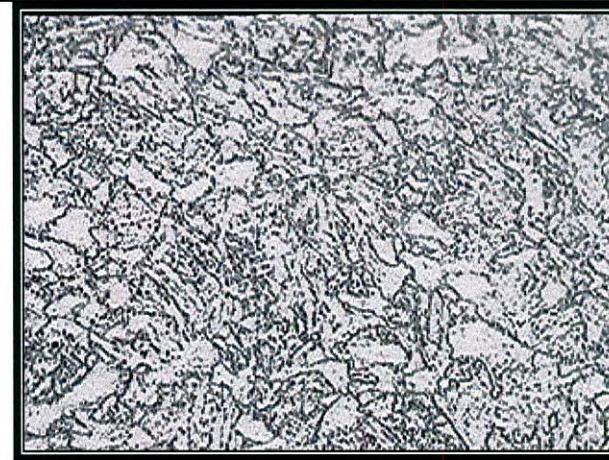
Name of Component: IP Bottom Casing
Location: IP Bottom outlet Casing steam inlet _ Replica No. 36
 Hardness: 168-171HB

Observation: Microstructure shows tempered bainite with spheroidisation of the carbides.

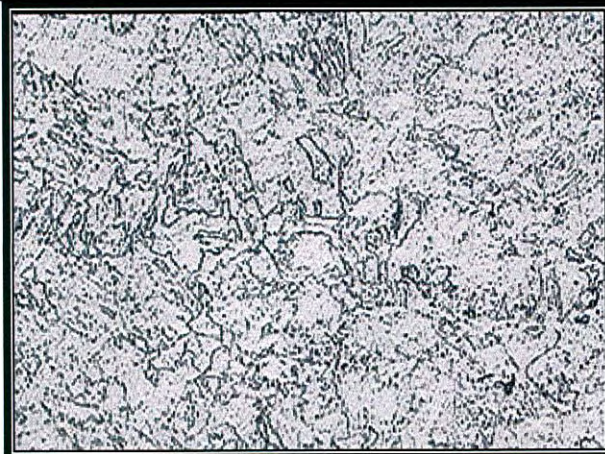
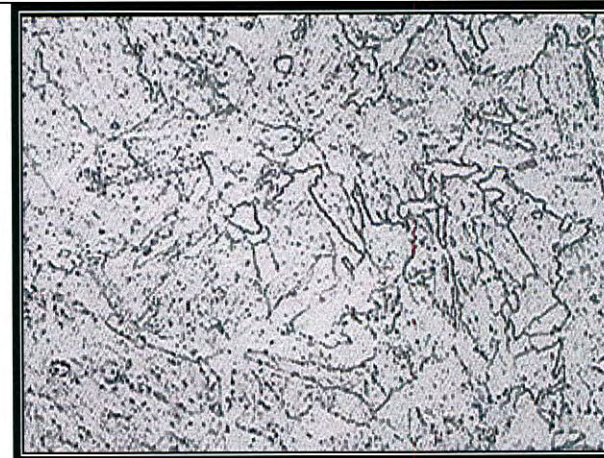
Name of Component: IP Bottom Casing
Location: IP Bottom outlet Casing steam Exit_ Replica No. 37
 Hardness: 141-143HB

Observation: Microstructure shows tempered bainite with spheroidisation of the carbides.

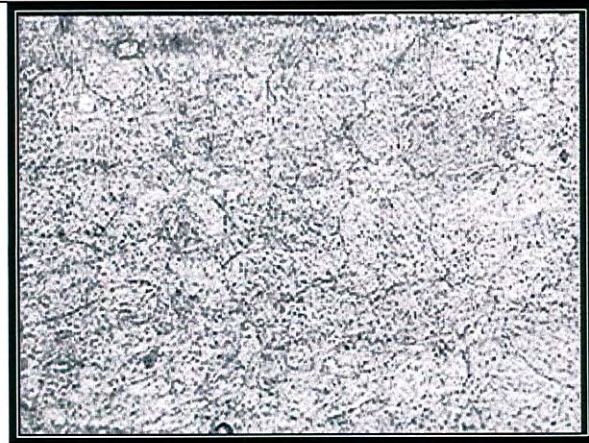
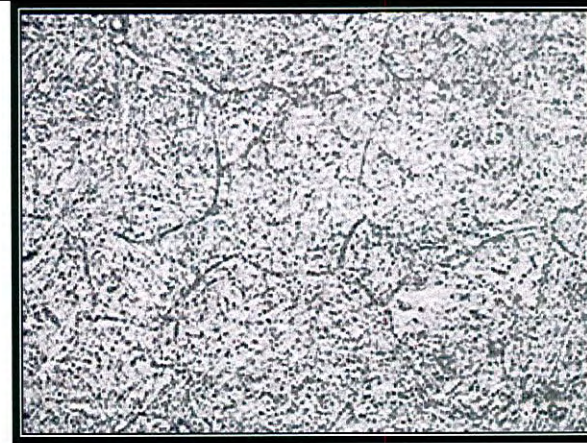
Name of Component: IP Bottom Casing
Location: IP Bottom inner Casing Blade stage-1 _ Replica No. 44
 Hardness: -141-143HB

Observation: Microstructure shows tempered martensite with spheroidisation of the carbides.

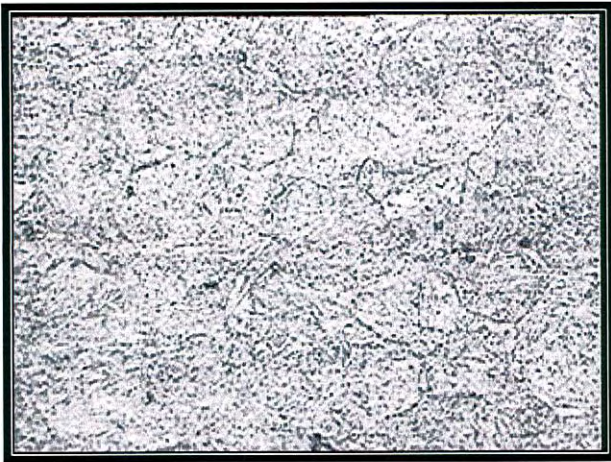
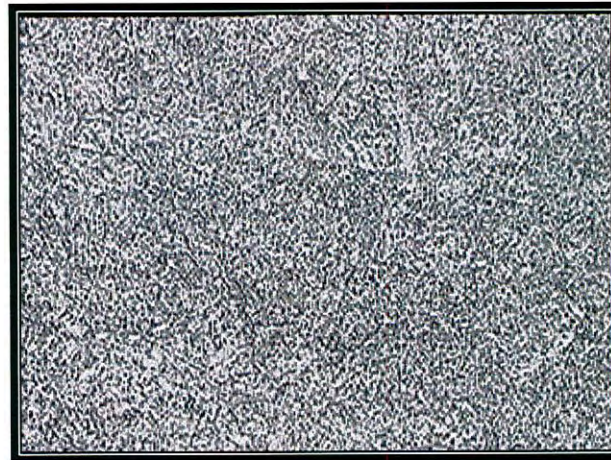
Name of Component: IP Bottom Casing
Location: IP Bottom inner Casing Blade stage-2 _ Replica No. 45
 Hardness: -142-144HB

Observation: Microstructure shows tempered martensite with spheroidisation of the carbides.

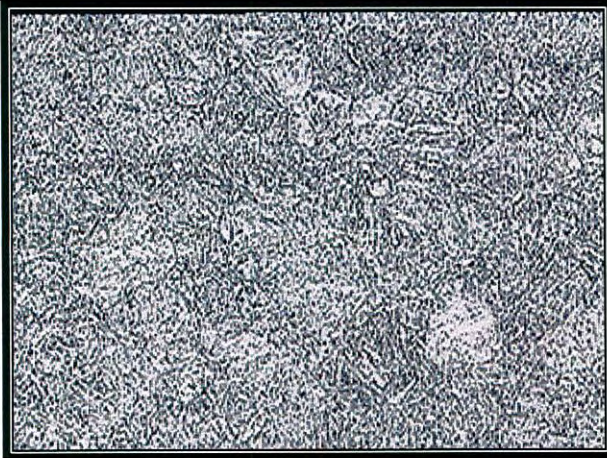
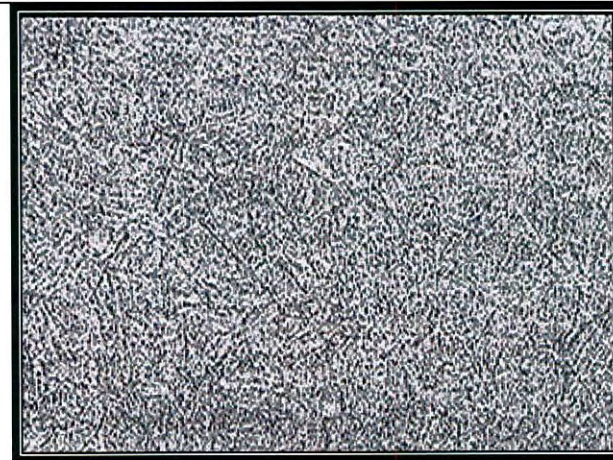
Observation: Microstructure shows tempered martensite with spheroidisation of the carbides.

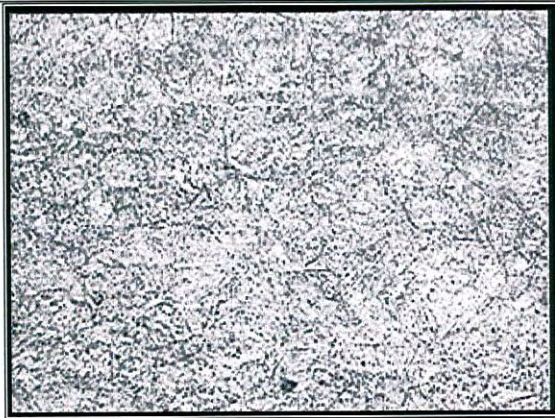
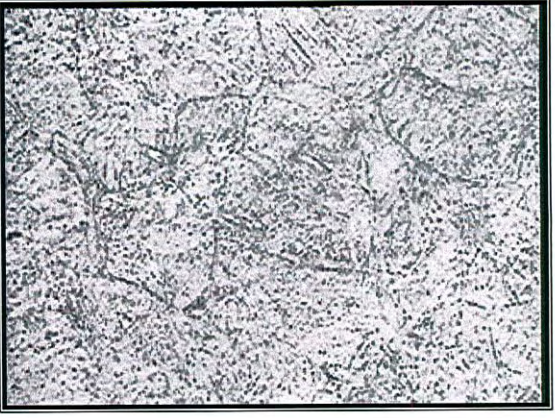
Name of Component: IP Bottom Casing
Location: IP Bottom inner Casing Blade stage-4 _ Replica No. 47
 Hardness: - 141-143HB

Observation: Microstructure shows tempered martensite with spheroidisation of the carbides.

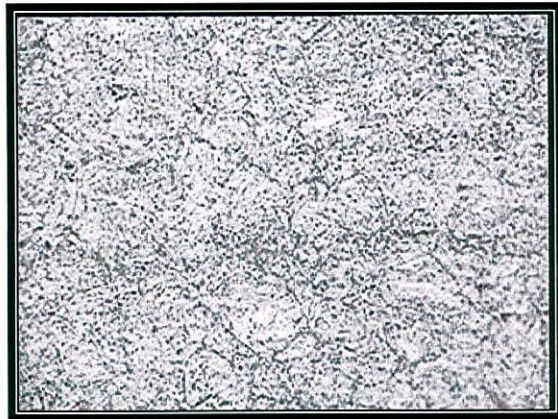
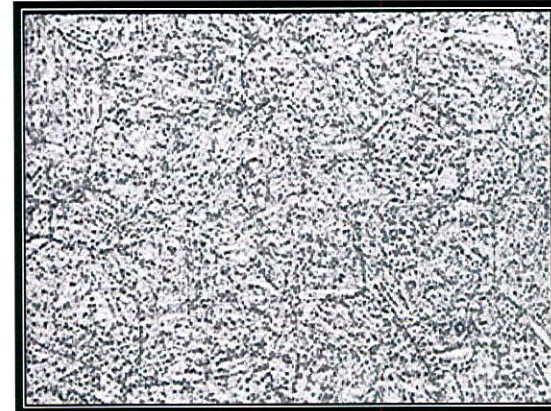
Observation: Microstructure shows tempered martensite with spheroidisation of the carbides.

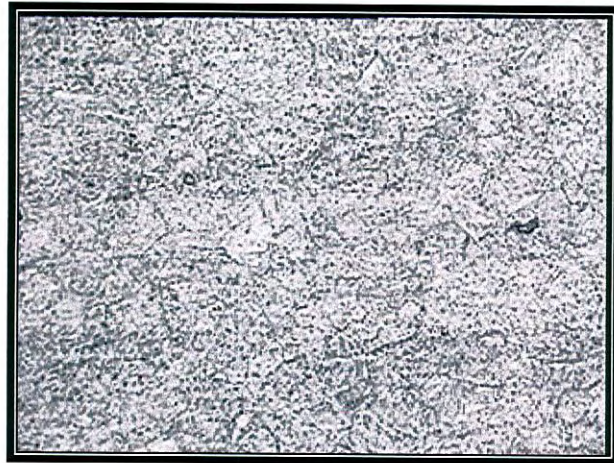
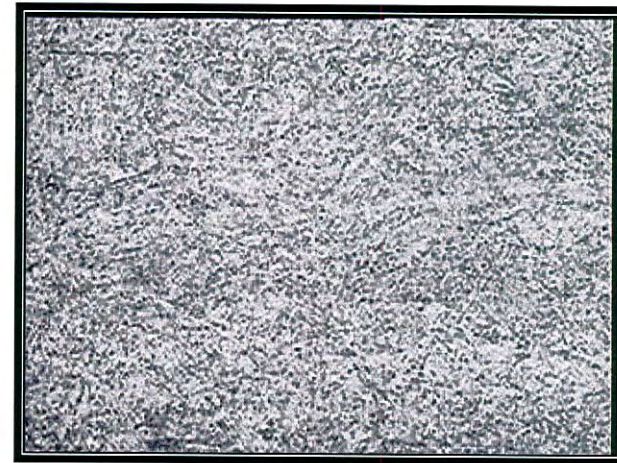
Name of Component: IP Bottom Casing
Location: IP Bottom inner Casing Blade stage-2 _ Replica No. 49
 Hardness: -144-146HB

Observation: Microstructure shows tempered martensite with spheroidisation of the carbides.

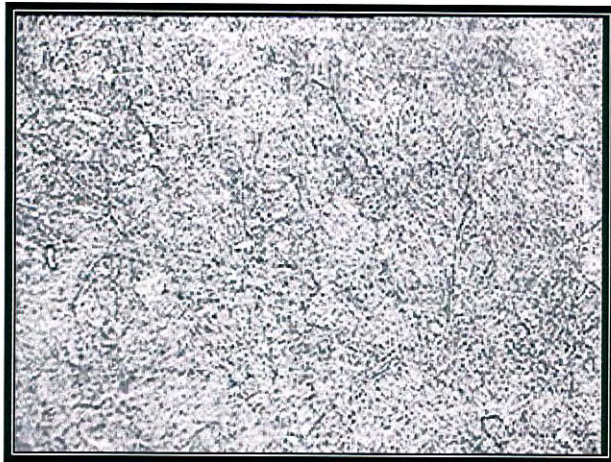
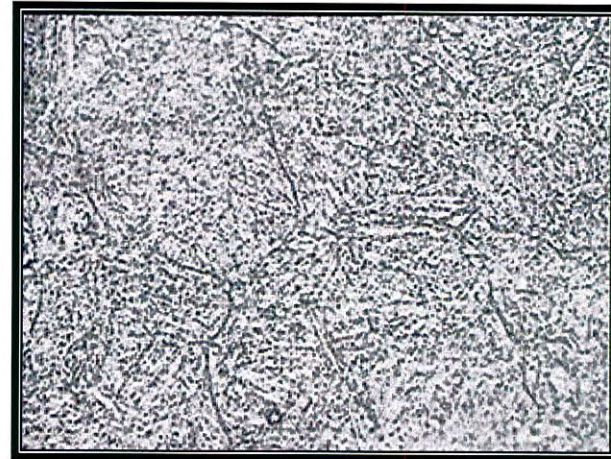
Name of Component: IP Bottom Casing
Location: IP Bottom inner Casing Blade stage-3 _ Replica No. 50
 Hardness: -141-143HB

Observation: Microstructure shows tempered martensite with spheroidisation of the carbides. Degradation Level- IIL

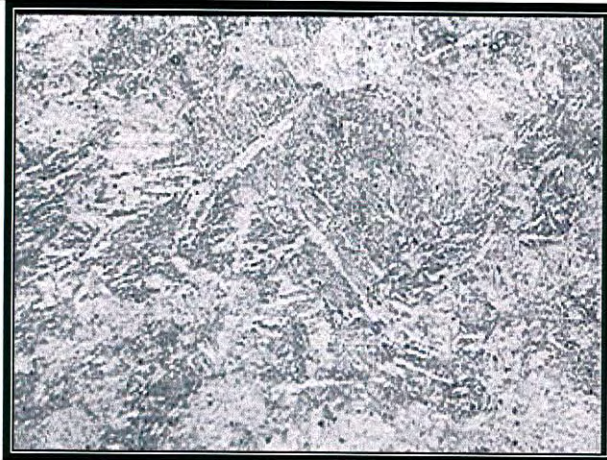
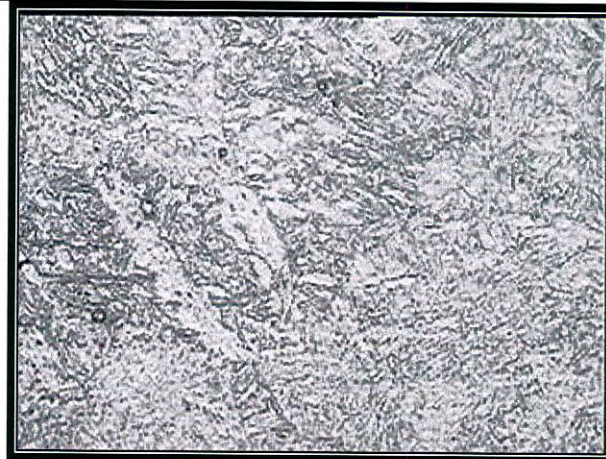
Name of Component: LP Rotor
Location: LP Rotor Steam Inlet _ Replica No. 14
 Hardness: 268-278HB

Observation: Microstructure shows tempered bainite.

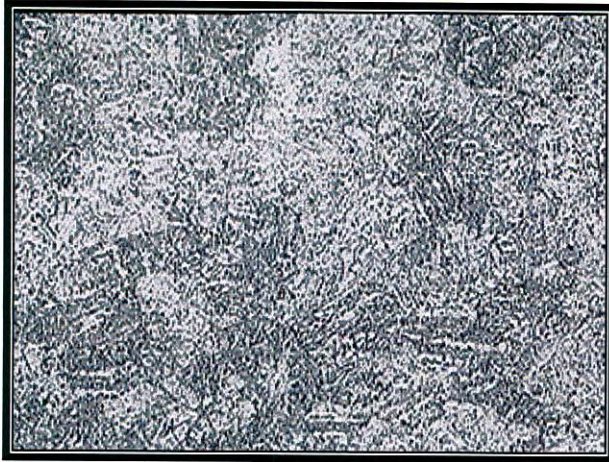
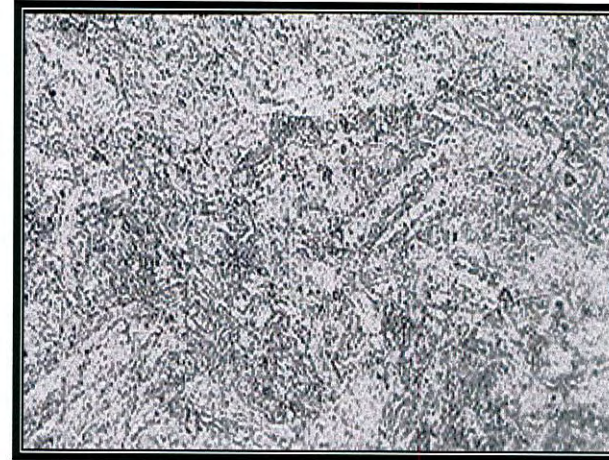
Name of Component: LP Rotor
Location: LP Rotor Steam Outlet _ Replica No. 15
 Hardness: 261-271HB

Observation: Microstructure shows tempered bainite.

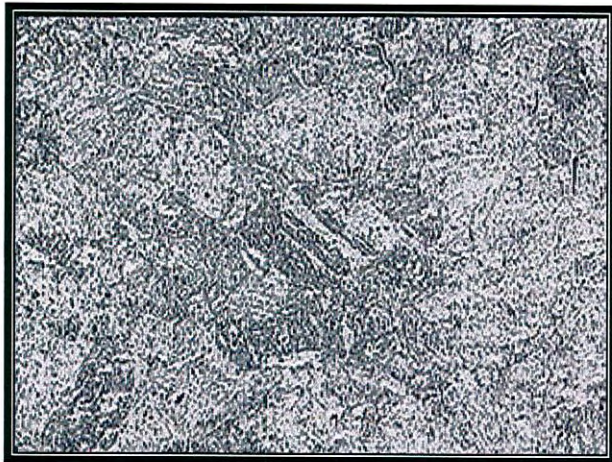
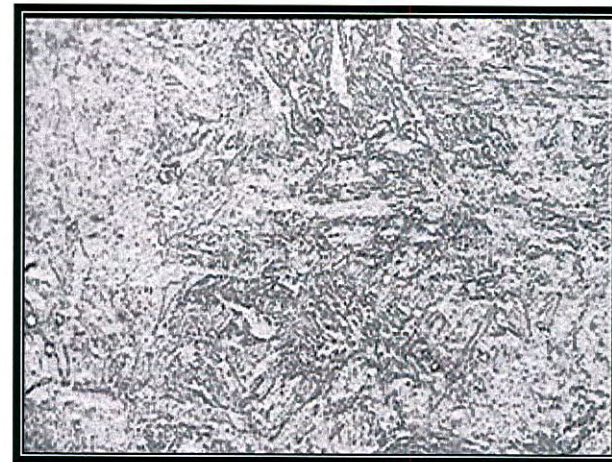
Name of Component: LP Rotor
Location: LP Rotor Blade No. 12 _ Replica No. 16
 Hardness: -

Observation: Microstructure shows tempered bainite.

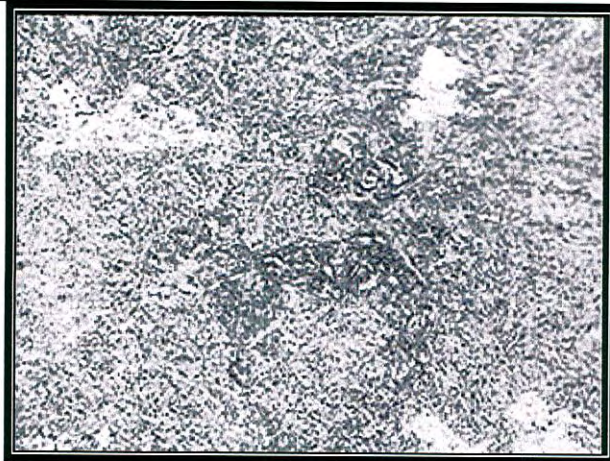
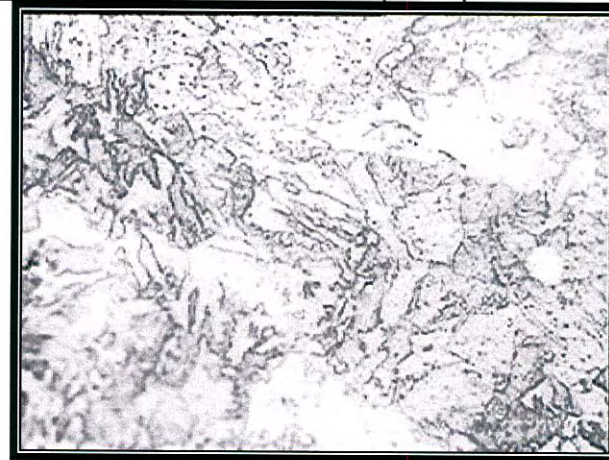
Name of Component: IP Integral pipe
Location: IP Integral pipe on weld joint _ Weld Metal _ Replica No. 33
 Hardness: 190-200HB

Observation: Microstructure shows tempered bainite with spheroidisation of the carbides. Degradation Level- IIL

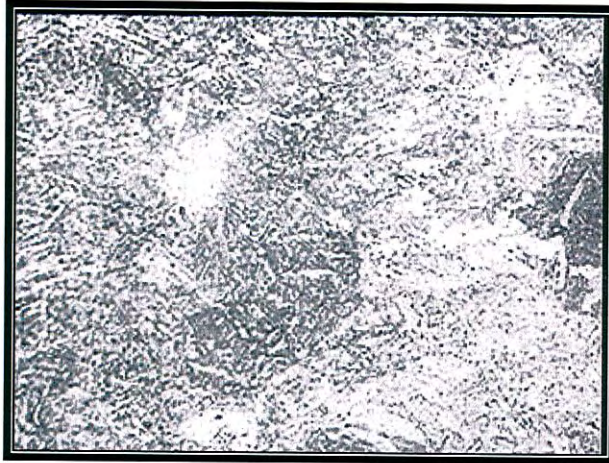
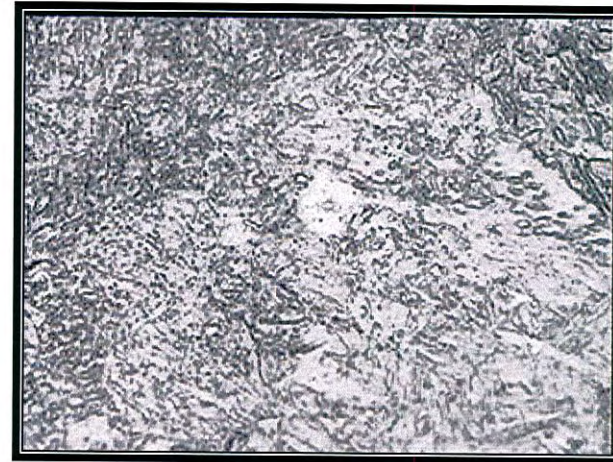
Name of Component: IP Integral pipe
Location: IP Integral pipe on weld joint _ Heat affected zone _ Replica No. 33
 Hardness: - 190-200HB

Observation: Microstructure shows tempered bainite with spheroidisation of the carbides.

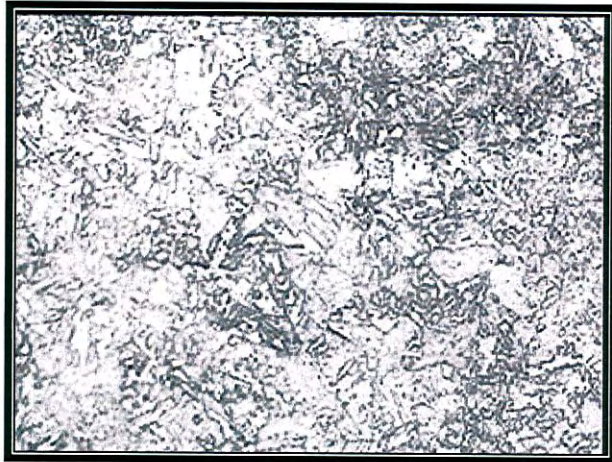
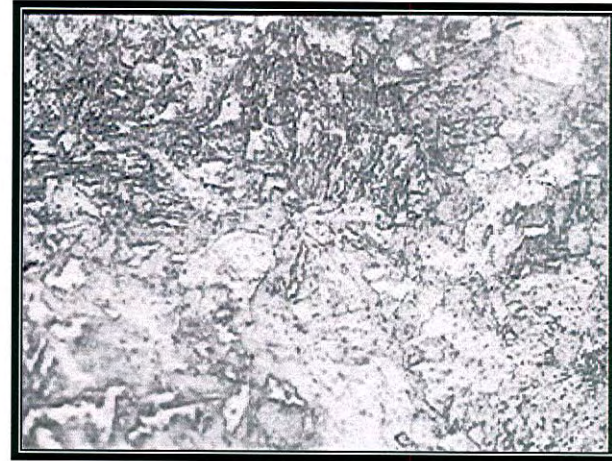
Name of Component: IP Integral pipe
Location: IP Integral pipe on weld joint _ Parent Metal _ Replica No. 33
 Hardness: 148-158HB

Observation: Microstructure shows tempered bainite with spheroidisation of the carbides.

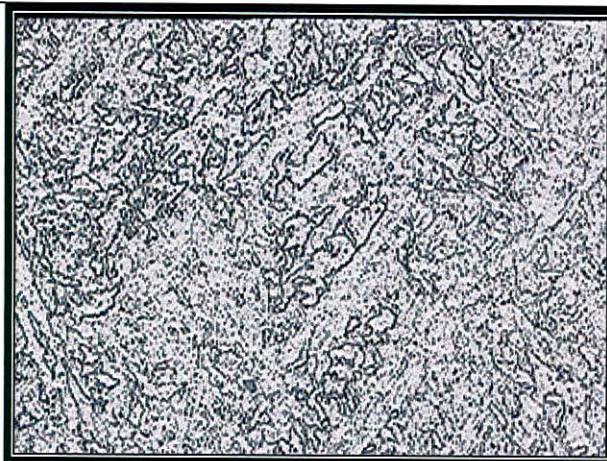
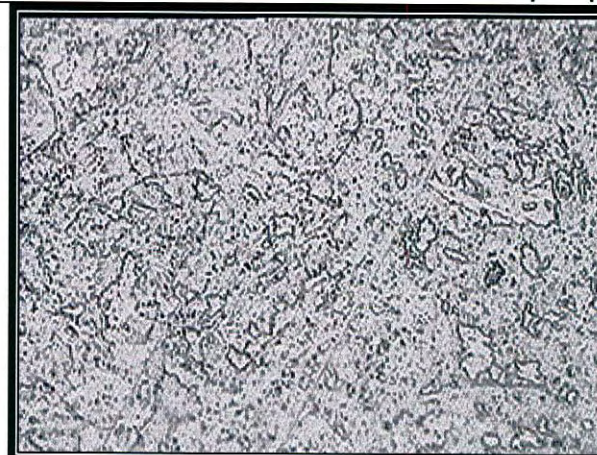
Name of Component: Main Steam line
Location: Main Steam line RHS _ Weld Metal _ Replica No. 21
 Hardness: 161-169HB

Observation: Microstructure shows tempered bainite with spheroidisation of the carbides.

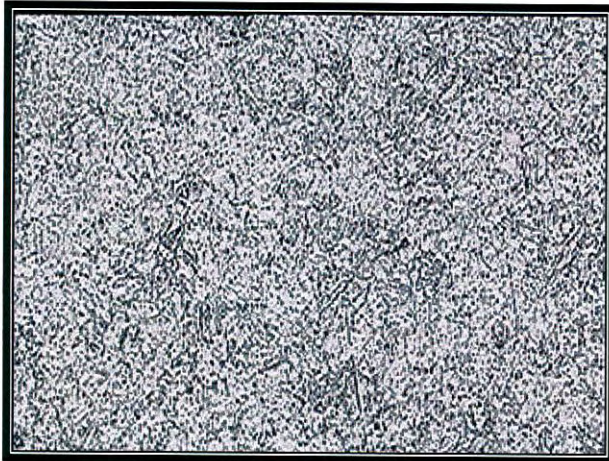
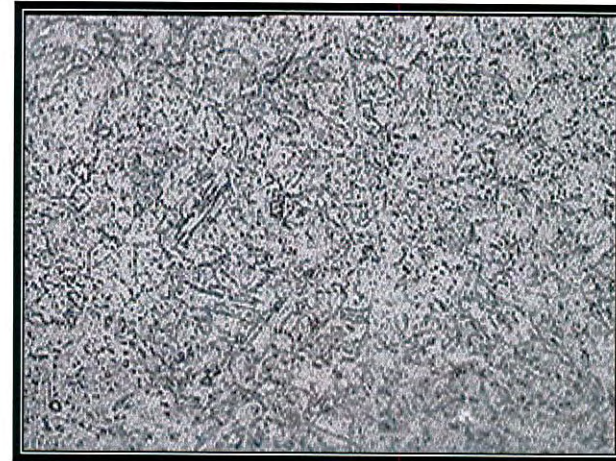
Name of Component: Main Steam line
Location: Main Steam line RHS _ Heat affected zone_ Replica No. 21
 Hardness: -164-172HB

Observation: Microstructure shows tempered bainite with spherodisation of the carbides. Degradation Level- IIL
