4.4 Water Quality and Bottom Sediments

Structures along the coast of the lagoon in Funafuti could have a great influence on transport of sand and gravel on the atoll side. A study will be conducted on the current conditions of those structures to examine their influence on coastal erosion and sedimentation. The figure below shows the locations of the major port facilities and coastal protection works constructed on Fongafale Islet and Tengako Islet, located to the north of Fongafale Islet.

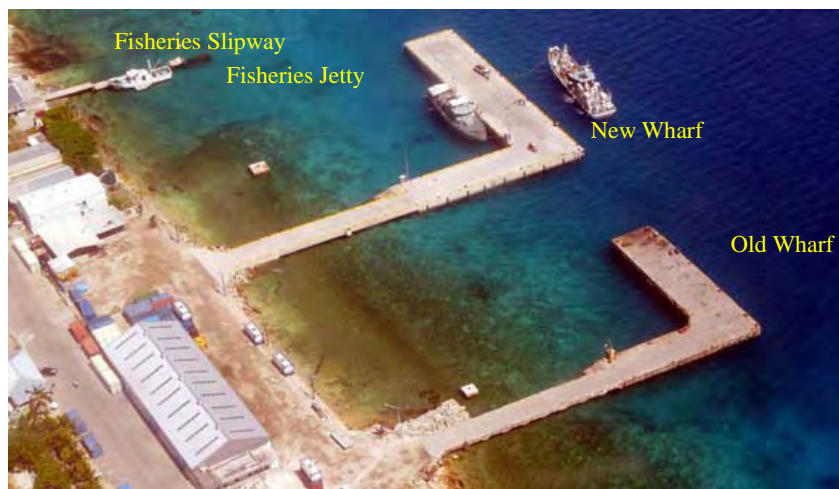
The far end of the jetty started collapsing in 2008 and the far half of the jetty collapsed completely when a storm hit the port in December 2009.

Photo 5.1 Port Facilities in Funafuti Port

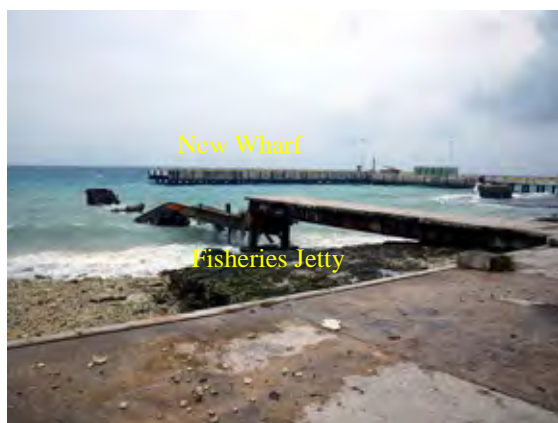
Part of its far end collapsed in the spring of 2008 and the central part collapsed in December 2009.

Photo 5.2 Collapsed Fisheries Jetty

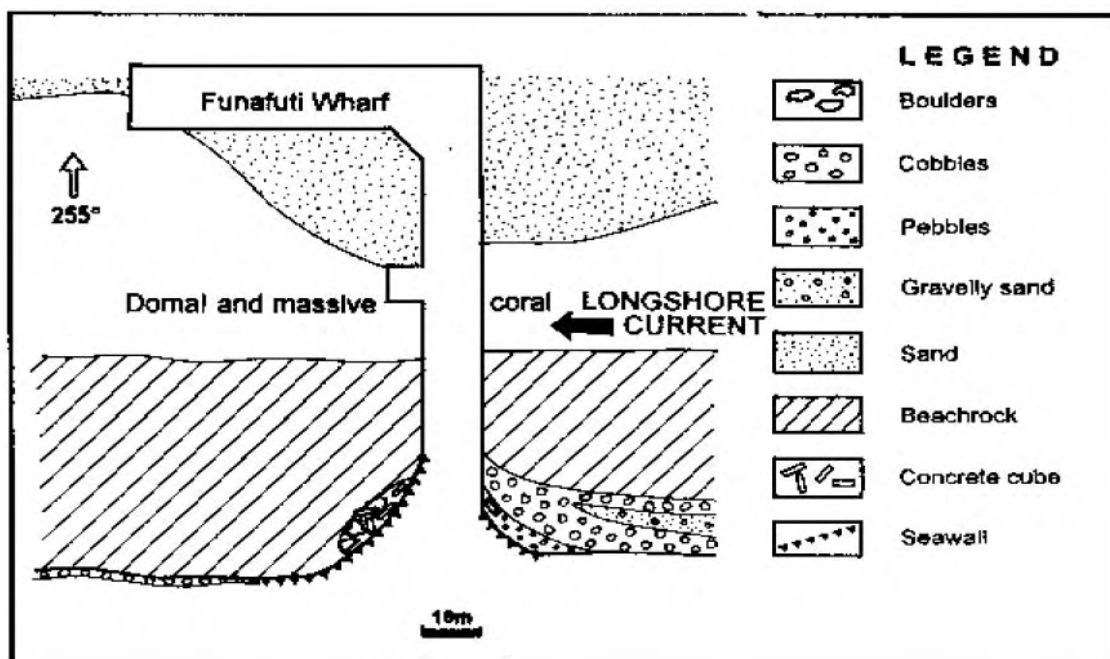
The figure below shows the results of the coastal bottom sediment survey of the area around the Old Wharf of Funafuti Port carried out by SOPAC in 1995. Concrete cubes with sides of 30cm were placed as rubble-mound seawall on the southeastern side of the base of the Old Wharf as a measure against erosion. Meanwhile, sedimentation of gravel is found on the northwestern side. The concrete blocks were relocated and the deposited gravel was used to transform the rubble-mound seawall into a temporary yard on the northeastern side of the Old Wharf from 2008 to 2009 for the construction of the New Wharf. Implementation of these measures resulted in a slight change in sedimentation. Nonetheless, little change was observed in sedimentation patterns between before the construction of the New Wharf and at the time of the survey in 1995. The asymmetry in shoreline between the northern and southern sides of the impermeable jetty at the base of the wharf indicates prevalence of southerly littoral drift at this point.

Figure 5.3 Sedimentation and Erosion around the Old Wharf of Funafuti Port

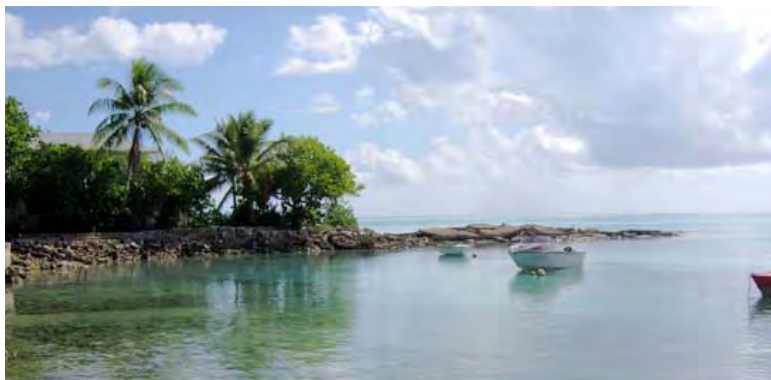
This is a jetty-type ramp to haul seaplanes constructed hastily by the American troops in 1943 during the Pacific War. Several attacks by cyclones caused cracks on its concrete floor. Earth packed inside the ramp has flowed through the cracks and the jetty has been completely

collapsed. Pieces of concrete and stone materials are scattered around the ramp. The total length of the ramp (from the shoreline); *ca.* 130m, width; 20m, and water depth at the far end; D.L. -5m (estimates), when it was constructed.

Photo 5.5 Catalina Ramp

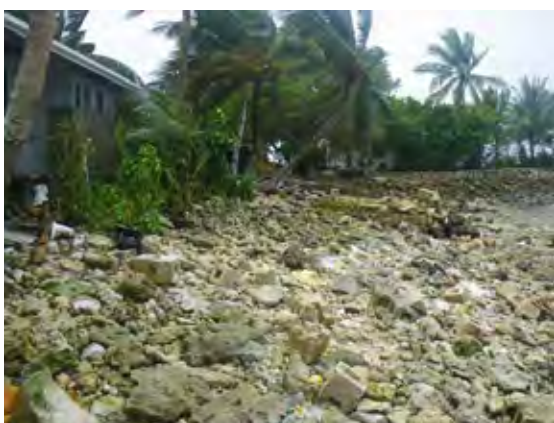
Seawalls were constructed with concrete cubes with sides of 30 cm on the shorelines both to the north and to the south of Catalina Ramp around 1990. As seen in the figure below, the seawalls have collapsed gradually since then and, at present, most part of the shore is in such desperate condition with scattered concrete blocks and gravel that it is difficult to walk along the shore and, thus, people’s access to the shorelines is very poor.

Slight erosion and slight sedimentation of sand gravel are observed on the northern and southern sides of Catalina Ramp, respectively.

Photo 5.8 Seawall on the Northern Side of Catalina Ramp

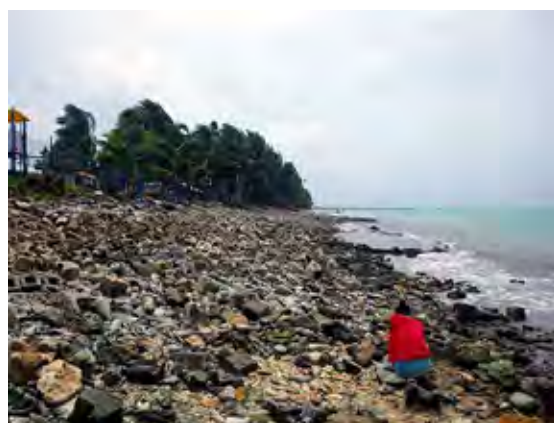
Photo 5.9 Seawall on the Southern Side of Catalina Ramp

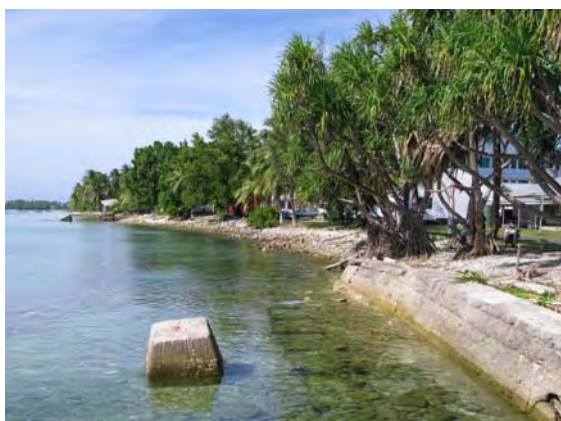
On the northern side of the Vaiaku Wharf (photograph below left), no gravel beach exists in front of the seawall and the shoreline in front of the Government Building is curved because of erosion. On the other hand, a gravel beach in a triangular shape toward the base of the wharf has been formed on the southern side. Such asymmetry of shoreline confirms the prevalence of northerly littoral drift at this point.

Photo 5.16 The Northern Side of Vaiaku Wharf

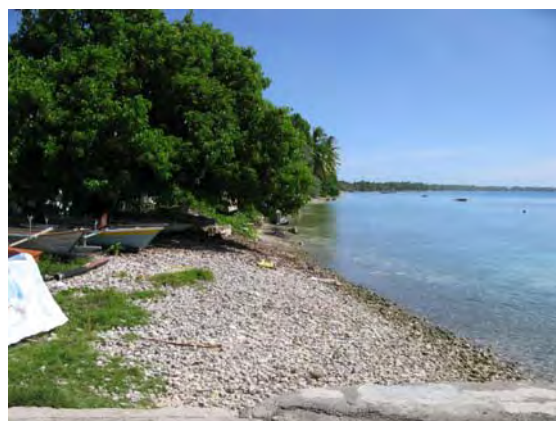
Photo 5.17 The Southern Side of Vaiaku Wharf

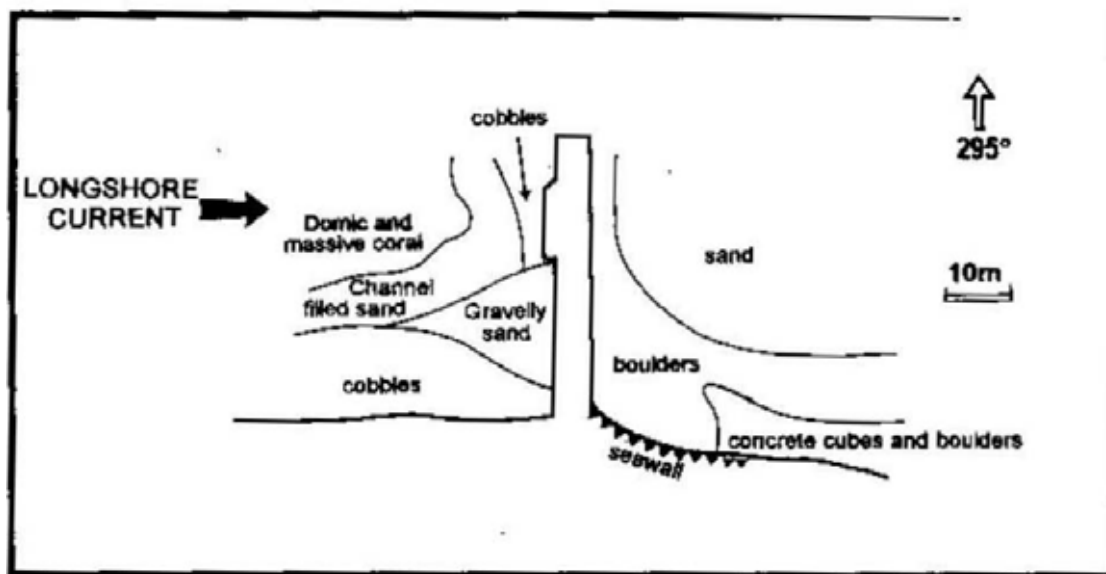
The figure below shows the results of the coastal bottom sediment survey of the area around Vaiaku Wharf implemented by SOPAC in 1995. Comparison between the results of the survey in 1995 and the current conditions revealed no significant change in sedimentation patterns. The sediments composing the shoreline area, as well as the asymmetry of the shoreline mentioned above, confirm the prevalence of the northerly littoral drift at this point.

Figure 5.4 Sedimentation and Erosion around Vaiaku Wharf

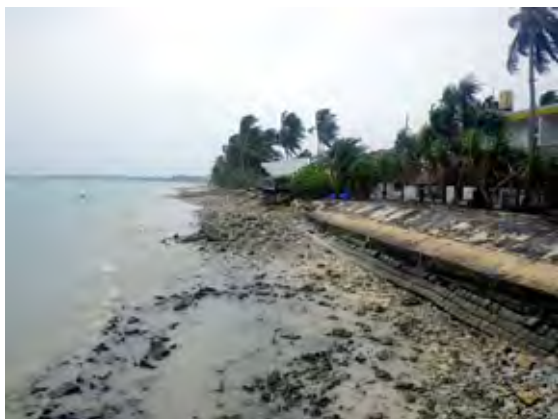
Although the small jetty in front of the Hotel is not a completely impermeable jetty, there is no gravel beach in front of the seawall of the hotel on the northern side, while a gravel beach in a triangular shape toward the base of the jetty has been formed on the southern side, as seen at the above-mentioned Vaiaku Wharf.

Photo 5.18 The Northern Side of Small Hotel Jetty

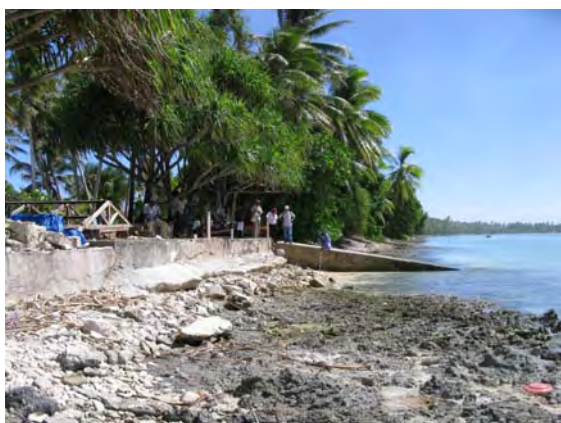
This is the same characteristic observed at the impermeable jetties in the southern part of the islet mentioned above.

In other words, prevalence of northerly littoral drift in this area has been confirmed.

Photo 5.20 The Northern Side of a Small Boat Ramp

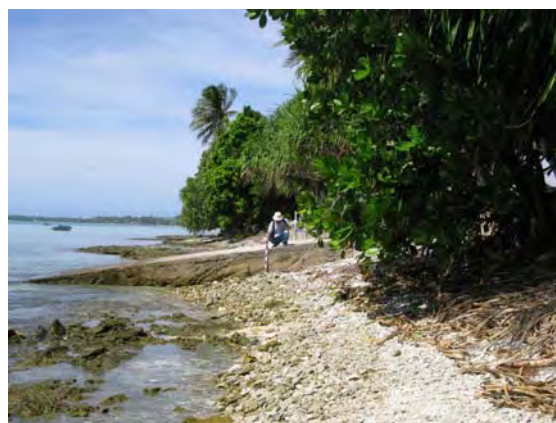
Photo 5.21 The Southern Side of the Same Boat Ramp

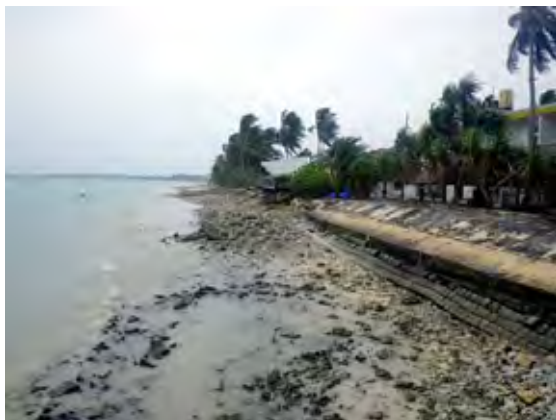
The seawalls at the side of Vaiaku Wharf and in front of the former government building and the government-owned hotel have a structure similar to a vertical concrete seawall. At many places, this structure causes scour by creating reflected waves and downward flow of water when wave run-ups fall in front of the seawall, instead of having a wave absorption effect, and, thus, makes sedimentation of gravel and sand on the foreshore difficult. Many places were observed where the seawalls were the very cause of the erosion in the surrounding area.

Photo 5.24 A Seawall Implemented as a Public Work - the Mixed Vertical/Sloping Seawall in front of Vaiaku Lagi Hotel

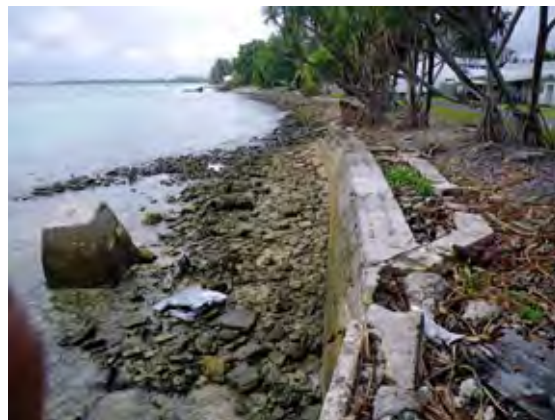
Photo 5.25 A seawall Implemented as a Public Work – a Vertical Seawall on the Northern Side of Vaiaku Wharf
(Remnant of part of a gabion seawall is seen.)

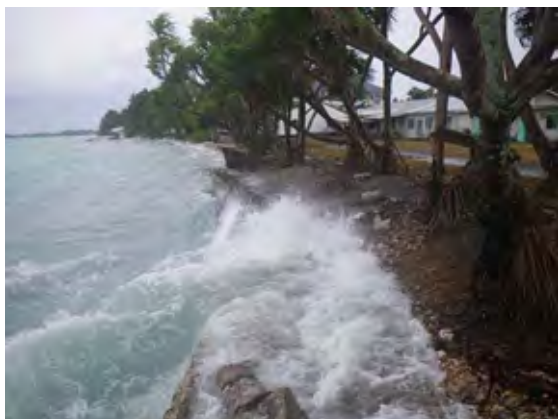
Most of these seawalls constructed as public works are vertical seawalls which do not have a wave absorption effect. Therefore, when a high wave hits a seawall, a large amount of sea spray is produced. Such spray washes ashore gravel and rubbish and is the main cause of salt damage to structures. Photos 5.26 and 5.27 were taken at the same locations as the photographs in the figure above at the end of January 2010 when a low pressure system went through the area at the time of a spring tide.

Photo 5.26 Wave Run-ups in front of a Vertical Seawall - the Mixed Vertical/Sloping Seawall in front of Vaiaku Lagi Hotel

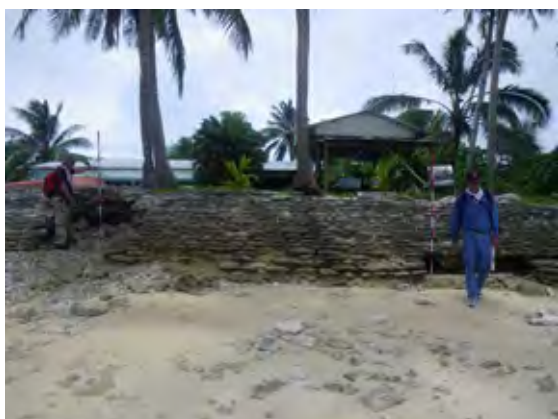
Photo 5.28 A Privately-Implemented Seawall – a Wet Masonry Seawall to the North of Vaiaku Lagi Hotel (partially collapsed)

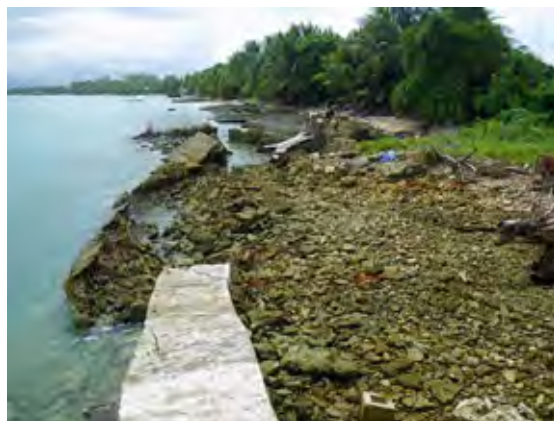
Almost all of the privately constructed seawalls are causing erosion and sedimentation in the surrounding shoreline areas by blocking littoral drift because they were constructed on the seaward side of the shorelines. In addition, most of them are structurally inappropriate: some have structurally insufficient wave tolerance. Others have cross-sections similar to a vertical seawall, which are likely to cause scour at their base, to create a large amount of sea spray when waves hit them, and/or to cause disturbance of waves by generating reflected waves. Yet others facilitate erosion of the surrounding shorelines. For these reasons, many of them have collapsed even before their construction has been completed. The condition in which people are taking their own initiatives to construct seawall structures with their haphazard reclamation/seawall plans will be a problem in formulating a coastal protection program in future.

Photo 5.31 A Privately-Implemented Seawall – Collapsed because of Inappropriate Structure

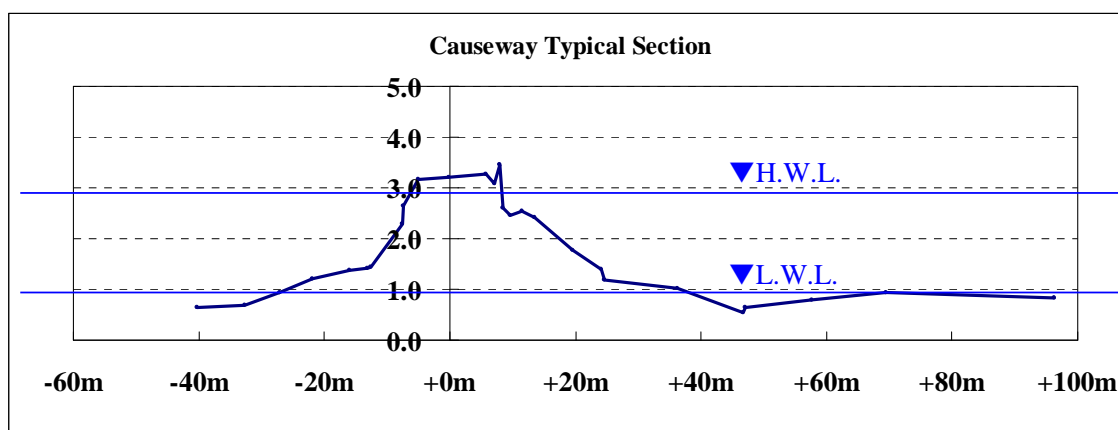
Figure 5.6 Causeway Typical Section

There is a significant possibility the construction of the causeway has contributed to further erosion along the lagoon coast on Fongafale Islet by reducing the source of materials for the lagoon side longshore drift as a result of the inflow of foraminifera, sand, and gravel from the ocean being cut-off or reduced.

Removing the causeway and returning it to its original condition can be expected to be effective in increasing the amount of foraminifera, sand and gravel flowing into the lagoon, and the amount of sand deposited on the lagoon side coastline. However, in order to predict how effective this will be, it is necessary to consider a variety of factors starting with wave measurements, also how much foraminifera (sand) will flow into the lagoon from the ocean, and whether there is sufficient external force to transport the sand as longshore drift in the lagoon. It is desirable to excavate a waterway of sufficient width and depth in order to secure ample flow through the causeway into the lagoon, however, this will also mean a great deal of wave energy will be enter from the ocean, namely, this is expected to change the wave and flow dynamics within the lagoon and lead to new coastal geomorphological activity on both ends of the causeway opening. Moreover, this will also lead to not only foraminifera and sand derived from it being washed in, but also coral gravel, which may reduce the effectiveness of this measure by chocking up the waterway with gravel. Therefore, it is important to consider issues surrounding the maintenance of this waterway.
