3.3.4 Results of bridge inspection

The results of visual inspection are shown here for each bridge. This section primarily describes major damages. For details, refer to the inspection recording forms, separately prepared for each span of bridges, in Appendix-4 Results of Bridge Inspection (visual inspection).

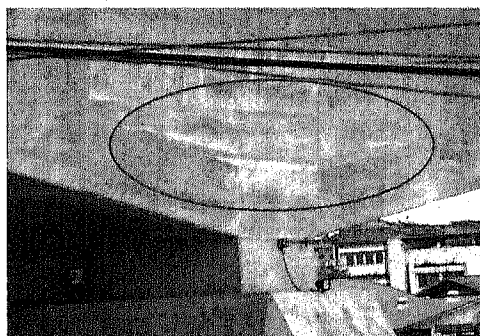
Major damages include cracks on a side surface of the main girder near supporting point and free lime observed on the bottom surface of main box girder. (Fig3.3.2, Fig3.3.3)

Cracks on the side surface of main girder near supporting points are confirmed not only in the Rama 4 but also at multiple places of other PC box girder bridges having the same structure. In addition, although a comparatively small number of damages were detected in the main structure, many damages were found in attached facilities, e.g., inclination of poles for lighting facilities, lack of bolts in poles for hoisting national flags (probably, bolts were not installed from the beginning of construction).

Figure 3.3.2: Cracks in Rama 4
(Web of main girder)

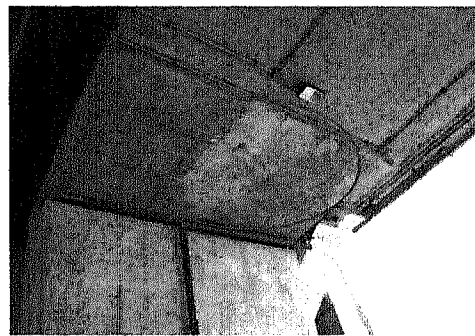
Figure 3.3.3: Free lime of Rama 4
(Lower Flange of girder)

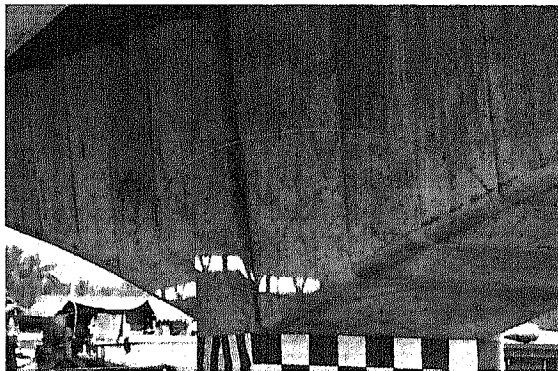
Cracks and free lime were found on a web of the main girder and bottom surface of projected deck. (Fig 3.3.5, 3.3.6) Inclined columns, ground settlement around them, ejection of sand were found in the Thon Buri side. (Fig3.3.7, 3.3.8) Although inclined bridge columns may cause moving constraint of bearings, cracks and pop-outs were not found in the upper structure around bearings. The urgent needs for repair may not be needed, however, in-depth survey was recommended for searching the causes of that phenomenon. In response to a report submitted to the DRR from a viewpoint of the necessity of more detailed inspection of these damages, investigation for determining the cause, and monitoring the movements, the DRR made a prompt notification of its intension to start monitoring.

*Figure 3.3.5: Cracks in Rama 5
(Web of main girder)*

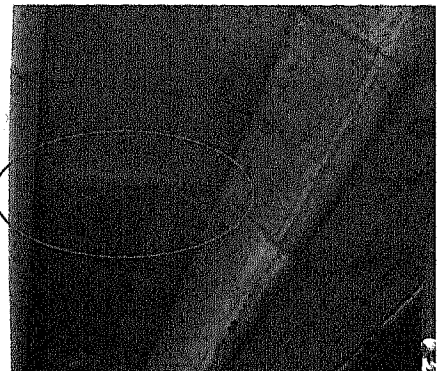
*Figure 3.3.6: Cracks and free lime in Rama 5
(Bottom surface of projected deck)*

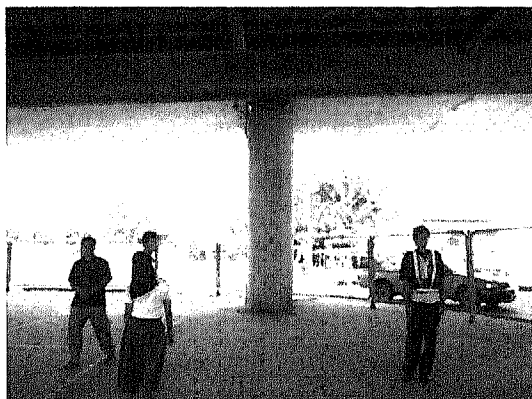
*Figure 3.3.7: Inclination of bridge columns of
Rama 5 (Thon Buri side)*

Damages were few in whole, and same damages were apparently repaired. Like Rama 5, however, inclination was found in bridge columns. The details would be appeared in 3.5.2.

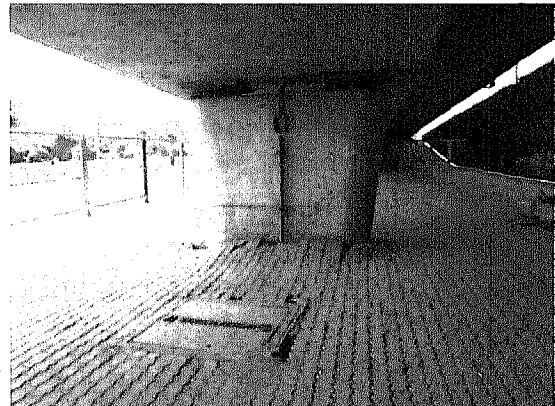
*Figure 3.3.8: Ground settlement around Rama 5
(Thon Buri side)*

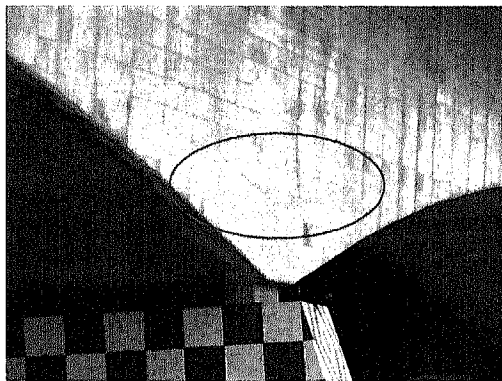
Similar to other PC box girder bridges, cracks were found on a web of the main girder around supporting points. (Fig3.3.10, 3.3.11) These cracks had marks of repair in the past. Free lime on bottom surface of a deck and pop-outs at ends of beams were detected. Although the possibility of moving constraint of a bearing was found, no cracks were observed in the shoe seat motor or an abutment near the relevant bearing.

Figure 3.3.10: Cracks in Rama 7
(Web of main girder)

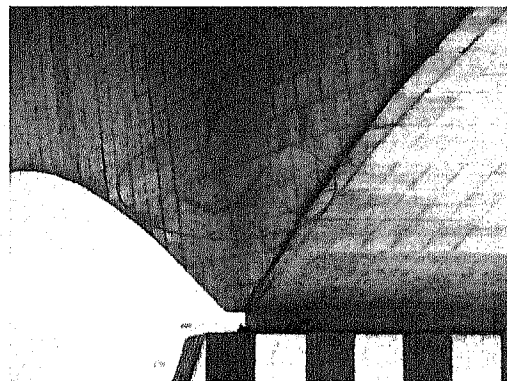
Figure 3.3.11: Cracks in Rama 7
(Web of main girder)

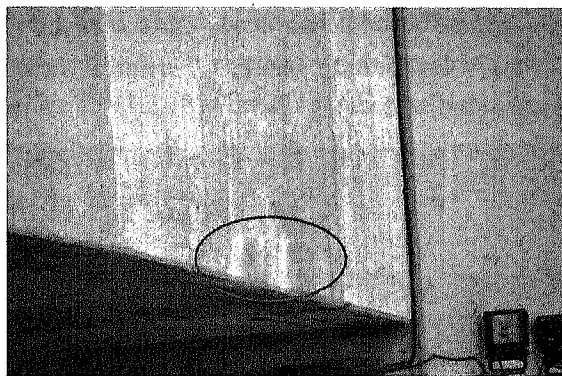
Cracks and free lime were found on a web and lower flange of main girder. (Fig3.3.13,3.3.14)

Figure 3.3.13: Phra Pinklao
(Cracks and free lime on girder)

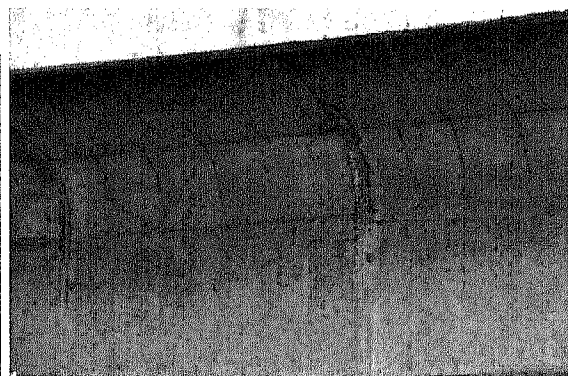
Figure 3.3.14: Phra Pinklao
(Cracks and free lime on girder)

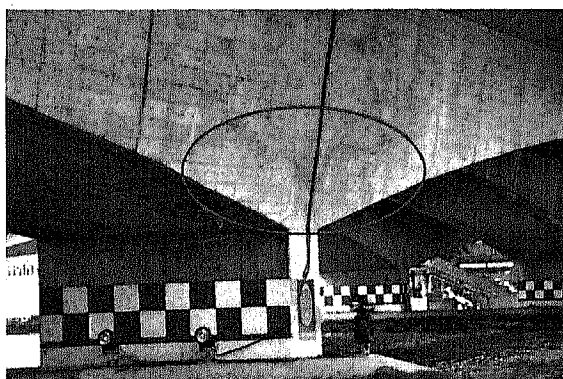
Similar to other PC box girder bridges, cracks were observed on a side surface of the main beam near supporting points. (Fig3.3.16, 3.3.17) In addition, marks of contact with ship (collision), pop-outs of handrail, and cracks were observed.

Figure 3.3.16: Cracks in the Phra Pokklao
(Web of main girder)

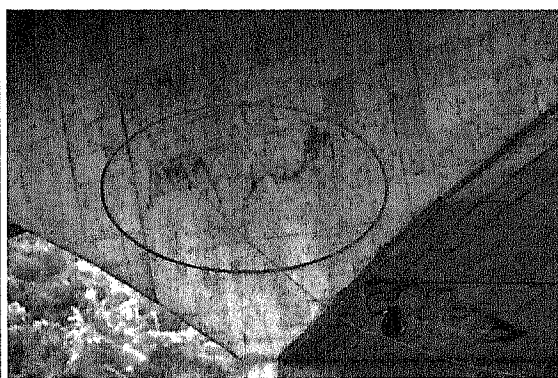
Figure 3.3.17: Cracks in the Phra Pokklao
(Web of main girder)

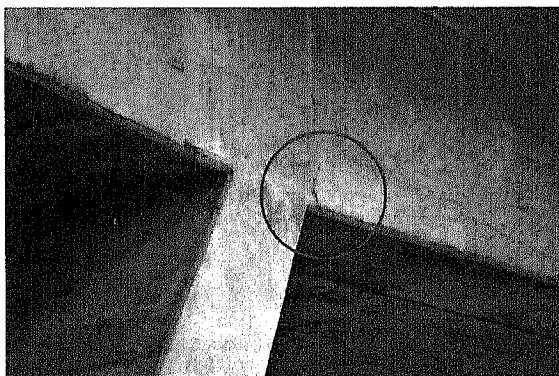
Cracks in the diagonal direction were found on a web of the main girder. In addition, cracks were found around the corner of intersection in bridge main girders and on a web of bridge columns. (Fig3.3.18) Cracks together with free lime and the possibility of moving constraint of bearings were confirmed. (Fig3.3.20)

Figure 3.3.18: Cracks in the Taksin
(Web of main girder)

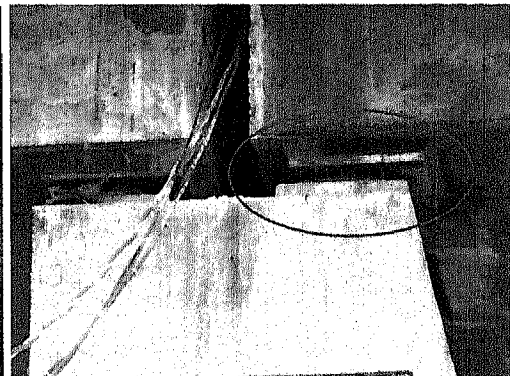
Figure 3.3.20: Moving constraint of
bearings in the Taksin

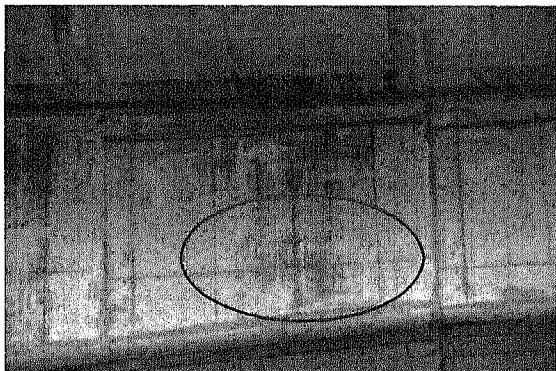
Cracks were found on the bottom of a web and bottom surface of projected area of a deck.

Figure 3.3.21: Cracks in Rama 3
(Web of main girder)

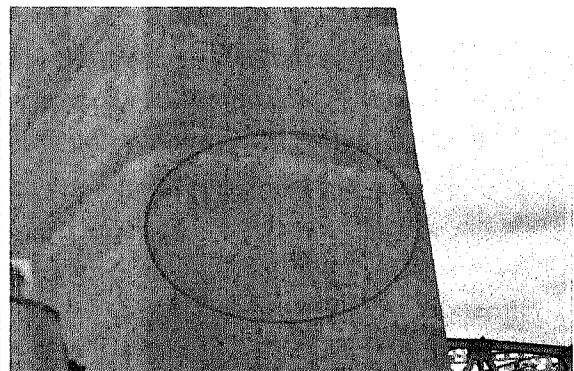
(Fig3.3.21) Cracks with free lime in part were also found.(Fig3.3.23)

Figure 3.3.23: Cracks in Rama 3
(Web of bridge column)

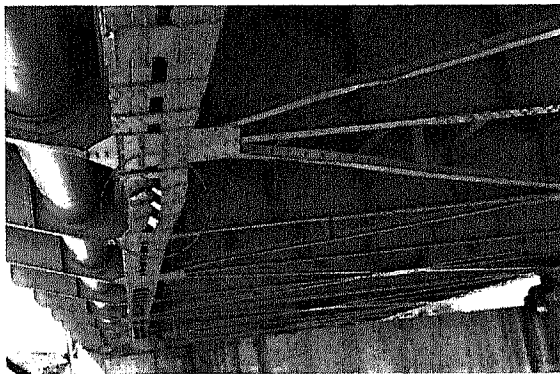
Deformation was observed in many members, lower chords, lower lateral bracings. (Fig3.3.25,3.3.26) They were caused by the collision with ships passing under the bridge. In addition, deformation was observed in some places at the top of vertical members of the bridge.

Figure 3.3.25: Deformation of the Krung Thon
(Lower chord, Lower lateral
bracing)

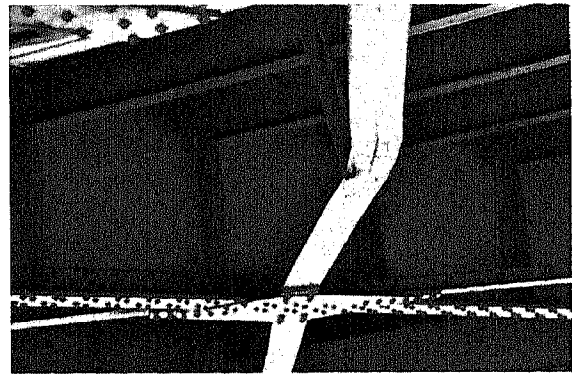
Figure 3.3.26: Deformation of the Krung Thon
(Lower lateral bracing)

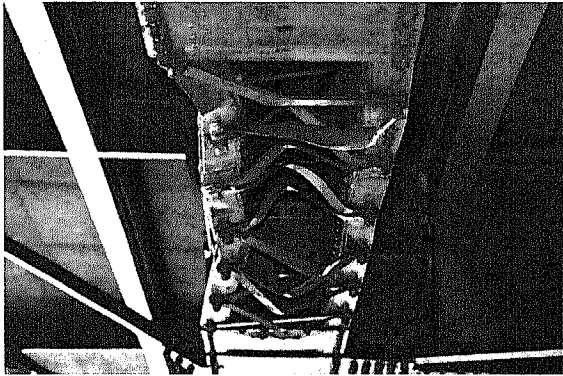
Similar to the Krung Thon, lower chords, lower lateral bracings were observed deformed. They are also considered to be caused due to collision with ships/ vehicles passing under the bridge.(Fig3.3.28, 3.3.29)

*Figure 3.3.28: Deformation of the Memorial
(lower chord)*

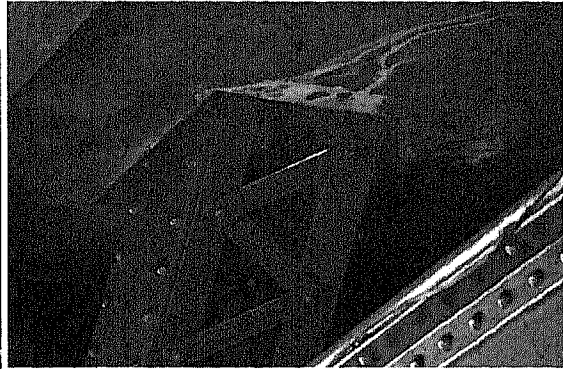
In addition to corrosion and cracks of protection concrete at the bottom of diagonal, free lime and marks of water leakage from the place where diagonal passes through a deck on the bridge face were observed. In particular, free lime and marks of water leakage from the deck pass-through area confirmed entry of rain, and water that has entered the deck may pond depending on the configurations of the diagonals pass-through decks.

*Figure 3.3.29: Free lime of the Memorial
Mark of water leakage
(Deck pass-through area)*

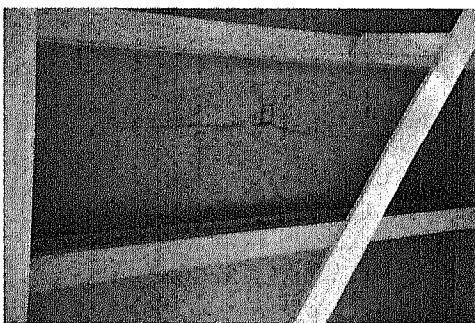
Inspectors on a ship found cracks propagated on the steel plate at the bottom surface of the deck in the bascule leaf (Thon Buri side). Road surface at the center joint of the leaves seemed to be a gap approximately 30 mm. Other observed damages included cracks and free lime in an RC deck.

Figure 3.3.31 Krung Thep Crack
(steel plate at the bottom surface of a deck)

Considering the in-service period, the maintenance was fully implemented. However, procedures are considered to be necessary to detect crack propagation in composite decks of Krung Thep at an early stage. If cracks are detected during repainting work and reported them to DRR, DRR officers can make a decision to do next steps before the damage becomes more serious. Lower chords and lower lateral bracing were deformed and some lateral bracing were missing due to collision with ships and/or vehicles passing through those bridges. Including those, further discussions are appeared in 3.5.1(2).

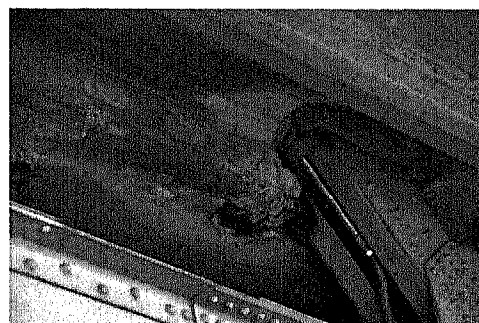
Pop-outs were observed on the bottom surface of the deck where diagonal passed through. (Fig3.3.32)

Figure 3.3.32: Pop-outs in the Krung Thep

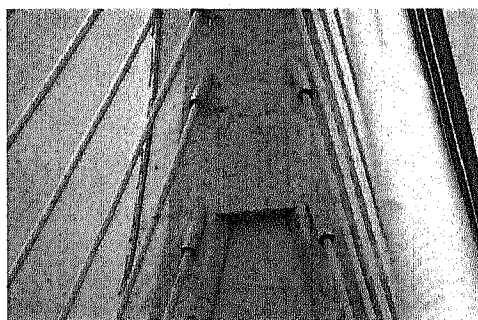
Cracks were also found around the cable fixing area on the main tower, and oil leaked from a cable damper. (Fig3.3.34,3.3.35)

Figure 3.3.34: IRR South
(Cracks around a cable fixing area)

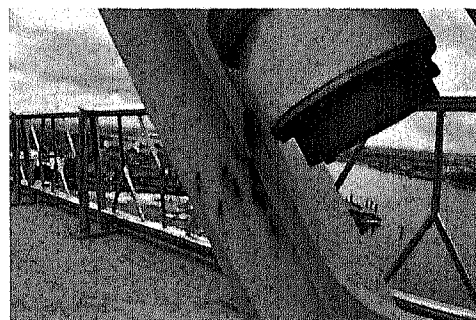
Figure 3.3.35: IRR South
(Oil leakage)

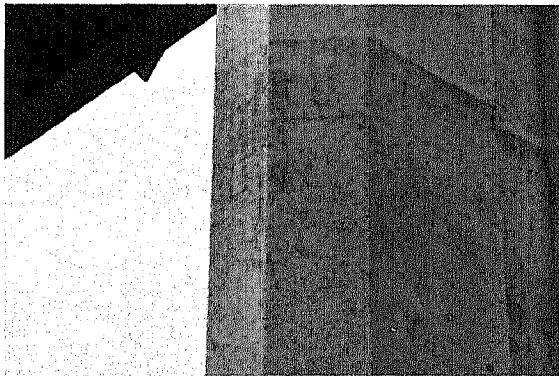
Cracks were in the vertical direction on the lower side of main tower, and reticulated cracks were found at the end bridge column. Cracks were also visually confirmed from the acute angle corner at the rigid joint connected the cap beam with the tower.

Figure 3.3.37: Cracks in the main tower of the IRR North

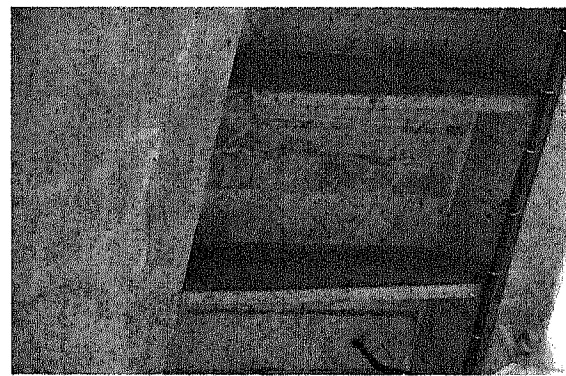
In the projected decks (concrete slab), multiple cracks were found in the same direction. (Fig 3.3.38)

Figure 3.3.38: Cracks of a deck of the IRR North

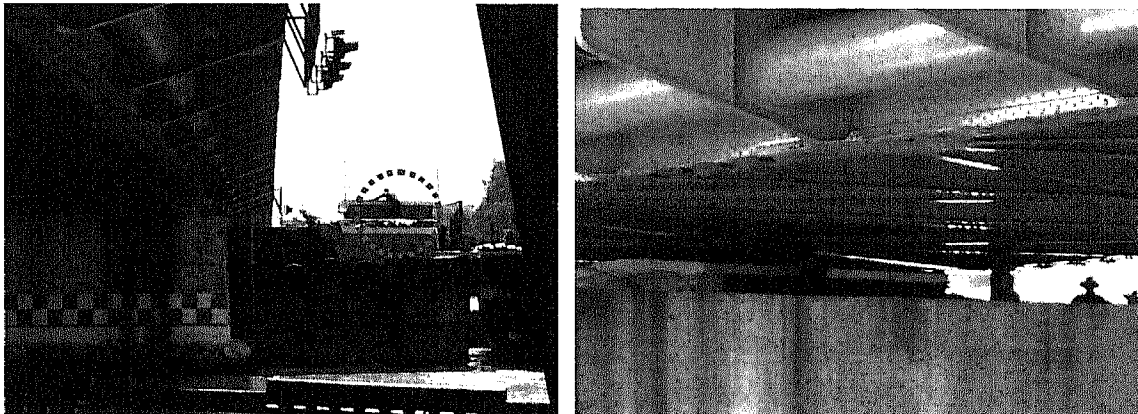
was observed. In the both picture of Figure 3.4.1 and 3.4.2, the upper stream is at the left and the downstream is at the right. The photo was taken near Thon Buri said. (Bangkok is at the further in this picture). Figure 3.4.1 shows that a sailor checks the space by his eyes whether the vessel can be passed. Figure 3.4.2 shows the space between the vessel and lower lateral chord can be seen 50 cm at most.

Once a tugboat begins towing such the vessels, they cannot actually stop before the bridge, although water flow decelerates them. If visual check is adopted for confirming the space, it will not be able to avoid collision with bridges.

Figure 3.4.1: Condition of passage of a vessel (1) Figure 3.4.2: Condition of passage of a vessel (2)

For the reasons above, a realistic way for preventing ships from contacting bridges is to implement the device which is currently planed by the DRR.
