PHOTOGRAPHS OF WORKS EXECUTED

Measurement of survey stakes, Before and After Rainy Season

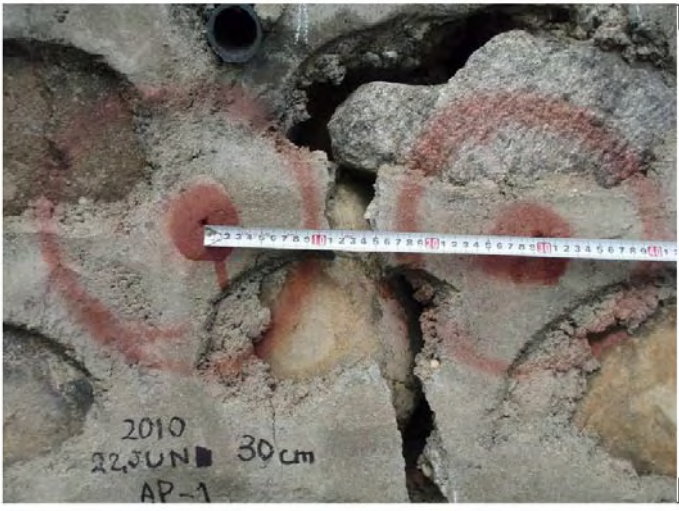
| | <p>LOCATION :- STA 18+200 AP-1</p> |

| | <p>DESCRIPTION :- Masonry Work at upper Side Crack is 4.5cm and PIN is 30.0cm</p> |

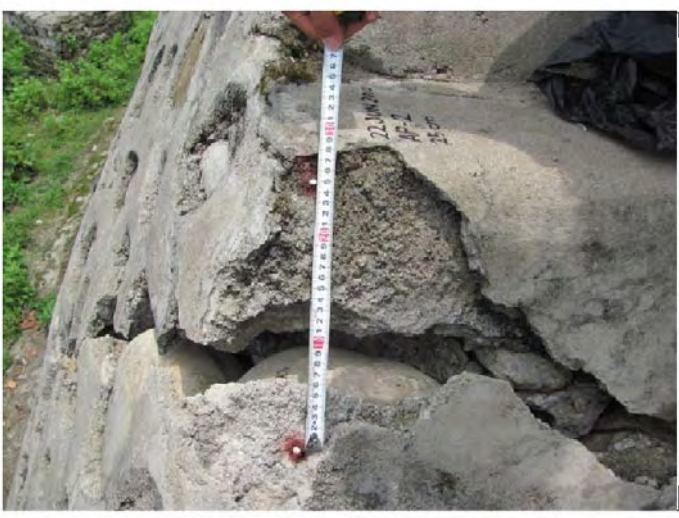
| | <p>LOCATION :- STA 18+200 AP-2</p> |

| | <p>DESCRIPTION :- Masonry Work at upper Side Crack is 7.5cm and PIN is 25.0cm</p> |

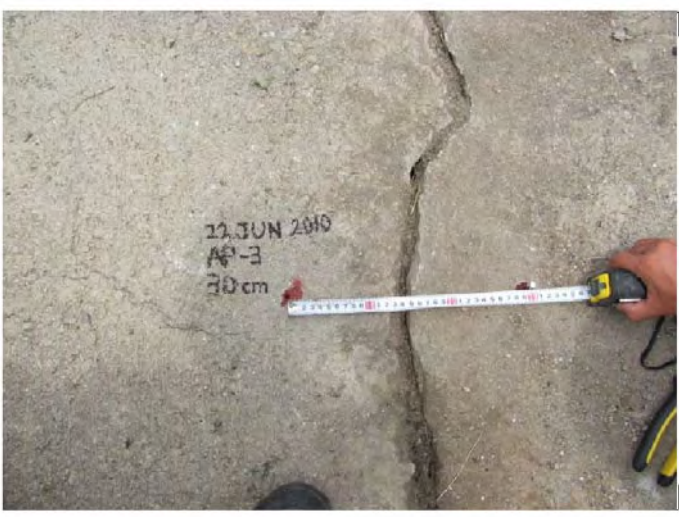
| | <p>LOCATION :- STA 18+200 AP-3</p> |

| | <p>DESCRIPTION :- Masonry Work at upper Side Crack is 2.2cm and PIN is 30.0cm</p> |

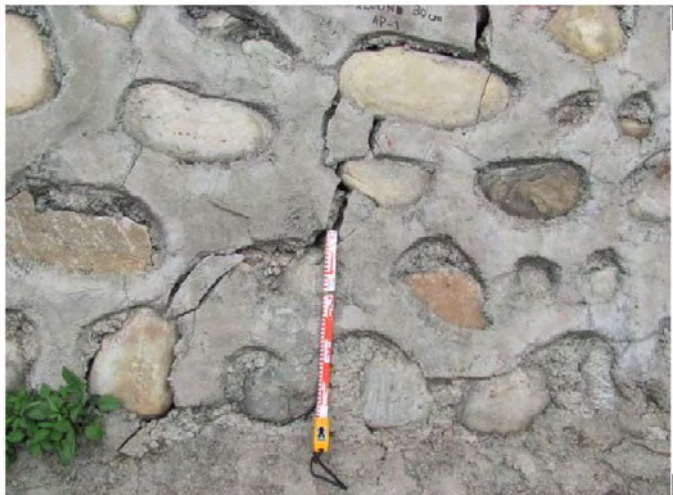
| | <p>DATE :- 23 June 2010</p> <p>DESCRIPTION :- Masonry Work at upper Side Before crack is location</p> <p>LOCATION :- STA 18+200 AC-1</p> |

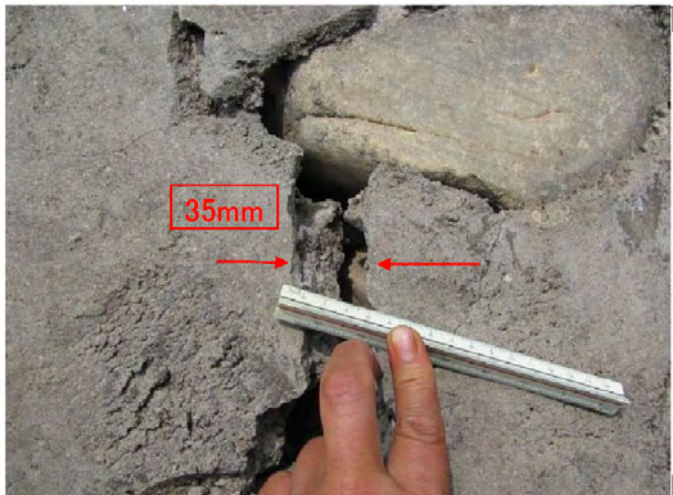
| | <p>DATE :- 23 June 2010</p> <p>DESCRIPTION :- Masonry Work at upper Side Before crack is cementation Crack is 3.5cm</p> <p>LOCATION :- STA 18+200 AC-1</p> |

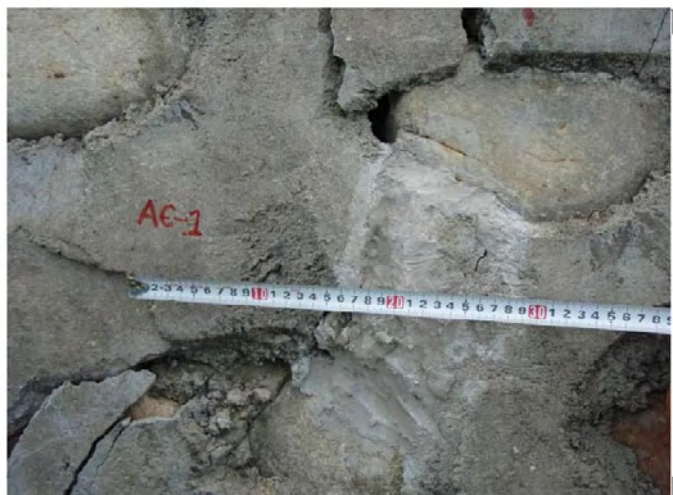
| | <p>DATE :- 23 June 2010</p> <p>DESCRIPTION :- Masonry Work at upper Side After Crack is cementation</p> <p>LOCATION :- STA 18+200 AC-1</p> |

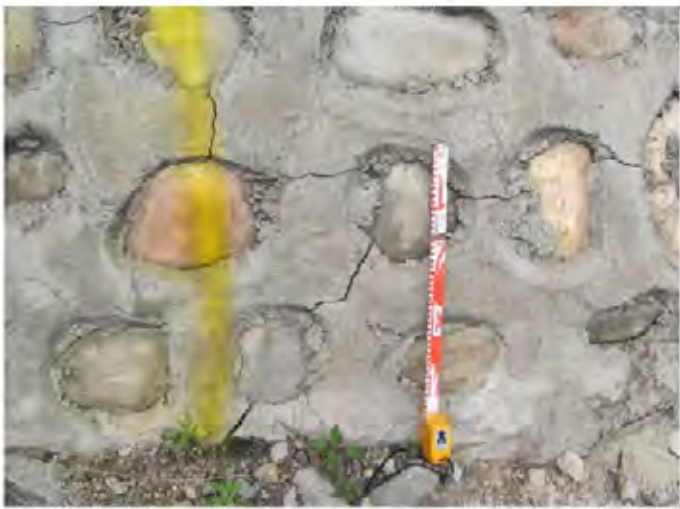
| | <p>LOCATION :- STA 18+200 AC-2</p> |

| | <p>DESCRIPTION :- Masonry Work at upper Side Before crack is location</p> |

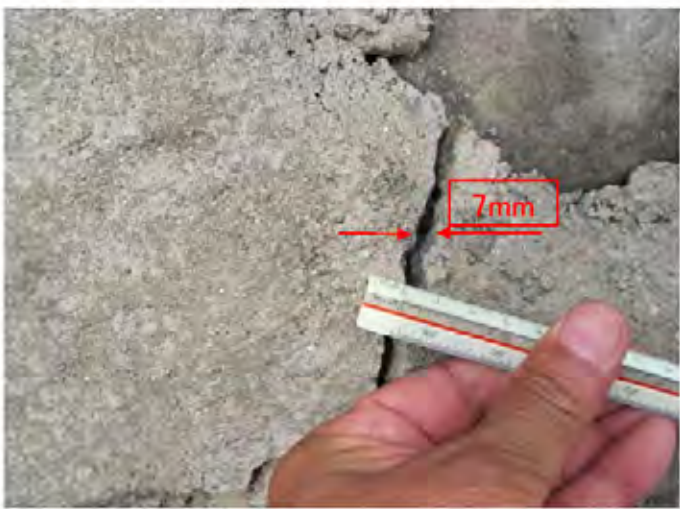
| | <p>LOCATION :- STA 18+200 AC-2</p> |

| | <p>DESCRIPTION :- Masonry Work at upper Side Before crack is cementation Crack is 0.7cm</p> |

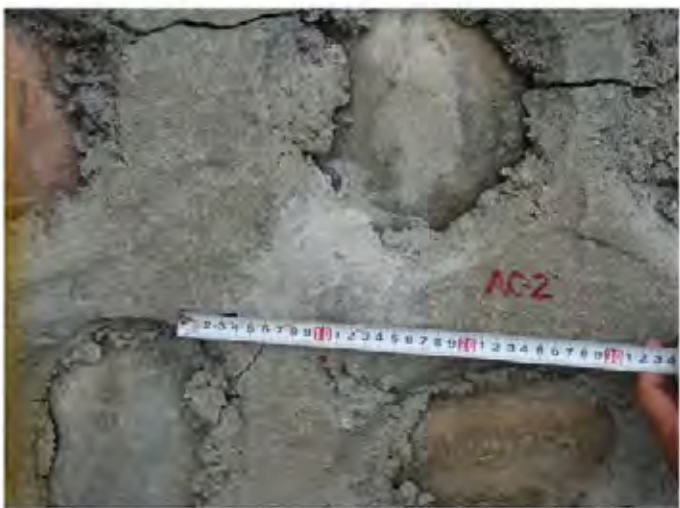
| | <p>LOCATION :- STA 18+200 AC-2</p> |

| | <p>DESCRIPTION :- Masonry Work at upper Side After Crack is cementation</p> |

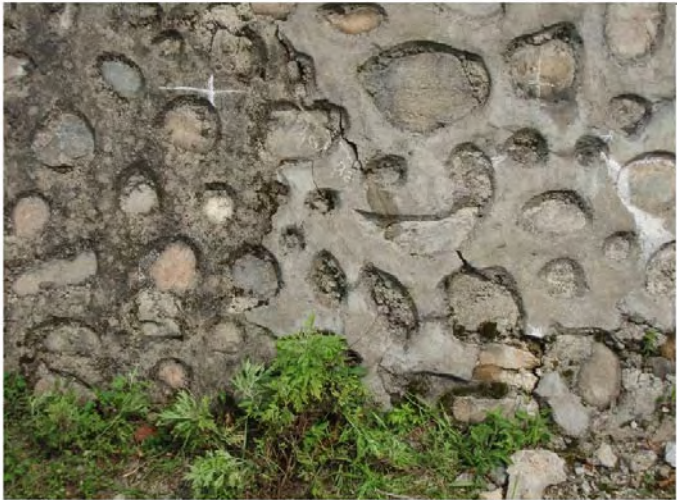
| | <p>LOCATION :- STA 18+200 AC-3</p> |

| | <p>DESCRIPTION :- Masonry Work at upper Side Before crack is location</p> |

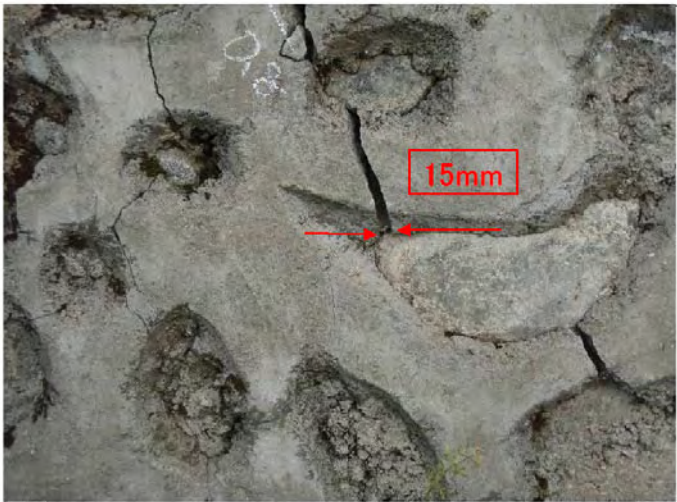
| | <p>LOCATION :- STA 18+200 AC-3</p> |

| | <p>DESCRIPTION :- Masonry Work at upper Side Before crack is cementation Crack is 1.5cm</p> |

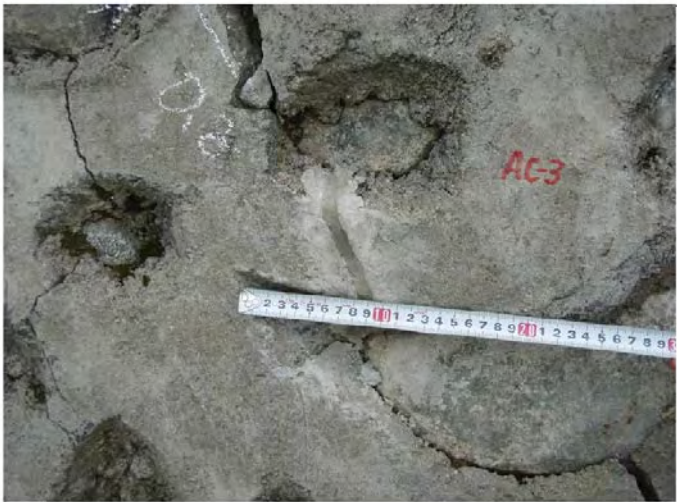
| | <p>LOCATION :- STA 18+200 AC-3</p> |

| | <p>DESCRIPTION :- Masonry Work at upper Side After Crack is cementation</p> |

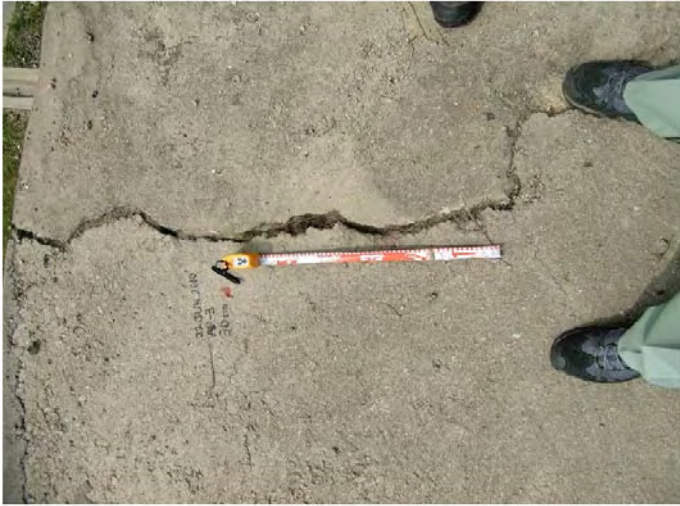
| <p>A photograph showing a long, irregular crack in a concrete surface. A ruler is placed horizontally across the crack to provide a scale. The crack is approximately 30 cm long. The surrounding concrete is light-colored and appears to be in good condition.</p> | <p>DATE :- 23 June 2010</p> <p>DESCRIPTION :- Masonry Work at upper Side Before crack is location</p> <p>LOCATION :- STA.18+200 AC-4</p> |

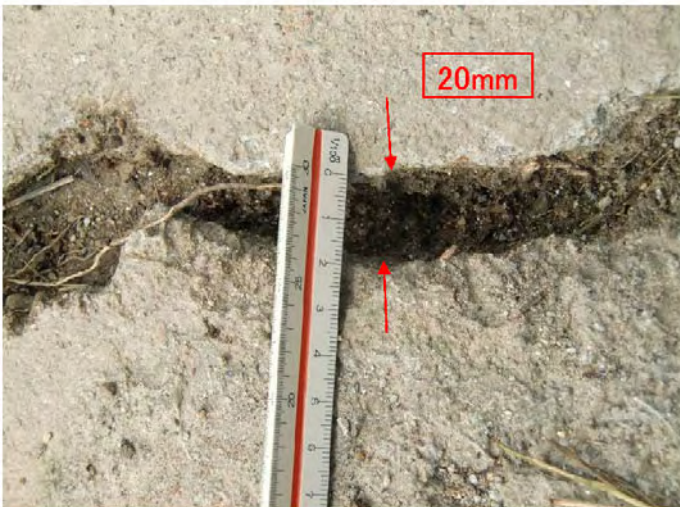
| <p>A close-up photograph of a crack in the concrete. A ruler is placed vertically next to the crack. Two red arrows point to the width of the crack, which is labeled as 20mm in a red box. The crack is filled with dark, fibrous material, likely a repair or sealant.</p> | <p>DATE :- 23 June 2010</p> <p>DESCRIPTION :- Masonry Work at upper Side Before crack is cementation Crack is 2.0cm</p> <p>LOCATION :- STA.18+200 AC-2</p> |

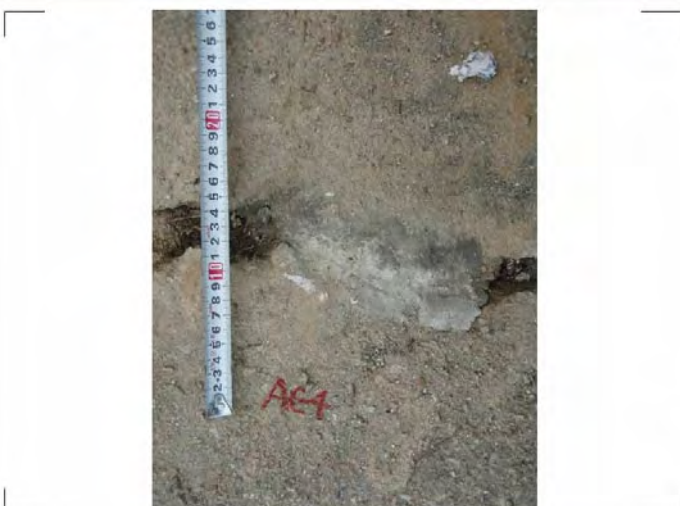
| <p>A photograph showing a crack in the concrete surface. A ruler is placed vertically next to the crack. The crack is filled with a grey, fibrous material. The marking 'AC4' is written in red on the concrete surface below the crack.</p> | <p>DATE :- 26 June 2010</p> <p>DESCRIPTION :- Masonry Work at upper Side After Crack is cementation</p> <p>LOCATION :- STA.18+200 AC-2</p> |

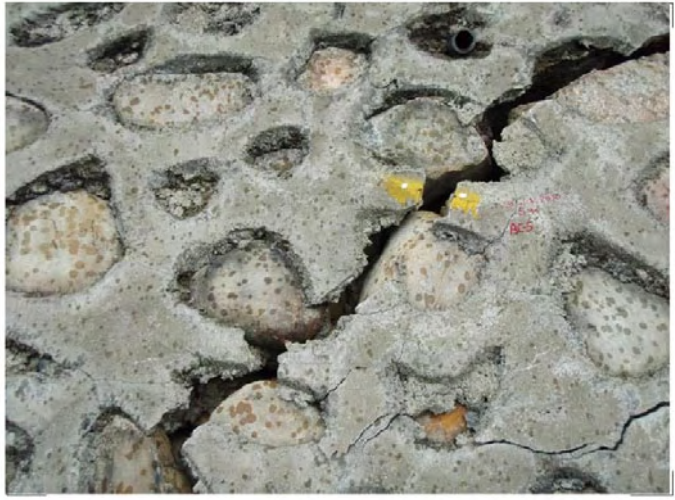
| | <p>LOCATION :- STA 18+200 AC-5</p> |

| | <p>DESCRIPTION :- Masonry Work at upper Side Crack is 6.0cm and Mark is 10.0cm</p> |

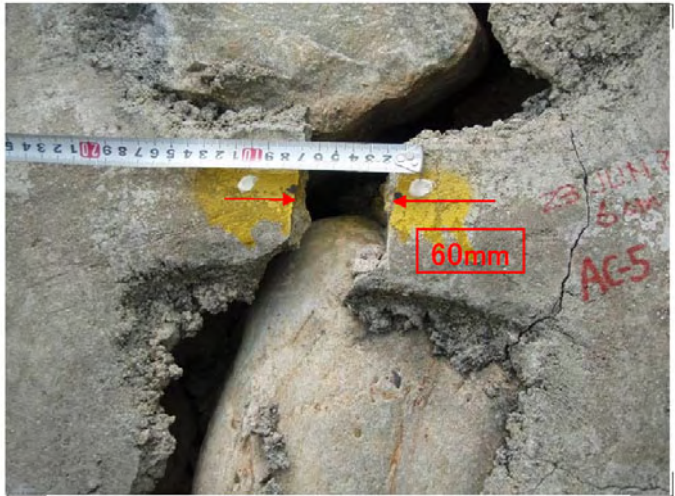
| | <p>LOCATION :- STA 18+200 AC-5</p> |

| | <p>DESCRIPTION :- Masonry Work at upper Side zoom up Crack is 6.0cm and Mark is 10.0cm</p> |

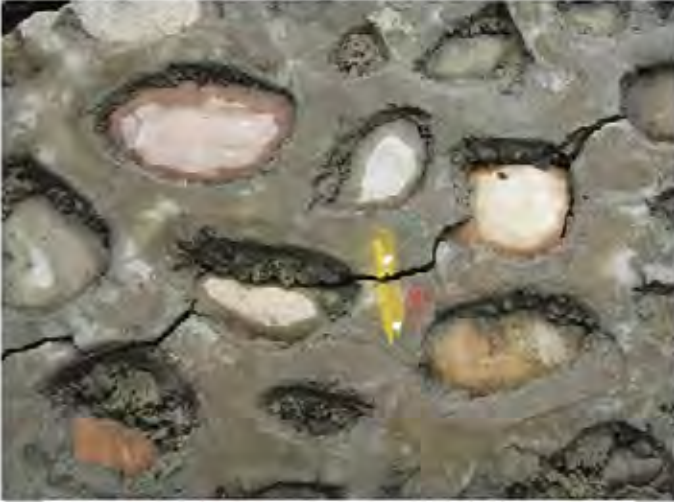
| | <p>LOCATION :- STA 18+200 AC-6</p> |

| | <p>DESCRIPTION :- Masonry Work at upper Side Crack is 1.0cm and Mark is 10.0cm</p> |

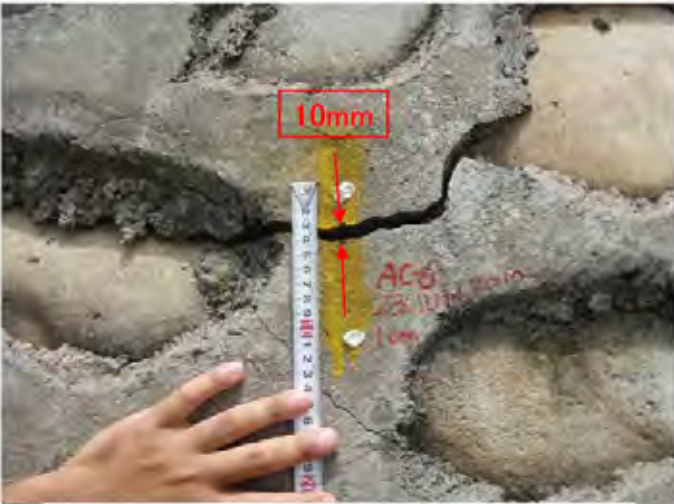
| | <p>LOCATION :- STA 18+200 AC-6</p> |

| | <p>DESCRIPTION :- Masonry Work at upper Side zoom up Crack is 1.0cm and Mark is 10.0cm</p> |

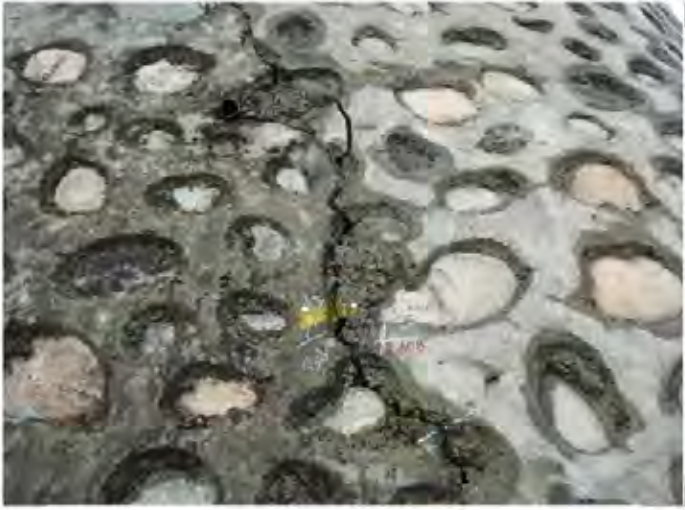
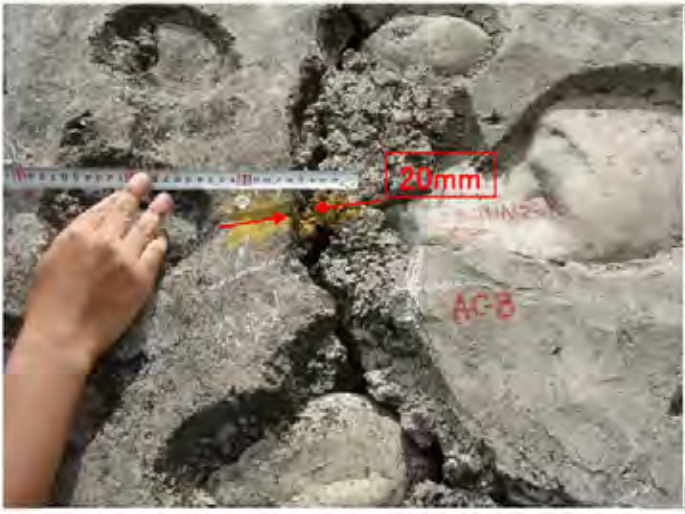
| <p>LOCATION :- STA 18+200 AC-8</p> | <p>DATE :-</p> |

| | <p>DESCRIPTION :- Masonry Work at upper Side Crack is 2.0cm and Mark is 10.0cm</p> |

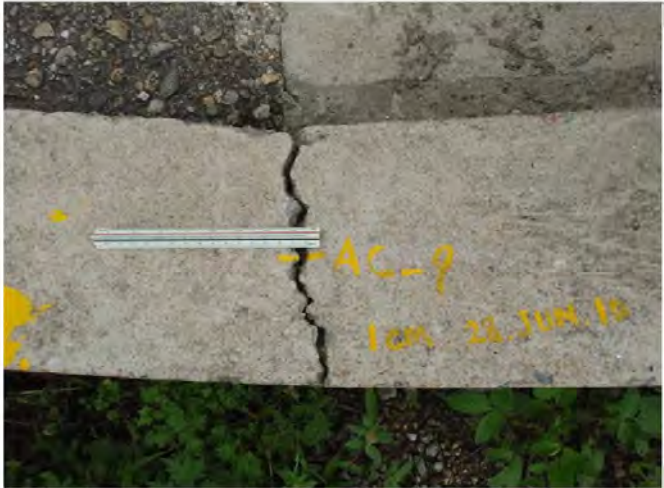
| | <p>LOCATION :- STA 18+200 AC-9</p> |

| | <p>DESCRIPTION :- Road Crack is 1.0cm</p> |

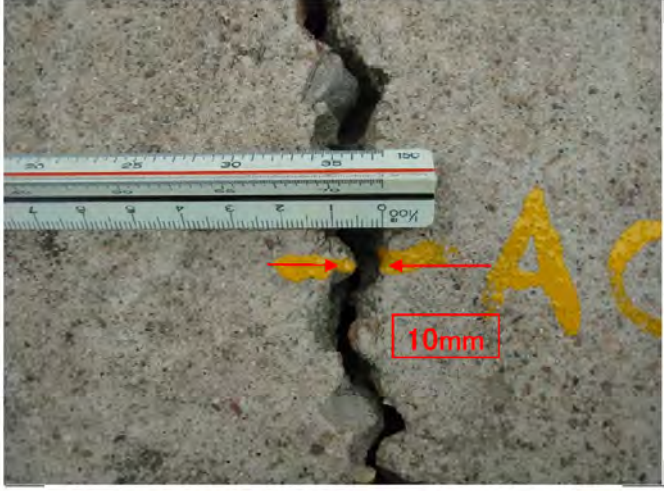
| | <p>LOCATION :- STA 18+200 AC-9</p> |

| | <p>DESCRIPTION :- Road Crack is 1.0cm</p> |
