**THE PREPARATORY SURVEY  
ON  
THE PROJECT  
FOR  
COUNTERMEASURE CONSTRUCTION  
FOR  
THE LANDSLIDES  
ON  
SINDHULI ROAD (SECTION II)**

March 2011

JAPAN INTERNATIONAL COOPERATION AGENCY  
NIPPON KOEI CO., LTD.

Main Report

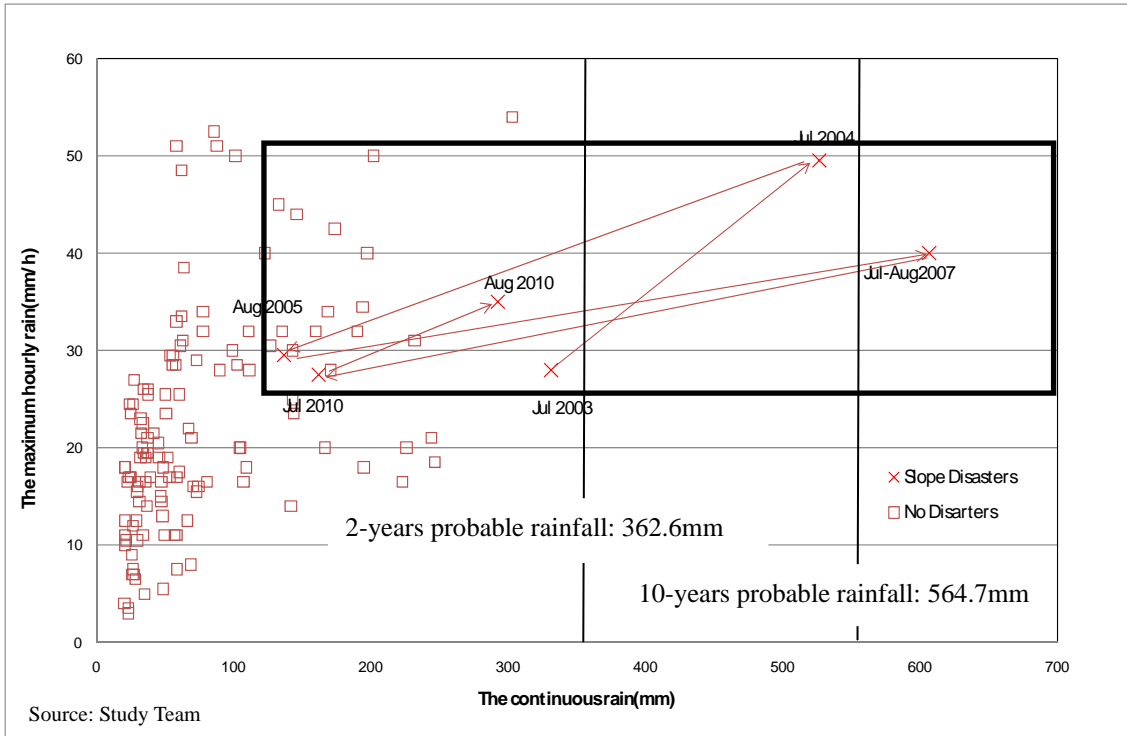
**Figure 2.2.1 Correlation between Disaster Occurrences and Rainfall Intensity (Sta.17+400)**

Based on the analyses of the correlation between the past rainfalls and velocities of failure, the latter was estimated to be 10 cm/year and 60 cm/year under the condition of one-year probable rainfall and five-years probable rainfall, respectively. In other words, it will take 30 years for the failure to erode approximately 6 m of the slope, consequently reaching and damaging the road section. (Refer to the Appendix III for details)

Figure shows the correlation between disaster occurrences and rainfall intensity.

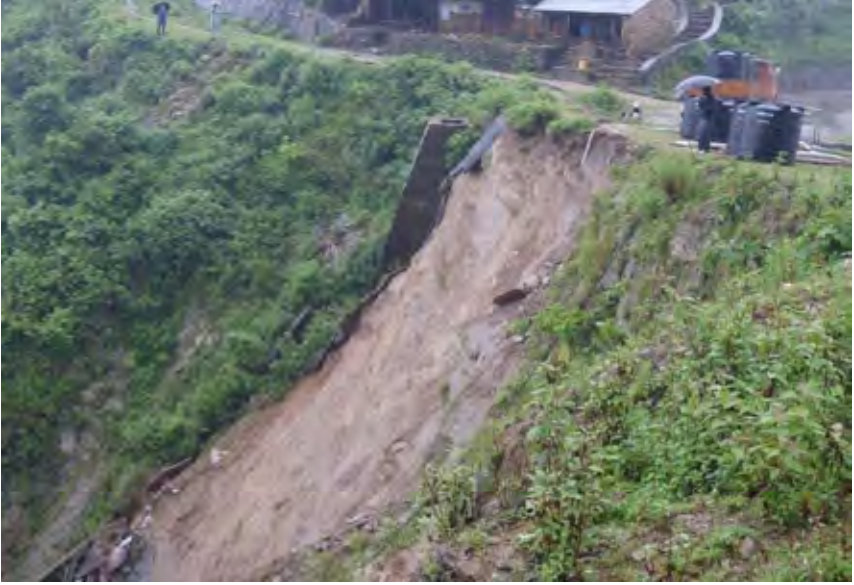
Full view

Failure Mechanism	Repeat of surface failures on high-weathered part
Geology / Geological structure	<ul style="list-style-type: none"> <li>• Mica schist, green schist and quartzite schist.</li> <li>• The dip of Schistosity of 40~50-degree eastward is almost normal to the slope in this section.</li> </ul>
Primary causes	<ul style="list-style-type: none"> <li>• Weathered schist is distributed on the arete-like col.               <ul style="list-style-type: none"> <li>⇒ Schist rocks are erodible and brittle.</li> </ul> </li> <li>• Severely weathered mica schist around the boundary with green schist.               <ul style="list-style-type: none"> <li>⇒ Green schist is hard and low-permeable; mica schist on the green schist is thus likely to be weathered.</li> </ul> </li> <li>• Topographically, the failure slope is located on the valley head, that is, on the erosion front.</li> </ul>
Triggers	<ul style="list-style-type: none"> <li>• Erosion on the slope surface caused by rainfall</li> <li>• Earthquake</li> </ul>

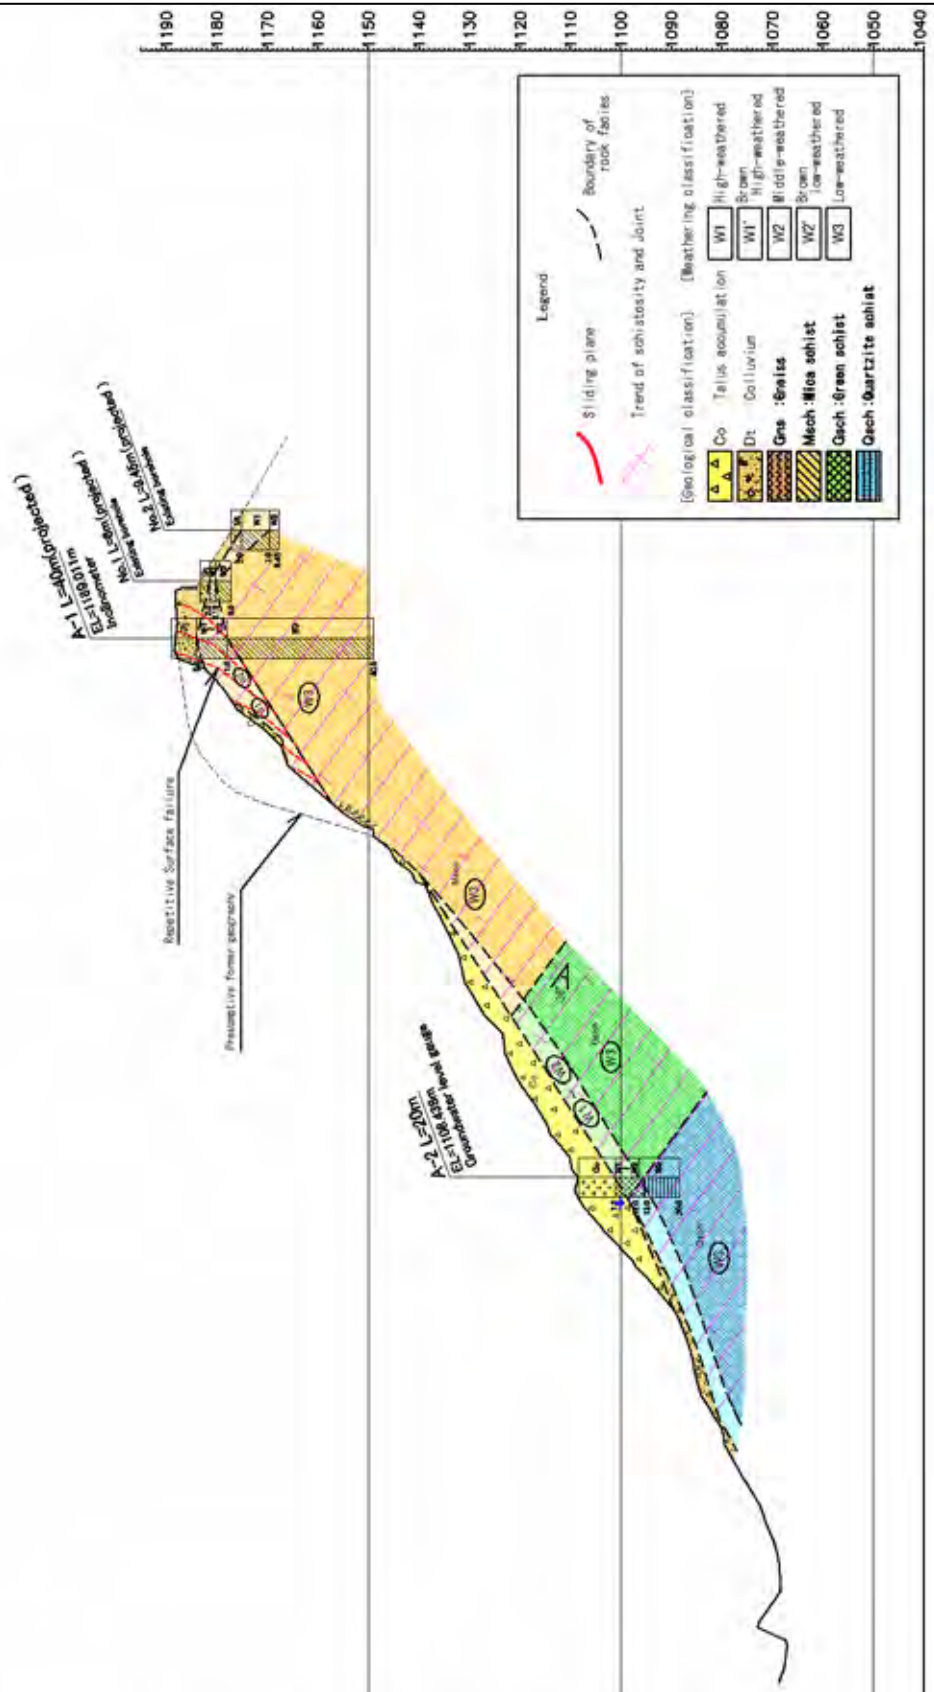
Figure 2.2.3 Geological Profile of Sta.17+400 (A1-1 cross section)

Failure type of the slope around Sta. 17+400 is 'collapse' of steep slope (40 to 70 degrees) and around 40 m in height. This slope is composed of mica schist, green schist and gneiss with geological structure almost orthogonal to the slope surface. Distinct defects (discontinuities and/or geologically weak zones) are not found in the slope. The monitoring results with the two tilt meters and one borehole inclinometer on the ridge suggested no significant movements/deformations in each device.

Plan III is therefore recommended as the most suitable countermeasure for Sta. 17+400.

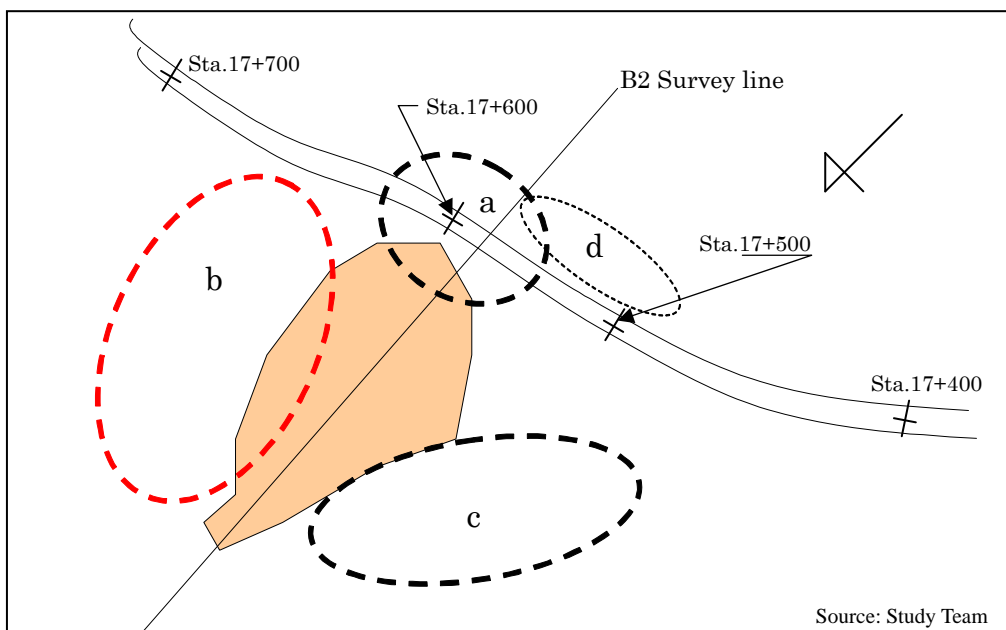
**Figure 2.2.5 Schematic View of Sta.17+600**

Unstable areas around Sta.17+600 were confirmed as described below, and shown in Figure 2.2.5.

- a) A scarp just below Sta.17+600 of the road, including related structures such as road surface and retaining wall,
- b) A loosened zone consisting of weathered and bended rocks below the road on Kathmandu side,
- c) A landslide on the foot of the slope below the road next to the slope failure,
- d) Upper slope of Sta.17+600.

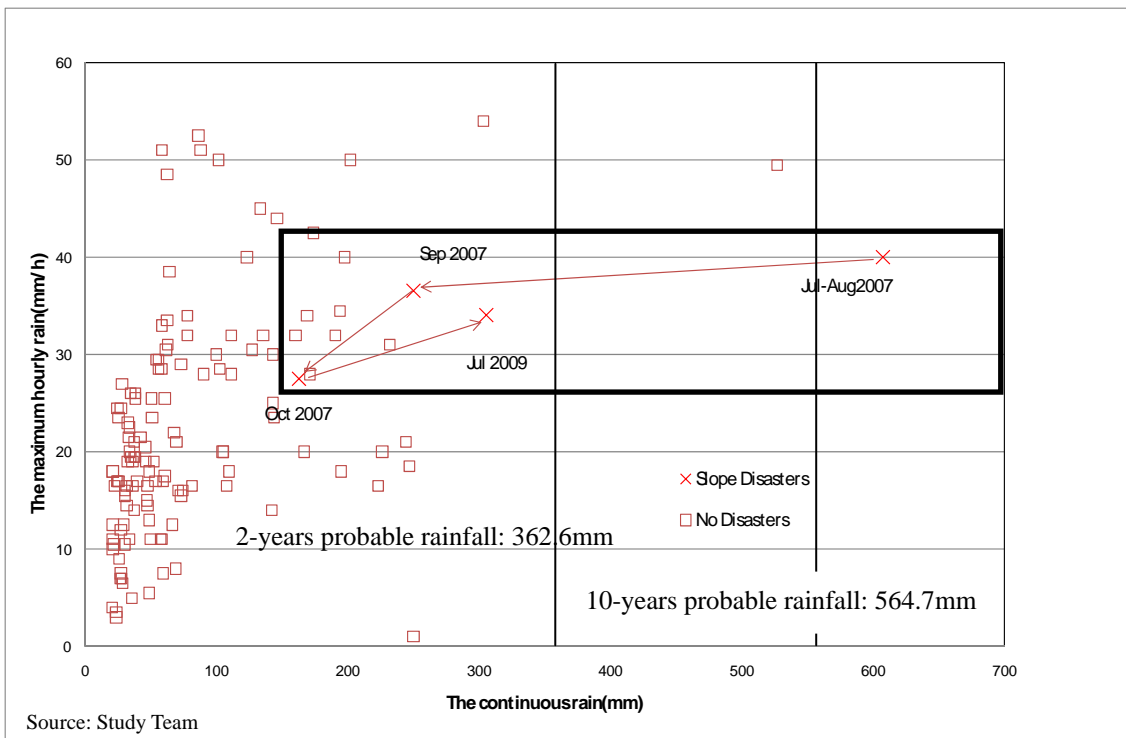
**Figure 2.2.6 Correlation between Disaster Occurrences and Rainfall Intensity (Sta.17+600)**

times, no collapse occurred. The correlation between the hourly rainfall and the collapses was not clearly understood. It is also noted that there were no incidents of collapse during this study period.

Figure 2.2.6 shows the Correlation between disaster occurrences and rainfall intensity.

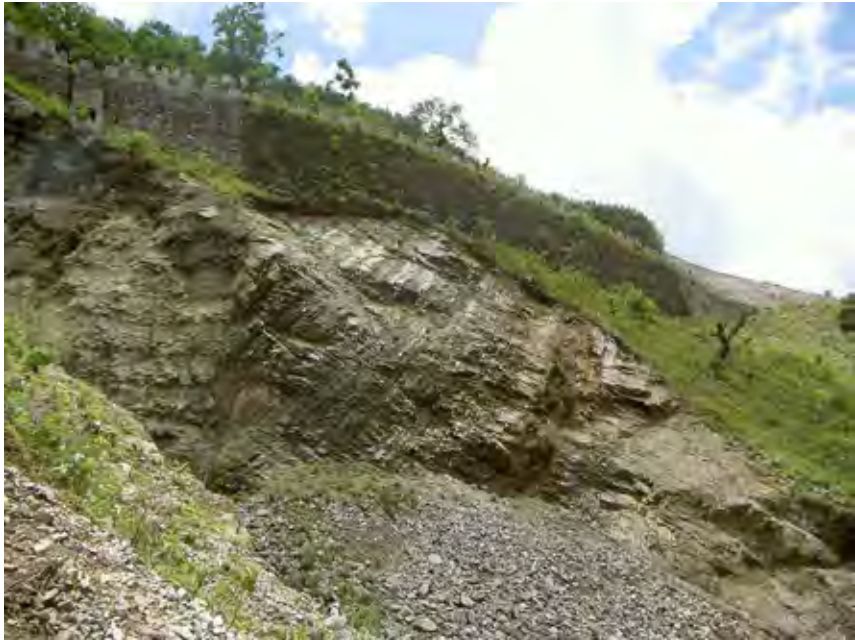
**Table 2.2.2 Slope Failure Mechanism (Sta.17+600: Beginning Side)**

Failure Mechanism	Planar failure and wedge failure
Geology / Geological Structure	<ul style="list-style-type: none"> <li>• Schistosity of the quartzite schist is almost normal to the slope. Schistosity dips 40~50-degrees toward eastern direction (Kathmandu direction)</li> <li>• Sheeting joints dipping out of the slope face</li> </ul>
Primary Causes	<ul style="list-style-type: none"> <li>• Surface water tend to concentrate in the catchment area formed such as the valley as a whole,</li> <li>• Sheeting joints dipping out of the slope face.  <ul style="list-style-type: none"> <li>⇒ The slides on slip plane along joints tend to occur.</li> </ul> </li> </ul>
Triggers	<ul style="list-style-type: none"> <li>• Collapses on the foot of the slope and rainfall</li> <li>• Continuous gravity action</li> <li>• Earthquake</li> </ul>
Full View

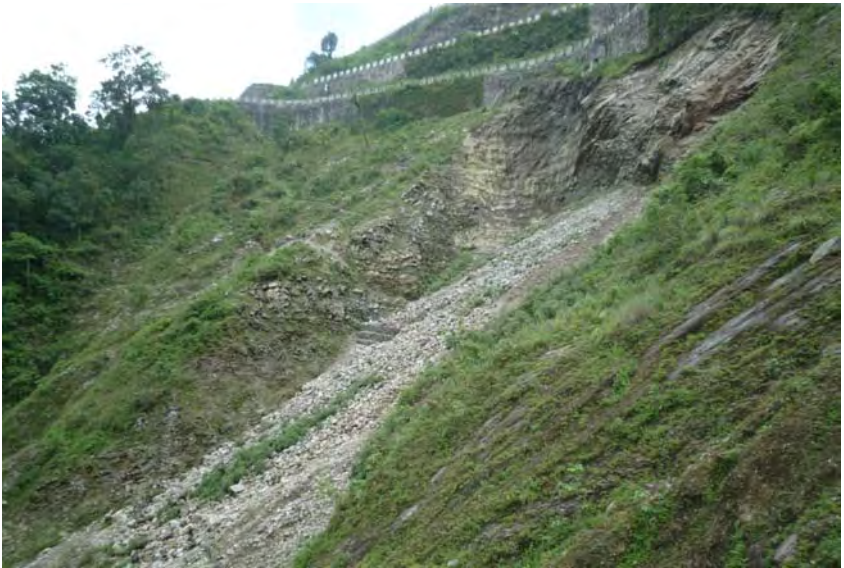
**Table 2.2.3 Slope Failure Mechanism (Sta.17+620: End Side)**

Failure Mechanism	Toppling failure
Geology / Geological Structure	<ul style="list-style-type: none"> <li>• Schistosity of the quartzite schist is almost normal to the slope. Schistosity dips 40~50 degrees toward the eastern direction (Kathmandu direction)</li> </ul>
Primary Causes	<ul style="list-style-type: none"> <li>• The creep deformation by toppling phenomenon in the whole lower slope has become evident.               <ul style="list-style-type: none"> <li>⇒ Weathering and loosening in rock slope tend to further develop.</li> </ul> </li> <li>• Progress of creep deformation has become evident in the lower slope; rock has been completely fractured at the toe of the slope.</li> </ul>
Triggers	<ul style="list-style-type: none"> <li>• Rainfall and the collapses on the flank cause destabilization of the loosened zone.</li> <li>• Heavy rainfall causes the failure in loosened zone, and the road above this zone also collapses due to the removal of the counterweight at the toe.</li> </ul>

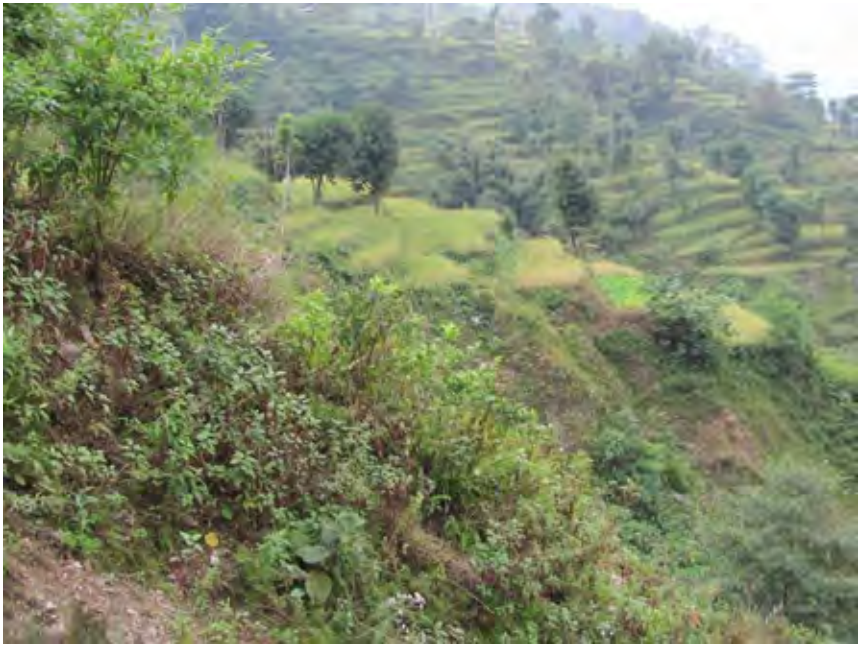
**Table 2.2.4 Slope Failure Mechanism (Sta.17+600: Landslide at the Beginning Side)**

Failure Mechanism	Landslide
Geology / Geological Structure	Schistosity of quartzite schist is oblique to the slope face. The detailed survey for failure mechanism is necessary
Primary Causes	<ul style="list-style-type: none"> <li>•The whole slope shows a typical landslide topography.</li> <li>•The toe of the landslide faces a failure slope which is fractured.</li> </ul>
Triggers	<ul style="list-style-type: none"> <li>•The whole landslide slope becomes unstable during heavy rains.</li> <li>•A collapse for the flank of the failure slope causes destabilization of the landslide.</li> <li>•At present, significant deformations are not observed and slope is generally stable against landslides.</li> </ul>
Full View

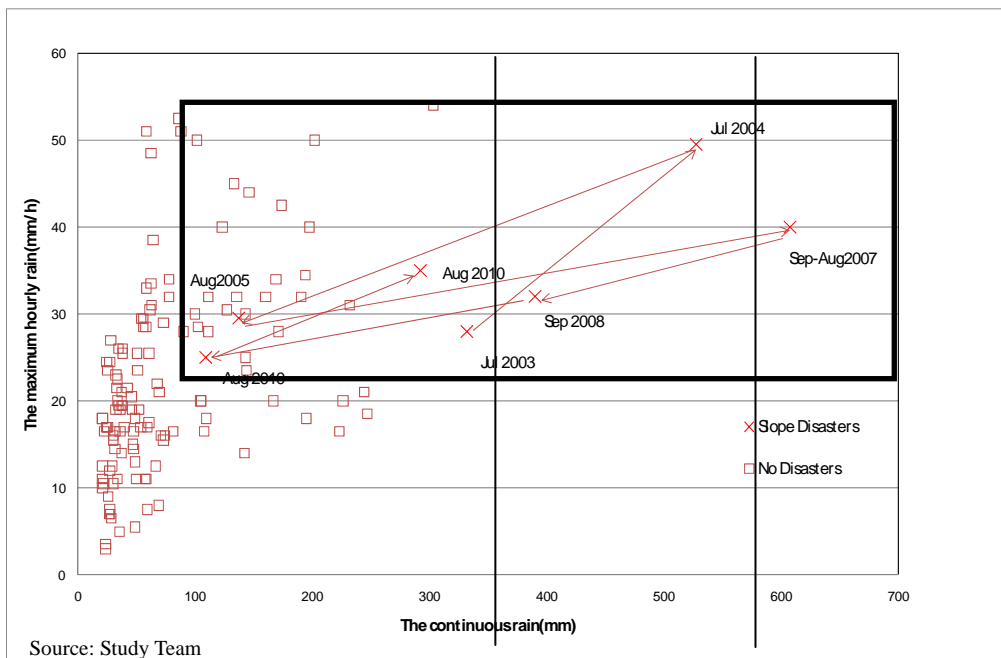
Figure 2.2.10 Correlation between Disaster Occurrences and Rainfall Intensity (Sta.18+200)

The correlation between the hourly rainfall and the collapse were not clear.

Figure 2.2.10 shows the correlation between disaster occurrences and rainfall intensity.

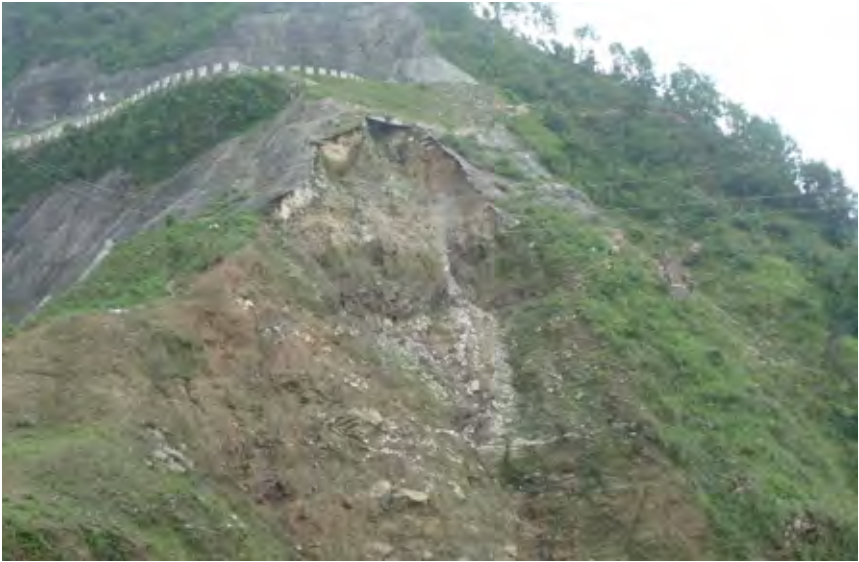
Full View

Failure Mechanism	Toppling failure
Geology/Geological Structure	<ul style="list-style-type: none"> <li>• Quartzite schist • Gneiss</li> <li>• Stratum of opposite dip</li> </ul>
Primary Causes	<ul style="list-style-type: none"> <li>• Located on the toe of the ridge               <ul style="list-style-type: none"> <li>⇒ Weak against weathering and deformation by gravity.</li> </ul> </li> <li>• Toppling failure on whole schist slope with schistosity dipping steeply in to the slope.               <ul style="list-style-type: none"> <li>⇒ Susceptible to weathering and loosening of rock slope.</li> </ul> </li> <li>• Quartzite schist on the steep cliff has been severely weathered by the past failure along the cracks; on the highest part it has decomposed into soil.</li> <li>• Weathering and creep deformation have progressed at the southern slope next to the past failure .</li> </ul>
Triggers	<ul style="list-style-type: none"> <li>• Destabilization of the rock slope by loosening of materials caused by rainfall.               <ul style="list-style-type: none"> <li>⇒ Collapses occurred on the lower shotcrete slope due to heavy rains</li> </ul> </li> <li>• Earthquake</li> </ul>
