PHOTOGRAPHS OF WORKS EXECUTED

Measurement of survey stakes, Before and After Rainy Season

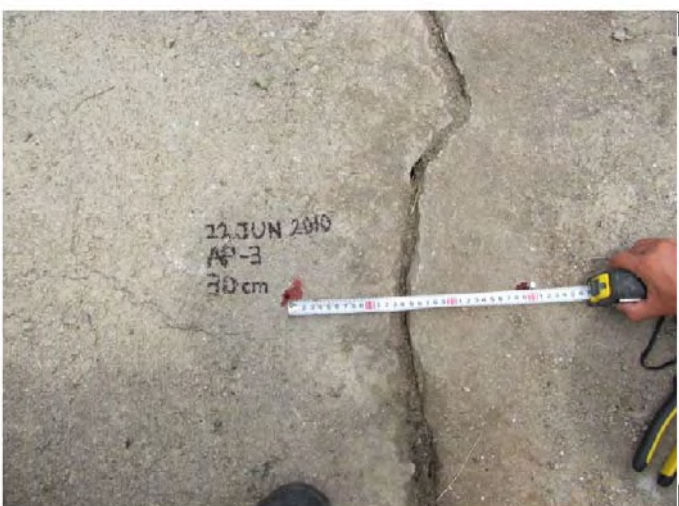
<p>DATE :- 22 June 2010</p>
	<p>DESCRIPTION :- Masonry Work at upper Side Crack is 2.2cm and PIN is 30.0cm</p>
	<p>LOCATION :- STA 18+200 AP-3</p>

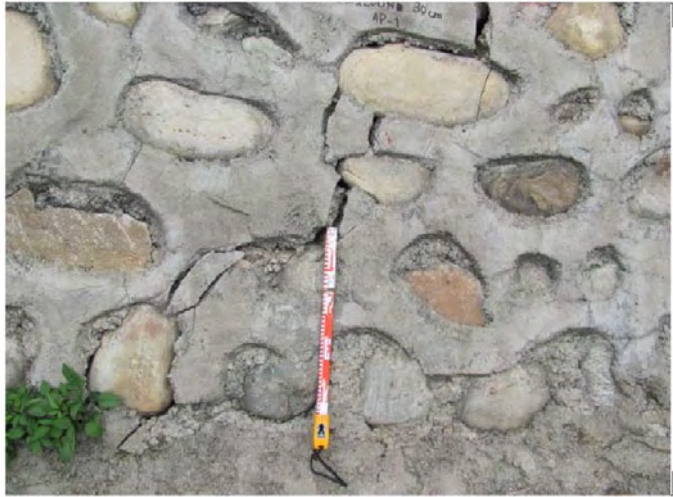
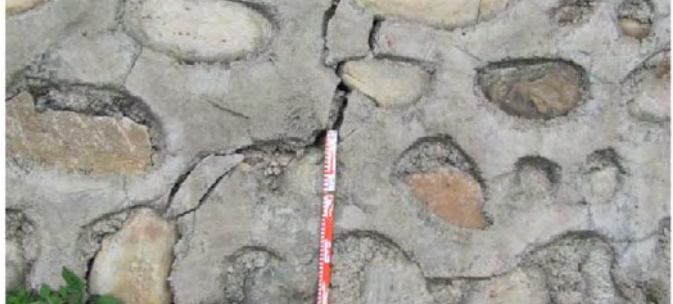
<p>LOCATION :- STA 18+200 AC-1</p>

<p>DESCRIPTION :- Masonry Work at upper Side Before crack is location</p>

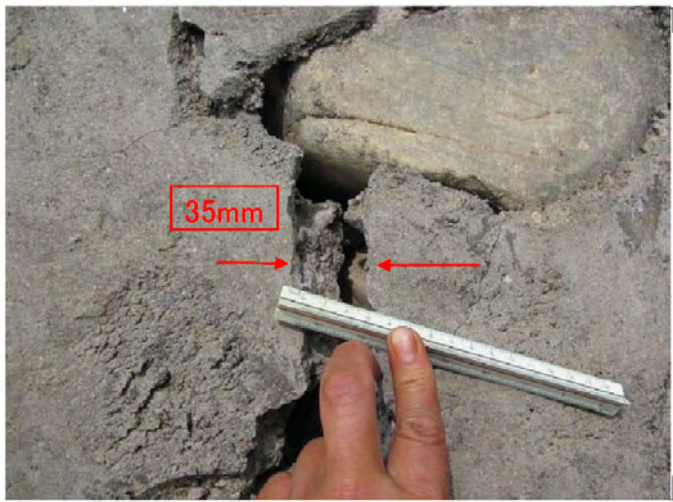
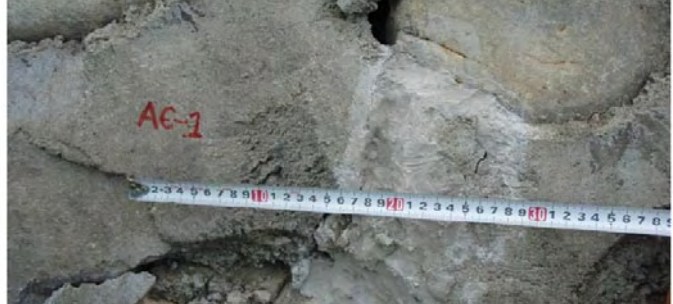
<p>LOCATION :- STA 18+200 AC-1</p>

<p>DESCRIPTION :- Masonry Work at upper Side Before crack is cementation Crack is 3.5cm</p>

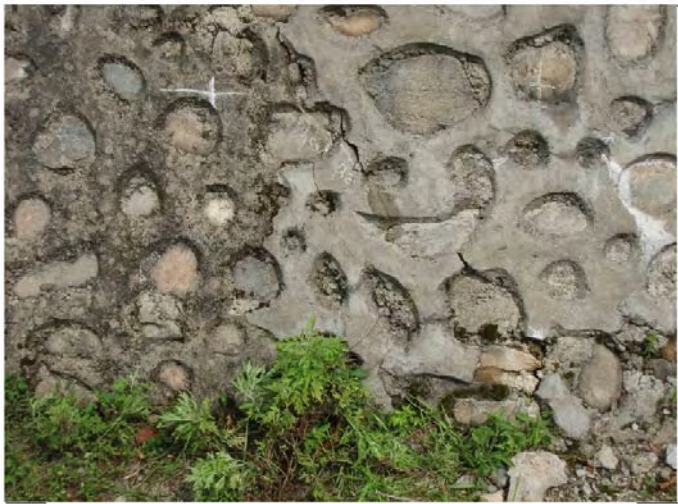
<p>DATE :- 23 June 2010</p>
	<p>DESCRIPTION :- Masonry Work at upper Side Before crack is location</p>
	<p>LOCATION :- STA 18+200 AC-3</p>

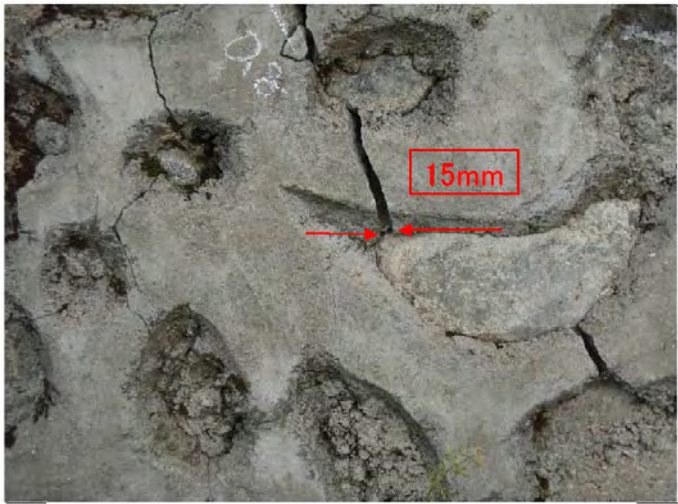
<p>DATE :- 23 June 2010</p>
	<p>DESCRIPTION :- Masonry Work at upper Side Before crack is cementation Crack is 1.5cm</p>
	<p>LOCATION :- STA 18+200 AC-3</p>

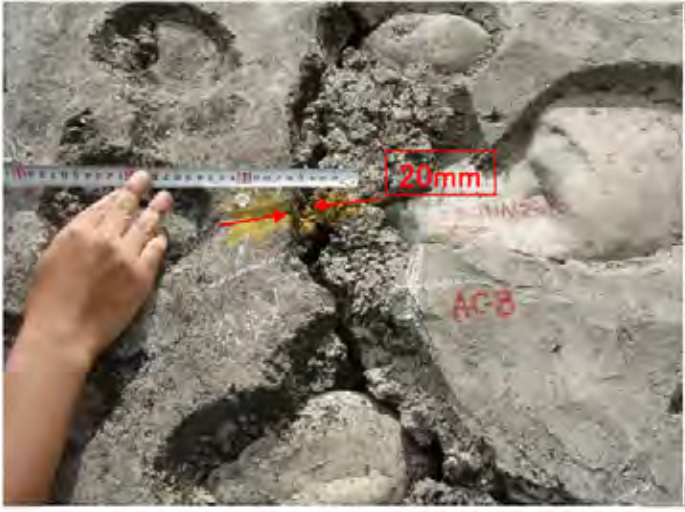
<p>DATE :- 23 June 2010</p>
	<p>DESCRIPTION :- Masonry Work at upper Side zoom up Crack is 2.0cm and Mark is 10.0cm</p>
	<p>LOCATION :- STA 18+200 AC-8</p>

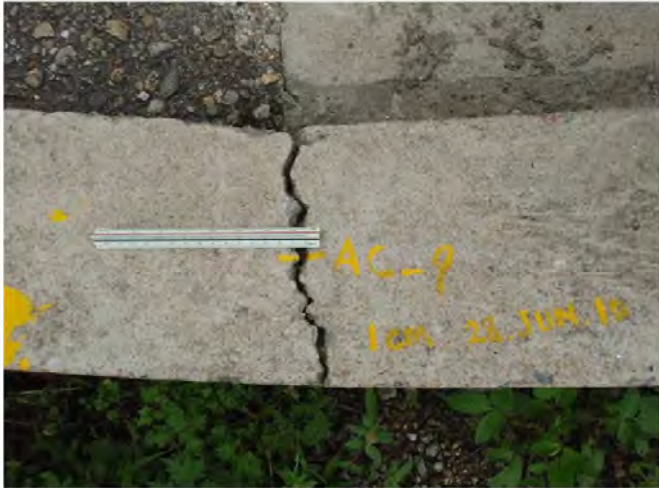
<p>A photograph showing a vertical crack in a concrete slab. A metal scale bar is placed horizontally across the crack. Yellow paint markings on the concrete include '-AC-9' and '1cm 22 JUN 10'.</p>	<p>DATE :- 28 June 2010</p>
	<p>DESCRIPTION :- Road Crack is 1.0cm</p>
	<p>LOCATION :- STA 18+200 AC-9</p>

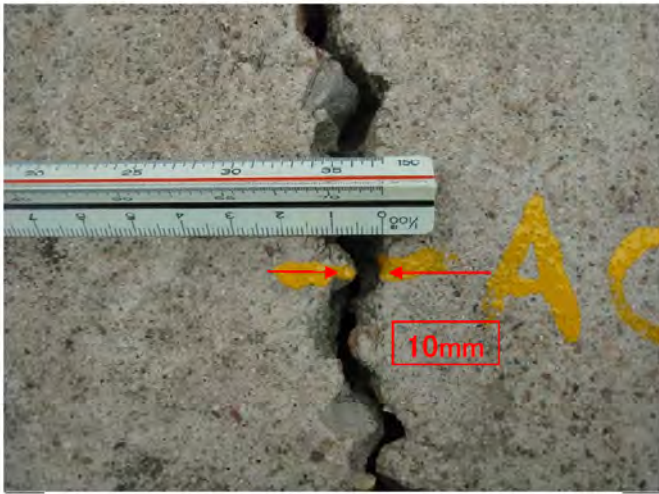
<p>A close-up photograph of the crack. A ruler is placed above the crack. Red arrows point to the crack's width, which is labeled '10mm' in a red box. Yellow paint markings 'AC' are visible to the right.</p>	<p>DATE :- 28 June 2010</p>
	<p>DESCRIPTION :- Road Crack is 1.0cm</p>
	<p>LOCATION :- STA 18+200 AC-9</p>
