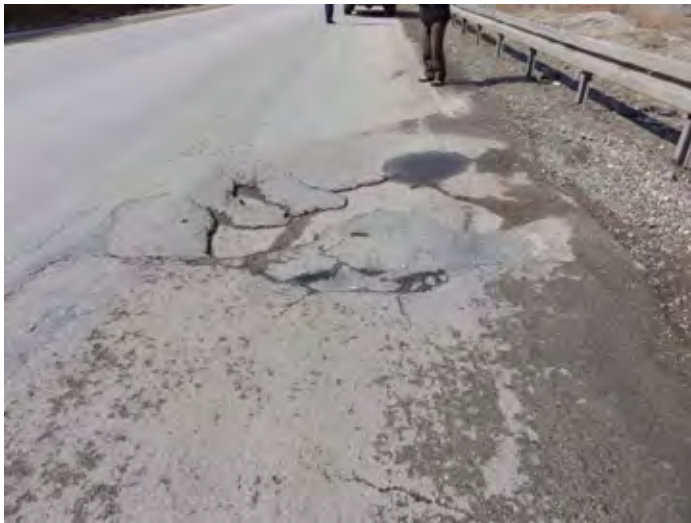
393K+700

舗装の剥がれ

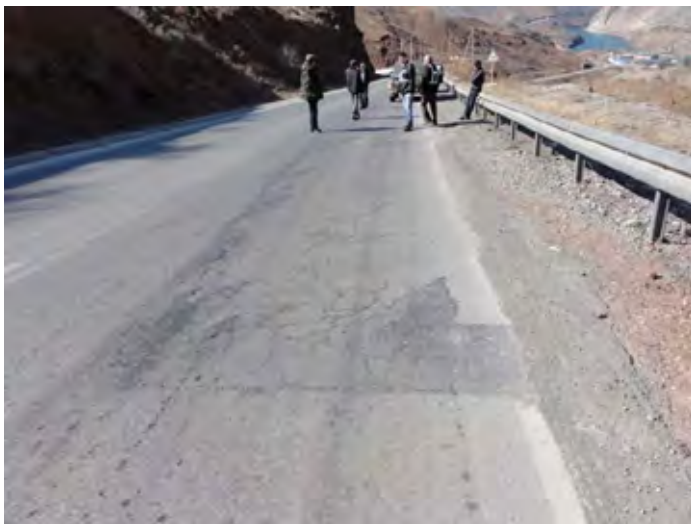
舗装の剥がれ

オーバーレイのパッチング舗装が車
輛走行によって剥がれてきた

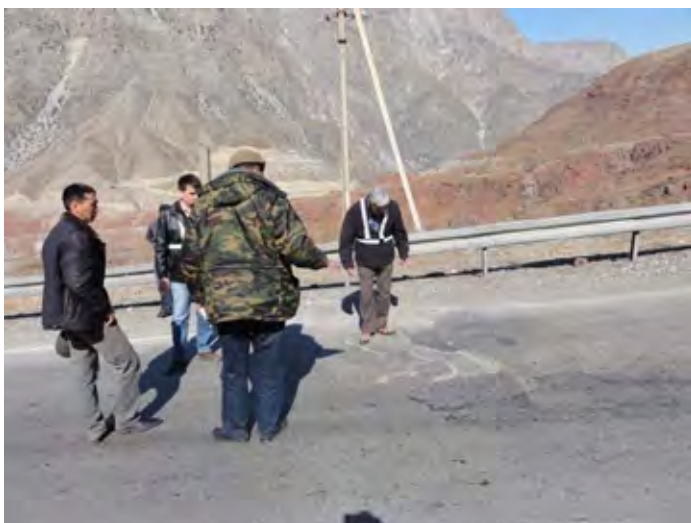
坂道のためブレーキをかけているタ
イヤの荷重が路面に影響する

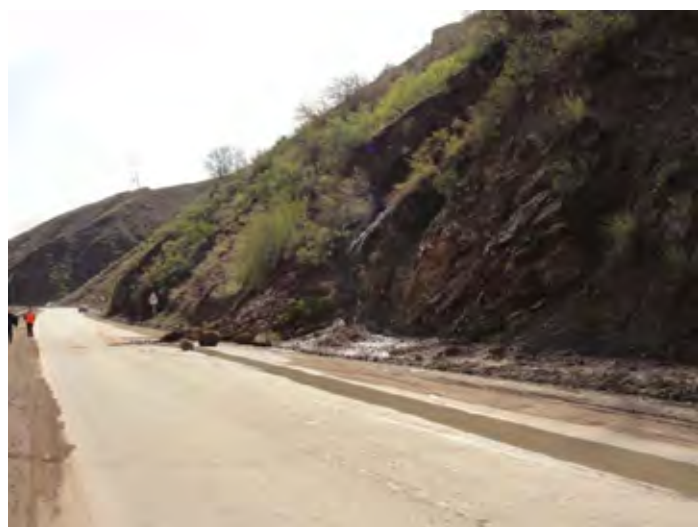
397K+500

土砂崩れ

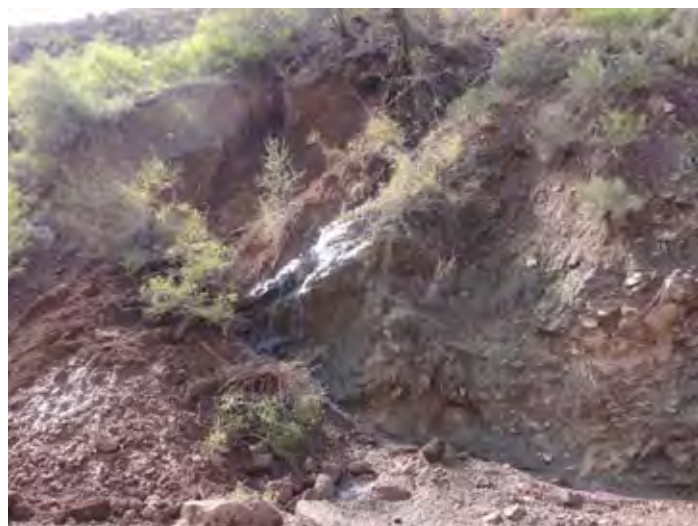
土砂崩れ

降水量が多かった翌日などに発生する

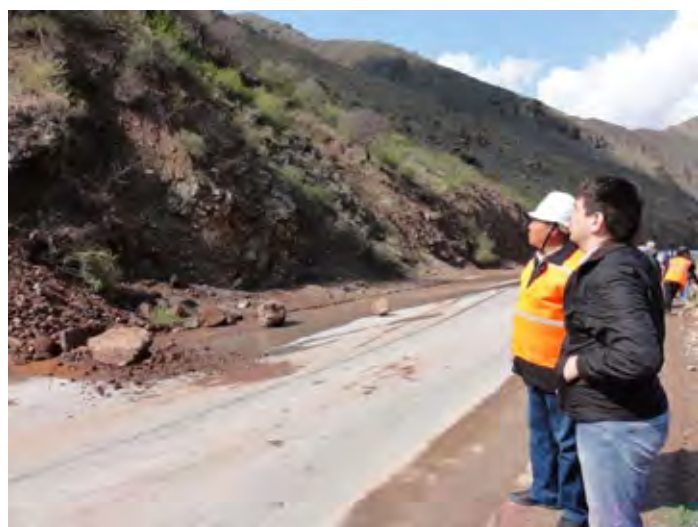
この箇所は例年崩れている
2時間後に復旧終了した

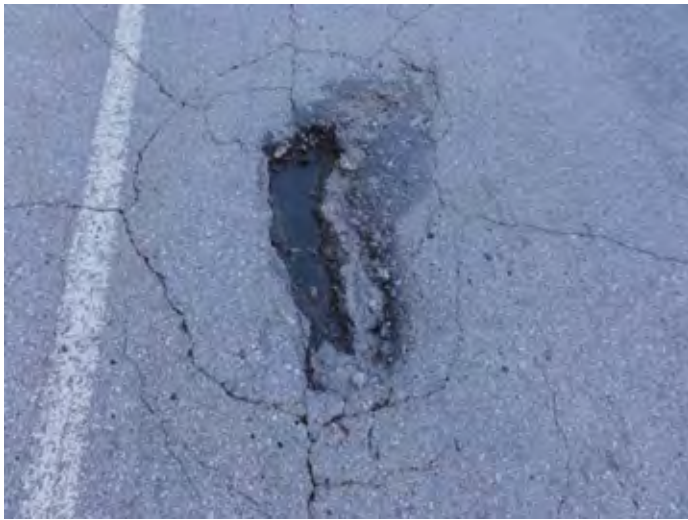
401K+200

ポットホール

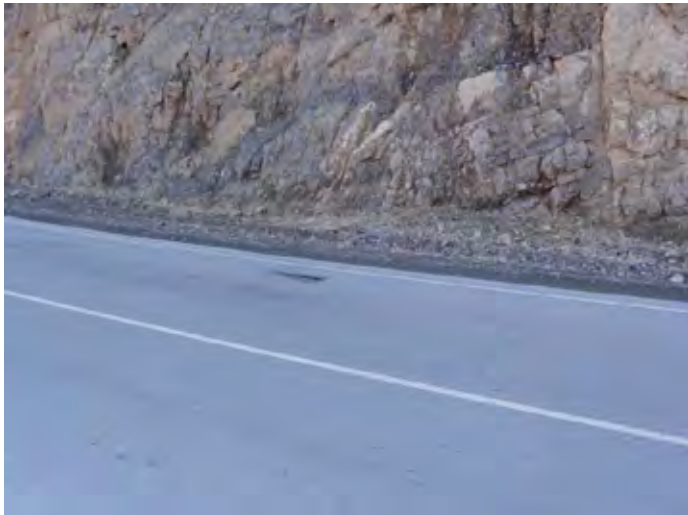
ポットホール

30cm×100cm

落石により発生したと思われる

落石の衝撃により周囲に放射状のクラックが進展している

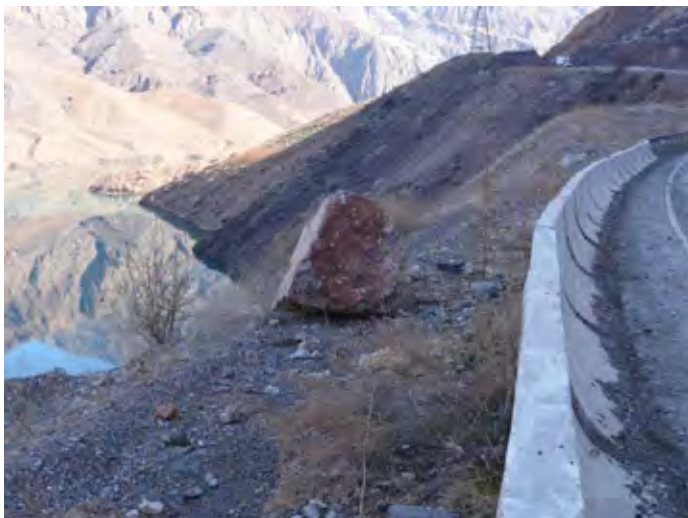
ポットホール

山側の路線で発生

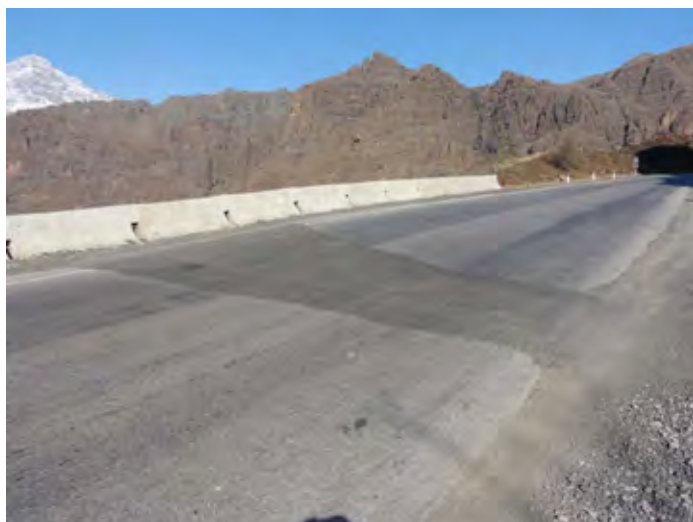
403K+550

路面沈下による段差

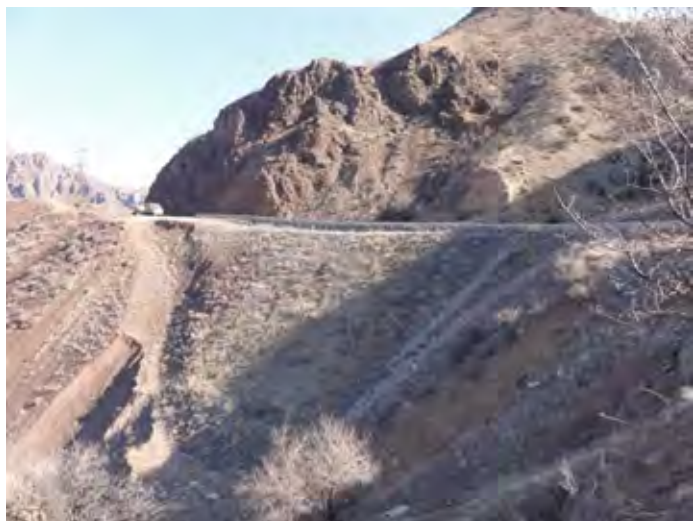
段差
延長 6m×幅 9m
切土と盛土の境界部

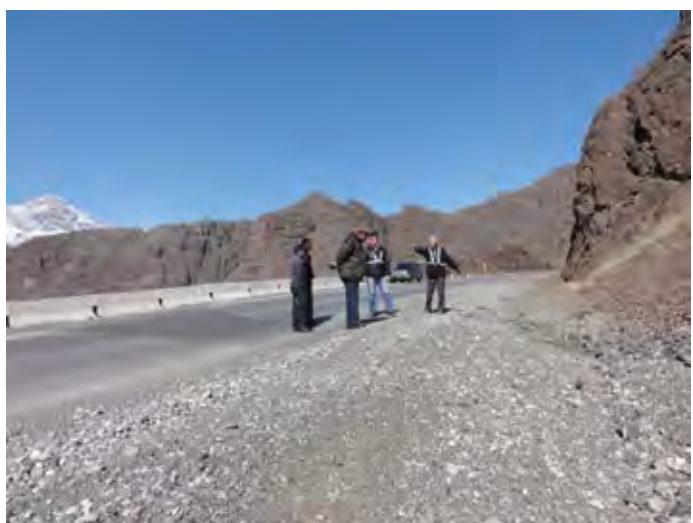
盛土法面
一部崩落している

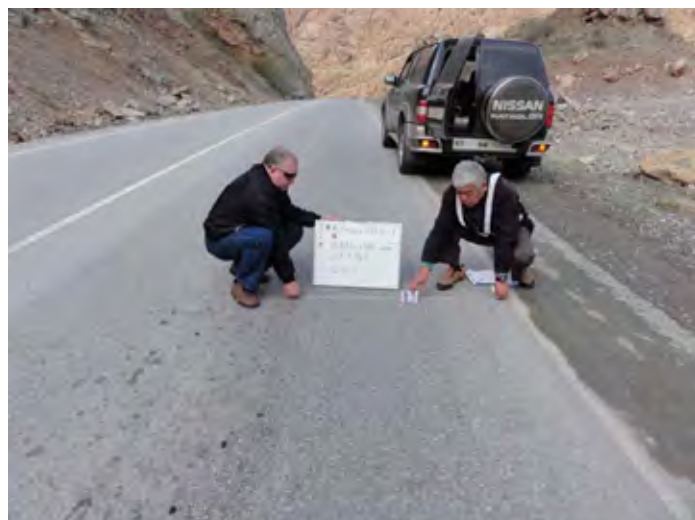
404K+540-600

わだち掘れ

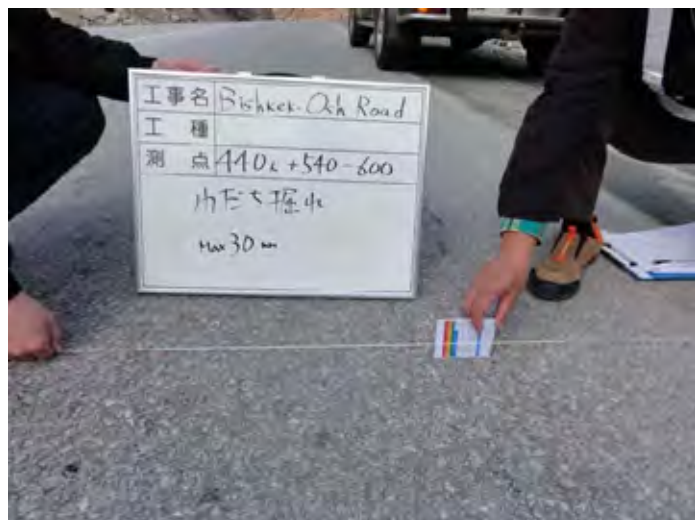
わだち掘れ

わだち掘れ量=最大 30mm

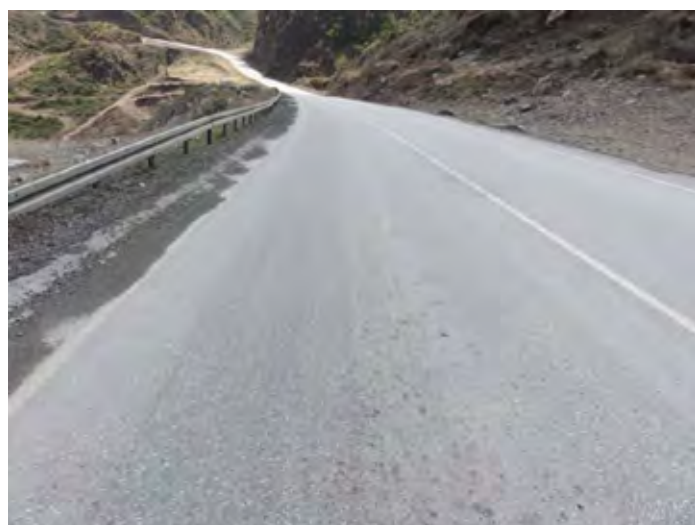
わだち掘れ
