Ex-Post Evaluation Report of Japanese ODA Loan Projects 2009 (Bulgaria, Albania)

January 2011

Port of Bourgas Expansion Project

External Evaluator: Kenichi Inazawa, Office Mikage, LLC

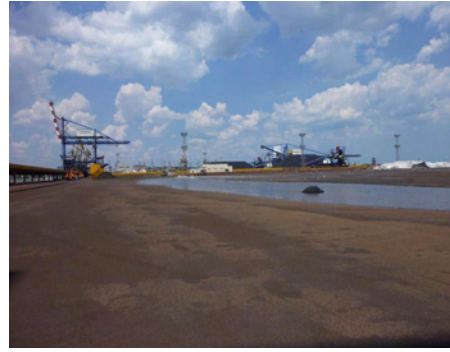
As shown in Figure 8 below, there is a damaged part (a dent) on the surface of Berth No. 32. According to POB, the dent was made when bulk transport that should have not been conducted was actually conducted, due to the lack of cargo handling equipment.³⁹ As a result, it seems that an excessive load was placed on the area where the dent eventually formed, making the foundation sag.⁴⁰

³⁹ Transport by bulldozers and heavy machineries adds lots of burden (excess load).

Figure 8: Dent at Berth No.32⁴¹

As a general conclusion of the “Current Status of Operation and Maintenance,” there is no problem regarding the implementation details of maintenance. Nevertheless, as mentioned above, there are concerns that damage has occurred at the berth and that there is no plan to repair this affected area even now. Repair work must be conducted as soon as possible.

2) Regarding the damage in Berth No. 32 at Terminal 2A, Bulgarian side should immediately identify repair methods, a schedule, and costs. The cargo handling volume is currently decreasing, and should berth operating hours become longer because the berths are being used as a transit port, cargo handling will be affected if repairs are delayed. This could become a heavy burden on the financial condition of the Executing Agency, if concerns regarding the lack of maintenance budgets cannot be resolved.

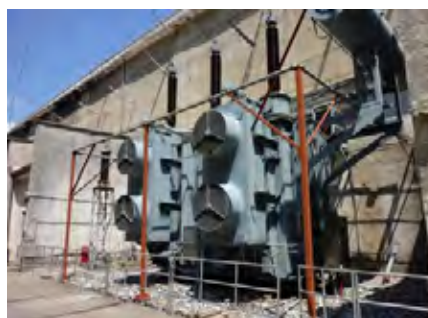
¹⁵ In June 2005, a malfunction of a wall tube insulator installed in the step-up transformer caused a fire. The transformer was set in a generator that connected to the No. 2 generator unit. (The suspected cause was an aged instrument.) Due to this accident, the entire generator units went into abeyance for nearly a month, and the No. 2 generator unit was in abeyance until March 2006. Since rehabilitation and inspection took place during this period, the power generation amount during 2005–2006 dropped in comparison with that of 2004. Like the situation at the Fierza Hydropower Station, it should be noted that the high-pressure wall tube insulator was not included in the rehabilitation target of the entire project. After the rehabilitation work completed, the entire generator unit has operated without problems.

Figure 9: Generator Step-up Transformer²³
(Adjacent to Power Generation Building at
Fierza Hydropower Station)
