JICA (Japan International Cooperation Agency)
Rehabilitation and Renovation of Polders and Embankment in
Ayeyarwaddy Division

Ref. No. JICA-RRPE (Ayeyarwaddy) -01

Re: Submission of Check List for Sluice Gates Functioning Condition

Re: Recommendation on Dike Repairing (Myitkyo Sluice)

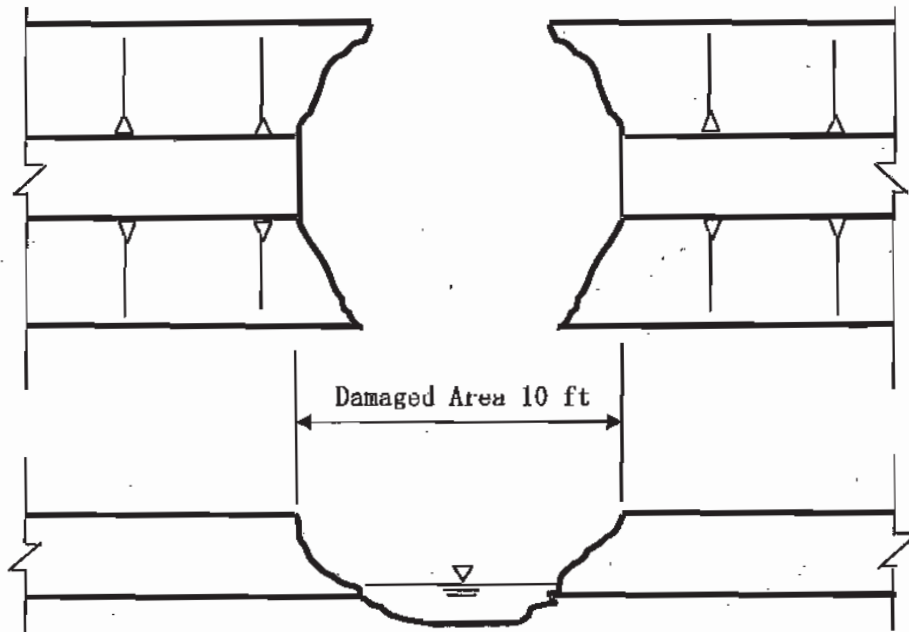
A JICA mission has inspected small damage of dike near Thabyegon village where the dike at old Chaung portion flashed twice during Nargis cyclone and following rainy season in 2008. Damaged area of the said dike is very small but it may cause saline water intrusion into polder and farm practice will face difficulties. An attached sketch is recommended dike repairing at the said portion.

Sketch of Damaged Portion of Dike at Old Chaung Route
