7. Site Note

Poders in Labutta Township

Labutta North Polder

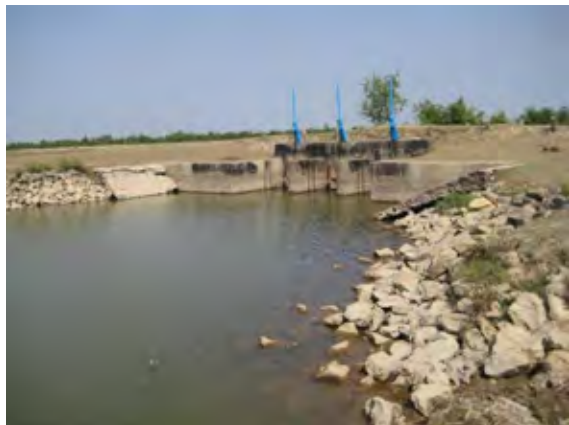
Shansu Sluice Gate

- Shansu sluice locates in Labutta (North) polder, it is about 1.5 km north direction from Labutta town.
- Sluice gate is composed of total 3 openings, upstream side is slide gate, downstream side is flap gate system.
- The said sluice has received no damage by Nargis Cyclone.

Gate No.	1	2	3
	Slide Gate	Slide Gate	Slide Gate
Land Side	It may be good but to be checked because corrosion was observed at the guide frame	It may be good but to be checked because corrosion was observed at the guide frame	It may be good but to be checked because corrosion was observed at the guide frame
	Flap Gate	Flap Gate	Flap Gate
River Side	Does not function well and saline water intruded when tide rises up. Required to be repaired	Does not function well and saline water intruded when tide rises up. Required to be repaired	Does not function well and saline water intruded when tide rises up. Required to be repaired

- Polder construction project “Paddy I” constructed 3m height above sea level dike but ECL (existing crest level) is only 2.1m so 0.9m of dike embankment from the top has been eroded due to water and wind erosion within last 30 years.

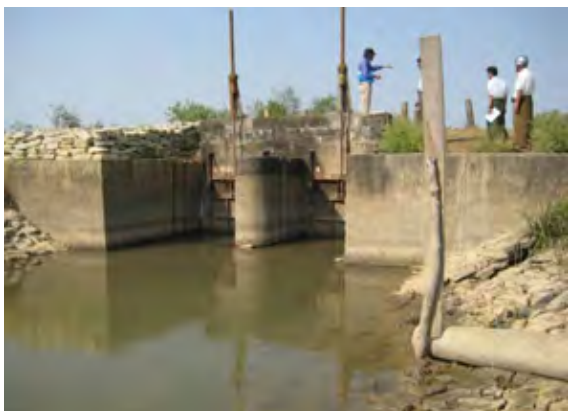
Kyaukchaung Sluice Gate

- Kyaukchaung sluice locates at northern part of Labutta (North) polder and it has 2 numbers of openings with relatively narrow leading and outfall channels.
- There was no damage due to Nargis cyclone according to the site engineer of Irrigation Department
- By inspection with site engineer, the condition of sluice is as follow;

Gate No.	1	2
Land Side	Slide Gate	Slide Gate
	It may be good but to be checked	It may be good but to be checked
River Side	Flap Gate	Flap Gate
	Does not function well and required to be repaired	Does not function well and required to be repaired

- Existing crest level of dike is about 2m and the original crest elevation after Paddy I project was 3m.

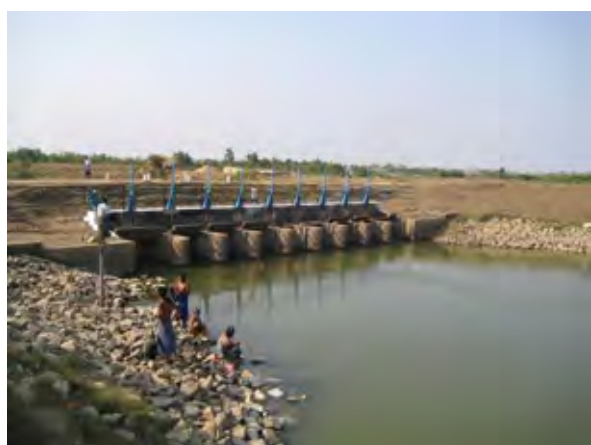
Labuttalok Sluice Gate

- Labuttalok sluice locates at west side of Labutta (North) polder, where is 1.5km inside from confluence between Thetkelthaung river and Labuttalok river.
- There is no damage due to Nargis cyclone.
- Total 9 openings have been installed, upstream side is slide gate system and downstream side is flap gate system and condition of each gate was checked with site engineer as follows;

Gate No.	1	2	3	4	5	6	7	8	9
Land Side	Slide Gate	Slide Gate	Slide Gate	Slide Gate	Slide Gate	Slide Gate	Slide Gate	Slide Gate	Slide Gate
	It may be good but corrosion was observed at the guide frame	It may be good but corrosion was observed at the guide frame	It may be good but corrosion was observed at the guide frame	It may be good but corrosion was observed at the guide frame	It may be good but corrosion was observed at the guide frame	It may be good but corrosion was observed at the guide frame	It may be good but corrosion was observed at the guide frame	It may be good but corrosion was observed at the guide frame	It may be good but corrosion was observed at the guide frame
River Side	Flap Gate	Flap Gate	Flap Gate	Flap Gate	Flap Gate	Flap Gate	Flap Gate	Flap Gate	Flap Gate
	Leakage of water due to sealing trouble	Leakage of water due to sealing trouble	Leakage of water due to sealing trouble	Leakage of water due to sealing trouble	Leakage of water due to sealing trouble	Leakage of water due to sealing trouble	Leakage of water due to sealing trouble	Leakage of water due to sealing trouble	Leakage of water due to sealing trouble

- Bank rehabilitation is recommended at both sides of leading channel embankment 300m from the sluice at

upstream, at both sides of outfall channel bank embankment 200m at downstream side from the sluice.

- Masonry steps shall be provided at the upstream of sluice for community utilization such as bathing and cloth washing where deep embankment erosion is observed, and gabion works are not recommended because the location has risk of saline water intrusion from downstream side.

- Existing crest level at the sluice is about 2.7 – 3.0m at this moment so execution of model embankment is considered not so difficult.
- Dike embankment length at right side will be about 300m, that of left side will be about 2.3km.

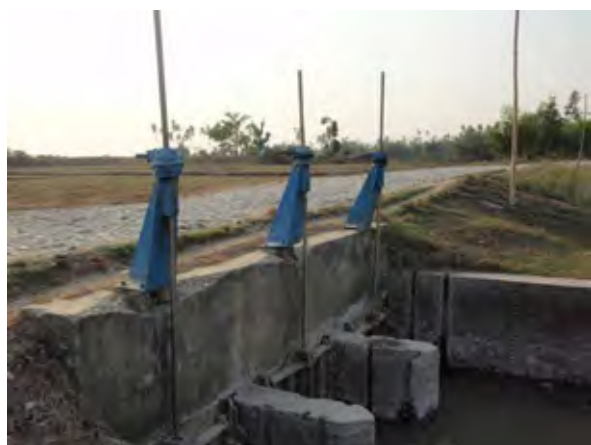
- Nyaunglain water retention gate locates along the branch river of Labuttalok river, near the confluence of the said both rivers (Labutta (North) polder).
- There is no sluice damage due to Nargis cyclone.
- condition of each gate was checked with site engineer as follows;

Gate No.	1	2	3
	Slide Gate	Slide Gate	Slide Gate
	RC concrete base was broken. Hoisting assembly to be repaired.	RC concrete base was broken. Hoisting assembly to be repaired.	RC concrete base was broken. Hoisting assembly to be repaired.

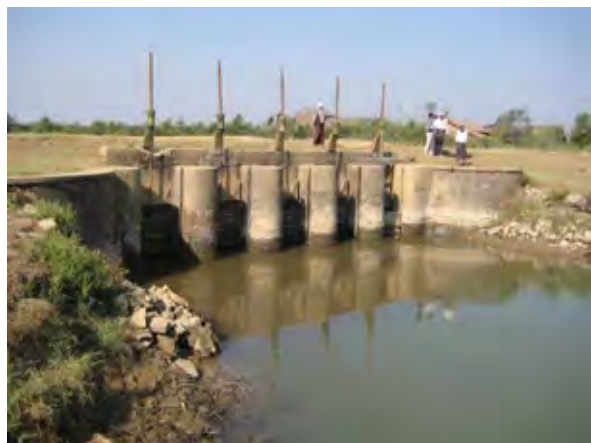
Latwaikwe Sluice Gate

- Latwaikwe sluice locates at southern side of Labutta (North) polder and it consist of five (5) opening.
- According to the site engineer of Irrigation Department, there is no damage of sluice due to Nargis cyclone.
- By inspection with site engineer, condition of sluice is as follows;

Gate No.	1	2	3	4	5
	Slide Gate	Slide Gate	Slide Gate	Slide Gate	Slide Gate
Land Side	RC base for Hoisting assembly is damaged. Hoisting assembly to be replaced.	RC base for Hoisting assembly is damaged.	RC base for Hoisting assembly is damaged. Hoisting assembly to be replaced.	RC base for Hoisting assembly is damaged.	RC base for Hoisting assembly is damaged.
	Flap Gate	Flap Gate	Flap Gate	Flap Gate	Flap Gate
River Side	Need to repair due to sealing trouble.	Need to repair due to sealing trouble.	Need to repair due to sealing trouble.	Need to repair due to sealing trouble	Need to repair due to sealing trouble.

- “Save the Children” had their activity to purify canal water up to the end of January 2009 and delivered water to 10 villages near by about 4,500 peoples but salt content of the canal water became high so they have abandoned this place for water purifying and shifted to another place.
- Existing crest level of dike around the sluice was about 1.8m and implemented dike height was 3.0m so 1.2m of soil erosion had occurred.
- About 0.3m depth of flood water overtopping (saline water) was observed by a gate keeper at Nargis cyclone.

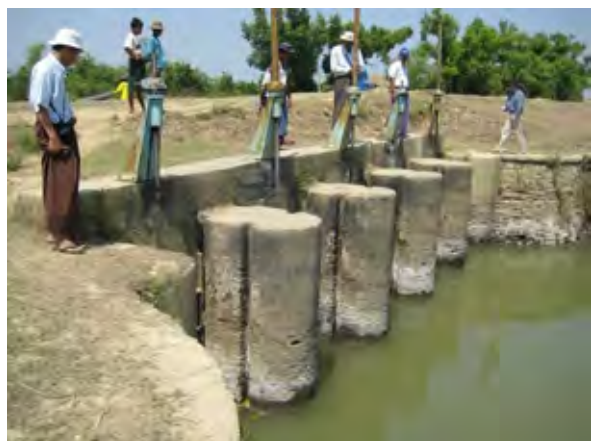
Mayan (south) Sluice Gate

- Mayan (south) sluice locates along Mayan river at southwest side of Labutta (north) polder, consist of five (5) numbers of openings.
- There is no sluice damage due to Nargis cyclone.
- By inspection with site engineer, condition of the sluice gate is as follows;

Gate No.	1	2	3	4	5
Land Side	Slide Gate	Slide Gate	Slide Gate	Slide Gate	Slide Gate
	Hoisting assembly to be repaired.	It may be good, but to be checked.	It may be good, but to be checked.	Hoisting assembly to be repaired.	It may be good, but to be checked.
River Side	Flap Gate	Flap Gate	Flap Gate	Flap Gate	Flap Gate
	Seal portion to be repaired due to leakage of water.	Seal portion to be repaired due to leakage of water.	Seal portion to be repaired due to leakage of water.	Seal portion to be repaired due to leakage of water.	Seal portion to be repaired due to leakage of water.

- Existing crest level of dike around sluice is 1.8m, original height of it is 3.0m after implementation of Paddy I project.

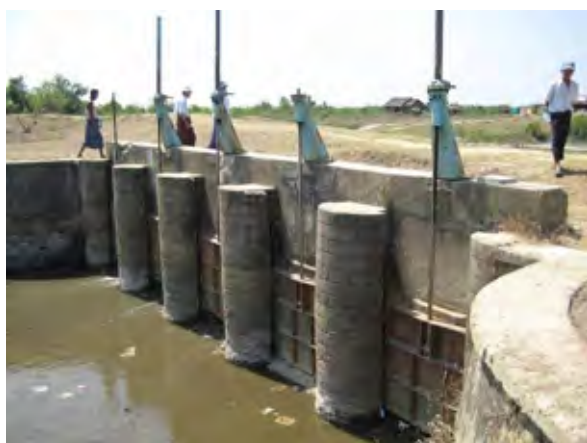
Mayan (north) Sluice Gate

- This sluice locates just north side of Mayan (south) sluice and is composed of 5 openings.
- By inspection with site engineer, condition of the sluice gate is as follows;

Gate No.	1	2	3	4	5
Land Side	Slide Gate	Slide Gate	Slide Gate	Slide Gate	Slide Gate
	Hoisting assembly to be repaired.	It may be good, but to be checked.	Hoisting assembly to be repaired.	Hoisting assembly to be repaired.	It may be good, but to be checked.
River Side	Flap Gate	Flap Gate	Flap Gate	Flap Gate	Flap Gate
	Seal portion to be repaired due to leakage of water.	Seal portion to be repaired due to leakage of water.	Seal portion to be repaired due to leakage of water.	Seal portion to be repaired due to leakage of water.	Seal portion to be repaired due to leakage of water.

- Existing crest level of dike is 1.75m but there was no flood water overtopping during Nargis cyclone passing.
- Some portions of dike neat this sluice was damaged by Nargis cyclone and emergency repairing was carried out by Irrigation Department.

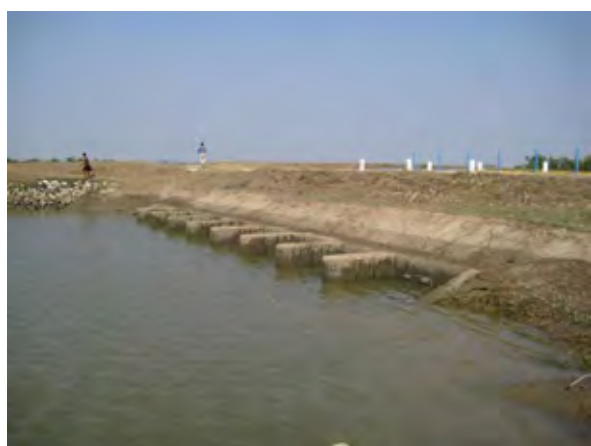
Phope Sluice Gate

- Phopea sluice locates northern side of Labutta (north) polder, along Kyauk Phyu river with wide width.
- The sluice consists of ten (10) numbers of openings.
- By inspection with site engineer, condition of the sluice gate is as follows;

Gate No.	1	2	3	4	5	6	7	8	9	10
Land Side	Slide Gate	Slide Gate	Slide Gate	Slide Gate	Slide Gate	Slide Gate	Slide Gate	Slide Gate	Slide Gate	Slide Gate
	It may be good but to be checked.	It may be good but to be checked.	It may be good but to be checked.	It may be good but to be checked.	It may be good but to be checked.	It may be good but to be checked.	RC base and Hoisting assembly are damaged	RC base and Hoisting assembly are damaged	RC base and Hoisting assembly are damaged	RC base and Hoisting assembly are damaged
River Side	Flap Gate	Flap Gate	Flap Gate	Flap Gate	Flap Gate	Flap Gate	Flap Gate	Flap Gate	Flap Gate	Flap Gate
	Leakage of water and to be checked	Leakage of water and to be checked	Leakage of water and to be checked	Leakage of water and to be checked	Leakage of water and to be checked	Leakage of water and to be checked	Leakage of water and to be checked	Leakage of water and to be checked	Leakage of water and to be checked	Leakage of water and to be checked

- Stop logs between two (2) gates made by iron are all rusted and it can not be used.
- In stead of iron stop logs, stop logs with concrete piers are recommended.

- There is no sluice damage by Nargis cyclone.

Location	Items	Feet (ft)	Meter (m)
Land Side	Temporary coffer dam length	148	45
	Temporary coffer dam height	6	1.8
River Side	Temporary coffer dam length	197	60
	Temporary coffer dam height	11	3.3

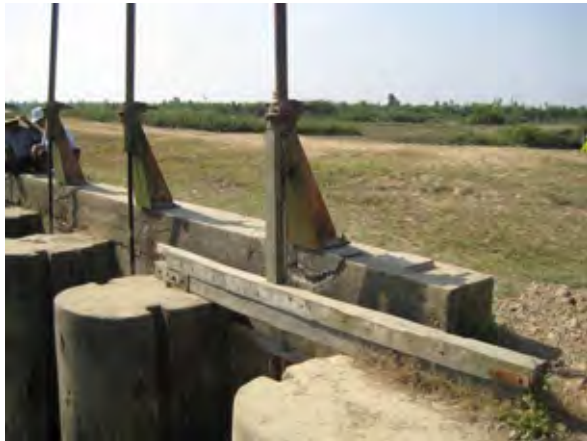
Gantate Sluice Gate

- Gantate sluice located at west side of Labutta (south) polder and consist of 3 openings.
- There is no damage by Nargis cyclone in this sluice.
- By inspection with site engineer, condition of the sluice gate is as follows;

Gate No.	1	2	3
Land Side	Slide Gate	Slide Gate	Slide Gate
	It may be good but to be checked.	It may be good but to be checked.	It may be good but to be checked.
River Side	Flap Gate	Flap Gate	Flap Gate
	To repair seal to reduce the water leakage	To repair seal to reduce the water leakage	To repair seal to reduce the water leakage

- No flood overtopping was observed at the time of Nargis cyclone passing.
- Existing crest level of dike around sluice is about 1.8m, it is considered to be eroded from 3.0m after Paddy I project implementation.

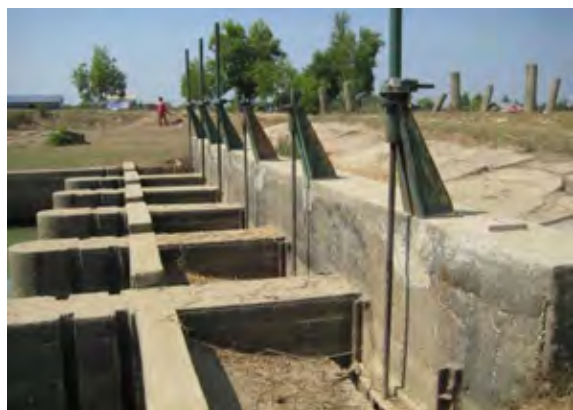
Kwaklake Sluice Gate

- Kwaklake sluice locates at the northern side of Gantate sluice in Labutta (south) polder and is composed of six (6) numbers of openings.
- There is no damage due to Nargis cyclone and any flat water over topping.
- By inspection with site engineer, condition of the sluice gate is as follows;

Gate No.	1	2	3	4	5	6
Land Side	Slide Gate	Slide Gate	Slide Gate	Slide Gate	Slide Gate	Slide Gate
	Hoisting assembly to be repaired or replaced	It may be good, but to be checked.	It may be good, but to be checked.	Hoisting assembly to be repaired or replaced	Hoisting assembly to be repaired or replaced	It may be good, but to be checked.
River Side	Flap Gate	Flap Gate	Flap Gate	Flap Gate	Flap Gate	Flap Gate
	Leakage of water and seal to be repaired	Leakage of water and seal to be repaired	Leakage of water and seal to be repaired	Leakage of water and seal to be repaired	Leakage of water and seal to be repaired	Leakage of water and seal to be repaired

- “Save the Children” worked at Latwaikwe sluice has shifted to this place for purifying water, targeting 46 villages, 20,000 people, 3 liter per day per capita, and their water purifying capacity is about 2,400liter per day at this moment.
- Drinking water activities by “Save the Children” are planned up to the end of May 2009, it is not sure their schedule after May.
- Existing crest level of dike around sluice is 2.1m, which has been eroded from 3.0m height after completion of Paddy I project.

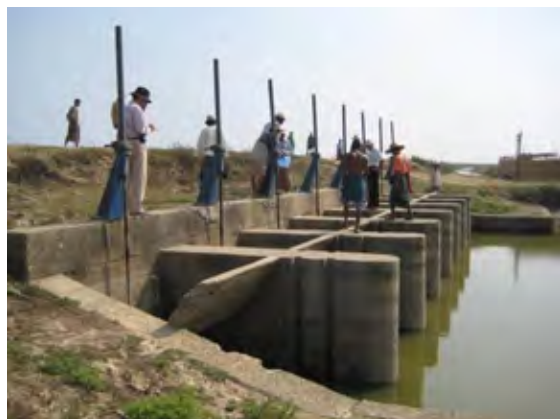
Mi U Sluice Gate

- Mi U Sluice locates at south of Labutta (South) polder and consist of 8 openings.
- By inspection with site engineer, condition of the sluice gate is as follows;

Gate No.	1	2	3	4	5	6	7	8
Land Side	Slide Gate	Slide Gate	Slide Gate	Slide Gate	Slide Gate	Slide Gate	Slide Gate	Slide Gate
	It may be good but to be checked. RC concrete base to be repaired.	It may be good but to be checked. RC concrete base to be repaired.	It may be good but to be checked. RC concrete base to be repaired.	It may be good but to be checked. RC concrete base to be repaired.	It may be good but to be checked. RC concrete base to be repaired.	It may be good but to be checked. RC concrete base to be repaired.	It may be good but to be checked. RC concrete base to be repaired.	It may be good but to be checked. RC concrete base to be repaired.
River Side	Flap Gate	Flap Gate	Flap Gate	Flap Gate	Flap Gate	Flap Gate	Flap Gate	Flap Gate
	Seal were to be repaired	Seal were to be repaired	Seal were to be repaired	Seal were to be repaired	Seal were to be repaired	Seal were to be repaired	Seal were to be repaired	Seal were to be repaired

- The dike was overlapped by 0.3m during Nargis and erosion occurred at that time was repaired by Irrigation Department as emergency repairs. At the time of inspection, the dike was repair as communication road from Labutta to Pyinsalu.
- There was a temporary coffer dam at Downstream channel made by “Save the children” to purify the water for drinking of villagers near by the purifying machine are still installing and not yet functioning.

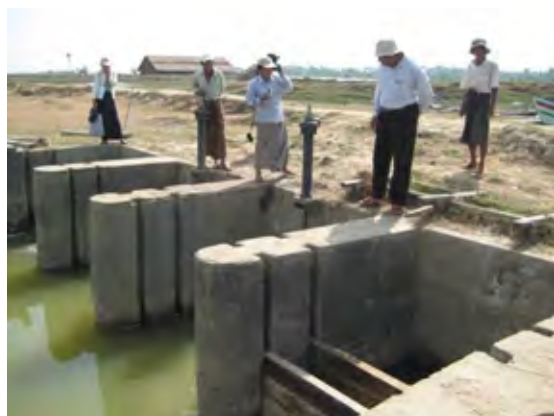
Tawgaung Sluice Gate

- Tawgaung sluice gate locates in Alekyun No. 3 polder.
- There are four (4) openings at this sluice, No. 1 and No. 4 gates at upstream side are stop log system, No. 2 and No. 3 at upstream side are slide gate system.
- Four (4) numbers of flap gates are installed at downstream side openings.
- By inspection with site engineer, condition of the sluice is as follows;

Gate No.	1	2	3	4
Land Side	Stop log	Stop log	Stop log	Stop log
	Slide should be installed	Shaft is to be replaced	Damaged by Cyclone Nargis. Gear assembly shaft, Guide frame are to be repaired.	Slide should be installed
River Side	Flap Gate	Flap Gate	Flap Gate	Flap Gate
	Leakage of water and need to repair seal	Leakage of water and need to repair seal	Leakage of water and need to repair seal	Leakage of water and need to repair seal

- Temporary cofferdam for the said repairing will be 30m with 2.7m height at upstream and 45m with 4.6m width at downstream side.

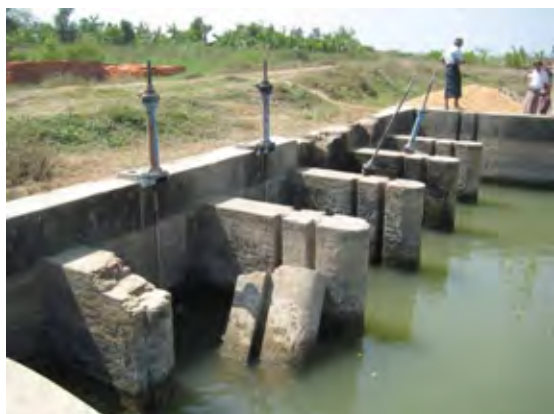
Kaingtaw Sluice Gate

Kaingtaw Sluice locates at west of Betud (3) polder.

- Total numbers of upstream side gates are 6 numbers.
- Out of six 6 gates, Number 1 and Number 6 gates are composed of stop log system.
- From No.2 to No.5 gates are composed of slide gate system..
- By inspection with site engineer, condition of sluice is as follows.

Gate No.	1	2	3	4	5	6
	Stop log	Slice Gate	Slice Gate	Slice Gate	Slice Gate	Stop log
Land Side	Damaged by Nargis New Slide gate should be installed.	Shaft to be repaired.	Shaft to be repaired.	Damaged by Nargis.	Damaged by Nargis.	New slide gate should be installed.
	Flap Gate	Flap Gate	Flap Gate	Flap Gate	Flap Gate	Flap Gate
River Side	To be repaired to seal for water tightness.	To be repaired to seal for water tightness.	To be repaired to seal for water tightness.	Gate leave was broken to be replaced.	To be repaired to seal for water tightness.	To be repaired to seal for water tightness.

- About 1.2m in depth of overtopping was observed at the time of Nargis cyclone.
- Irrigation Department has executed emergency recovery embankment works around this area especially at water breaching dike portion.
- Constructed dike height at Paddy I was implemented with 3.05m in height.
- ECL (existing crest elevation) is 1.2m so 1.85m has been eroded by water and wind affects after thirty

years period of embankment of Paddy I project.

If gate repairing work is required, estimated coffer dam site is as follows.

Location	Items	Feet (ft)	Meter (m)
Land Side	Temporary coffer dam length	80	24
	Temporary coffer dam height	6	1.8
River Side	Temporary coffer dam length	120	36
	Temporary coffer dam height	18	5.2

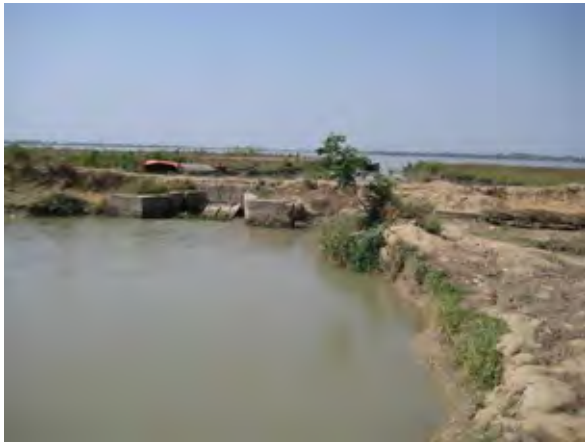
Kadauksat Sluice Gate

Kadauksat Sluice locates at North of Betud (3) polder.

- There is only 1 sluice gate system at this portion.
 - After Paddy I project implementation, there was no sluice gate system at this portion.
 - After the said implementation, Irrigation Department has prepared one sluice gate for summer paddy cultivation.
 - The sluice gate has 4 feet and 4 feet square cross section of concrete barrel.
- The said sluice gate system is composed of 1 flap gate at downstream side and also 1 flap gate at upstream side by inspection with site engineer, the sluice condition is as follows.

Gate No.	1
Land Side	Flap Gate
	Damaged due to long time operation.
River Side	Flap Gate
	Damaged due to long time operation.

- Existing crest level is 1.22m, original height after dike completion by Paddy I project is 3.05m, and planned dike height after Nargis by Irrigation Department is 3.05m.
- Overtopping flood of 0.91m was observed by a gate keeper, U Myint Swe at the time of Nargis cyclone.
- According to U Myint Swe, yield of 80 baskets per acre was average around this area before Nargis cyclone.
- After Nargis cyclone, average yield goes down to about 40 baskets per acre
- This area is just downstream side of saline water intrusion boundary so recovery of paddy yield may be limited comparing with that in Pogwegyi sluice gate service area.
- Water in canal system can be used for not only domestic purpose but also drinking.

If gate repairing work is required, estimated coffer dam site is as follows.

Location	Items	Feet (ft)	Meter (m)
Land Side	Temporary coffer dam length	55	17
	Temporary coffer dam height	9	2.74
River Side	Temporary coffer dam length	100	30
	Temporary coffer dam height	12	3.66

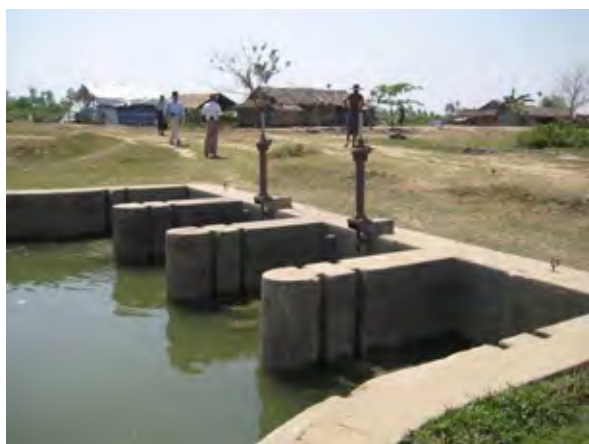
Pogwegyi Sluice Gate

Pogwegyi Sluice locates west of Betud (4) polder.

- Total sluice gate system number at this site is total four (4).
- No. 1 and No. 4 gates at upstream side are flap gates.
- Remaining No. 2 and No. 3 gates at upstream are slide gates.
- Four (4) numbers of flap gates were installed at downstream side of this sluice gates system.

Gate No.	1	2	3	4
	Flap Gate	Slide Gate	Slide Gate	Flap Gate
Land Side	Leakage of water and need to repair alloy seal.	It may be good but to be checked.	It may be good but to be checked.	Leakage of water and need to repair alloy seal.
	Flap Gate	Flap Gate	Flap Gate	Flap Gate
River Side	Need to repair for water tightness.	Need to repair for water tightness.	Need to repair for water tightness.	Leakage of water and need to repair alloy seal.

- Existing crest level 1.22m, original height after dike completion by Paddy I project is 3.05m, and planned dike height after Nargis by Irrigation Department is 3.05m.
- Overtopping flood of 0.91m was observed by a gate keeper, U Kala at the time of Nargis cyclone.
- According to U Kala, yield of 70-80 baskets per acre was average around this area before Nargis cyclone.
- After Nargis cyclone, average yield goes down to about 60 baskets per acre.
- This area is upper side of saline water intrusion boundary so villagers can get fresh water easier than that of sea side area.
- Water in canal system can be used for not only domestic purpose but also drinking purpose.
- Some farmers can cultivate summer even after Nargis cyclone.
- After Nargis cyclone, WFP provided villagers rice and beans.

If gate repairing work is required, estimated coffer dam site is as follows.

Location	Items	Feet (ft)	Meter (m)
Land Side	Temporary coffer dam length	80	25
	Temporary coffer dam height	10	3.05
River Side	Temporary coffer dam length	150	45
	Temporary coffer dam height	13	3.96

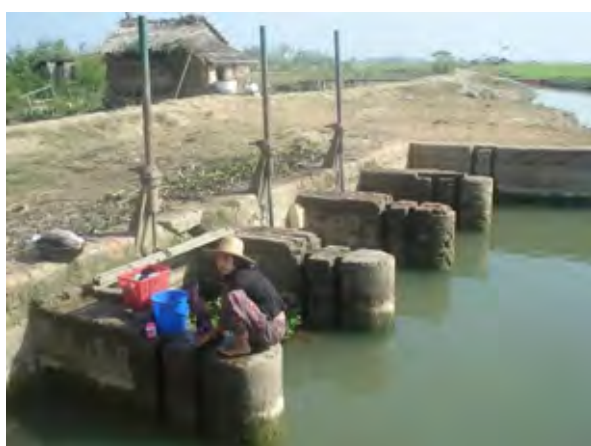
Kakayan Sluice Gate

- Kakayan sluice locates in Bitut No. 4 polder and consists of five (5) openings.
- No. 1 and 5 at upstream side are flap gates, No. 2, 3, 4 are slide gates.
- Shaft of those three (3) slide gates are bent but not due to Nargis cyclone, those shaft to be repaired.

Gate No.	1	2	3	4	5
Land Side	Flap Gate	Slide Gate	Slide Gate	Slide Gate	Flap Gate
	Seal to be repaired.	Shaft is bent and RC base to be repaired.	Shaft is bent and RC base to be repaired.	Shaft is bent and RC base to be repaired.	Seal to be repaired.
River Side	Flap Gate	Flap Gate	Flap Gate	Flap Gate	Flap Gate
	Seal portion to be repaired due to leakage of water.	Seal portion to be repaired due to leakage of water.	Seal portion to be repaired due to leakage of water.	Seal portion to be repaired due to leakage of water.	Seal portion to be repaired due to leakage of water.

- Existing crest level around dike is 1.5m, 0.3 – 0.6m of flood water overtopping was observed during Nargis cyclone passing.
- Temporary cofferdam at downstream side will be 45m length with 4.5m high, upstream side will be 30m with 1.8m high.
- Monsoon paddy average yield before Nargis Cyclone was 80 basket per acre, but it declined to 60 baskets per acre after Nargis cyclone passing.
- At this present, summer paddy is cultivated.

If gate repairing work is required, estimated coffer dam site is as follows.

Location	Items	Feet (ft)	Meter (m)
Land Side	Temporary coffer dam length	100	30
	Temporary coffer dam height	6	1.8
River Side	Temporary coffer dam length	150	45
	Temporary coffer dam height	15	4.5

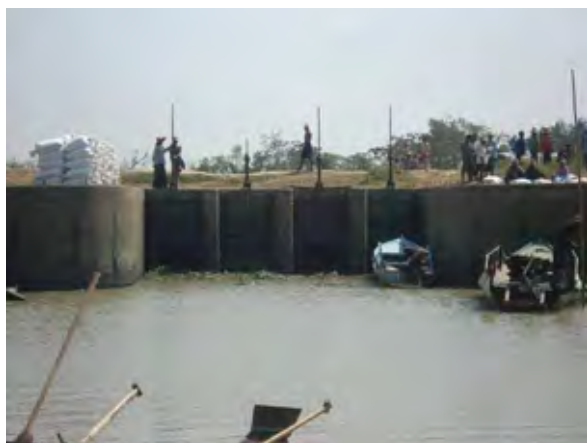
Chaug Bwe Sluice Gate

- Chaug Bye sluice locates in Bitut No. 4 polder and consists of four (4) openings.
- River side of the sluice faces always fresh water.
- Riverside (downstream side) has four (4) slide gates and land side has four (4) flap gates.

- By inspection with site engineer the condition of the sluice is as follows;

Gate No.	1	2	3	4
	Flap Gate	Flap Gate	Flap Gate	Flap Gate
Land Side	Leakage of water and seal to be repaired.	Leakage of water and seal to be repaired.	Leakage of water and seal to be repaired.	Leakage of water and seal to be repaired.
	Slide Gate	Slide Gate	Slide Gate	Slide Gate
River Side	Seal should be repaired.	Hoisting assembly to be repaired.	Hoisting assembly to be repaired.	Seal should be repaired.

- Existing crest level is EL. 1.5m and flood water overtopping was observed during Nargis cyclone passing about 0.3 – 0.6m.
- Average paddy yield per acre was 80 baskets, but after cyclone it became 60 baskets.

- If gate repairing work is required, estimated coffer dam site is as follow:

Location	Items	Feet (ft)	Meter (m)
Land Side	Temporary coffer dam length	65	20
	Temporary coffer dam height	8	2.5
River Side	Temporary coffer dam length	120	36
	Temporary coffer dam height	15	4.5

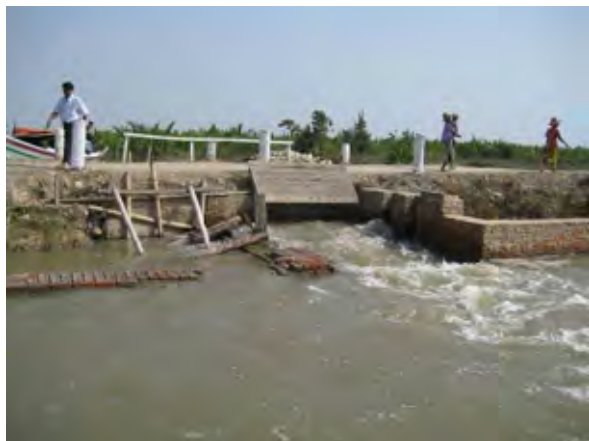
Lake Queen Sluice Gate

- This gate was newly designed by Irrigation Department in several years ago.
- There planned one (1) opening gate system only.
- During gate system construction, Nargis cyclone hit this gate system and gate under construction was broken.
- One sub-assistant engineer at this site passed away due to the said cyclone.
- Designed gate system is wooden flap gate so its function of water tightness is doubtful.
- Proper design with proper material is recommended.

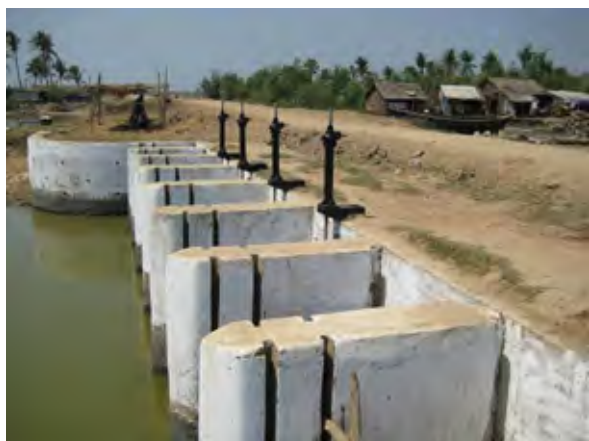
Kyon Kaw Sluice Gate

- Kyon Kaw Sluice locates in Sat San Village, at north-west side of Daung Gyi Polder.
- Checked sluice gate condition together with staff of Irrigation Department is as follows.

Gate No.	1	2	3	4	5	6	7	8
Land Side	Stop Log	Stop Log	Slide Gate	Slide Gate	Slide Gate	Slide Gate	Stop Log	Stop Log
	Slide gate to be installed	Slide gate to be installed	Hoisting assembly shall be maintained	Hoisting assembly shall be maintained	Hoisting assembly shall be maintained	Hoisting assembly shall be maintained	Slide gate to be installed	Slide gate to be installed
River Side	Flap Gate	Flap Gate	Flap Gate	Flap Gate	Flap Gate	Flap Gate	Flap Gate	Flap Gate
	Good but to be checked	Good but to be checked	Good but to be checked	Good but to be checked	Good but to be checked	Good but to be checked	Good but to be checked	Good but to be checked

- For repairing works of gates, estimated temporary cofferdam size is estimated as follows.

Location	Items	Feet (ft)	Meter (m)
Land Side	Temporary coffer dam length	131	40
	Temporary coffer dam height	9	2.7
River Side	Temporary coffer dam length	148	45
	Temporary coffer dam height	15	4.6

- In case of improvement of this sluice, recommended works are as follows.

Location	Description of works	Length (ft)	Length (m)
Land Side	Left side bank of leading channel improvement	328	100
	Right side bank of leading channel improvement	984	300
River Side	Left side bank of outfall channel improvement	1,312	400
	Right side bank of outfall channel improvement	1,312	400
