## Kathabaung Sluice Gate

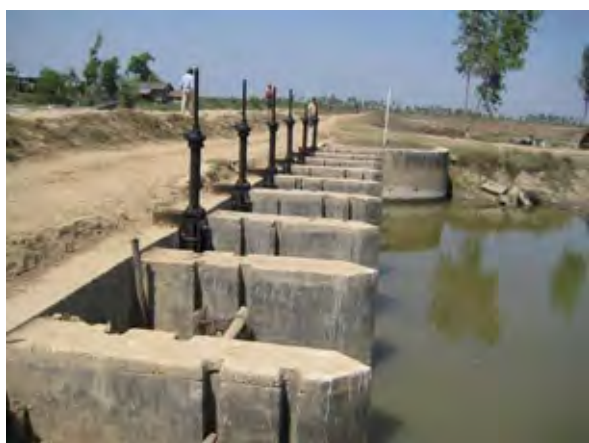
- Kathabaung Sluice faces the middle of northern side of the Daunggyi polder.
- Checked sluice gate condition together with staff of Irrigation Department is as follows.

Gate No.	1	2	3	4	5	6	7	8	9	10
Land Side	Stop Log	Stop Log	Slide Gate	Slide Gate	Slide Gate	Slide Gate	Stop Log	Stop Log	Stop Log	Stop Log
	Slide gate to be installed	Slide gate to be installed	Hoisting assembly shall be maintained	To maintain hoisting assembly, need to repair gate seal	To maintain hoisting assembly, need to repair gate seal	To maintain hoisting assembly, need to repair gate seal	Hoisting assembly shall be maintained	Hoisting assembly shall be maintained	Slide gate to be installed	Slide gate to be installed
River Side	Flap Gate	Flap Gate	Flap Gate	Flap Gate	Flap Gate	Flap Gate	Flap Gate	Flap Gate	Flap Gate	Flap Gate
	It may be good but to be checked	It may be good but to be checked	Gate seal shall be repaired	Gate seal shall be repaired	Gate seal shall be repaired	Leakage is not so serious but to be repaired	Leakage is not so serious but to be repaired	Seal condition seems to be good	It may be good but to be checked	Seal condition to be checked

- Existing crest level of dike around the sluice before Nargis cyclone was 2m (6.5 ft) and there was flood water overtopping 0.5 – 1.0m (1.6 – 3.3 ft) more or less (villagers’ explained figure was not the same).
- Irrigation Department (Construction Division (6)) had provided emergency embankment works around the sluice and its height was EL. 2.6m (8.5 ft)
- According to U Myint Soe, a staff of MFE, average yield of paddy around this area was about 45 – 50 baskets per acre and that of after the cyclone declined to 25 baskets per acre.
- According to U Kyaw Than, a gate keeper, salinity condition after Paddy I project had been improved because of function of flap gates but it was contaminated by saline water after the cyclone and salt content in channel increased.

- For repairing works of gates, estimated temporary cofferdam size is estimated as follows.

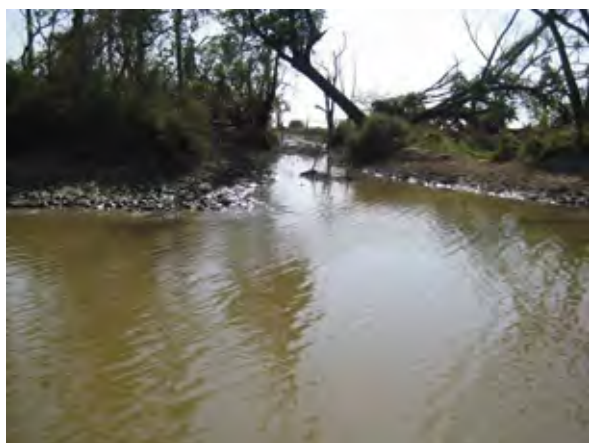
### Drainage channel enlargement

- There are opinions from farmers in Daung Gyi polder to deepen and widen drainage channel for obtaining supplemental water for summer crops.
- The observed channel bed level of said drainage is about 0.2m (0.7 ft) below average sea water level.
- Dredging of the said channel will result it result saline water reservoir because it can not drain saline water due to low elevation of channel bed level.
- Before improvement of Kathabaung sluice, it is not recommended to deepen and widen the said channel.

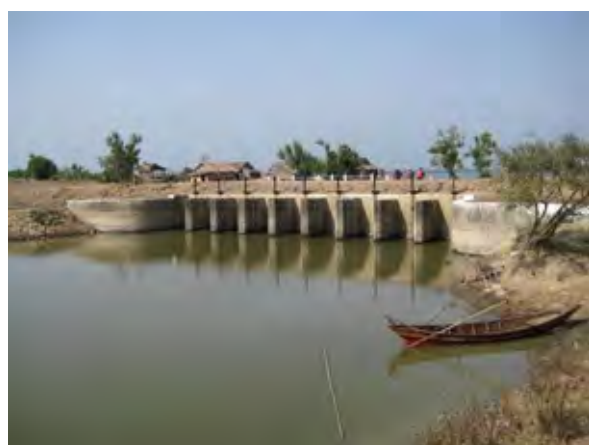
### Asigale Sluice Gate

- Asigale Sluice locates at western edge side of Daung Gyi Polder, directly facing Bogalay River.
- The location of this sluice is about 60m (200ft) from the confluence of Bogalay River so left bank of river side about 11m and right bank of it 15m are seriously eroded.
- There are nine (9) openings in the sluice and condition of each gate of opening was checked together with a gate keeper, U Hlaing Htun, Irrigation Department was as follows.

Gate No.	1	2	3	4	5	6	7	8	9
Land Side	Slide Gate	Slide Gate	Slide Gate	Slide Gate	Slide Gate	Slide Gate	Slide Gate	Slide Gate	Slide Gate
	There is leakage, to be repaired	It may be good but to be checked	It may be good but to be checked	It may be good but to be checked	It may be good but to be checked	It may be good but to be checked	There is leakage, to be repaired	It may be good but to be checked	There is leakage, to be repaired
River Side	Flap Gate	Flap Gate	Flap Gate	Flap Gate	Flap Gate	Flap Gate	Flap Gate	Flap Gate	Flap Gate
	There is leakage, to be repaired	There is leakage, to be repaired	There is leakage, to be repaired	It may be good but to be checked	There is leakage, to be repaired	It may be good but to be checked	It may be good but to be checked	It may be good but to be checked	It may be good but to be checked

- There was no damage of sluice structure by the cyclone.
- For repairing works of gates, estimated temporary cofferdam size is estimated as follows.

- The top elevation of sluice parapet was EL. 2.56m (8.41ft) and flood water overtopping was observed about 0.9m (3ft) above the parapet concrete.
- Present dike height around the sluice was 3.3m (10.9ft) and design dike level by Paddy I project was 2.6m (8.5ft).

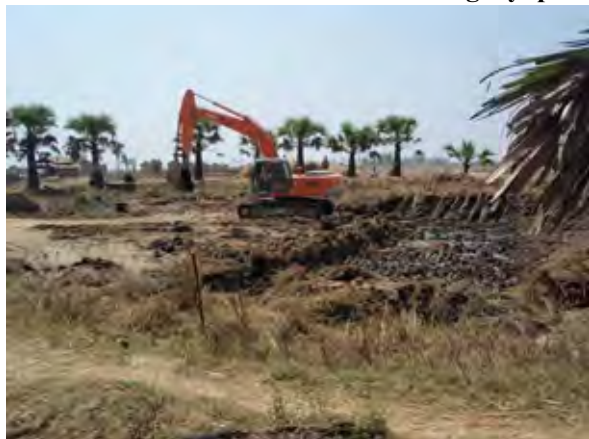
### Dike construction at west side of Daung Gyi polder

- Original dike of 1.8m (6ft) height, which design height was 2.6m (8.5ft) by Paddy I project was eroded by the cyclone hitting and ID constructed emergency dike at land side with 2.6m (8.5ft) height.
- Public Works Department is now carrying out communication and rural high way with height of 3.8m (12.5 ft) at the west side of polder.

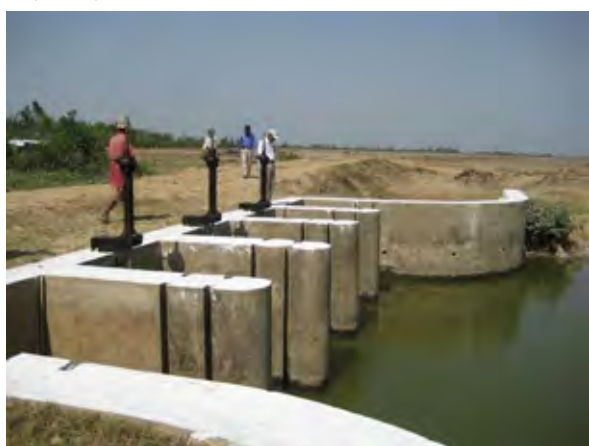
### Myit Kyo Sluice Gate

- Myit Kyo Sluice locates at southern side of Daung Gyi Polder.
- There are five (5) openings in the sluice and condition of each gate of opening was checked together with a staff of Irrigation Department was as follows.

Gate No.	1	2	3	4	5
Land Side	Stop Log	Slide Gate	Slide Gate	Slide Gate	Stop Log
	Stop log is completely embanked	It may be good but to be checked	It may be good but to be checked	It may be good but to be checked	Stop log is completely embanked
River Side	Flap Gate	Flap Gate	Flap Gate	Flap Gate	Flap Gate
	It may be good but to be checked	It may be good but to be checked	It may be good but to be checked	It may be good but to be checked	It may be good but to be checked

- There was no damage of sluice by the cyclone.
- If gate repairing work is required, estimated temporary cofferdam size is estimated as follows.

- Sluice concrete parapet top elevation was EL. 1.8m (6ft), emergency embankment was 2.3m (7.5ft), the present bank crest level around sluice was Existing Crest Level was 2.1m (6.75ft) about 0.2m (0.75ft) of height was settled.

- Design crest level by Paddy I project was 2.6m (8.5ft) and it might be eroded.
- According to information from U Kyaw Thu Ya, a 100 households leader, water quality of channel in the polder was good because of protection form saline water by dike and gates but salinity increased after the cyclone hitting due to dike breaching at Wei Chaung.

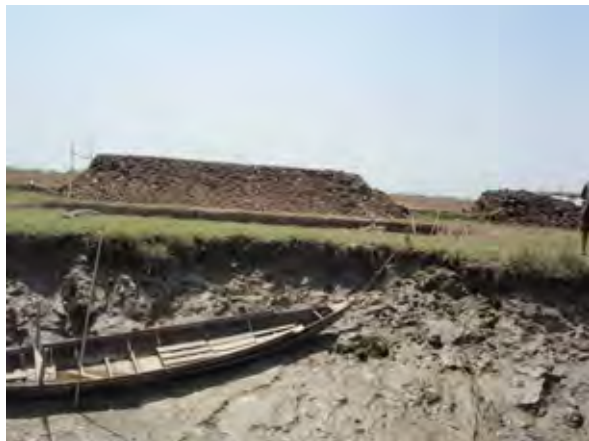
### Present condition of Reserved Forest

- Farmers occupied Pyindaye reserved forest already and utilized there as paddy farm land.
- Farmers Group organized to construct flood wave protection dike about 1.8m above ground level (6ft), which will be 3.8m (12.5ft) above sea level with their own cost.
- Labor charge of the dike construction is 2 US\$ (2,000 Kyat) per 1 suddram (2.8m<sup>3</sup>)
- Only two (2) area of reserved forests are kept as

reserved forest, other areas are developed as farm lands by farmers without any permission from the government

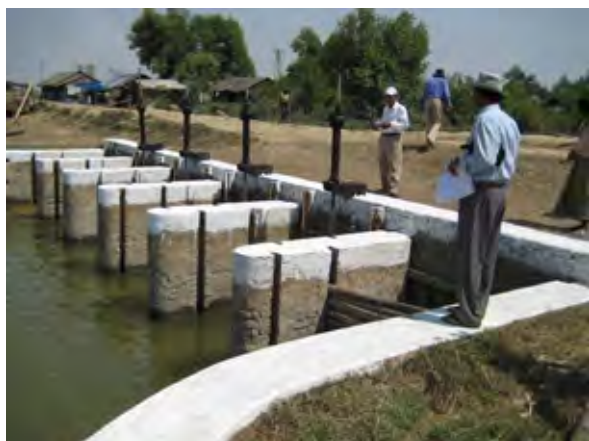
### Thechaung Sluice Gate

- Thechaung Sluice locates at southern part of Daunggyi Polder.
- There are six (6) numbers of openings in the sluice and condition of each gate of opening was checked together with a gate keeper U Tin Tun and staff of Irrigation Department was as follows.

Gate No.	1	2	3	4	5	6
	Stop Log	Slide Gate	Slide Gate	Slide Gate	Slide Gate	Stop Log
Land Side	Slide gate to be installed	Gate shaft is bent, hoisting holder is taken out	A fixing nut was lost	A fixing nut was lost	It may be good but to be checked	Slide gate to be installed
	Flap Gate	Flap Gate	Flap Gate	Flap Gate	Flap Gate	Flap Gate
River Side	It may be good but to be checked	It may be good but to be checked	There is leakage, to be repaired	It may be good but to be checked	It may be good but to be checked	It may be good but to be checked

- There was no damage by Nargis cyclone.
- If gate repairing work is required, estimated temporary cofferdam size is estimated as follows.

- Parapet concrete top elevation was 1.62m (5.3ft) and existing crest level was 1.68m (5.5ft) around the sluice, flood water overtopping at the cyclone was 0.3m (1ft), the top elevation of emergency embankment by Irrigation Department was 1.89m (6.2ft), design crest level by Paddy I project was 2.59m (8.5ft) respectively.

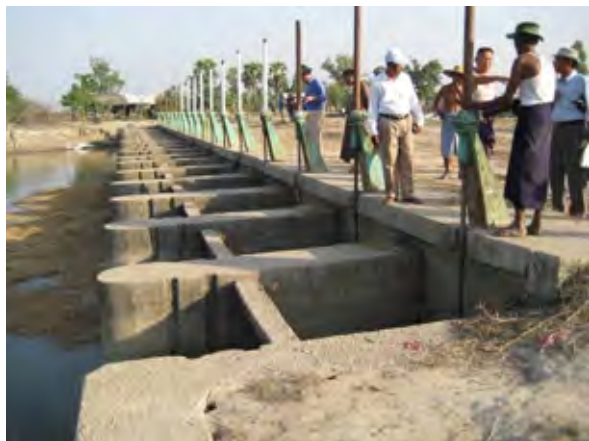
### Ye Kyaw Toe Sluice Gate

- Ye Kyaw Toe Sluice locates at southern part of Daunggyi (east) polder.
- There are twenty one (21) numbers of openings in the sluice and condition of each gate of opening was checked together with a gate keeper U Saw Shwe and staff of Irrigation Department was as follows.

Gate No.	1	2	3	4	5	6	7	8	9	10
	Slide Gate	Slide Gate	Slide Gate	Slide Gate	Slide Gate	Slide Gate	Slide Gate	Slide Gate	Slide Gate	Slide Gate
Land Side	Slide gate to be installed	Hoisting assembly shall be repaired, fixing nuts are lost	Hoisting assembly shall be repaired, fixing nuts are lost	Fixing nuts of hoisting assembly holder are lost	Hoisting assembly shall be repaired, fixing bolts are lost	Hoisting assembly shall be repaired	A part of hoisting assembly holder is broken, fixing bolts are lost	Fixing bolts, nuts of hoisting assembly holder are lost	Fixing bolts of hoisting assembly holder are lost	Concrete base of hoisting assembly holder is broken
	Flap Gate	Flap Gate	Flap Gate	Flap Gate	Flap Gate	Flap Gate	Flap Gate	Flap Gate	Flap Gate	Flap Gate
River Side	It may be good but to be checked	It may be good but to be checked	There is leakage, to be repaired	It may be good but to be checked	It may be good but to be checked	It may be good but to be checked	There is leakage, to be repaired	It may be good but to be checked	It may be good but to be checked	It may be good but to be checked

Gate No.	11	12	13	14	15	16	17	18	19	20	21
	Slide Gate	Slide Gate	Slide Gate	Slide Gate	Slide Gate	Slide Gate	Slide Gate	Slide Gate	Slide Gate	Slide Gate	Slide Gate
Land Side	A part of hoisting assembly holder is broken, fixing bolts are lost	It cannot be operated (very tight), fixing nuts are lost	Fixing nuts of hoisting assembly holder are lost	It may be good but to be checked	Fixing nuts of hoisting assembly holder are lost	Fixing nuts of hoisting assembly holder are lost	It cannot be operated (very tight), fixing nuts are lost	It cannot be operated (very tight), fixing nuts are lost	It may be good but to be checked	It may be good but to be checked	Fixing nuts of hoisting assembly holder are lost
	Flap Gate	Flap Gate	Flap Gate	Flap Gate	Flap Gate	Flap Gate	Flap Gate	Flap Gate	Flap Gate	Flap Gate	Flap Gate
River Side	It may be good but to be checked	It may be good but to be checked	It may be good but to be checked	It may be good but to be checked	It may be good but to be checked	It may be good but to be checked	It may be good but to be checked	It may be good but to be checked	It may be good but to be checked	It may be good but to be checked	It may be good but to be checked

- Before Nargis cyclone three (3) gates had trouble for operation at No. 13, No. 17, No. 18 but after the cyclone another six (6) numbers of gates become trouble, namely No.2, No.3, No. 8, No.9, No. 10, No. 11.
- If gate repairing work is required, estimated temporary cofferdam size is estimated as follows.

- Design dike height above sea level in Paddy II project was 2.6m (8.5ft), parapet concrete top elevation was 1.4m (4.5ft) and it was the same as existing crest level before the cyclone, flood water overtopping was 0.75m (2.5ft), emergency embankment after the cyclone by Irrigation Department was 0.3m (1ft).

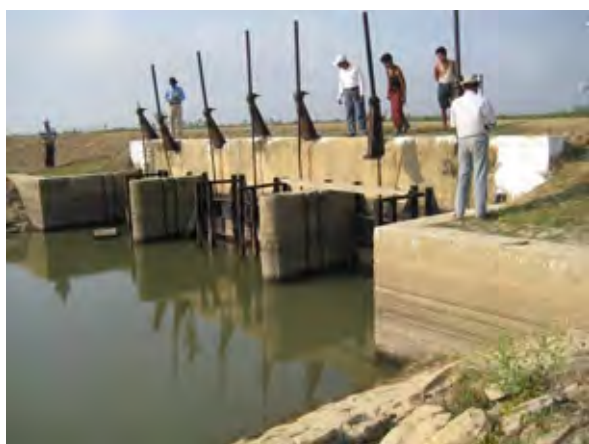
### Ponnayeik Sluice Gate

- Ponnayeik Sluice locates at west part of Daunggyi (west) polder
- There are seven (7) numbers of openings in the sluice and condition of each gate of opening was checked together with a gate keeper U Aung Ko Oo, a son of passed away gate keeper by the cyclone and staff of Irrigation Department was as follows.

Gate No.	1	2	3	4	5	6	7
Land Side	Slide Gate	Slide Gate	Slide Gate	Slide Gate	Slide Gate	Slide Gate	Slide Gate
	A hoisting assembly holder and a shaft were bent, a fixing nut is lost	A hoisting assembly holder moved, the gate is not functioning	There is no fixing bolt and nut at a hoisting assembly holder	An assembly holder does not support the gate due to no fixing nuts	There is no fixing nut at a assembly holder	Hitting by boat, a holder moved, a shaft was bent	Hitting by boat, a holder moved, a shaft was bent, no bolt, no nuts
River Side	Flap Gate	Flap Gate	Flap Gate	Flap Gate	Flap Gate	Flap Gate	Flap Gate
	There is a little leakage	It may be good but to be checked	It may be good but to be checked	It may be good but to be checked	There is leakage, to be repaired	There is leakage, to be repaired	There is leakage, to be repaired

- A concrete base for hoisting assembly holder with size of 0.45m (1.5ft: W) X 0.3m (1ft: H) X 14m (46ft: L) was seriously broken so it should be replaced.
- If gate repairing work is required, estimated temporary cofferdam size is estimated as follows.

- The top of parapet concrete wall was 2.5m (8.3ft), flood water overtopping was 1.4m (4.5ft) above the parapet wall.
- According to information from a farm labor U Thit Lwin Oo, paddy yield before the cyclone was about 50 – 55 baskets per acre, and after the cyclone it decreased down to 25 – 30 baskets per acre.

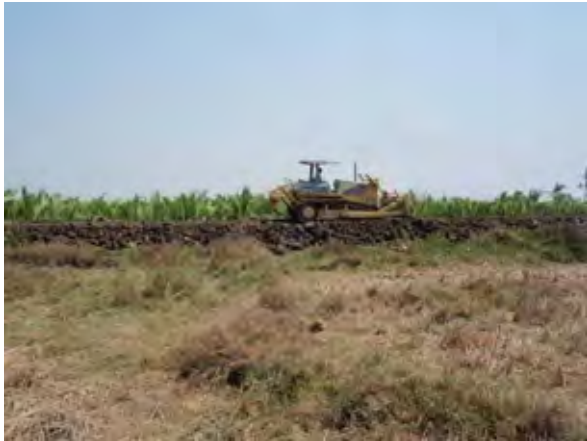
#### **Dike embankment works of Irrigation Department near Ponnayeik Sluice**

- Soil spreading thickness for dike embankment is about 0.45m – 0.6m (1.5ft – 2ft) by works of Irrigation Department near by Ponnayeik Sluice.
- Spreading works are done by Class II dozer (20tons class bulldozer) and compaction works on the dike embankment are two (2) to three (3) times of round passing.
- The embanking soil water content seemed to be less than OMC (optimum moisture content) but not

being in saturated condition and it seemed to be in good condition because soil classification was CH.

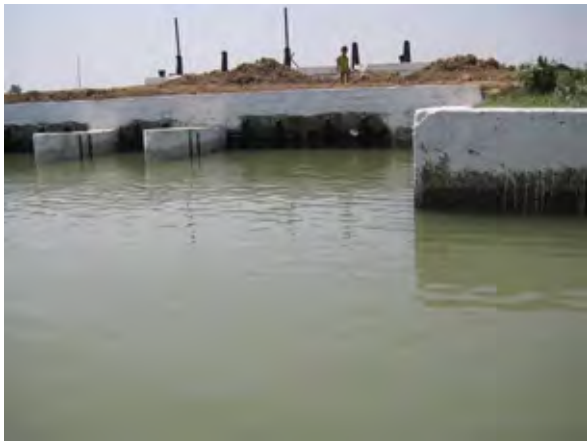
#### **Mangegale Sluice Gate**

- Mangegale Sluice locates at west part of Daunggyi (west) polder.
- There are five (5) numbers of openings in the sluice and condition of each gate of opening was checked together with and staff of Irrigation Department was as follows.

Gate No.	1	2	3	4	5
Land Side	Slide Gate	Slide Gate	Slide Gate	Slide Gate	Slide Gate
	Concrete base moved from proper position	Concrete base moved from proper position	Concrete base moved from proper position	Concrete base moved from proper position	Concrete base moved from proper position
River Side	Flap Gate	Flap Gate	Flap Gate	Flap Gate	Flap Gate
	A gate is local made, gate is broken due to corrosion, to be replaced	A gate is local made, gate is broken due to corrosion, to be replaced	A gate is local made, it seems to be functioning but to be checked	A gate is local made, it seems to be functioning but to be checked	A gate is local made, it seems to be functioning but to be checked

- At the center of concrete barrel of No. 1 and No. 2, water leakage was found at the surface of embankment.
- By observation of the Study Team, concrete sealing of concrete barrels could not be functioning and the leakage portion connected directly to river side that was why water leakage occurred with high tide.

- Two possible reasons were considered on non-functioning of concrete seal of concrete barrel, one was soil consolidation after construction and other was improper concrete sealing during construction period.

- The cause of concrete sealing non-functioning would be improper concrete dealing because there was no concrete (there was void space) just beside of concrete barrel between No. 1 and No. 2.

- RC Concrete base of hoisting assembly holders was totally broken so replacement of it would be required.
- If gate repairing work is required, estimated temporary cofferdam size is estimated as follows.

- It was observed about 0.9m (3ft) of flood water overtopping during the cyclone, which was equivalent to 2.4m (7.83ft) above sea level.
- Total four (4) drinking water ponds were affected by the cyclone and villagers pumper water out about two (2) to three (3) times.
- Water in two (2) drinking water ponds out of the said four (4) ponds became drinkable condition but it would be used out within the end of March 2009.
- The size of water quality improved pond is 18m X 18m (60ft X 60ft) for both.
- The number of Beneficiaries of the said improved pond is about 250 people, 1 village.
- “EGG” (Ever Green Group) had constructed twenty seven (27) of houses and “GAA” (German Agro Action) had constructed four (4) numbers of houses.

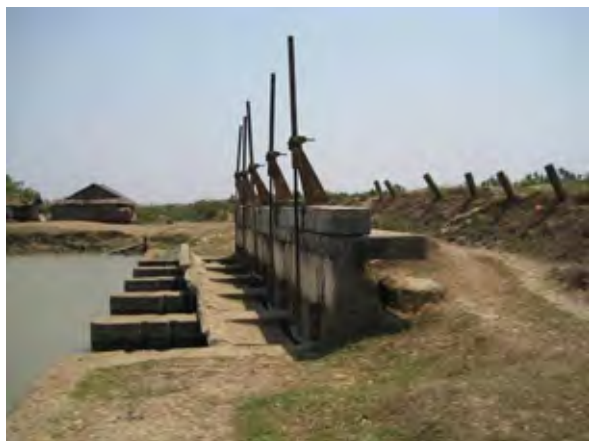
### Kamakalu Sluice Gate

- Kamakalu Sluice locates in Daunggyi (upper) polder at southern part of Daunggyi (upper) polder.
- There are five (5) numbers of openings in the sluice and condition of each gate of opening was checked together with a gate keeper U Win Myint and staff of Irrigation Department was as follows.

Gate No.	1	2	3	4	5
Land Side	Slide Gate	Slide Gate	Slide Gate	Slide Gate	Slide Gate
	Concrete base moved from proper position	Concrete base moved from proper position	Concrete base moved from proper position	Concrete base moved from proper position	Concrete base moved from proper position
River Side	Flap Gate	Flap Gate	Flap Gate	Flap Gate	Flap Gate
	A gate is local made, gate is broken due to corrosion, to be replaced	A gate is local made, gate is broken due to corrosion, to be replaced	A gate is local made, it seems to be functioning but to be checked	A gate is local made, it seems to be functioning but to be checked	A gate is local made, it seems to be functioning but to be checked

- If gate repairing work is required, estimated temporary cofferdam size is estimated as follows.
