MORUPULE POWER STATION

UNIT-3 SITE OBSERVATIONS REPORT

MORUPULE PS – PALAPYE BOTSWANA

4 X 33 MW

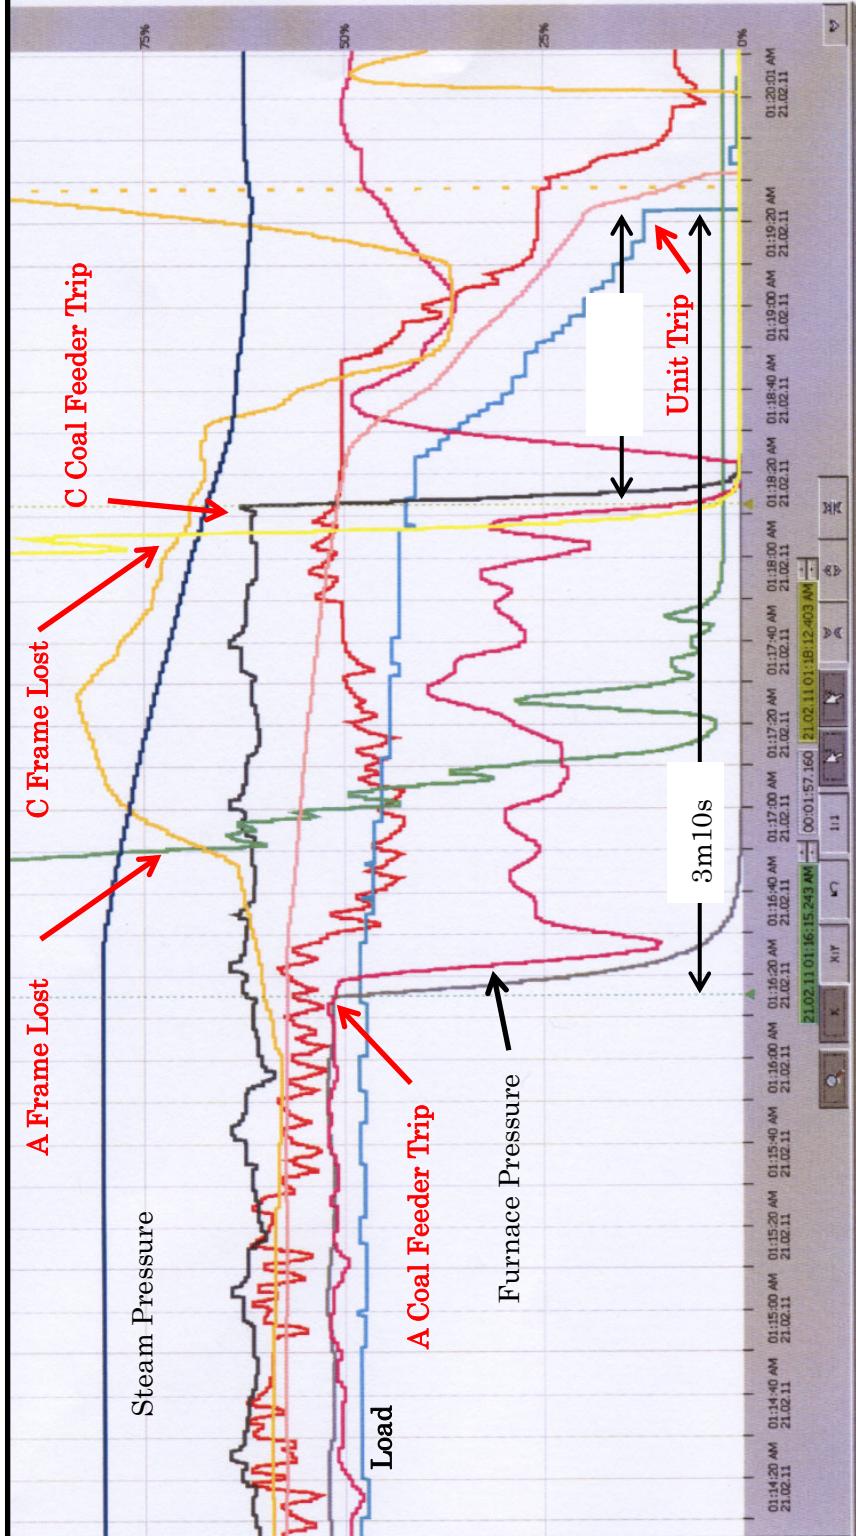
Appendix 3-1 Frame Failure Trip (21. 02. 2011)

At first, the A coal Feeder tripped on some reason, next the frame detector detected the frame lost and finally the unit trip took place.

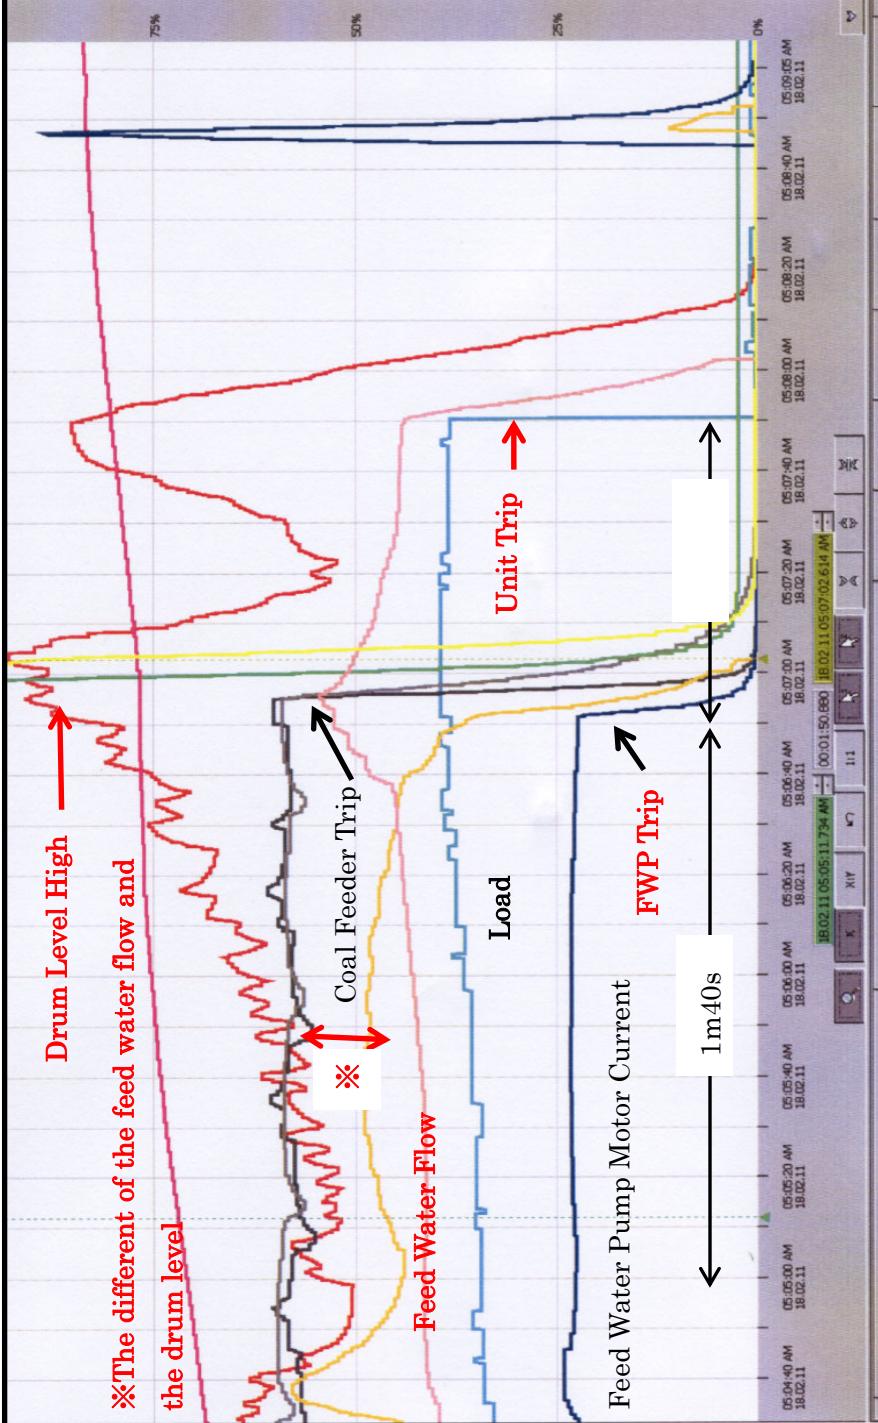
Appendix 3-2 Drum Level High Trip (18. 02. 2011)

At first, the drum water level rose, but the feed water supply flow did not decrease. So the drum water level continued higher. Finally the feed water pump trip by the drum level extra high, the C coal feeder trip (the boiler trip), finally the unit trip took place.

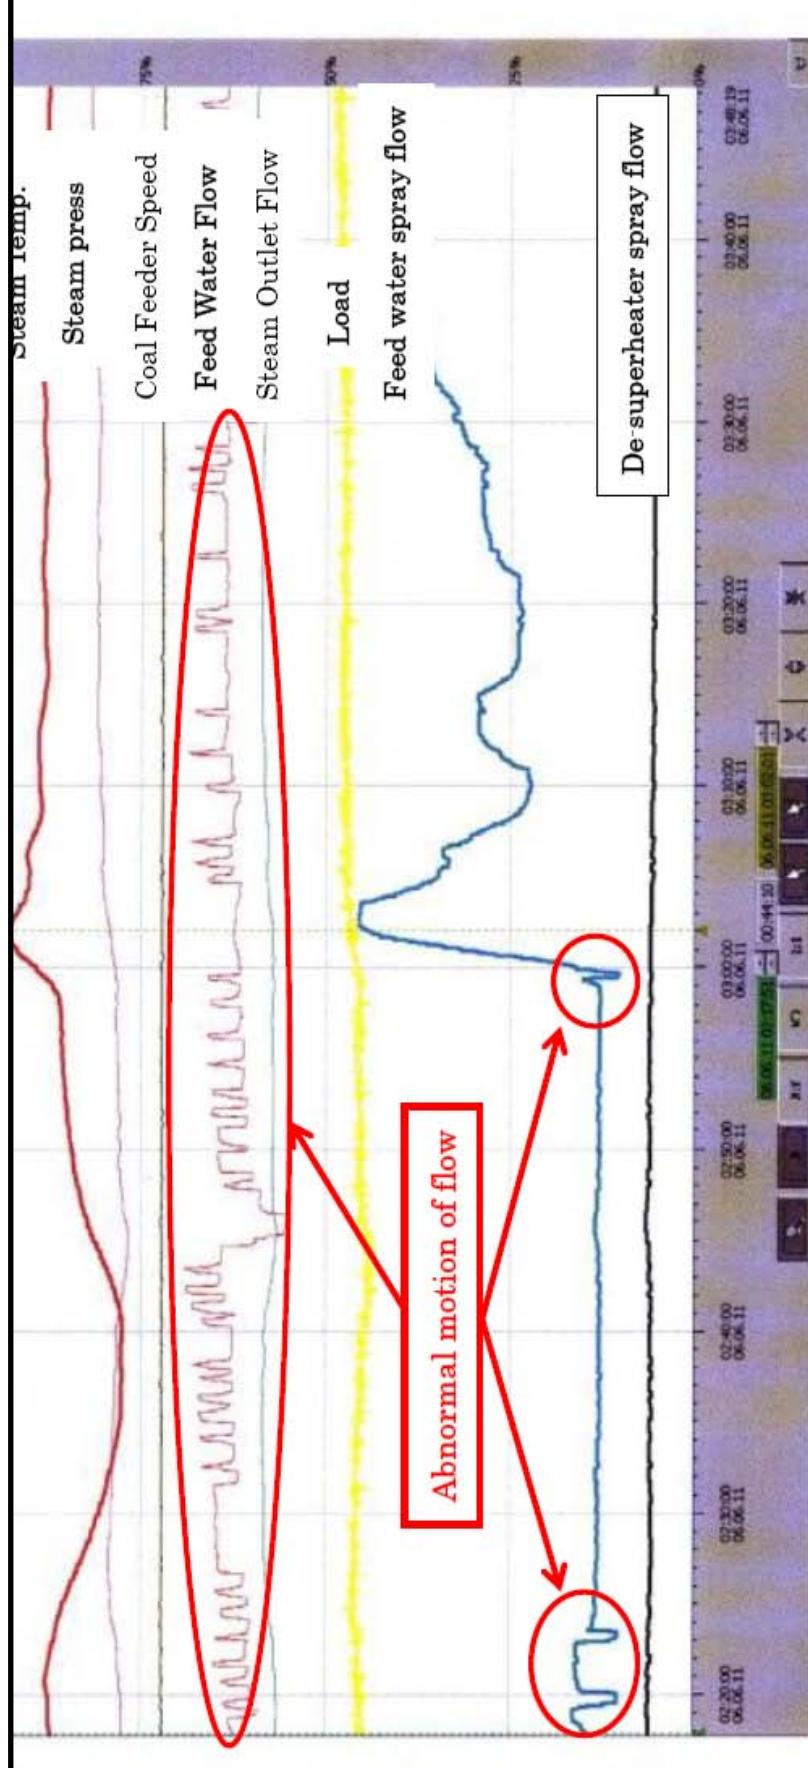
Appendix 3-3 Stream Temperature Control on Unit No.1 Boiler

The feed water flow was behaved in step response, and the feed water spray flow was behaved in step response occasionally, because those normally shall behave continuously. The de-superheater spray flow was not behaved for the change of the stream temperature. These were abnormal phenomena,
