**FOLLOW-UP COOPERATION STUDY
ON
THE PROJECT FOR CONSTRUCTION
OF
THE SUEZ CANAL BRIDGE**

**FOLLOW-UP COOPERATION
STUDY REPORT**

NOVEMBER 2011

JAPAN INTERNATIONAL COOPERATION AGENCY

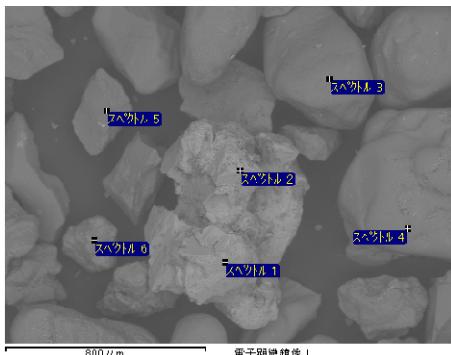
Figure 1 SEM Image

As a result, sand containing rock salt was found.

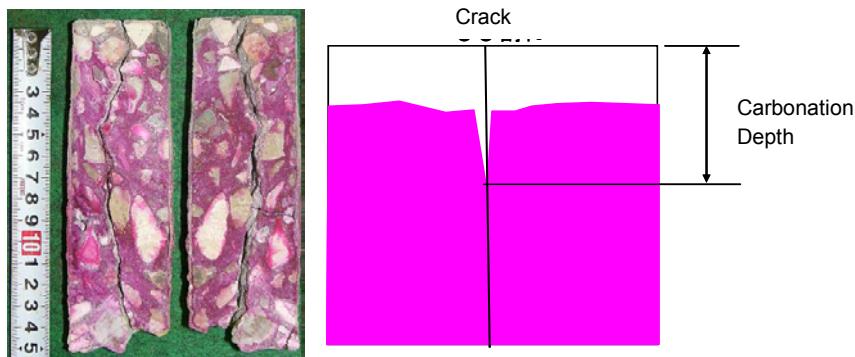
Figure 6 Sample of Carbonation at the Crack (Pile Cap of PW43)

Maximum carbonation depth is 40 mm, which is found at the crack on the pile cap of PW43.

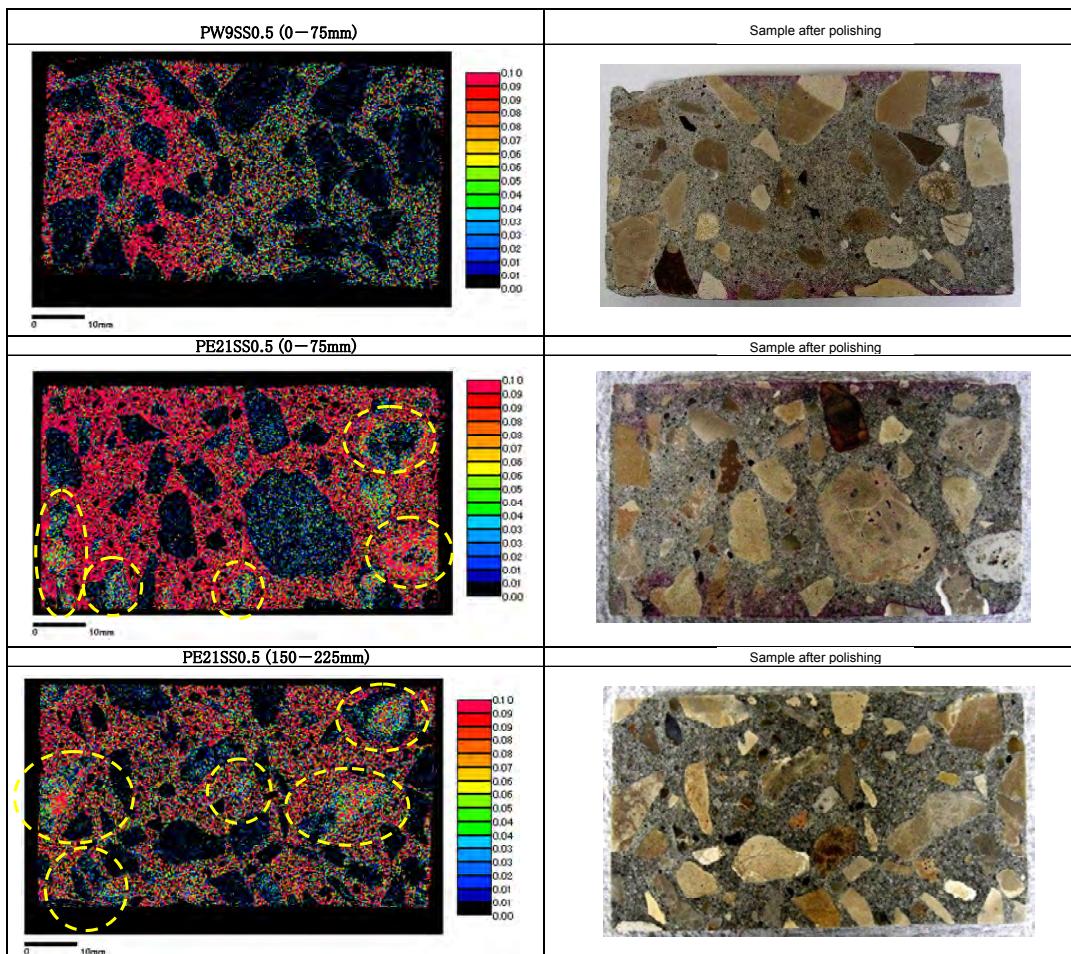
Figure 11 EPMA Result

It is considered that chloride has been transferred from coarse aggregates since high chloride contents were found around some coarse aggregates.

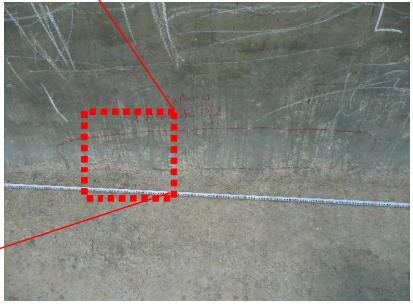
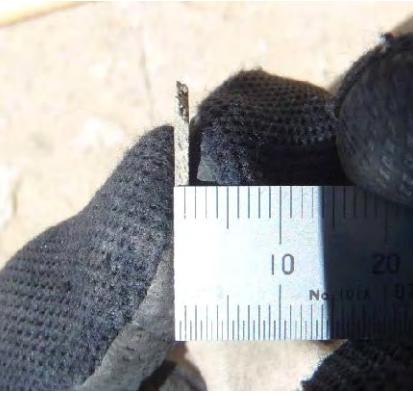
Photo 2.1.1 Delamination near Ground Surface at PW40SE

No.	Picture	Comments
1		<ul style="list-style-type: none"> PW40SE 0.2m Center Delamination
2		<ul style="list-style-type: none"> After Chipping

3		<ul style="list-style-type: none"> Thickness 1.5mm

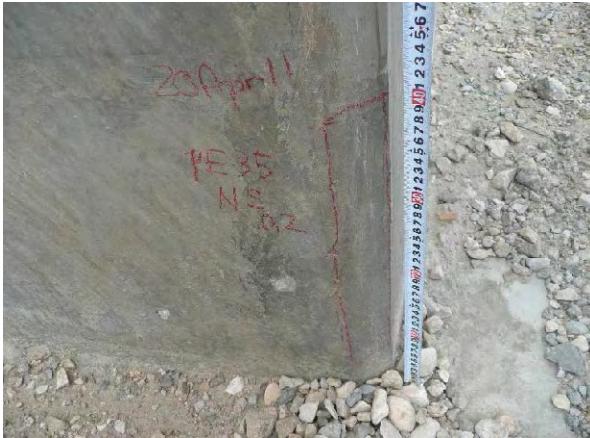
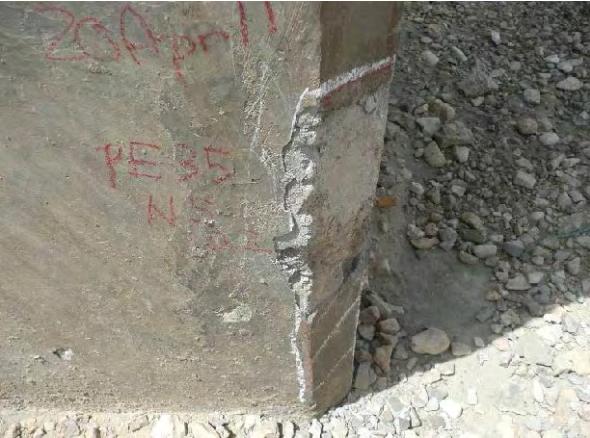
Photo 2.1.2 Delamination near Corner at PE35NS

<ul style="list-style-type: none"> PE35NS 0.2m Delamination
2

<ul style="list-style-type: none"> After Chipping

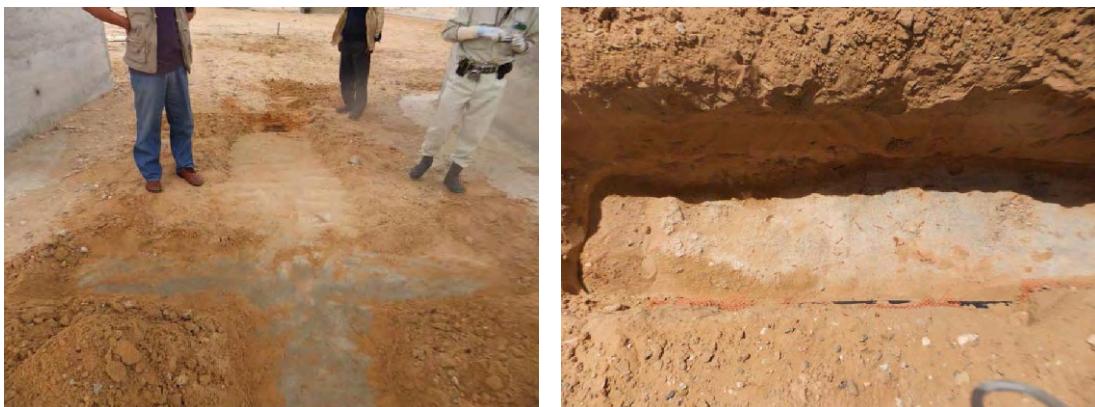
Photo 2.1.3 Upper Surface of Pile Cap in the East Side (Confirmed by Excavation)

- Definition of crack to be repaired is the crack with 0.35 mm width and more.
- Cracks to be repaired were found on only pile caps in the west side.
- Crack was not found from pile caps in the east side, which was confirmed by excavation for 3 pile caps.

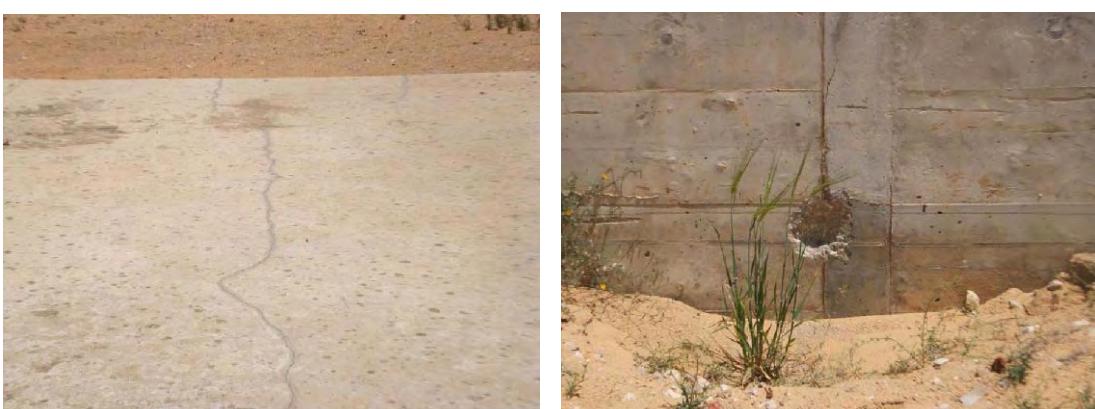
Photo 2.1.4 Crack on Pile Cap (Upper and Side Surface)

It is considered that cracks have occurred by not corrosion of reinforcing bar but thermal restraint with heat of cement hydration.

- Cause of cracks on the pile cap is assumed to be thermal restraint from crack patterns and the depth of 200 mm and more at the largest.

For pile caps, it is evaluated as “B or C”, therefore, repair work is necessary for pile caps with wider than 0.35 mm of cracks.

Filling material shall be refilled in cracks on pile cap since crack depth and width for pile cap are deep and wide (0.5 mm).

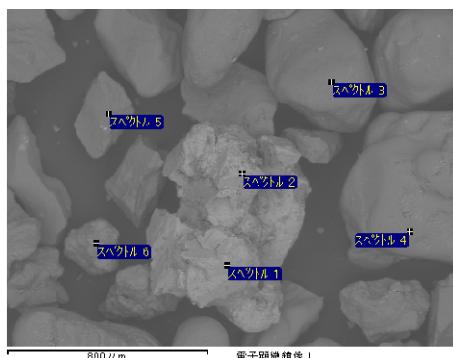
Figure 2.3.1 SEM Image

In addition, rock salt was found by microscope observation. Therefore, there is a possibility that rock salt did not dissolve by washing during construction, and then it has become a supply source of chloride in the concrete.

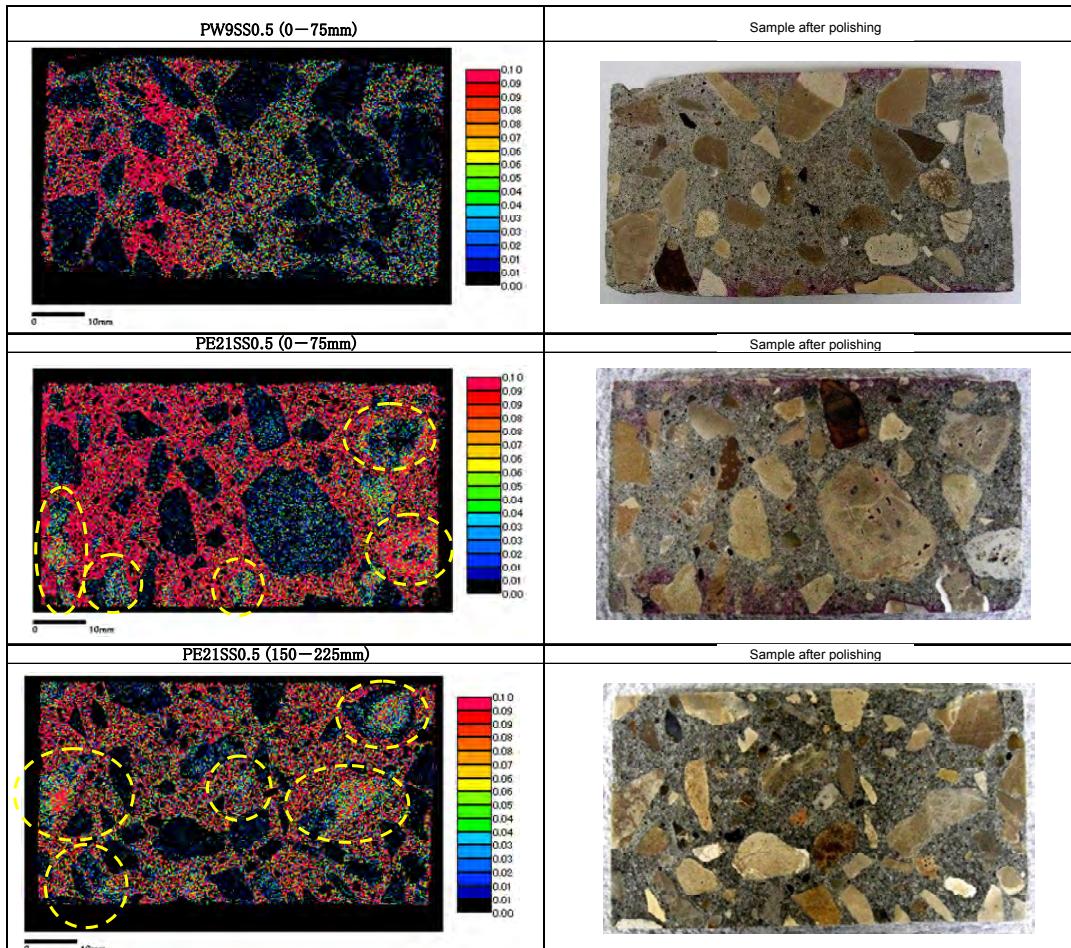
Figure 3.1.15 EPMA Result

It is considered that chloride has been transferred from coarse aggregates since high chloride contents were found around some coarse aggregates.
