**JAPAN INTERNATIONAL COOPERATION AGENCY  
GEOLOGICAL SURVEY OF ETHIOPIA**

**THE PROJECT FOR DEVELOPING  
COUNTERMEASURES AGAINST LANDSLIDERS IN  
THE ABAY RIVER GORGE**

**FINAL REPORT**

**January 2012**

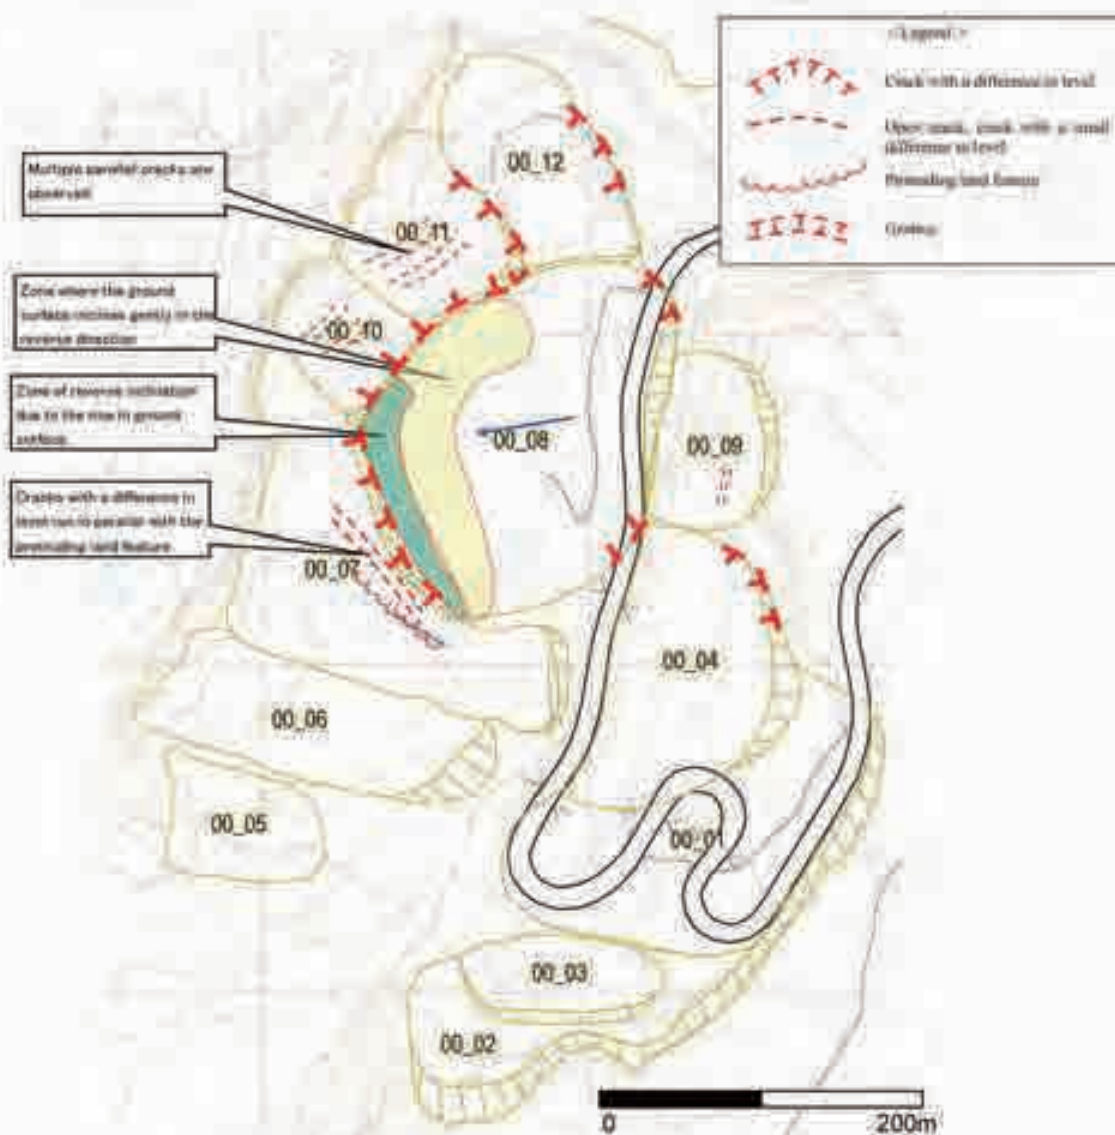
Figure 3.4.8 Surface anomalies in L/S00 (ST.0+200 to 1+100)

Relatively new cracks were observed in the two landslide blocks on the upper side of the road. Therefore several minor deformations seem to be still continuing.

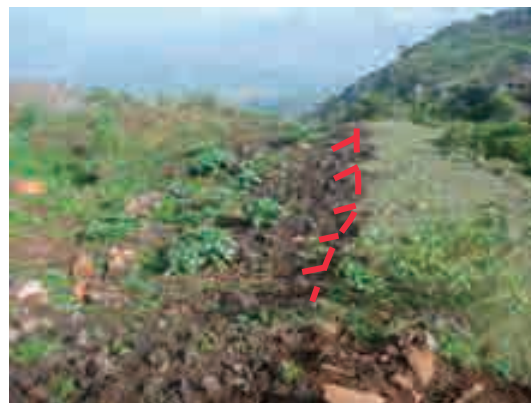
Photo (1)  
Distant view near the boundary of the lower part of L/S00-1 and L/S00-5  
Wrinkle-like irregular land features running in parallel.  
Deformation seems to be occurring in L/S00-5 due to movement of L/S00-1.

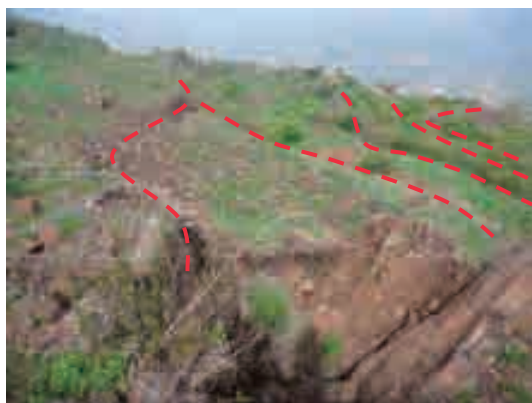
Photo (2)  
Lateral cracks on the L/S00-2 block  
Multiple small cracks are opening on the right flank of L/S00-2.

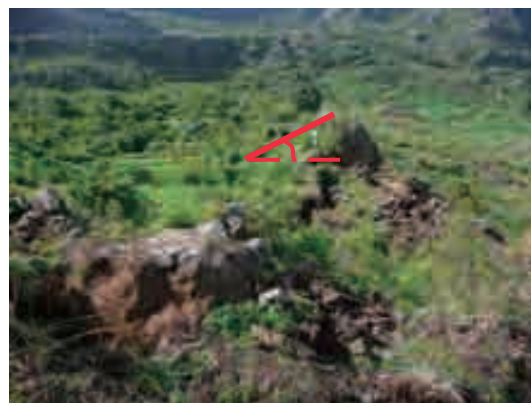
Photo (3)  
Cracks near the boundary of the toe of L/S00-1 and L/S00-3.  
The maximum difference in level of the cracks is about 2m. The transported land mass could also be seen to have taken on a toppling style.

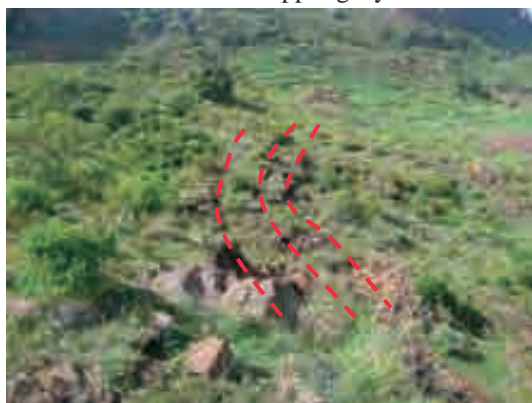
Photo (4)  
Inclination of the surface near the lower part of L/S00-1.  
The surface is upthrusting at the lower part; it is dipping in the reverse direction.

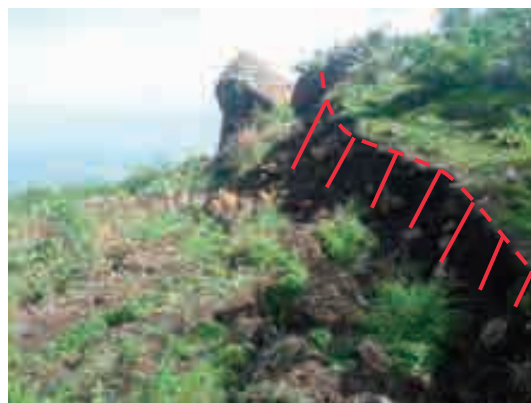
Photo (5)  
Parallel cracks with a difference in level at the lower part of the L/S00-1 block.  
Land features with a difference in level oriented toward the valley run in parallel near the boundary of the L/S00-1 and the L/S00-5.

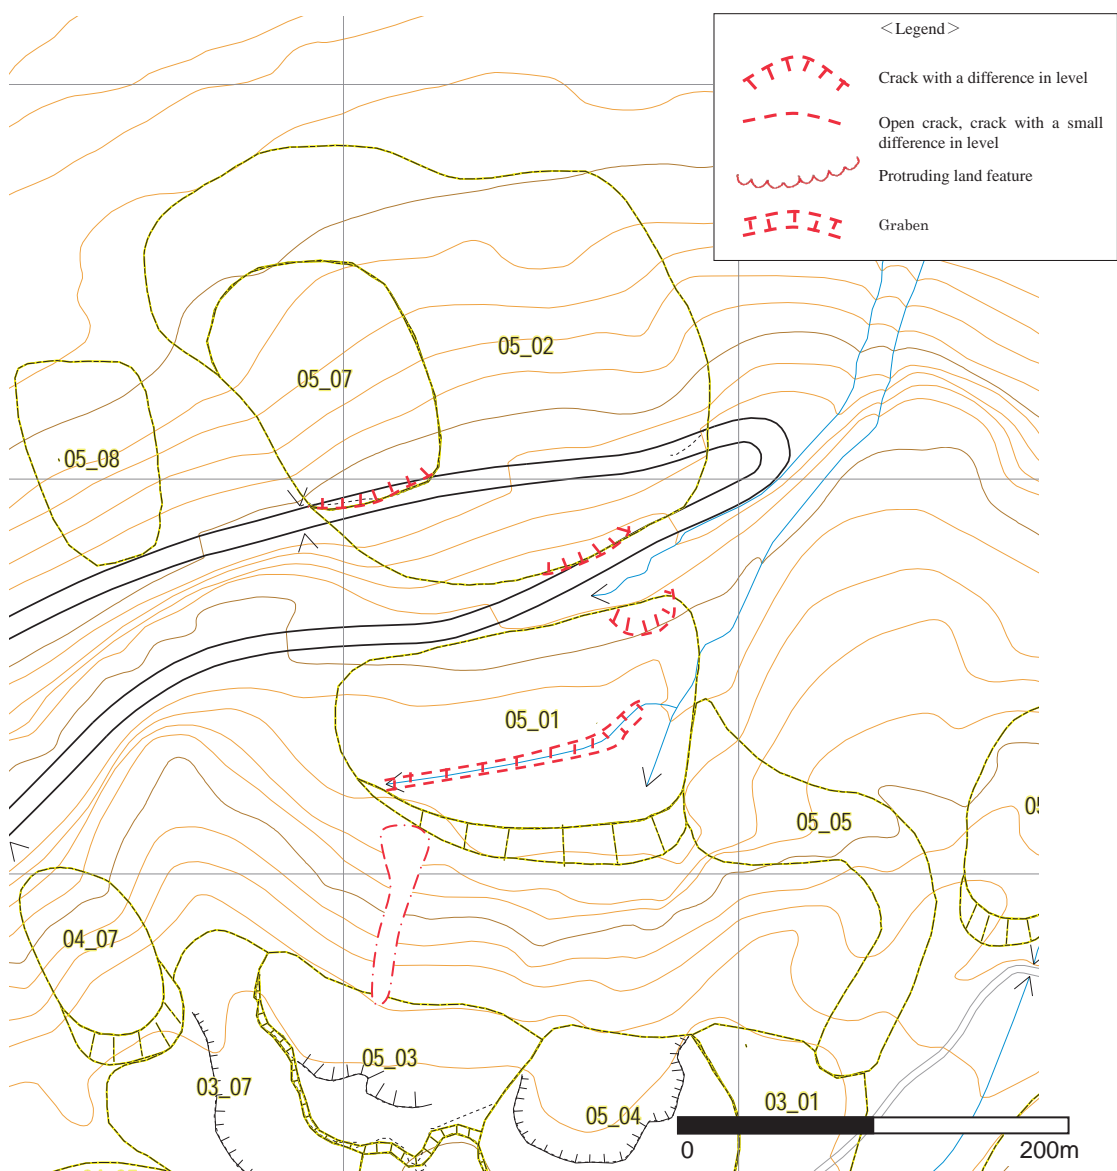
Figure 3.4.9 Surface anomalies in L/S05 (ST.4+800 to 5+600)

New cracks at the top of the L/S05-2 on the valley side of the road indicate a continuing series of small collapses; therefore it is considered that small displacement is also occurring in this block.

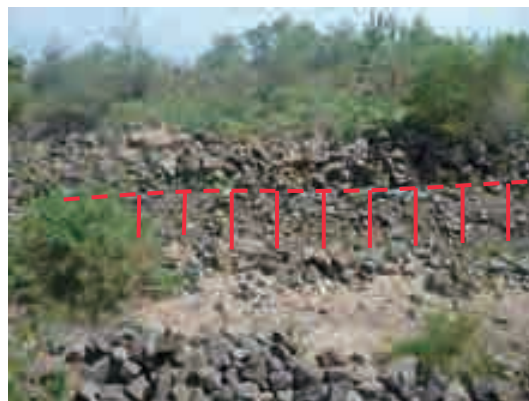
Photo (1)  
L/S05-1 block as viewed from the top  
An old channel crosses the L/S05-1, and debris from the upper part is piled up on the block. The debris is a load on the L/S05-1 block.

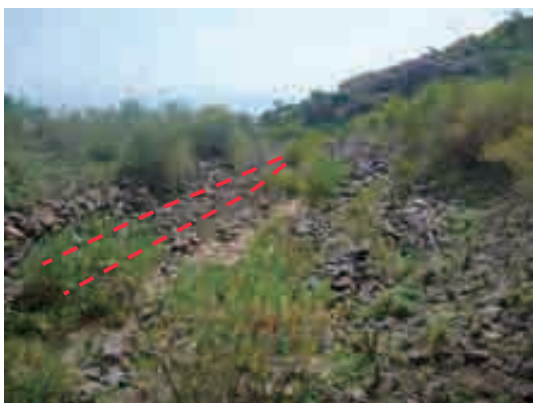
Photo (2)  
Expansion of the cracks along the channel in the L/S05-1.  
The blue vinyl sheet that was covering the old channel has been torn, so it can be considered that cracks are expanding along the old channel.

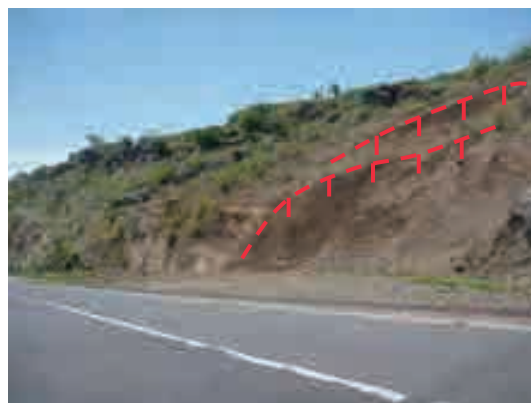
Photo (3)  
A continuous crack along the channel in the L/S05-1  
The crack continues along the old channel.

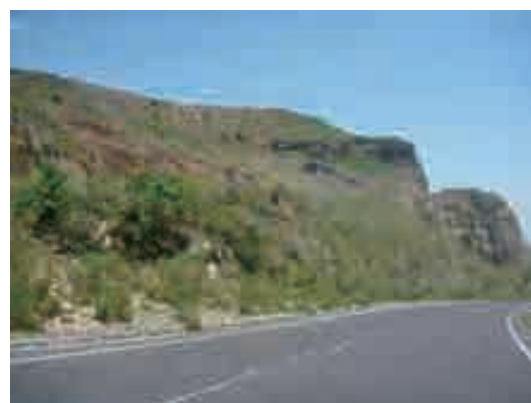
Photo (5)  
Small collapses on the mountain side of the toe of the L/S05-1 (2)  
Small collapses as viewed from inside the block.

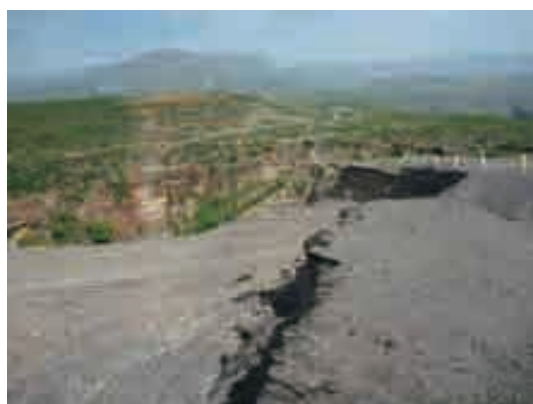
The main scarp and cracks 1 to 2 m in height on the valley side are quite close to the new road.

Photo 3.4.10 Main scarp of the L/S22-1

The main scarp and cracks with a difference in level are close to a new road that has been relocated.

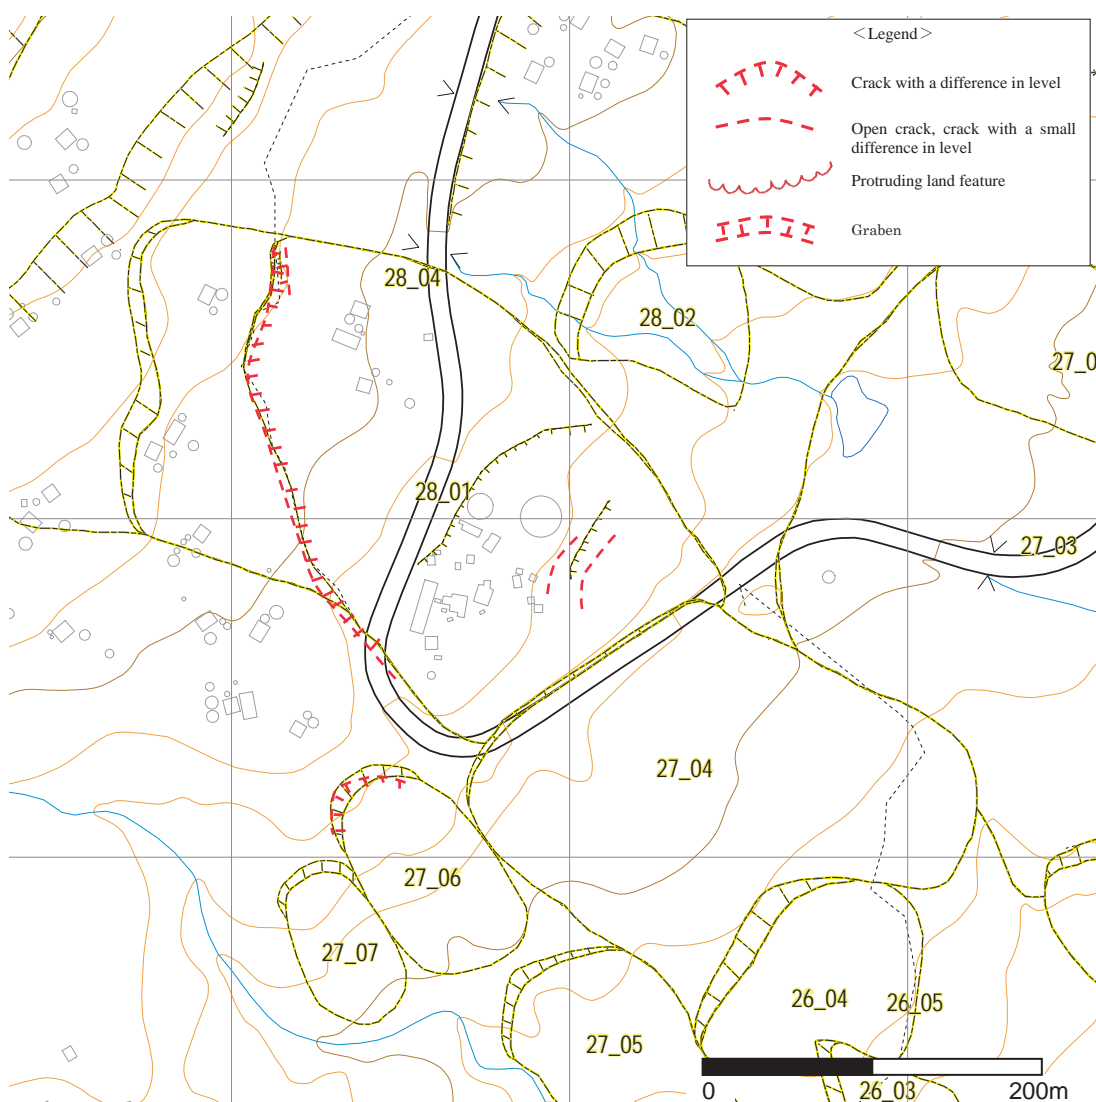
Figure 3.4.11 Surface anomalies in L/S27 (ST.27+200 to 28+400)

In contrast, a new continuous crack, as well as the main scarp and graben, can be observed in the L/S28-1; a subsidence on the road can also be an extension of the deformation direction.

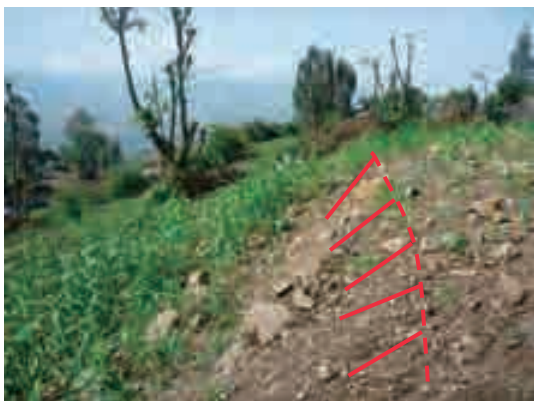
Photo (1)  
Displacement on the L/S208-1

There are continuous displacements on the slope above the broken church, and there is a new and clear crack on a line extending from it (Photo 2).

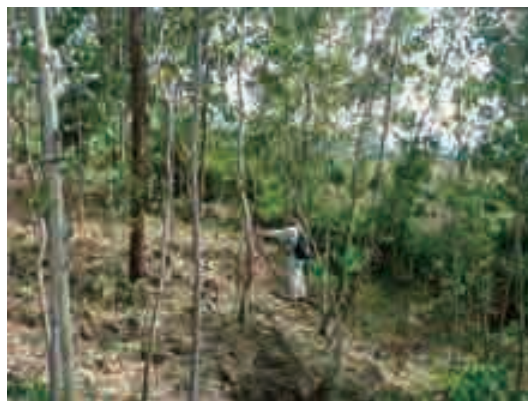
Photo (2)  
Crack at the head of the L/S28-1 block (1).

There is a new crack extending from the displacement seen in Photo 1.

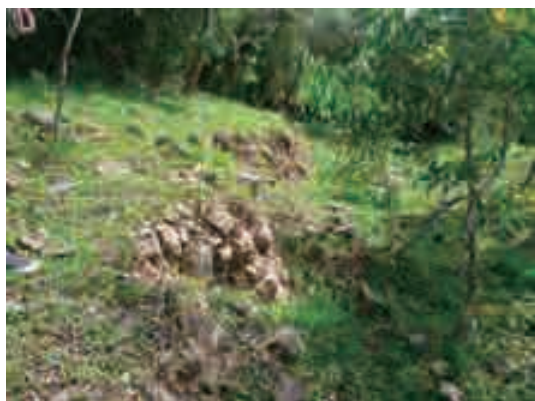
Photo (3)  
Crack at the head of the L/S28-1 (2).

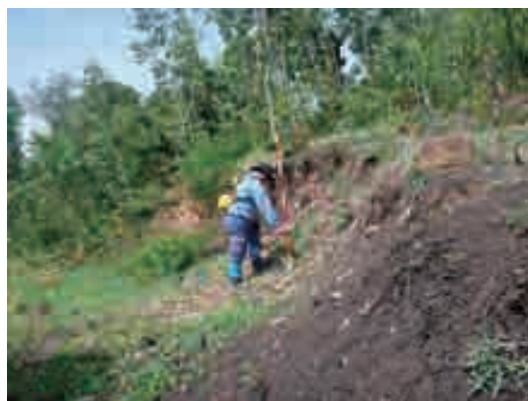
Photo (4)  
Main scarp in the L/S28-1

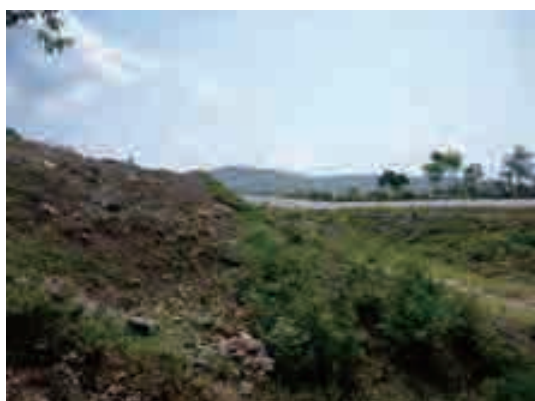
Photo (5)  
Subsidence on the head of the L/S28-1.

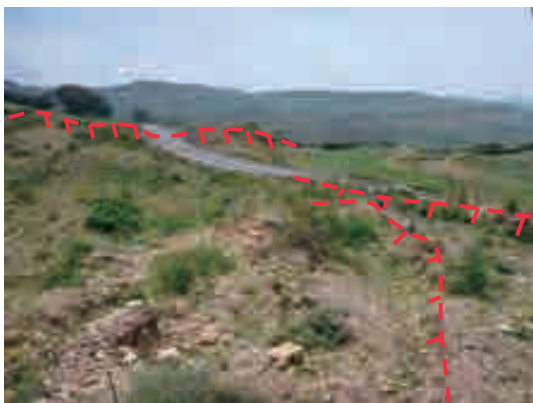
Photo (1)  
Main scarps and subsidence in the L/S28-3 (1).  
A new and clear main scarp with about 10 m difference is continuing, and the displacement is also occurring on the road. On the valley side, cracks, whose mountain side is sinking, that runs roughly in parallel with the main scarps.

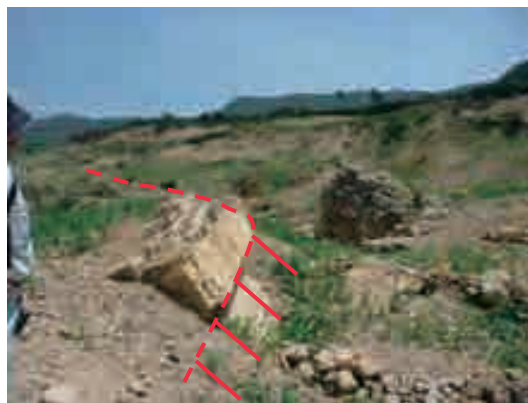
Photo (2)  
Main scarp and subsidence in the L/S28-3 (2).  
Cracks whose mountain side is sinking can be seen on the head of the slope. New cracks are continuing from this crack.

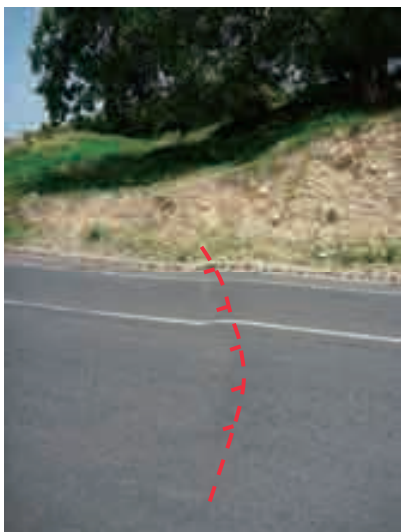
Photo (3)  
Cracks on the main scarp of the L/S28-2.  
The displacement that occurred on the national road continues toward the old main scarp.
