# Chapter 4

*Landslide Analysis and Interpretation*

## 4 Landslide Analysis and Interpretation

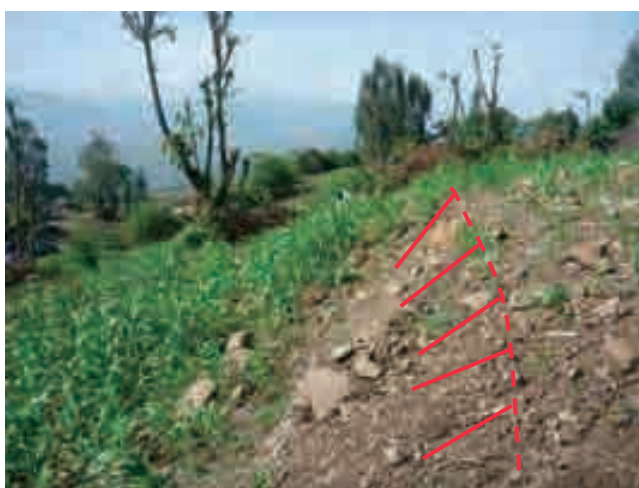
Steps are often observed in landslide areas (Photo 4.3.3). In areas where there is a step crossing the road, the road surface is often deformed, hampering the movement of vehicles. Also, the fields in Abay Gorge have artificial steps and stone fences, which are mostly difficult to distinguish from steps caused by landslides.

Photo 4.3.3 Step Caused by Landslide

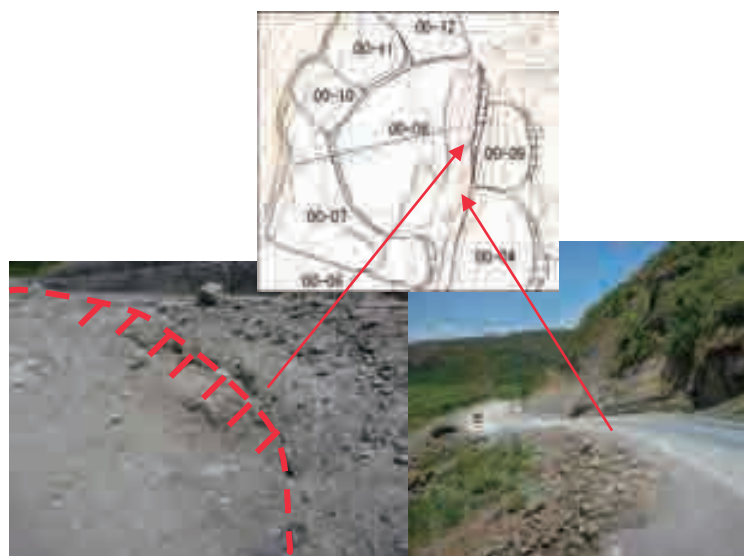
Figure 4.3.16 Top part of L/S00-08

Figure 4.3.16 shows the landslide map and photos of L/S00-08. After every rainy season, the depression increases gradually, the gap of the main scarp crossing the road has become larger. As the section of depression of the road corresponds to the L/S00-08 landslide block delineated from photo interpretation and field investigations, this depression is considered to be caused by the landslide movement of L/S00-08. Small scarp of new small landslide appeared at the north side of L/S00-08 head shown in the left photo of Figure 4.3.16.

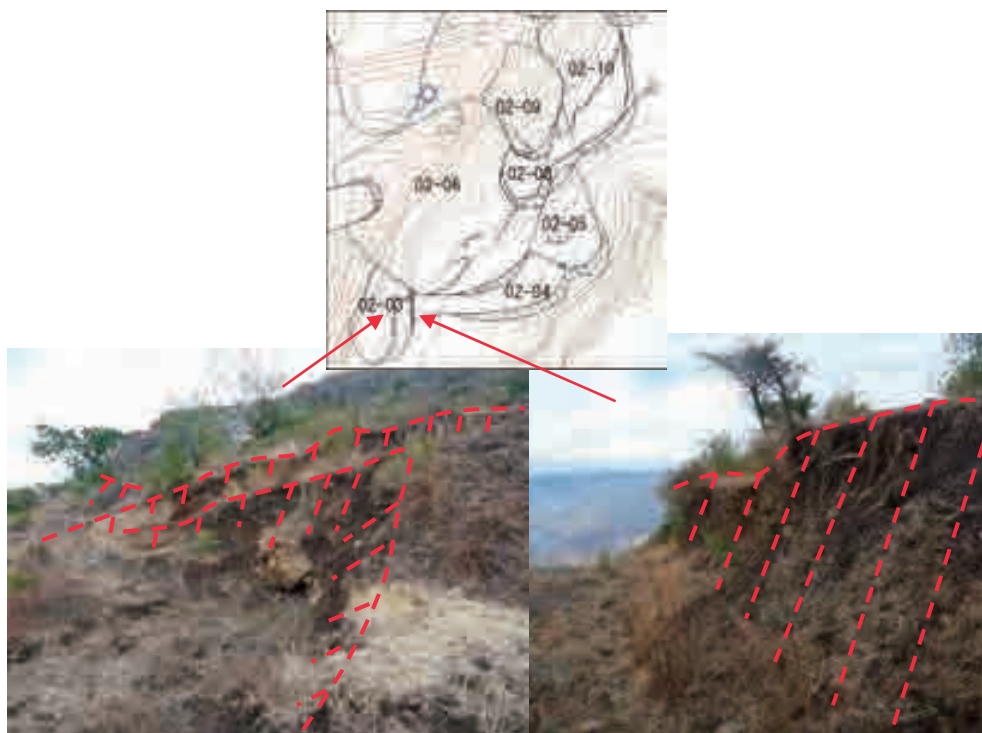
Figure 4.3.18 New Cracks at the Head of L/S02-03

There are many stepped cracks and currently active landslide blocks (five locations) on the upper portion of the slope at L/S02. Figure 4.3.18 shows a new crack at the head of L/S02-03. There are many new cracks with a maximum step of up to 2m.

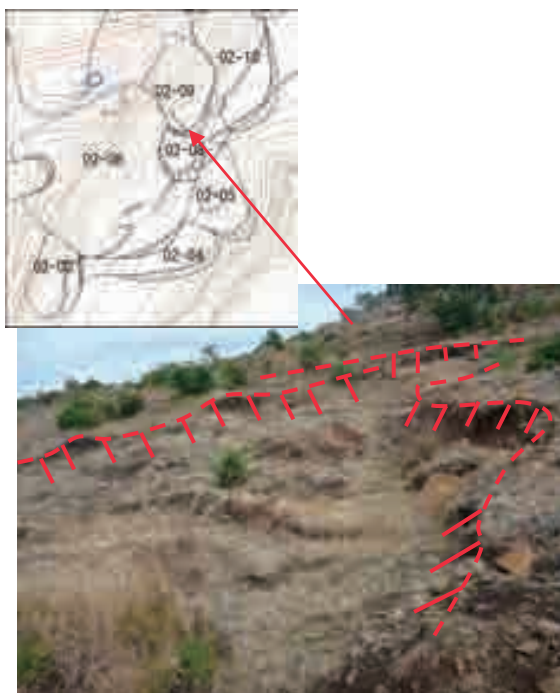
Figure 4.3.19 New Cracks at the Head of L/S02-09

Figure 4.3.19 shows new cracks at the head of L/S02-09. These cracks are continuing like a horseshoe-shape, indicating the movement of small blocks in the landslide at L/S02-09. There are other multiple new stepped cracks, so the head of L/S02-09 as a whole may have become unstable.

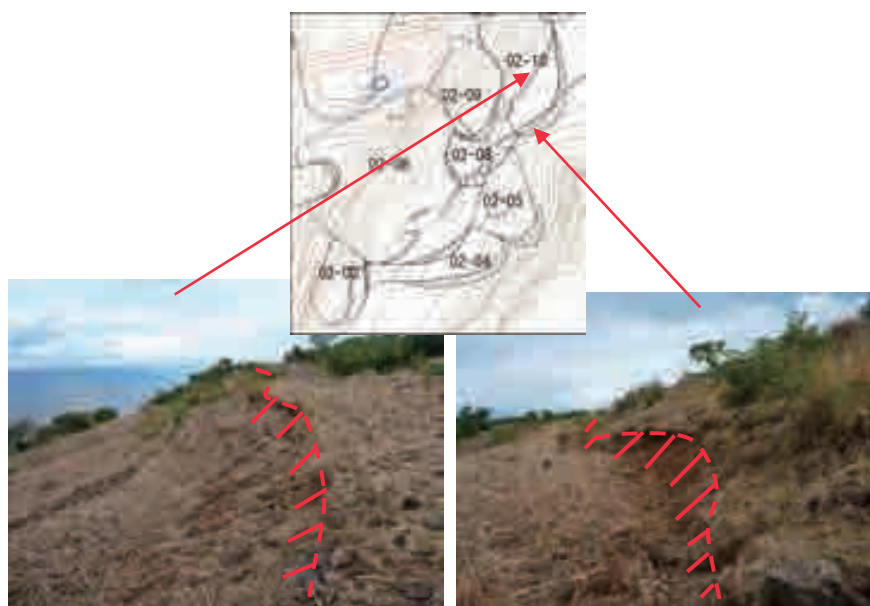
Figure 4.3.20 View of the Head of L/S02-10

Figure 4.3.20 shows new cracks at the head of L/S02-10. These cracks are multiple and form small bumps. The multiple steps are small but old landforms, and new cracks exist together. Therefore, this block seems to have activated repeatedly for a considerably long time.

Tremendous damage such as road blockage may occur when many landslide blocks around L/S02 activate on a large scale. Therefore, these blocks have higher priorities among the landslide blocks ranked A in terms of risk for the road.

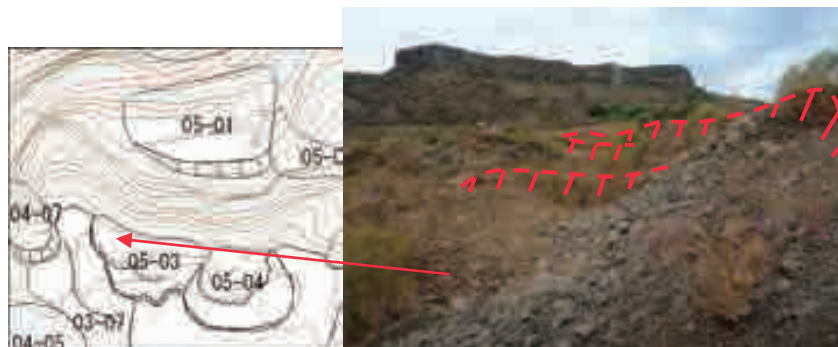
Figure 4.3.21 Landslide Area at L/S05-03

Around L/S05-01, there are many landslides with higher priorities. Figure 4.3.21 and Figure 4.3.22 show landslide blocks on the crown of L/S05-01. Both landslide blocks have many new continuous cracks (three locations in either case), so these landslides are currently activating. The moving mass has piled up at the head of L/S05-01 and collapsed. This is one of the causes for slope failure of L/S05-01. Therefore, for L/S05-03 and L/S05-04, the influence on the road are evaluated as “B” though they are located a long distance from the road. Suppression of the activities of L/S05-03 and L/S05-04 will be one countermeasure against L/S05-01.

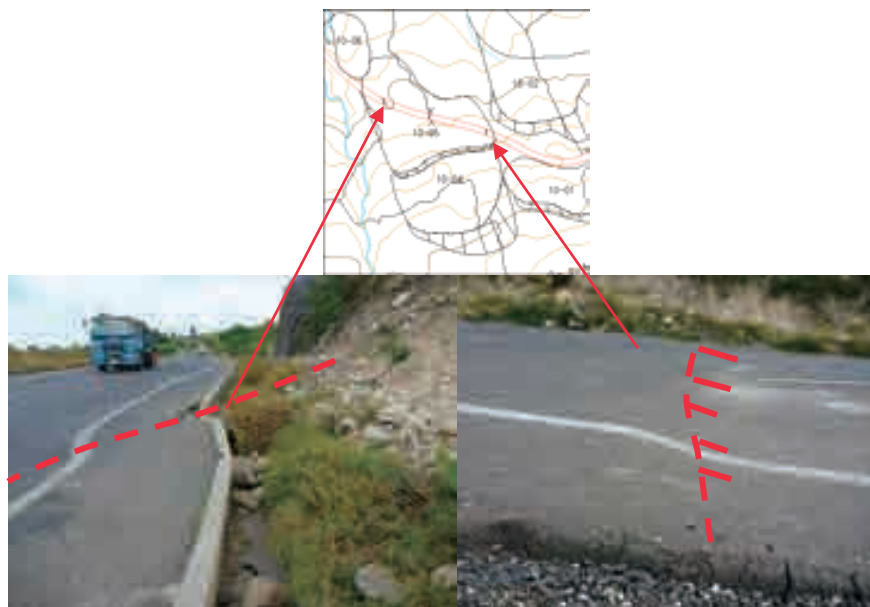
Figure 4.3.24 Deformation of the road by L/S10-05

Figure 4.3.24 shows a distribution chart of L/S10-05 and steps and cracks on the road, and these deformations have become larger year by year. Landslide blocks moving and damaging the road are a little smaller than the landslide blocks interpreted from the satellite images. Considering from the progression of the deformation of the road, the rate of movement of L/S10-05 is approximately 10cm per year.

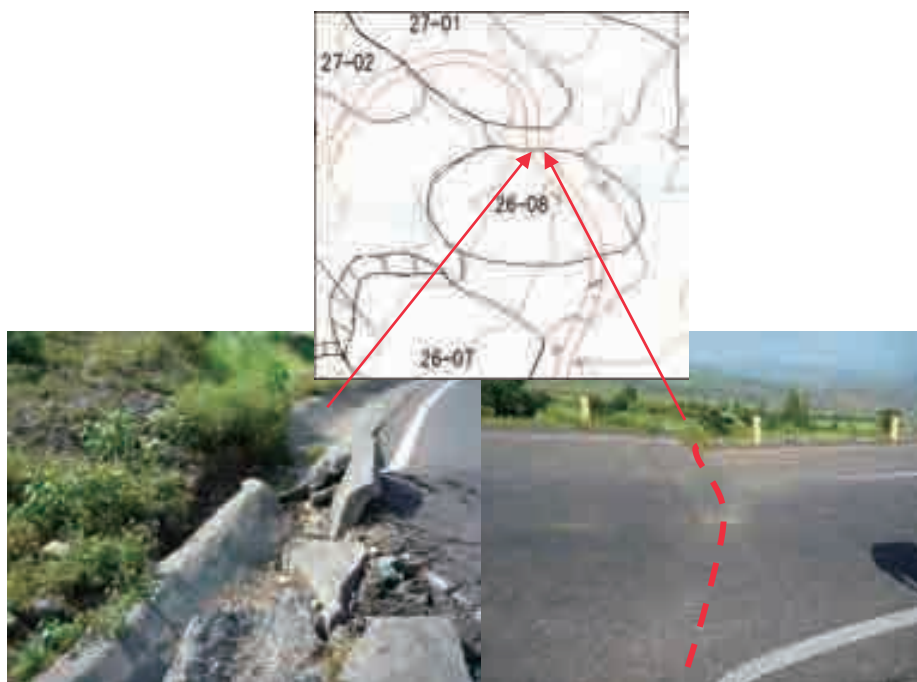
Figure 4.3.26 Side crack of L/S26-08

Figure 4.3.26 shows the deformation of the side part of L/S26-08. 20 cm steps with left-lateral movement appeared and the deformation is increasing year by year. The ratio of the movement is considered 20 cm or less per year.

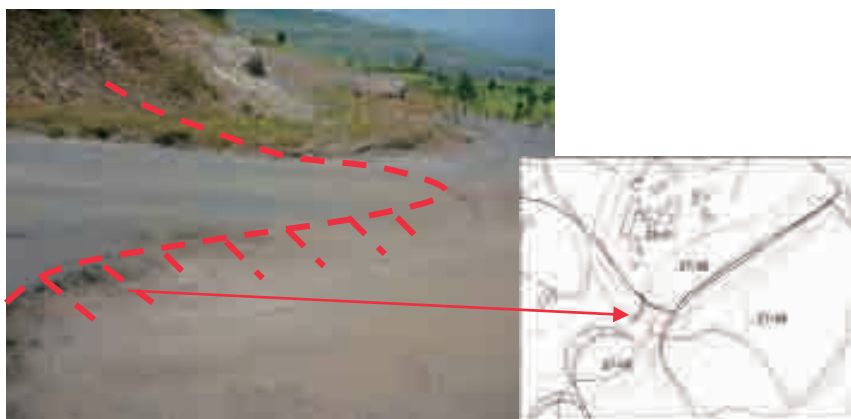
Figure 4.3.27 Deformation by the extension of L/S27-04

Figure 4.3.27 shows the step on the road by the movement of extending landslide. This step extends to the cracks on cutting slope and under ground of extensometer (EX-5), and the step has become larger year by year.

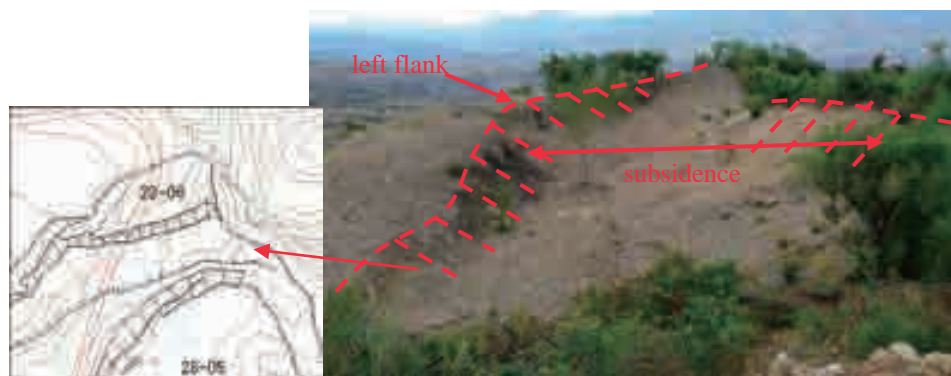
Figure 4.3.28 L/S28-05 Left Flank Where Landslide is Clearly Shown at L/S28-05

The road near the main scarp at L/S28-05 is deforming continuously. This indicates that L/S28-05 is moving actively. At L/S28-05, the main scarp for the whole block is clear, but the positions of the flanks are not clear. The new stepped cracks on the left flank are shown in Figure 4.3.28. Figure 4.3.28 shows the confluence the left flank and the crack of the subsidence. Figure 4.3.28 shows the uplift on the left flank of L/S28-05. The step on the left flank that continues from the main scarp, which is seen on the left of the figure, clearly reverses in the middle, so the landslide body has been uplifted.

There are signs indicating that these cracks on the flank also expanded recently. Therefore, the whole L/S28-05 block appears to be moving actively. There are multiple continuous stepped cracks in the landslide body of L/S28-05, so there is a trend of dividing into smaller blocks.

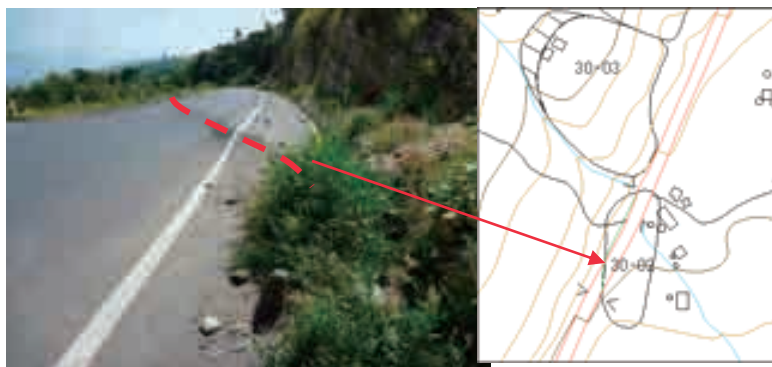
Figure 4.3.30 Step of L/S30-02

Figure 4.3.30 shows the steps of L/S30-02. Although the step has become larger year by year, only vertical movement and no horizontal movement was observed. Mountain-facing steps can be observed, but valley-facing steps in pairs were not observed. The culvert crosses under the road diagonally, and road bank materials may be discharged/ eroded with leaking water during the rainy season.

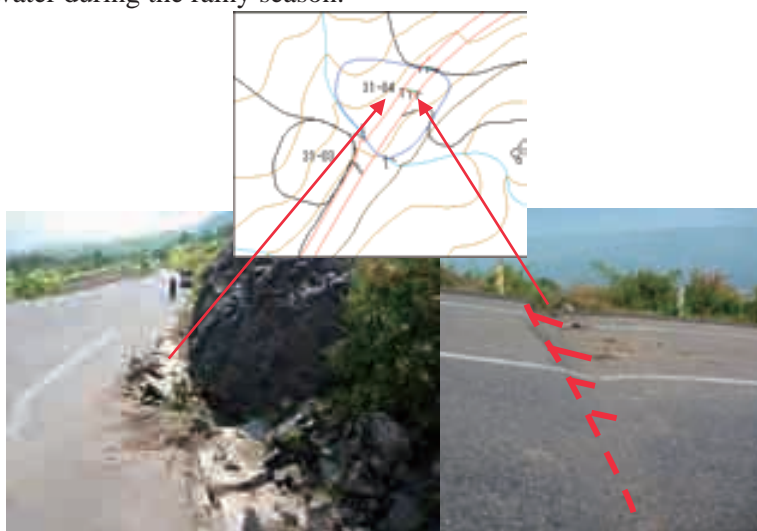
Figure 4.3.31 Deformation of the road at L/S31-04

Figure 4.3.31 shows the deformation of L/S31-04. Steps and lateral slips appeared on the road surface, and a huge basalt boulder pushed out and crashed into the road side ditch. The steps have become larger year by year. Two valley-facing steps, which are 10m apart, can be observed, but no other steps in pairs can be observed on the other side. Similar to L/S30-02, a culvert crosses under the road diagonally, and road bank materials may be discharged/ eroded by leaking water during the rainy season.

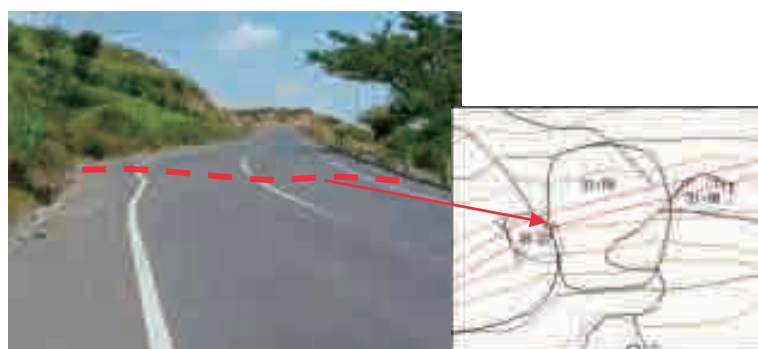
Figure 4.3.32 Deformation of the road at L/S31-07

Figure 4.3.32 shows the deformation of L/S31-07. Steps and lateral slips appeared on the road surface, and side ditch is also deformed. The steps have become larger year by year. The valley-facing steps can be observed in the down slope from the road, but no other mountain-facing steps in pair can be observed on the other side. Culvert crosses under the road, road bank materials may be discharged/ eroded by leaking water in the rainy season.

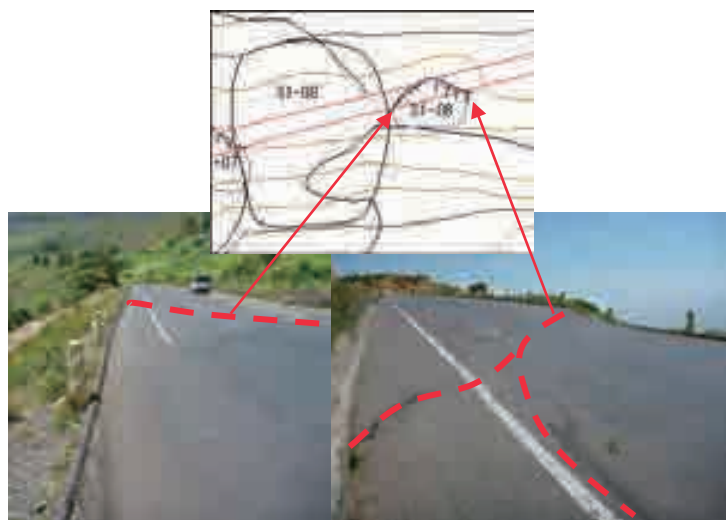
Figure 4.3.33 Deformation of the road at L/S31-08

Figure 4.3.33 shows the deformation of L/S31-08. Steps and lateral slips appeared on the road surface, and side ditch is also deformed. The steps have become larger year by year. The valley-facing steps can be observed in the slope below the road. Deformation of the side ditch can be observed on the mountain side, and a major step ends in the center of the road. The road of the section is built by rock fill, and slight swelling can be observed on the filled road slope. The swelling seems to be caused by weakness of the road fill material and buried landform, such as shallow valley with saturated groundwater. So, the swelling may be a precursor of road slope collapse.

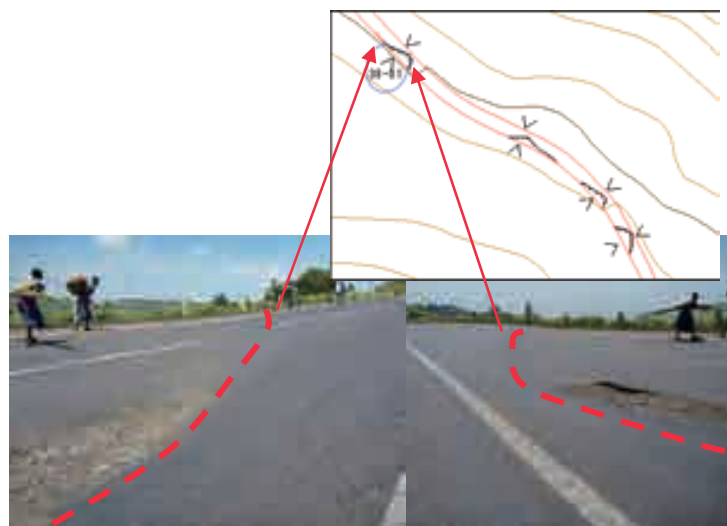
Figure 4.3.34 Deformation of the road at L/S38-01

Figure 4.3.34 shows the deformation of L/S38-01, close to Dejen Town. As steps in pairs can be observed, this section is considered to be a small landslide. Four small deformations and pot holes appeared. The symbol of < shows culvert in the Figure 4.3.34, and most of the deformations appear above the culvert. Some destruction can be observed in the holes of the culverts, discharging water may leak at the points of destruction. According to the phenomena, road bank materials may be discharged/ eroded by leaking water in the rainy season.
