8. Satellite image interpretation for geomorphologic survey

Geomorphological Survey  
Satellite image interpretation

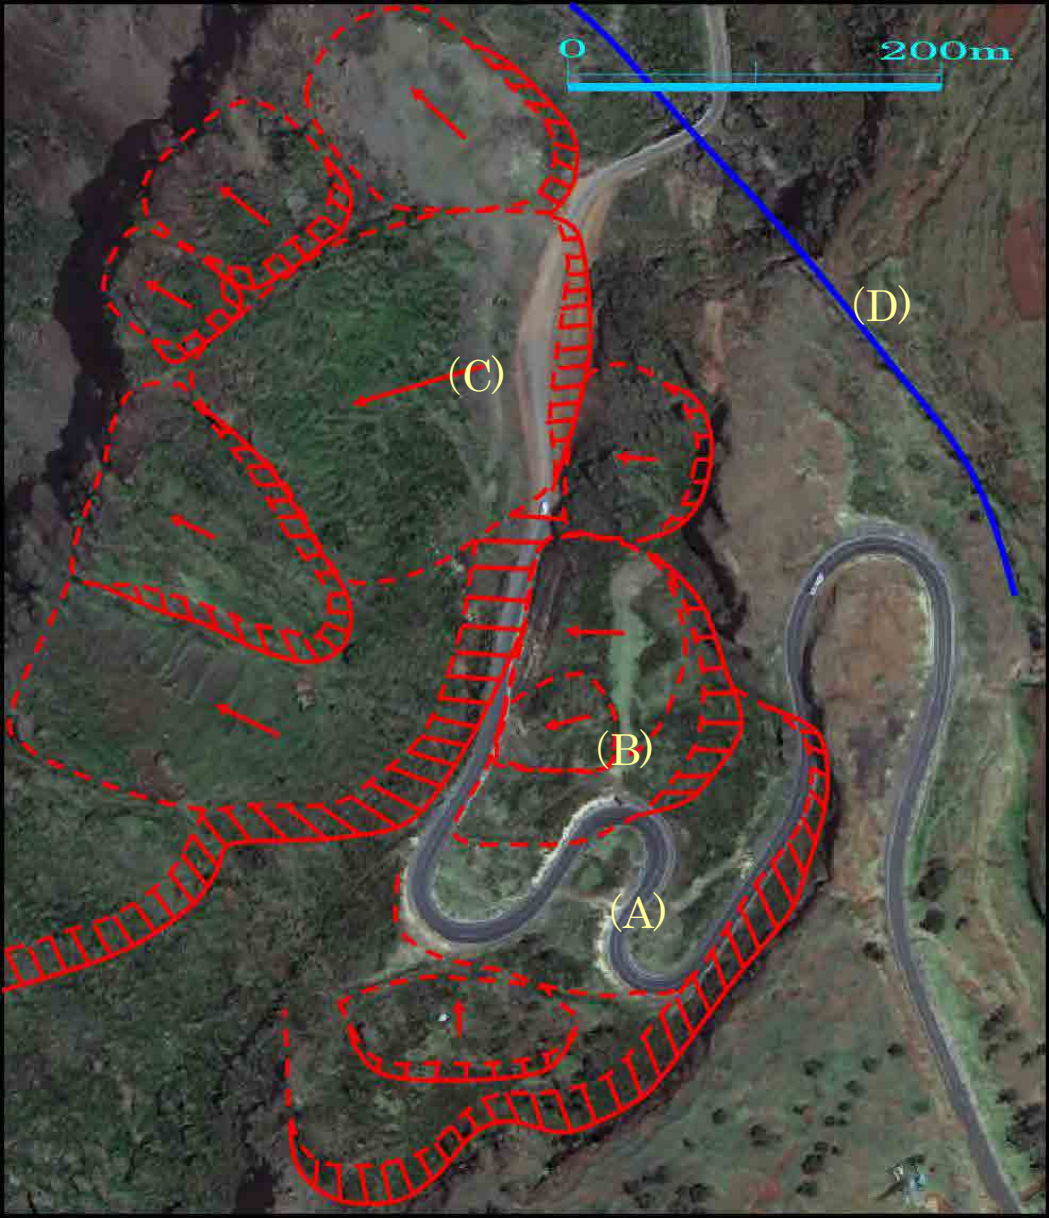
Fig.3.3.4 Satellite image interpretation ST.0+000 to ST1.200

A horse-shoe shaped depression surrounds the S-curve in the road near ST.0+000, which is the remains of an old landslide (A). Within that, several smaller landslides, thought to have occurred more recently, can be identified. Within this large landslide there is a smaller landslide formation (B).

Landslide (C) is interpreted as moving in-line with or obliquely—west-southwest—to the road, judging from the mound near the foot of the moving mass.

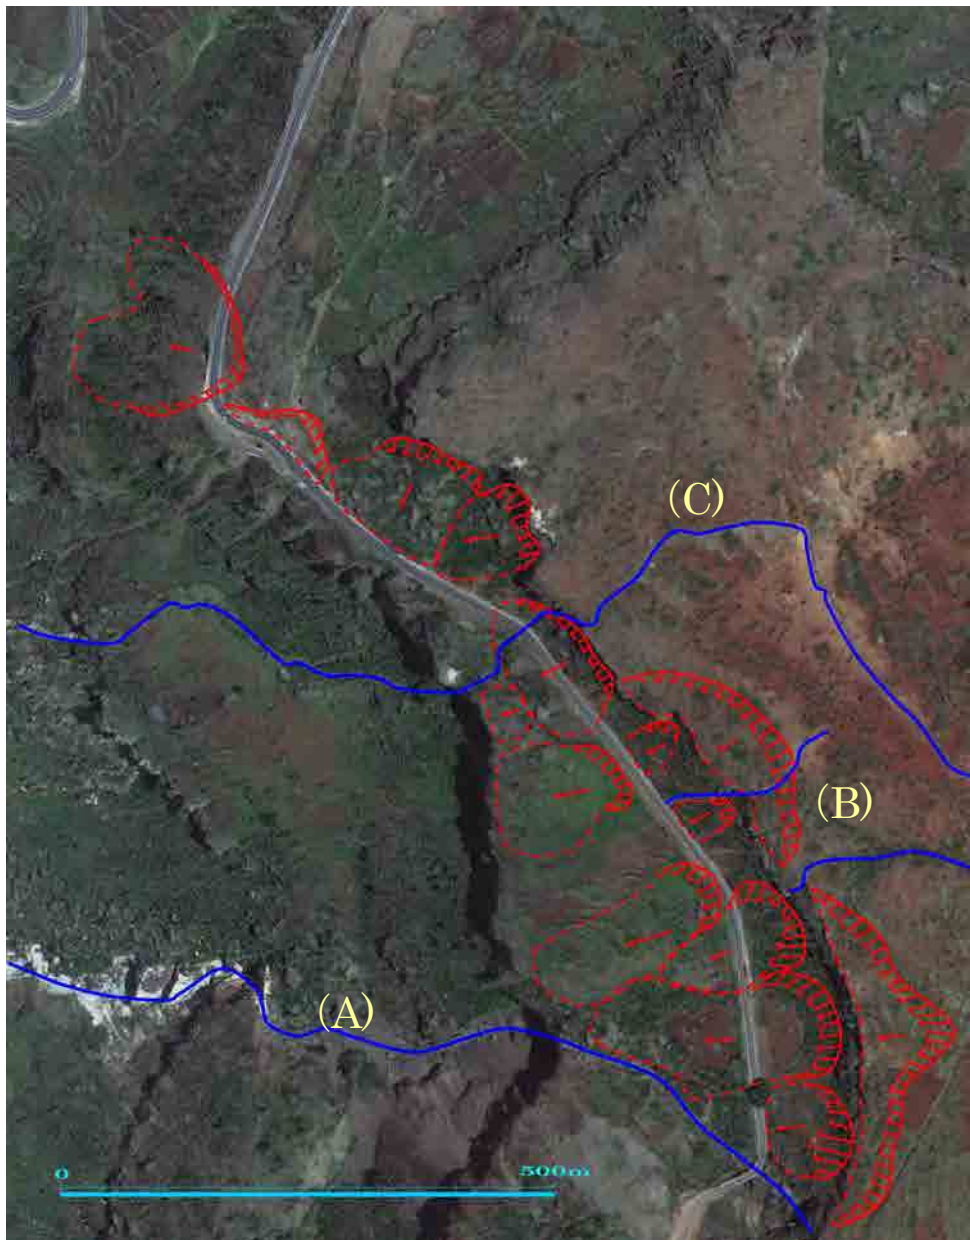
Fig.3.3.5 Satellite image interpretation ST.1+100 to ST.2+500

There are several medium- to small-scale landslides along the road in this area. Landslides are also confirmed on the basalt lava plateau above the cliff; around which several parallel steps can be confirmed.

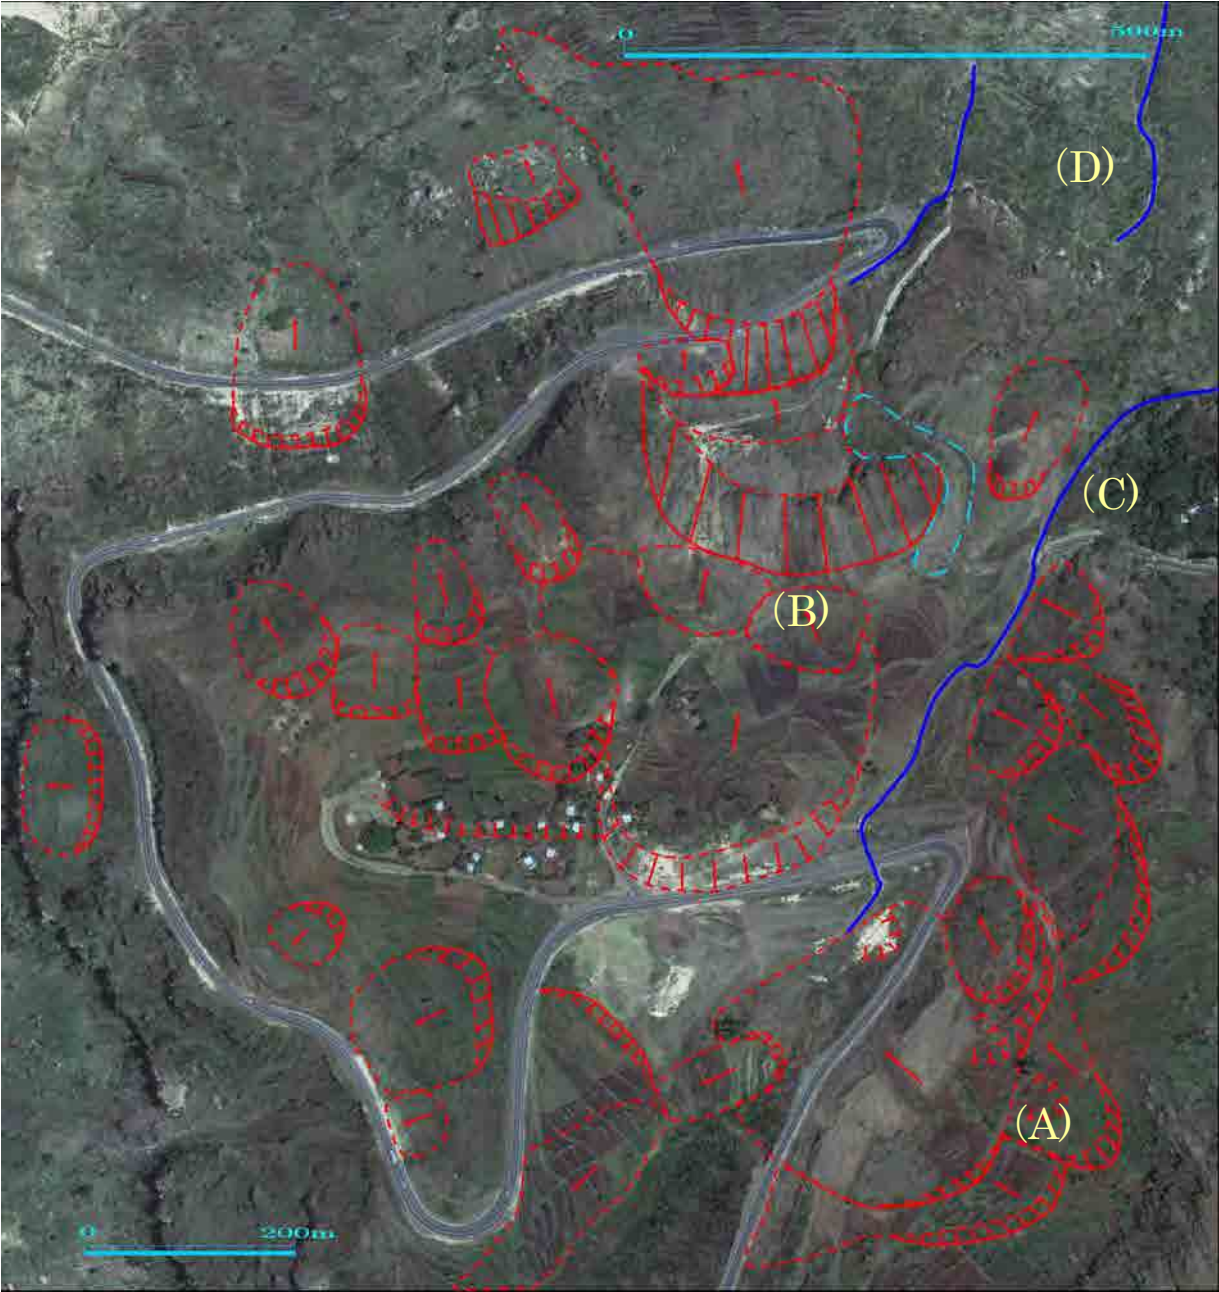
Figure 3.3.6 Satellite image interpretation ST.2+400 to ST.6+000

Many large to small landslides can be confirmed in this area. Steps and cracks can be confirmed at (A), and minor deformations are considered to be active. Steps and cracks are confirmed at (B) also. Three river systems can be confirmed in this area (C, D).

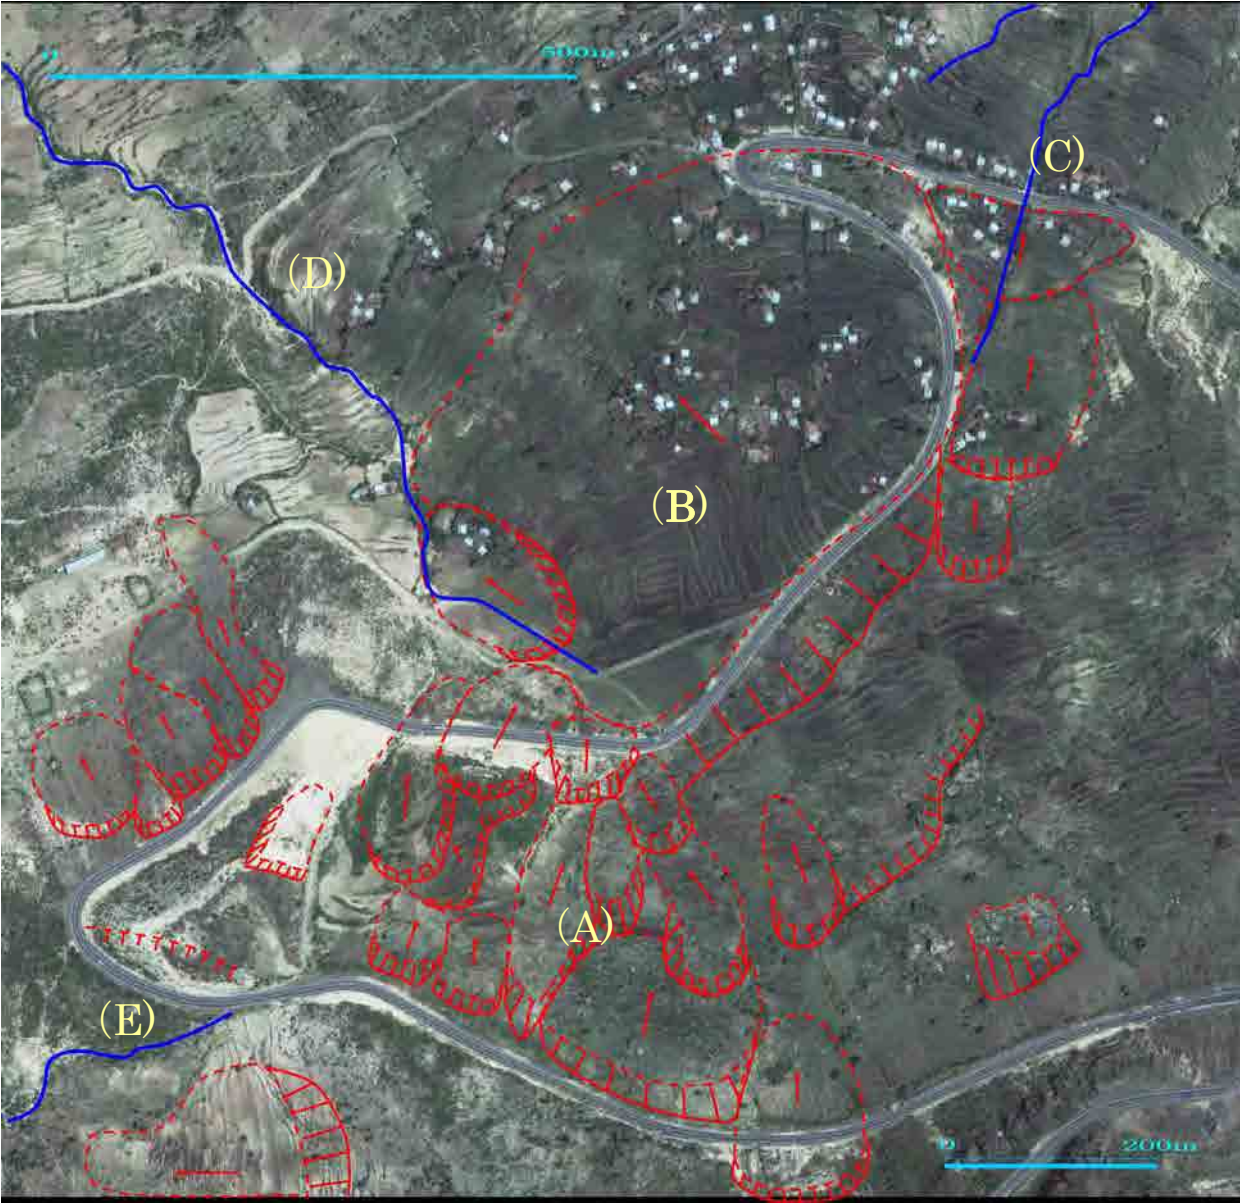
Fig.3.3.7 Satellite image interpretation ST+5500 to ST+8400

Many landslides can be confirmed around (A), which are thought to be relatively old. (B) is an old large-scale landslide, however, it is considered to be stable. Three river systems are confirmed in this area (C, D and E).

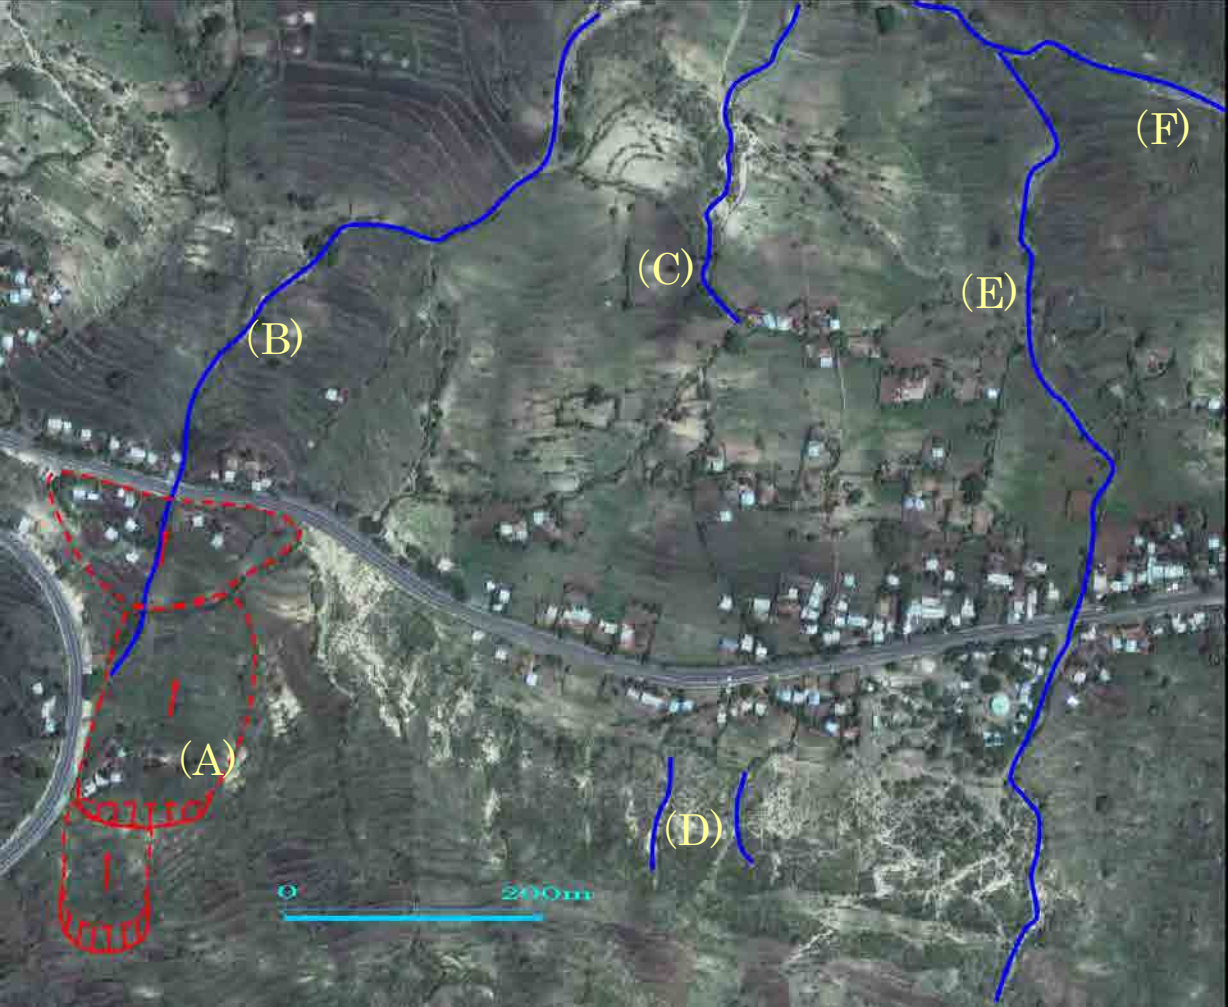
Fig.3.3.8 Satellite image interpretation ST.8+100 to ST.9+000

Landslides are confirmed at (A), however, they are all old. There is also evident dissection underway, and old landslides with vague crowns. These are not thought to have a direct or indirect impact on the road; therefore, they have not been interpreted. Six river systems (B to F) are confirmed in this area.

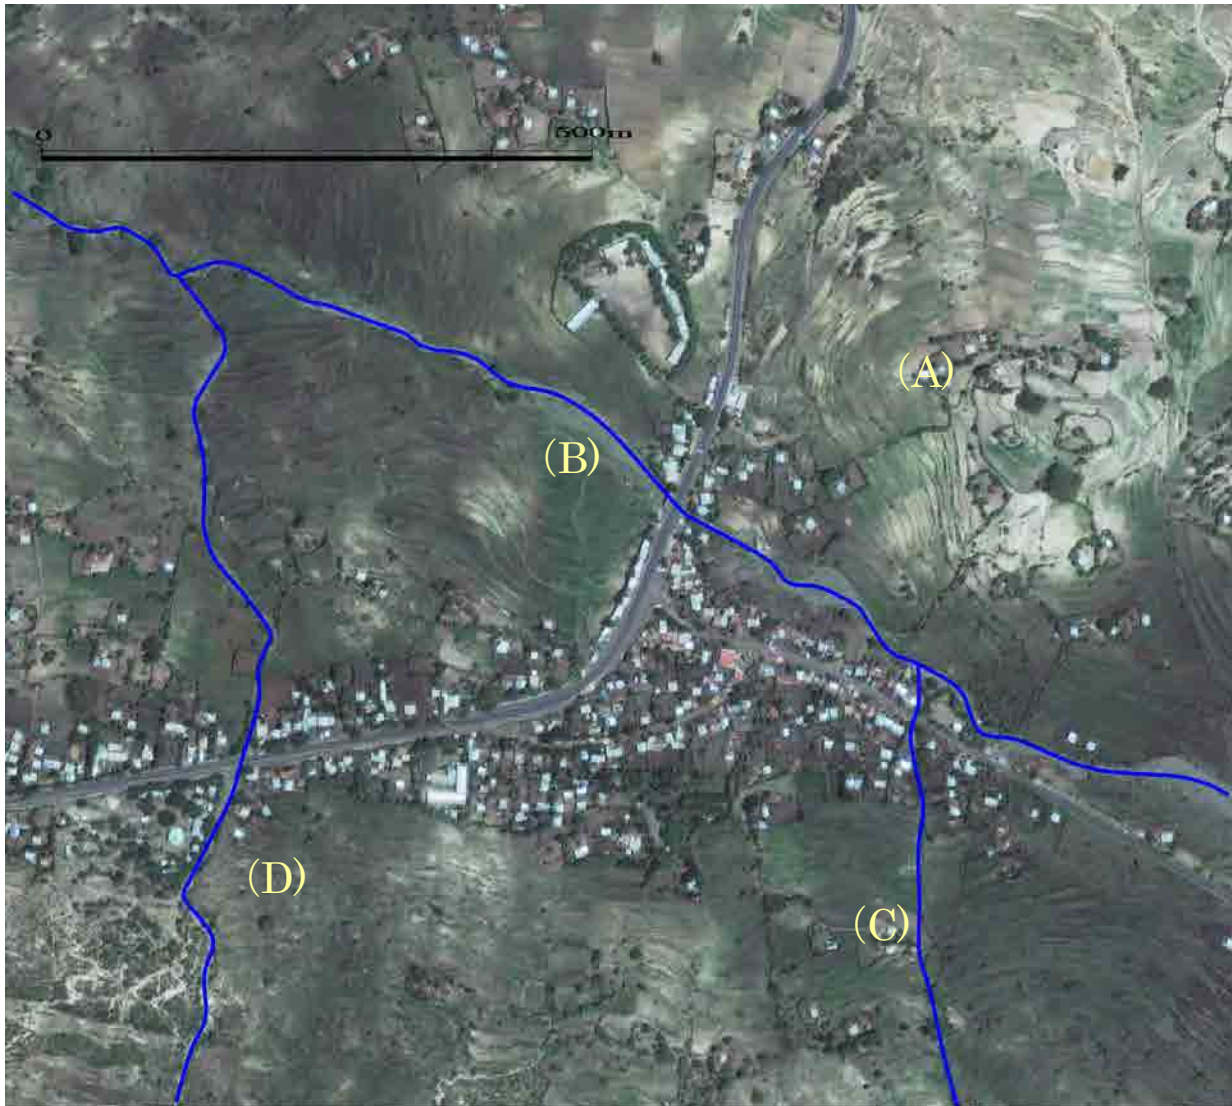
Fig.3.3.9 Satellite image interpretation ST.8+900 to ST.9+500

There is also evident dissection, with several old landslides with vague crowns apparent along the river. There are no distinct landslides. There is a relatively large river system (B) into which two tributaries (C, D) flow.

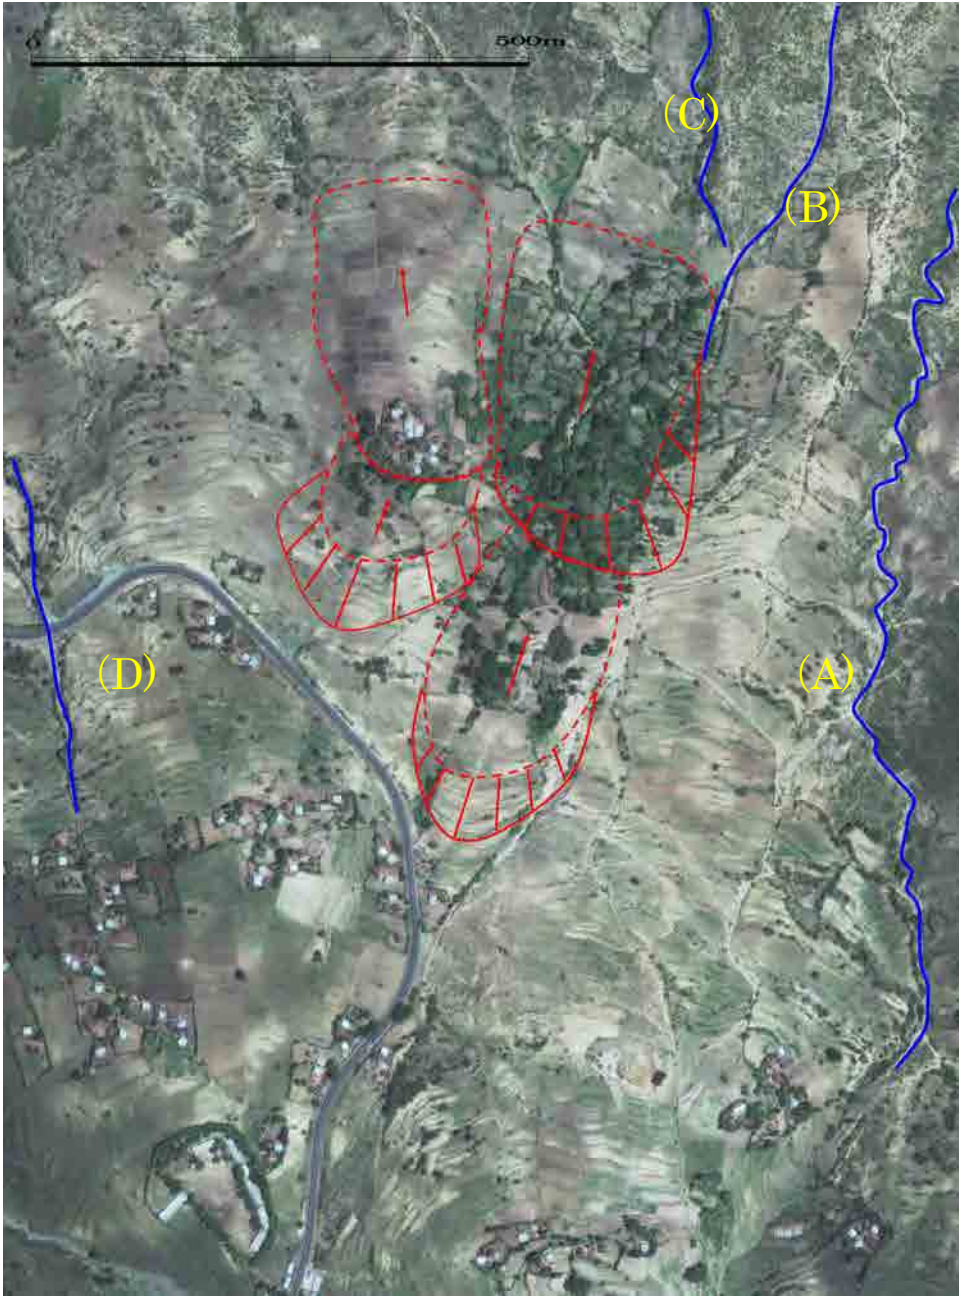
Fig.3.3.10 Satellite image interpretation ST.9+200 to ST10.400

There are several landslides below the main road; however, they are all old. Four river systems (A to D) are confirmed in this area.

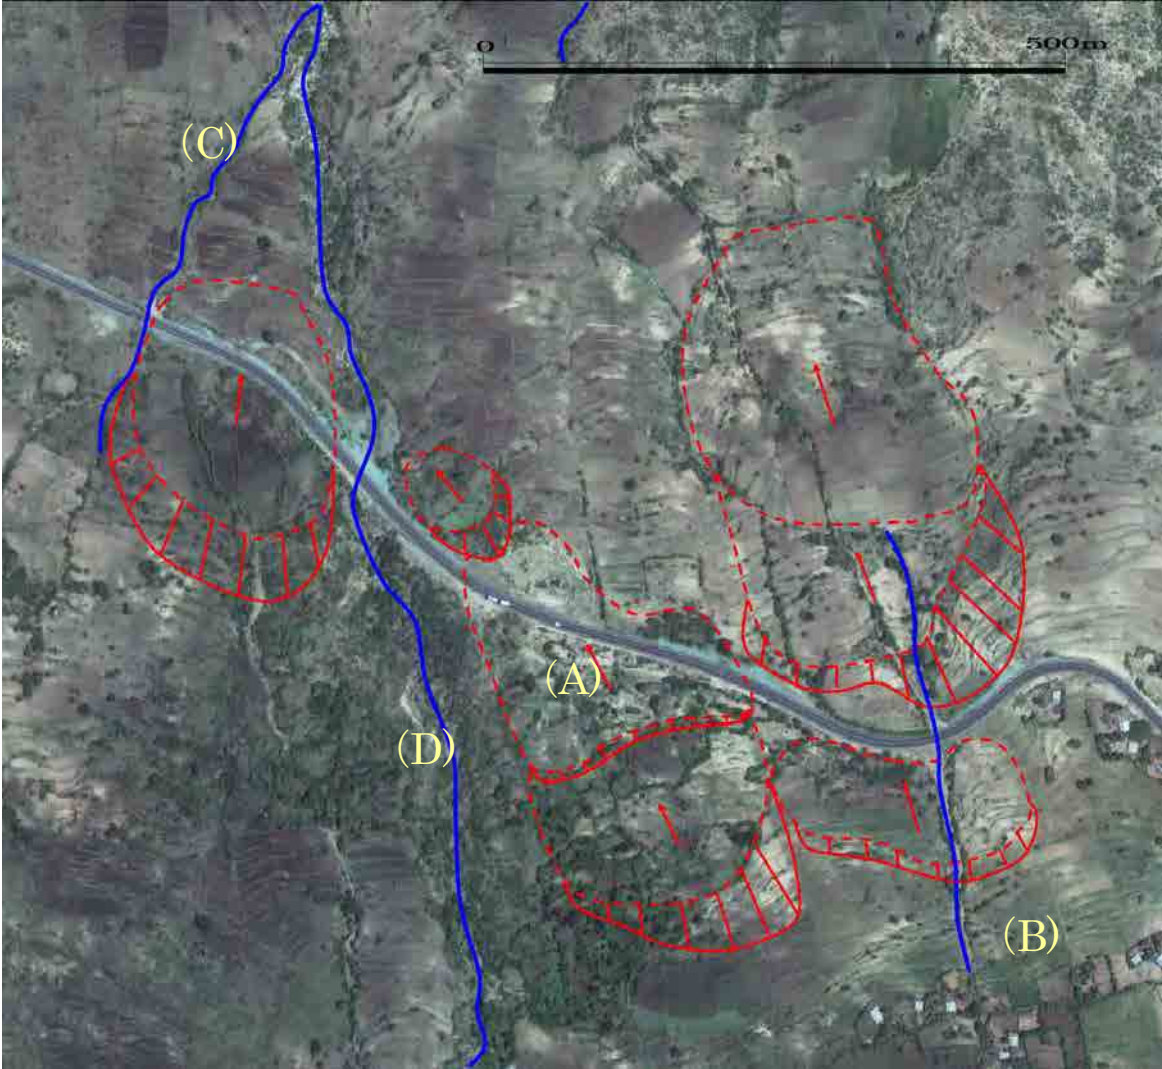
Fig.3.3.11 Satellite image interpretation ST.10+100 to ST.11+000

There are several relatively large landslides along the main road in this area. Of those, (A) is considered to be active, as steps are confirmed on either side of the road here. Three river systems, (B,D and D) are confirmed in this area.

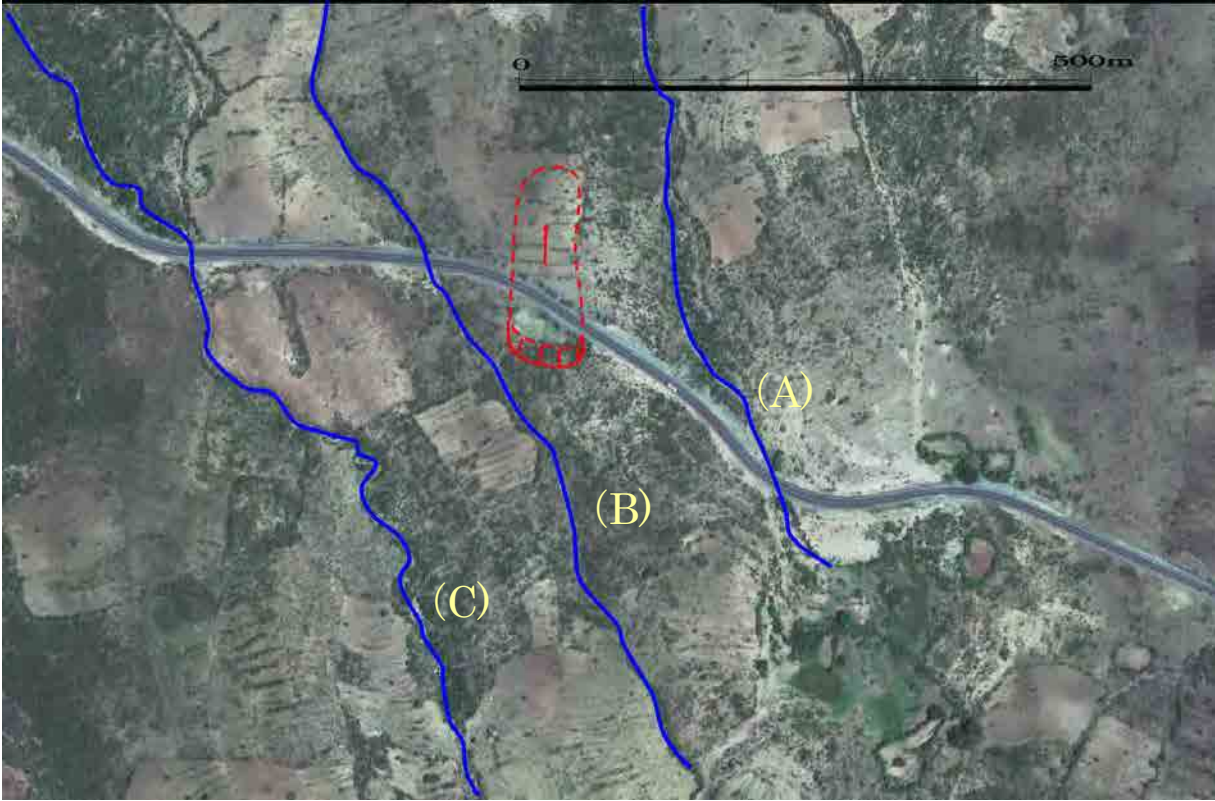
Fig.3.3.12 Satellite image interpretation ST.11+000 to ST12+000

One landslide is confirmed to intersect the main road in this area. There are no other landslides affecting the road in this area. Three river systems, (A to C), are confirmed in this area.

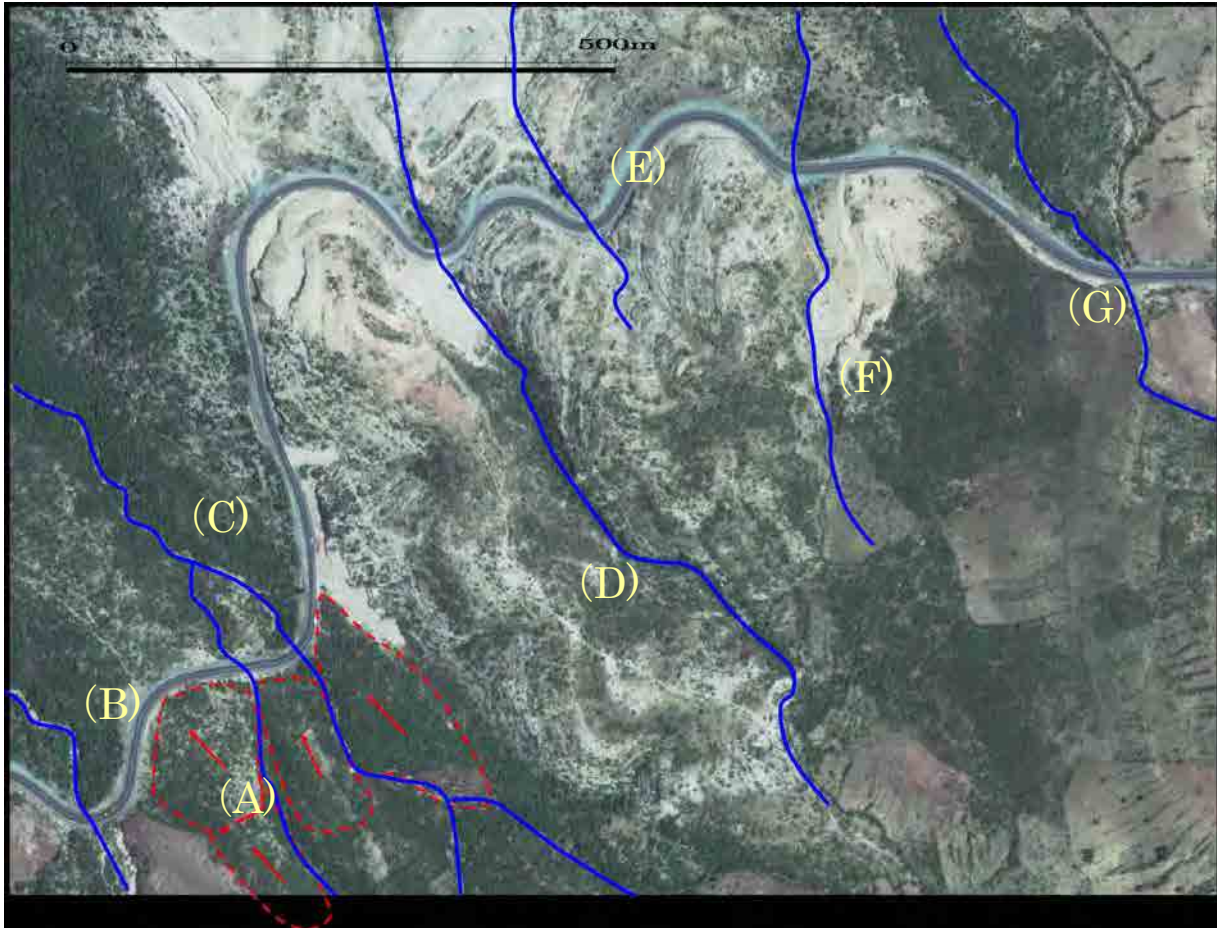
Fig.3.3.13 Satellite image interpretation ST.12+000 to ST.13+700

Several landslides (A) are confirmed in this area; however, these are secondary landslides that occurred in the debris of a larger landslide of the entire upper slope of a mountain. There are many river systems in this area, with six confirmed (B to G).

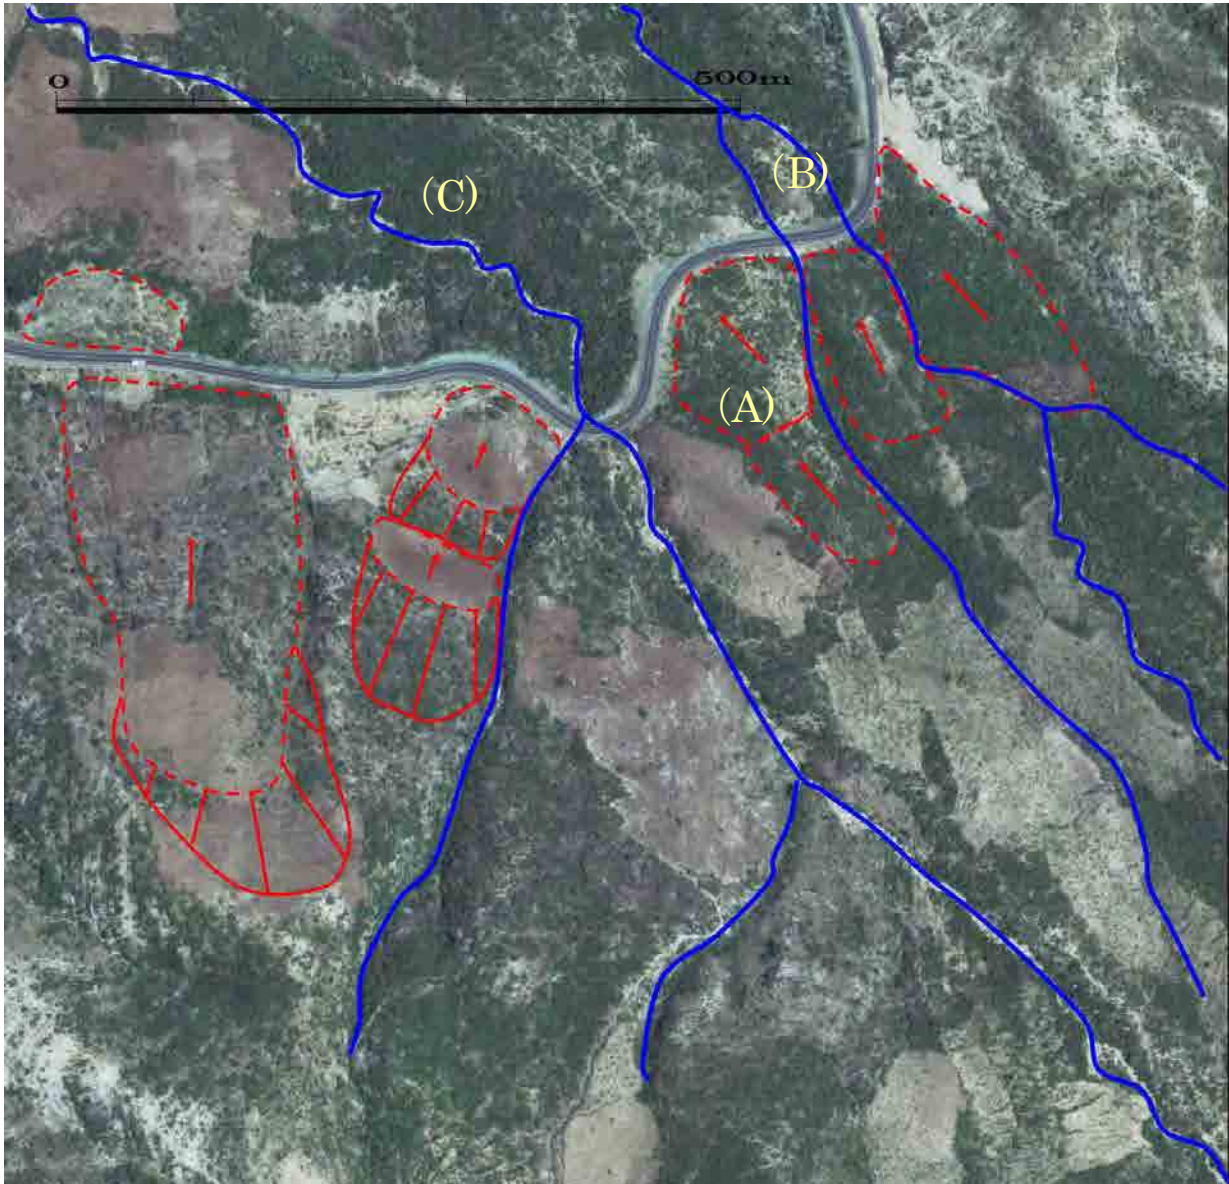
Fig.3.3.14 Satellite image interpretation ST+14200 to ST+15100

Several landslides can be confirmed along the main road; however, all of them are old. As mentioned earlier, landslides in area (A) are secondary landslides that occurred in the debris of a large landslide encompassing an entire mountain slope. Two main river systems can be confirmed (B and C).

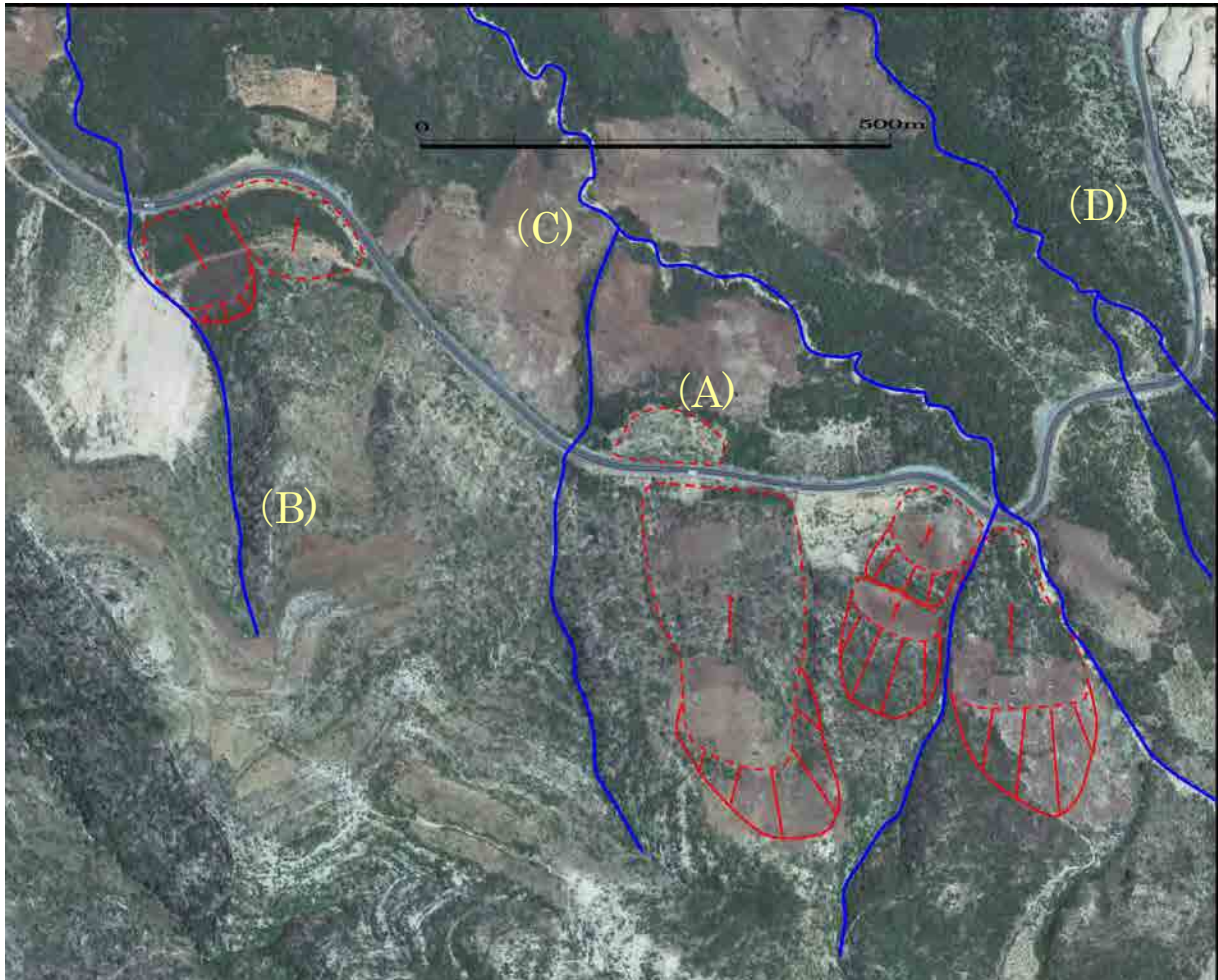
Fig.3.3.15 Satellite image interpretation ST+14600 to ST+15800

Several landslides are confirmed along the main road in this area, all of which are old. There is a small slope failure on the valley side of the road (A). There are three river system divisions (B,C and D) in this area.

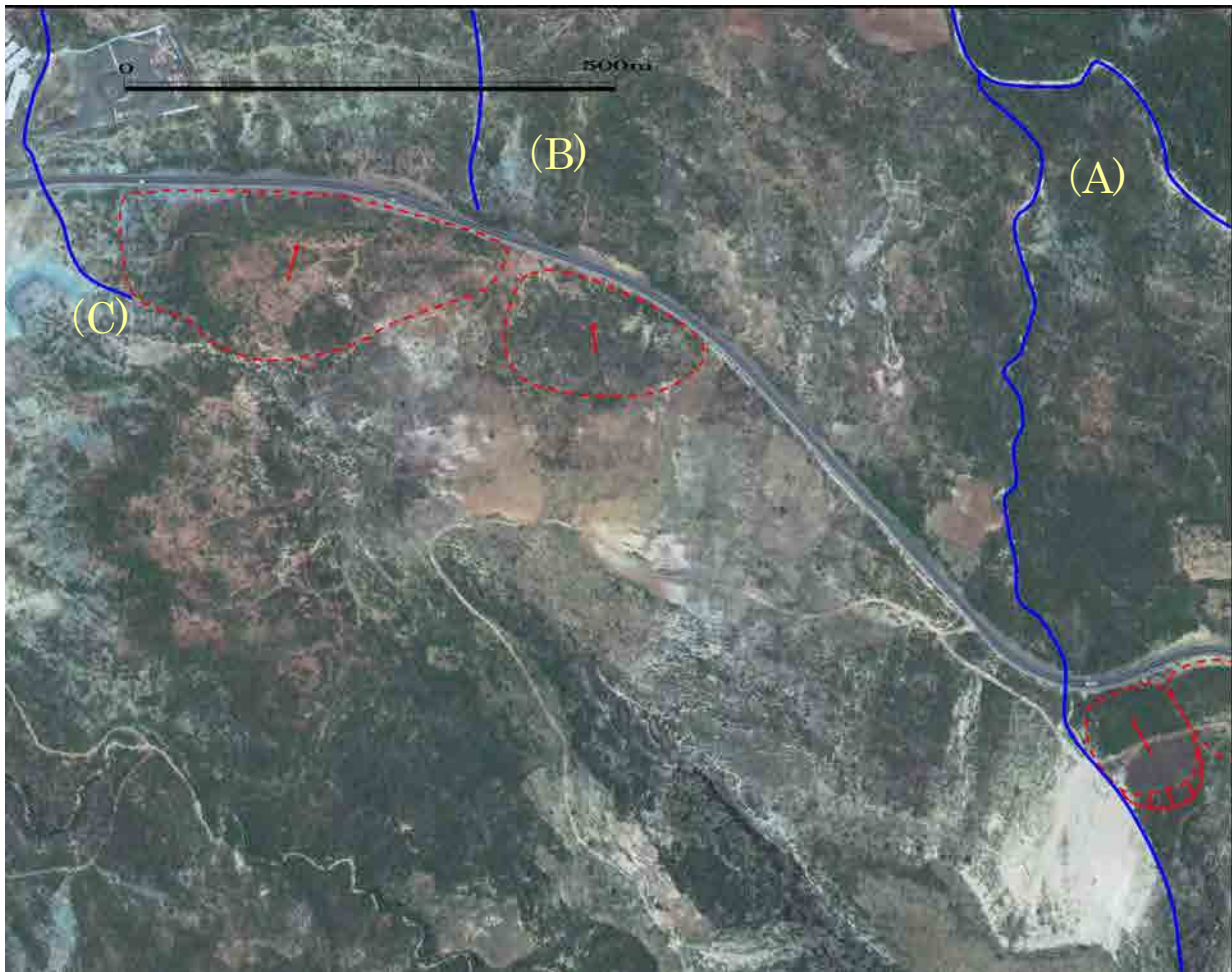
Fig.3.3.16 Satellite image interpretation ST.15+600 to ST.16+800

Several landslides are confirmed along the main road in this area, all of which are old. There are three main river systems (A to C) in this area.

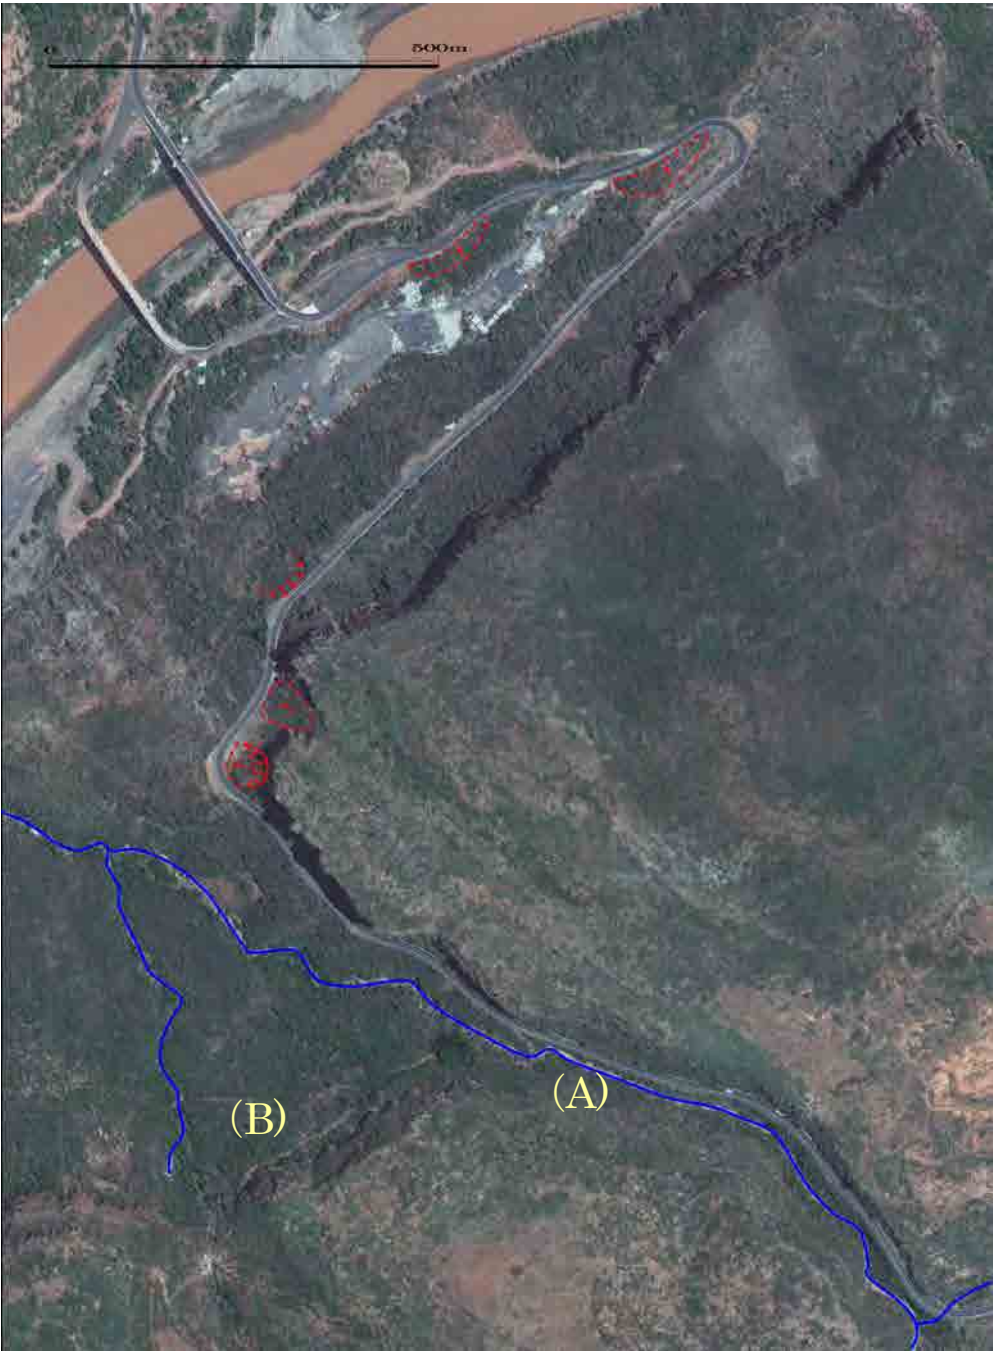
Fig.3.3.18 Satellite image interpretation ST.17+700 to ST.21+000

Several small landslides/slope failures are scattered along the main road. Two tributaries (A and B) are confirmed flowing into the Blue Nile in this area.

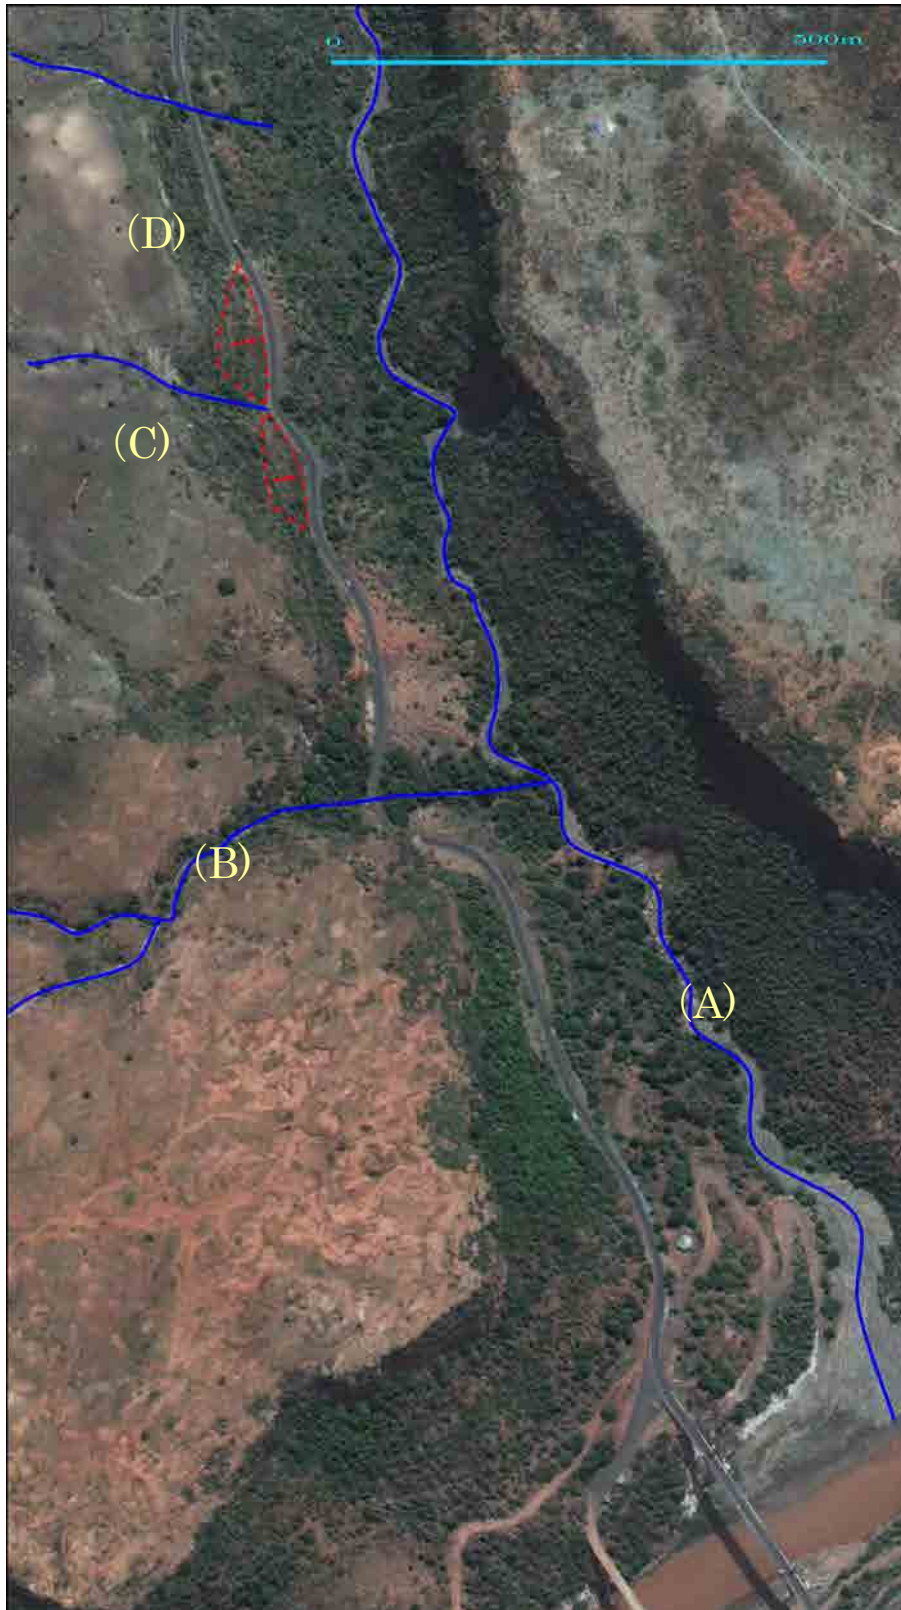
Fig.3.3.19 Satellite image interpretation ST+21000 to ST+22000

Small landslides are scattered along the main road in this area. Small deformations are thought to have occurred in recent years due to the presence of steps and cracks. Three tributaries (B to D) are confirmed for the river system (A).

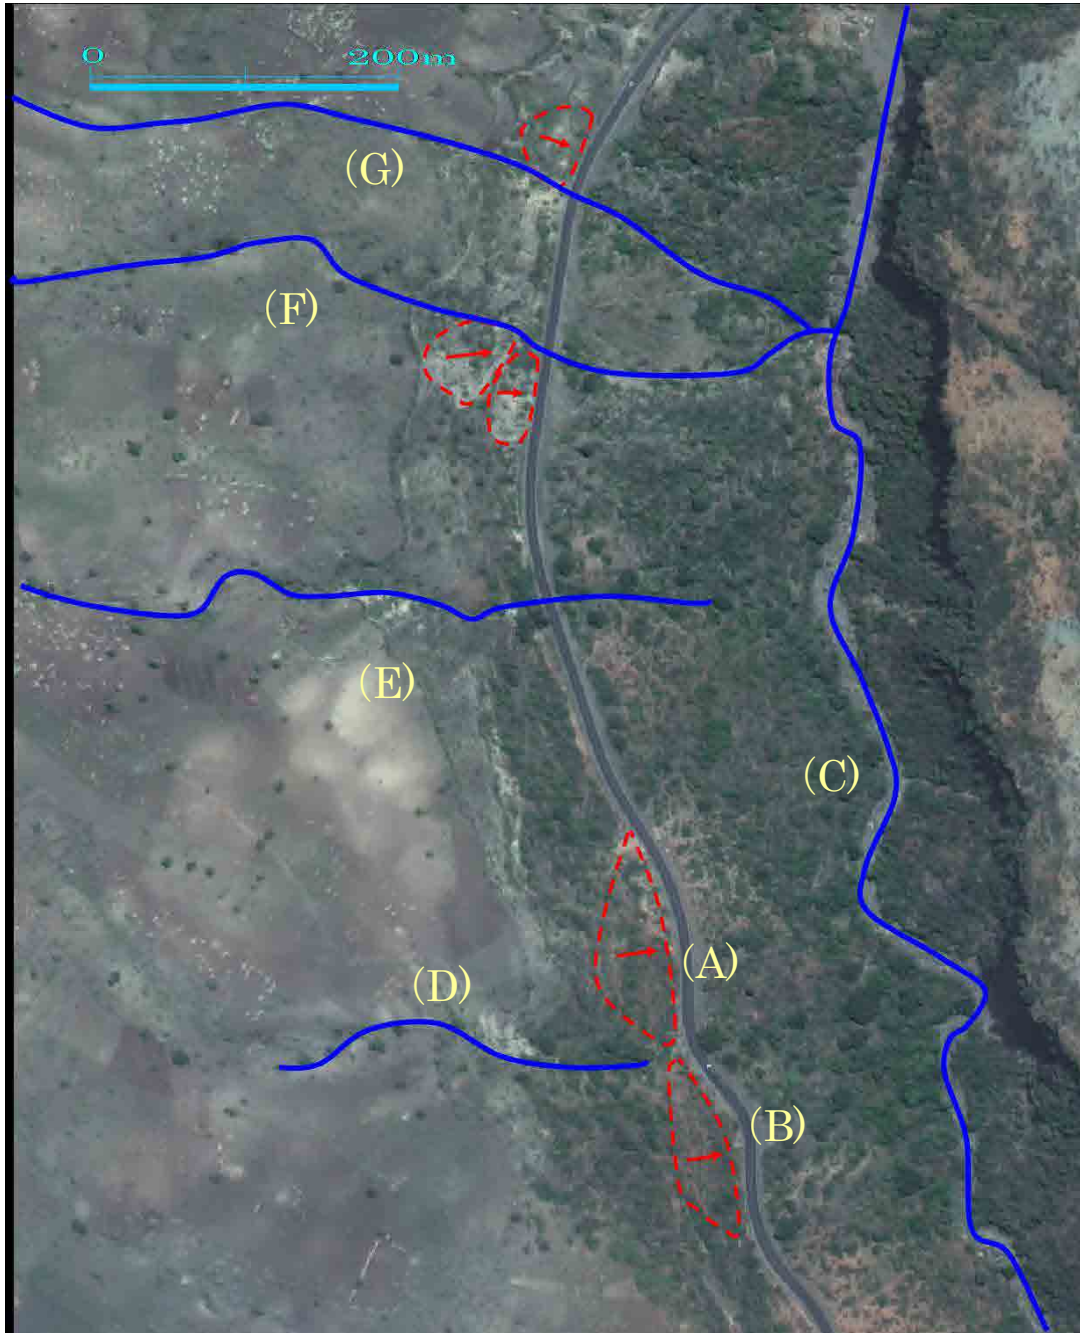
Fig.3.3.20 Satellite image interpretation ST+21700 to ST+22600

Small landslides are scattered along the main road in this area. Small deformations are thought to have occurred in recent years due to the presence of steps and cracks at (A) and (B). Four tributaries (D to G) are confirmed for the river system (C).

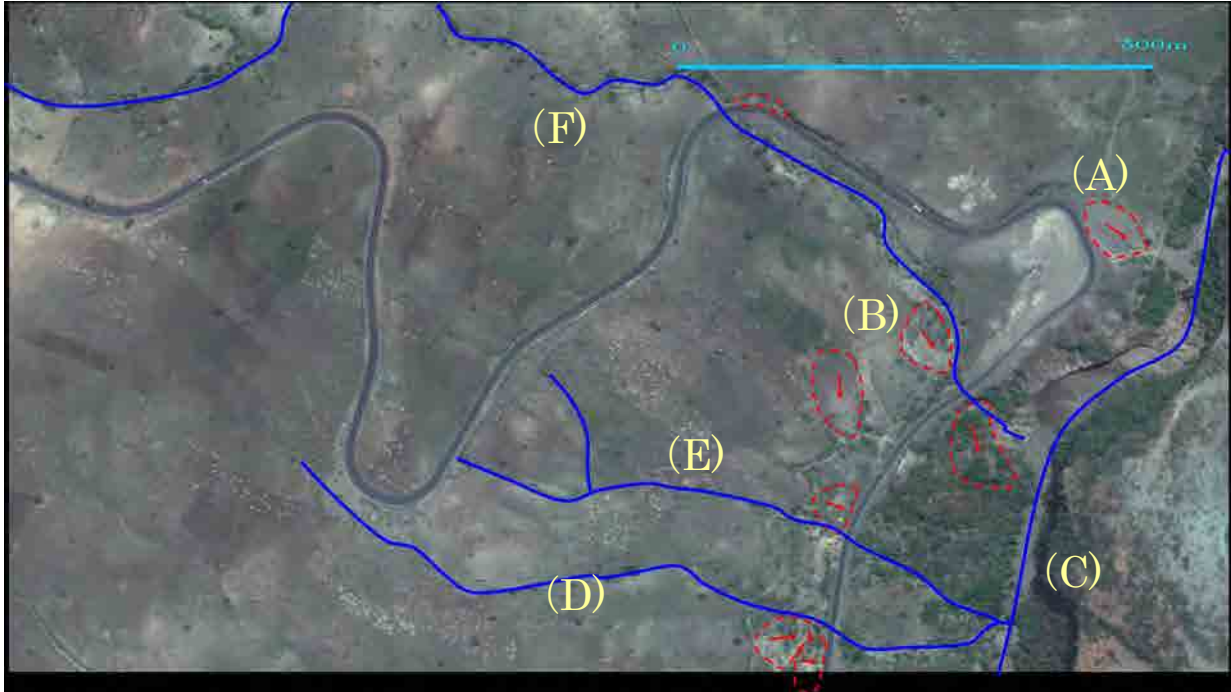
Fig.3.3.21 Satellite image interpretation ST.22+200 to ST.24+700

Small landslides are scattered along the main road in this area. Movements are thought to be continuing recently due to the presence of new cracks in the main scarp at points A and B. Three tributaries (D to F) are confirmed for the river system (C).
