8. Satellite image interpretation for geomorphologic survey

Geomorphological Survey  
Satellite image interpretation

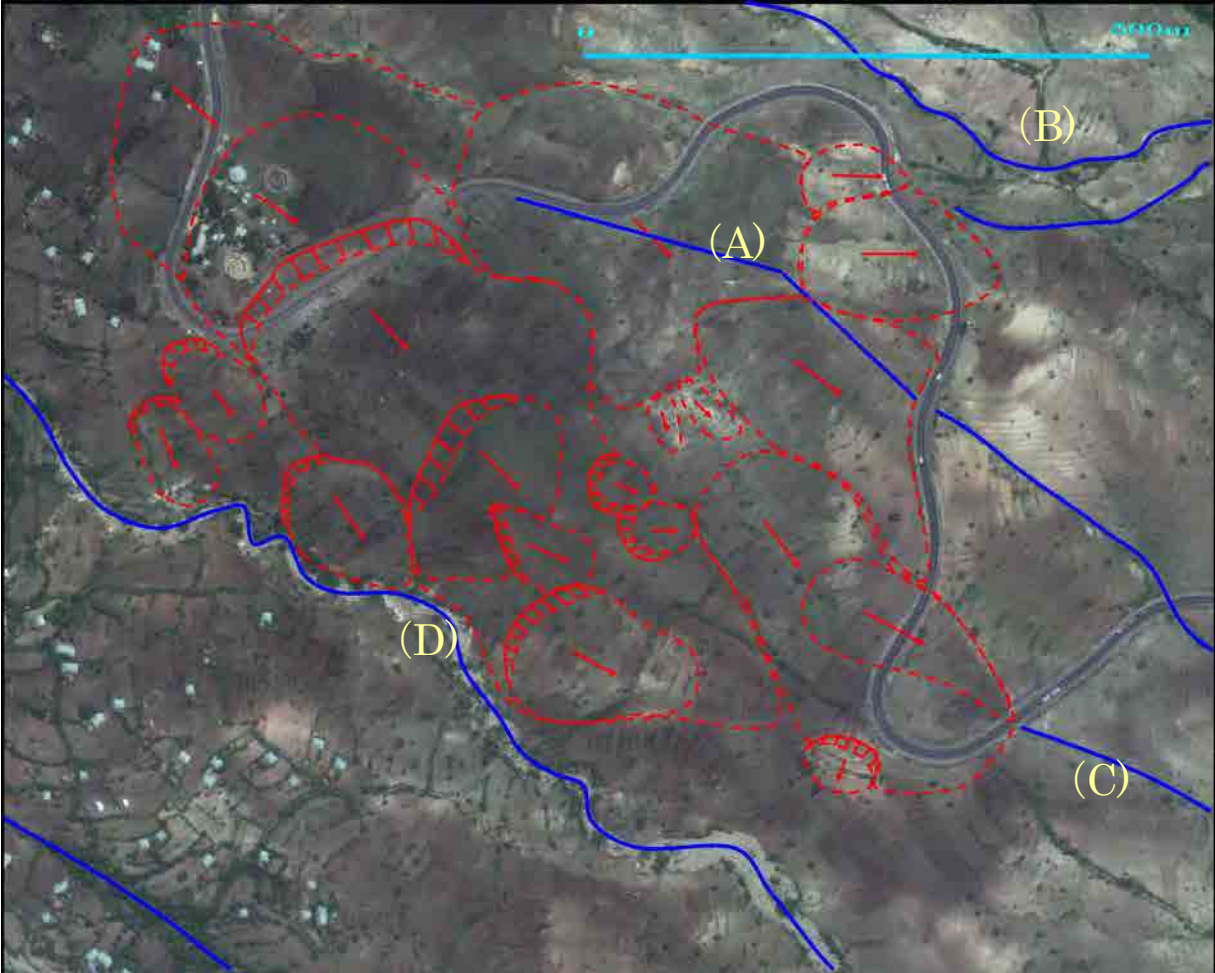
Fig.3.3.24 Satellite image interpretation ST.27+000 to ST.28+800

There are many landslides from small one to large one in this area. Many of these continue to be active as they have new main scarps and cracks. There is a man-made waterway (A), and several river systems surrounding the landslides (B, C, D).

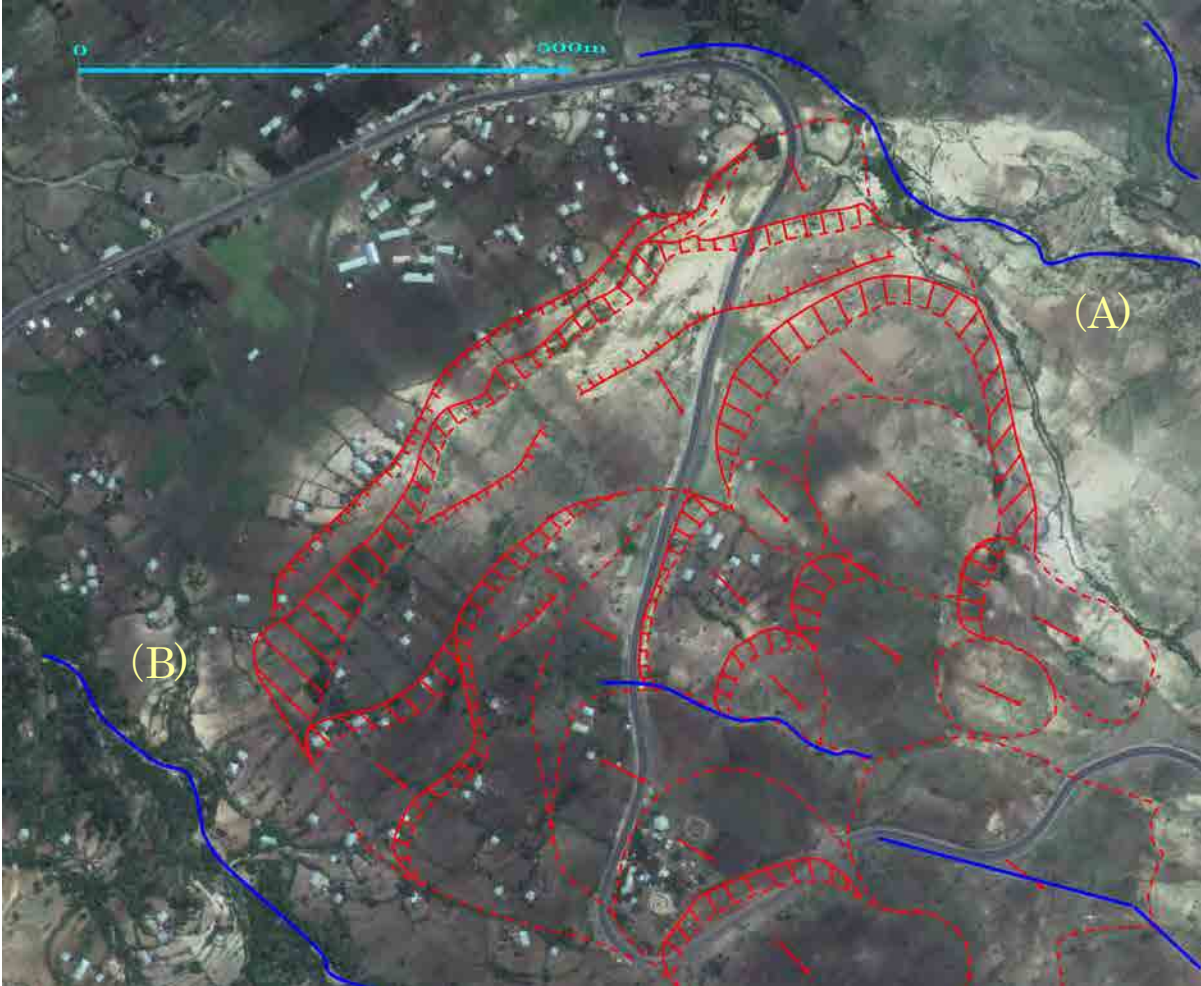
Fig.3.3.25 Satellite image interpretation ST.28+200 to ST.29+700

There are many landslides in this area. Amongst the larger landslides there are overlapping secondary-landslides, many of which continue to be active. There are also many new landslides with main scarps. There are large river systems (A and B) surrounding the landslides, while amongst them, there are only a few systems.

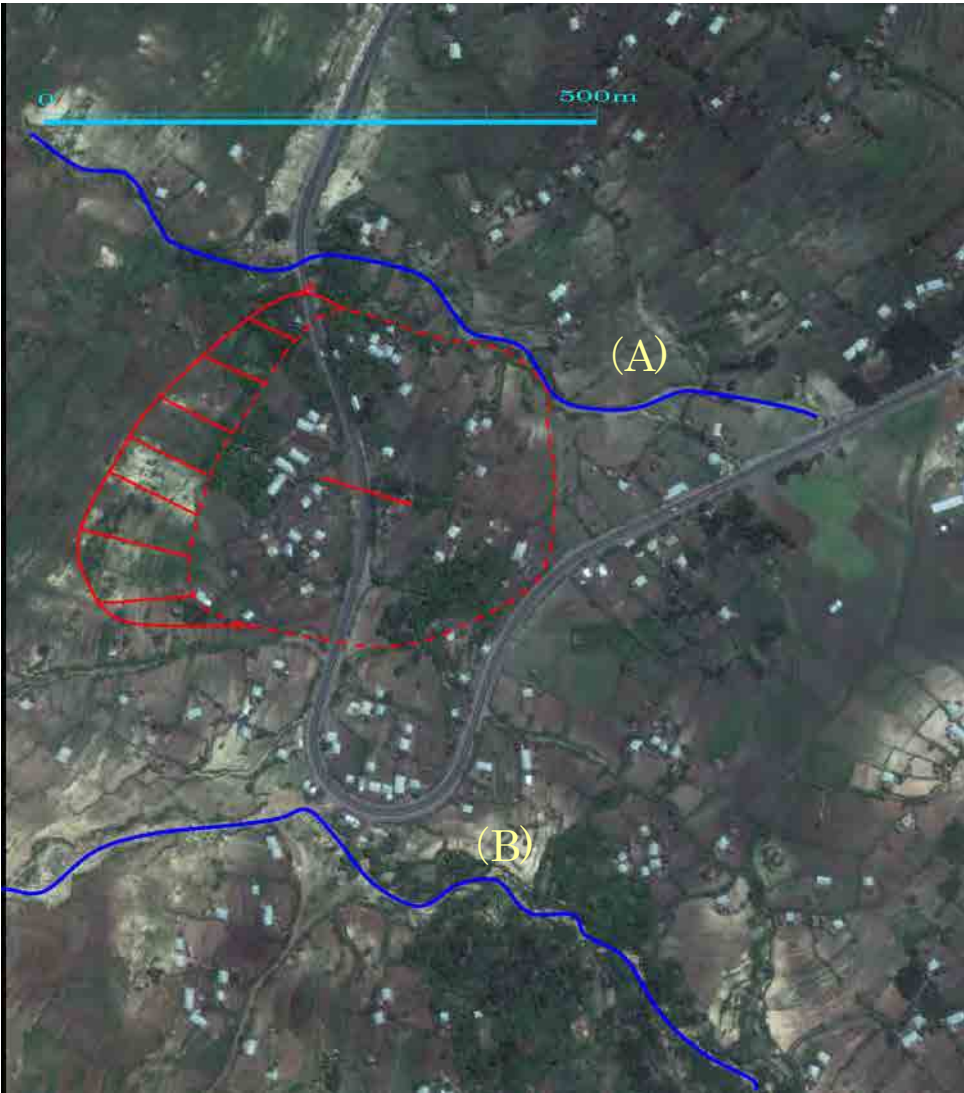
Fig.3.3.26 Satellite image interpretation ST.30+300 to ST.31+500

A large, old landslide is confirmed within this area. Two river systems (A and B) can be confirmed, one on either side of this landslide.

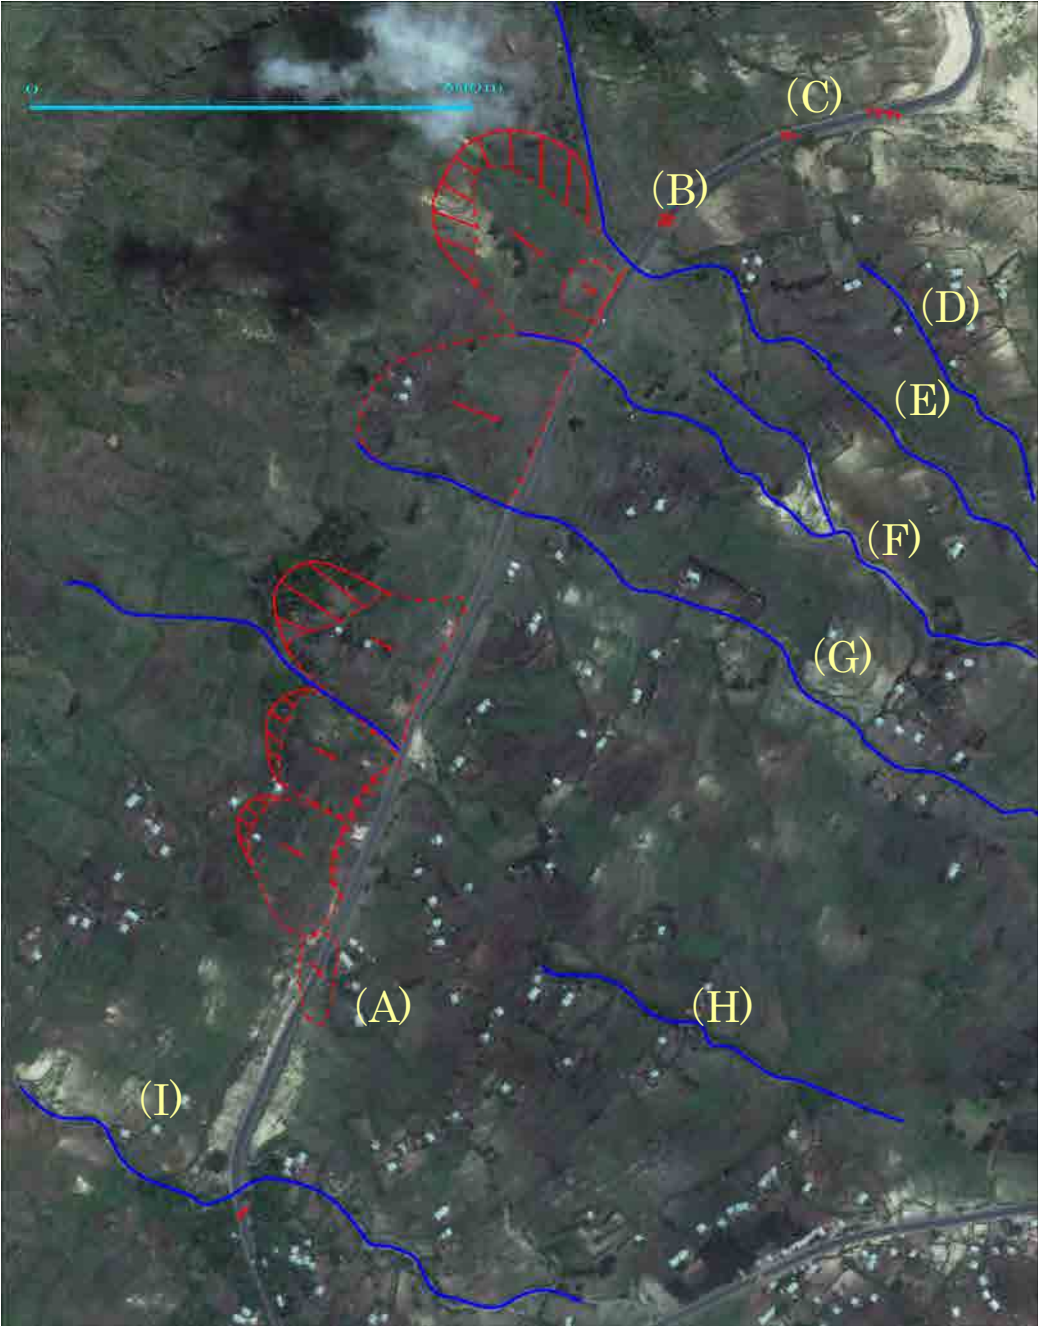
Fig.3.3.27 Satellite image interpretation ST.31+400 to ST.33+000

This entire area is within one old and extremely large landslide. There is a series of secondary landslides on the mountain side of the main road. The slope deformation can be considered to be active, because the slope on the mountain side of the road is being pushed out. One active landslide (A), while small, is causing deformation in the main road.

There are steps, B and C, confirmed in the road; however, they are not connected to any landslides. These are presumed to be the result of factors other than landslides such as sediment runoff around an old box culvert or a lack of strength in the road embankment materials. The river systems, D to I, occur mostly in parallel to the slope direction.

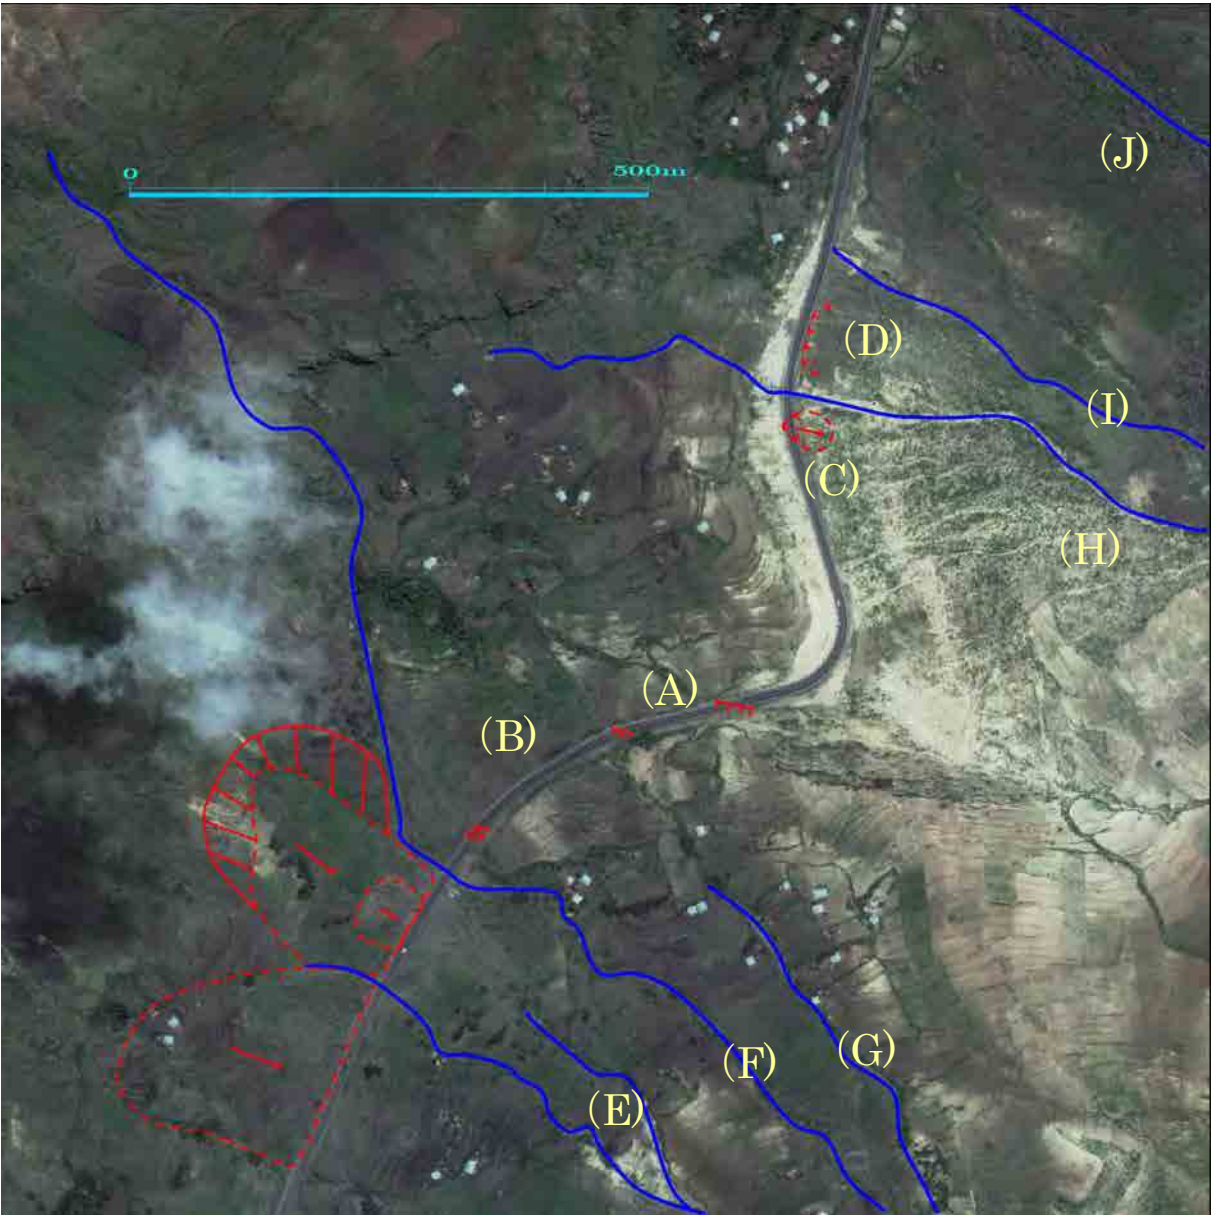
Fig.3.3.28 Satellite image interpretation ST.32+200 to ST.33+900

No landslides can be confirmed to be connected to the series of steps in the road at A and B in this area. As aforementioned, these steps are thought to be a result of an unrelated factor such as weak embankment materials. The small landslide, C, is thought to be a newly active slip because of the depression it has caused in the road. There is also a slope failure (D) on the valley side of the road.

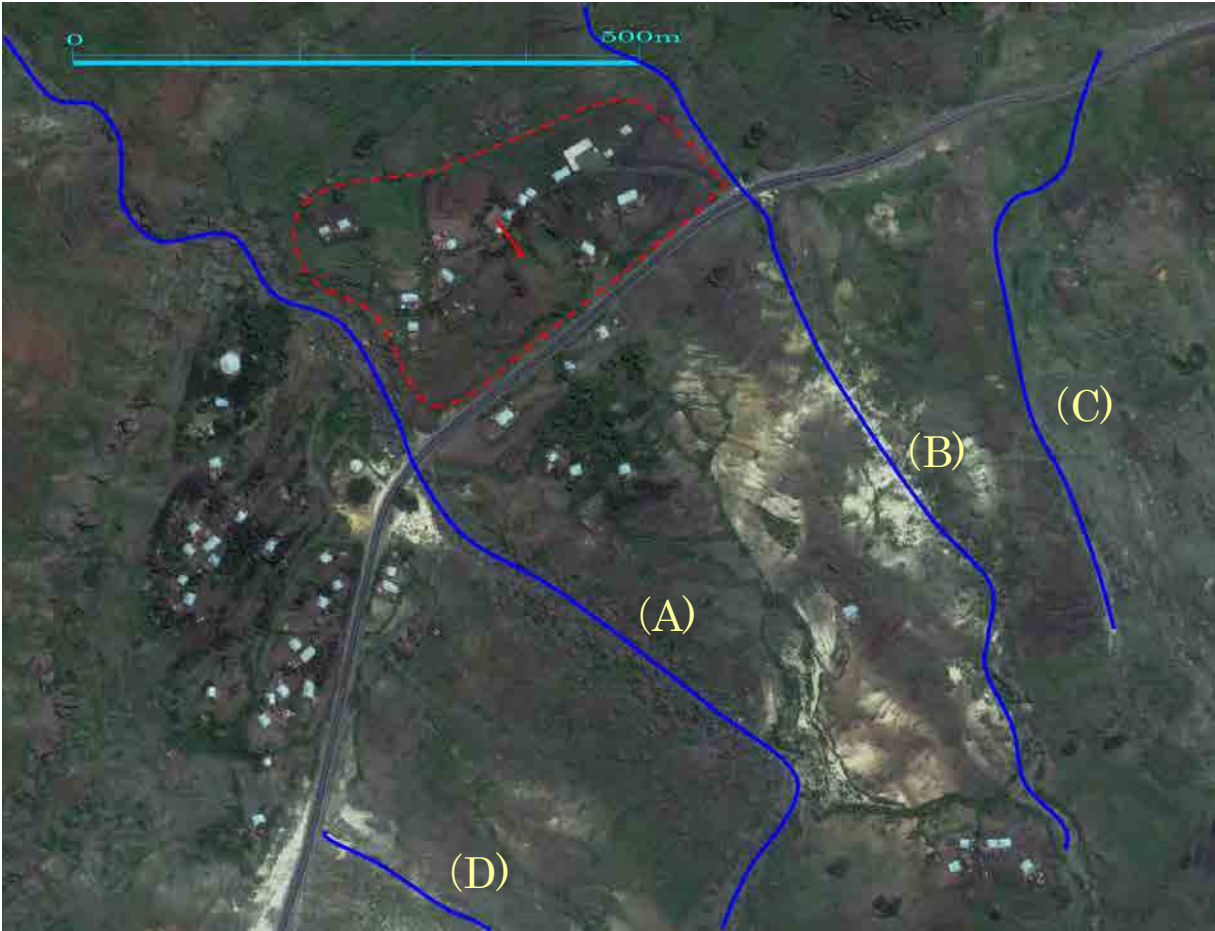
Fig.3.3.29 Satellite image interpretation ST.33+600 to ST.34+300

There is only one old landslide confirmed in this area. The river systems flow in parallel to the main slope direction, most notably A, flowing from Dejen Town, and also B and C.

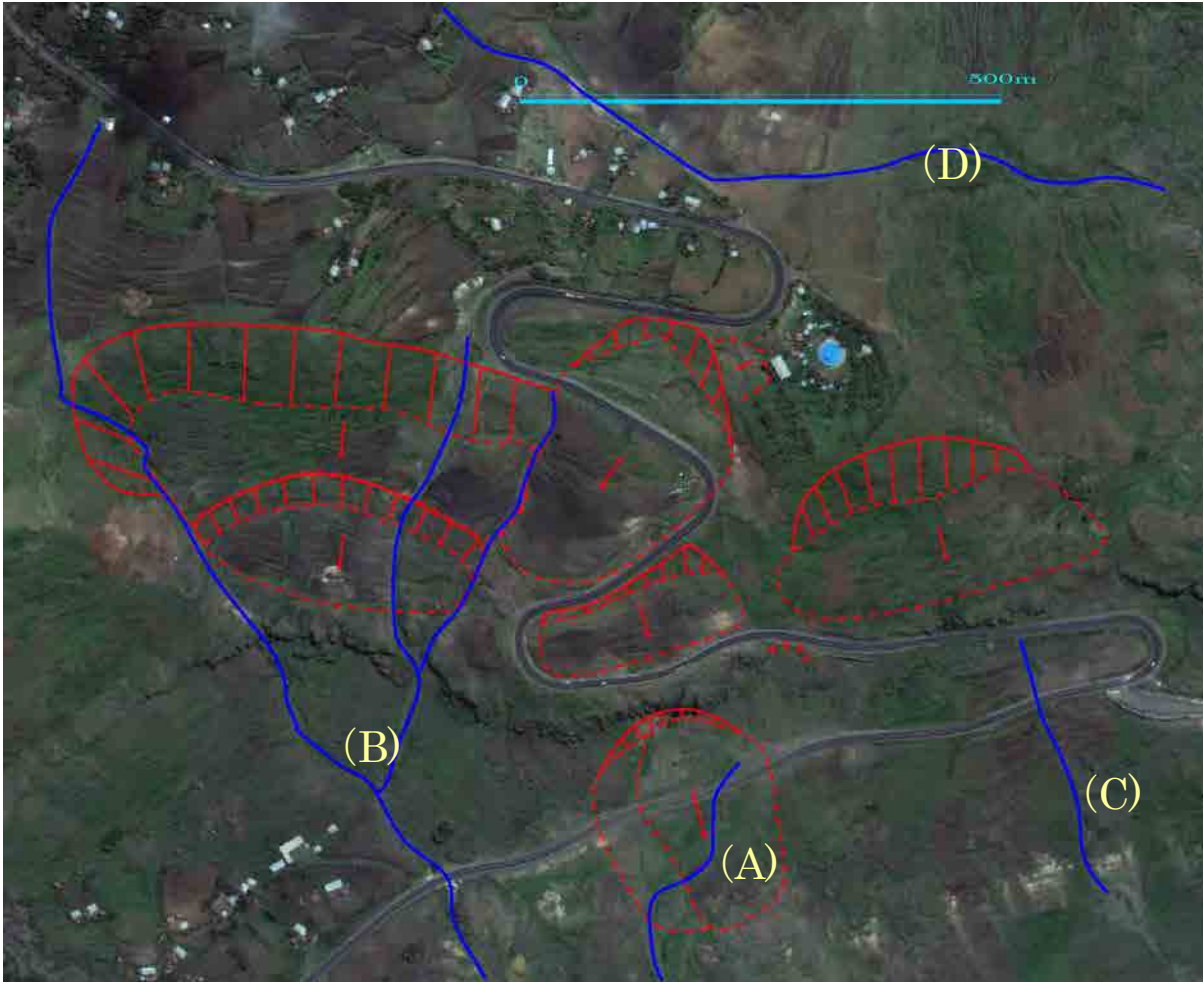
Fig.3.3.30 Satellite image interpretation ST.34+300 to ST.37+300

This area has a variety of large to small landslides along the main road, however, most are old. Of these, A is thought to have started moving in the last few years because it is confirmed to be pushing out the road. Several river systems are confirmed in this area (B, C and D).
