11. Debris flow survey

3.9 Debris Flow Survey

3.9.1 Debris flow site identification

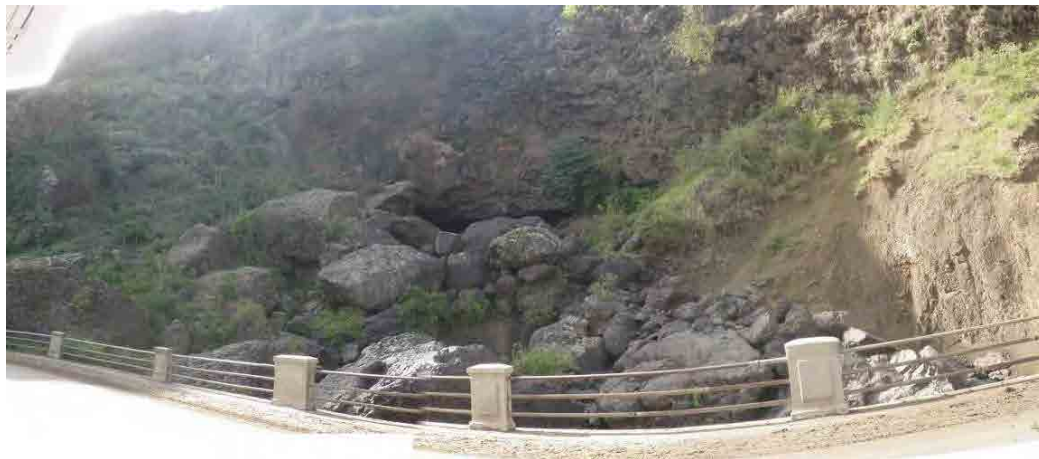
Most of the large boulders deposited in the channel are basalt of 1 to 5m in diameter. In the area upward of the road is a basaltic cliff wall with an approximate elevation of 60m. Many of the large fallen rocks scattered at the bottom of the cliff are mainly caused by rock topples.

Water level was very low during the survey and the channel width measured about 2m, however, during the rainy season, it rises considerably which eventually become a waterfall. The channel bed gradient above the waterfall is about 2°. There is only a small amount of unstable sediment.

Shallow landslides are observed in tuffaceous sandstone layers deposited at the base of the basaltic cliff wall due to erosion. Erosion under the basaltic layer also has resulted in overhanging. For this reason, there is a possibility that further erosion of the sandstone layers could lead to loss of stability for the entire cliff in the future.

Photo 3.9.1 Entire picture of MS001 (a waterfall exists in about 60m away from the bridge upstream from the road)

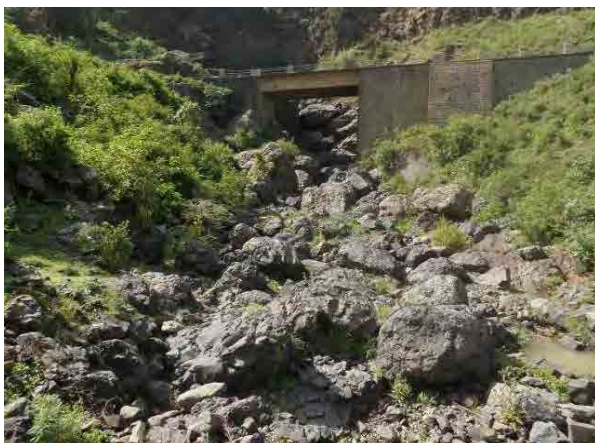
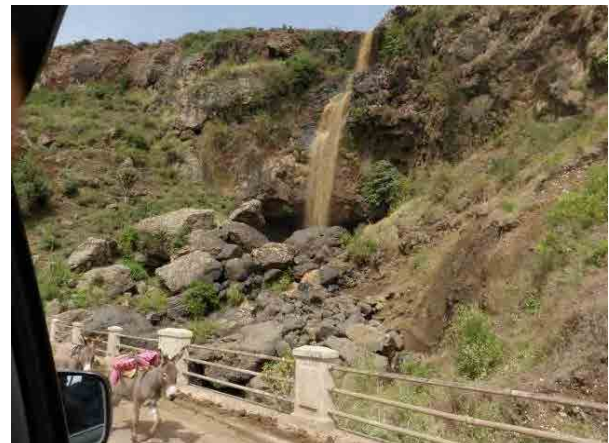
A number of large basaltic rock s is also distributed in the channel downward of the road. The channel bed gradient is about 3.5° to 7.0°, and the channel becomes a waterfall again at a point about 80m downward from the road. One of the mass movement processes that can be expected in this area is Rockfall which causes damage to the road and the bridge (the bridge is approximately 12m in height and 14m in total length). Furthermore, Rockfalls could grow into debris flows when the stream discharge increases.

Photo 3.9.2 Entire picture of MS001 (at downstream from the road) Photo 3.9.3 Water flow conditions in downpour time

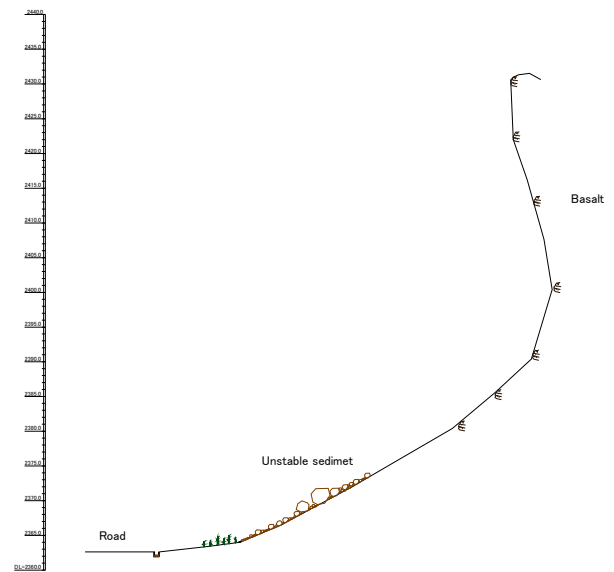
Figure 3. 9.1 Cross-sectional channel bed of MS002

The channel bed gradient is approximately 30° and the channel width is 3 to 4m. Basaltic rocks are exposed under unstable sediment.

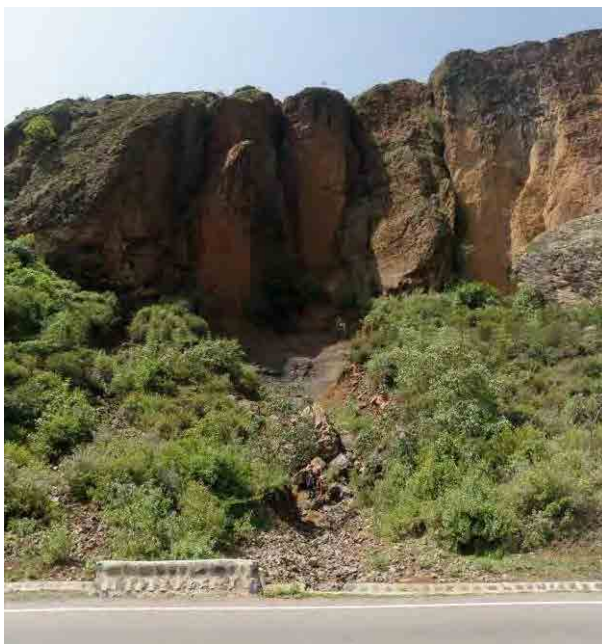
This section is located in a Rockfall hazard area where sediment runoffs are observed in addition to Rockfalls. Unstable sediment consists mainly of fallen rocks that have been exfoliated and detached from the basaltic cliff walls. They are deposited near the road.

Photo 3. 9.4 Entire picture of MS002 (the upstream from the road)

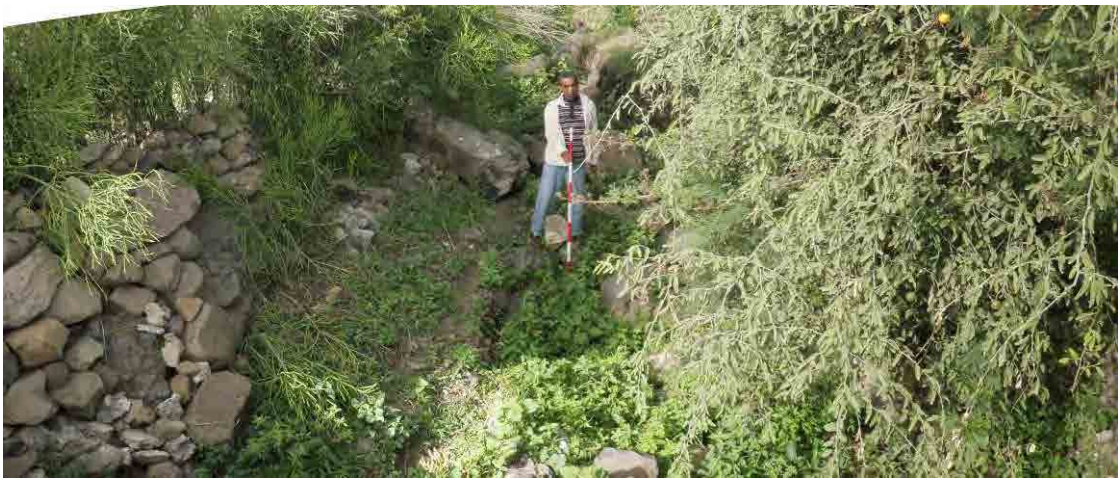
The channel bed gradient is approximately 12° and the channel width is 1.0 to 3.0m. Top of the channel is at the drainage gutter and crossing drainage pipe, and surface water flows into this small channel. In fact, gullies have developed over time to form the channel. There are houses and fields on the side of the channel closest to the road and the side erosion is in progress.

Photo 3. 9.6 Entire picture of MS003 (upstream from the road; fields and houses are scattered along the channel bank)

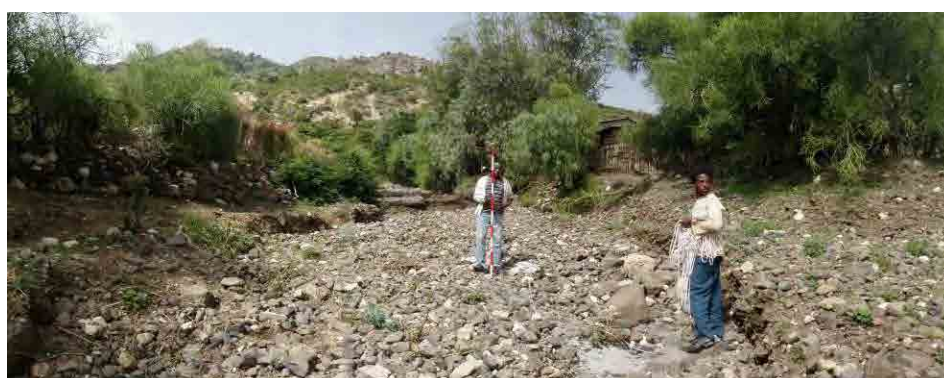
of debris flow. In fact, rock blocks are observed in the channel bed. The channel width is from 4 to 15m widening toward the road. Further upstream of the 90m section is the zone of transportation and erosion with a channel bed gradient of 18° . This section is partially disturbed. The channel width is 2 to 8m, and large basaltic and limestone rocks with maximum diameter of about 3m are distributed.

Photo 3. 9.9 Entire picture of MS004 (upstream from the road; the channel bed is covered with rock blocks)

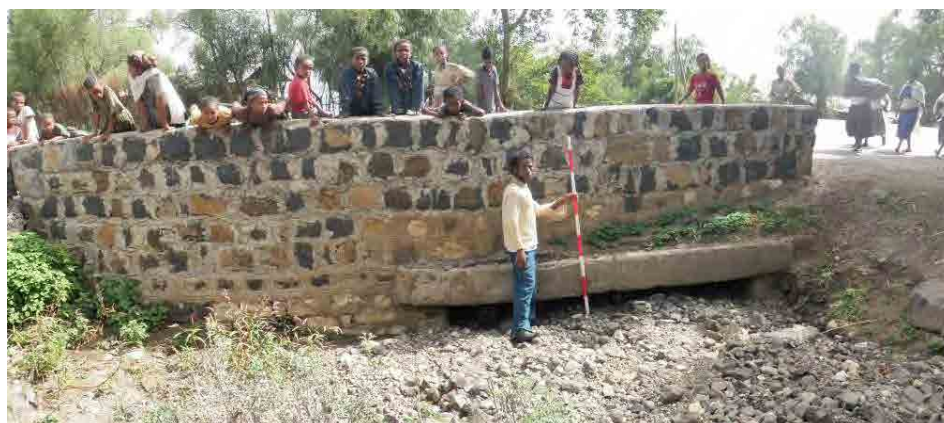
The box culvert installed under the road is mostly blocked. The residents told us that sediment runoff sometimes gets deposited on the road during rainy seasons. Additionally, the gabions installed upstream from the box culvert have been damaged, which indicates significant sediment discharge.

No water flow was confirmed when this survey took place; however, the box culvert has been already blocked, and unstable rock blocks are distributed in the channel upstream. There is a basin with a channel bed gradient of 18° located upstream of the channel. (Debris flows occur in watershed basins with over 15° of channel bed gradient) posing a high risk of sediment runoff during rainy seasons.

Photo 3. 9.10 Box culvert installed under the road (blocked by rock blocks)

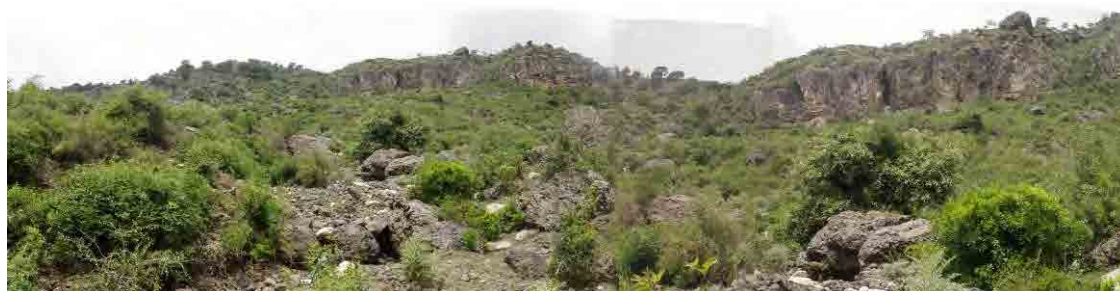
Photo 3. 9.11 Upstream of MS004 (large rocks are scattered; basaltic cliff walls exist at the top of upstream)

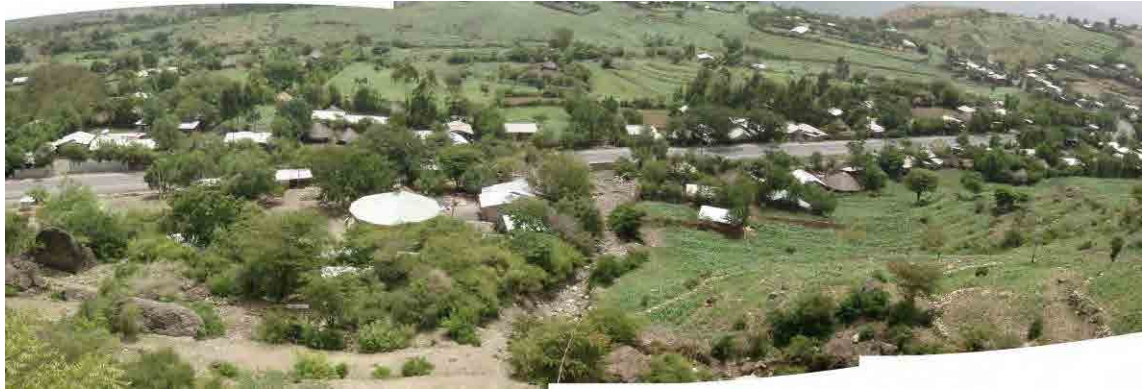
Photo 3. 9.12 Conservation facilities located downstream from the channel (houses and churches are scattered)

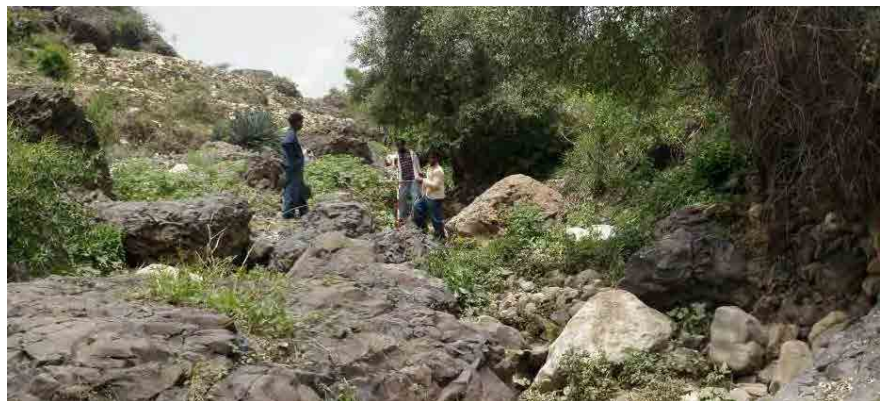
Photo 3. 9.13 Entire picture of MS005 (upstream from the road; large rocks are scattered)

Houses are scattered along the channel and bank erosion is also in progress. Thus, potential risk of houses to be affected by runoff water is high when the channel overflows.

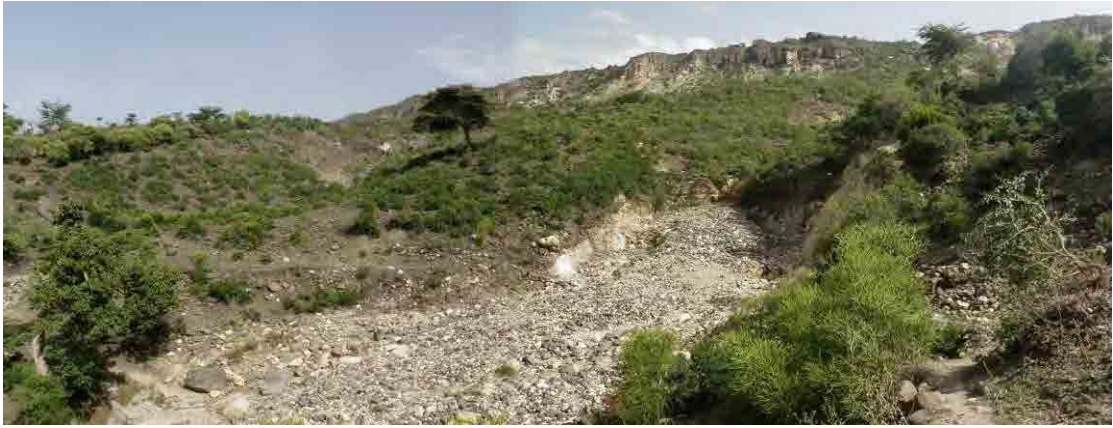
Photo 3. 9.14 Channel upstream (covered with rock blocks)

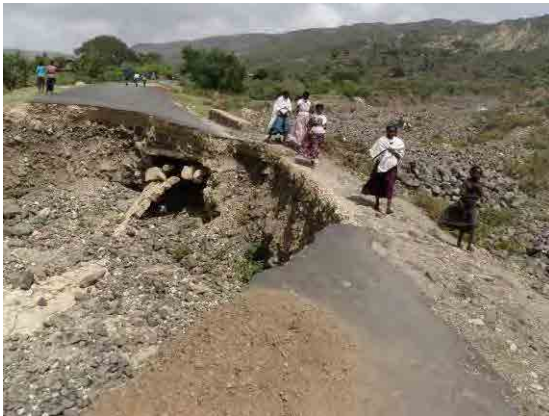
There is a damaged bridge in the upstream area, caused by a debris flow according to the interview with the local resident. A temporary road has been constructed further upstream of the bridge to be replaced. The total channel length is quite long, and branch channels have been also confirmed at a point approximately 850m upstream of the road. This indicates that stream discharge can increase immediately by rainfalls during rainy seasons.

Photo 3. 9.15 Damaged bridge

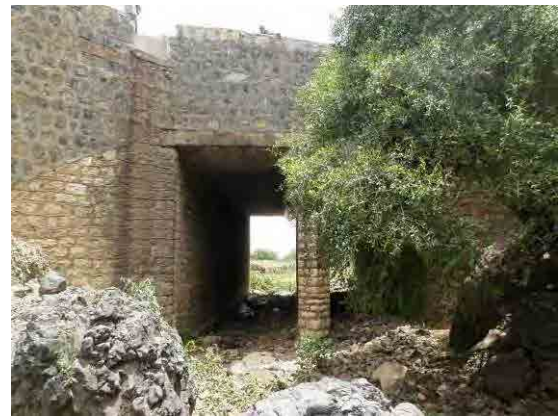
This box culvert is filled with sediments and rock blocks which were carried down from above during rainy seasons.

Photo 3. 9.16 Box culvert (with rock blocks deposited)

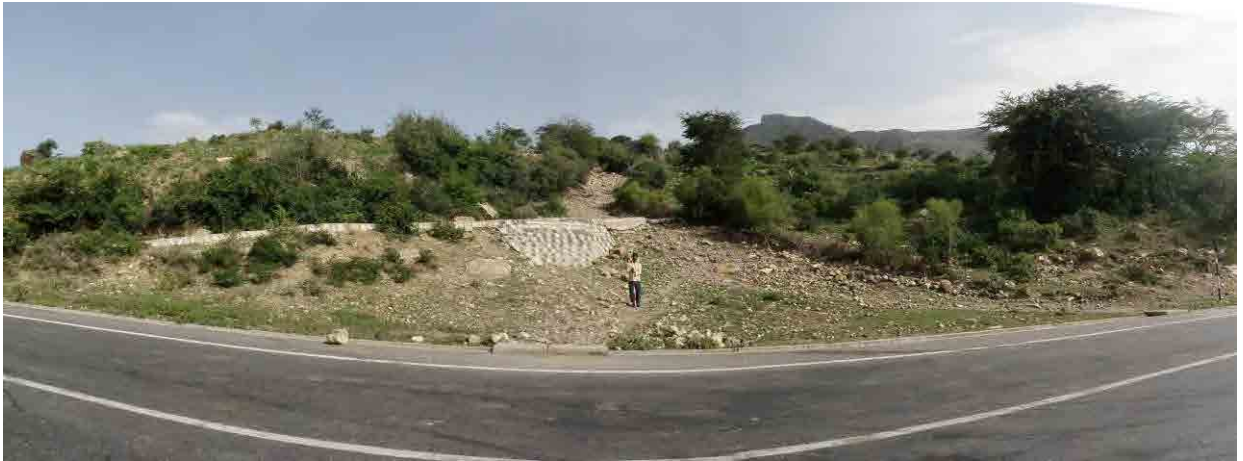
This channel does not resemble any form waterway nor have water flowing as it is usually used as a walking path for the local residents.. Nonetheless, trenches to direct flow into the gutter are installed along the channel upstream of the road for when water flows from upstream during rainstorm or rainy season. Gravels are scattered downstream from the road, which shows sediment ran off onto the road.

Photo 3. 9.17 Entire picture of MS006 (upstream from the road; water flow is drained from trenches to gutters on the road side)

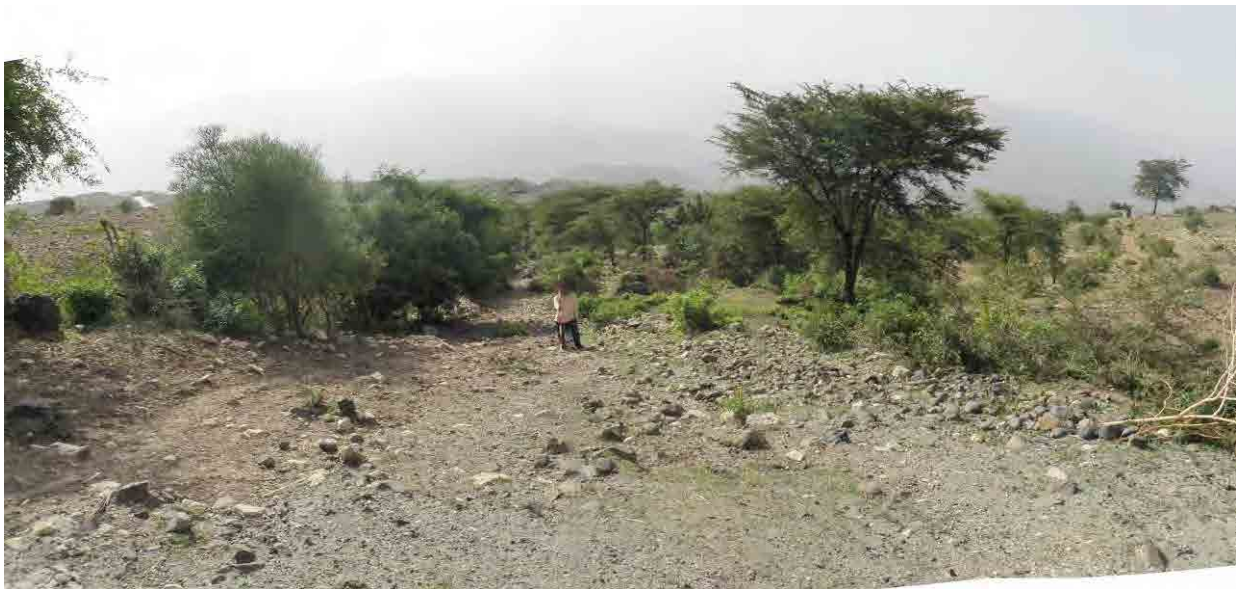
Many rock blocks of 30cm or smaller are scattered in the channel. Because channel bed gradient near the road is steep, there is a high risk of sediment runoff during rainy seasons. There are rock blocks and sediment deposited in this trench, so that proper maintenance such as the removal of the sediment is required.

Photo 3. 9.18 Entire picture of MS006 (downstream from the road; rock blocks are scattered)

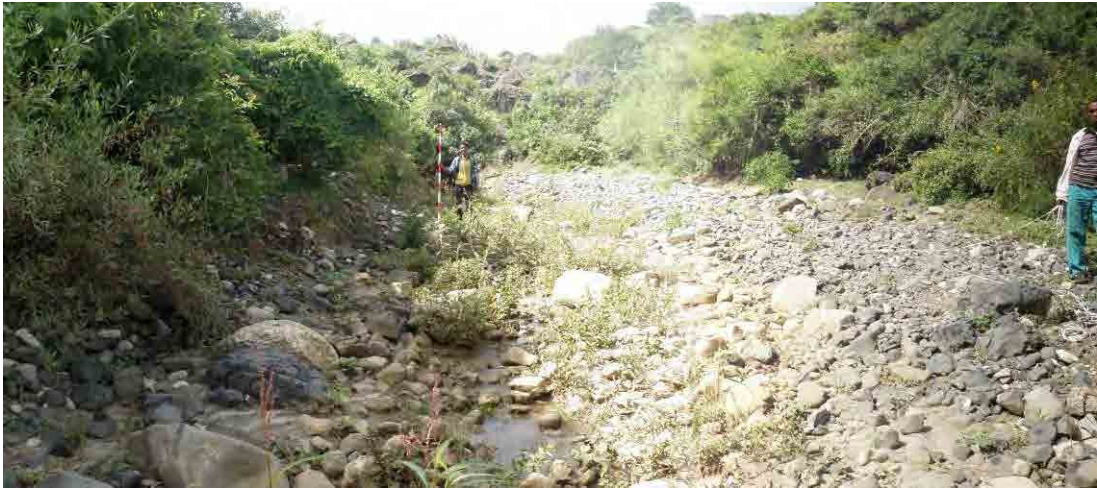
Photo 3. 9.19 Entire picture of MS007 (upstream from the road; slight water flow is seen)

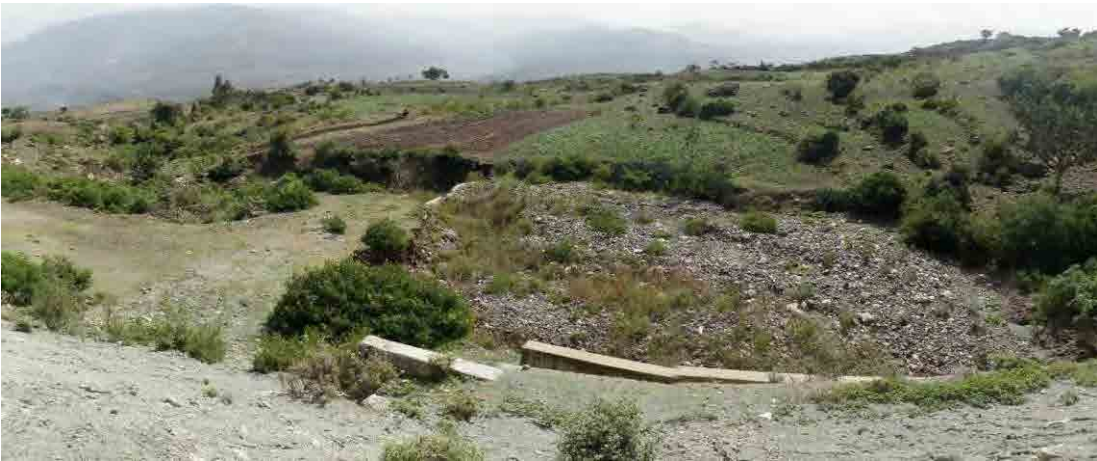
A dam (2.0 high and 13.0m long) is installed downstream of the road, which has been mostly filled high with

debris and sediment. The basin area is rather large-sized with a relatively large sediment supplies, so that there is a risk of debris flow.

Photo 3. 9.20 Entire picture of MS007 (downstream from the road; behind the dam is almost filled with sand)

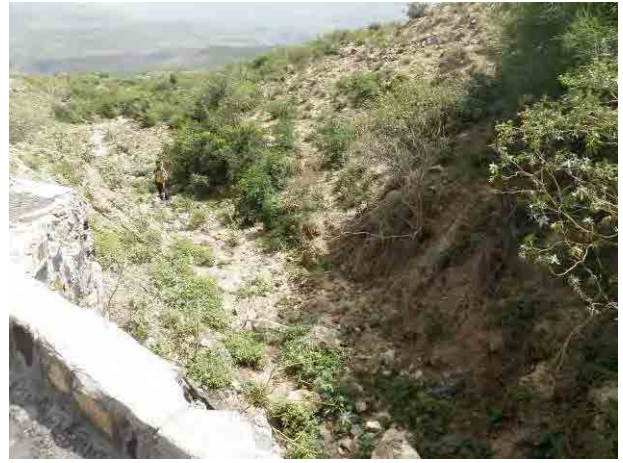
Photo 3. 9.22 Entire picture of MS008
(downstream from the road; gullies develop)

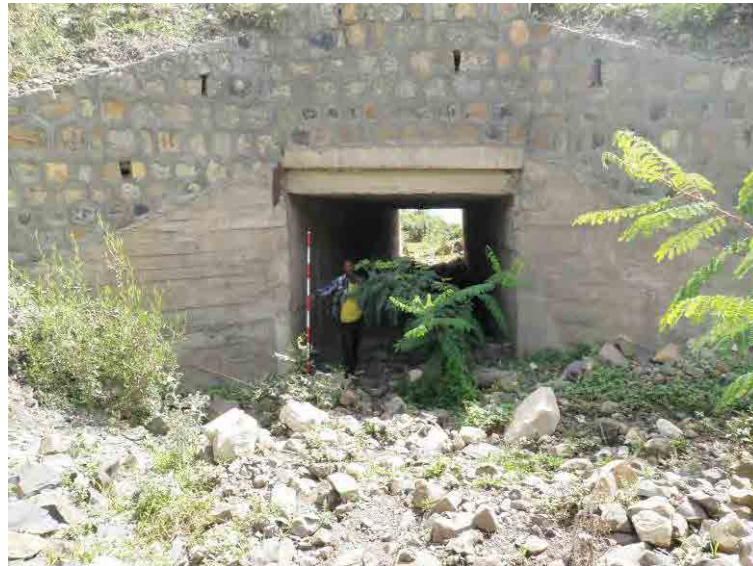
This channel has thick layers of sand and gravels deposited in the box culvert (2.5m high and 2.5m wide) installed under the road. Such deposits are also transported downstream. The elevation from the channel bed to the road is approximately 6.5m, which lowers a risk of sediment runoff entering the road.

Photo 3. 9.23 Box culvert installed under the road (rock blocks are distributed)

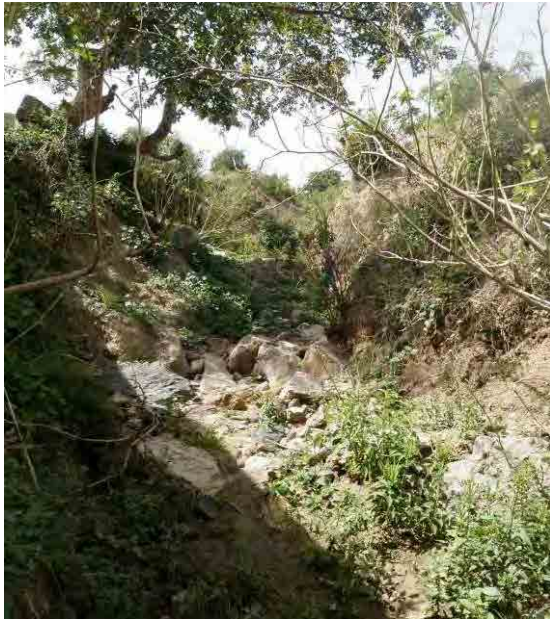
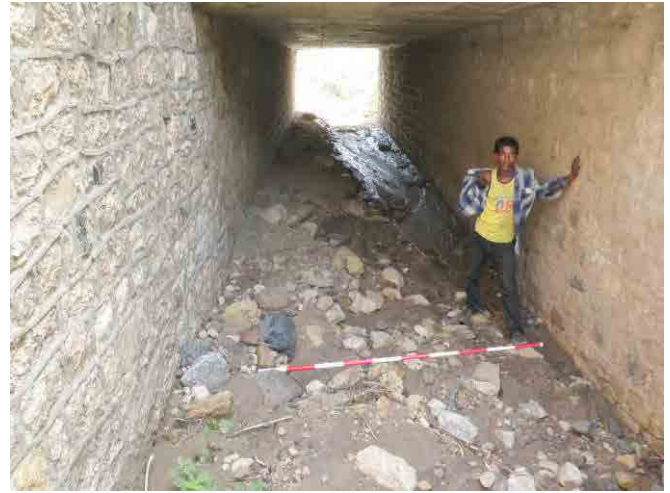
Sediment and many rock blocks are deposited in the box culvert (2.5m high and 2.5 wide) installed under the road indicating that sediment runoff is generated during rainstorm and rainy seasons.

Photo 3. 9.24 Entire picture of MS009 (upstream from the road) Photo 3. 9.25 Box culvert installed under the road

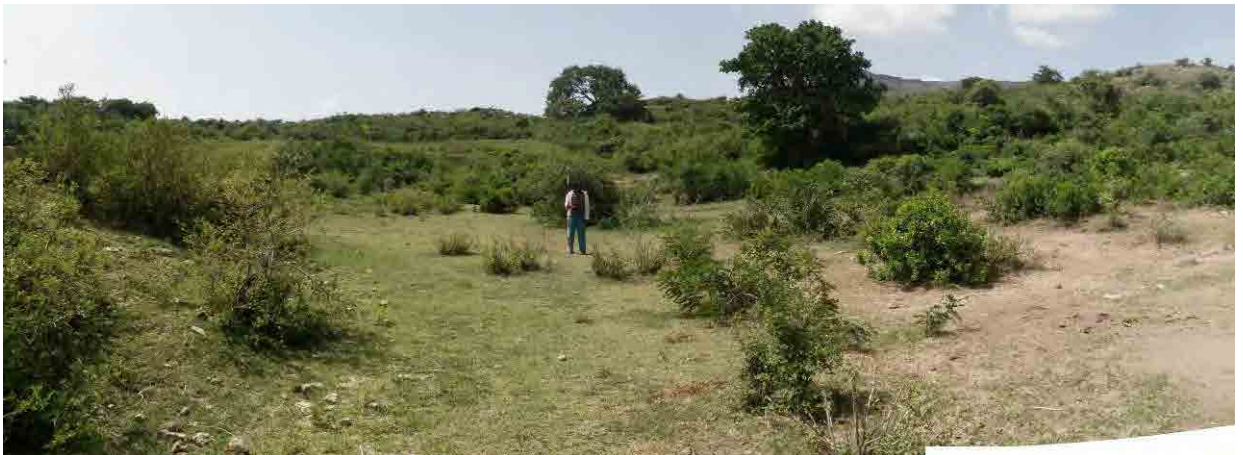
The channel banks are consisted of debris mound which induced significant bank erosion. A topographic depression or scour depression with vertical walls has been formed in the area upstream. The cliff is approximately 5m high. Further upstream of the cliff is flat terrain where no flow path was observed.

Photo 3. 9.26 Channel upstream area (flat terrain and no flow path seen)

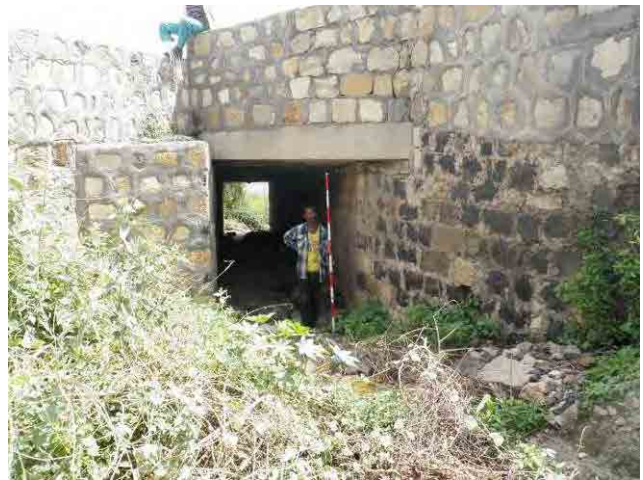
Little sediment deposit is observed in the box culvert (2.0m high and 2.0m wide) under the road, which shows that sediment runoff has not occurred recently. Rock blocks from 30 to 50cm in diameter are distributed in the channel bed, but main deposits are sand and silt.

Photo 3. 9.27 Box culvert installed under the road (no sediment deposits)

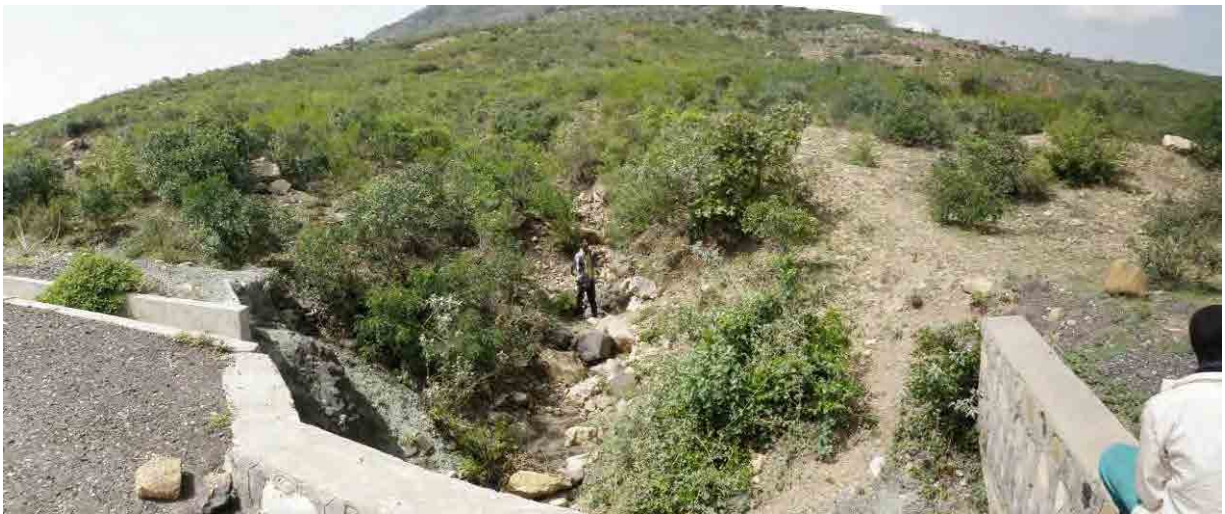
Photo 3. 9.28 Entire picture of MS010 (upstream from the road; no water flow)

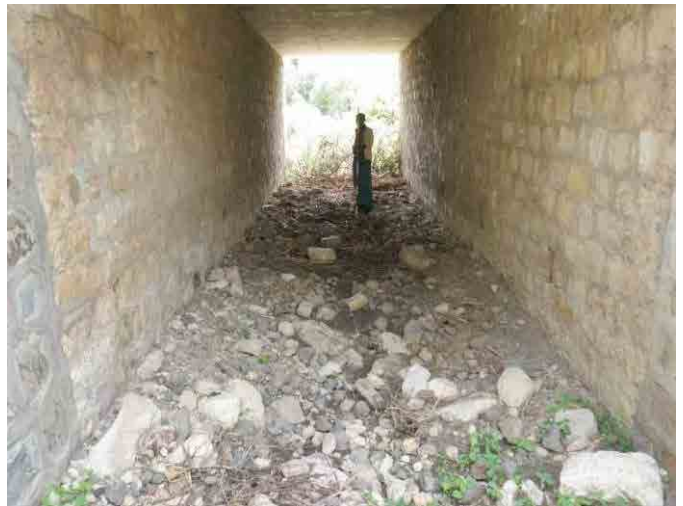
The box culvert (3.5m high and 3.0m wide) installed under the road is larger compared to that of the previous channel. Debris and rock blocks cover the entire floor of the box culvert indicating large amount of sediment supply.

Photo 3. 9.30 Box culvert installed under the road (sediment deposits cover the entire inside)

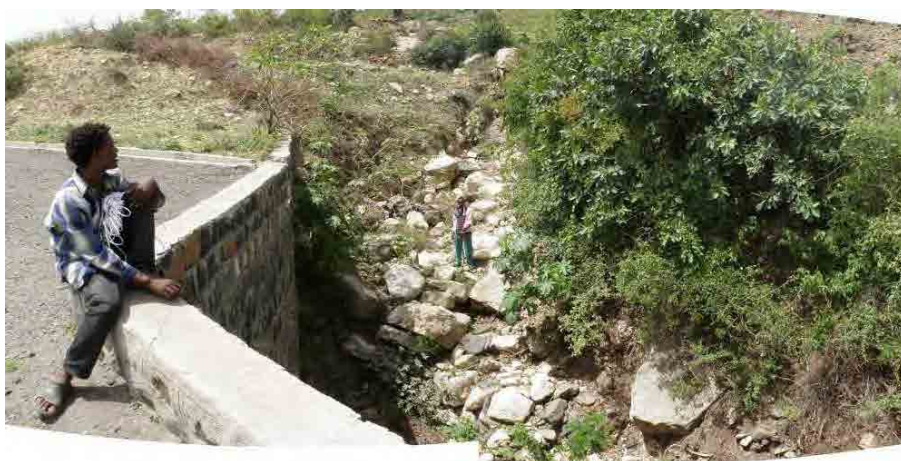
Photo 3. 9.31 Entire picture of MS011 (upstream from the road; no water flow confirmed)

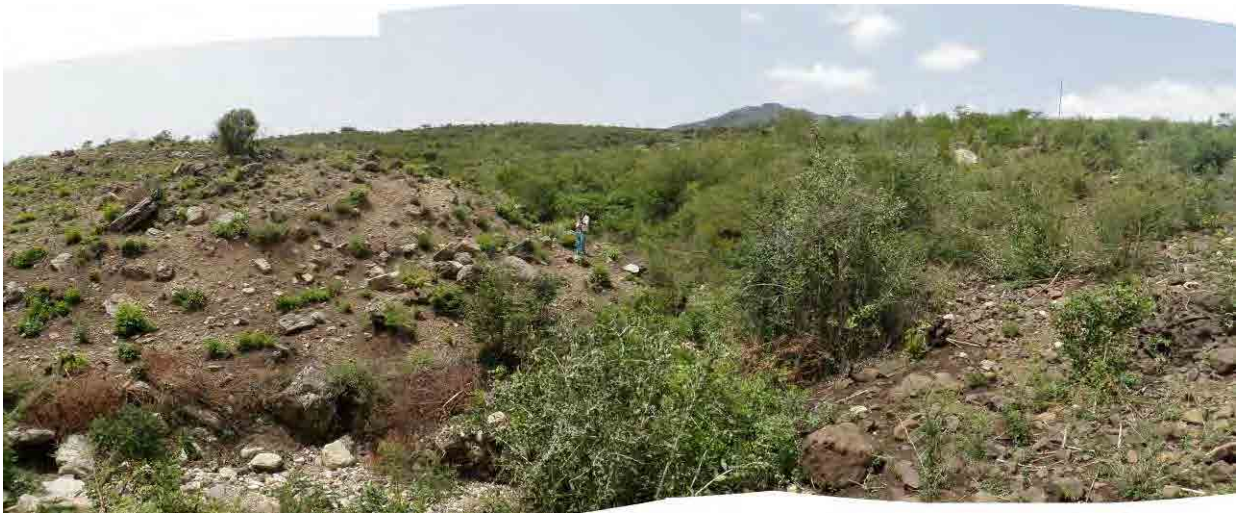
Photo 3. 9.32 Entire picture of MS011 (downstream from the road; a channel where gullies developed)

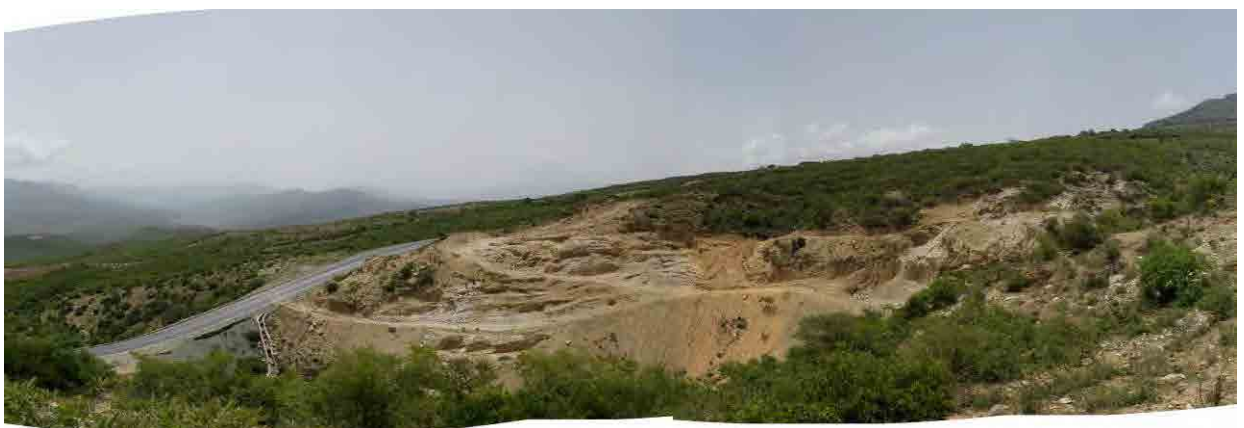
A quarry of limestone and gypsum is located on the right bank. The channel bed is covered with sediment having run off from the quarry in addition to rock blocks from about 30cm to 1m in diameter. The quarry extends approximately 150m where; no vegetation grows on the bare surface.

Photo 3. 9.33 Quarry located on the right channel bank (sediment runs off into the channel from the quarry)

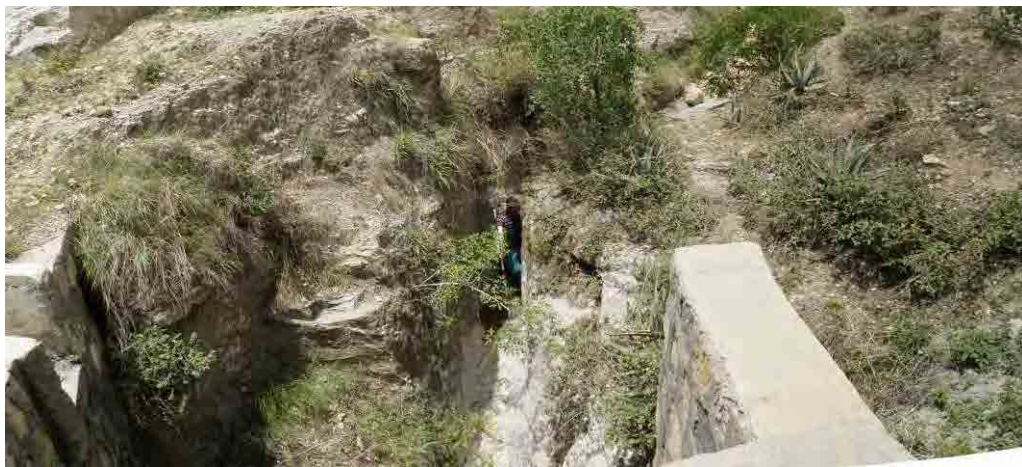
Photo 3. 9.36 Entire picture of MS013 (upstream from the road; no water flow)

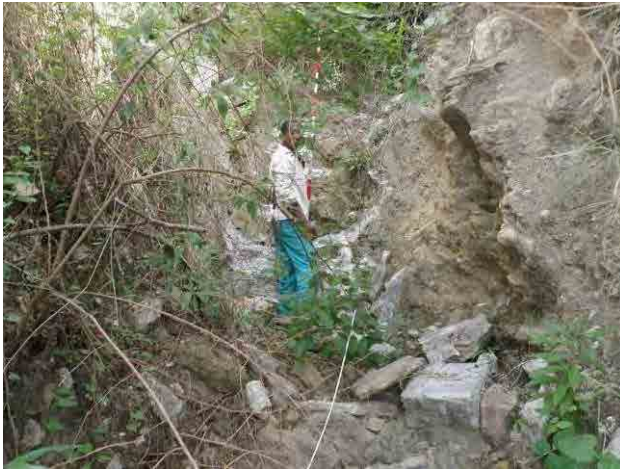
Photo 3. 9.56 Channel upstream (channel bank erosion)

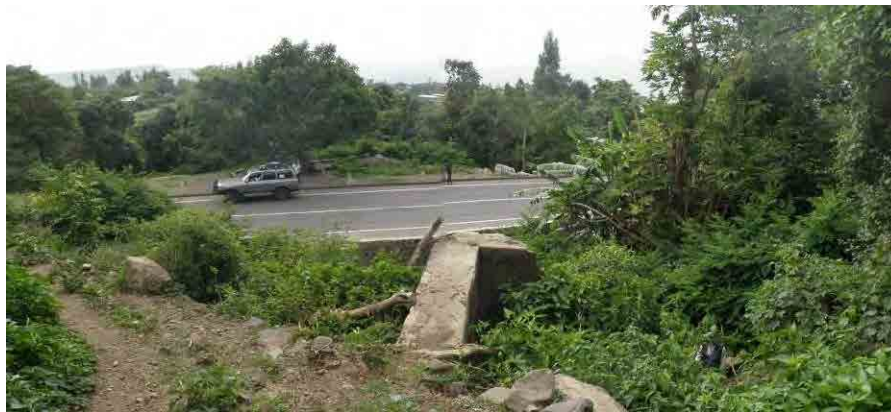
This small channel is located on the landslide, with a channel bed gradient of 14.0° (25%, read from the topographical map) and width of 1.0 to 2.0m. Vegetation is present around the channel, and upstream of the road is covered with shrubs. A dam is installed on the road side; however, this dam has been totally damaged to the point where it no longer retains its original form.

Photo 3. 9.88 Damaged dam (taken from the upstream of the road)

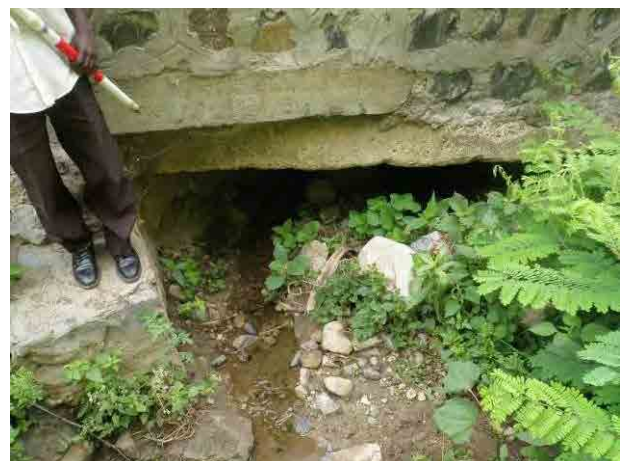
There is a large amount of sediment deposit in the box culvert installed under the road causing occasional overland flow of sediment onto the road in the rainy season according to the interviews conducted. Water flow was observed in the channel during the survey. Spring water occurring upstream is used for daily water consumption.

Photo 3. 9.90 Box culvert installed under the road

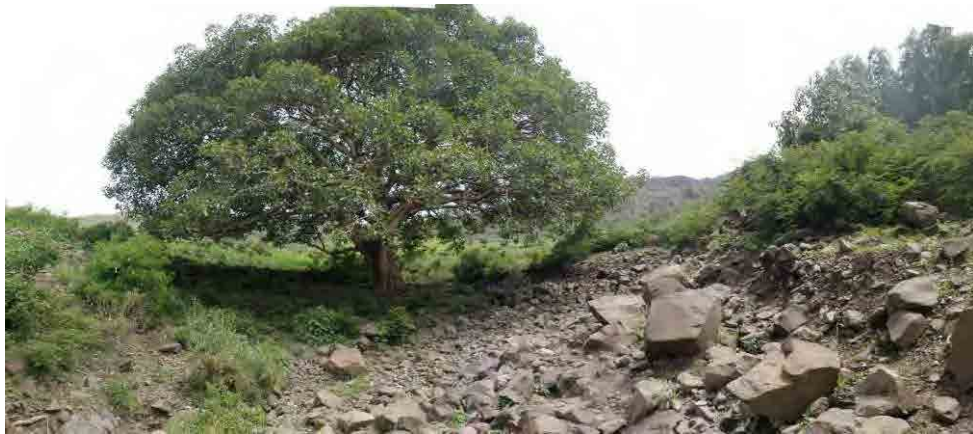
Photo 3. 9.93 Crushed rock deposits conditions in the channel upstream

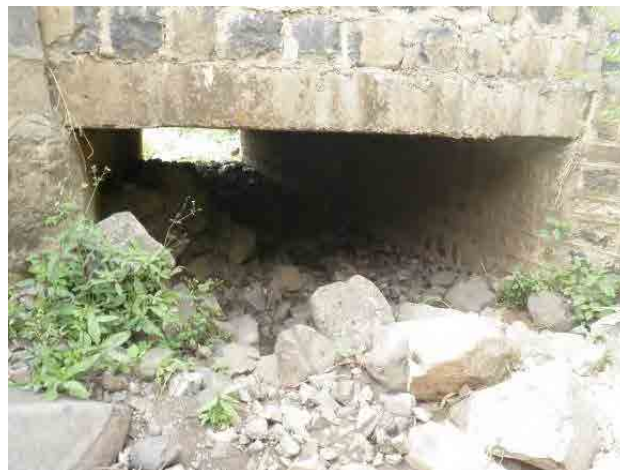
Gravels 10 to 30cm in diameter are deposited in the box culvert installed under the road indicating all types of sediments and debris are transported down during rainy seasons.

Photo 3. 9.98 Box culvert installed under the road (crushed rocks deposit)

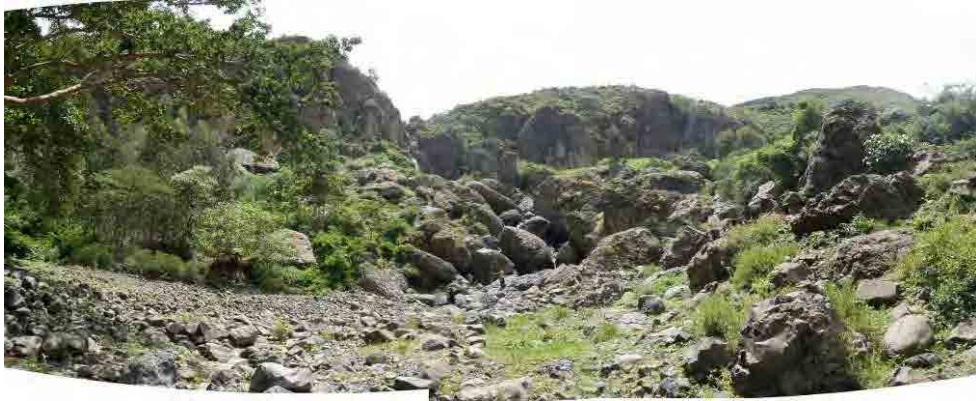
Photo 3. 9.107 Larger rocks scattered around the waterfall

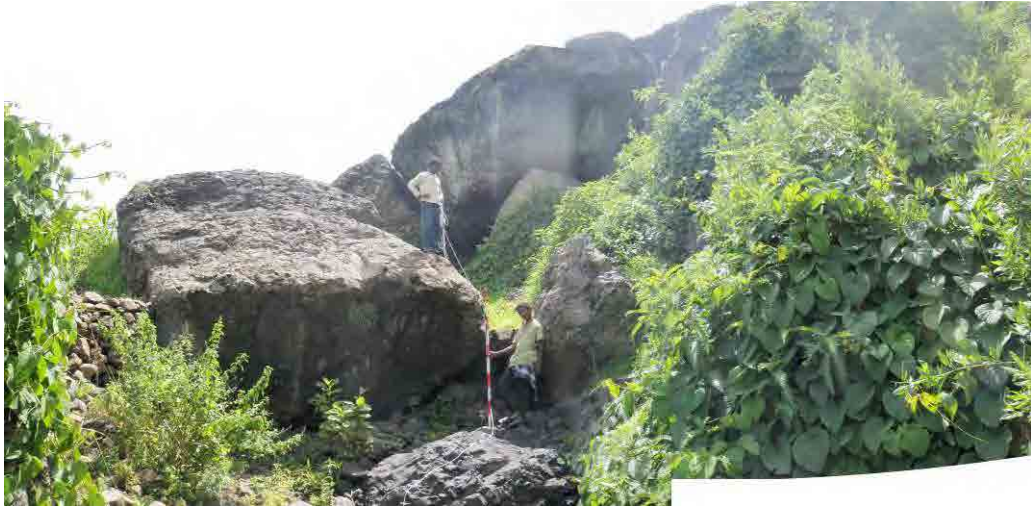
Photo 3. 9.112 Channel upstream (large rocks are scattered)
