(4) Diagnosis of Condition of Sewerage Networks

The following criteria have been considered in defining the condition of the sewerage pipes in the Lima Norte II Study Area:

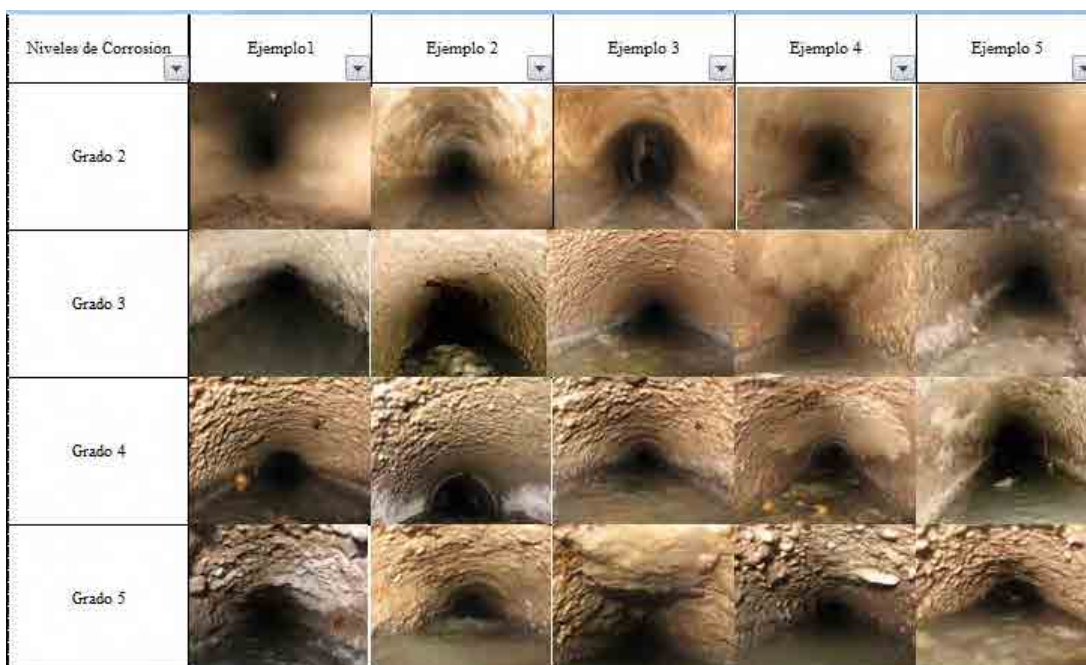
Picture 2.5.9-1: Condition of Corrosion of Pipes by Grade

The study of pipes and manholes was carried out in order to determine the physical condition of the pipes. The main problem of the existence of severe corrosion was found in the lower parts of the Study Area, which has direct relation with the deterioration of the pipes in those zones. The visual inspection was carried out by a set of pictures taken from inside of the manhole, which show the corrosion inside the pipes as shown in Picture 2.5.9-1.

In this study the manholes and pipes were scored according to different grades of corrosion, following the criteria established by the Water Resource Center (WRC) in England.

- Grade 1 Low Level of Corrosion
- Grade 2 Small Level of Corrosion
- Grade 3 Medium Level of Corrosion
- Grade 4 High Level of Corrosion
- Grade 5 Pipe Completely Corroded

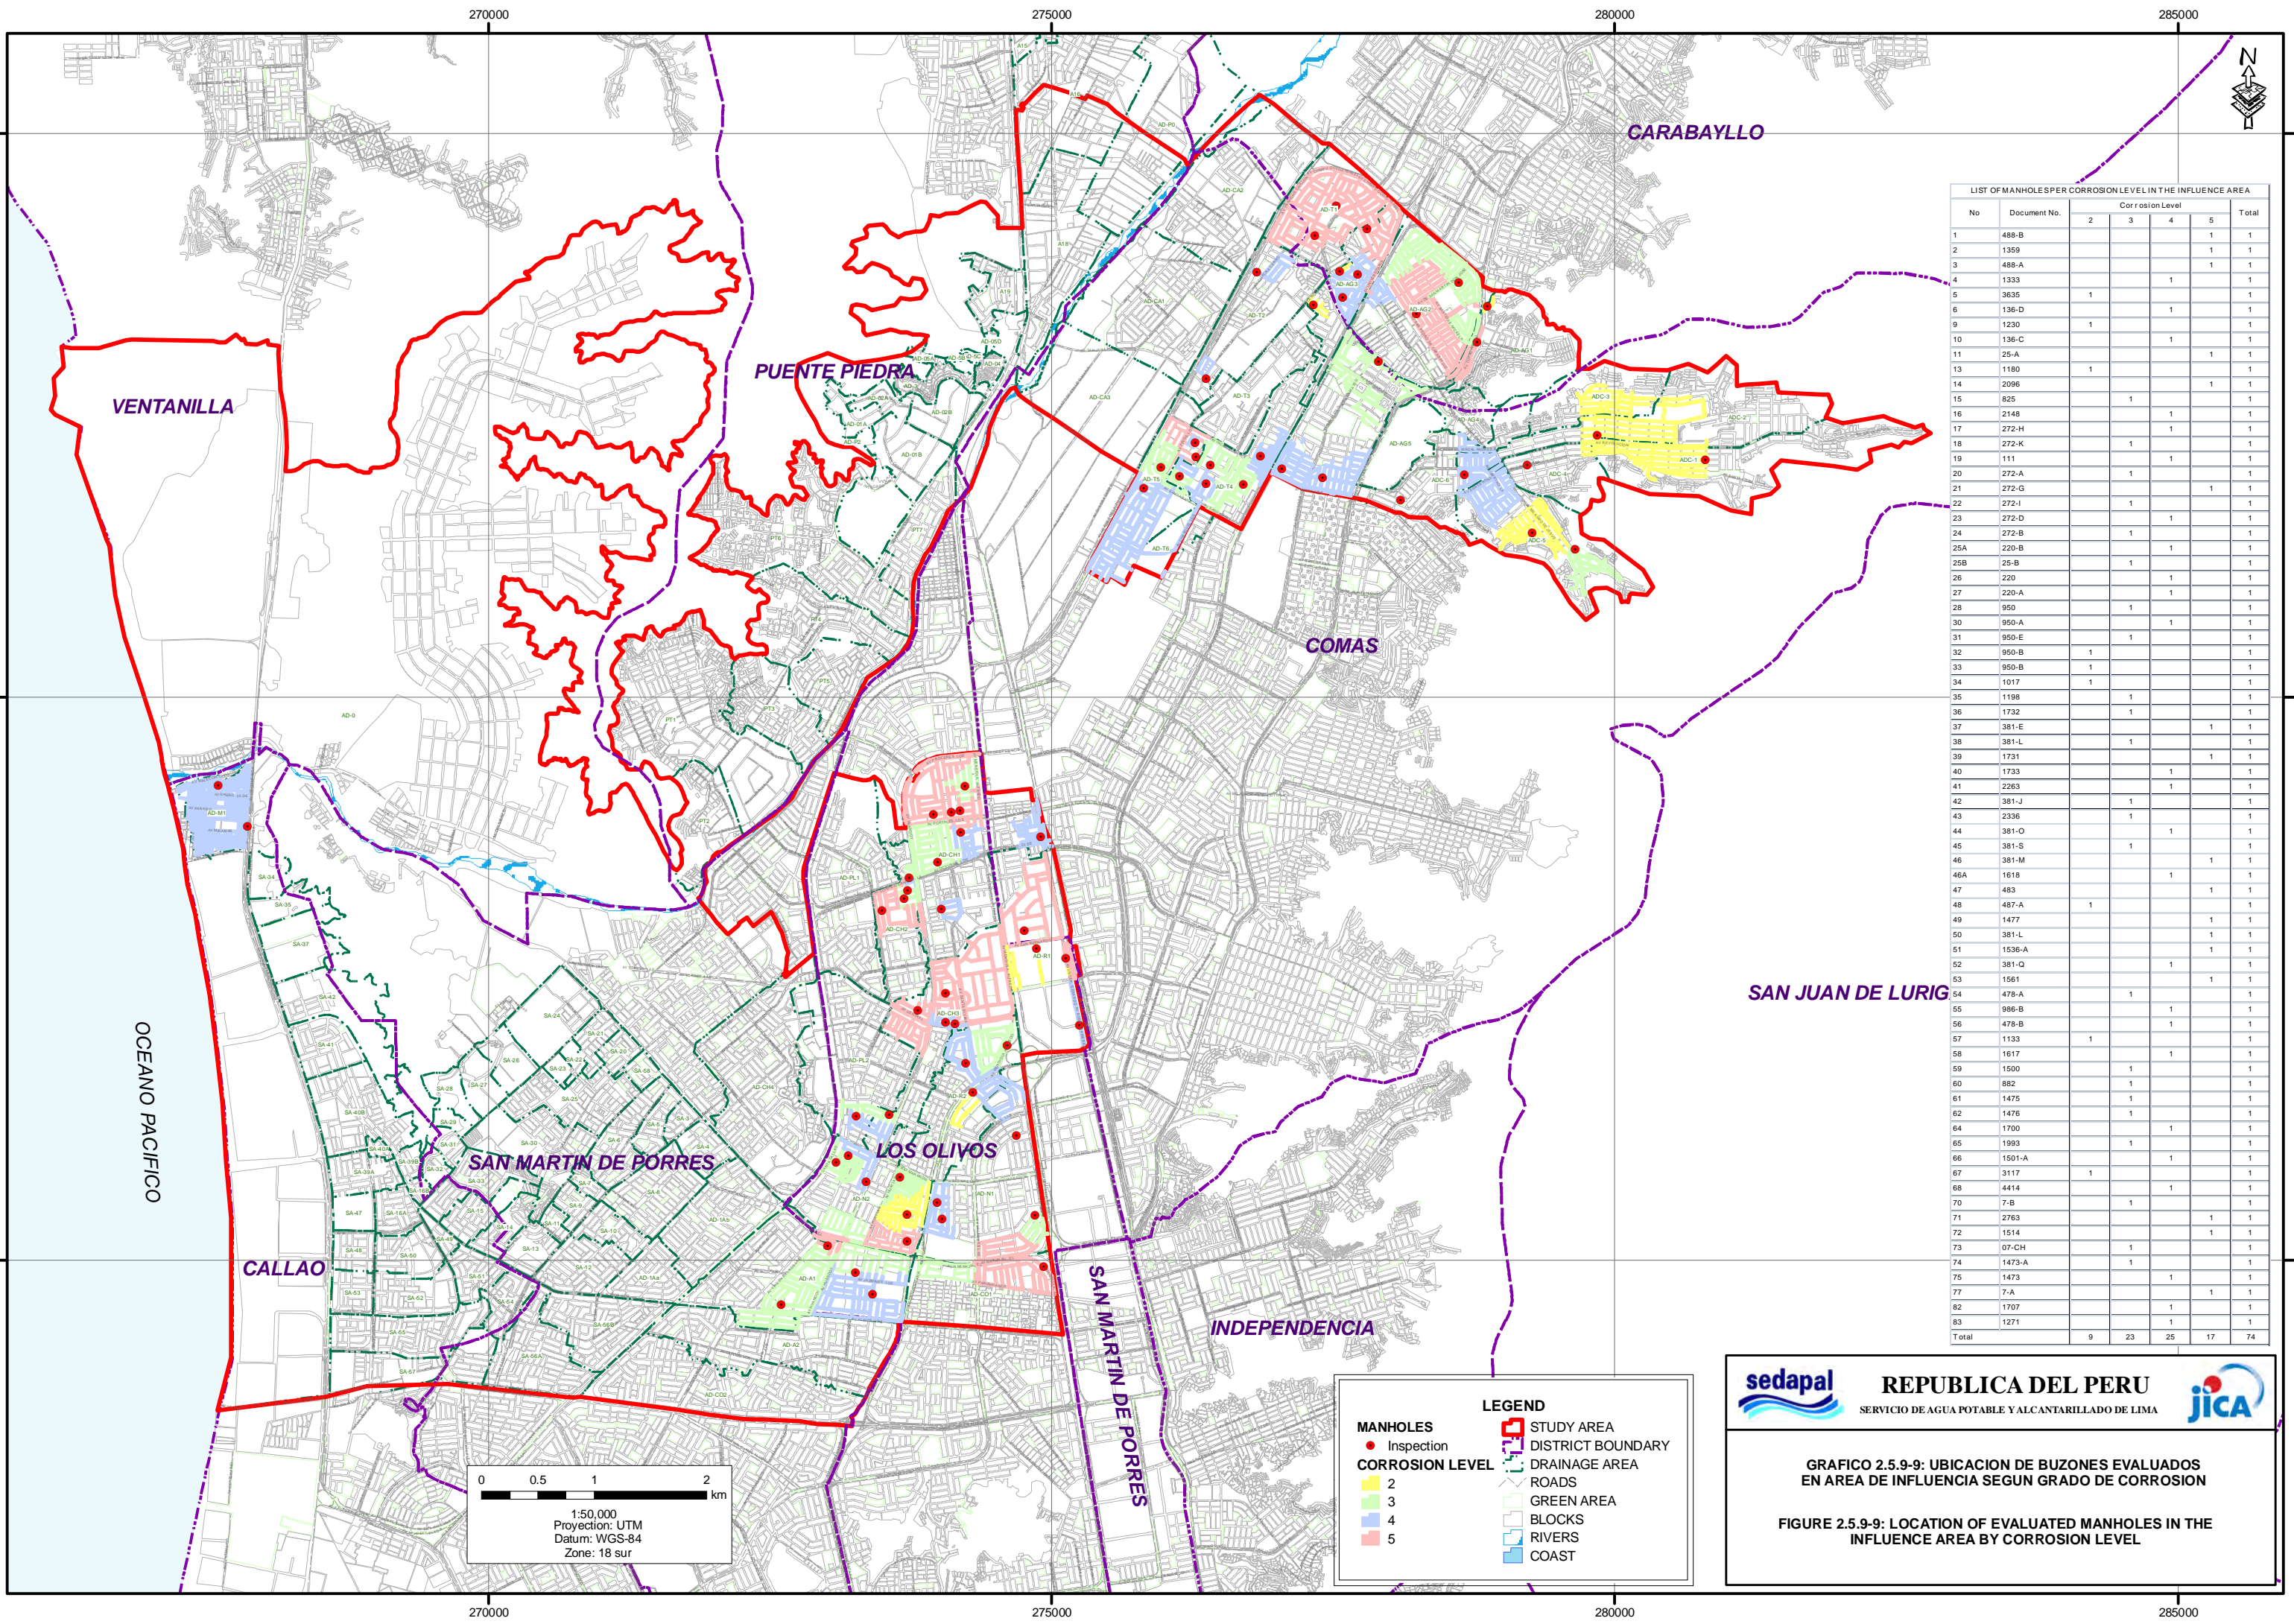
FIGURE 2.5.9-9: LOCATION OF EVALUATED MANHOLES IN THE INFLUENCE AREA BY CORROSION LEVEL

Figure 2.5.9-9 shows the location of surveyed manholes and the corrosion grades found in the pipes after conducting the Manholes and Pipes survey.

Grade of corrosion	2	3	4	5	Total
Total	9	23	25	17	74

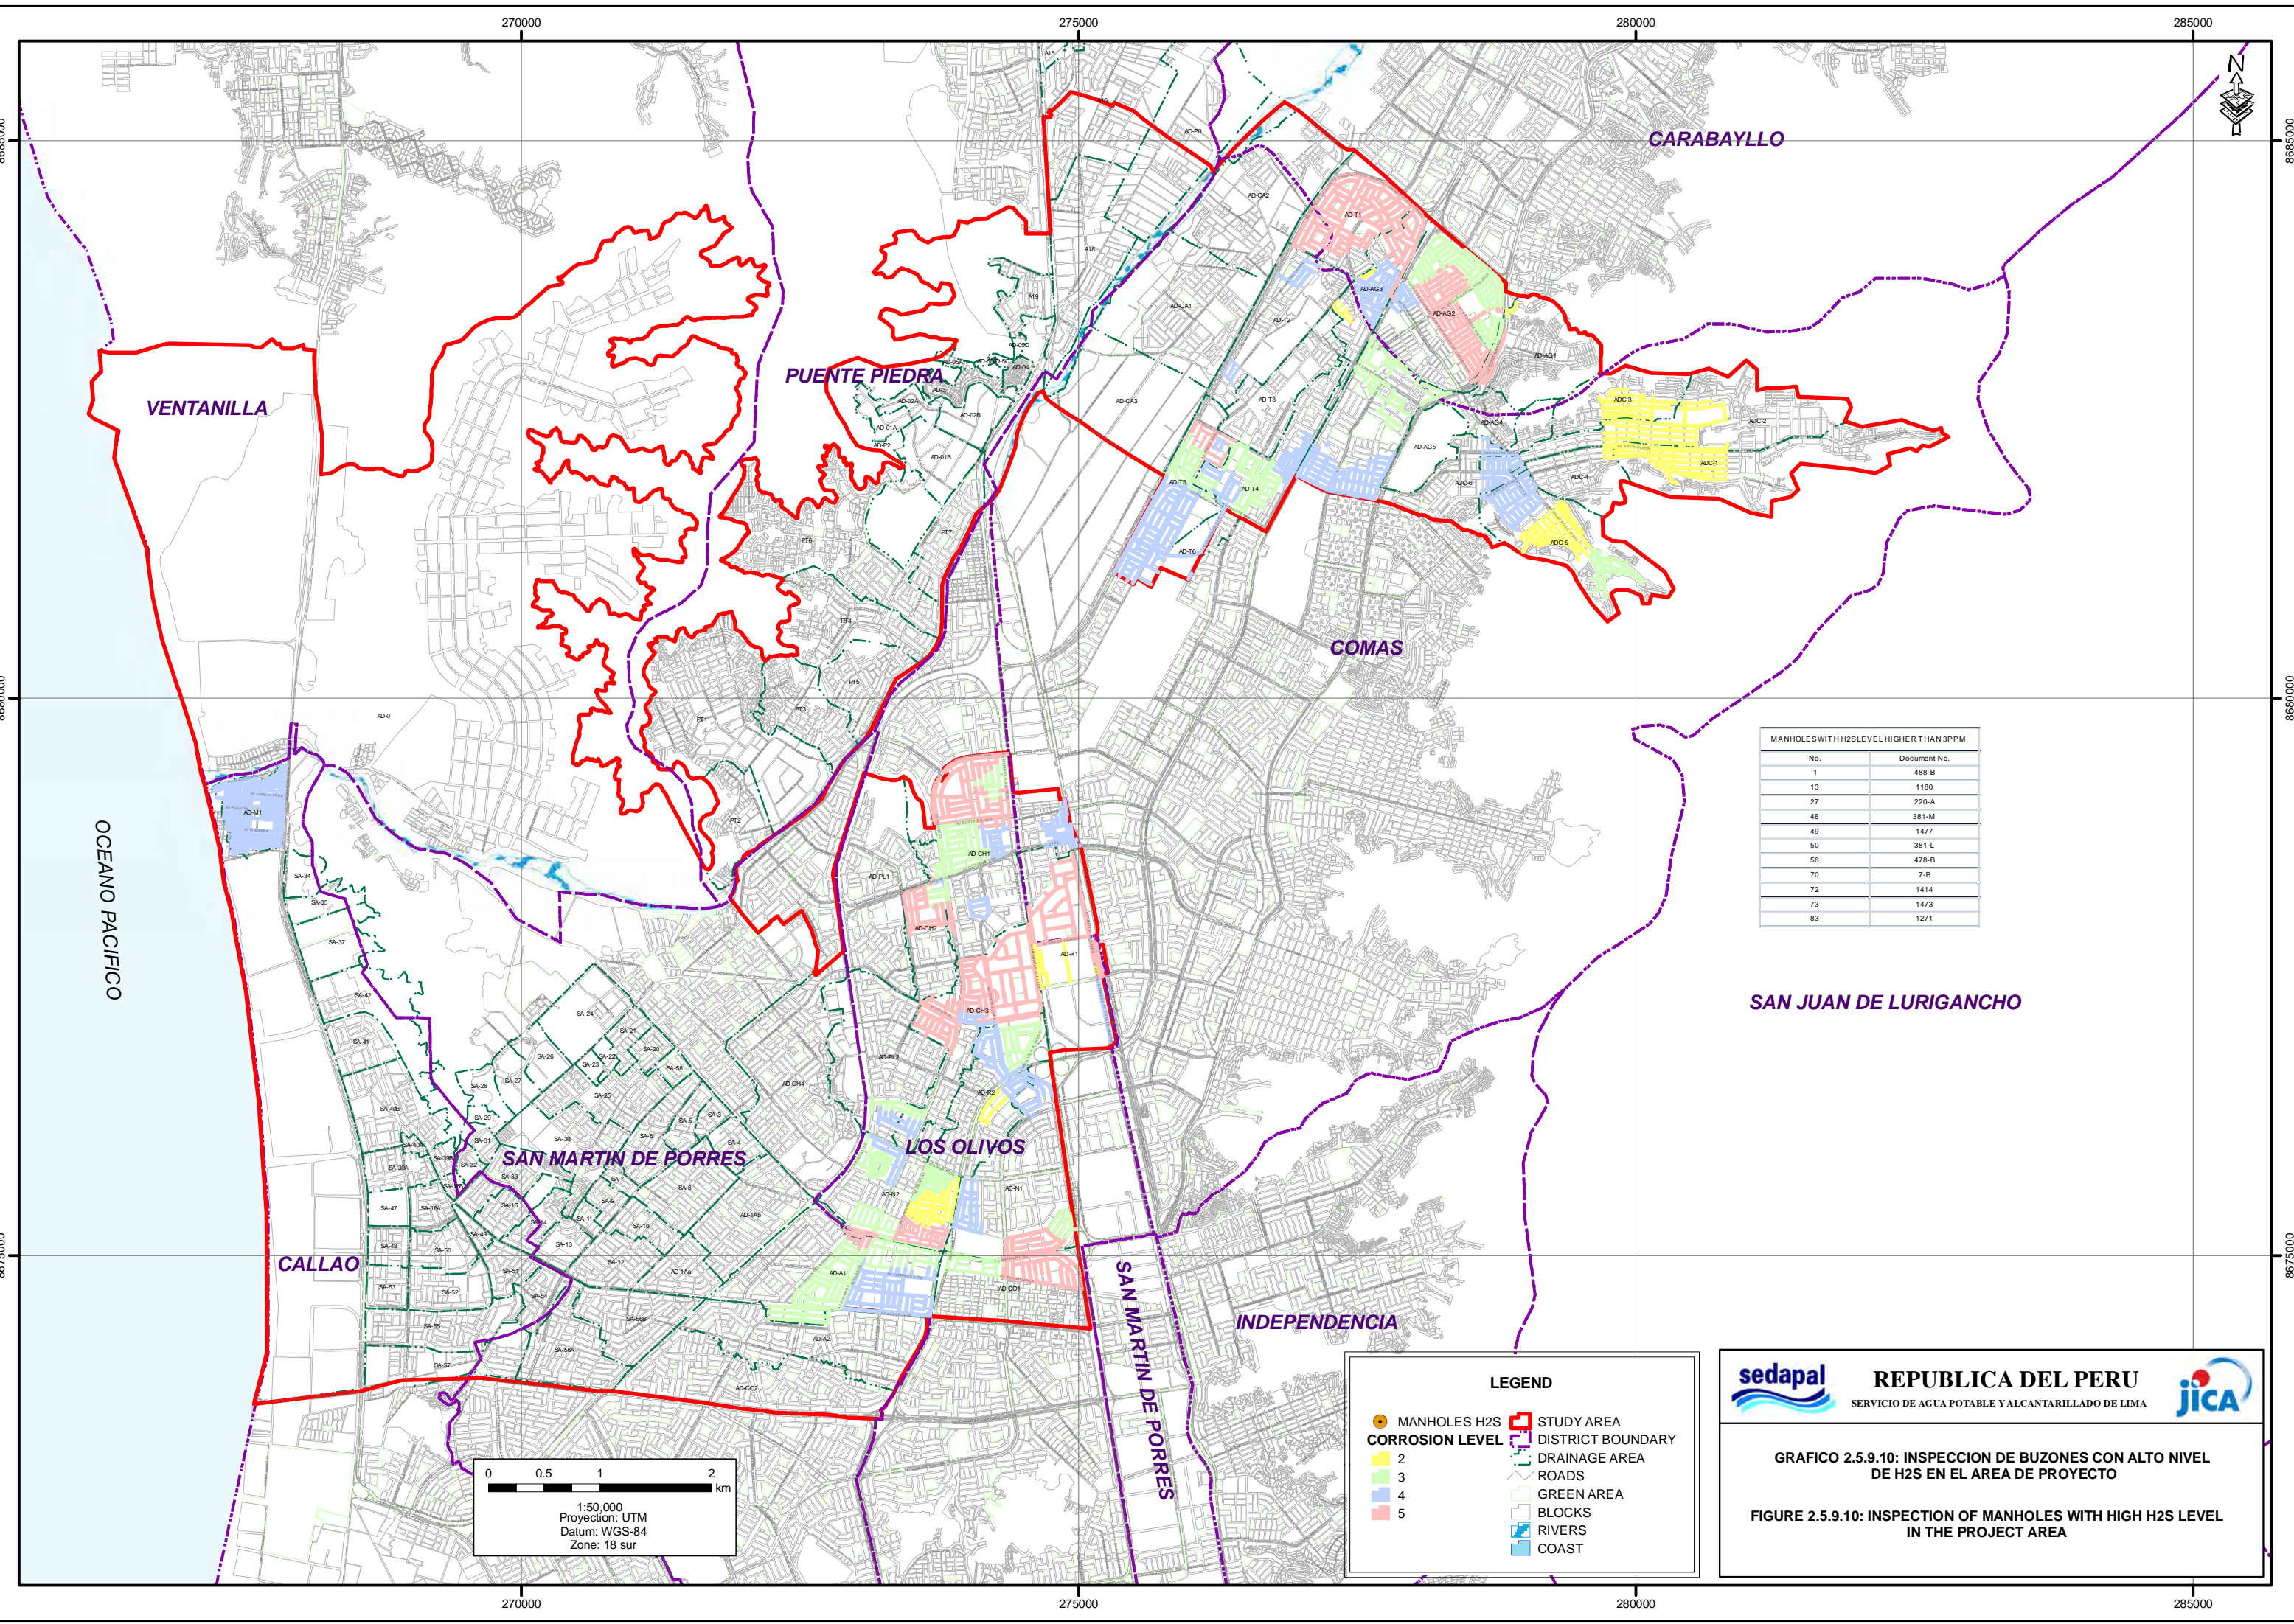
FIGURE 2.5.9.10: INSPECTION OF MANHOLES WITH HIGH H2S LEVEL IN THE PROJECT AREA

The Study expected to find some level of this gas. This gas was measured by a spot test and was found only in some manholes. In Figure 2.5.9-10, the manholes with H₂S more than 3ppm is shown.

MANHOLES WITH H2S LEVEL HIGHER THAN 3PPM	
No.	Document No.
1	488-B
13	1180
27	220-A
46	381-M
49	1477
50	381-L
56	478-B
70	7-B
72	1414
73	1473
83	1271

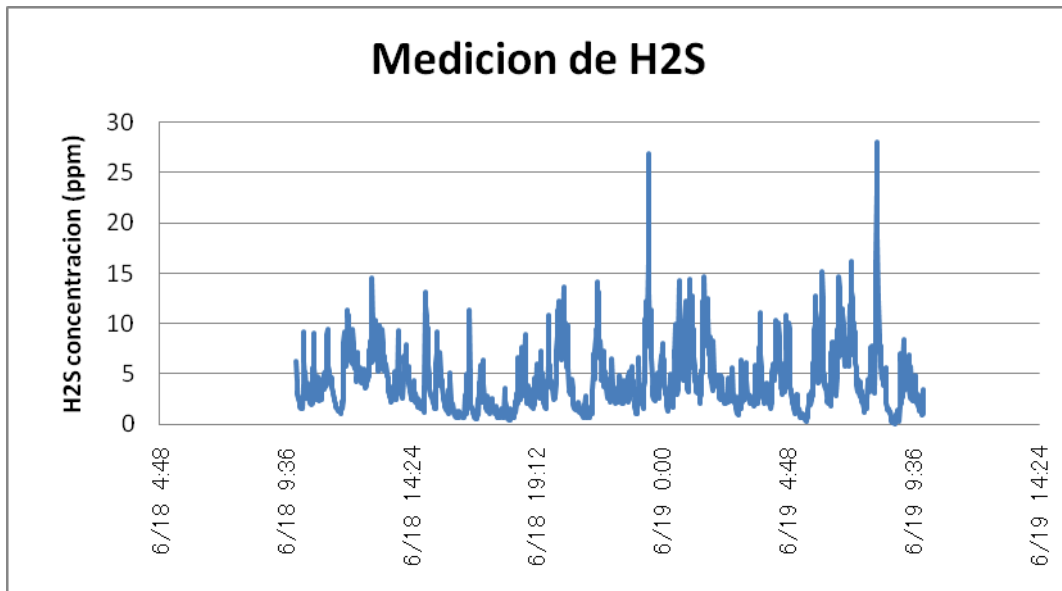
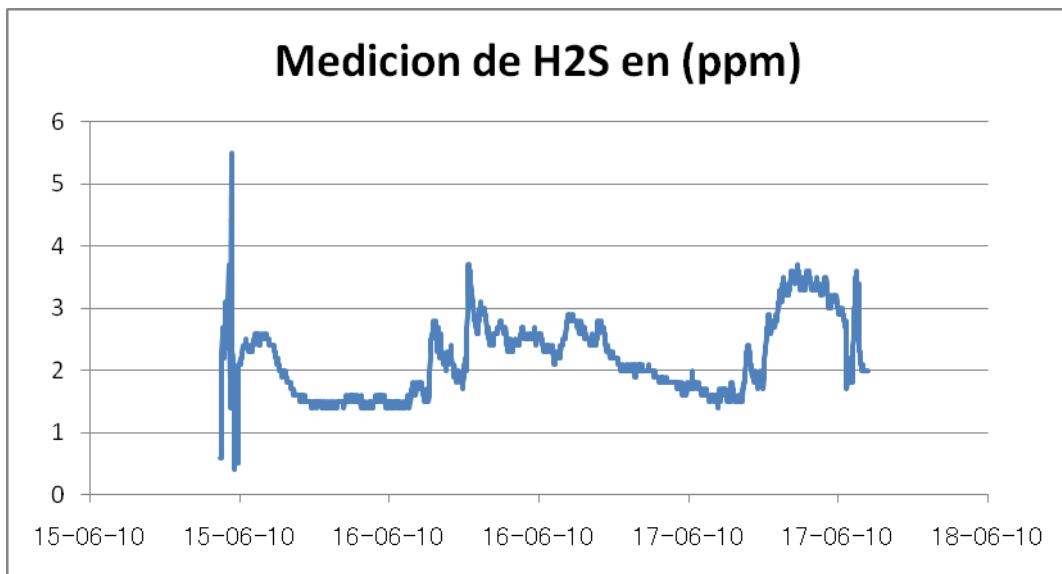
Figure 2.5.9-11: Evaluation of H₂S

However, for verification purposes, the H₂S was measured for a longer duration in two locations; which demonstrated the fluctuation of H₂S and the presence of this gas in the entire sewerage system. The measurement of gas emission of this evaluation are presented in the Figure 2.5.9-11

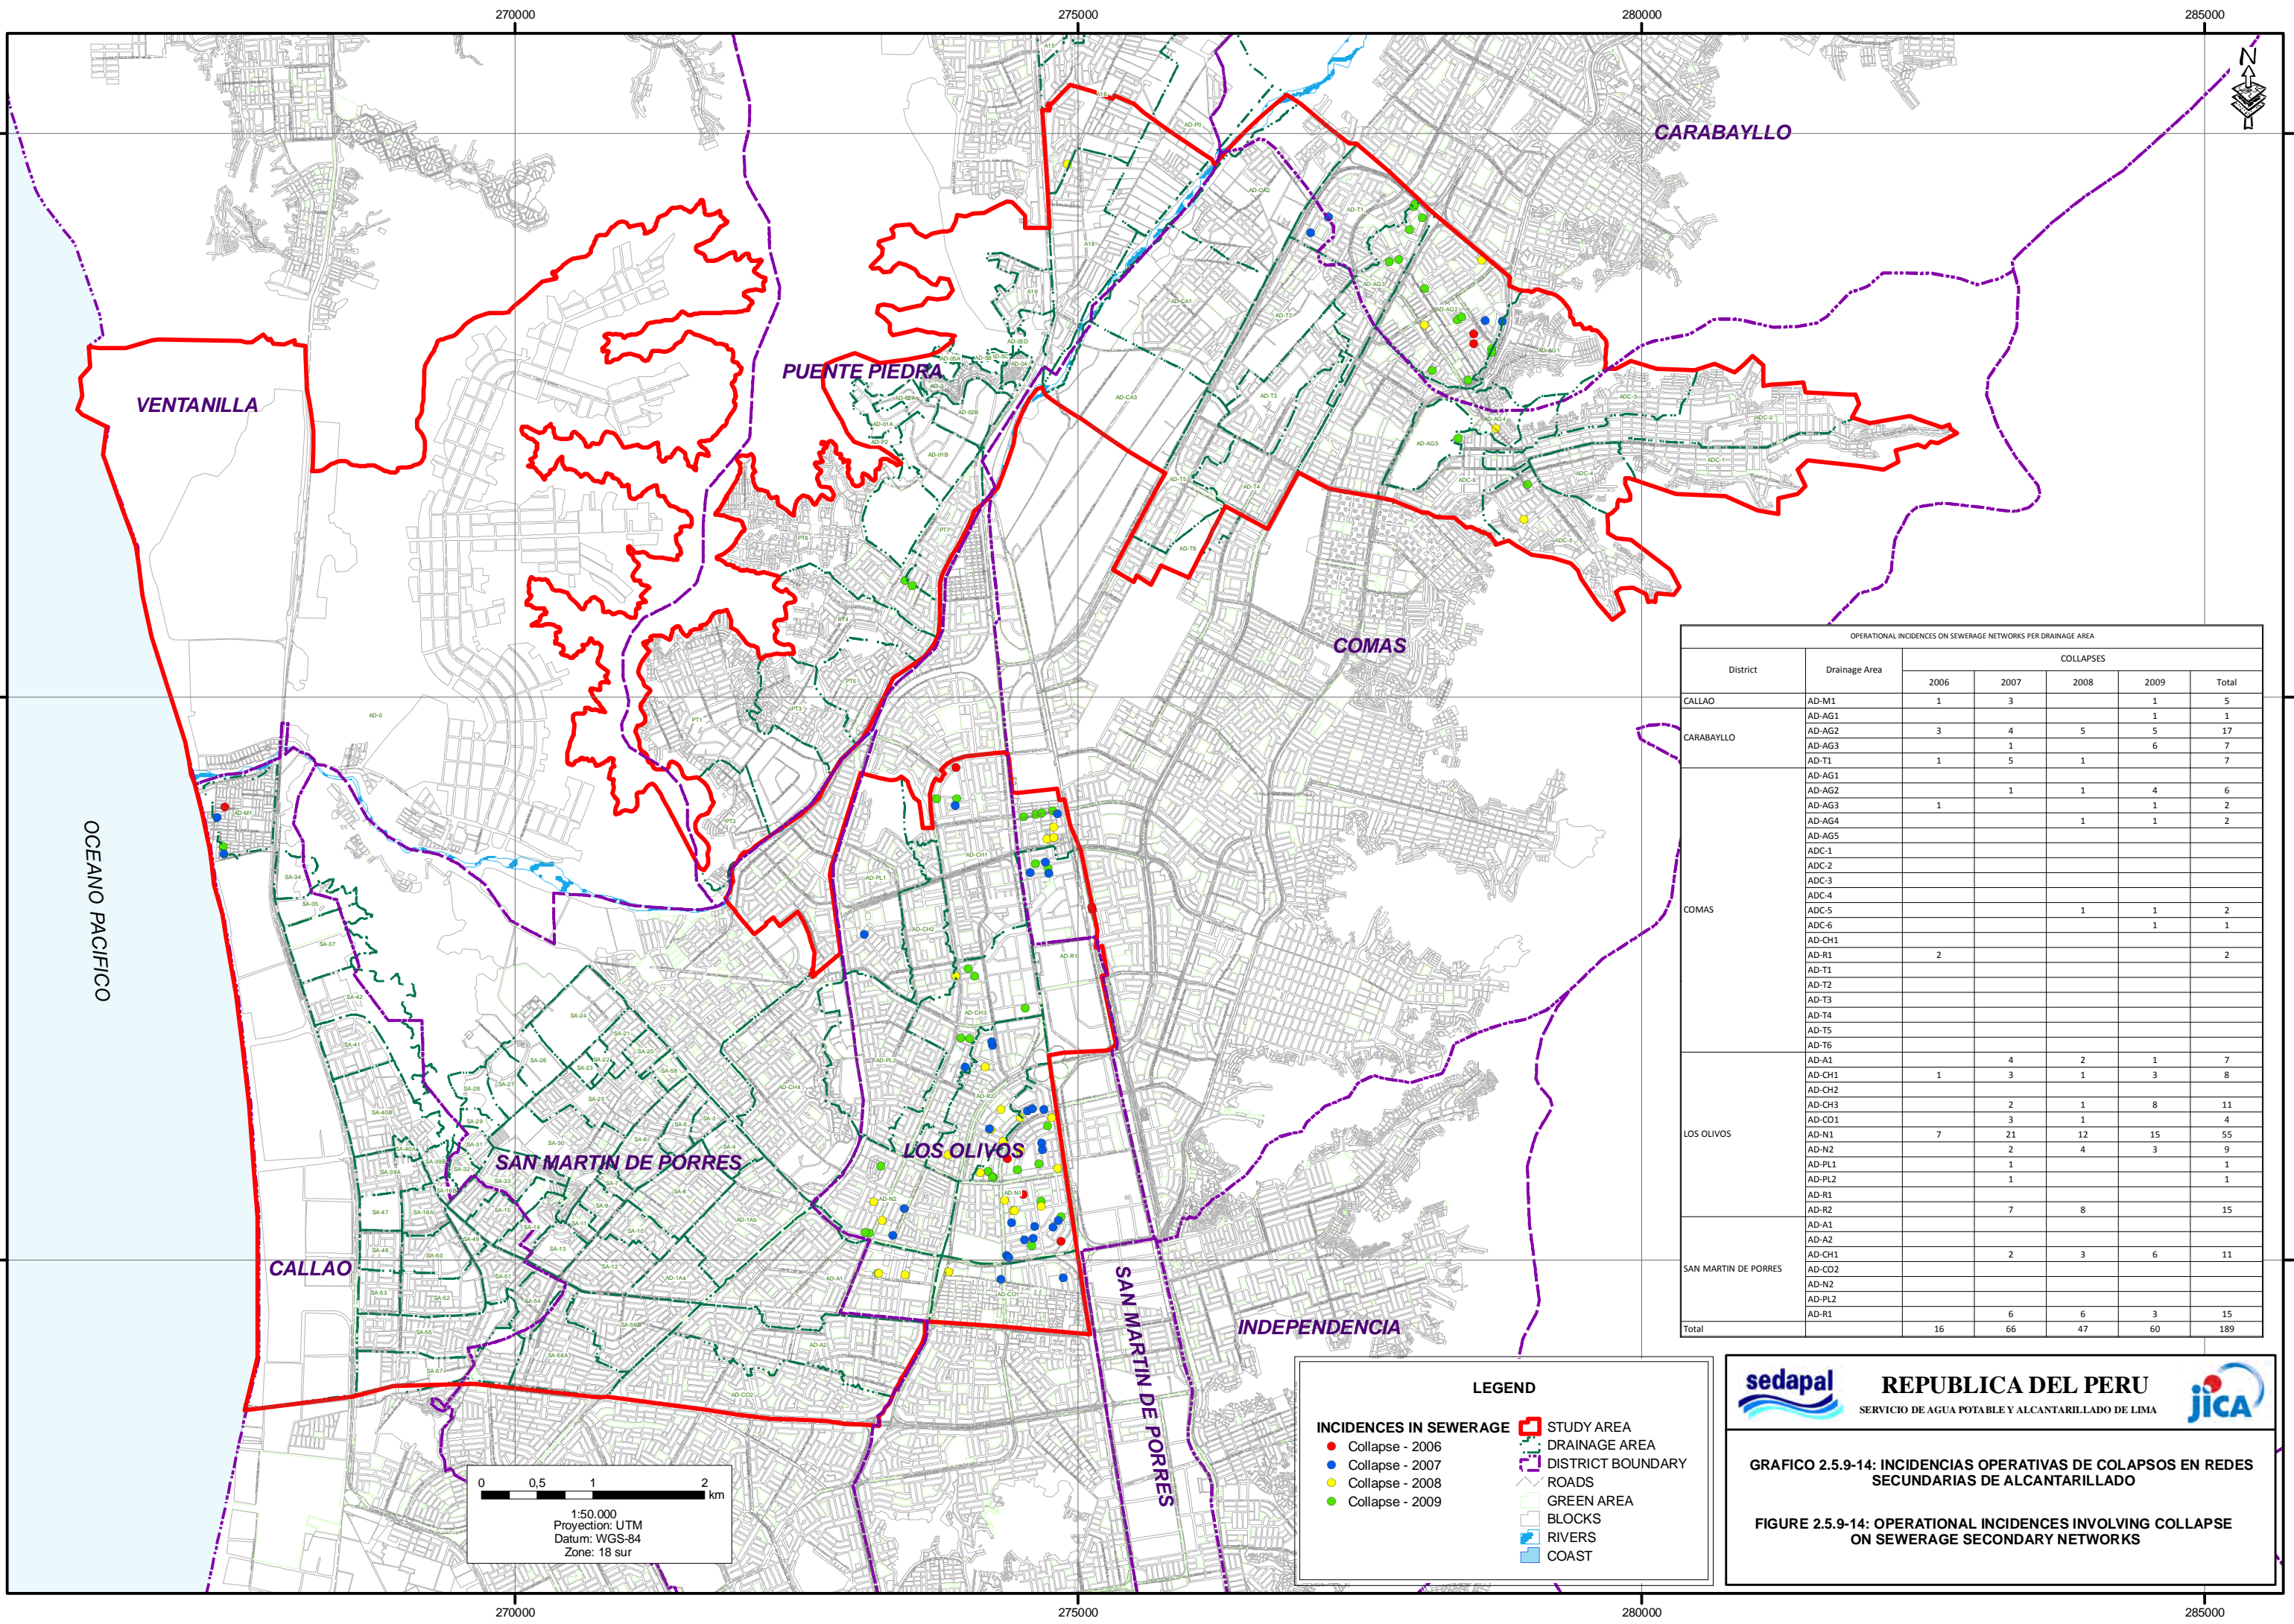
GRAFICO 2.5.9-14: INCIDENCIAS OPERATIVAS DE COLAPSOS EN REDES SECUNDARIAS DE ALCANTARILLADO
 FIGURE 2.5.9-14: OPERATIONAL INCIDENTS INVOLVING COLLAPSE ON SEWERAGE SECONDARY NETWORKS

These actions defined as collapses, and the analysis of the collapses was able to provide a better knowledge of the condition of the pipes. Knowing the number of collapses can give an idea of the places where the sewerage system is most deteriorated.

Figure 2.5.9-14 shows the location of these incidents, which have been called “Collapses.”

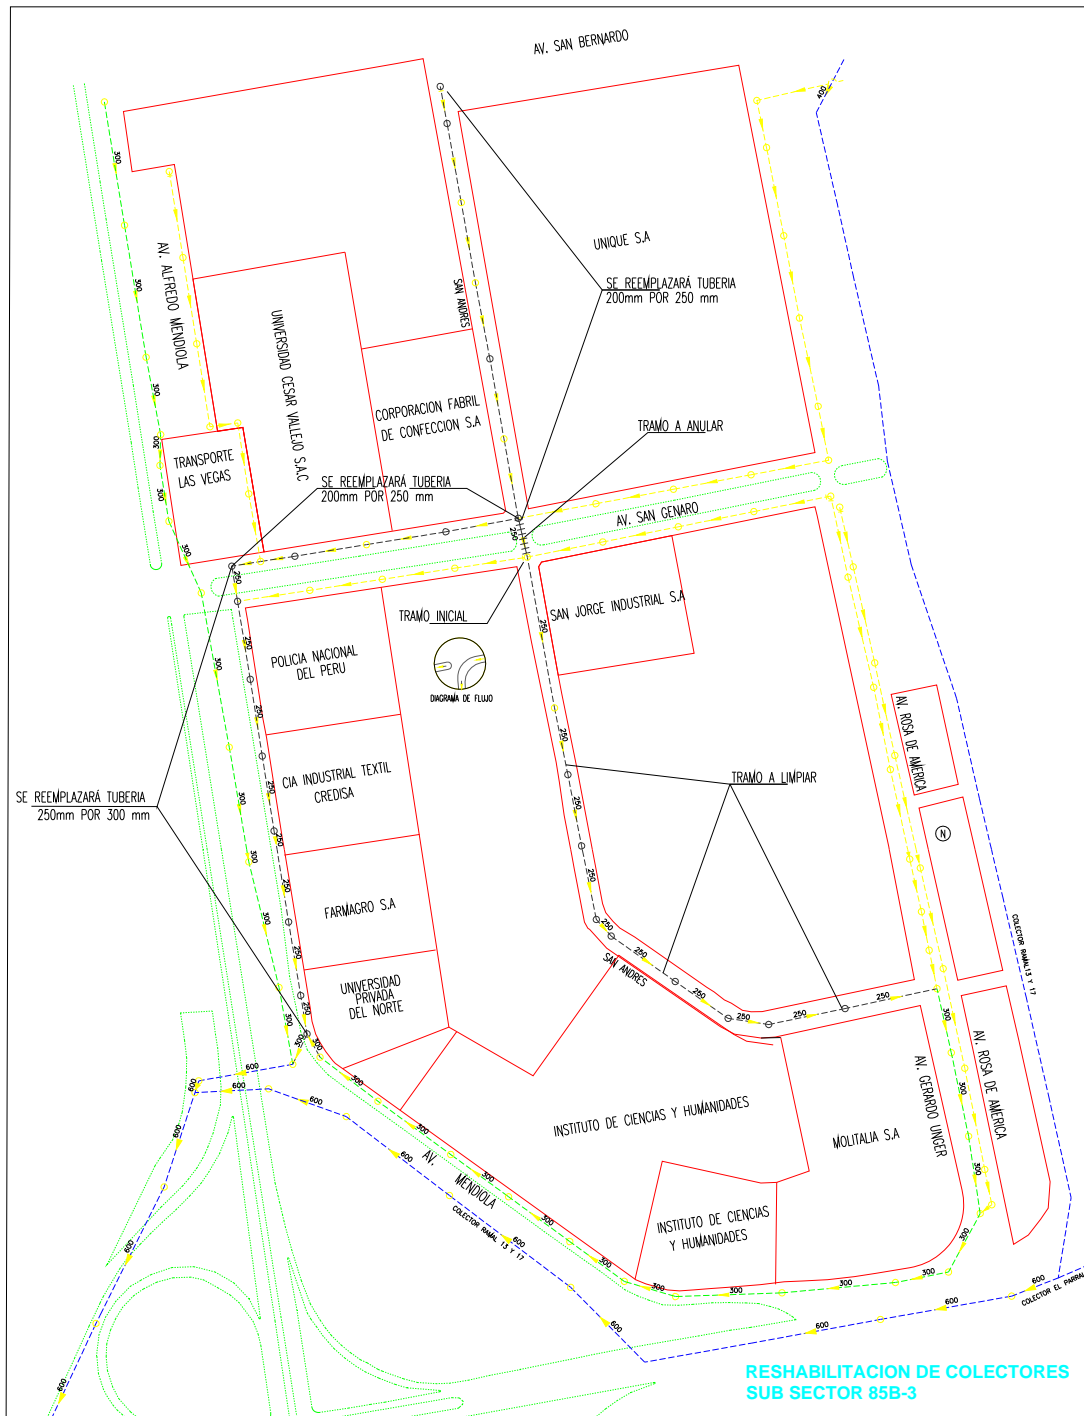
Figure 2.5.9-16: Collector rehabilitation in Sub Sector 85B-3

- Insufficient capacity:
 - ❖ San Andrés (Between the San Bernardo and San Genaro avenues)
 - ❖ San Genaro (Between the Gerardo Unger and Alfredo Mendiola streets)
- Insufficient gradient
 - ❖ Alfredo Mendiola
- Cleaning and maintenance issues:
 - ❖ San Andrés (Between the San Genaro avenue and the Gerardo Unger street)
