**DETAILED DESIGN (PHASE 2)
ON
PORT MORESBY SEWERAGE SYSTEM
UPGRADING PROJECT
IN
THE INDEPENDENT STATE OF
PAPUA NEW GUINEA**

FINAL REPORT

**Volume III – Result of
Natural Condition Surveys**

**DETAIL DESIGN ON
PORT MORESBY SEWERAGE SYSTEM UPGRADING PROJECT**

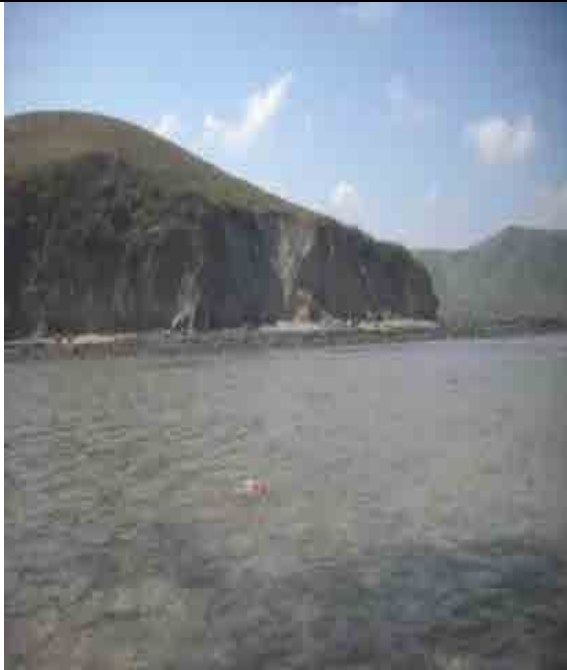
Plate 8: Headland and starting point.

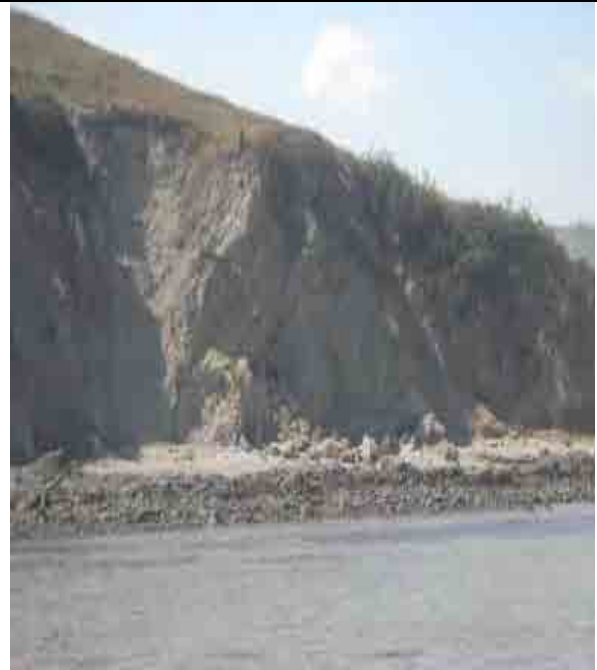
Plate 9: Cliff, loose rocks, rocky shoreline.

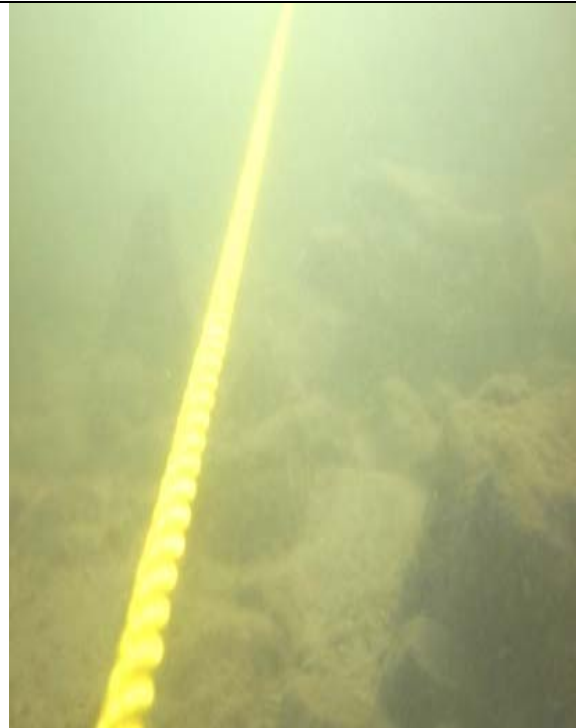
Plate 10: Rocky shoreline, murky water.

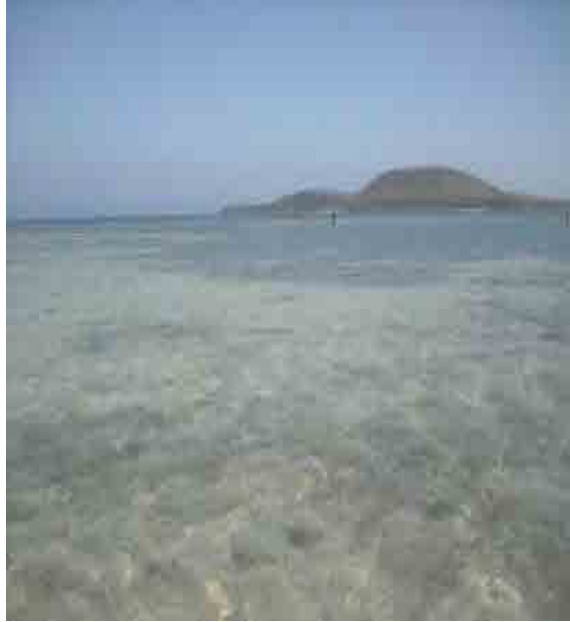
Plate 12. Rocks scattered over barren sandy reef bed.

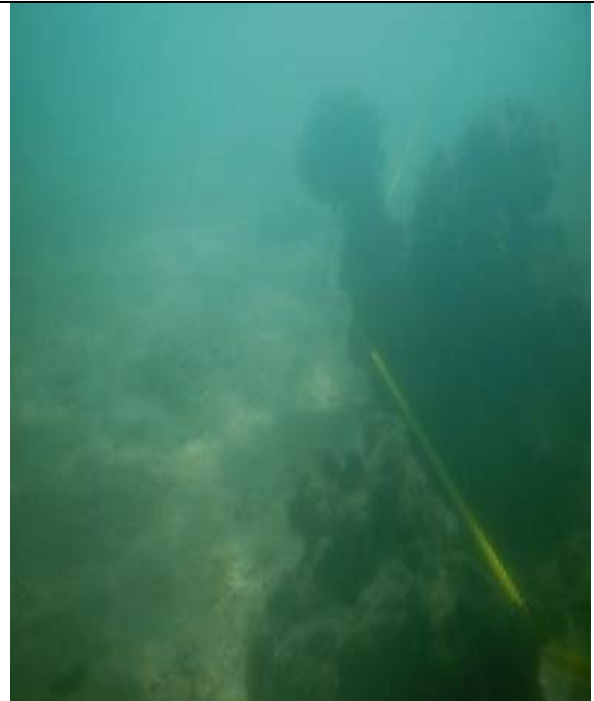
Plate 15. Dead boulder rock on sandy reef bed.

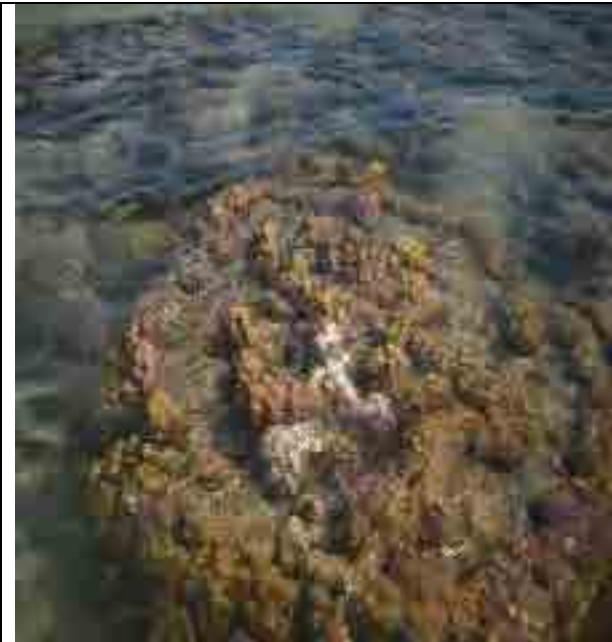
Remnants of *Porites sp* table-top coral boulders were observed from zones B to C. The corals are growing at the rim of the boulder and around the dead calcified centre or core of the colony. It was estimated that 10 or more of the large (> 1 m diameter) coral boulders and small boulders (30 cm – 80 cm diameter) could be counted in a box of 10m x 10m square.

Plate 40. Coral growth mainly around rim of boulder coral

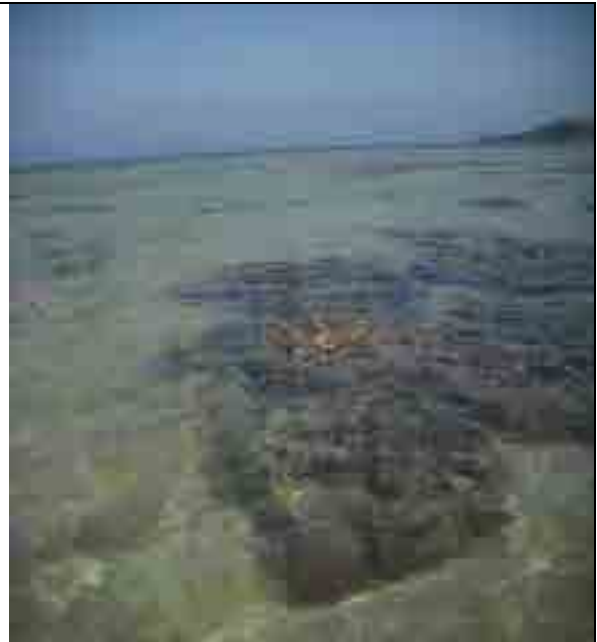
Plate 41. Boulder coral being exposed at low tide

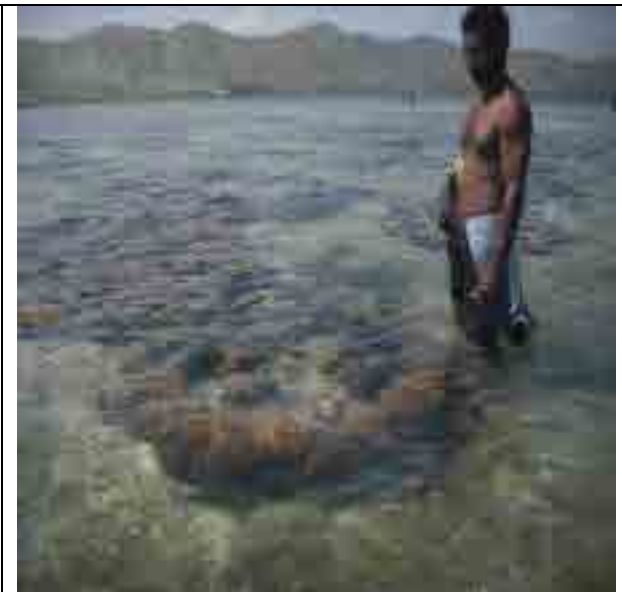
Plate 43. Scattered patches of boulder corals *Porites sp*

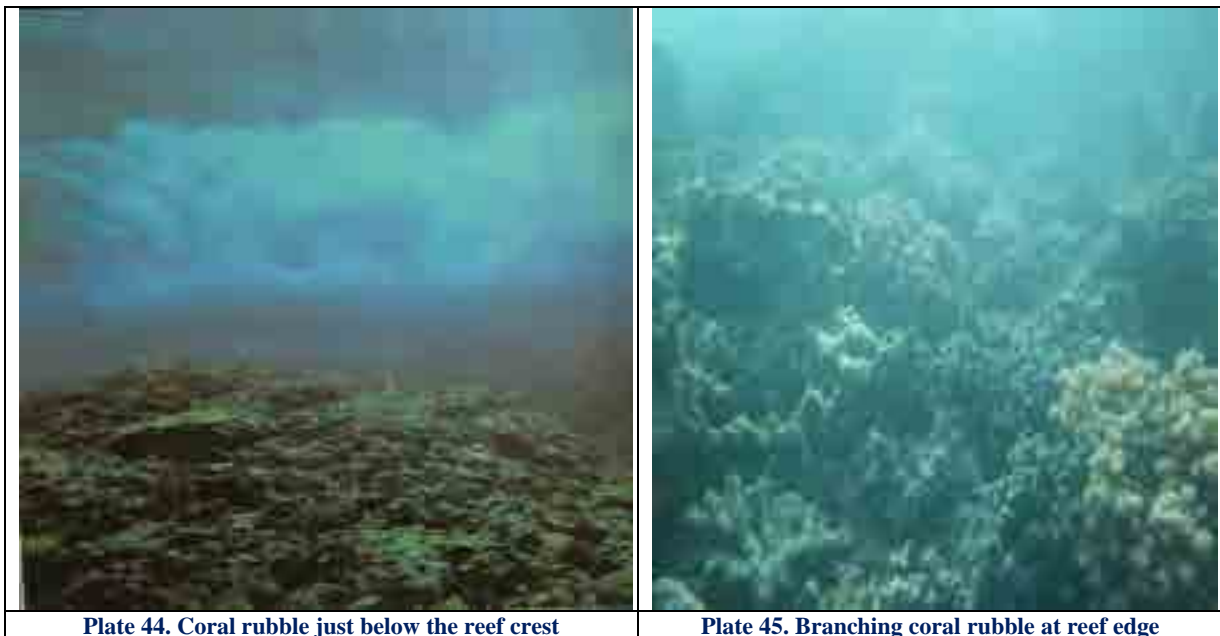
From zone G was the barren substrate of broken corals and coarse substrates. Plates 44- 45.

Plate 44. Coral rubble just below the reef crest

Plate 45. Branching coral rubble at reef edge

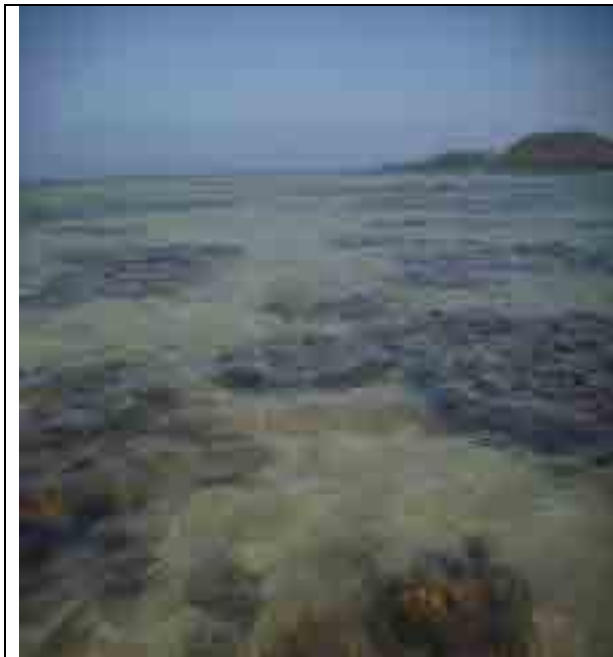
The coral counts were made inside the pipeline corridor to get an estimate of the extent of coral cover that will become removed and transplanted elsewhere. The corals in the shallower sections of the route are growing around the rim (periphery) of the large table-top shaped coral assemblages. The smaller size boulders are regenerated stand alone boulders growing in the interstices (spaces) between the larger boulders. Plates 46 -47.

Plate 46. Visual of percentage coverage of boulder coral.

The POMSSUP project design requires that corals found to be inside the 30m corridor on either side must be removed and transplanted to other locations within sections of this 120 m wide corridor. The sections of the corridor up to about 650 m (our estimate) from the coastline will need to be dug up or excavated for a trench to bury the 70 cm diameter pipeline.
