4. Existing Facility Survey

SURVEY REPORT – MANHOLE PICK UP

Survey Report: Manhole Pickup

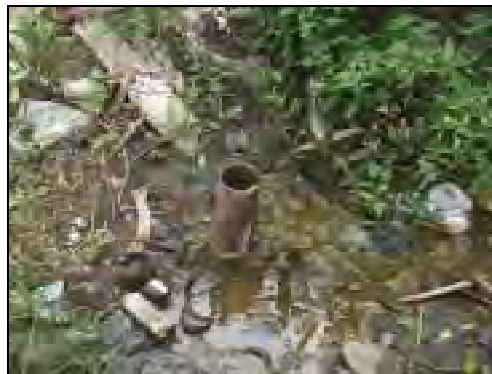
M05236

*Needs repair..

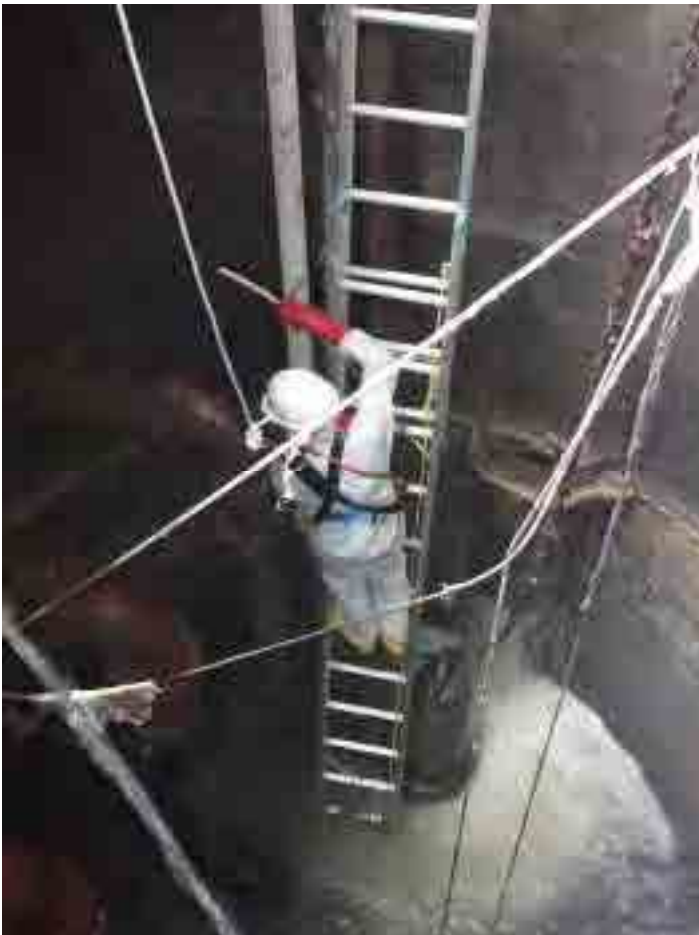
There are no visible leakages along the 3 Steel pressure pipes in the pump pit.
There is no visible sign of sea water entering.

1b. Pump Pit Leakage Check; Not many leakages

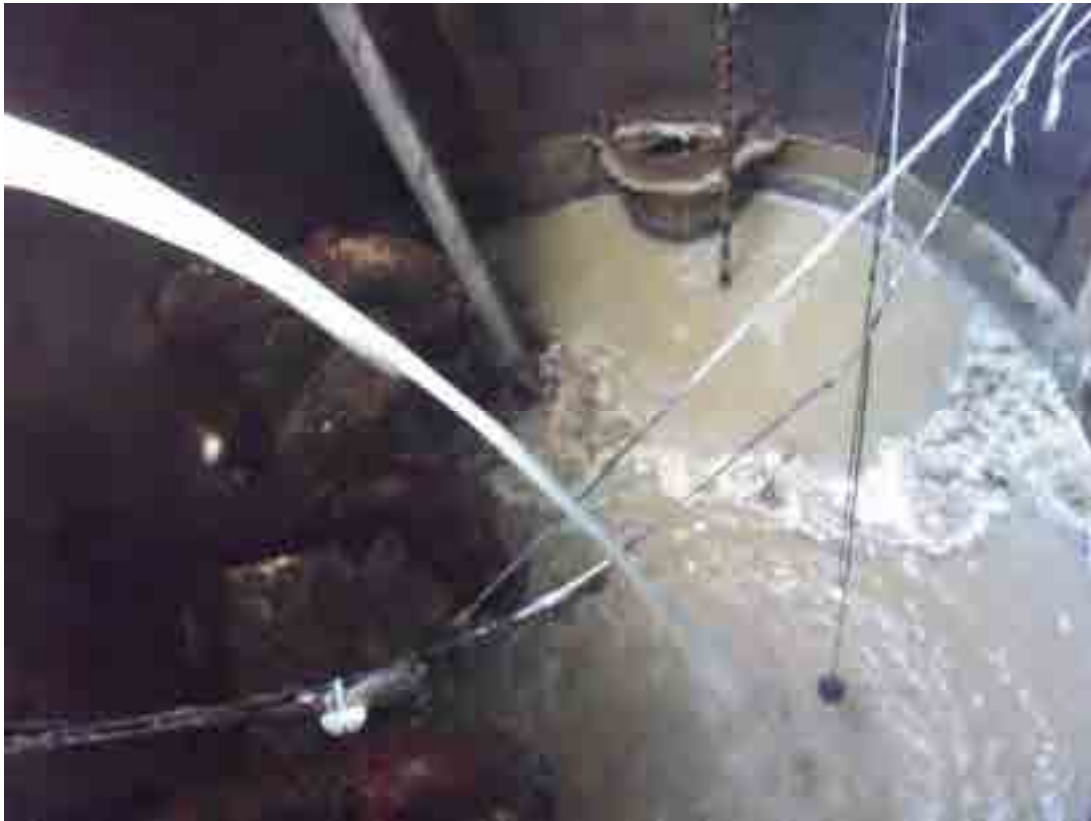
The 3 Steel Pressure Pipes clearly shows corrosion or rust taking place. Opening a Steel Pressure pipe would be impossible due to the severe corrosion.

1c. Leakage Check and Corrosion check; not many leakages however corrosion is severe

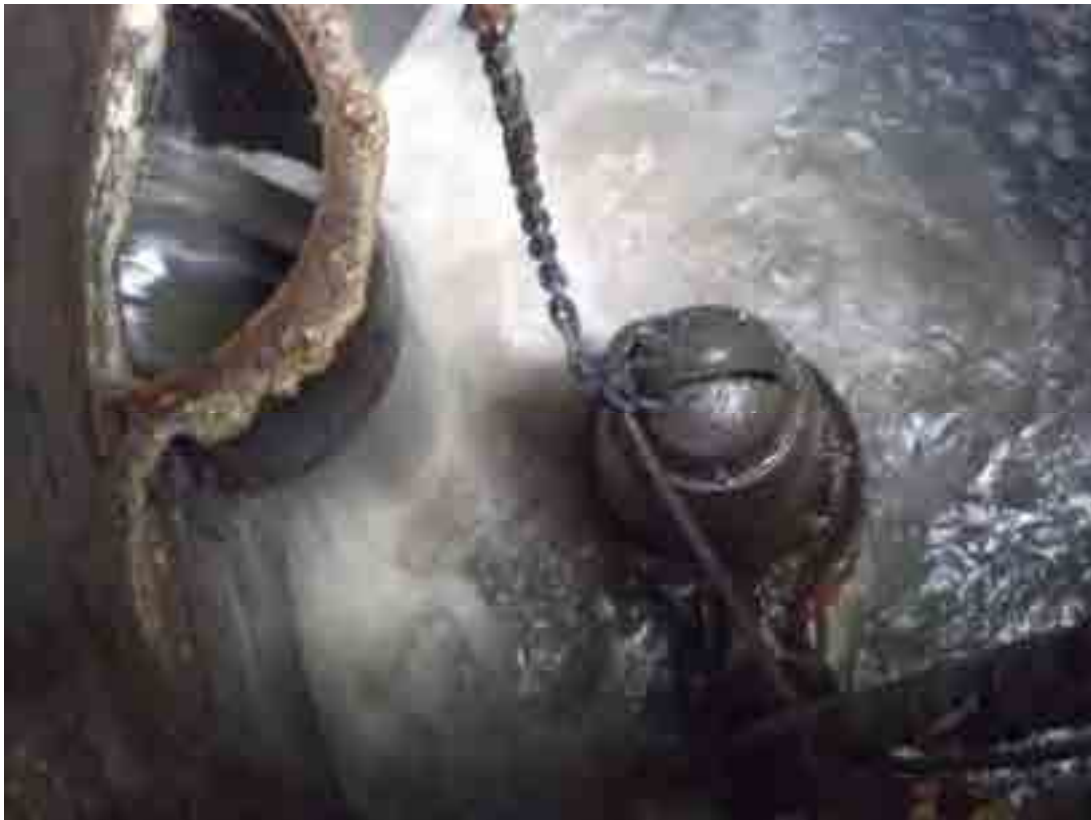
1d. Severe Place of Corrosion; Inflow pipe and pressure pipes

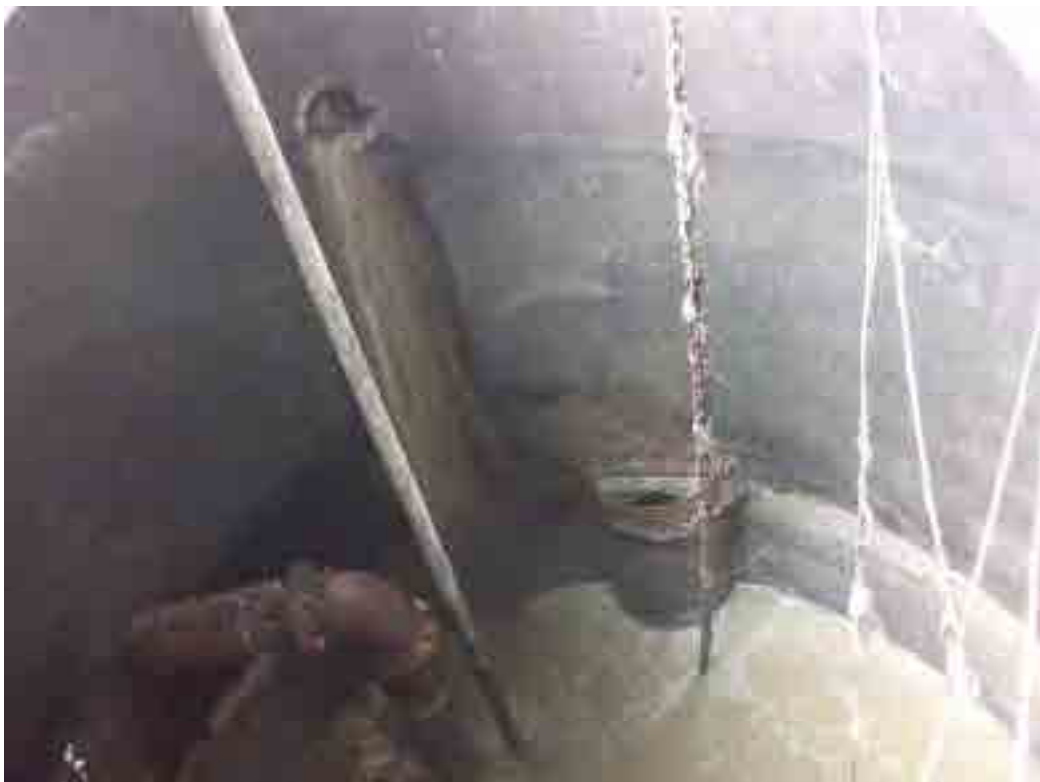
There is no cracks or steel work exposure in the pump walls.

1f. Crack; Not many cracks

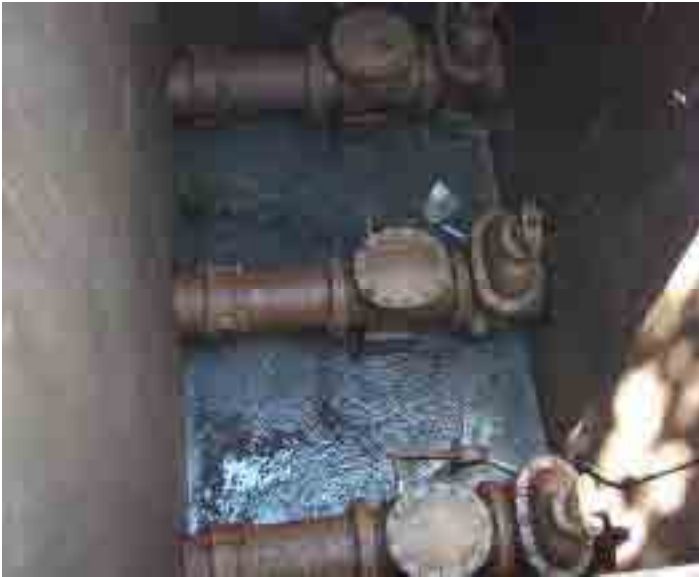
The Steel pressure pipes have no leakages.
There is no sign of sea water entering.

2a. Leakage Check; not many

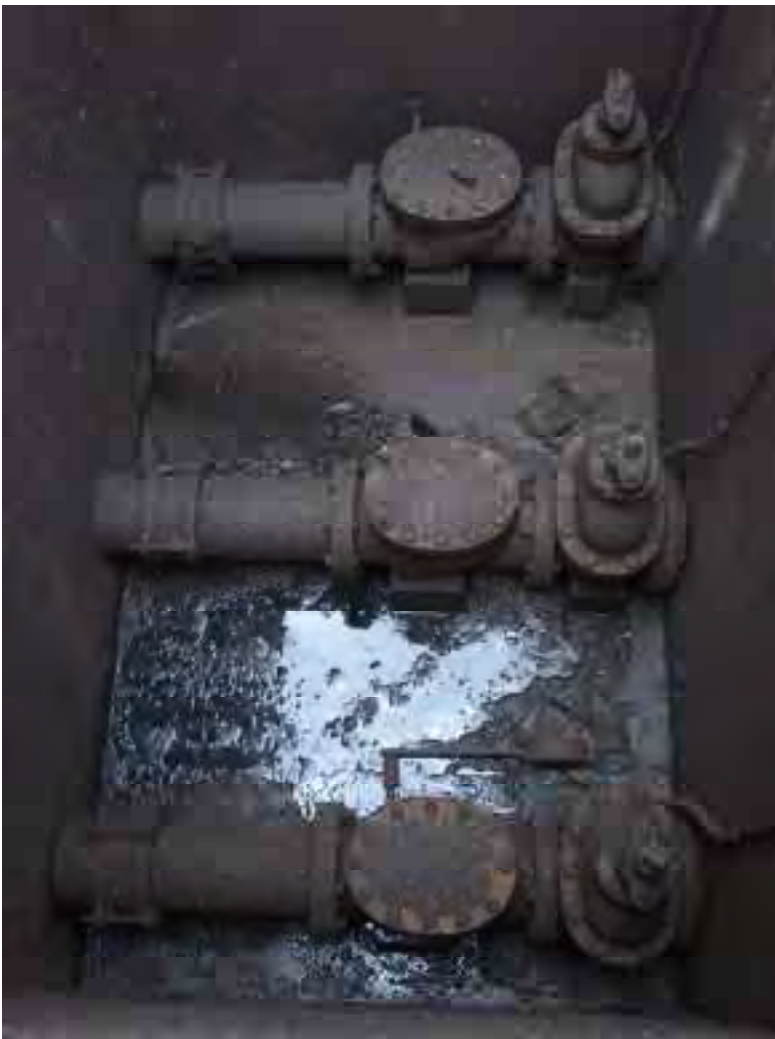
2b. Exposure of Steel and Corrosion

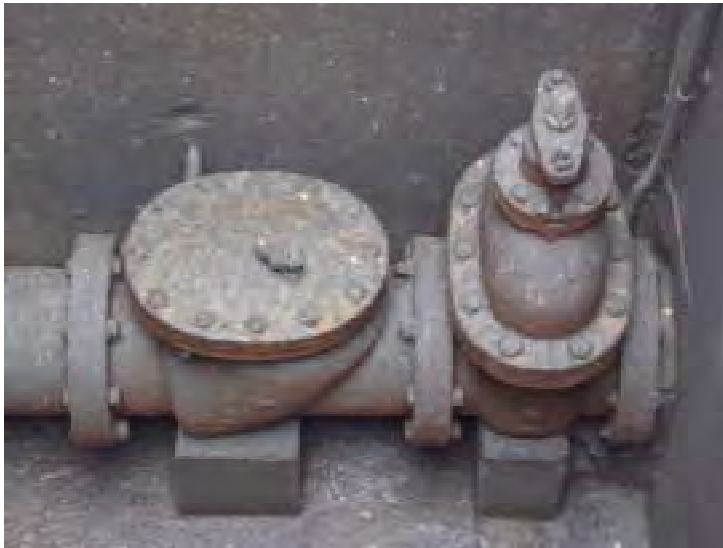
Most of the pressure pipes in the Valve pit are severely corroded.

2c. Most steel pipes are severely corroded like this one.

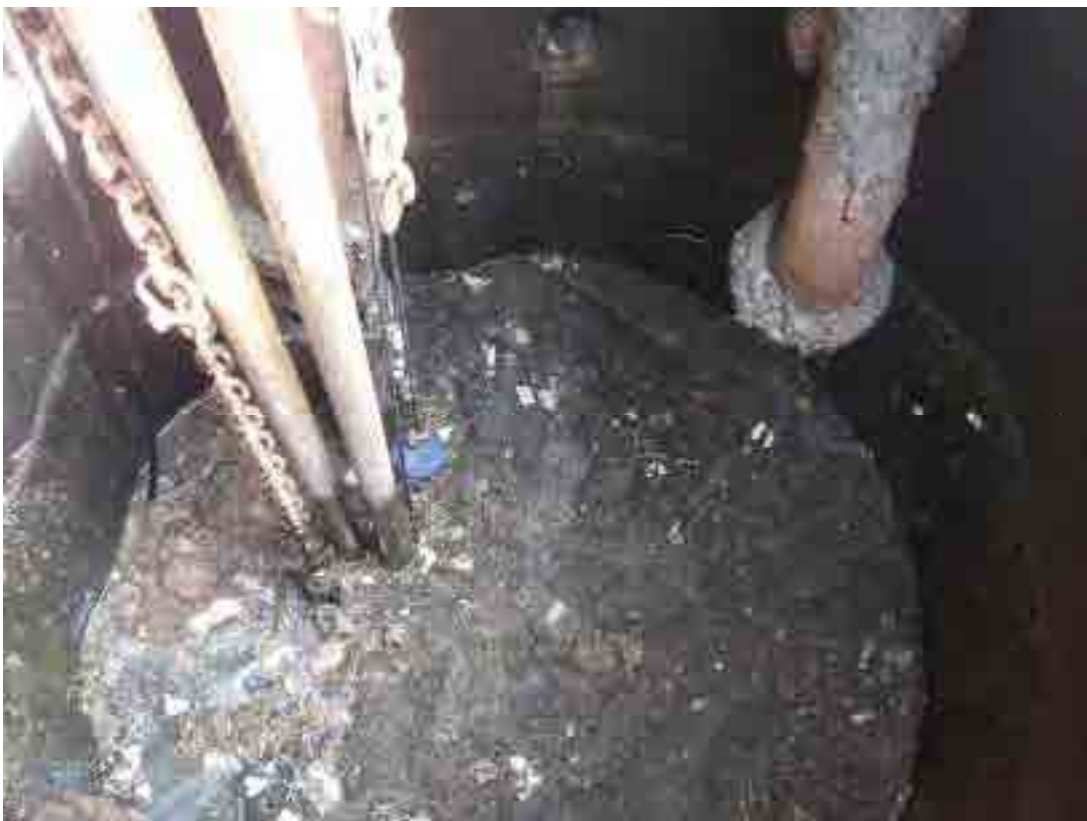
There were not many leakages along the only pressure pipe that is operating. However it is impossible to comment on the area below the blockage as it is not visible. There are no visible signs of salt water entering the pit.

One of the pressure pipes in the valve pit has leakage on it, for that same pipe part of it in the pump pit has been broken off. (See Photo 1b and 2a)

1b: Pump Pit Leakage Check; not many leakages

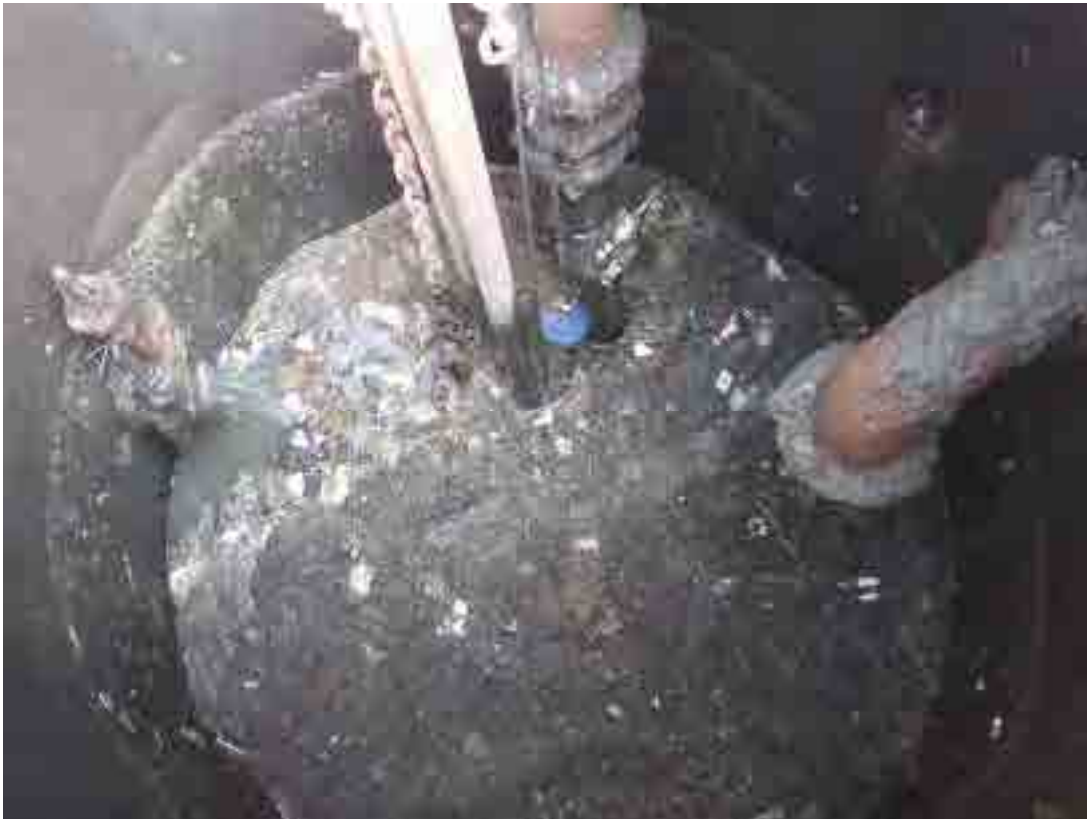
The Steel Pressure Pipes clearly shows corrosion.

1c: Steel Rod Exposed; Most Steel Pressure Pipes are rusting

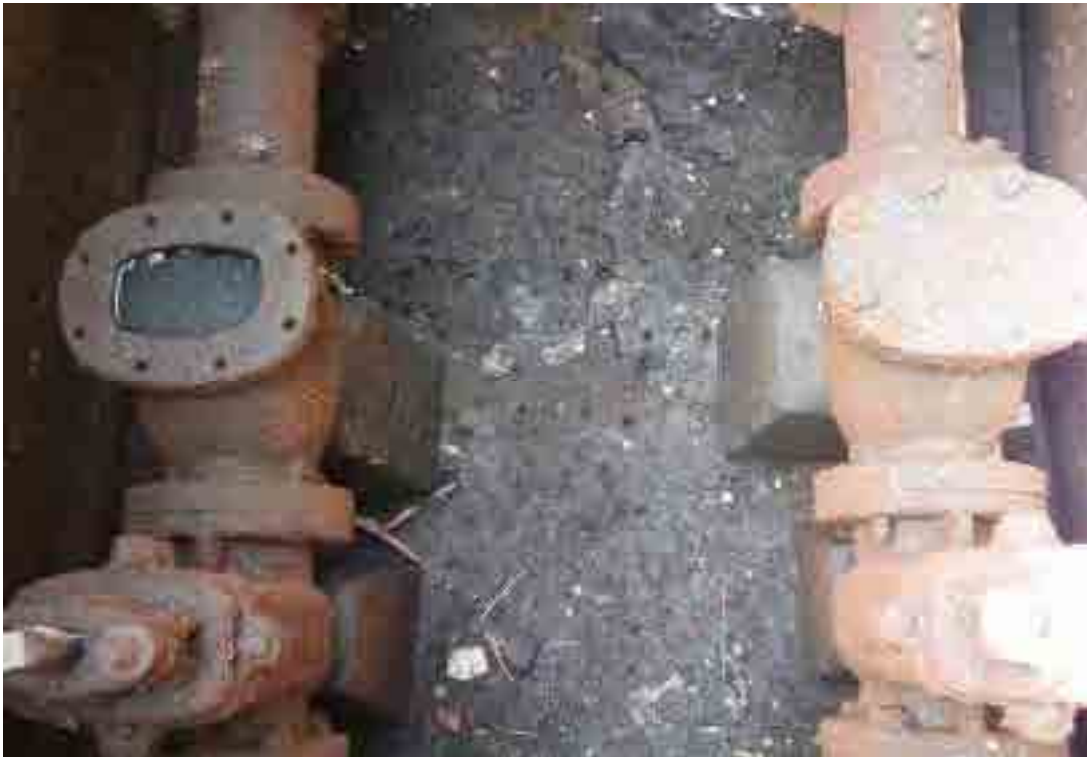
2a. Existence of Leakage

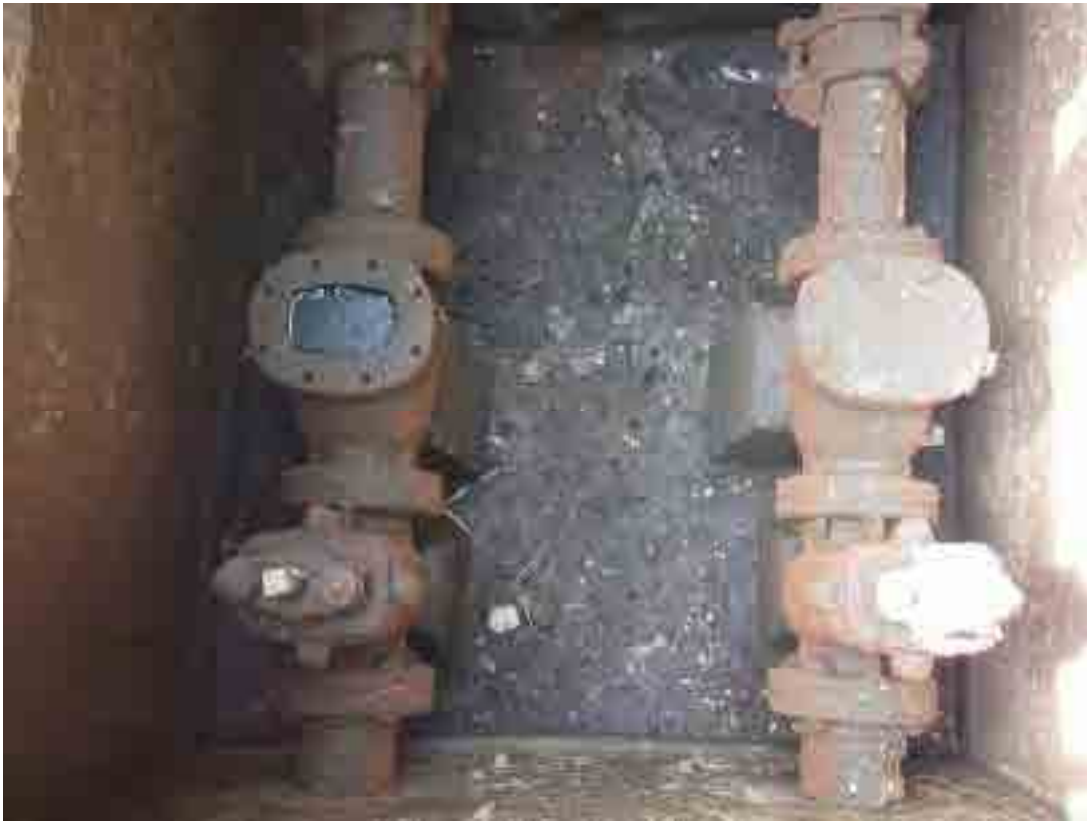
Most of the pressure pipe in the Valve pit is severely corroded.

2b. Steel Rod Exposed

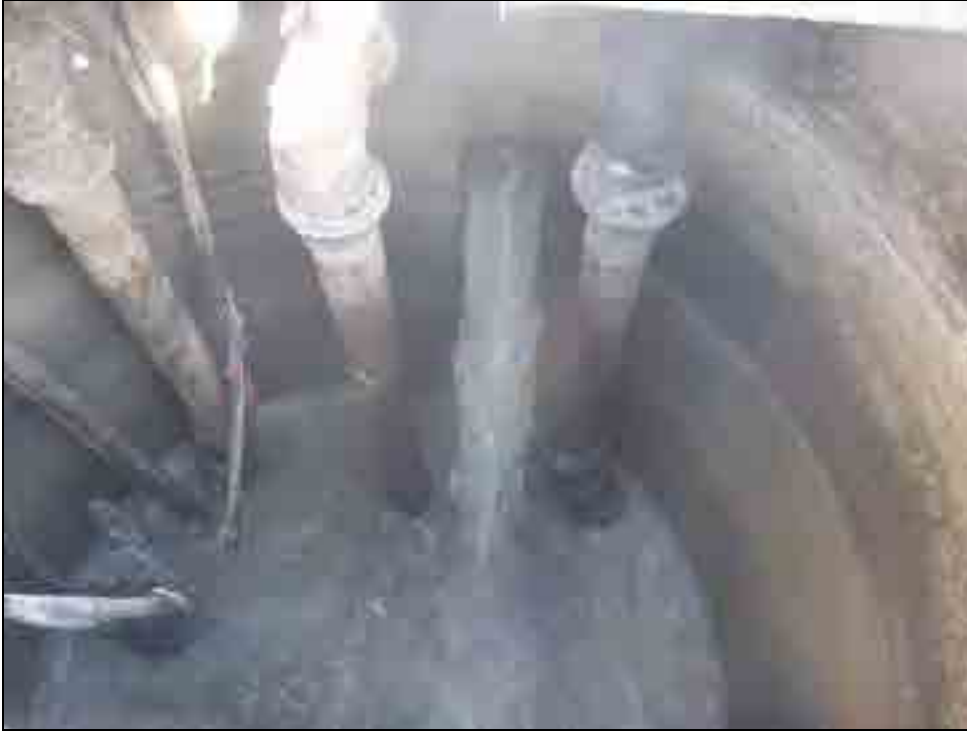
The Steel Pressure Pipes clearly shows corrosion or rust taking place.

1b. Corrosion Condition; medium level of corrosion occurring on steel pressure pipes

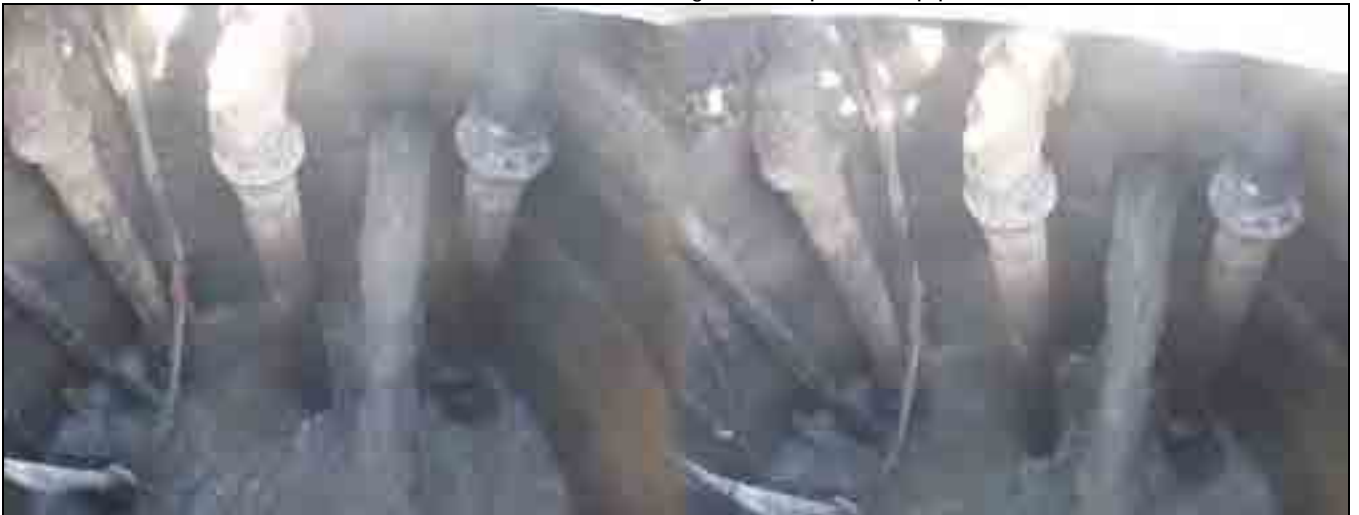
1c. Crack condition; There are no cracks.

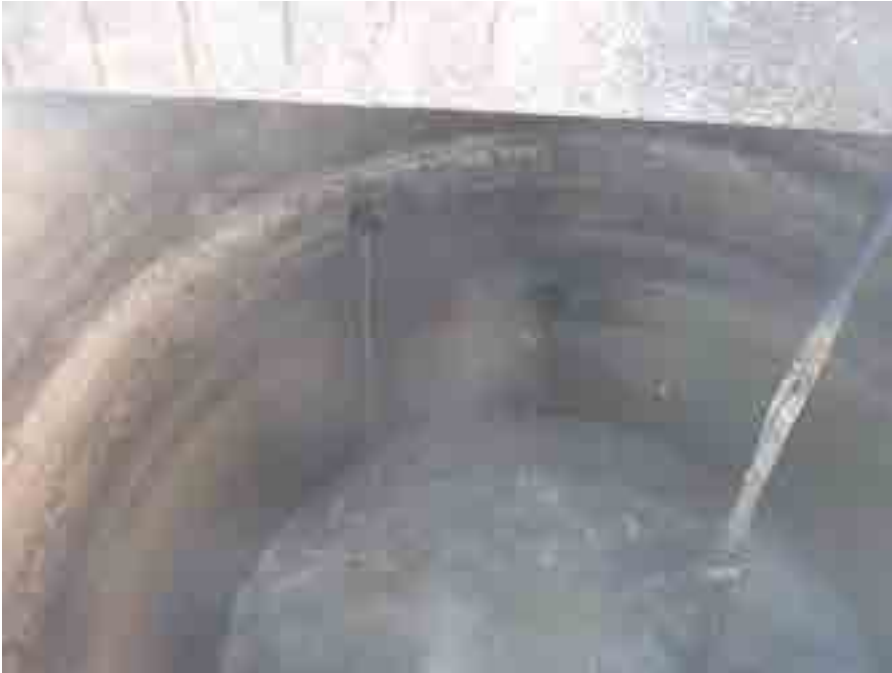
1e. Crack Condition; There are no cracks, (opposite side)

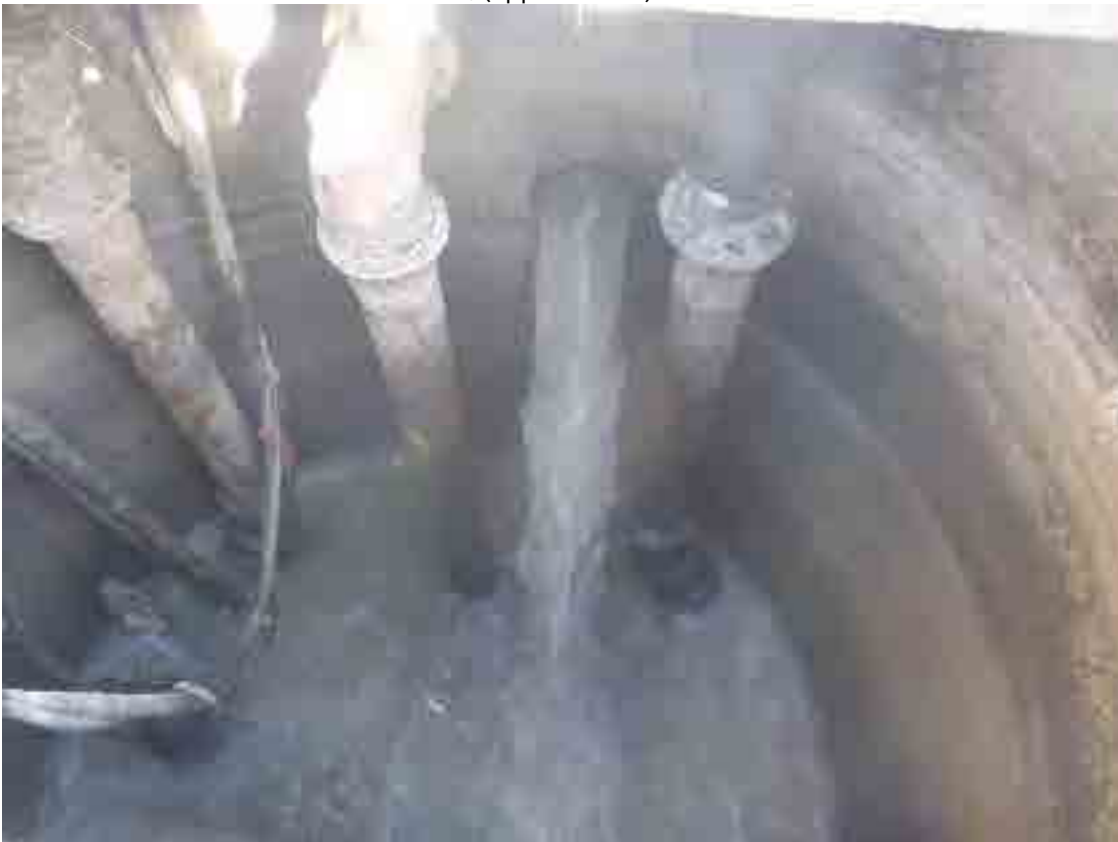
2a. Leakage condition; not many leakages, Corrosion condition; There is medium level of corrosion.
Crack condition; no cracks.

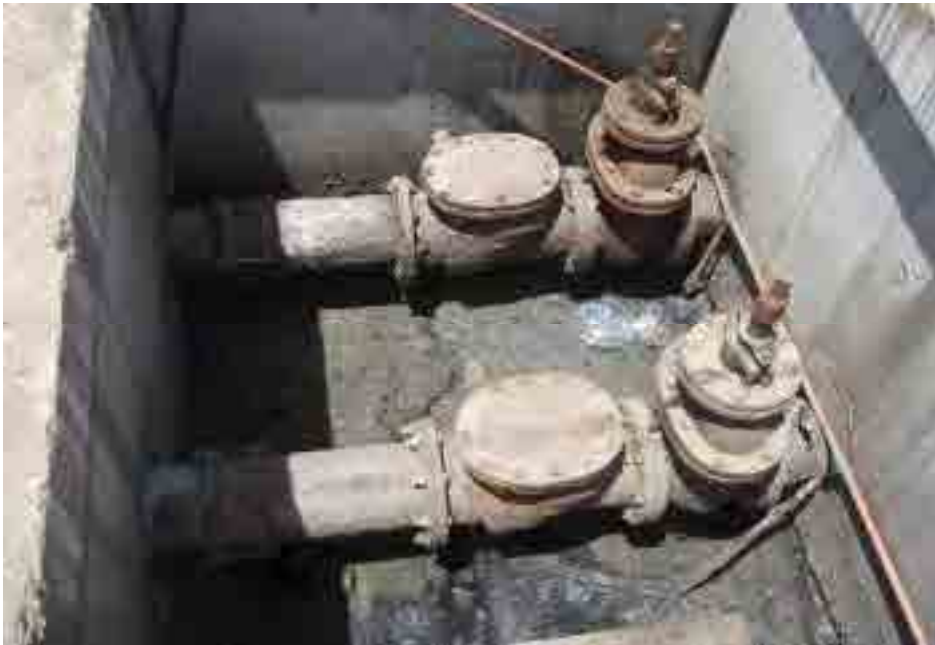
There are no leakages however there is a broken pipe. (*See photo 2b*)

2b. Broken pressure pipe in valve pit. This pipe is the 3rd pipe from left.

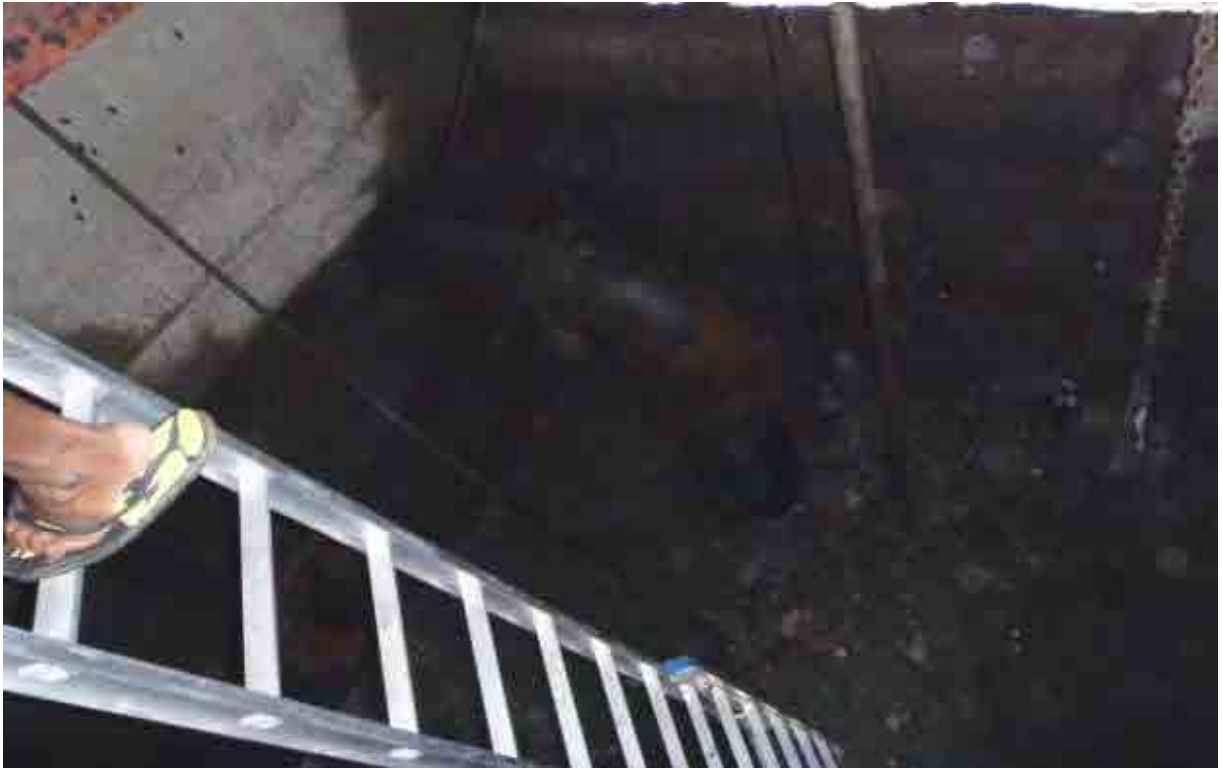
1j. Pump Pit Leakage Condition; no
leakages

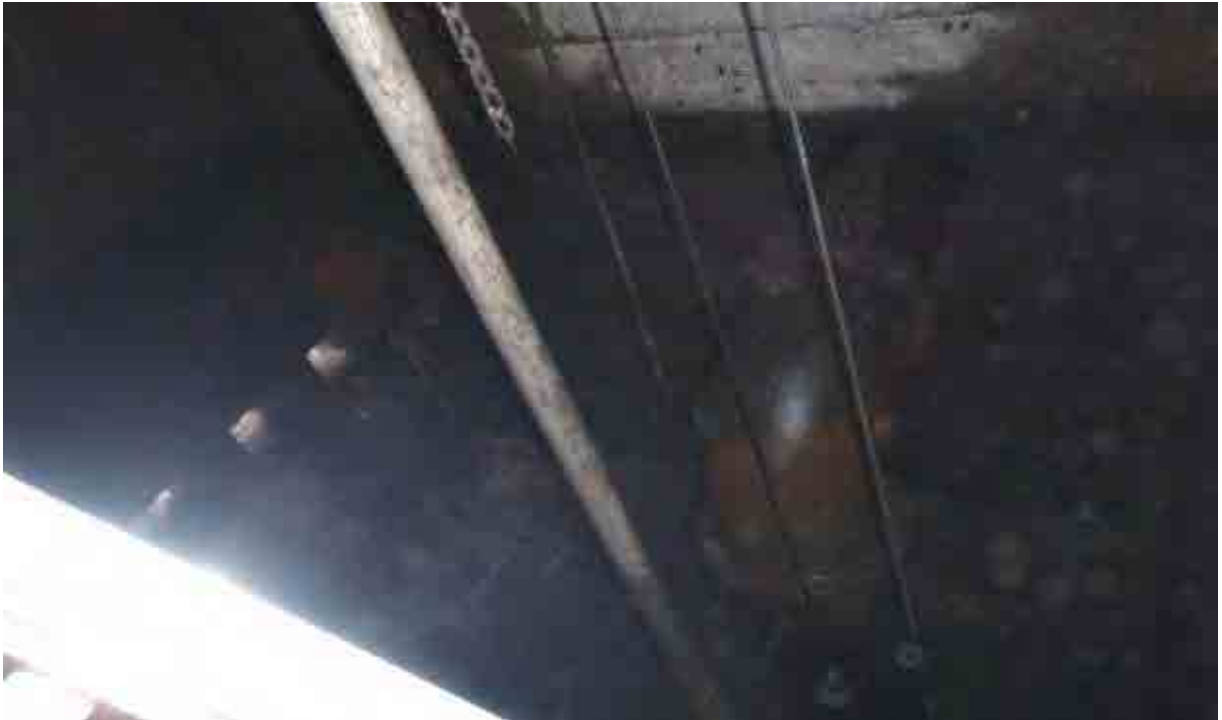
1k. Corrosion Condition; medium level of corrosion

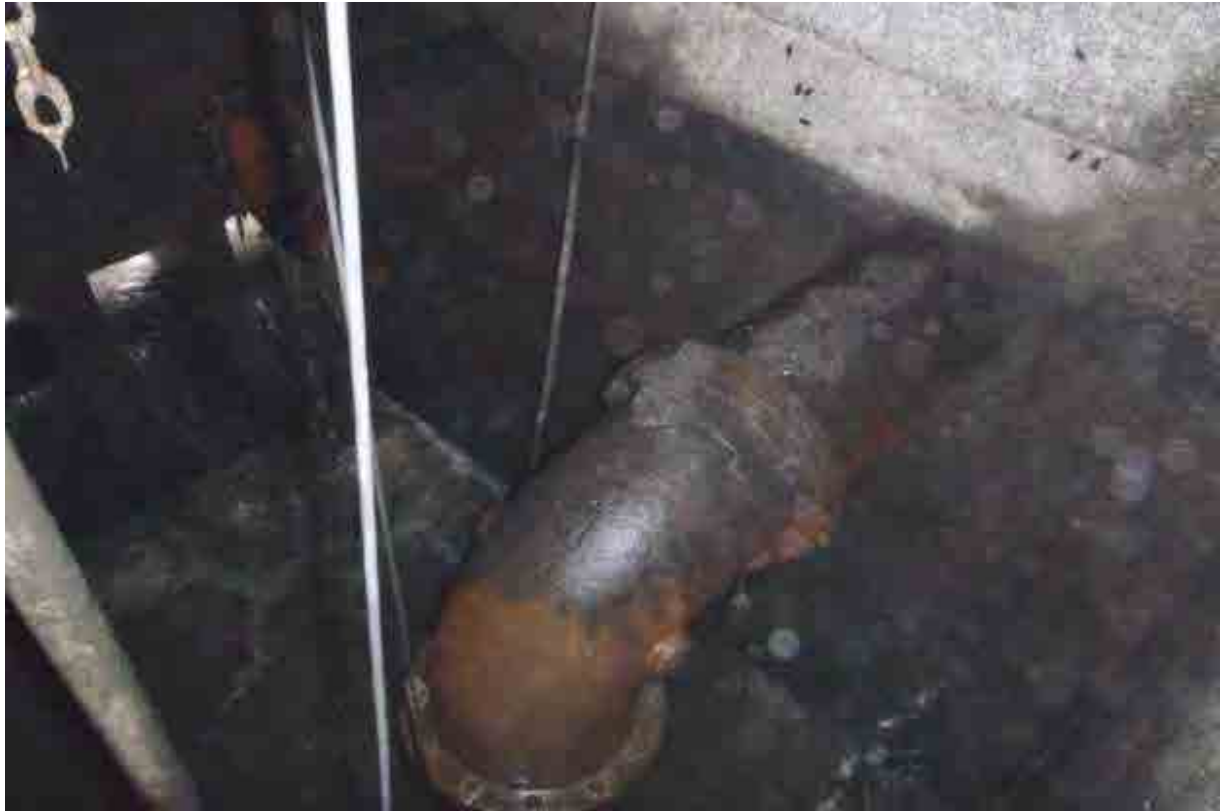
11. Crack condition; no
cracks

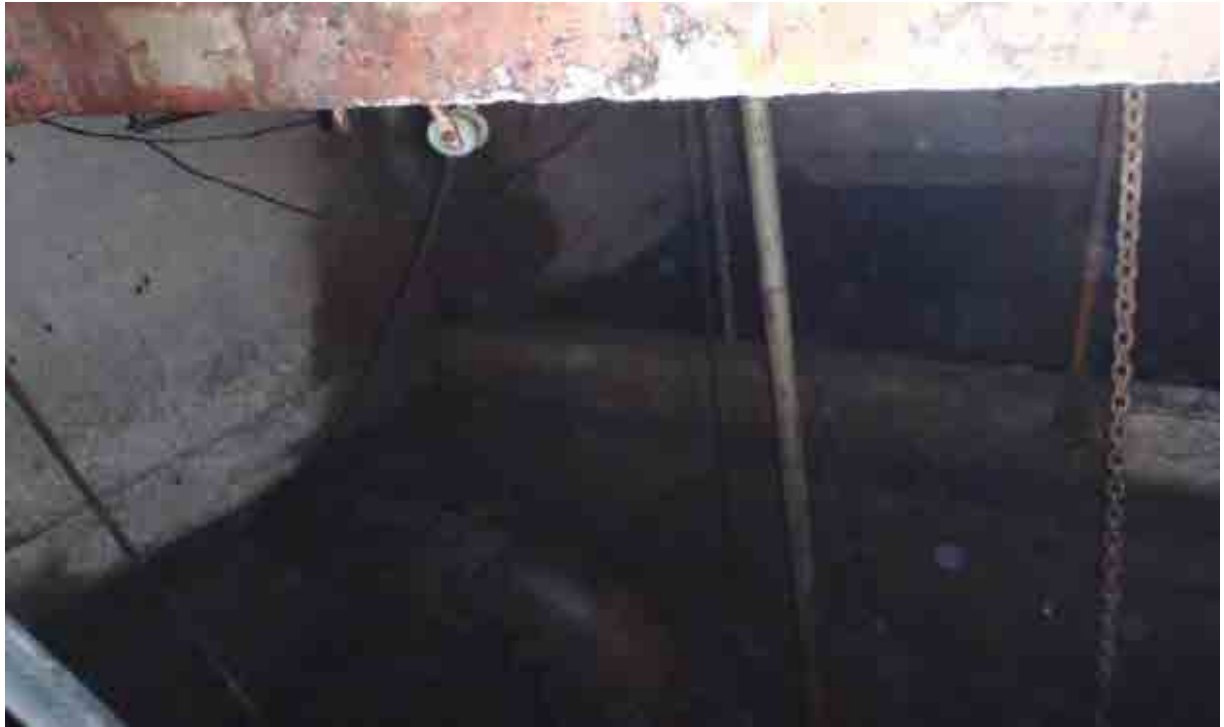
1m. Crack condition; no
cracks,

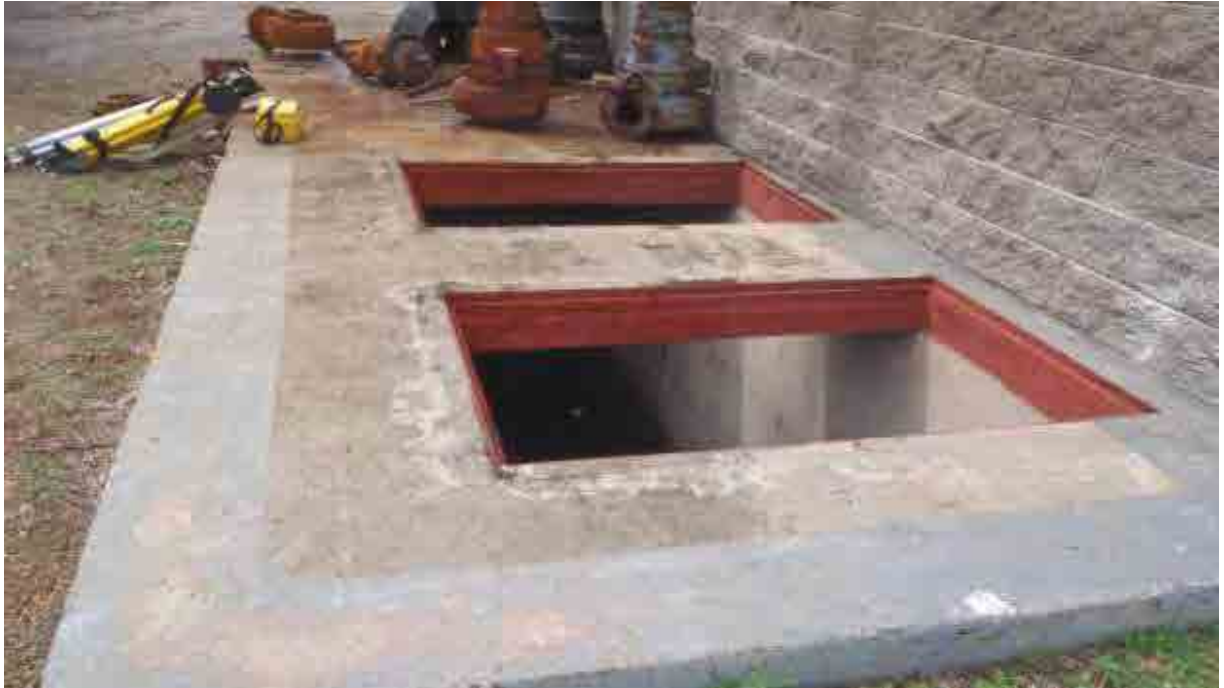
2b. Leakage condition; no leakages

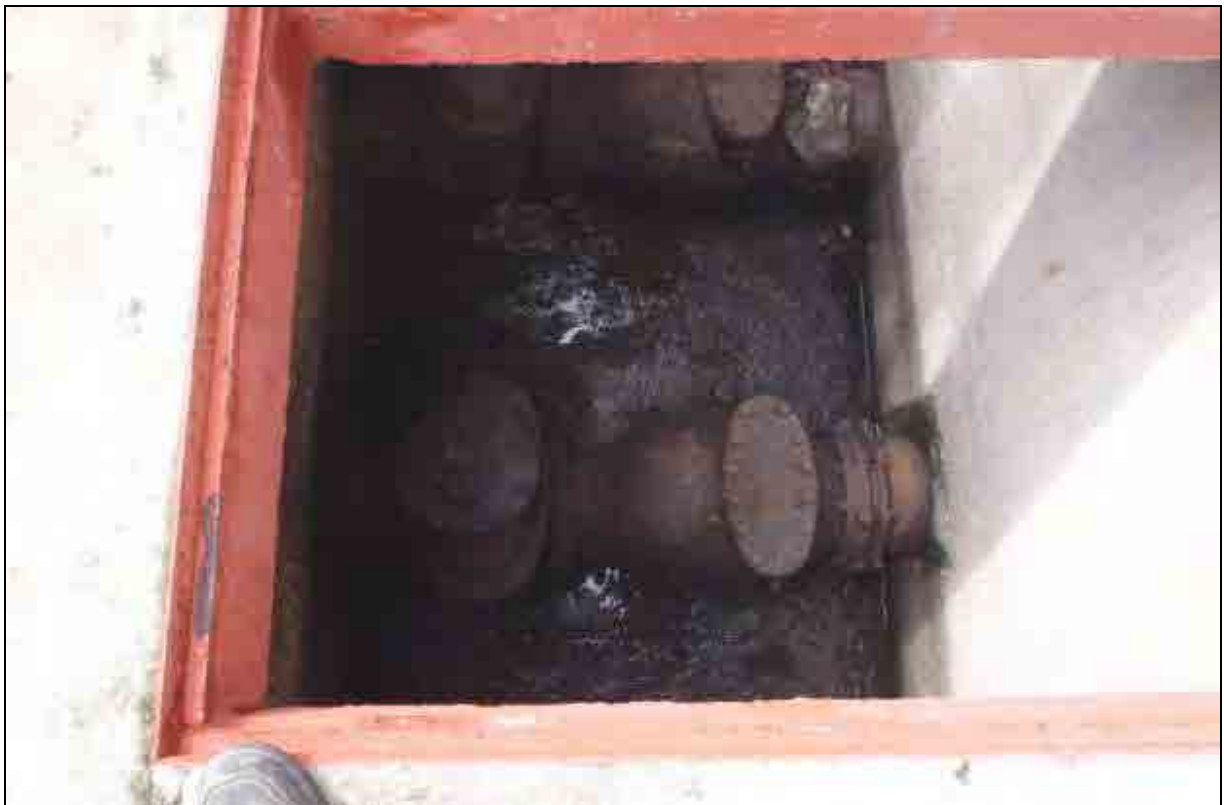
2c. Corrosion Condition; not much corrosion

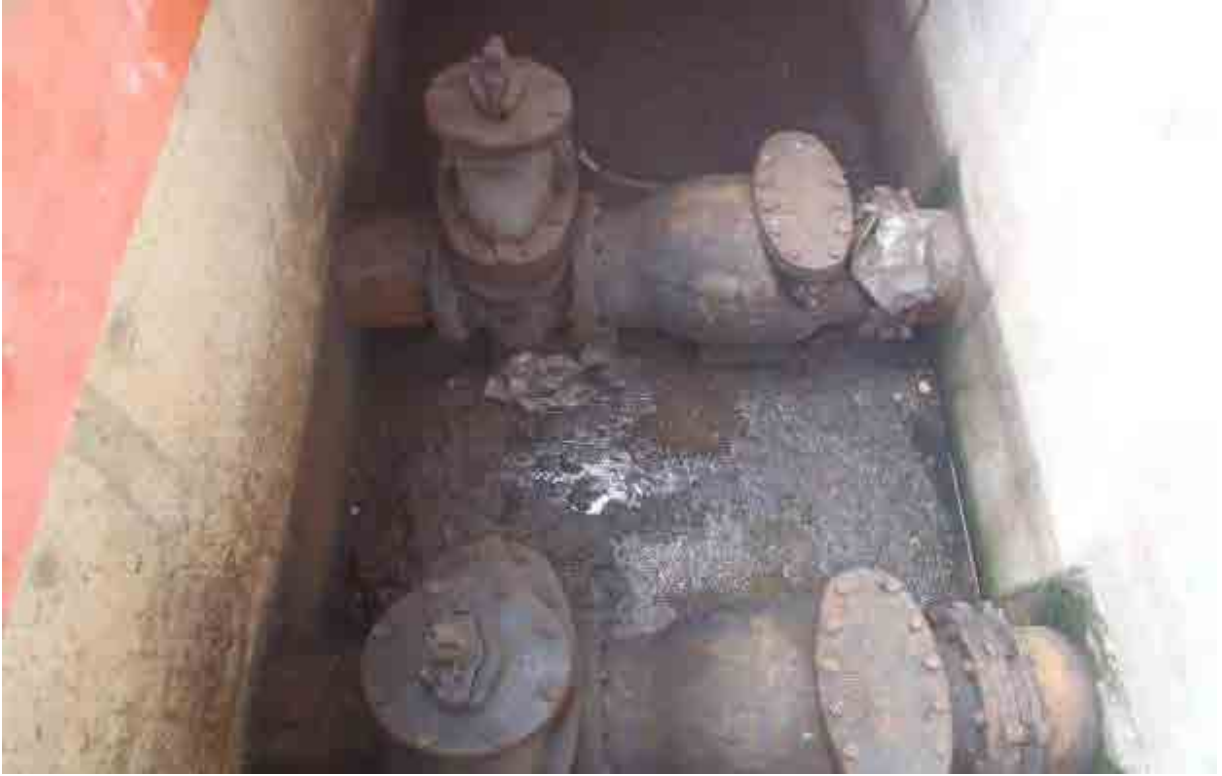
2d. Crack condition; no cracks

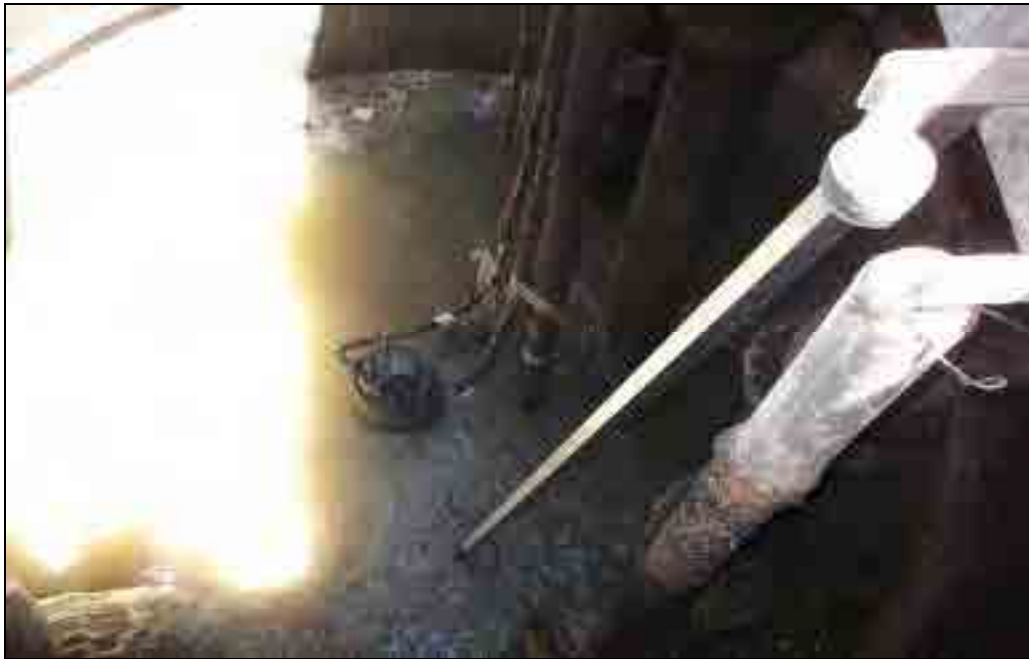
1b. Pump Pit Leakage Condition; Not many leakages

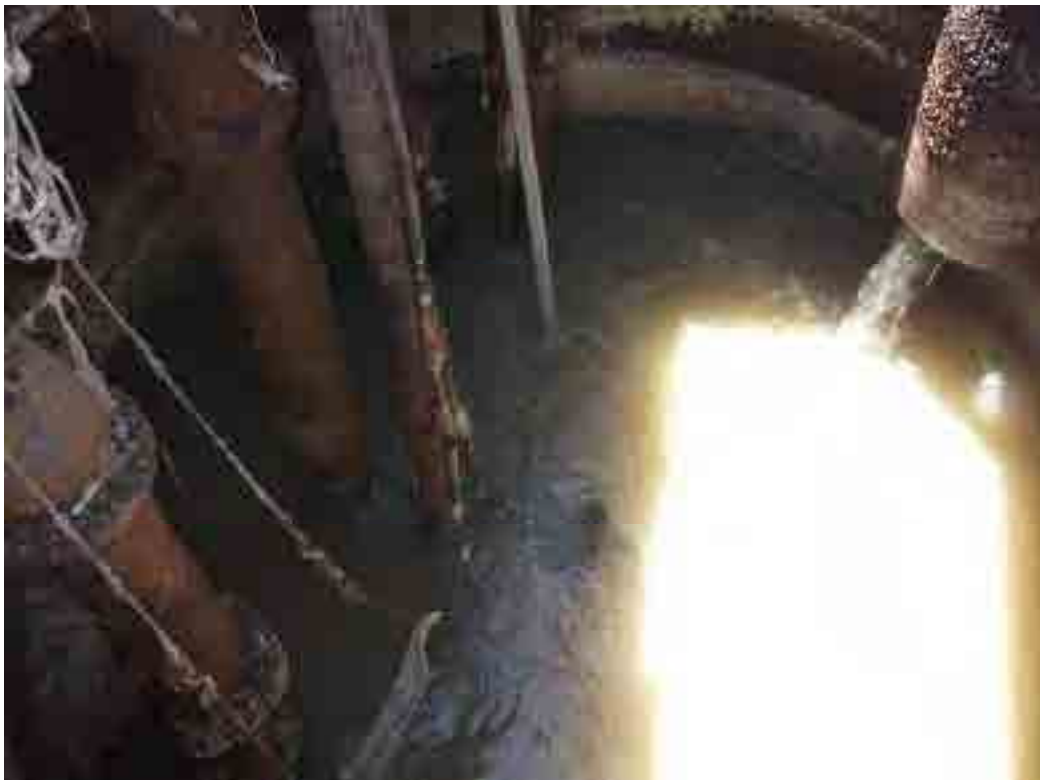
The Steel Pressure Pipes clearly shows corrosion or rust taking place as it is very close to the shoreline. Opening a Steel Pressure pipe would be impossible due to the severe corrosion.

1d. Corrosion Check; All Steel Pipes badly corroded.

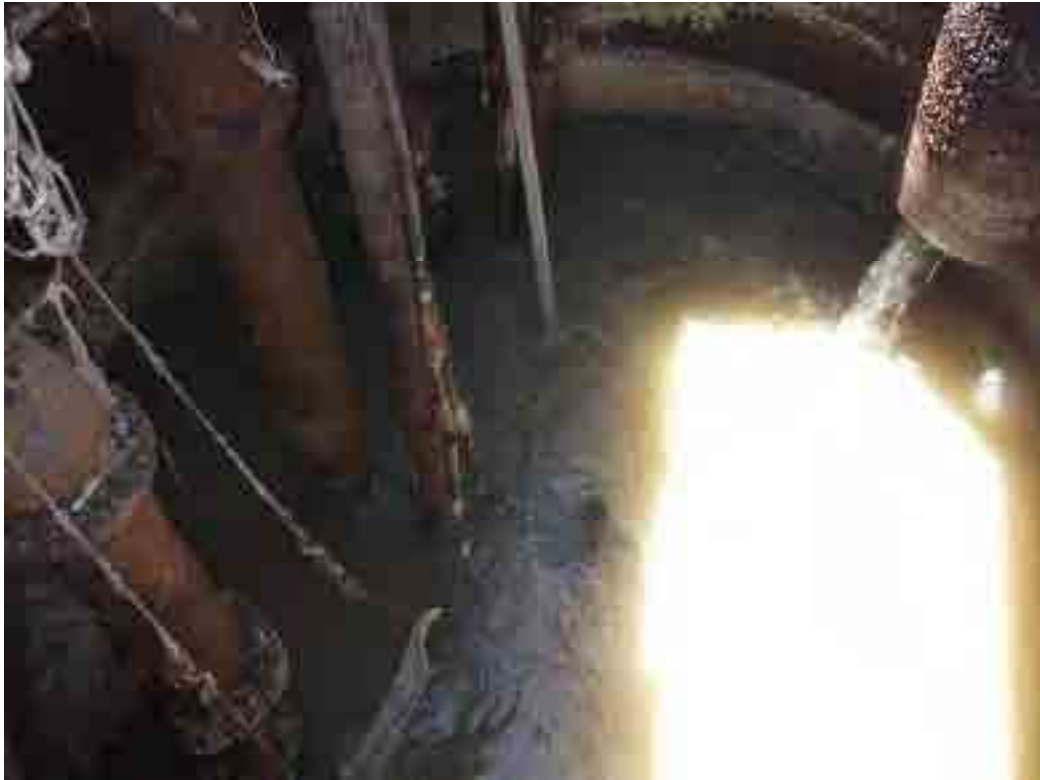
There are small cracks on the concrete walls of the pump pit.

1e. Crack Condition; Cracks can be seen in the background left

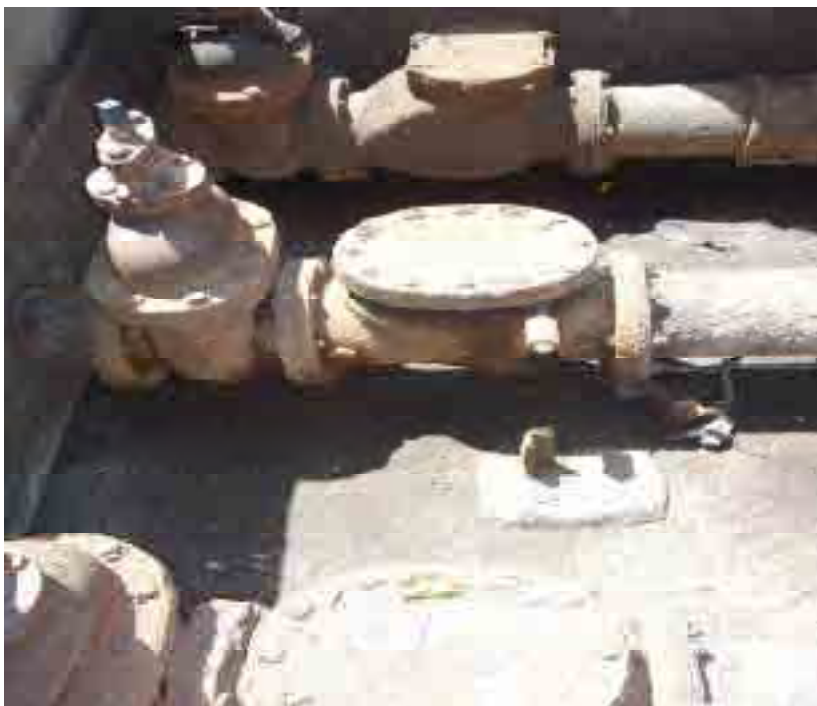
2a. Valve Pit Leakage Condition; not many leakages

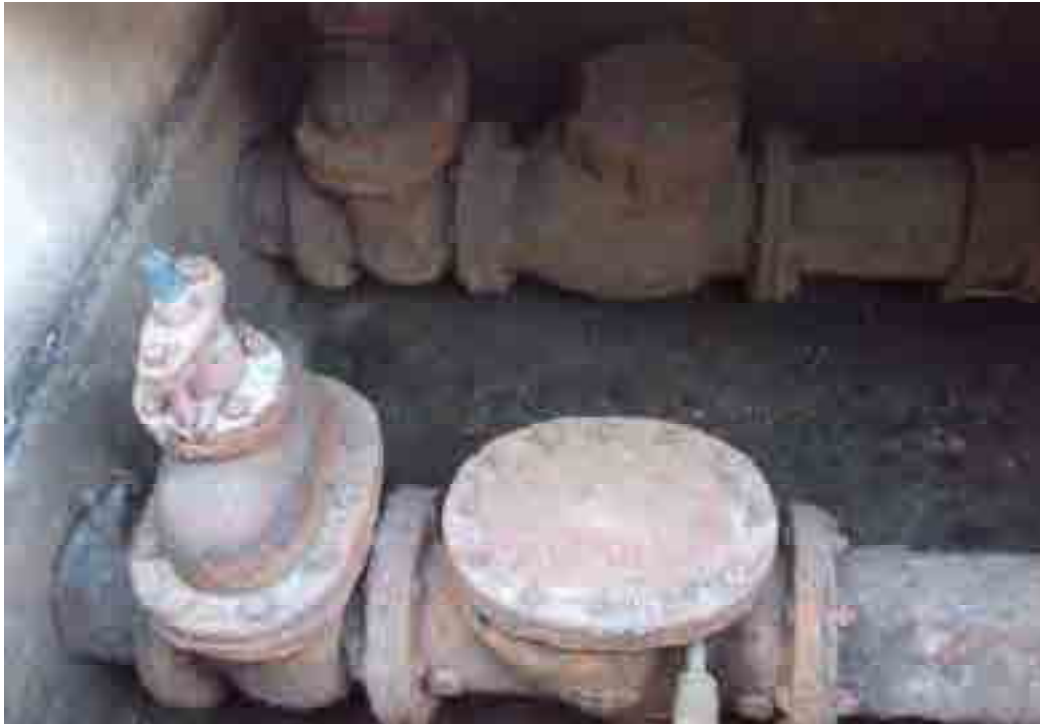
The pressure pipes in the Valve pit are severely corroded.

2b. Corrosion condition; Steel Pipes severely corroded.
