4. Existing Facility Survey

SURVEY REPORT – MANHOLE PICK UP

Survey Report: Manhole Pickup

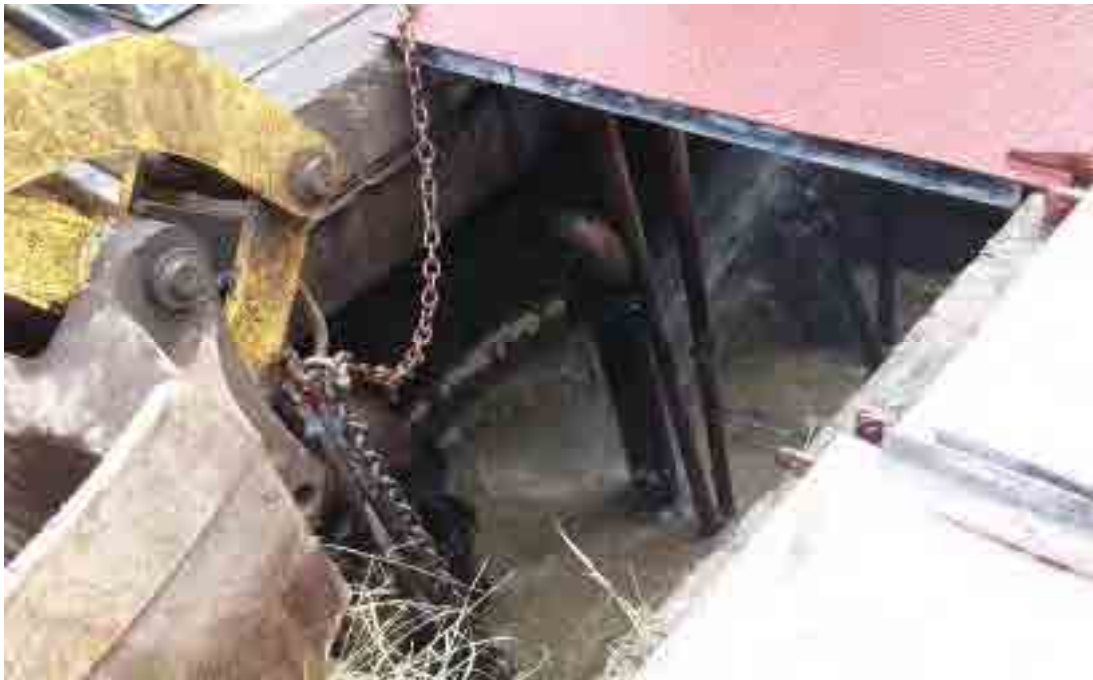
1b. Leakage Condition; not many leakages along the pressure pipes

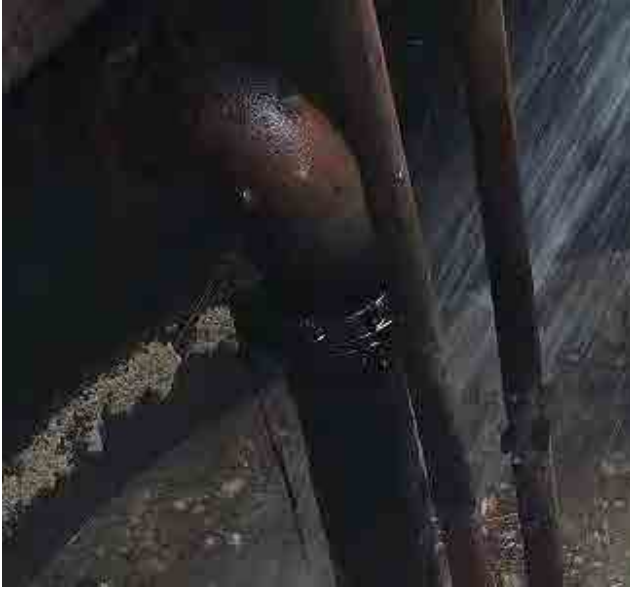
1c. Corrosion Condition; medium level of corrosion occurring on steel pipes

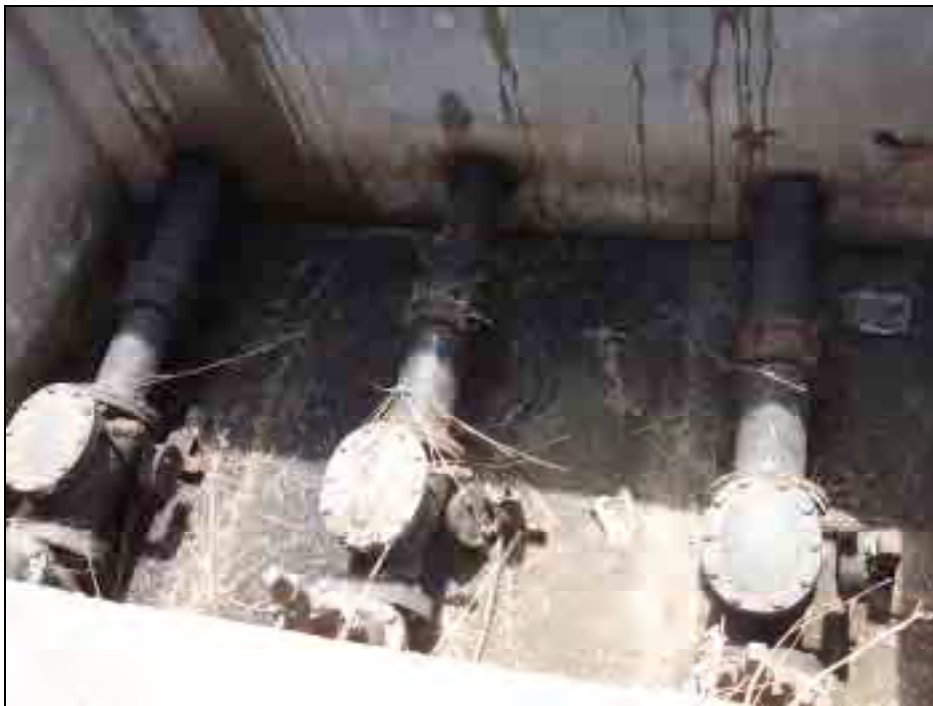
2a. Leakage condition; No major leakage at all

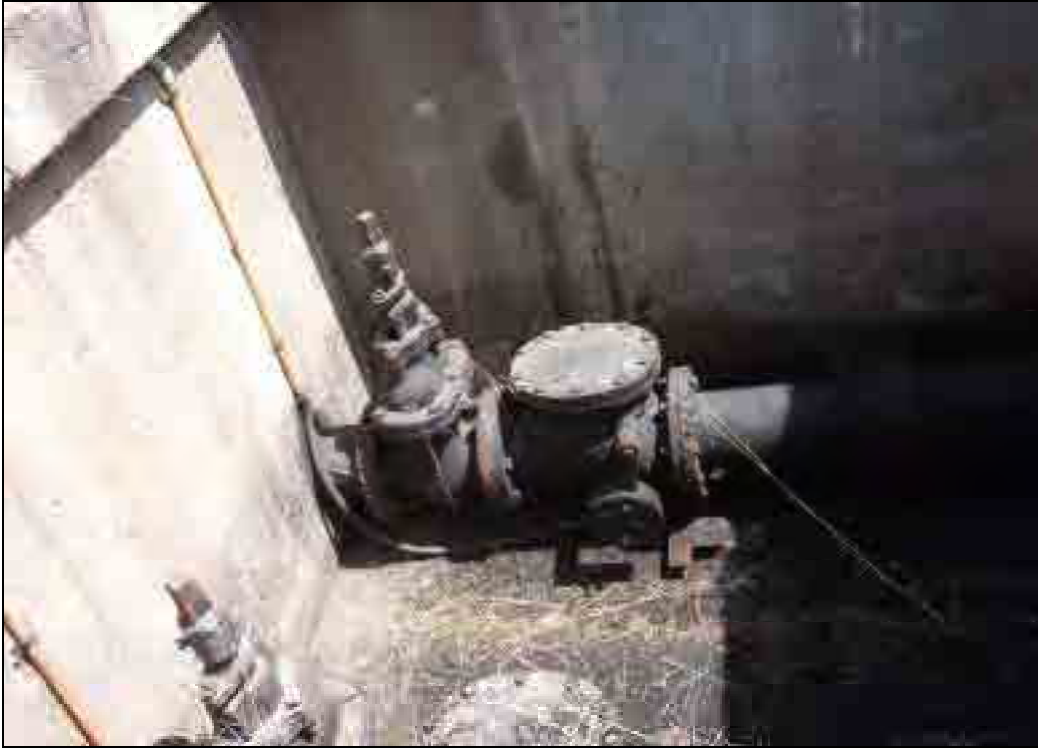
2b. Corrosion Condition; not much corrosion, Crack condition; not much cracks

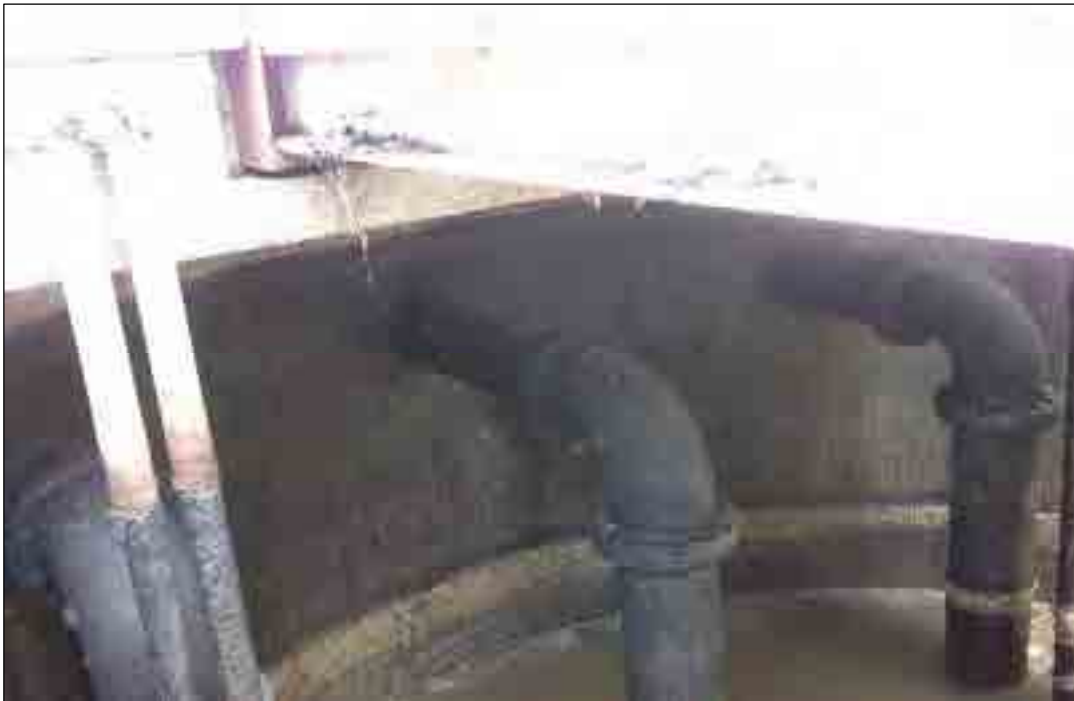
1b: Pump Pit Leakage Check; Not many leakages.

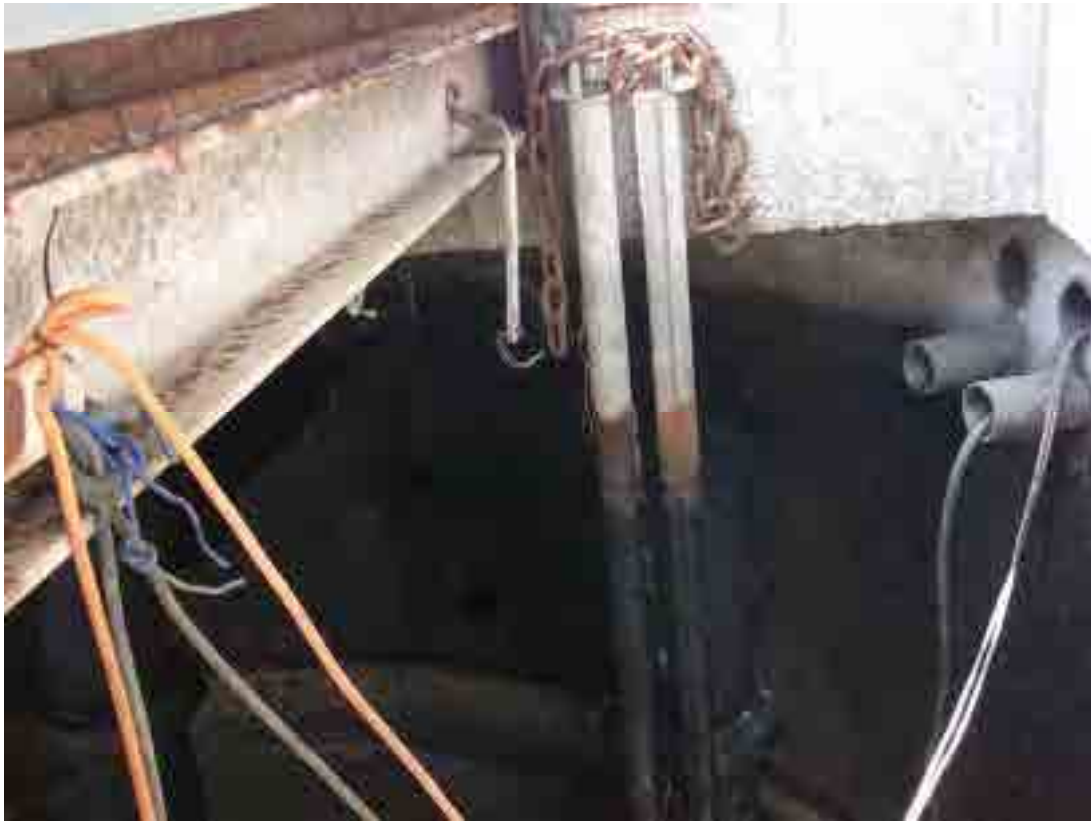
1c. Steel Rod Exposed; Corrosion not severe but starting

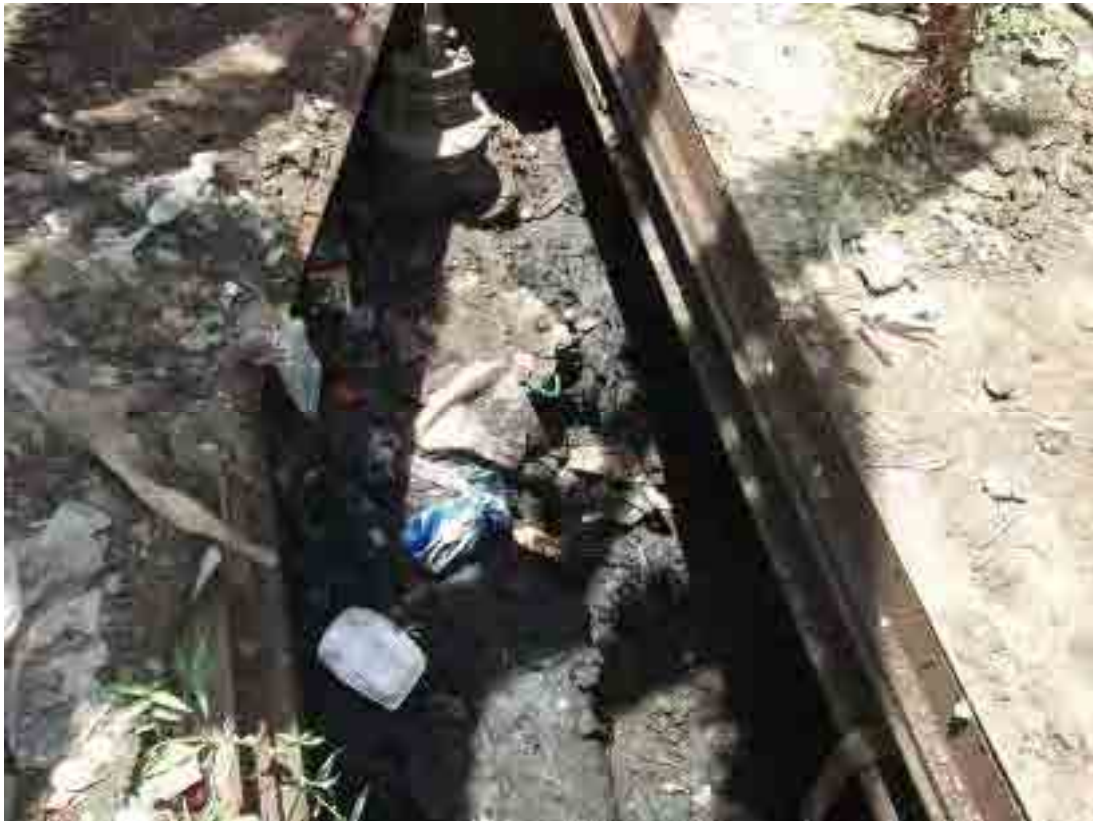
2b. Valve Pit covered with debris and rubbish

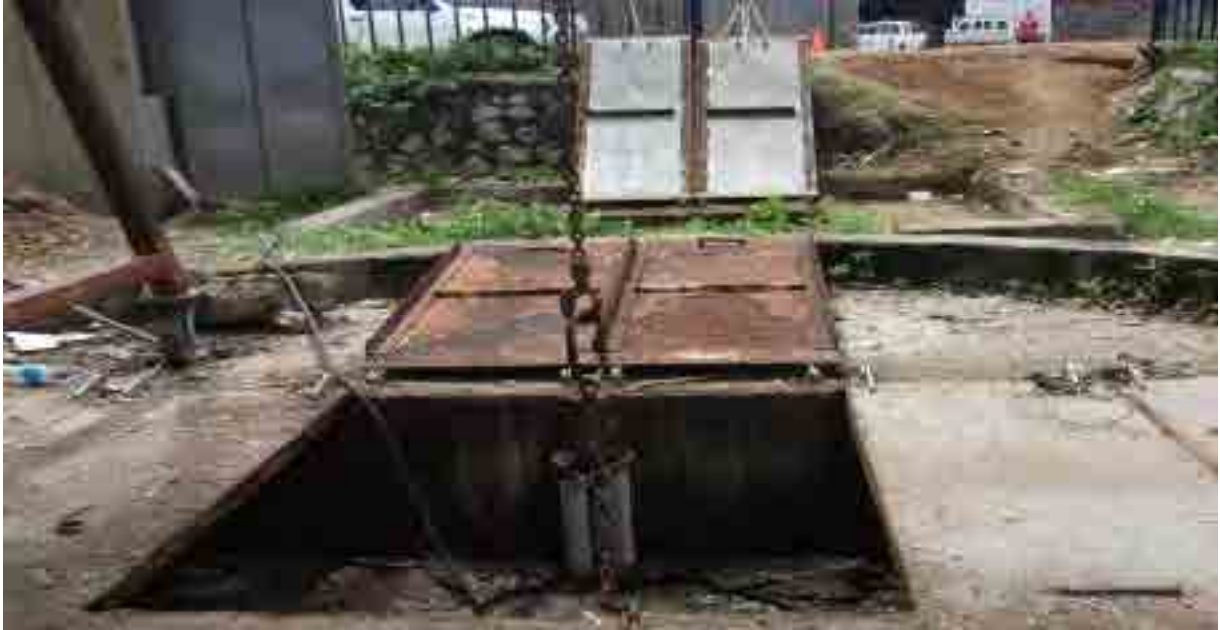
1b. Leakage Condition: there are no leakages

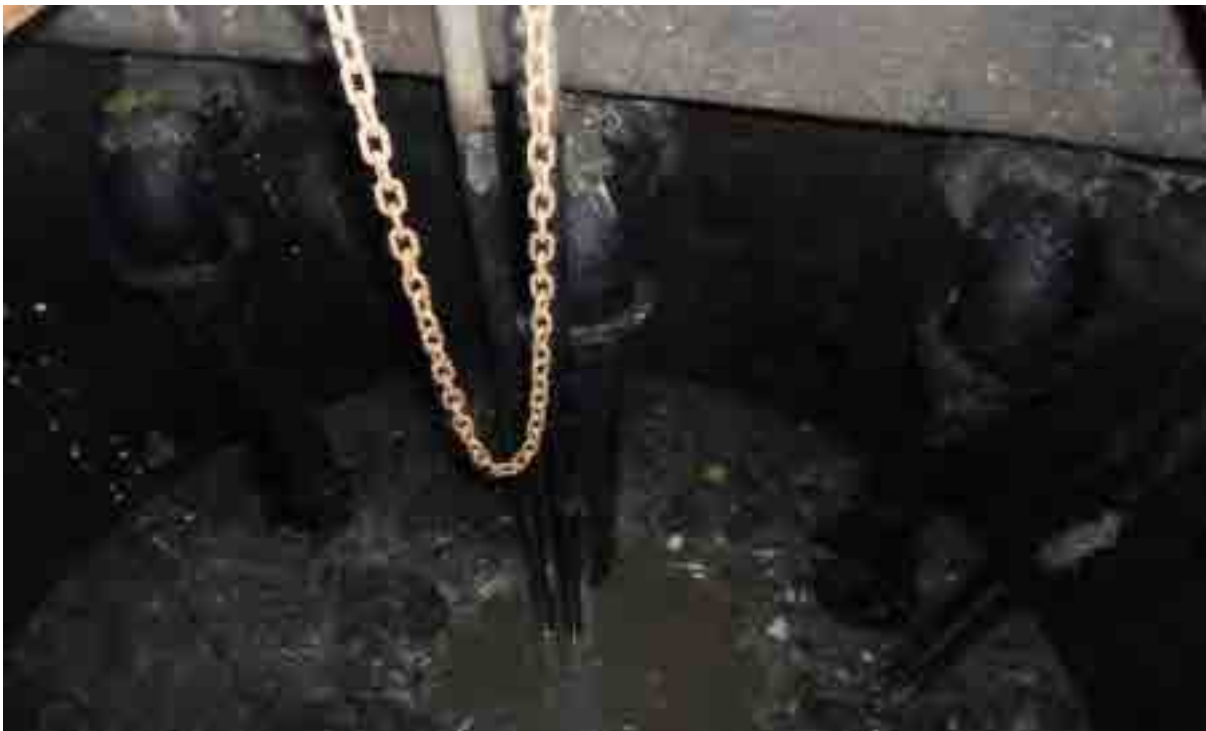
1c. Corrosion condition; medium level of corrosion

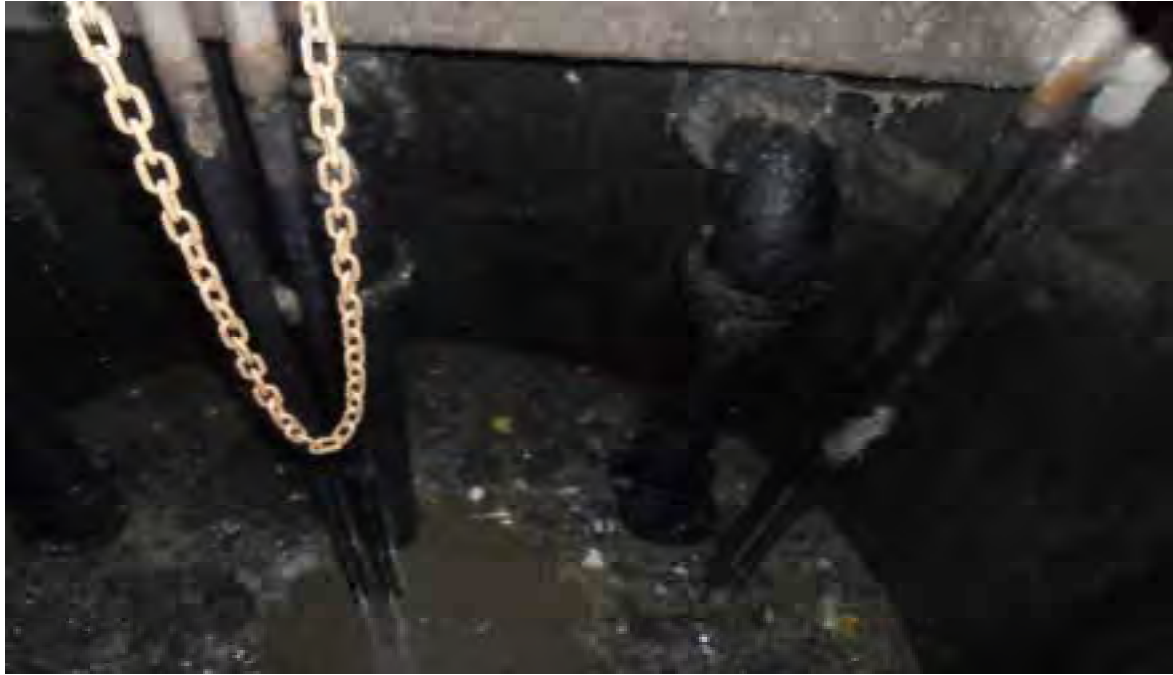
1d Crack condition, no cracks

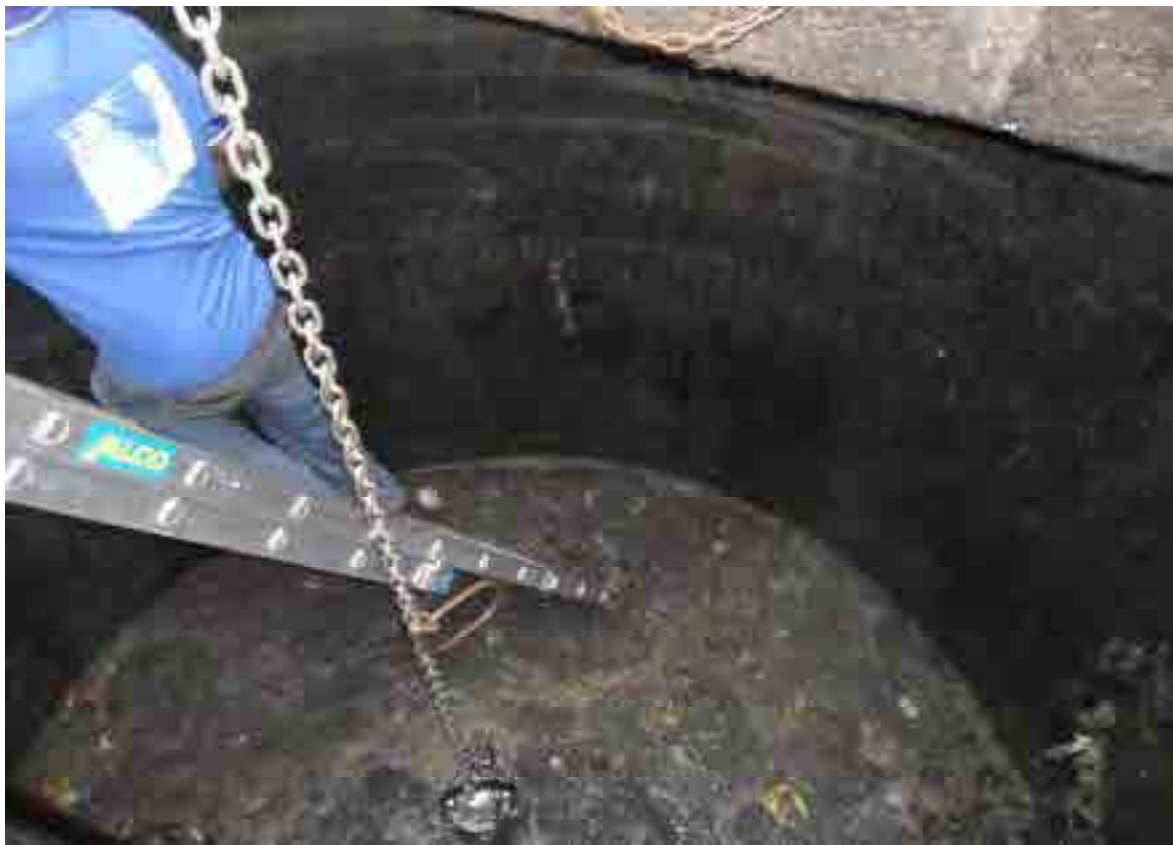
2a. Leakage Condition; no leakages

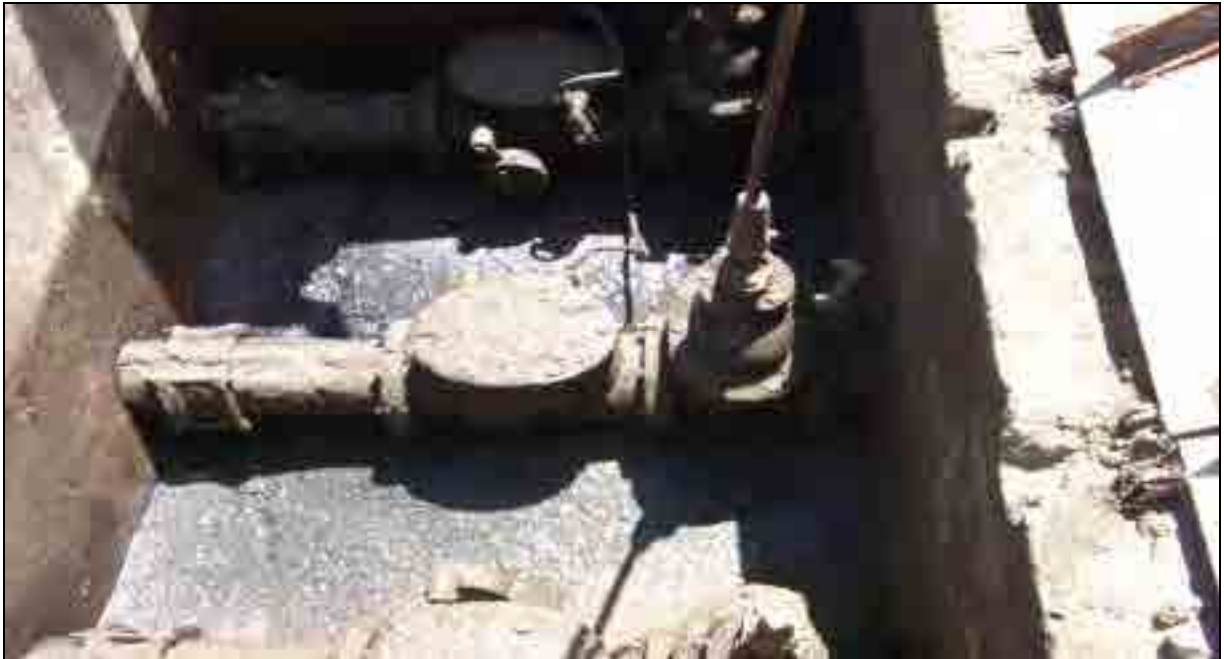
2b. Corrosion condition; medium level of corrosion occurring on steel

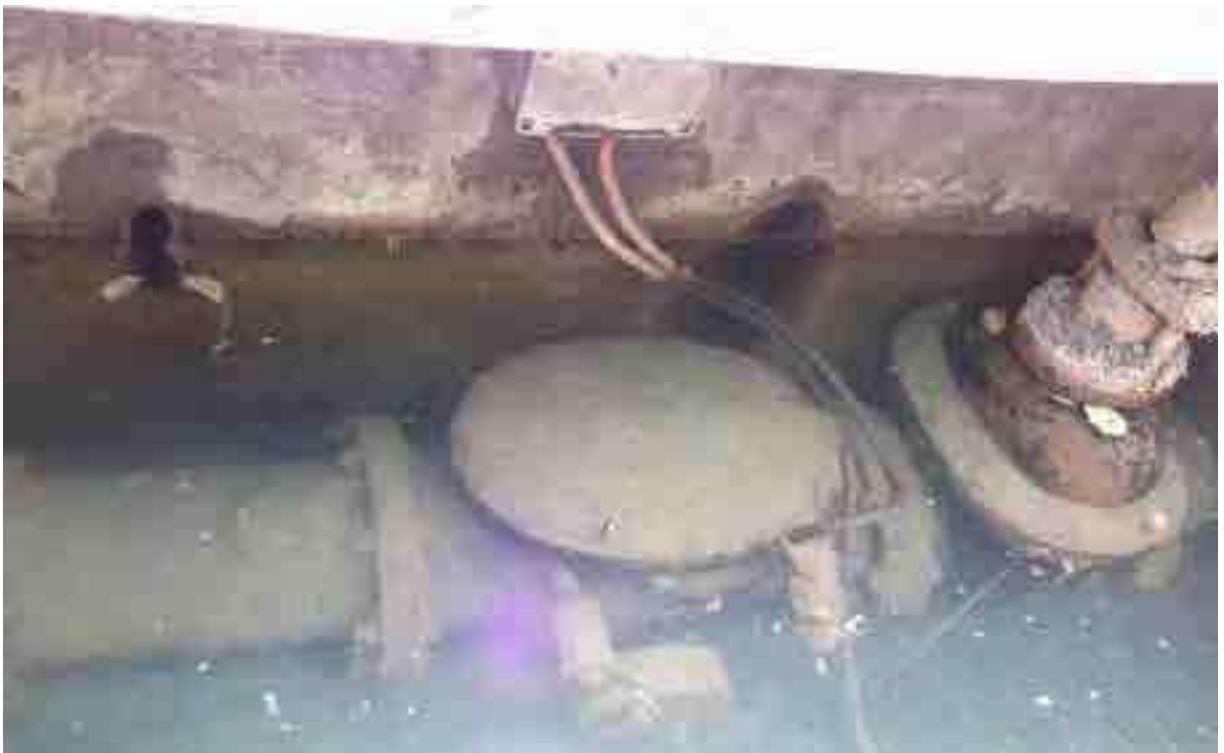
2c. Crack Condition; not many cracks.

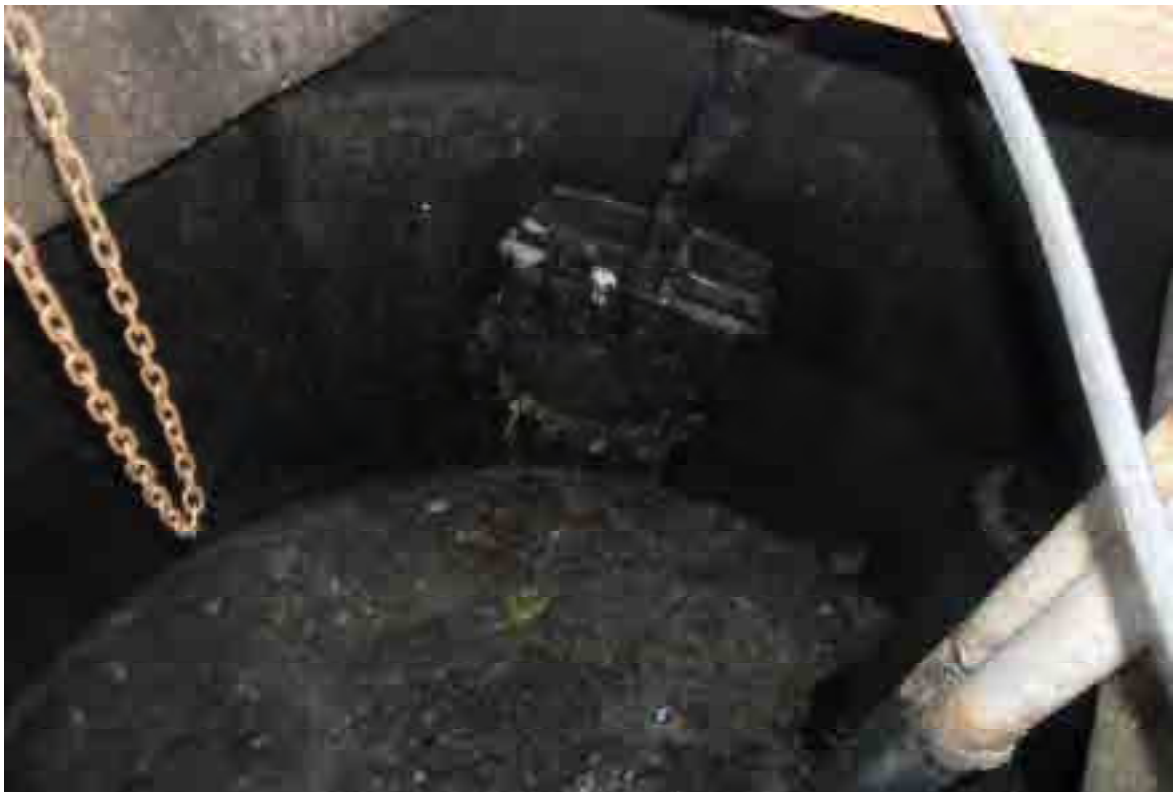
3b. Inflow Pipe 2; blocked Pipe. Diameter is 250mm.

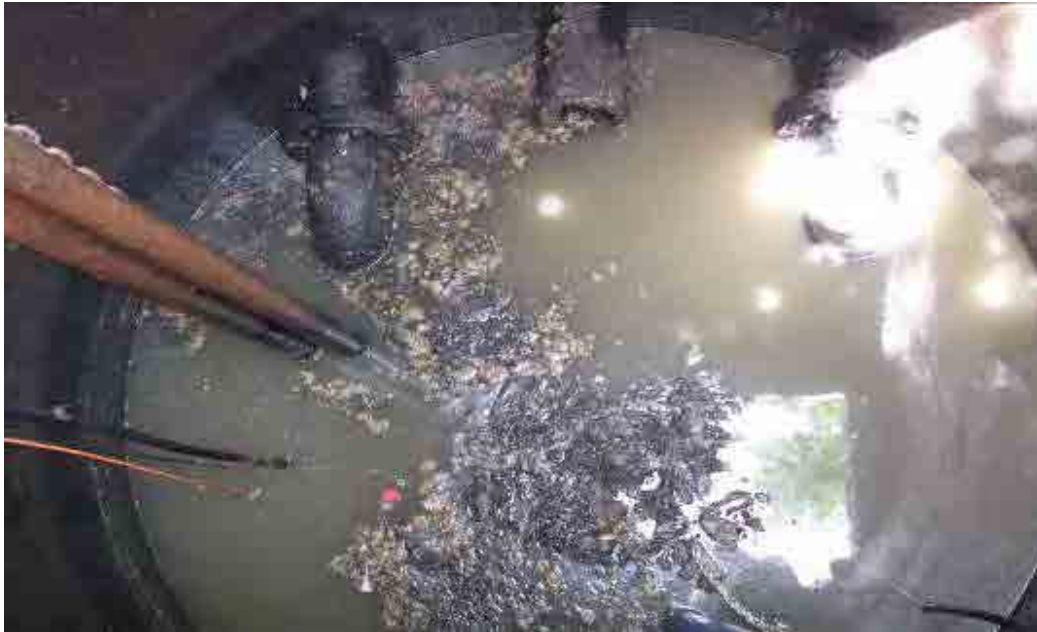
1a. Pump pit leakage Condition; there could be leakages below, middle pipe is spare pipe. Corrosion condition; Corrosion is occurring on steel pipes.

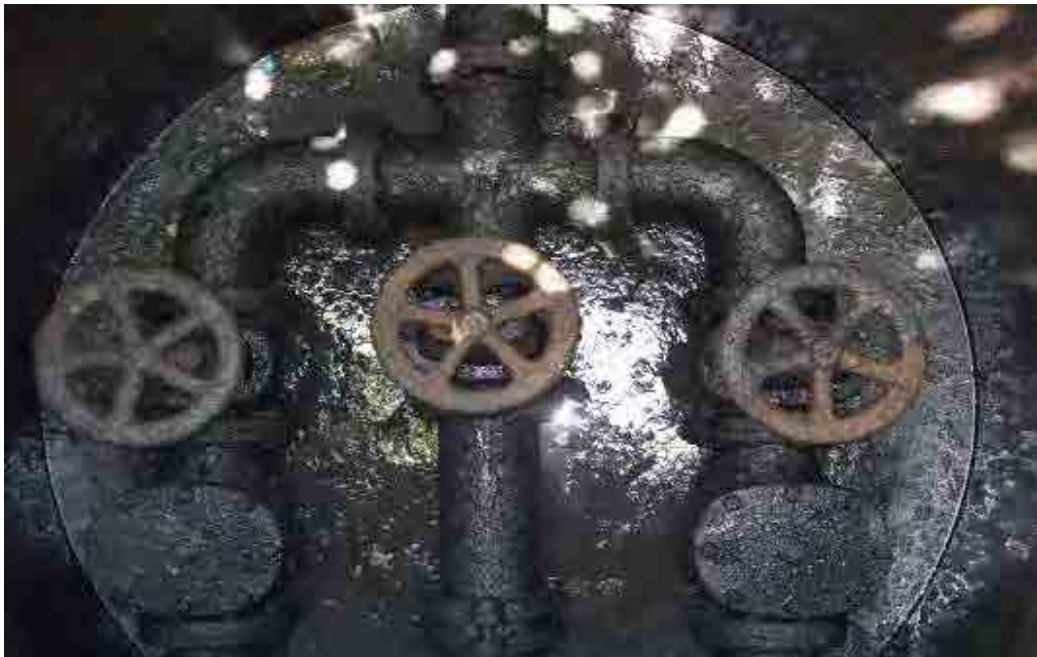
2a. Leakage condition; there is leakage in the valve pit

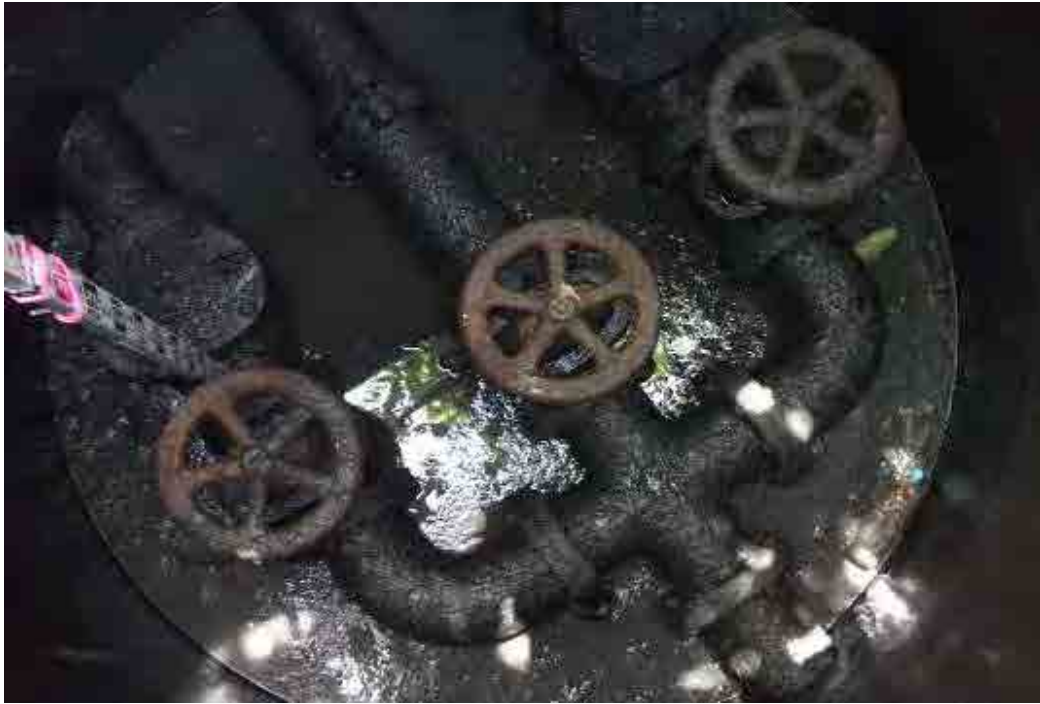
2b. Corrosion condition; there is corrosion in the valve pit steel pressure pipes
3.0 Manhole in front of one
