PHOTOGRAPHS OF WORKS EXECUTED

## 6.6 物理探查結果

## 1. 調査数量

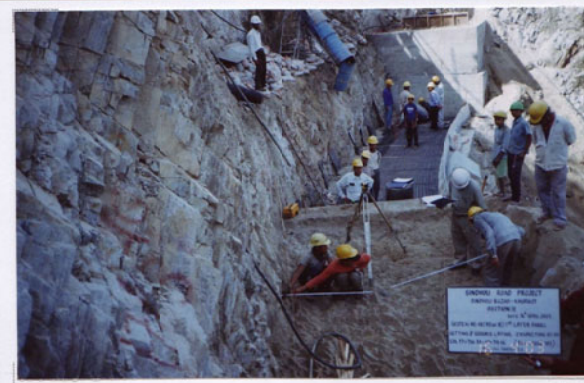
**Photo No. 15**  
**DATE :**  
 16 April 2003  
**DESCRIPTION :**  
 Reinforced Earth Wall  
 1st Layer Panel Setting, Geo Grid Laying & Gabion Bedding Inspection by the Consultant  
**LOCATION :**  
 Sta. 17+706-17+719

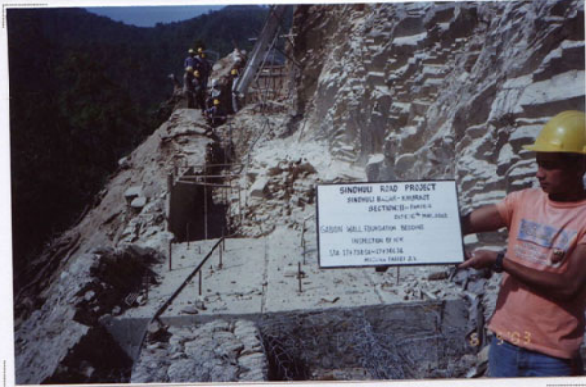
Photo No. 19

DESCRIPTION :  
Gabion Wall Foundation  
Bedding Inspection by the  
Consultant

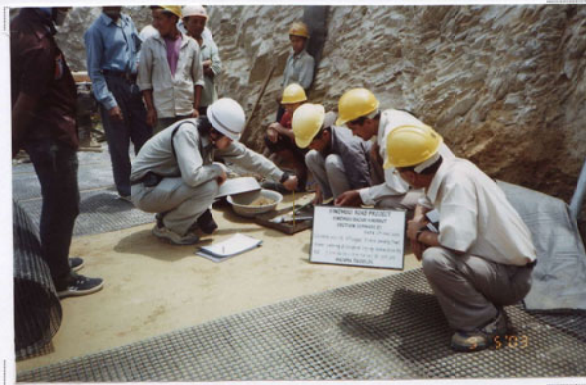
Photo No. 20

DESCRIPTION :  
Reinforced Earth Wall - B  
8th Layer Field Density  
Inspection by the Consultant

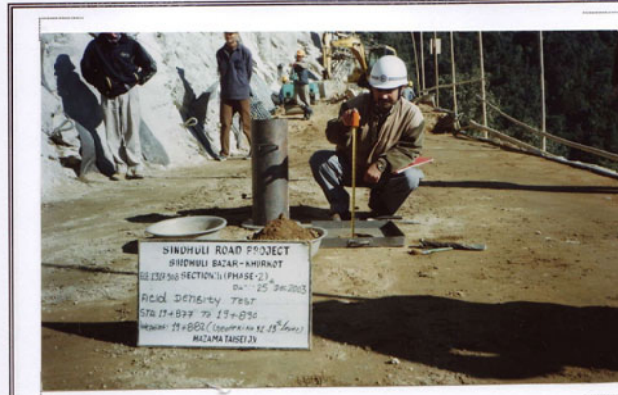
**Photo No. 25**  
**DATE :**  
 25 December 2003  
**DESCRIPTION :**  
 Reinforced Earth Wall - "B" Field Density Inspection by the Consultant  
**LOCATION :**  
 Sta. 19+877-19+890

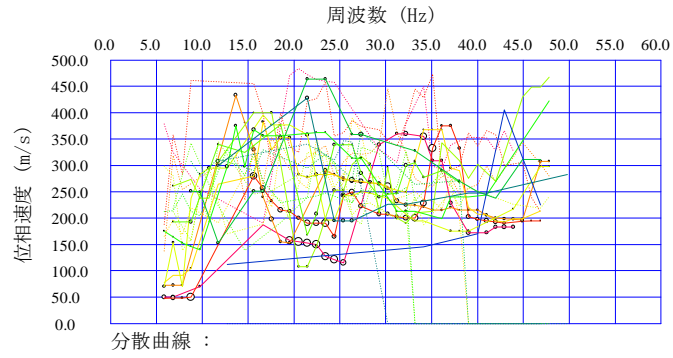
図-2.5-3 STA. 17+600 1測線 分散曲線

図-2.5-3はSTA. 17+600地区1測線の分散曲線である。ほとんどノイズであり解析不能である。

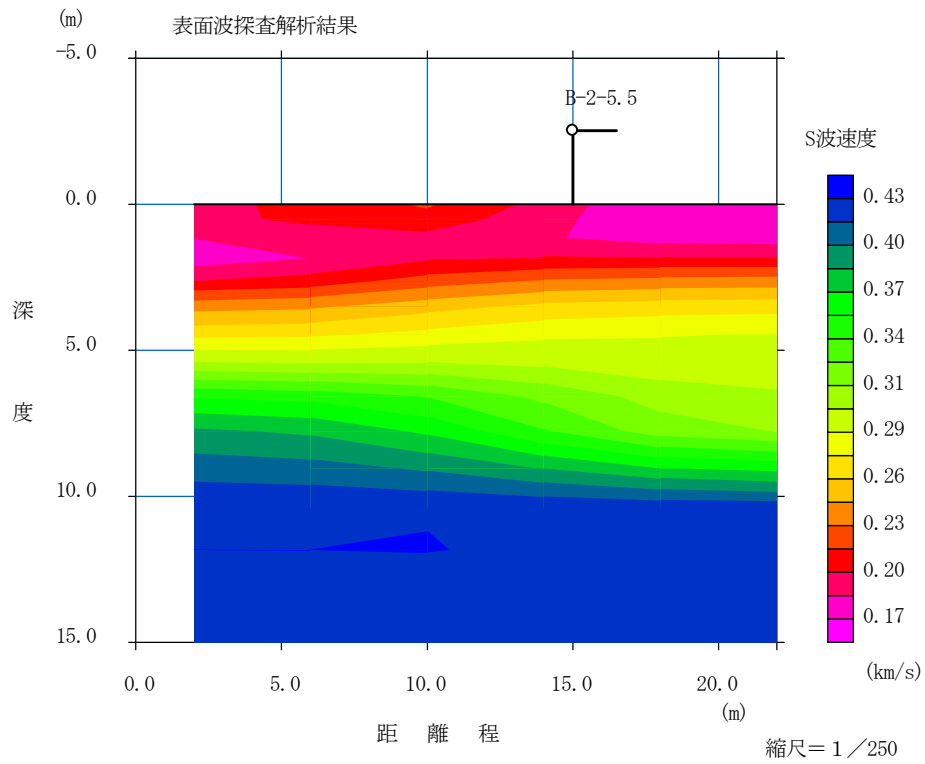
図-2.5-4 表面波探査解析断面図 2 Line

2測線は比較的ノイズが少なく、解析することができたので次に示す。

深度約10m付近より風化岩と考えられる。後に示す弾性波探査との結果と比較するとほぼ一致している。次項に表面波探査の位相速度曲線（分散曲線）を示す。

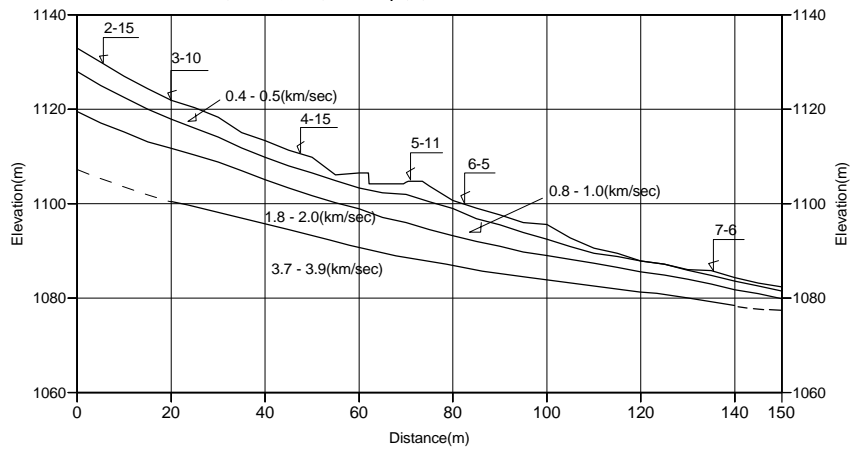
図 弾性波探査解析結果 B-2 Line

第1速度層は、B-2測線の起点側（崩壊地の上方）では深度約4mであるが、下方になるに従って徐々に薄くなり、距離程120m付近でほとんどなくなる。風化岩までの深度は、起点側で深度約10m、終点側で約深度3mとなっている。B-2測線の起点より上方の1測線は、2測線とほぼ同じ深度となっている。

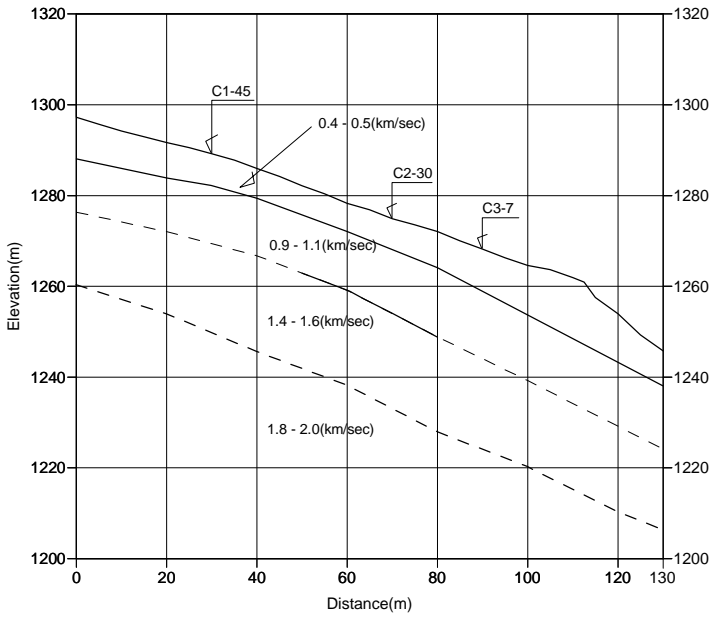
弹性波探查解析结果 C Line

本地区は第1速度層及び第2速度層が厚く分布しているため、解析時にハギトリ作業ができず、第2速度層はC測線の約50m~80mを除いて深度は推定となる、また、第3速度層及び第4速度層も推定深度となる (解析断面図には破線で表示)。

本地区は表層に巨礫のある個所がみられる。しかし第1速度層が尾根部でおよそ8mの深度に達しており、第2速度層の層厚もおおよそ12mとなっている。第3速度層は礫から風化岩までの漸移帯と考えられ、層厚は約20mと推定される。
