List of Field Survey Results (1/3)

List of Field Survey Results (2/3)

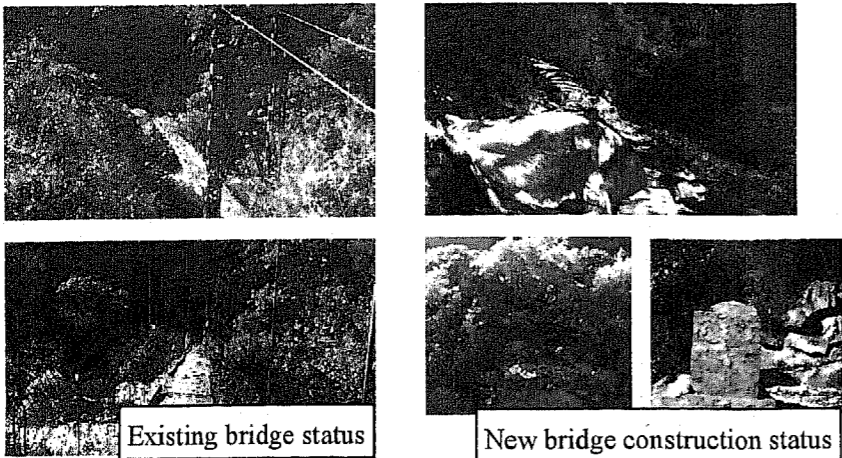
<p>Existing bridge status</p> <p>New bridge construction status</p>

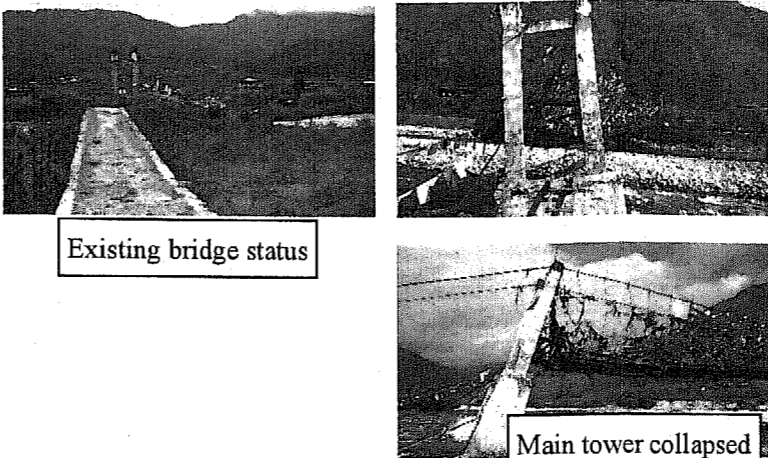
<p>Existing bridge status</p> <p>Main tower collapsed</p>

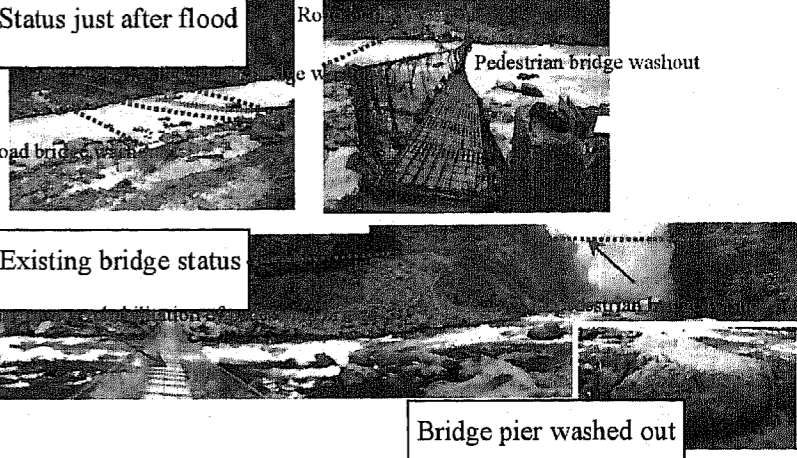
<p>Status just after flood</p> <p>Road bridge</p> <p>Pedestrian bridge washout</p> <p>Existing bridge status</p> <p>Bridge pier washed out</p>
Schematic plan view

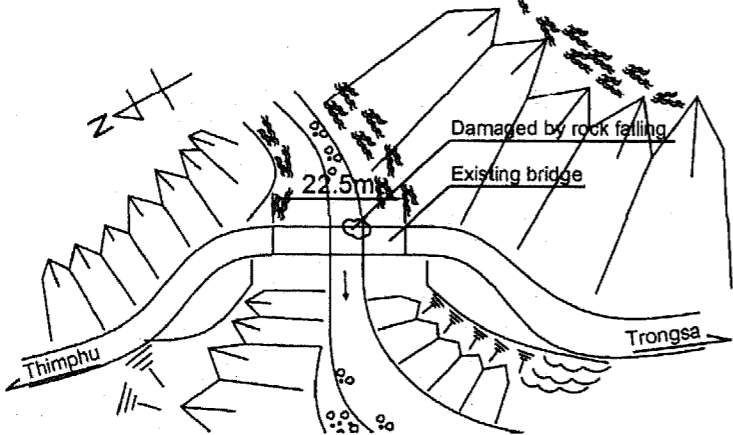
Bridge status quo	Damage to the truss main structure and the steel slab of the existing bridge due to fallen rocks have been confirmed.	Signs of scouring have been confirmed on the bridge abutment protections.	Distortion has been confirmed in the long span length. Signs of scouring have been confirmed on the bridge abutment protections.
Access road status	This is a bridge on National Highway No.4, and the access roads on both ends are open to traffic.	This is a bridge on National Highway No.5, and the access roads on both ends are open to traffic.	This is a bridge on National Highway No.5, and the access roads on both ends are open to traffic.
Importance of route	This national highway connecting Gelephu and Trongsa is relatively important.	This route connecting Gelephu, Wangdi, and Thimphu (capital) is exceedingly important as it is the route for transporting supplies to the Punatshangchu hydropower project and is related to the second east-west highway in southern Bhutan.	This route connecting Gelephu, Wangdi, and Thimphu (capital) is exceedingly important as it is the route for transporting supplies to the Punatshangchu hydropower project and is related to the second east-west highway in southern Bhutan.

Possibility of damage from similar floods	There is sufficient vertical clearance, and there is a low possibility of damage if an abnormal flood occurs.	The existing bridge has blocked the river section, and signs of washout of a bridge with an equivalent span have been confirmed. Therefore, there is a high possibility of damage if an abnormal flood occurs.	The distance between the bridge abutments and piers (span length) is short. Therefore, there is a high possibility of damage if an abnormal flood occurs.
