(7) Myaungmya Br.

(9) Panmawaday Br.

4. Field survey: Expressway structures (river bridges, interchange bridge, etc.)

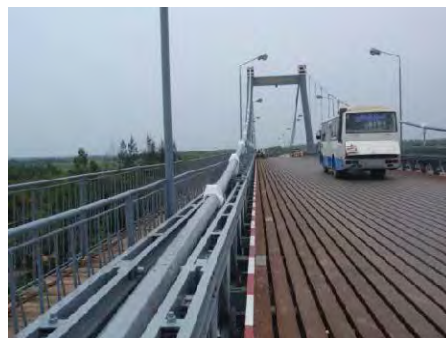
Situation of main cable

- A re-wrapping has been constructed.

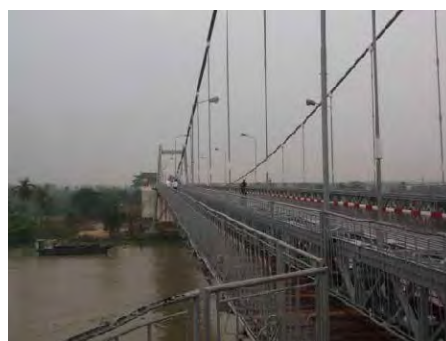
Pavement part: Board fence

- The board comes off easily.
- A part of balustrade levee crown raggedly : due to corrosion.

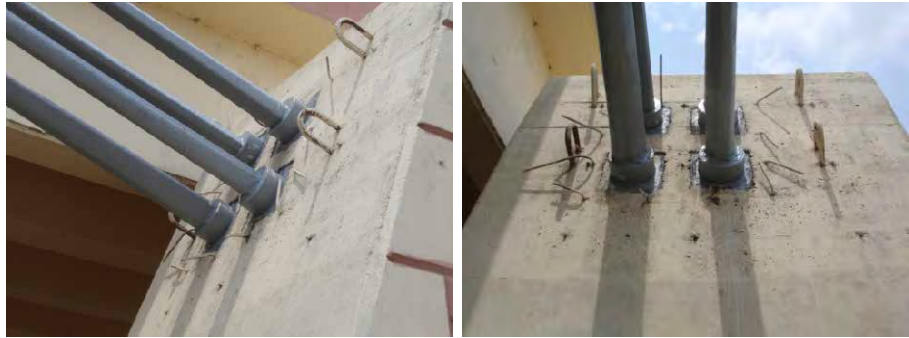
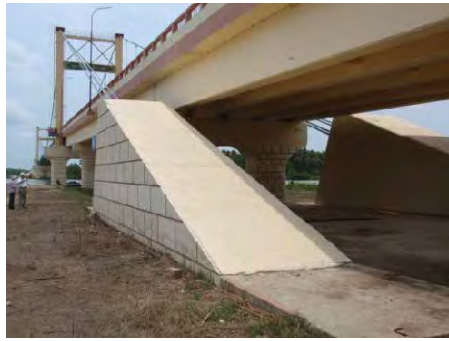
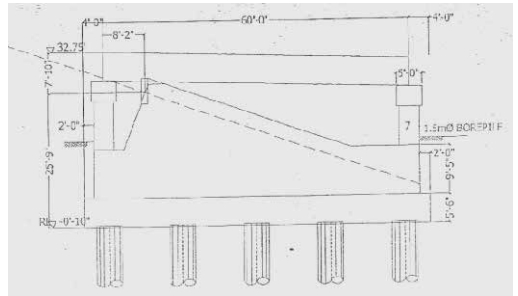
Situation of anchorage

- Neither damage nor the crack

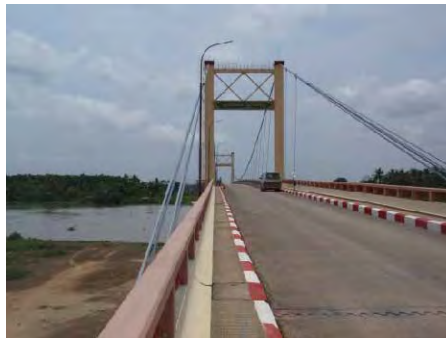
Expansion apparatus on anchorage

- An abnormal neither opening nor blocking

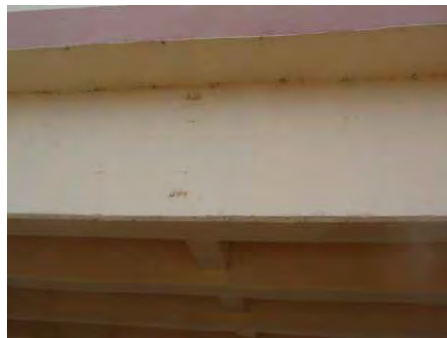
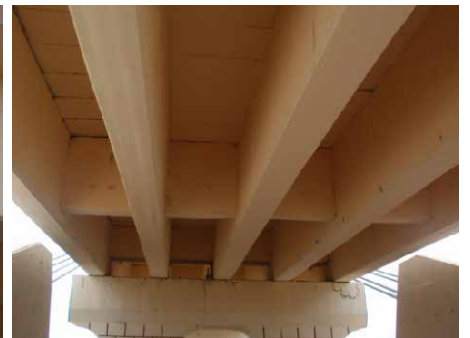
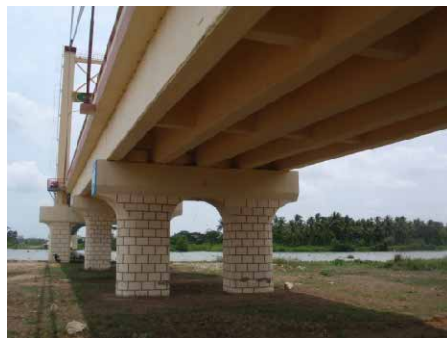
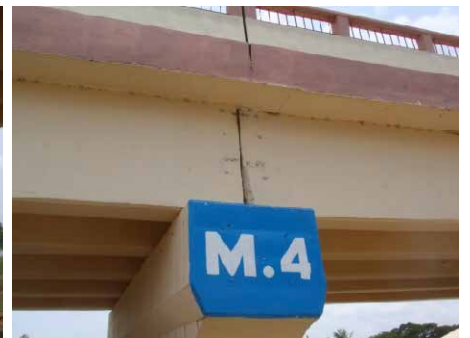
Approach girder (PC girder)

- Remarkable damage is not seen by the main girder and the deck slab.
- Horizontal girder (RC) : no prestressed concrete

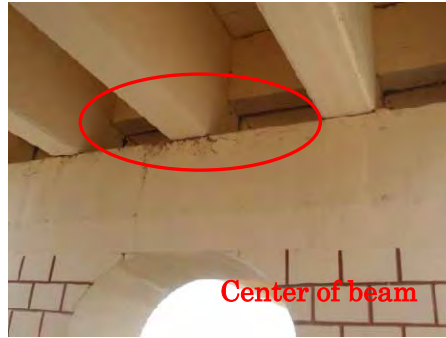
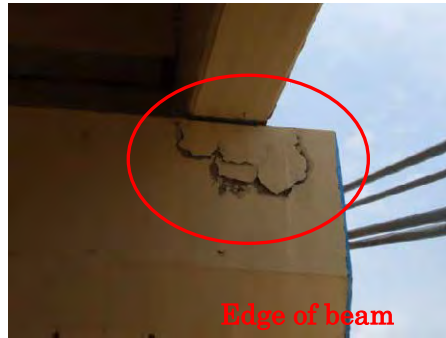
Pier of approach girder

- Concrete painting right under the main girder (beam) of the M3 pier starts peeling off.

(There is a possibility about the crack can be made by anchorage moving).

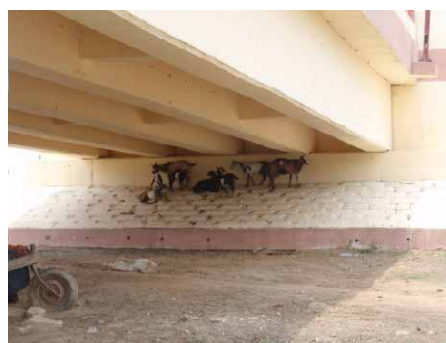
Bridge abutment

- Neither special steps nor damage are seen.

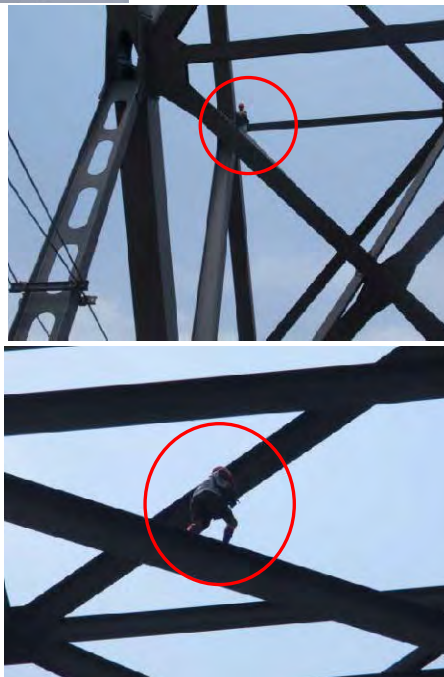
Situation of inspection work

- The life rope was no prepared.

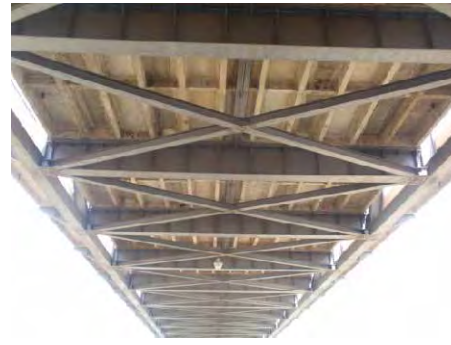
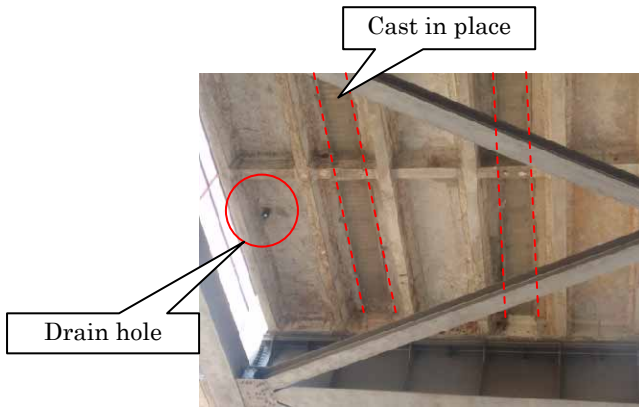
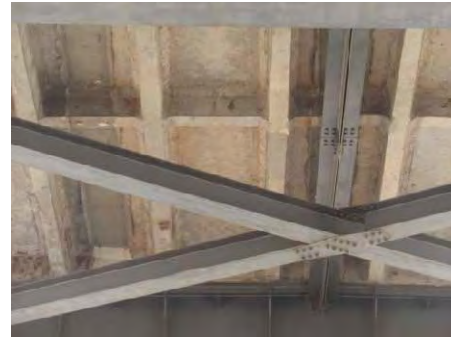
Situation of Deck slab (main bridge)

- Precasting RC deck slab
- The truss horizontal girder interval is about 4m. (from PW interview)
- In the external check, remarkable damage is not observed.

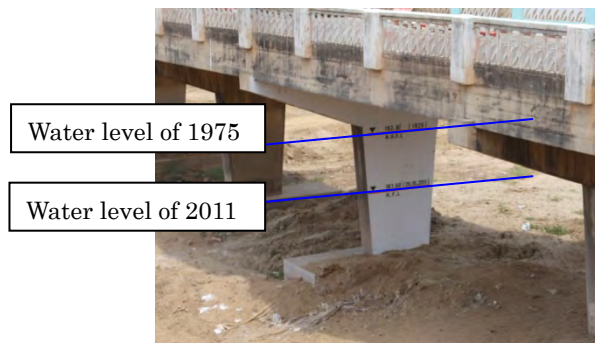
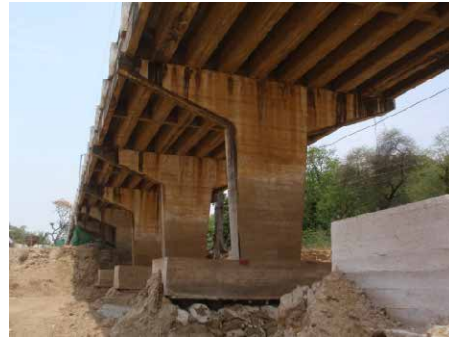
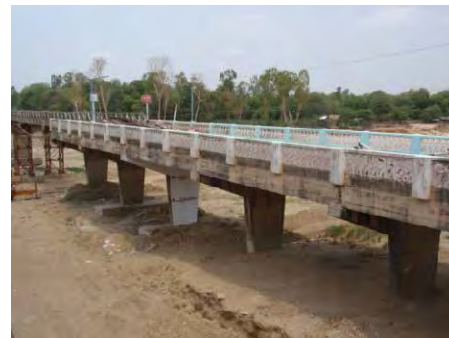
Parameter of old bridge

- RCI girder structure
- The thickness of the pier wall of an old bridge is about 60cm.

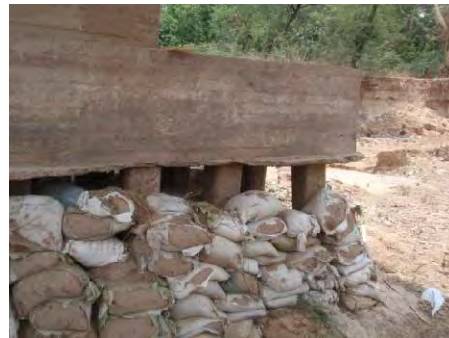
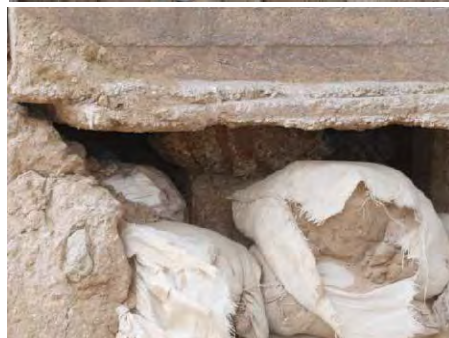
Situation of pile head of old bridge

- The stake is RC stake (rectangle).
- The reinforcing bar of the pile head rust and is bent.

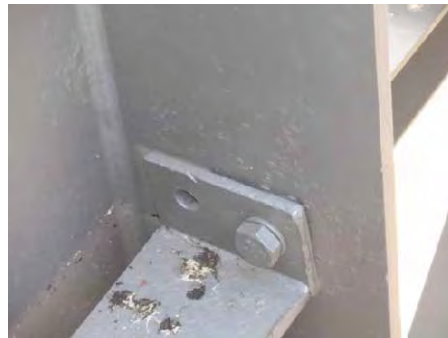
Situation of joint part

· There is a part where the bolt is missing.

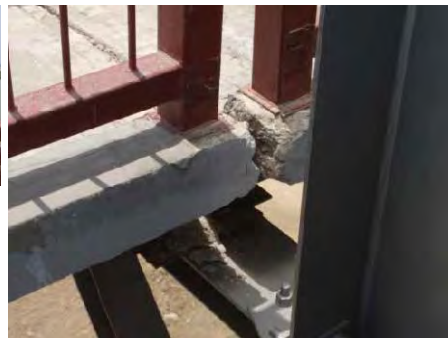
Deck slab of pavement

· There are some part where the edge concrete was dropped off

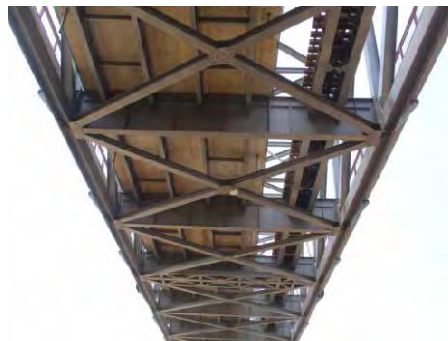
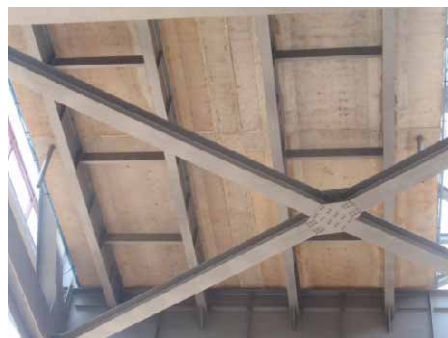
Situation of deck slab

· Remarkable damage is not observed.

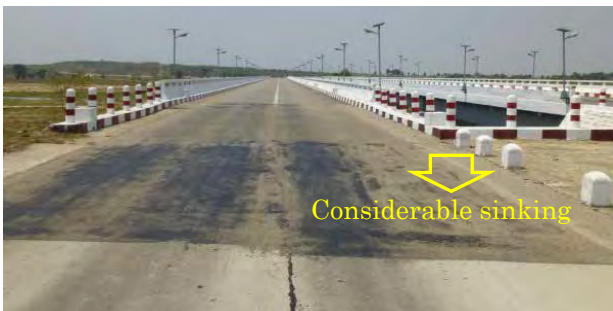
Road surface has sunk in backfill sections on the ends of bridges

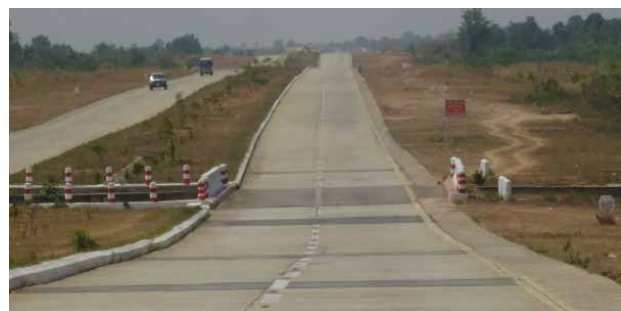
Sagging sections of road show severe damage
Concrete paving slabs exhibit nonuniform sinking

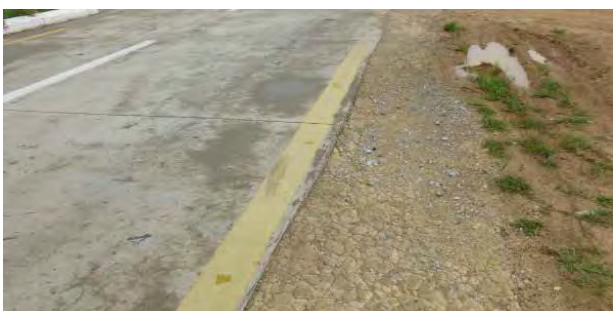
Shoulders constructed separately from carriageway
Damage is more severe than on carriageway

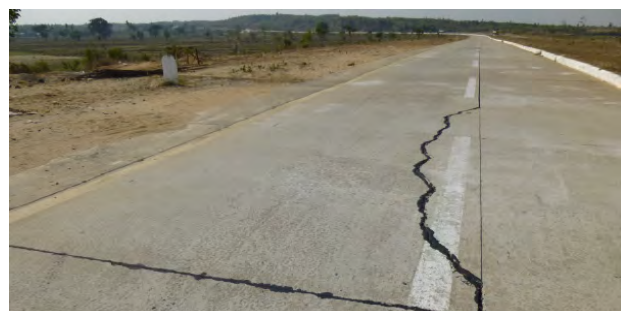
Numerous cracks run lengthways

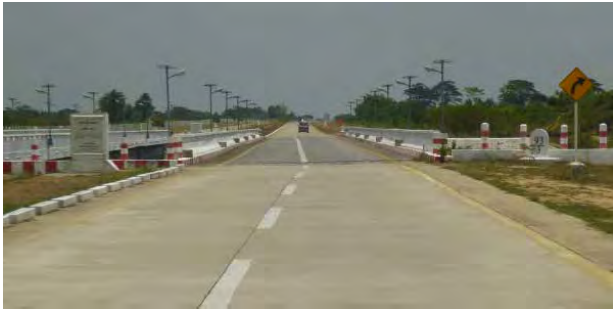
Abrupt a alignment of carriageway

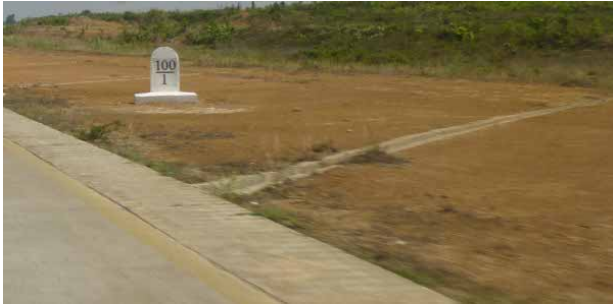
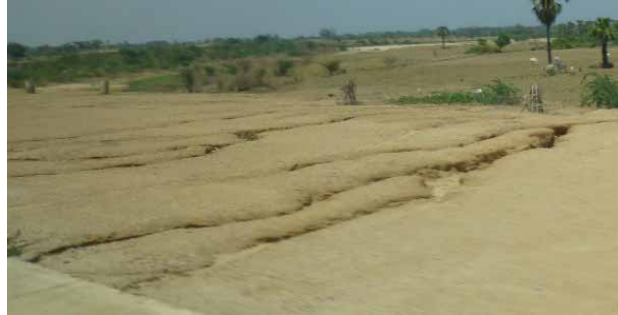
Conduit situation (In areas slated for future lane construction) Some areas with conduits are in relatively good condition However, in many sections without conduit on shoulders leads to severe erosion.

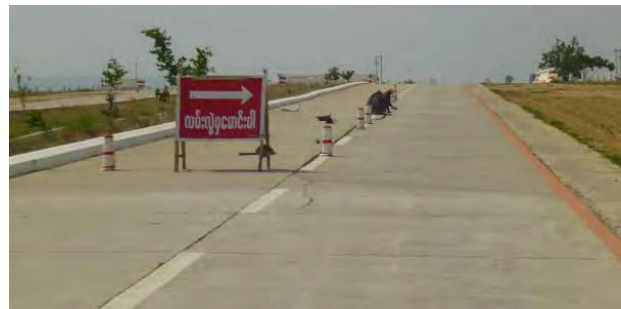
One lane closed due to re-painting work on central lane marker Worker is difficult to see, dangerous conditions.

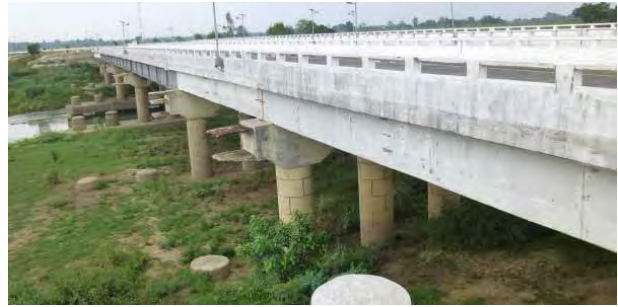
Near 51 miles 1 furlongs post

- In wide sections, steel bars of pier beams and pier bases are cured with concrete.
- Abutments are moving toward the river, meaning that the earthwork behind the abutments is loosening. The shift behind the abutments generates cracks in the pavement.

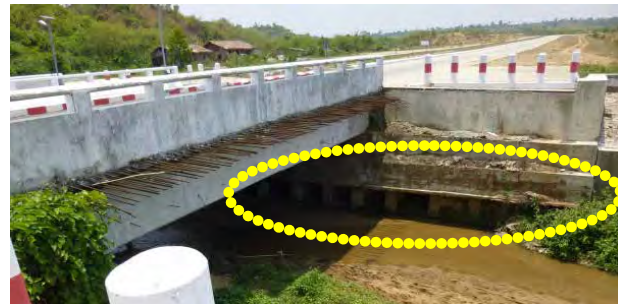
Scouring

- Steel beams of floor slabs for widening are protruding and not protected, therefore they are rusting.
- The riverbed has sunk drastically, exposing the abutment pilings and making the retaining wall foundation appear to float.
- The joints are butt joints where floor slab ends are fitted with angle bars, and rainwater easily seeps below the road surface.

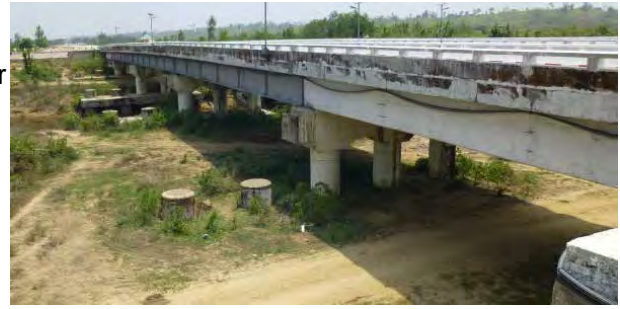
Near 67 miles 0 furlongs post

- In wide sections, steel bars of pier beams and pier bases are cured with concrete.
- Abutment has fallen and is interfering with the girder. This causes damage to the concrete paving.
- Stiffener for connecting parts, used during widening, is applied to the steel girder web.

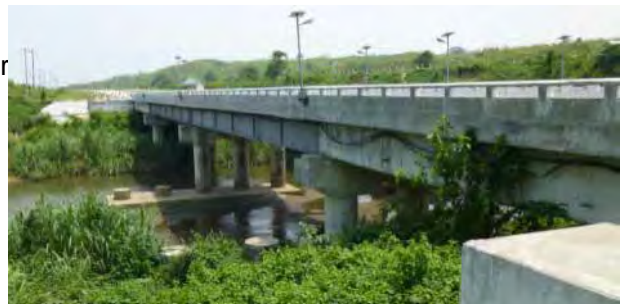
Near 77 miles 3 furlongs post

- There is a vertical ditch to drain water away from the median, but it is broken. As it is broken yet stays in place, the bottom of the block pitching is greatly scooped out. The hollowed-out part extends to beneath the abutments, and further damage is feared.

(It is not clear which the damage to the vertical ditch or the scouring of bottom of block pitching came first. However, it is evident that insufficient periodic inspections have made the damage worse.)

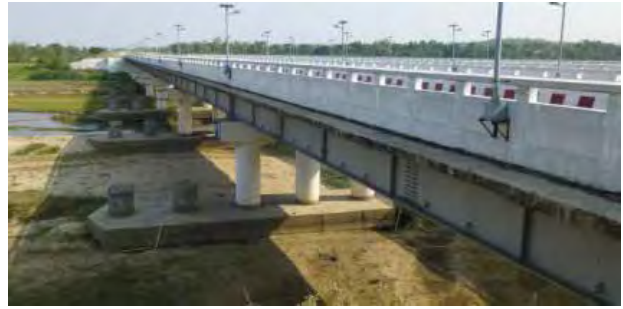
Near 165 miles 3 furlongs post

- The concrete retaining wall has completely fallen down, and the block pitching has been demolished. Outside the collapsed block embankment, a new block embankment is being erected.

The paving surface is cracked in a longitudinal direction.

Cracks can be seen in the curb in a location roughly corresponding to the vertical wall of the abutment.

- The destroyed slope indicates that the entirety of the earthwork, including the backfill, is in loosened condition.

This means it is necessary to investigate the effects on the lower part of the road surface.

- Currently, repair work is underway. However, for this to be effective, it is necessary to remove the entire loosened section and re-compact the earthwork densely. The current emergency construction work, which consists only of pushing down the earth, should be re-considered.

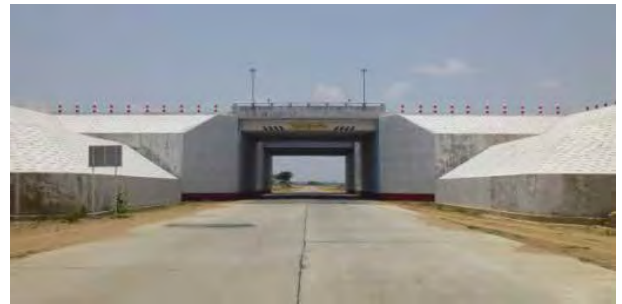
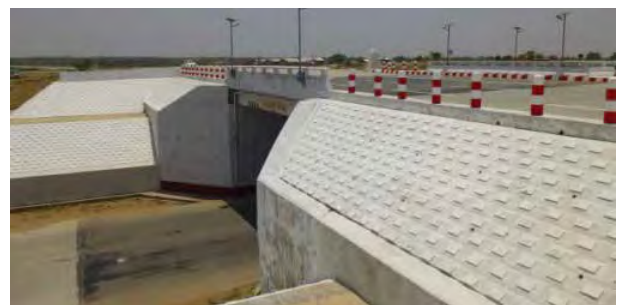
Near 294 miles 5 furlongs post

- The paving of the IC bridges has particularly severe height differentials compared to the rest of this expressway. For this reason, the pavement is being repaired as a sinking measure both on the main road and on the road it intersects with.

This situation is appeared to result from insufficient surface compaction despite the fact that the earthwork is piled higher than in other earthwork locations.

- The ends of the bridge are protected with concrete blocks and concrete seal. Repaired cracks were observed in the concrete seal sections. As these sections are entirely covered, it is impossible to observe the condition of the earthwork. If sinking or height differentials continue to progress in the future, it will be necessary not only to perform simple repairs but also to inspect the earthwork beneath.
- As the joints are structured to drain water, asphalt emulsion from the pavement repair of the main road has dripped down, dirtying the concrete wall.

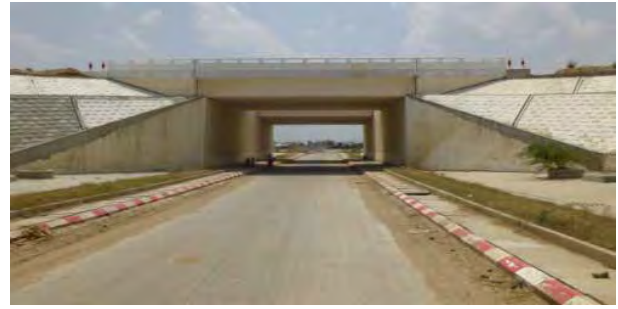
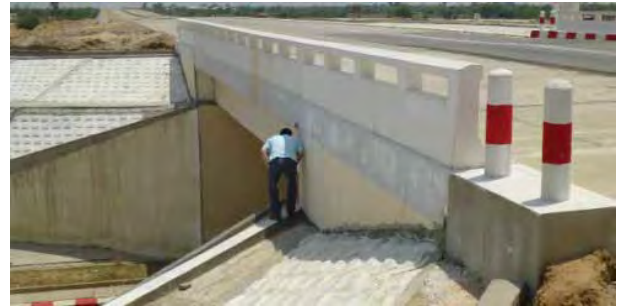
Near 325 miles 7 furlongs post

However, irregular sinking has caused the abutments to fall over as if bowing. Both the abutment parapets and girders are cracked.

- Steel bars used for holding in place during attachment of joint are still welded on and have not been removed. Even though this is a driving surface, this situation has been left as is for over a year, and no inspections appear to have been performed whatsoever.

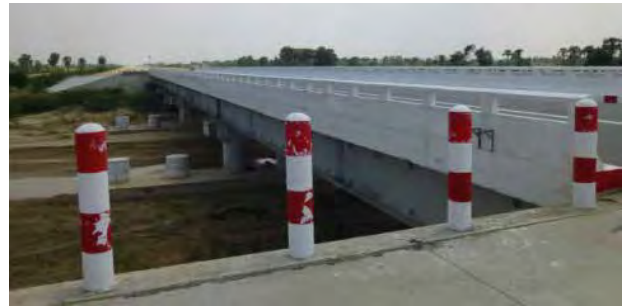
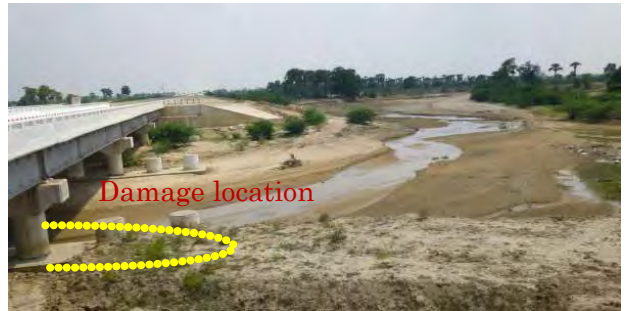
Near 341 miles 4 furlongs post

- This bridge is located at a major bend in the river. For this reason, in areas of fast current near the edge of the river, slopes (block embankments, etc.) have been destroyed, and restoration work has already been performed.
- This restoration work entails the deployment of structures which appear intended to slow the river current (it is questionable whether these are effective.)

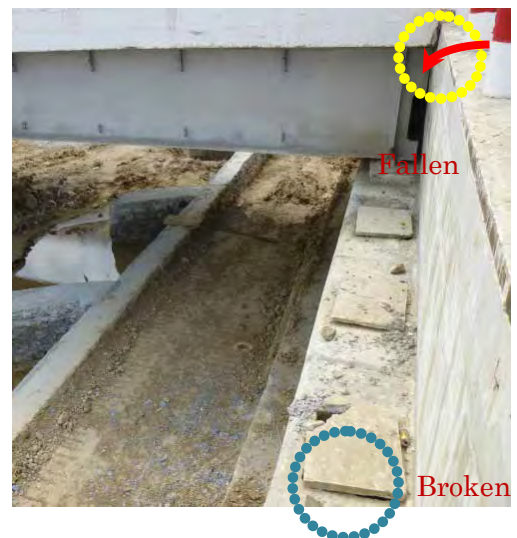
- The abutment is falling forward, and have collided with the upper sections of the girders.
- The boxed-out protective coverings of the support bearing anchor bolts for widening have broken.

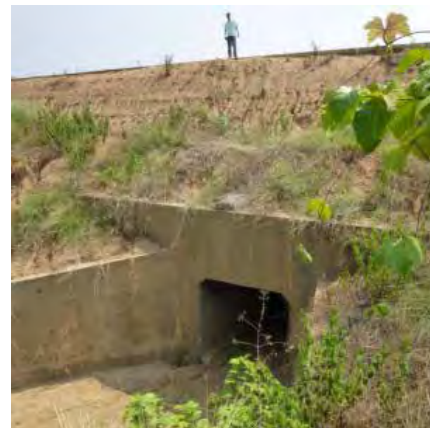
Walkway underpass

- The earth covering is made quite high.
- Vertical shafts in the median let in light as well as draining water.
- A man leading livestock passed through the tunnel while the survey was being conducted this time.
- As there is no pipe or channel, etc., water draining from the median falls directly into the culvert box.
- Water channels in the vicinity of the culvert box are not connected to plumbing, and at the ends of the ditches, erosion has occurred, and the drainage devices are broken.
(Removed from carriageway , no immediate influence on expressway)

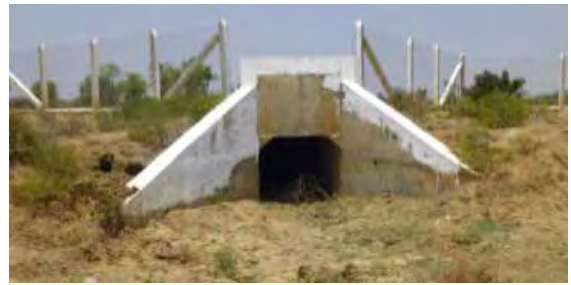
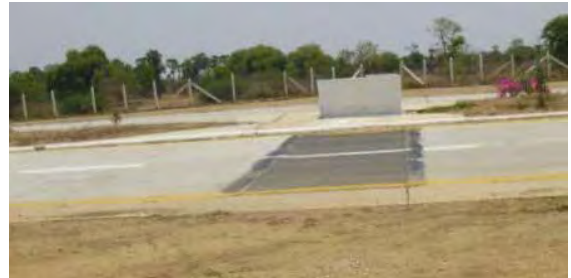
Near 280 miles 5 furlongs post

- This water channel underpass has a 1.5m-square cross section.
- As it is a small-scale culvert box, there are no water conduit facilities. For this reason, eroded soil accumulates around the entrances to the underpass.
- Due to the sinking of structures (culvert boxes), the road surface has sunk, and repairs are underway. It is likely that weight has caused the bottom plates to sink. This indicates that work on the bottom plates was not properly constructed.
- As there are no water drainage or collection facilities, erosion is progressing on the top of the slope.

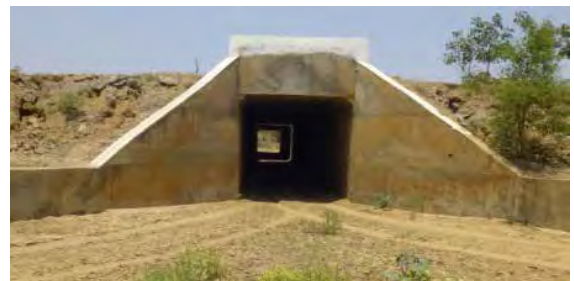
Near 280 miles 6 furlongs post

- Walkway underpass with 2m-square cross section
- As described above, the slope surface shows marks of erosion.
- The end of the wraparound section shows damage
