# ***ANNEX D***

## ***Attachment – 1***

*Results of Inventory Survey for  
Proposed Rehabilitation Works in  
Roleang Chrey Headworks Rehabilitation Sub-project*

**Results of Inventory Survey for Proposed Rehabilitation Works on North Main Canal (1/12)**

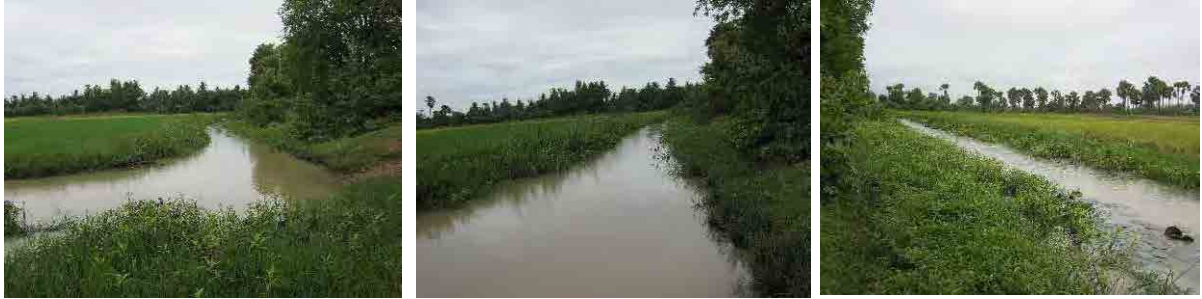
Canal No.: NMC	Proposed Works	Rehabilitation of Phum Thmey Andong Sla SC with construction of structures		Remarks: L = 3.1 km, (A = 300 ha) Improvement of Phum Thmey Andong Sla SC with 4 Turnouts and 3 Drain inlets
Station: 0.00+600	Map Ref. NAC-1	Coordinate	X: 0439329 Y: 1265317

Existing channel (just after turnout)		Upstream reach of existing channel		Middle reach of existing channel

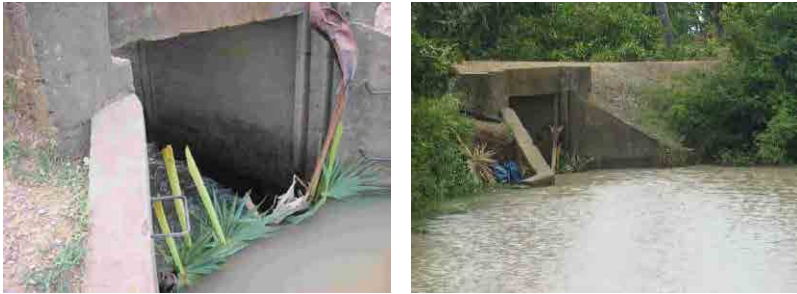
Canal No.: NMC	Proposed Works	Replacement of turnout for Phum Thmey Andong Sla SC		Remarks: Turnout for Phum Thmey Andong Sla SC (A=300 ha)
Station: 0.00+600	Map Ref. NAC-2	Coordinate	X: 0439329 Y: 1265317

Existing Turnout		Existing Turnout (Downstream View)

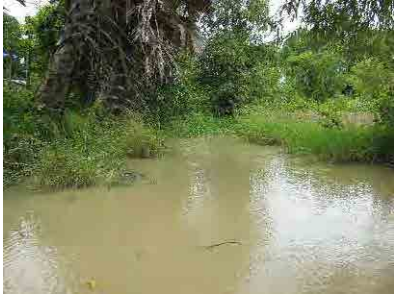
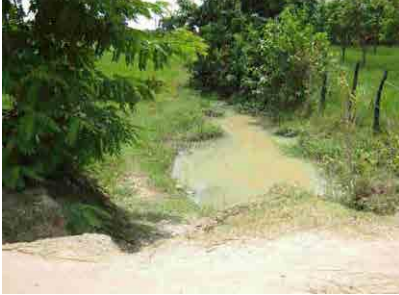
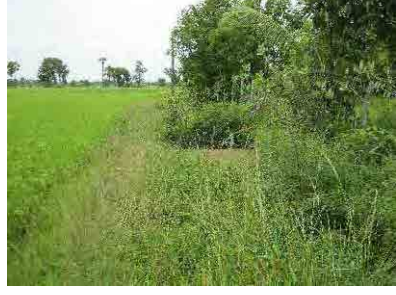
Canal No.: NMC	Proposed Works	Rehabilitation of Andong Thor SC with construction of structures		Remarks: L = 1.45 km (A = 120 ha) 4 checks / diversions structures
Station: 0.00+680	Map Ref. NAC-4	Coordinate	X: 0439125 Y: 1265416

Upstream View		Existing canal		Downstream View

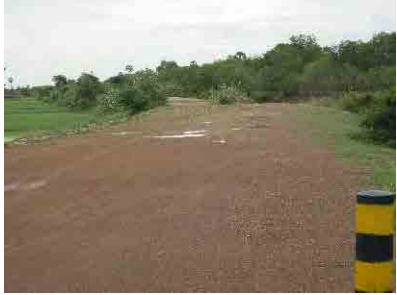
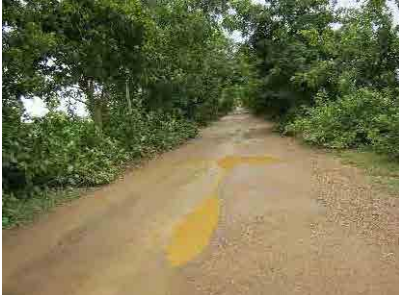
Canal No.: NMC	Proposed Works	Improvement of embankment	Remarks: Repair and provision of laterite pavement (both side)
Station: 0.00 ~ 1.00+150	Map Ref. NAC-7	Coordinate X: Y:

Upstream View		Downstream View

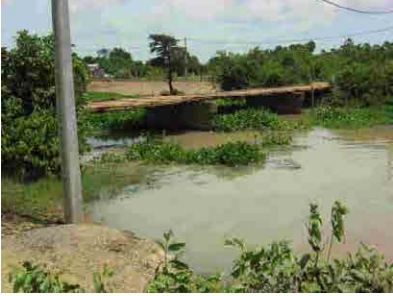
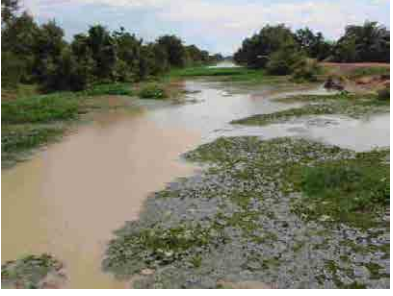
Canal No.: NMC	Proposed Works	Improvement of bridge		Remarks: Replacement of abatement of bridge
Station: 2.00+000	Map Ref. NMC-3	Coordinate	X: 0441313 Y: 1266615

Upstream View		Downstream View		Existing bridge

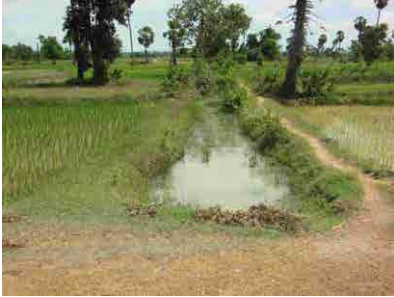
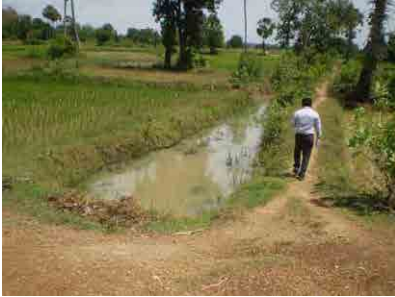
Canal No.: NMC	Proposed Works	Rehabilitation of Thmey SC-3		Remarks: L = 3 km (A = 300 ha) 3 checks/diversions
Station: 2.00+430	Map Ref. NMC-6	Coordinate	X: 0441611 Y: 1266870

Existing secondary canal		Existing secondary canal

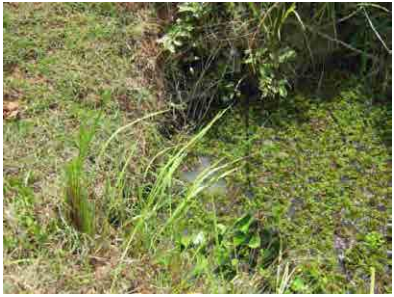
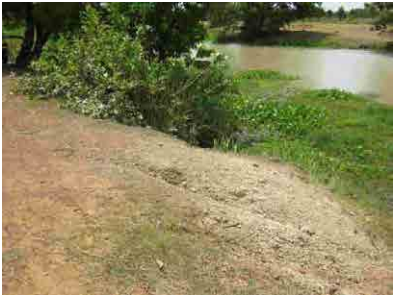
Canal No.: NMC	Proposed Works	Replacement of turnout for Thmey SC-3		Remarks: Turnout for Thmey-3 SC (A = 300 ha)
Station: 2.00+430	Map Ref. NMC-7	Coordinate	X: 0441611 Y: 1266870

Existing turnout		Existing turnout

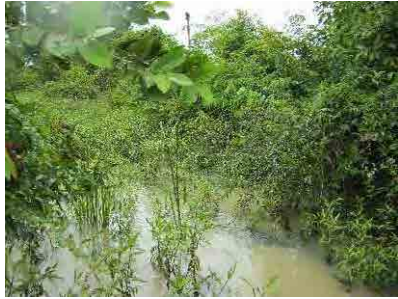
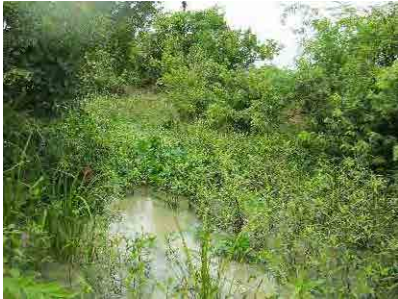
Canal No.: NMC	Proposed Works	Rehabilitation of Kravein-2 SC with construction of structures	Remarks: L = 810 m (A = 40 ha) 2 drain inlets and 3 turnouts
Station: 3.00+350	Map Ref. NMC-9	Coordinate X: 0442340 Y: 1267398

Existing secondary canal		Existing secondary canal

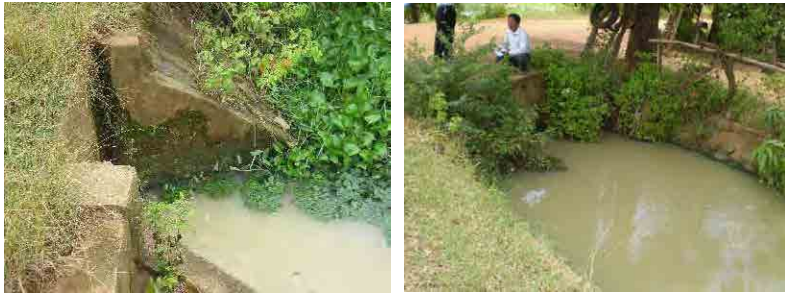
Canal No.: NMC	Proposed Works	Replacement of turnout for Prey Beng-1 SC	Remarks: Turnout for Prey Beng-1 SC (A = 60 ha)
Station: 5.00+100	Map Ref. NMC-13	Coordinate X: 0444065 Y: 1267913

Existing turnout (Inlet)		Existing turnout (Outlet)

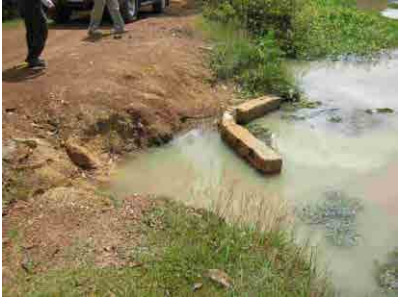
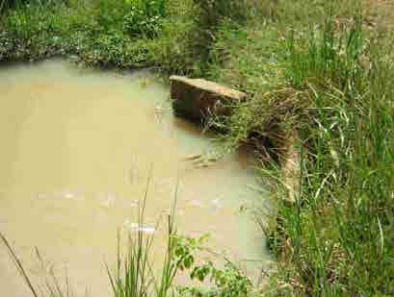
Canal No.: NMC	Proposed Works	Replacement of turnout for Sampove-2 SC		Remarks: Turnout for Sampov-2 SC (A = 100 ha)
Station: 5.00+200	Map Ref. NMC-15	Coordinate	X: 0444100 Y: 1267986

Existing turnout (Inlet)		Existing turnout (Outlet)

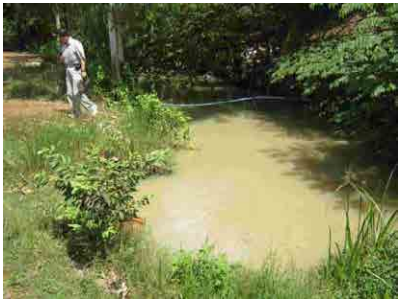
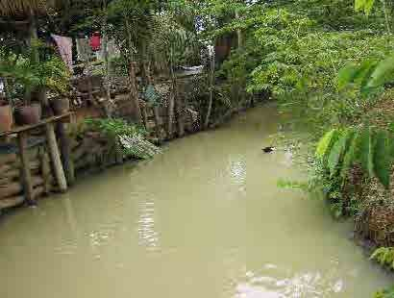
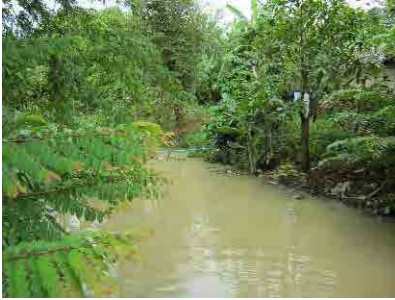
Canal No.: NMC	Proposed Works	Rehabilitation of Sampove-2 SC and construction of structures		Remarks: L = 1.2 km (A = 100 ha) 3 checks/diversions	
Station: 5.00+200	Map Ref. NMC-16	Coordinate	X: 0444100 Y: 1267986

Existing secondary canal			Existing secondary canal		Existing secondary canal

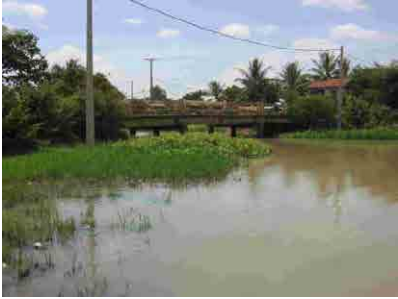
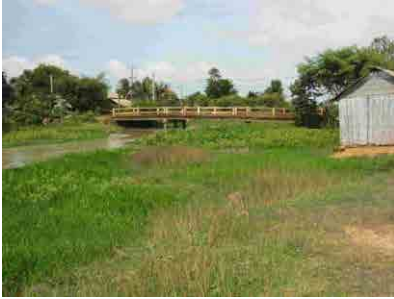
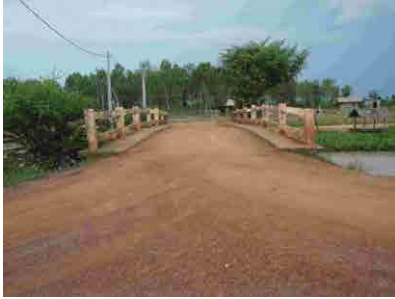
Canal No.: NMC	Proposed Works	Replacement of concrete bridge		Remarks:
Station: 5.00+250	Map Ref. NMC-17	Coordinate	X: 0444148 Y: 1268005

Upstream View		Downstream View		Existing bridge

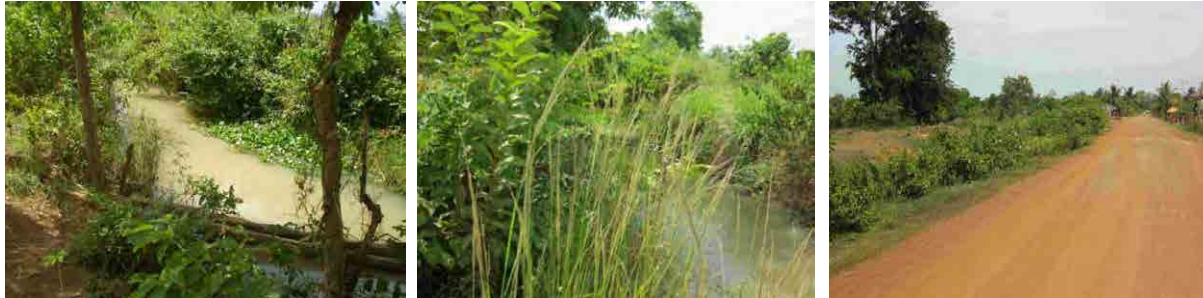
Canal No.: NMC	Proposed Works	Rehabilitation of Prey Beng-2 SC with construction of structures	Remarks: L = 1.8 km, (A = 70 ha) 4 checks/diversions
Station: 5.00+600	Map Ref. NMC-19	Coordinate X: 0444468 Y: 1267961

Existing secondary canal	Existing secondary canal	Road along secondary canal

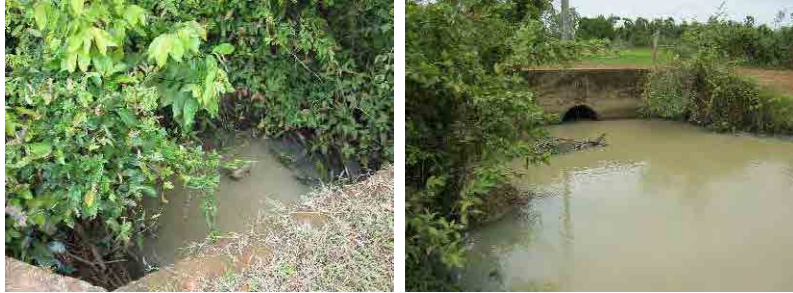
Canal No.: NMC	Proposed Works	Replacement of turnout for Prey Beng-2 SC	Remarks: Turnout for Prey Beng-2 SC (A=70 ha)
Station: 5.00+600	Map Ref. NMC-20	Coordinate X: 0444468 Y: 1267961

Existing turnout (Outlet)	Existing turnout (Outlet)

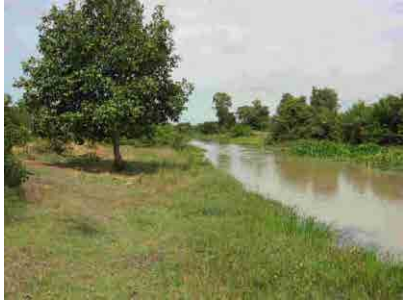
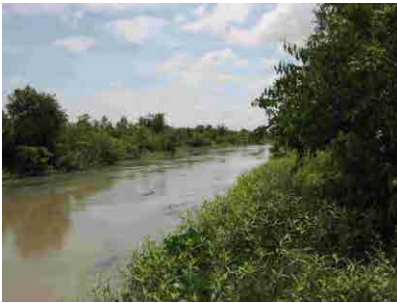
Canal No.: NMC	Proposed Works	Provision of drain inlet	Remarks:
Station: 6.00+500	Map Ref. NMC-21	Coordinate X: 0445039 Y: 1268473	
<div style="display: flex; justify-content: space-around;">

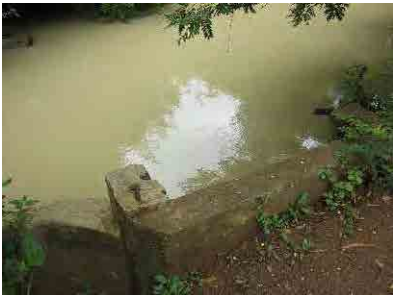
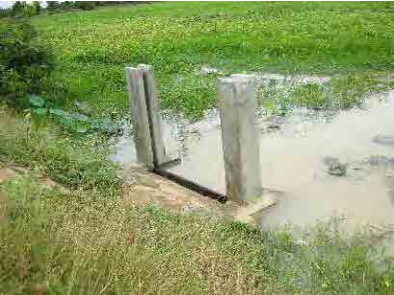
Canal No.: NMC	Proposed Works	Replacement of 3 outlets for small irrigated area	Remarks:
Station: 8+550 ~ 9+100	Map Ref. NMC-22	Coordinate X: 0447376 Y: 1269055	
<div style="display: flex; justify-content: space-around;">

</div> <div style="display: flex; justify-content: space-around; margin-top: 10px;"> <span>Existing turnout (Inlet)</span> <span>Existing turnout (Outlet)</span> </div>

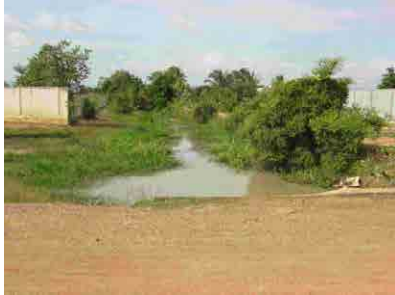
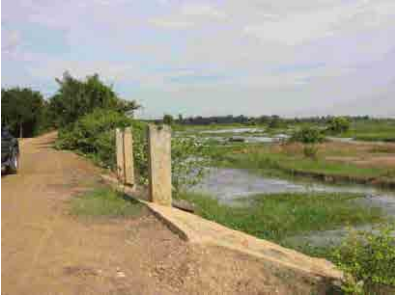
Canal No.: NMC	Proposed Works	Repair of turnout for Thmat Pong SC		Remarks: Turnout for Thmat Pong SC L = 6.2 km, (A = 265 ha)
Station: 8.00+800	Map Ref. NMC-24	Coordinate	X: 0447680 Y: 1269034

<p style="text-align: center;">Downstream View                      Existing turnout</p>

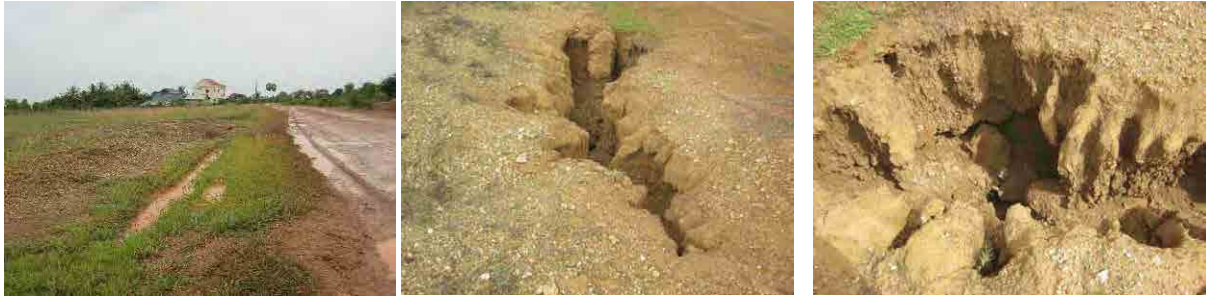
Canal No.: SMC	Proposed Works	Construction of drain inlet and field drain		Remarks: Both side : drain inlet Left side : drain canal
Station: 0+ 200 (B.P.)	Map Ref. SAC-1	Coordinate	X: 0440262 Y: 1263825

Preaent condition of embankemnt		Preaent condition of embankemnt		Preaent condition of embankemnt

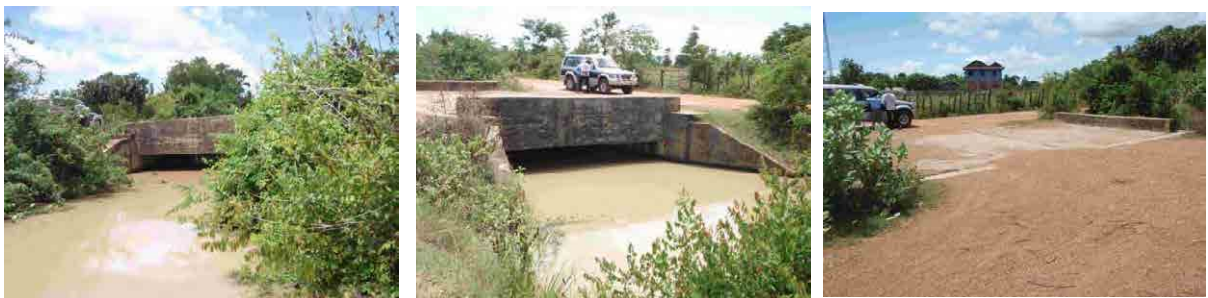
Canal No.: SMC	Proposed Works	Improvement of concrete bridge		Remarks: Bottom should be 1 m lower than existing level
Station: 0.00+580	Map Ref. SAC-2	Coordinate	X: 0439893 Y: 1263773

Upstream View		Downstream View		Existing bridge

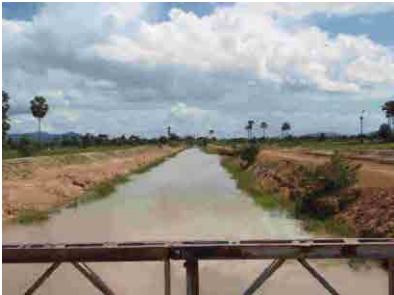
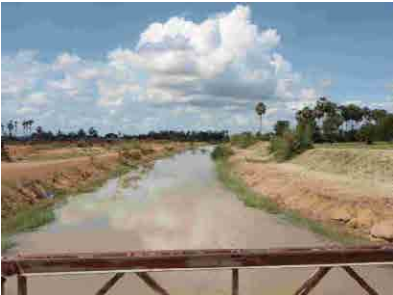
Canal No.: SMC	Proposed Works	Construction of check structure		Remarks: Check structure with new bridge at existing steel bridge
Station: 2.00 + 950	Map Ref. SMC-5	Coordinate	X: 0443137 Y: 1264220

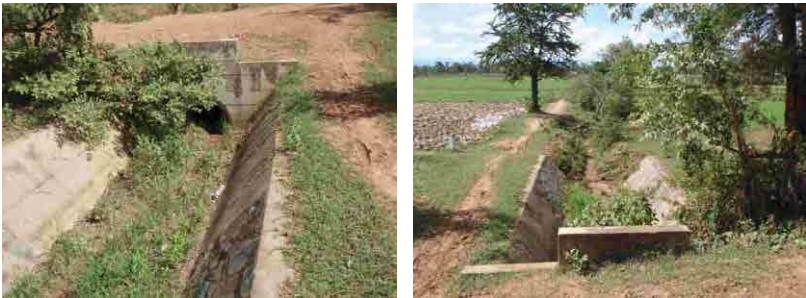
Canal No.: SMC	Proposed Works	Rehabilitation of Koh Té-1 SC with construction of structures		Remarks: L = 1 km (A = 80 ha) 3 checks/Turnouts
Station: 4.00 + 750	Map Ref. SMC-10	Coordinate	X: 0444752 Y: 1265073

Upstream View at turnout			Upstream of Koh Té-1 secondary canal

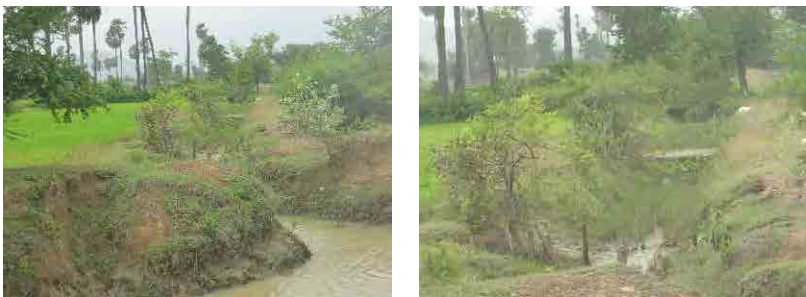
Canal No.: SMC	Proposed Works	Rehabilitation of Koh Té-2 SC with construction of structures		Remarks: L = 1.75 km (A = 110 ha) 3 checks/Turnouts
Station: 4.00 + 750	Map Ref. SMC-11	Coordinate	X: 0444752 Y: 1265073

Present condition (No structure)			Downstream View

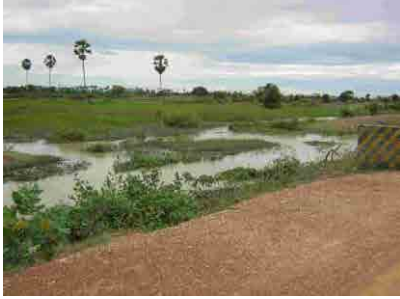
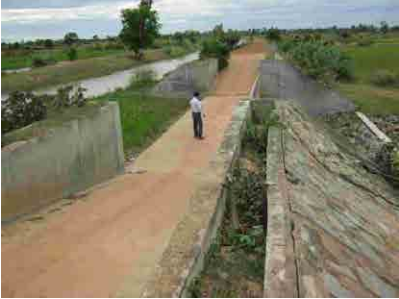
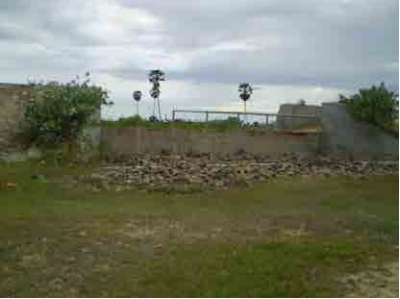
Canal No.: SMC	Proposed Works	Construction of embankment at level crossing reservoir		Remarks: Embankment (Right side, L = 700 m) with provision of new drainage gate and improvement of spillway
Station: 7.00+150	Map Ref. SMC-18	Coordinate	X: 0446993 Y: 1264648

<p style="text-align: center;">Level crossing reservoir                      Existing spillway                      Existing spillway (View from downstream)</p>

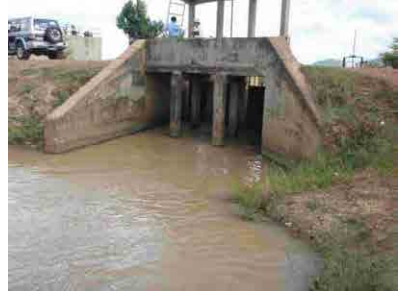
Canal No.: SMC	Proposed Works	Replacement of turnout		Remarks: Replacement of Turnout for Road-110 SC (A = 20 ha)
Station: 7.00+800	Map Ref. SMC-19	Coordinate	X: 0447469 Y: 1264229

<p style="text-align: center;">Existing turnout                      View from Upstream                      View from Downstream</p>

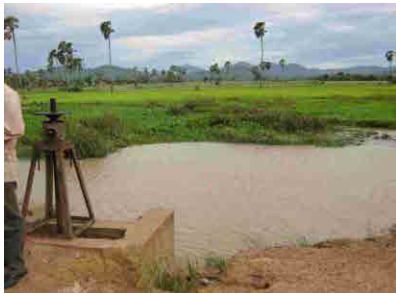
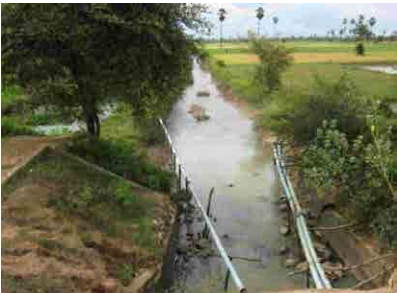
Canal No.: SMC	Proposed Works	Replacement of turnout for Phum Skous-2 SC	Remarks: Turnout for Phum Skous-2 SC (A = 100 ha)
Station: 8.00+700	Map Ref. SMC-22	Coordinate X: 0448274 Y: 1263799

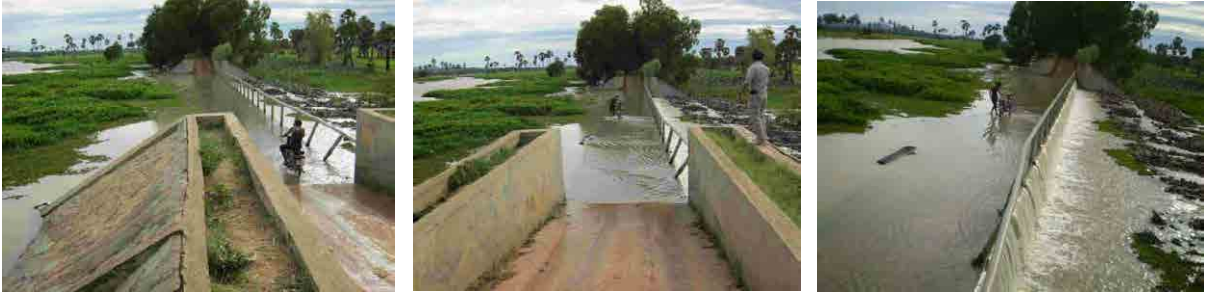
Canal No.: SMC	Proposed Works	Repair of spillway	Remarks:
Station: 9.00+400	Map Ref. SMC-24	Coordinate X: Y:

Existing spillwat	Existing spillwat (View from inspection road)		Existing spillwat (spillout)

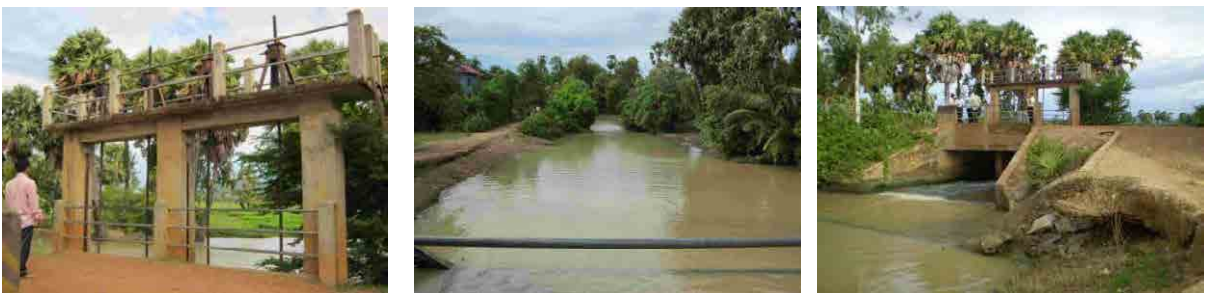
Canal No.: SMC	Proposed Works	Repair of Bak Thmenh gate for Bak Thmenh drainage canal	Remarks: Repair of Bak Thmenh gate for Bak Thmenh drainage cane
Station: 9.00+620	Map Ref. SMC-25	Coordinate X: 0448981 Y: 1263728

Existing drainage gate	Downstream view from drainage gate		View from drainage canal

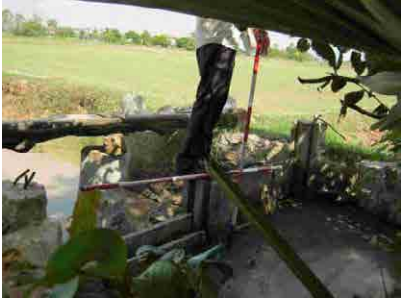
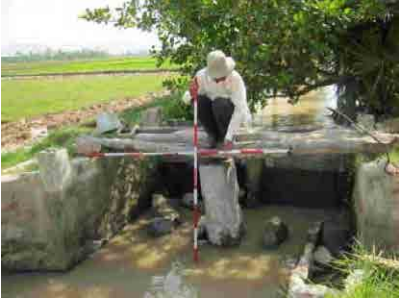
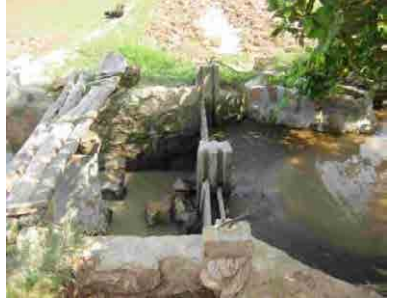
Canal No.: C21	Kind of structure: Check structure (Water obstruction)	Remarks:  Totally broken
Station: 3.00+870	Coordinate< Northing: 1221126 Easting: 0457214

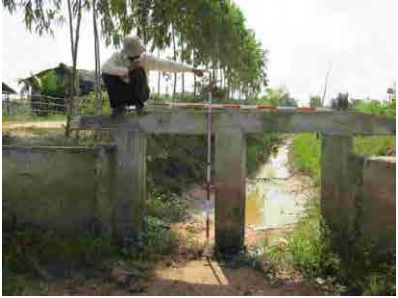
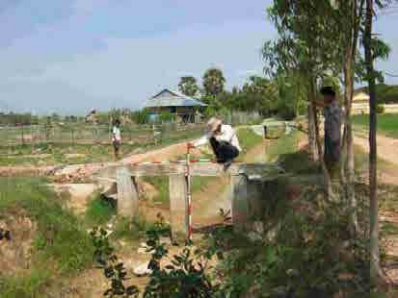
Canal No.: C22	Kind of structure(s): Check structure	Remarks: - Totally broken - Groove takes water into secondary canal, Length: 9500m
Station: 9.00+690	Coordinate< Northing: 1221900 Easting: 0461237

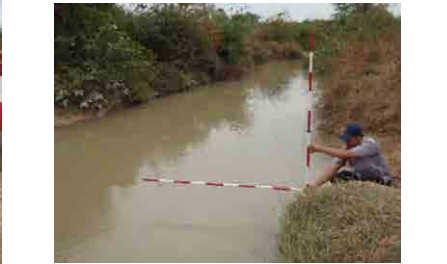
Canal No.: KC-1	Kind of structure(s): Turn out	Remarks:
Station: 3.00+020	Coordinate< Northing: 1261003 Easting: 480628	Broken

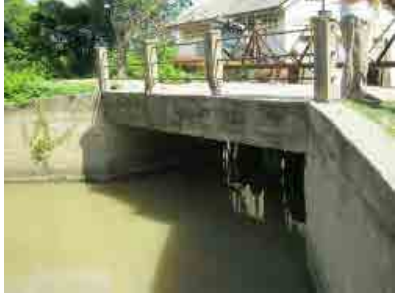
Canal No.: MC1	Kind of structure(s): Pumping Station No. 22-23 , Gate & Bridge	Remarks: Village Road
Station: 0.00(B.P.)	Coordinate< Northing: 1252808 Easting: 0484026	Routine Survey

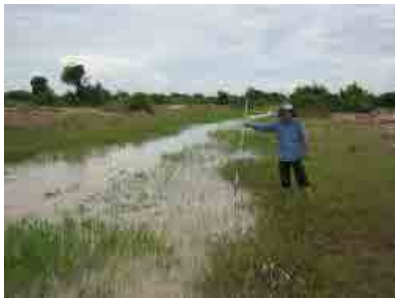
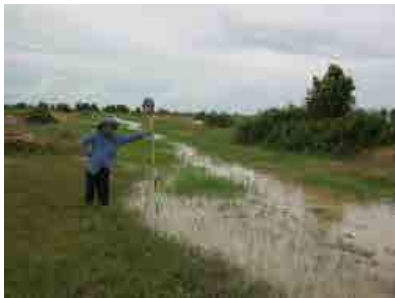
Canal No.: MC2	Kind of structure(s): Canal	Remarks: Routine Survey Length: 5500m
Station: 5.00+600	Coordinate< Northing: 1246524 East ing: 0484032

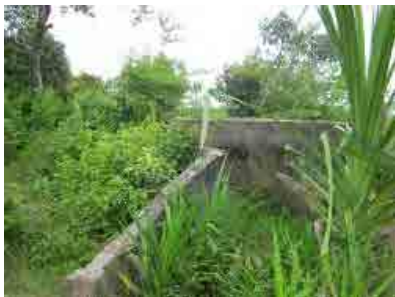
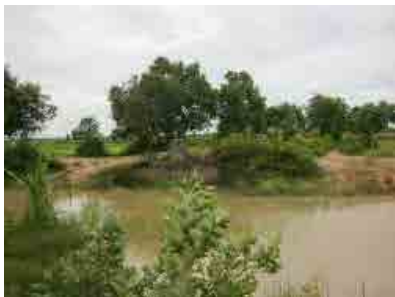
Canal No.: MC2	Kind of structure(s): Water Obstruction Structure	Remarks: Routine Survey The Water Obstruction Structure was constructed in Pol Pot Regime and now broken. It is on the right hand side of Canal.
Station: 6.00+40	Coordinate< Northing: 1246149 East ing: 0484036

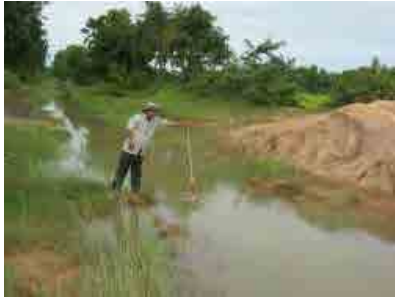
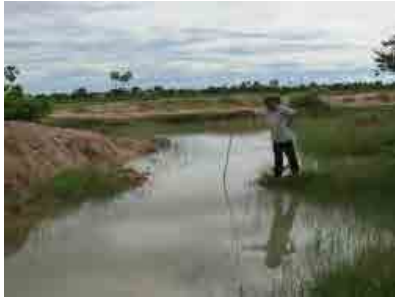
Canal No.: L4	Kind of structure(s): Canal	Remarks:
Station: 0.00(B.P.)	Coordinate< Northing: 1250990 Easting: 0485215	Diversion Point of MC1

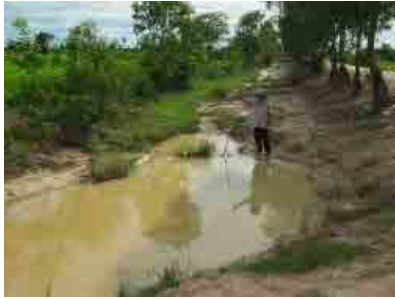
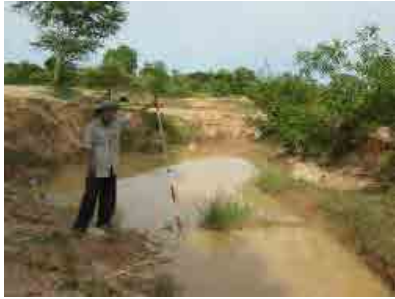
Canal No.: L5	Kind of structure(s): Canal	Remarks: Along the Commune Road Routine Survey
Station: 0.00(B.P.)	Coordinate< Northing: 1250442 Easting: 0485546

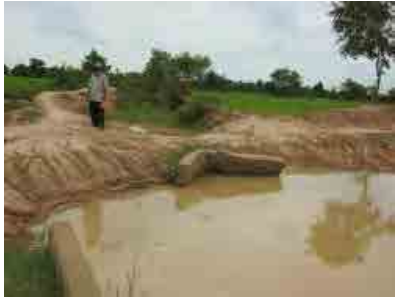
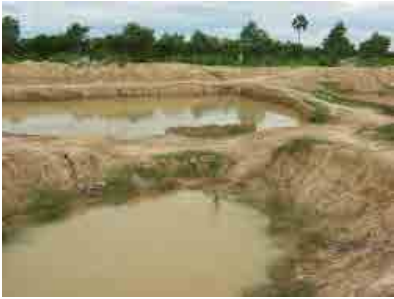
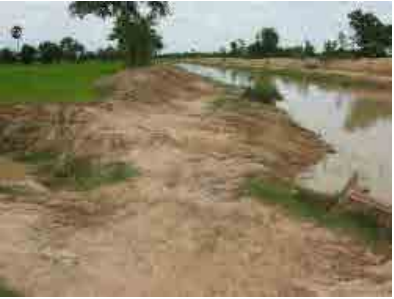
Canal No.: L6	Kind of structure(s): Pipe Culvert(Private)	Remarks:
Station: 0.00(B.P.)	Coordinate< Northing: 1249877 Easting: 0485978	Along the Farm Access Routine Survey

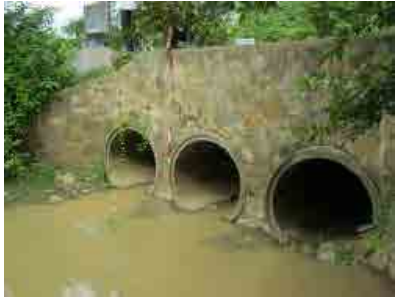
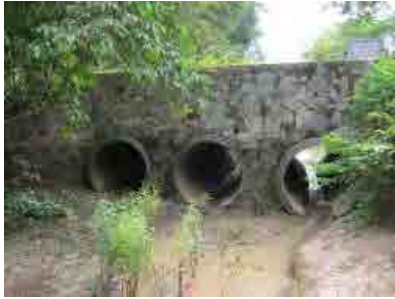
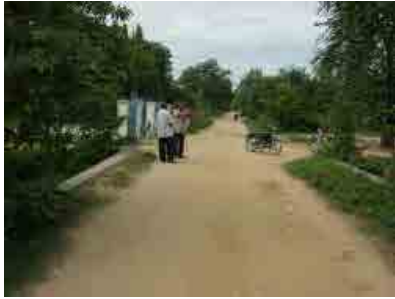
Canal No.: L8	Kind of structure(s): Pipe Culvert(Triple)	Remarks:
Station: 0.00(B.P.)	Coordinate< Northing: 1247164 Easting: 0486846	Commune Road Routine Survey
