4.2 Meghna Bridge

4.2.1 Crack, water leakage, isolated lime

4.3 Gumti Bridge

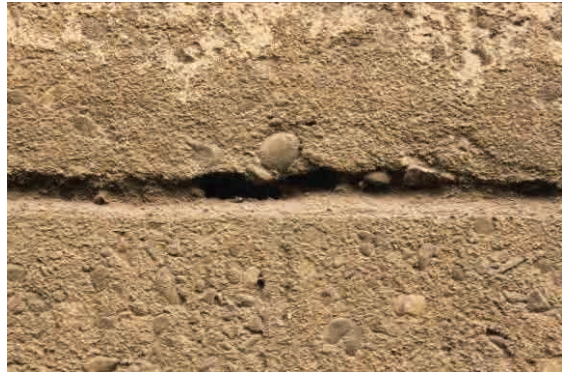
Pier 01	
Damage: a	Damage: c

No crack	Crack width over 0.2mm

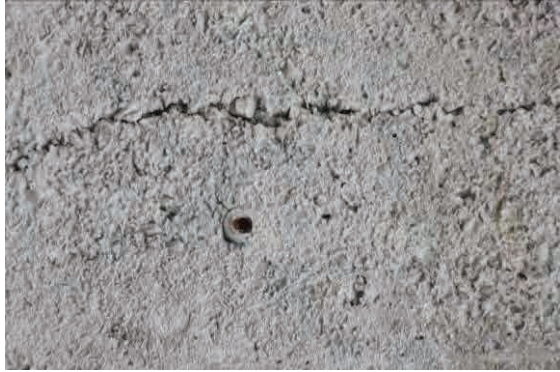
Pier 06	
Damage: a	Damage: c

No crack	Crack width over 0.2mm

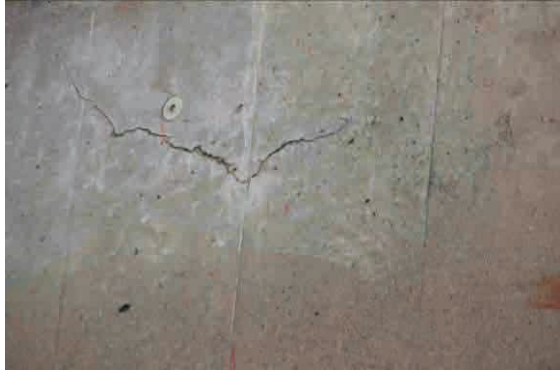
Pier 08	
Damage: a	Damage: c

No crack	Crack width over 0.2mm

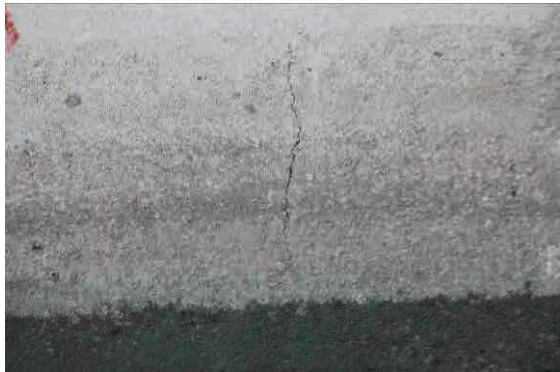
Pier 09	
Damage: a	Damage: c

No crack	Crack width over 0.2mm

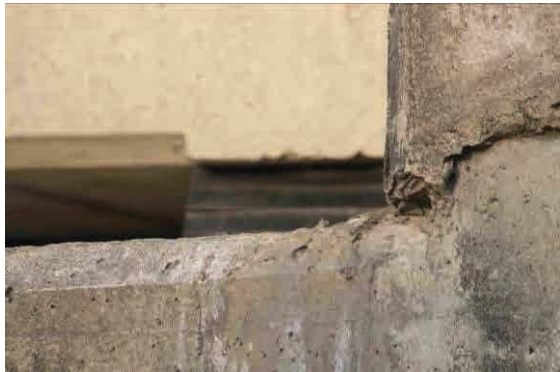
Abutment 02	
Damage: a	Damage: c

No crack	Crack width over 0.2mm

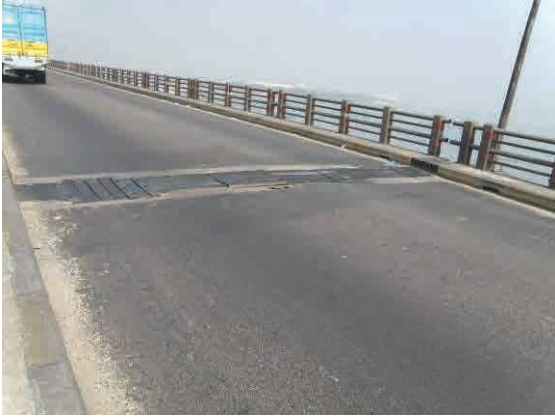
Surface	
Damage: Exist	Damage: Exist

Uneven more than 20mm	Uneven more than 20mm

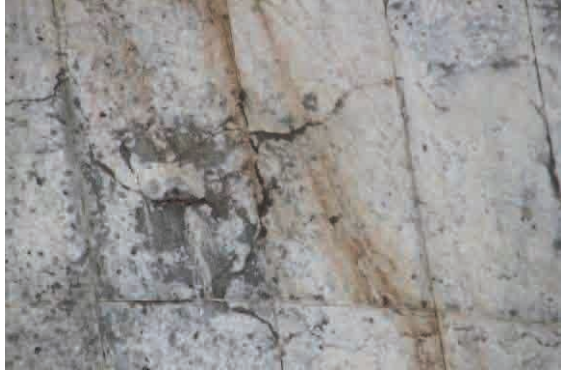
Pier 02	
Damage: a	Damage: c

No crack	Crack width over 0.2mm

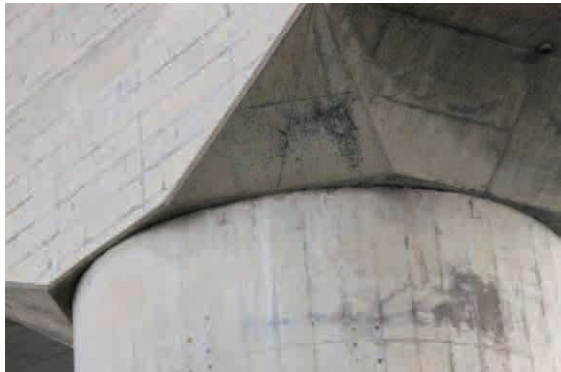
Pier 03	
Damage: a	Damage: c

No crack	Crack width over 0.2mm

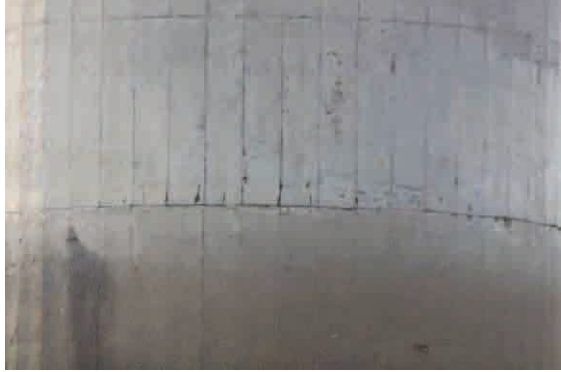
Pier 04	
Damage: a	Damage: c

No crack	Crack width over 0.2mm

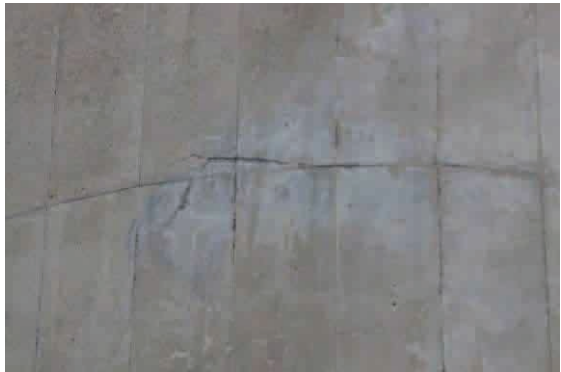
Pier 05	
Damage: a	Damage: c

No crack	Crack width over 0.2mm

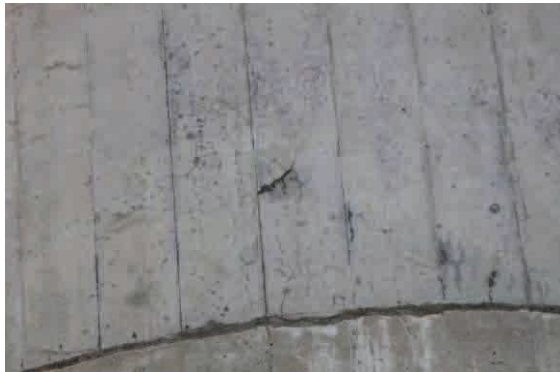
Pier 09	
Damage: a	Damage: c

No crack	Crack width over 0.2mm

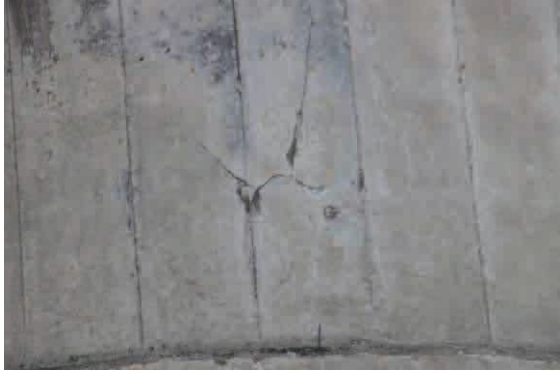
Pier 10	
Damage: a	Damage: c

No crack	Crack width over 0.2mm

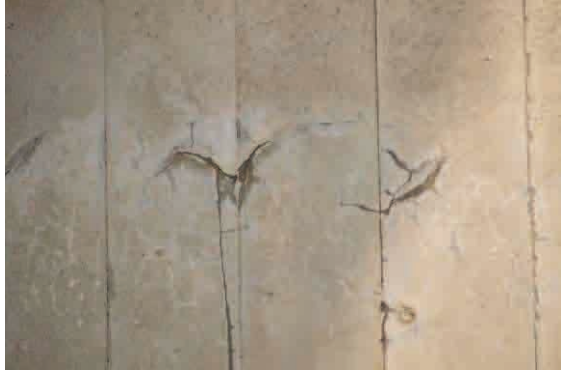
Pier 14	
Damage: a	Damage: d

No crack	Crack width over 0.2mm Water leakage only

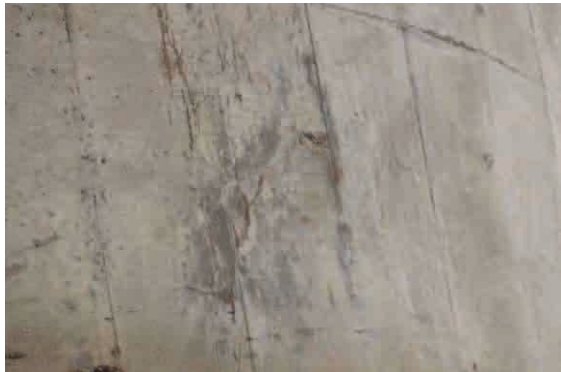
Pier 15	
Damage: a	Damage: c

No crack	Crack width over 0.2mm

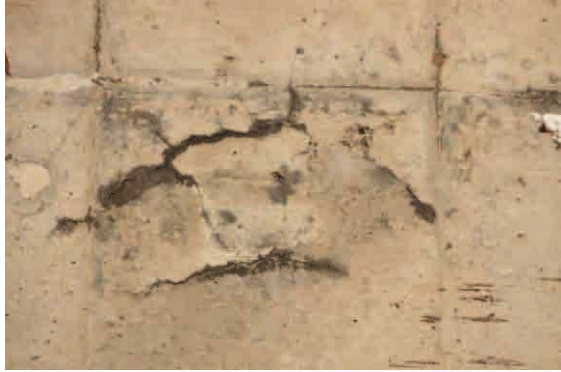
Pier 16	
Damage: a	Damage: d

No crack	Crack width over 0.2mm Water leakage only

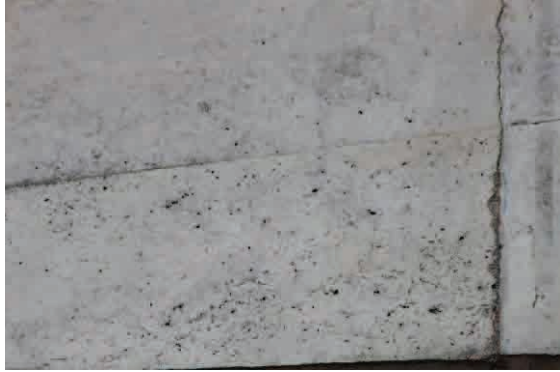
Superstructure P1	
Damage: a	Damage: c

No crack	Crack width over 0.2mm

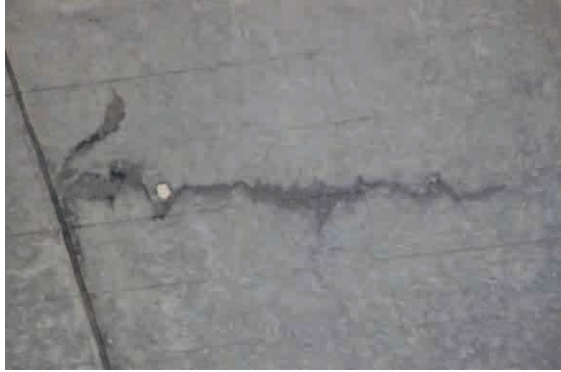
Superstructure P5	
Damage: a	Damage: d

No crack	Crack width over 0.2mm Water leakage only

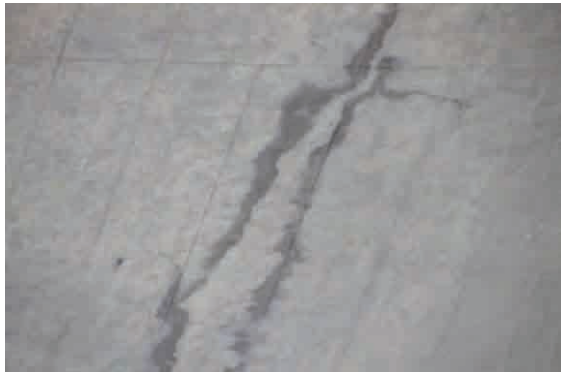
Superstructure P6	
Damage: a	Damage: d

No crack	Crack width over 0.2mm Water leakage only

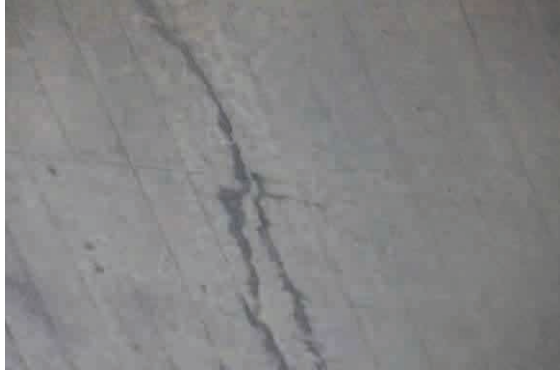
Superstructure P7	
Damage: c	Damage: d

Crack width over 0.2mm	Crack width over 0.2mm Water leakage only

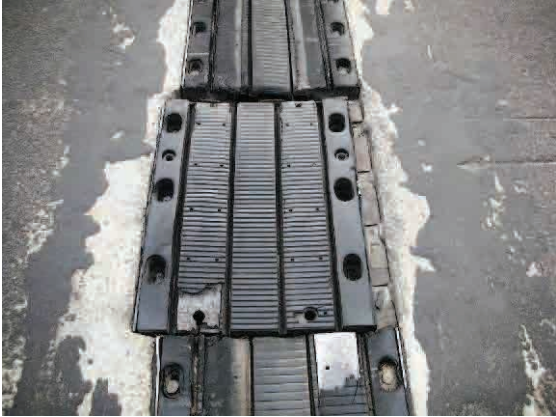
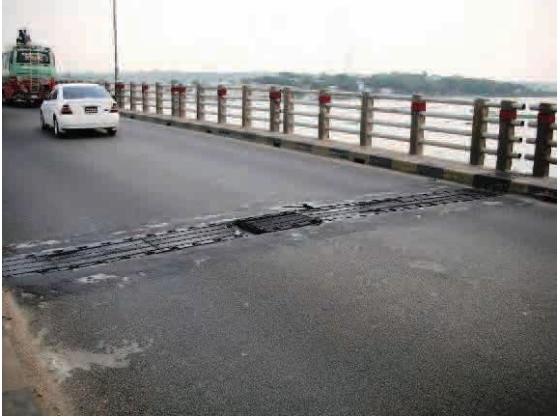
Surface	
Damage: Exist	Damage: Exist

Uneven more than 20mm	Uneven more than 20mm
