APPENDIX 5.
RECORDS OF BRIDGE SURVEY

1. Visual inspection survey

4.1 Kanchpur Bridge

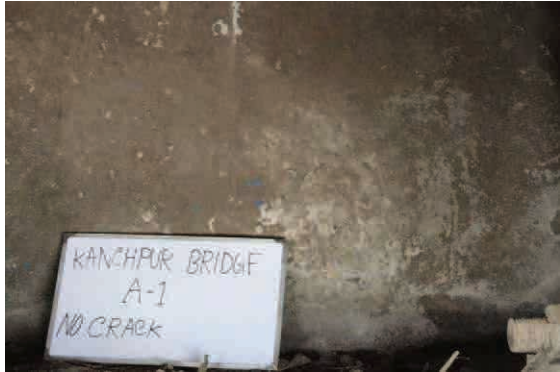
Abutment 01	
Damage: d	Damage: a

Crack width over 0.2mm Water leakage only	No crack

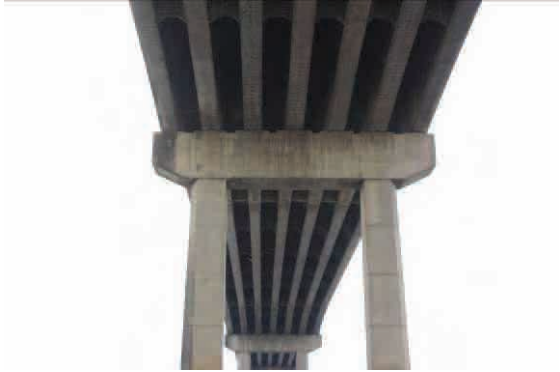
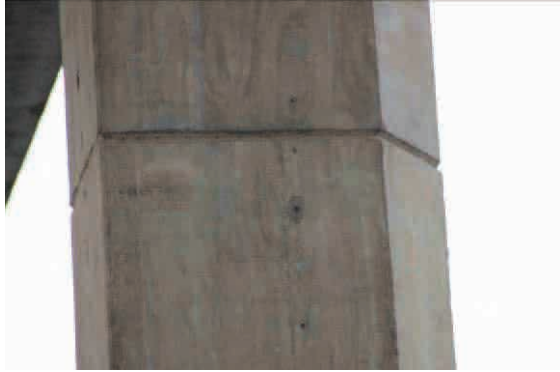
Pier 06	
Damage: a	Damage: a

No crack	No crack

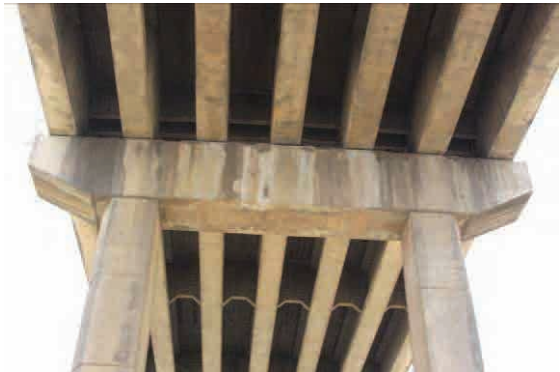
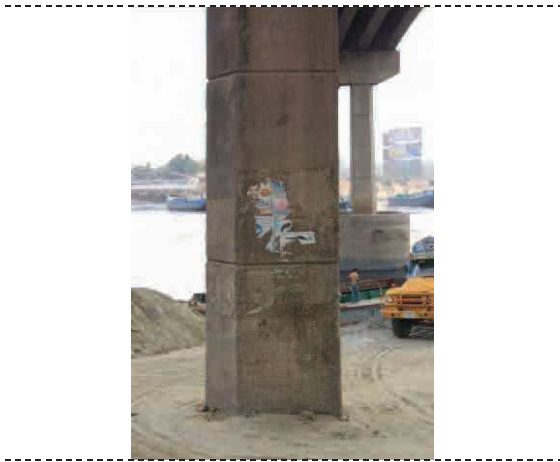
Pier 07	
Damage: a	Damage: a

No crack	No crack

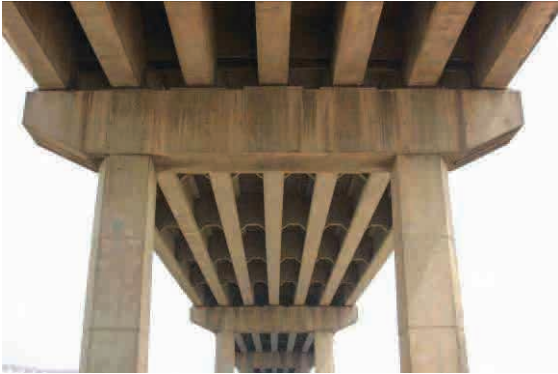
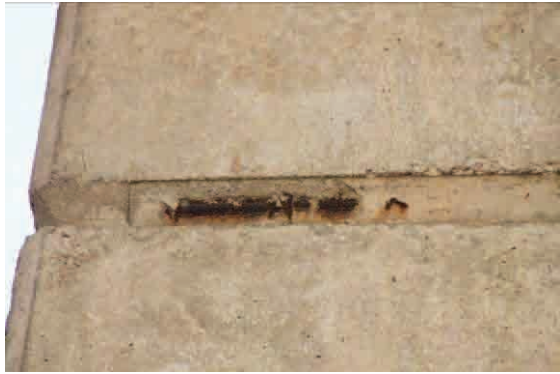
Pier 02	
Damage: Not exist	Damage: Existence of damage

No damage	Corrosion in reinforcement

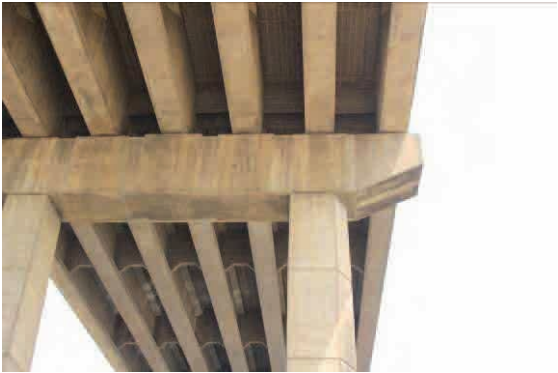
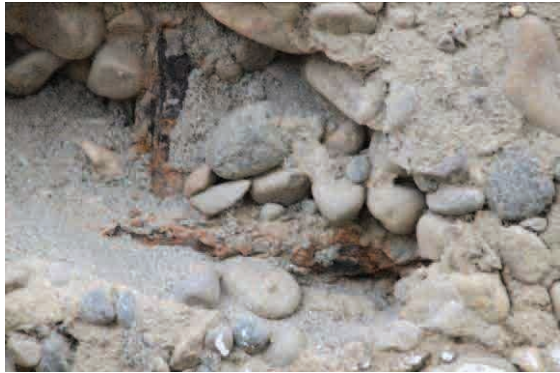
Pier 03	
Damage: Not exist	Damage: Existence of damage

No damage	Corrosion in reinforcement

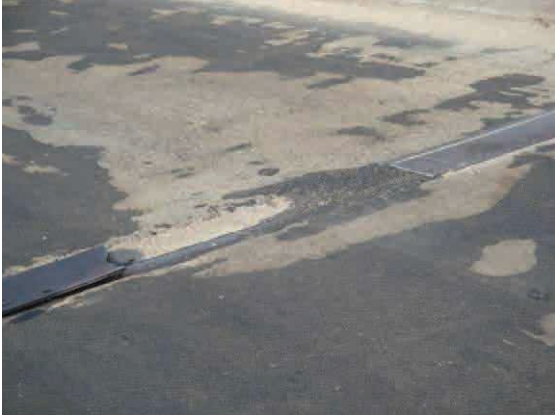
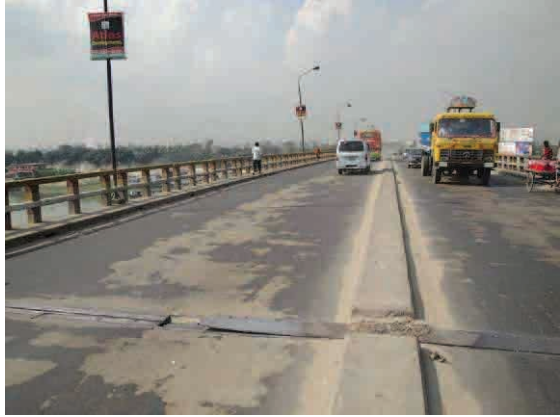
Surface	
Damage: Exist	Damage: Exist

Uneven more than 20mm	Uneven more than 20mm

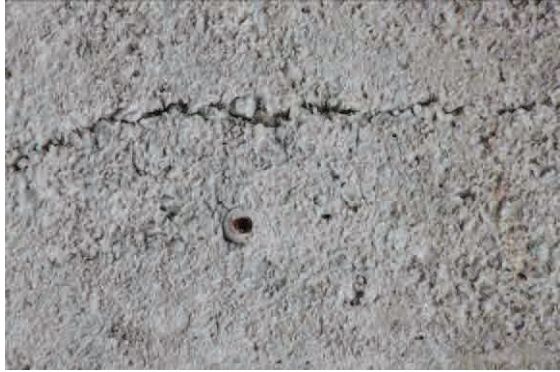
Pier 06	
Damage: a	Damage: c

No crack	Crack width over 0.2mm

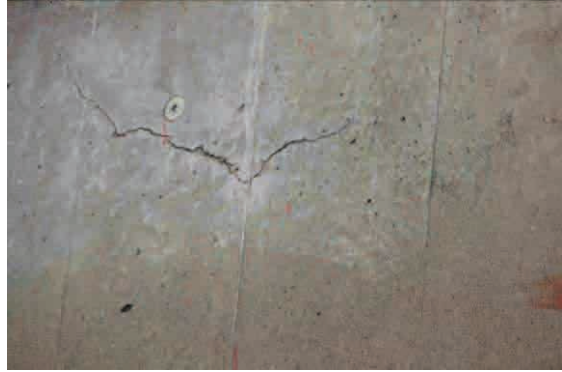
Pier 08	
Damage: a	Damage: c

No crack	Crack width over 0.2mm

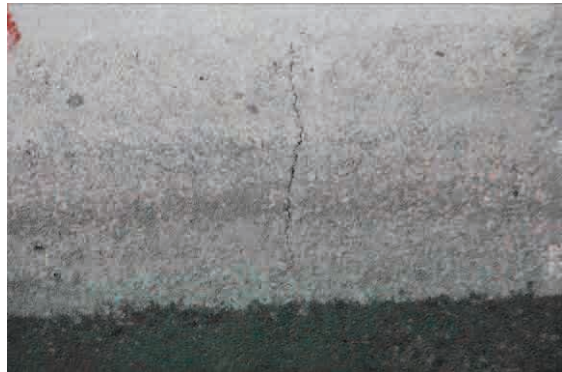
Pier 09	
Damage: a	Damage: c

No crack	Crack width over 0.2mm

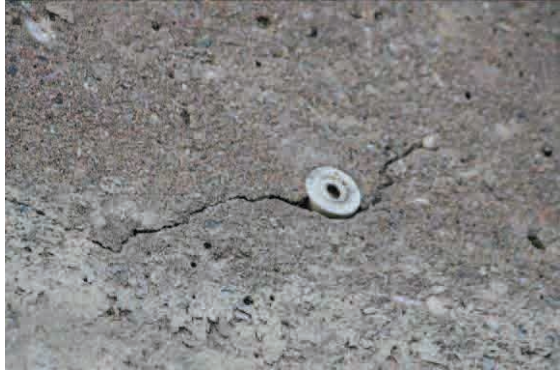
Pier 10	
Damage: a	Damage: c

No crack	Crack width over 0.2mm

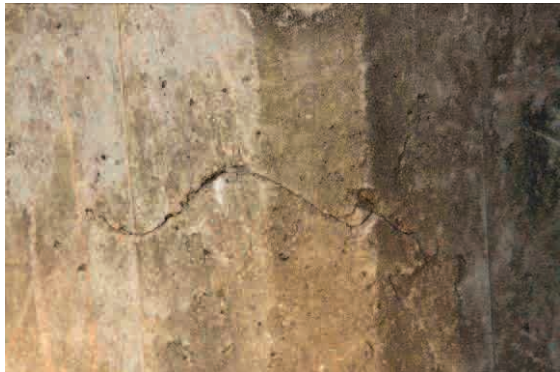
Pier 11	
Damage: a	Damage: c

No crack	Crack width over 0.2mm

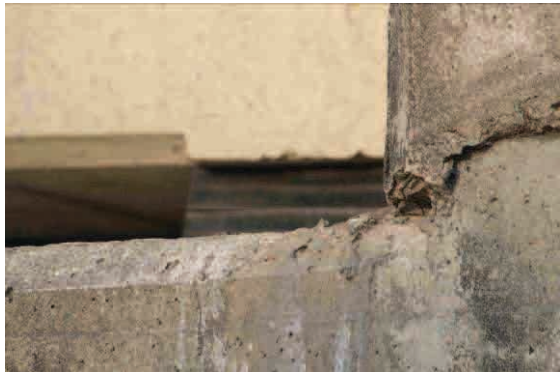
Abutment 02	
Damage: a	Damage: c

No crack	Crack width over 0.2mm

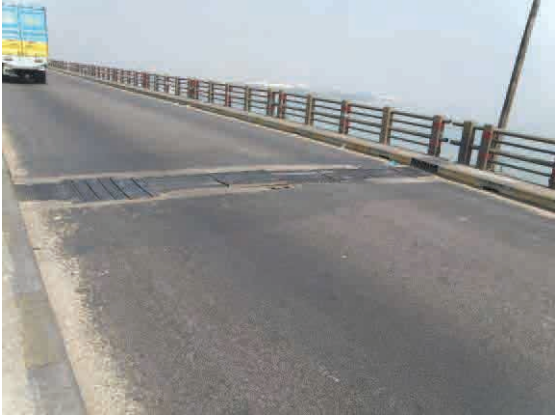
Surface	
Damage: Exist	Damage: Exist

Uneven more than 20mm	Uneven more than 20mm

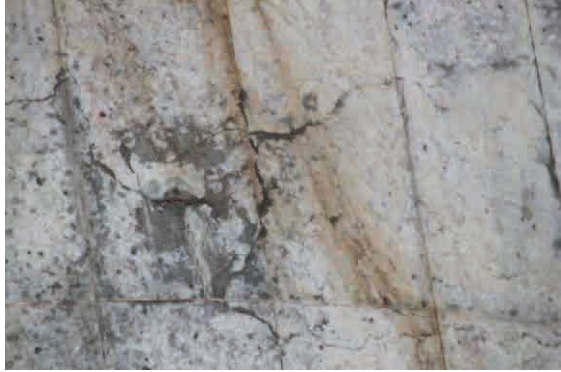
Pier 02	
Damage: a	Damage: c

No crack	Crack width over 0.2mm

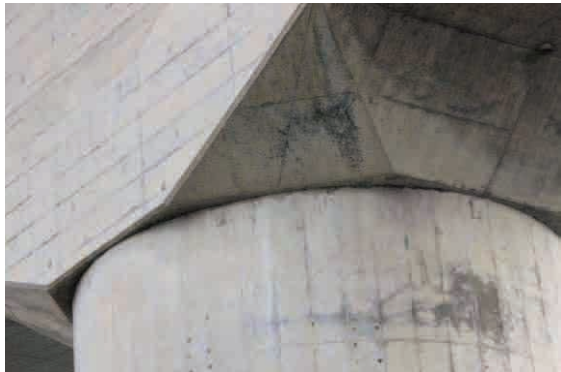
Pier 03	
Damage: a	Damage: c

No crack	Crack width over 0.2mm

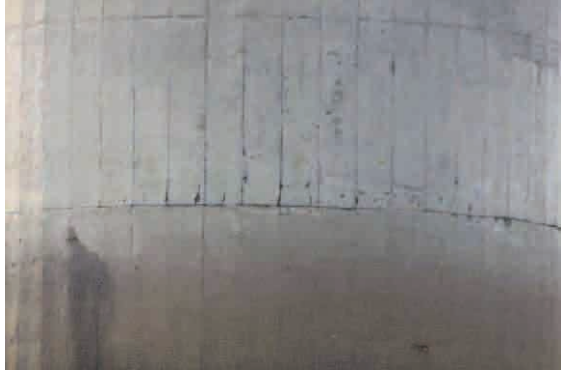
Pier 04	
Damage: a	Damage: c

No crack	Crack width over 0.2mm

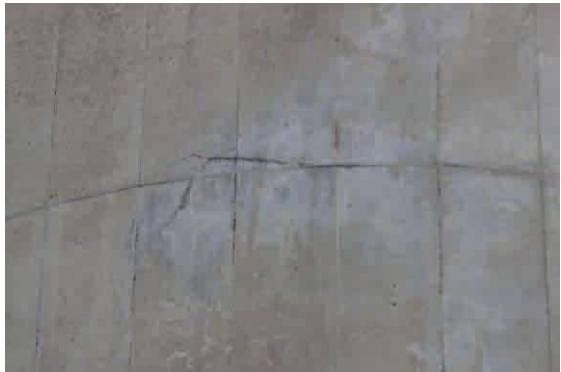
Pier 05	
Damage: a	Damage: c

No crack	Crack width over 0.2mm

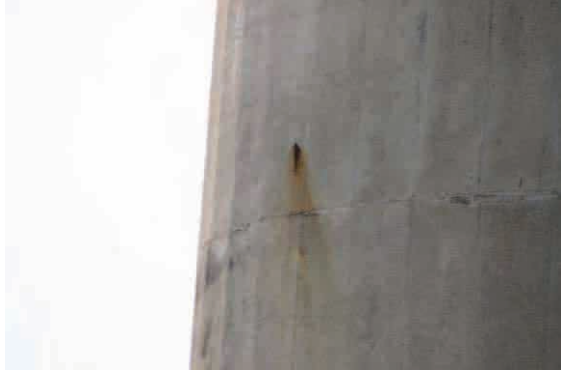
Pier 06	
Damage: a	Damage: c

No crack	Crack width over 0.2mm

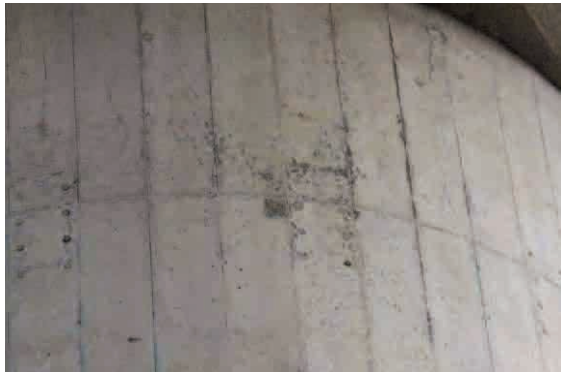
Pier 07	
Damage: a	Damage: c

No crack	Crack width over 0.2mm

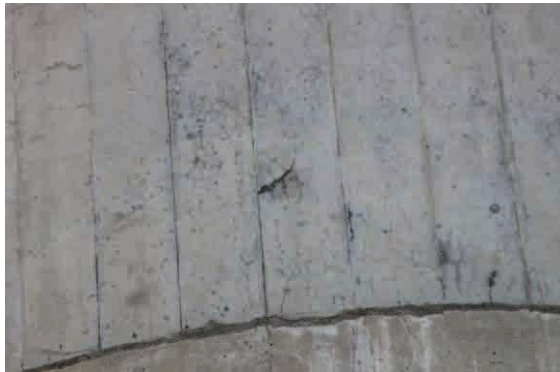
Pier 09	
Damage: a	Damage: c

No crack	Crack width over 0.2mm

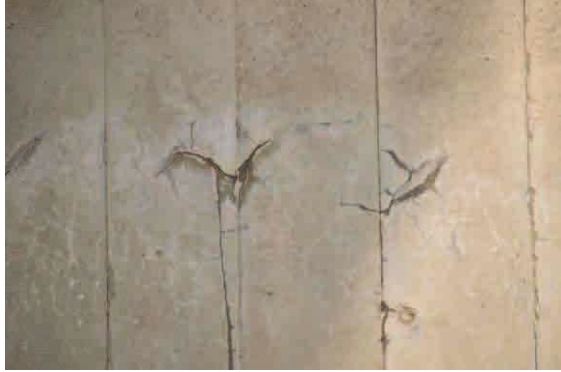
Pier 14	
Damage: a	Damage: d

No crack	Crack width over 0.2mm Water leakage only

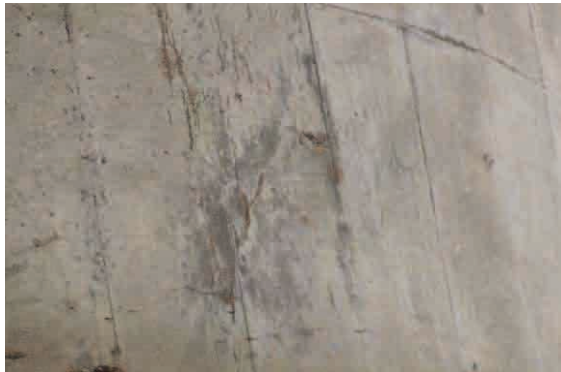
Pier 15	
Damage: a	Damage: c

No crack	Crack width over 0.2mm

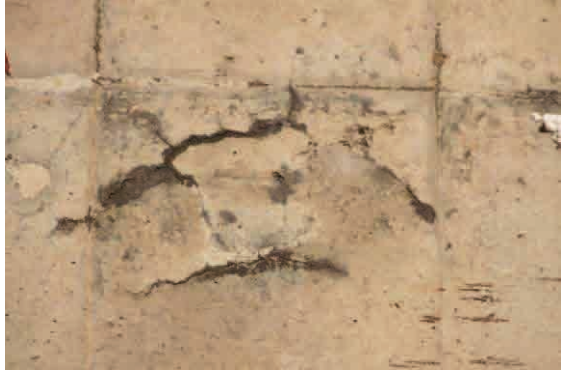
Pier 16	
Damage: a	Damage: d

No crack	Crack width over 0.2mm Water leakage only

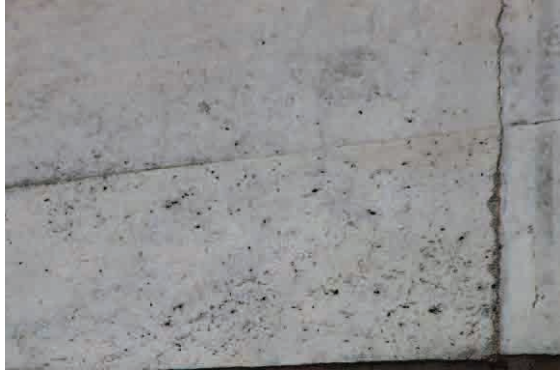
Superstructure P1	
Damage: a	Damage: c

No crack	Crack width over 0.2mm

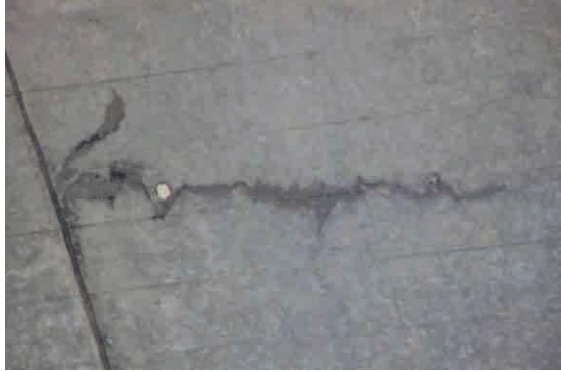
Superstructure P5	
Damage: a	Damage: d

No crack	Crack width over 0.2mm Water leakage only

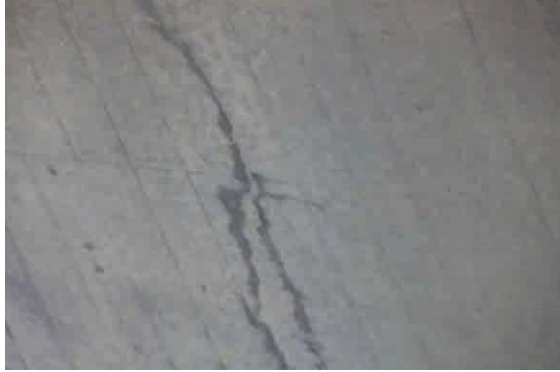
Superstructure P7	
Damage: c	Damage: d

Crack width over 0.2mm	Crack width over 0.2mm Water leakage only
