**THE PREPARATORY SURVEY (2)  
ON  
THE PROJECT  
FOR  
REHABILITATION OF BALUCHAUNG NO.2  
HYDROPOWER PLANT  
IN  
REPUBLIC OF THE UNION OF MYANMAR**

**Final Report  
(Annex)**

**March 2013**

### **CHECK LIST OF SITE INSPECTION**

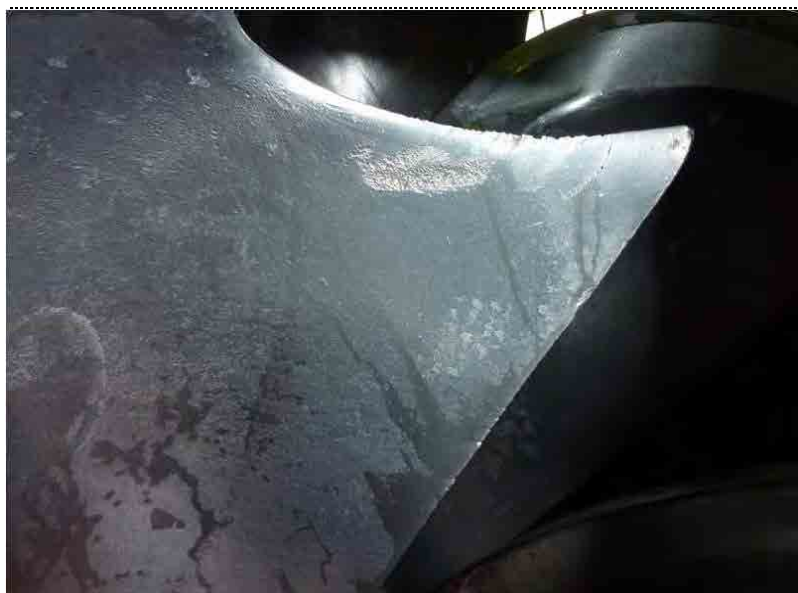
Unit No. 1 A Runner Bucket Cavitation

Near the inlet edge of the action surface of Bucket No.13, light cavitation is observed.

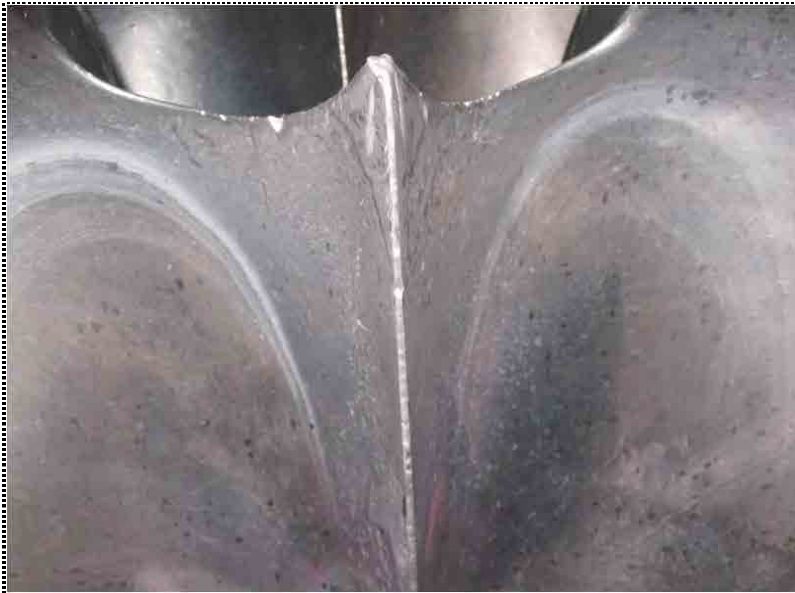
Cavitation pitting on back side of No. 13 Bucket Inlet, which is the most severe cavitation damage in Unit 1 runner bucket

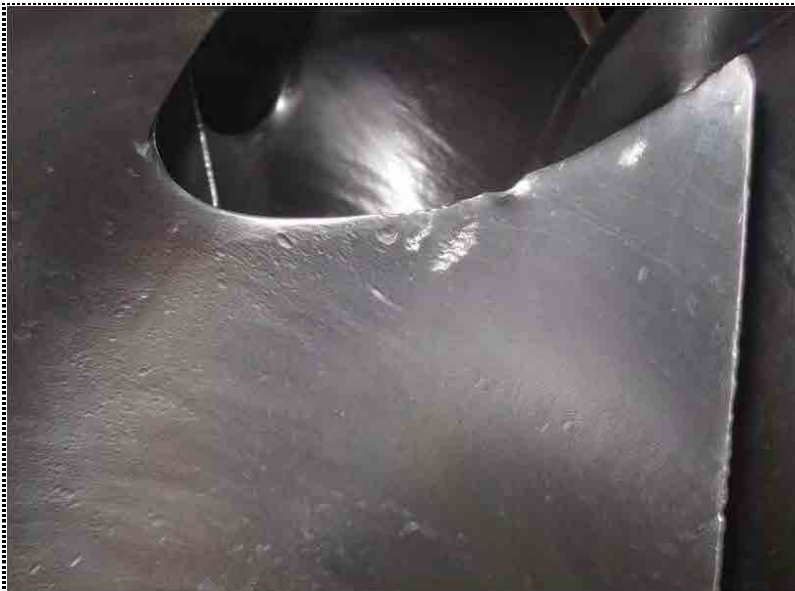
Unit No. 2 A Runner Bucket Cavitation

Near the inlet edge top of the action surface of Bucket No.9, light cavitation is observed.

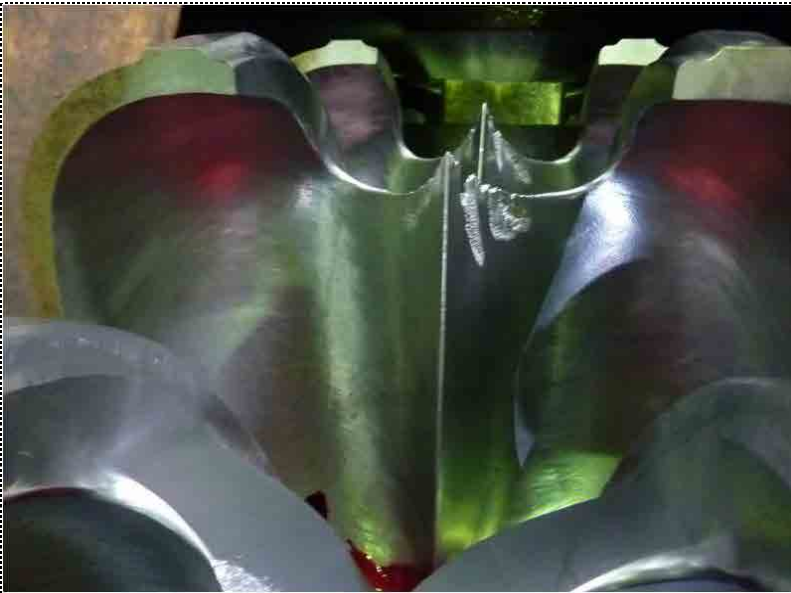
Cavitation pitting on back side of No. 9 Bucket Inlet, which is the most severe cavitation damage in Unit 2 A runner bucket

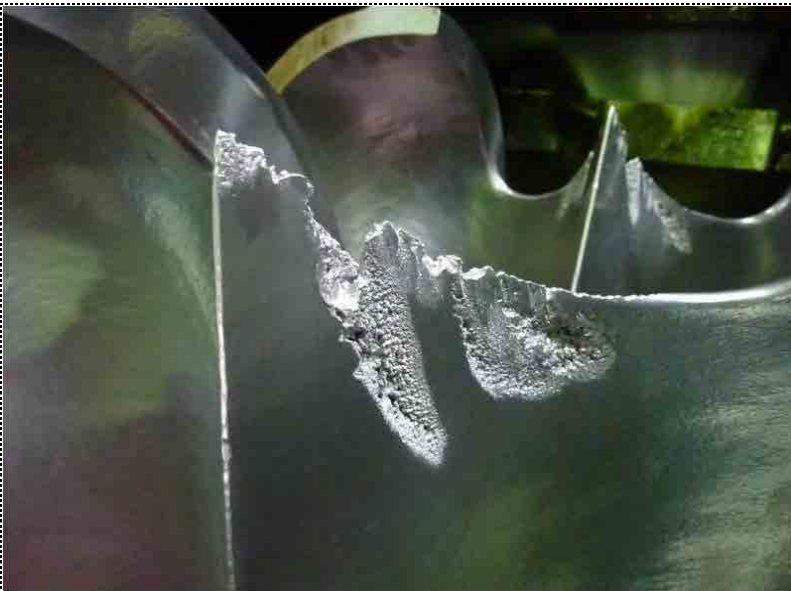
Unit No. 2 B Runner Bucket Cavitation

Quite heavy cavitation pitting is observed at the leading edge of the action side of Bucket No. 5

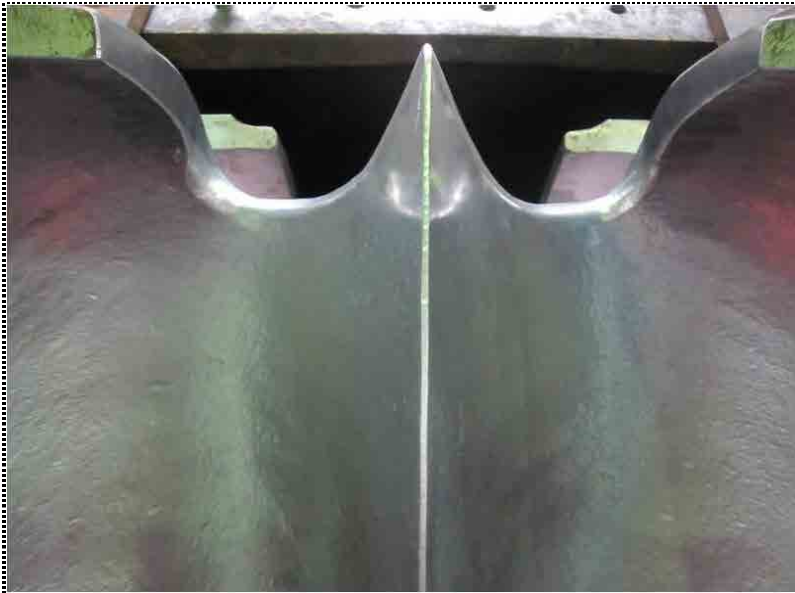
Cavitation pitting on back side of No. 5 Bucket Inlet, which is the most severe cavitation damage in Unit 2 B runner bucket

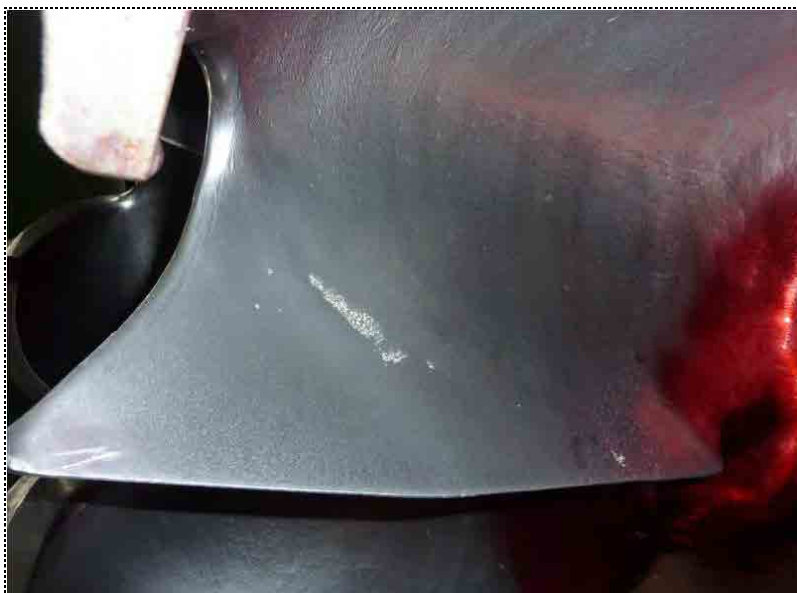
Unit No. 3 B Runner Bucket Cavitation

Light cavitation pitting is observed near the leading edge of the action side of Bucket No. 6

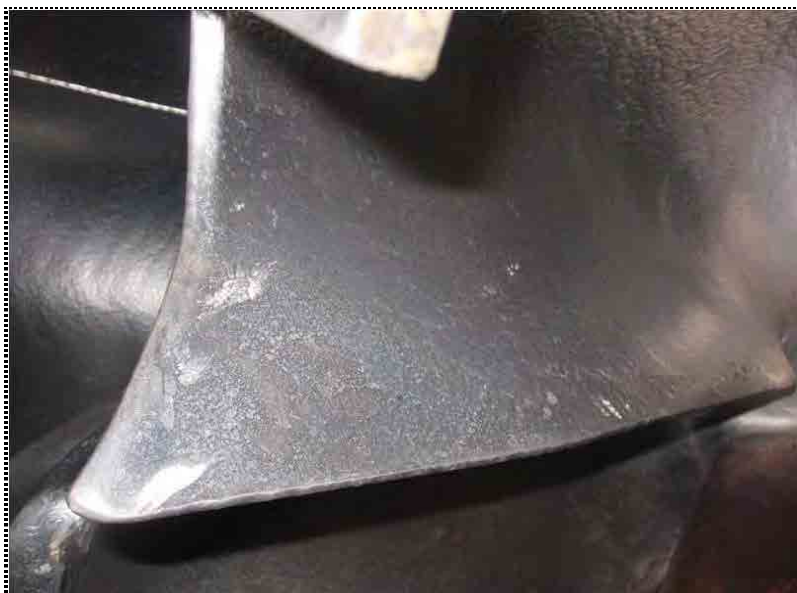
Unit No. 4 A Runner Bucket Cavitation

Small cavitation pitting is observed near the leading edge of the action side of Bucket No. 1

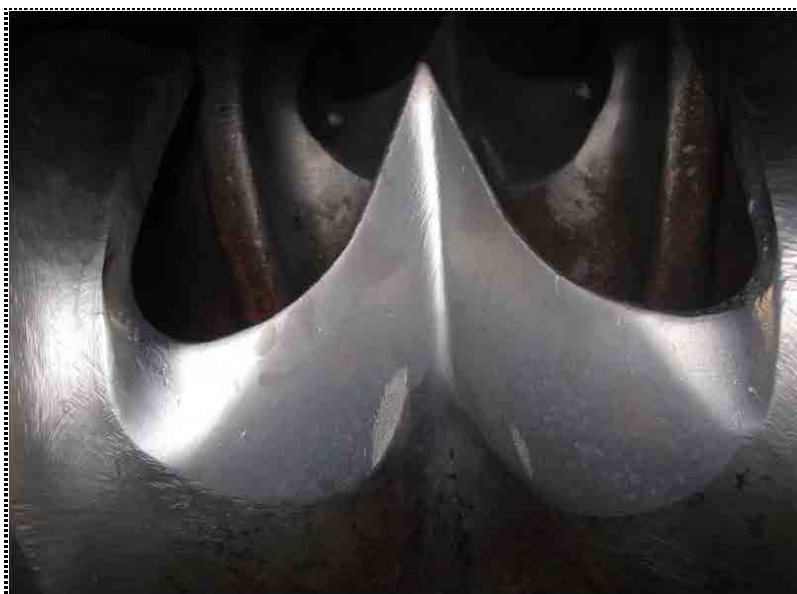
Unit No. 4 A Runner Bucket Cavitation

Typical photo of light inlet edge cavitation of action surface on Bucket No. 1  
Also, at the stream surface of the bucket erosion is observed.

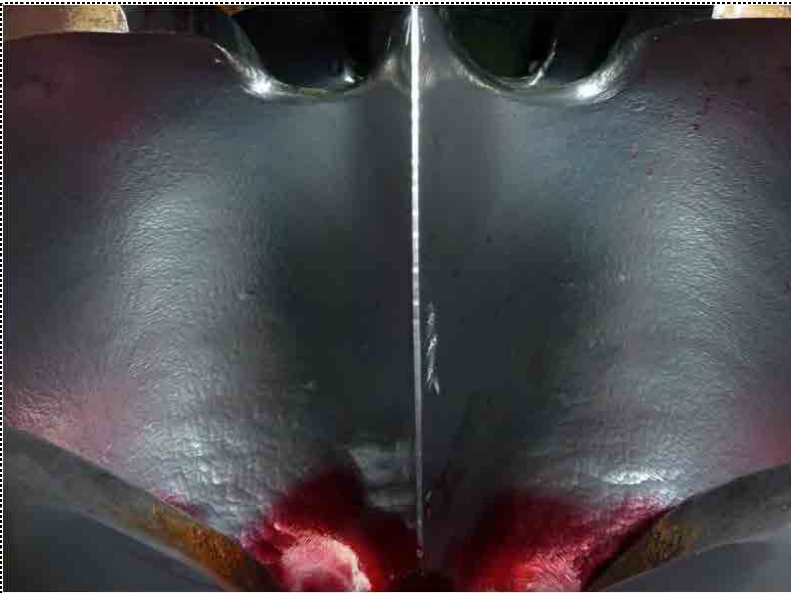
Minor cavitation pitting on back side of No. 1 Bucket inlet is observed.

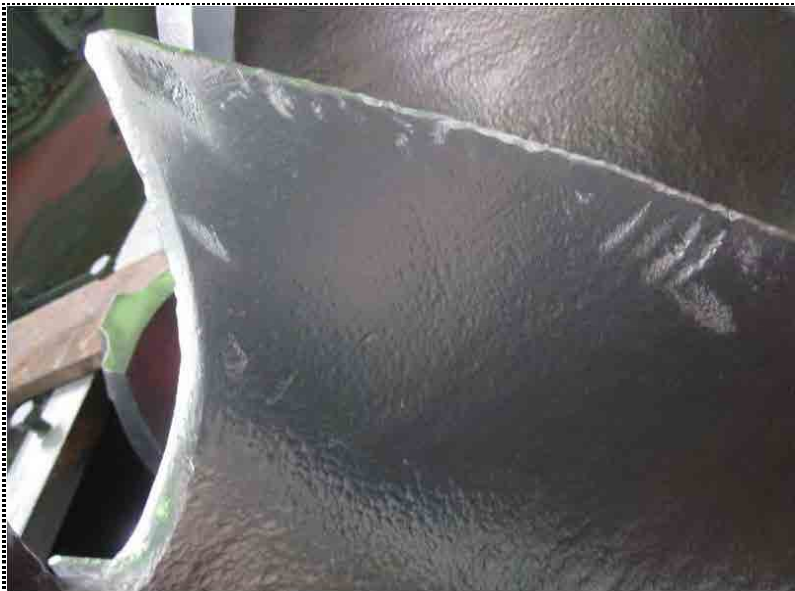
Unit No. 5 A Runner Bucket Cavitation

Light cavitation pitting at the leading edge of the action side of Bucket No. 19 and erosion at the stream surface of the bucket is observed.

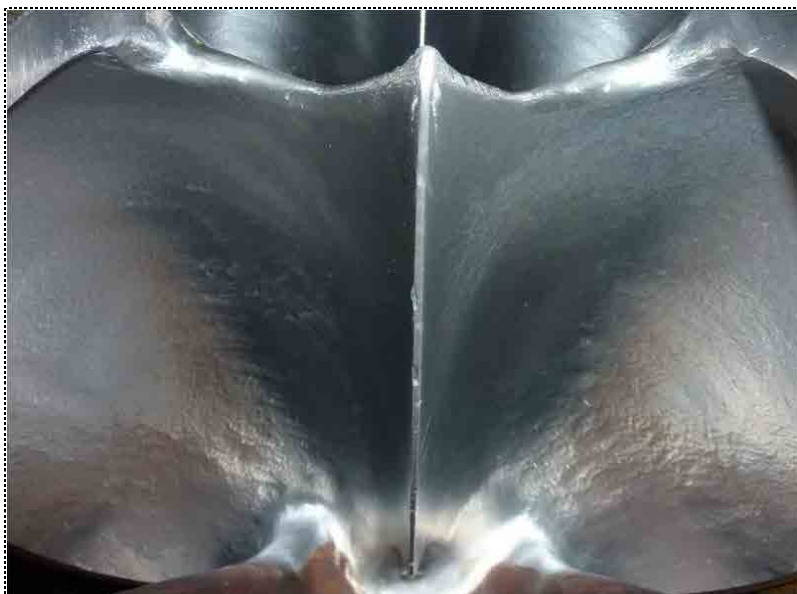
Cavitation pitting on back side of No. 19 Bucket Inlet, which is the most severe cavitation damage in Unit 5 A runner bucket

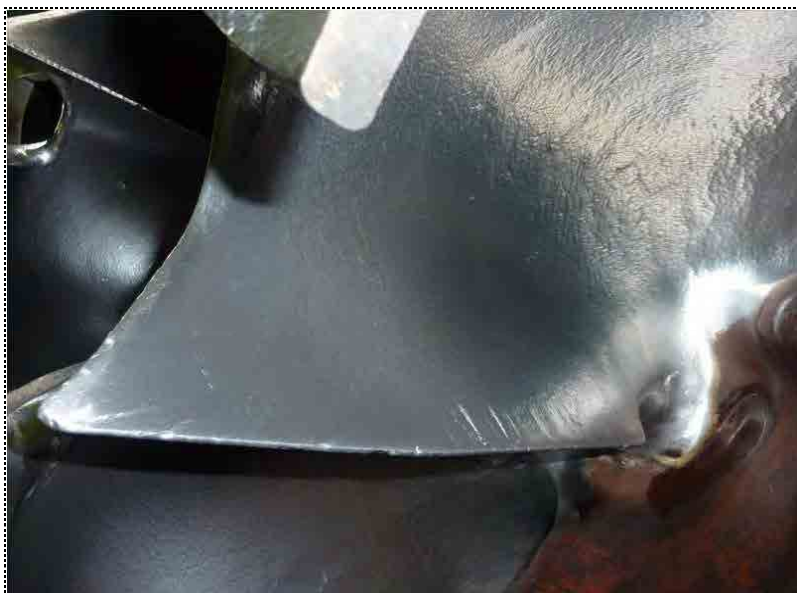
Unit No. 5 B Runner Bucket Cavitation

Light cavitation pitting is observed at the leading edge of the action side of Bucket No. 12

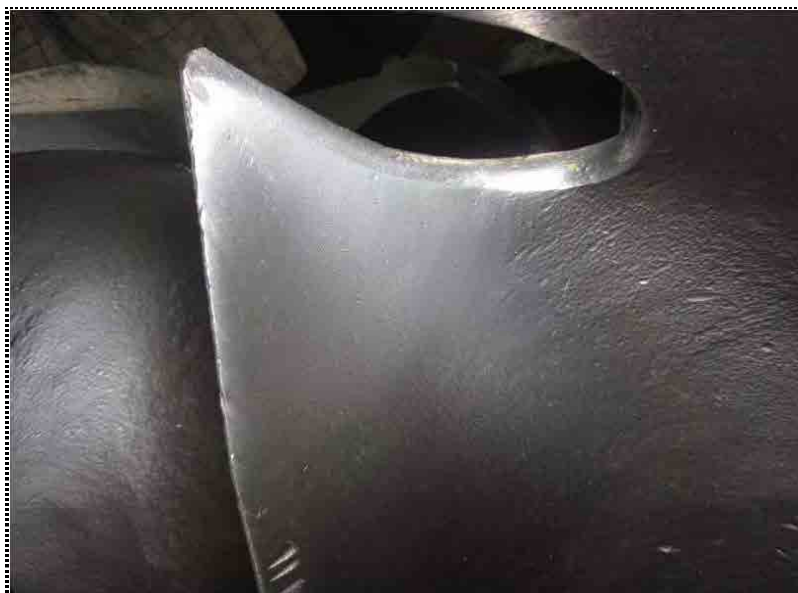
Unit No. 6 A Runner Bucket Cavitation

Light cavitation pitting is observed at the leading edge of the action side of Bucket No. 10

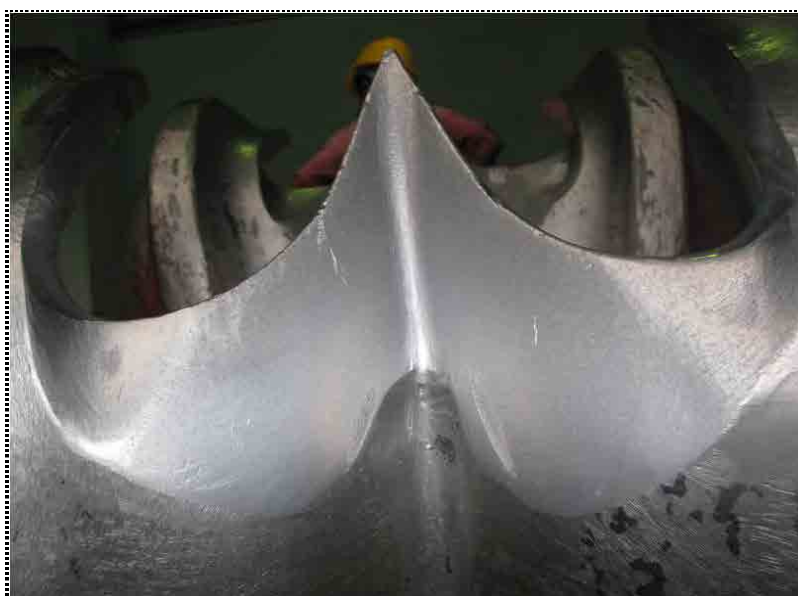
Unit No. 6 A Runner Bucket Cavitation

Typical photo of light inlet edge cavitation of action surface on Bucket No. 10

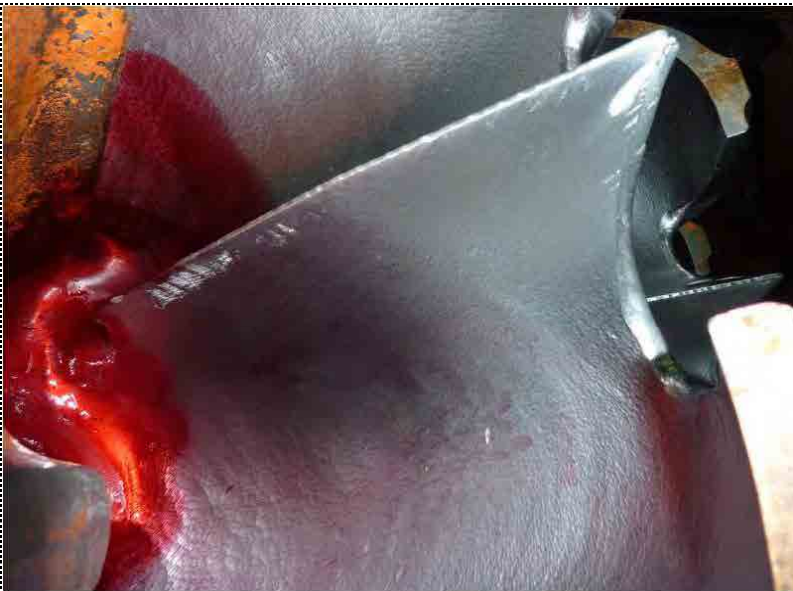
Unit No. 6 B Runner Bucket Cavitation

Rather light cavitation pitting is observed at the leading edge of the action side of Bucket No. 5

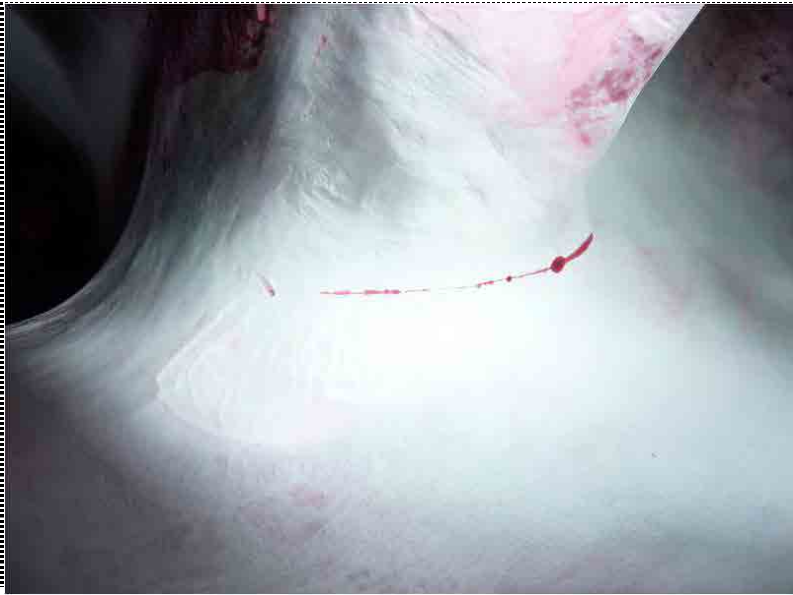
SideB No.9 bucket crack

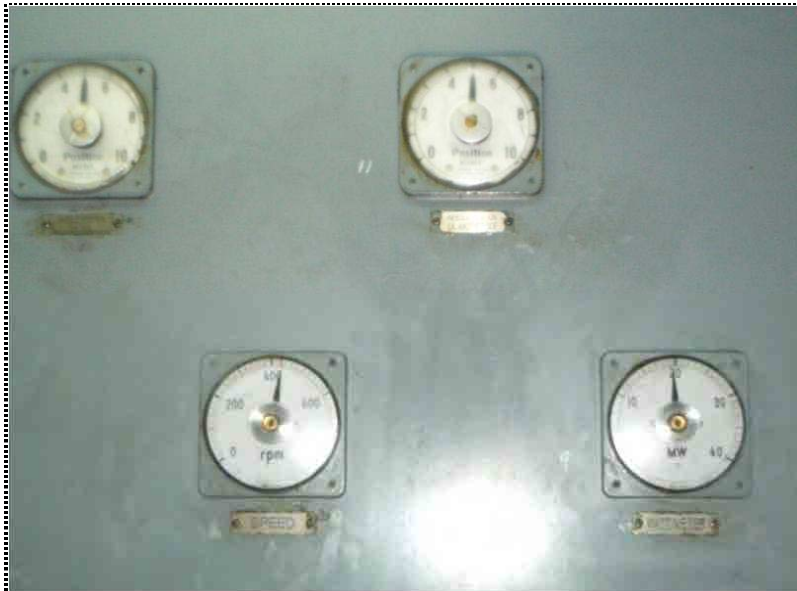
Unit No. 1 Governor Cabinet and Damaged Dial Indicators

- 1) It is observed that many instruments mounted on Instrument and Governor Cabinets are broken or malfunctioned. These instruments shall be replaced with new ones to have more reliability. Leaked oil inside of all governor cabinet is observed. Dirty governor oil shall be purified.

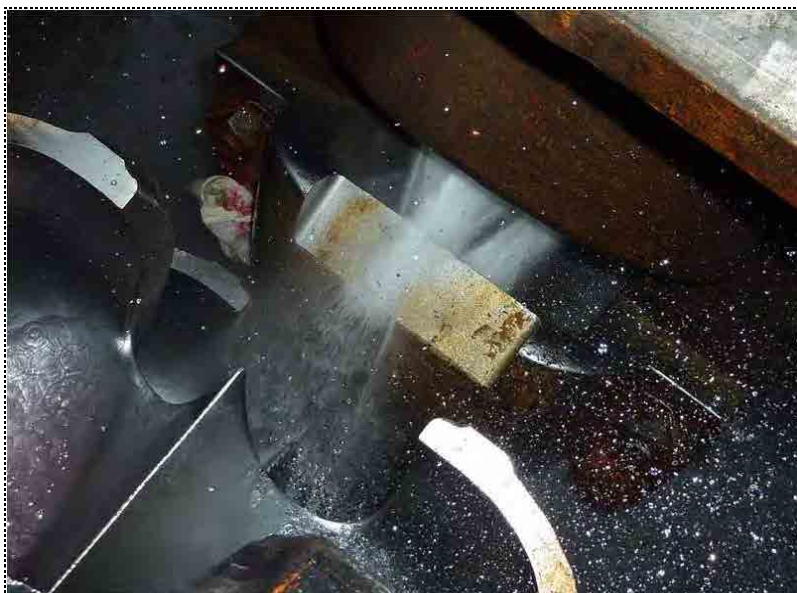
Unit No. 2 A Upper Needle Cavitation

Around the needle tip,  
cavitation pitting and erosion is observed.

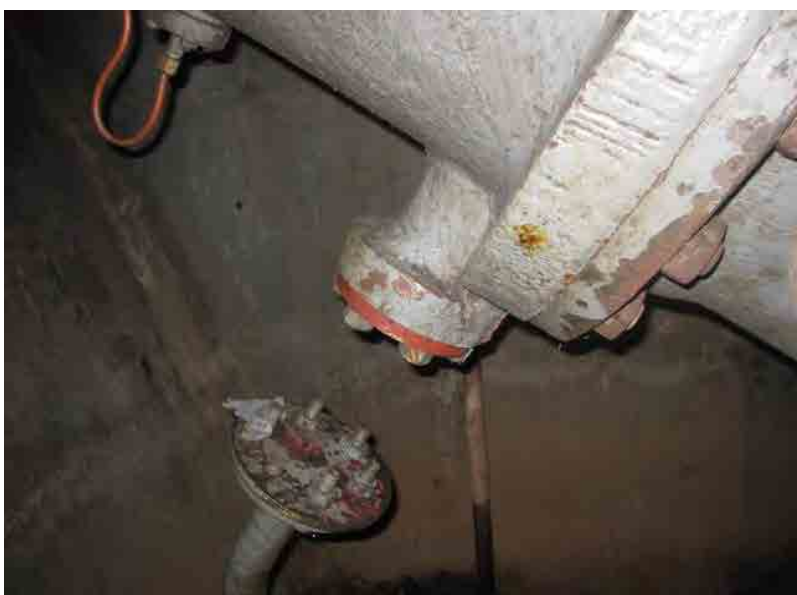
Unit No. 2 B Upper Needle Shaft Leakage

Due to damage of needle and nozzle,  
leakage water is observed.

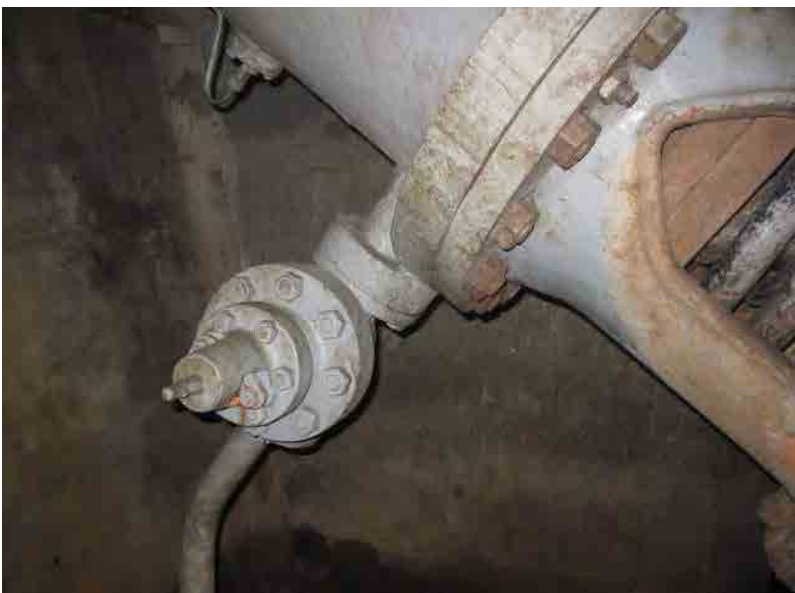
From relatively smaller water leakage from the needle tip, cavitation pitting around needle, nozzle and deflector seems to be lighter comparing with Unit No. 4 through 6,

This condition is the same with No. 3 B needle nozzle and deflector.

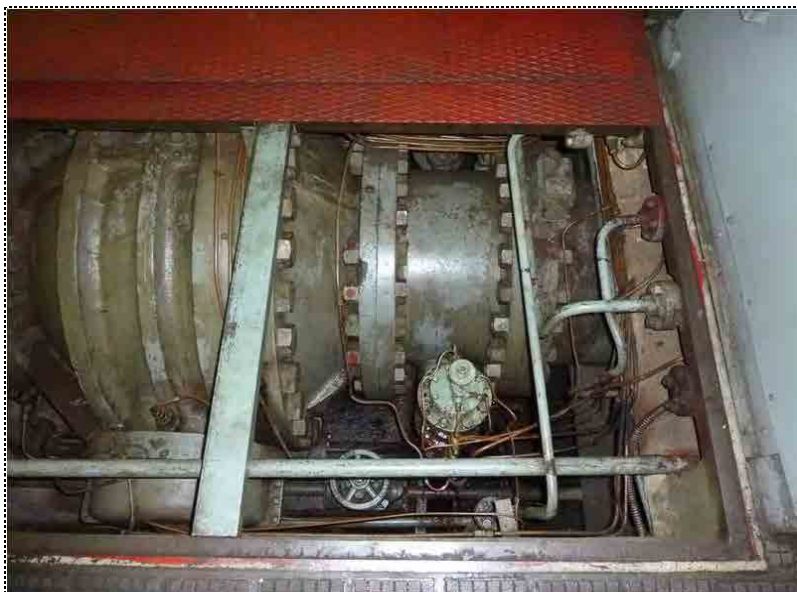
Unit No. 3 Jet Brake Valve

Due to sticking problem of the valve rod, jet brake is disassembled and repaired.

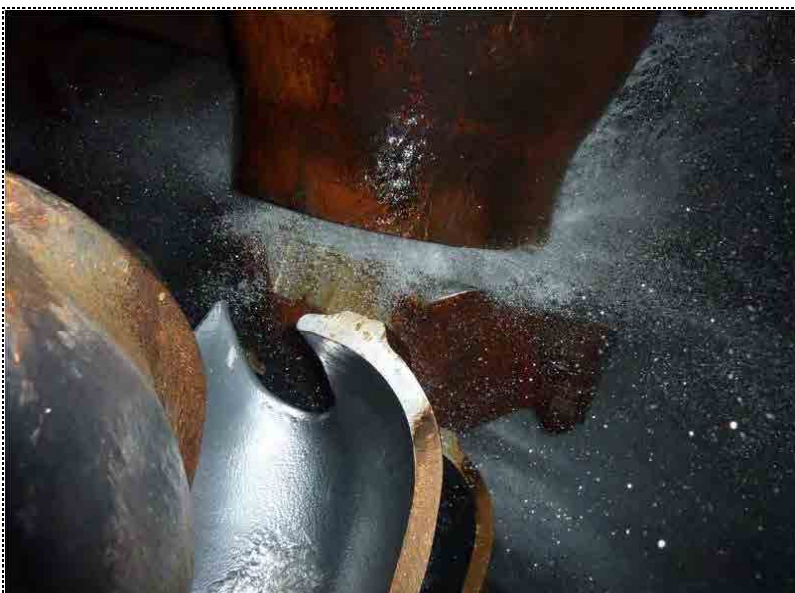
Large water leakage from 4A needle nozzle is observed.

Only deflector works to stop water not to hit the runner bucket.

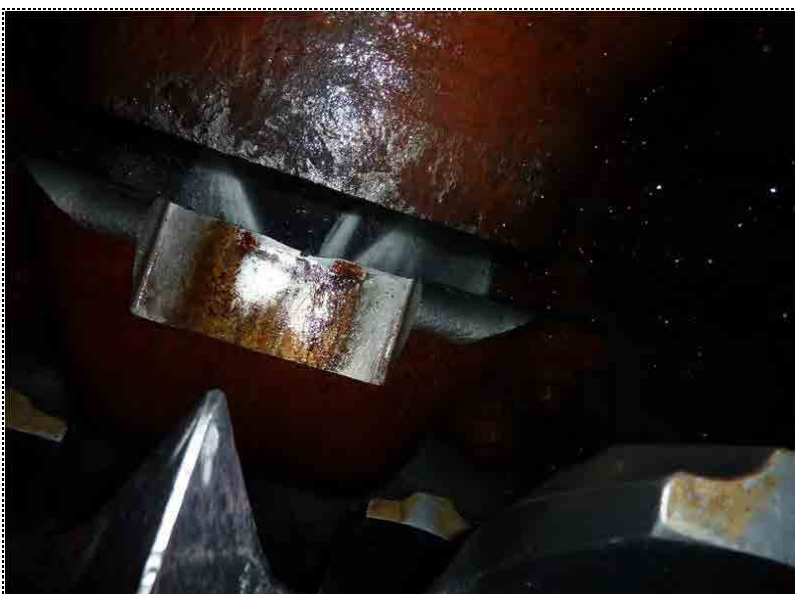
Unit No. 4 B Upper Needle Water Leakage

Leaked water hits the deflector heavily.

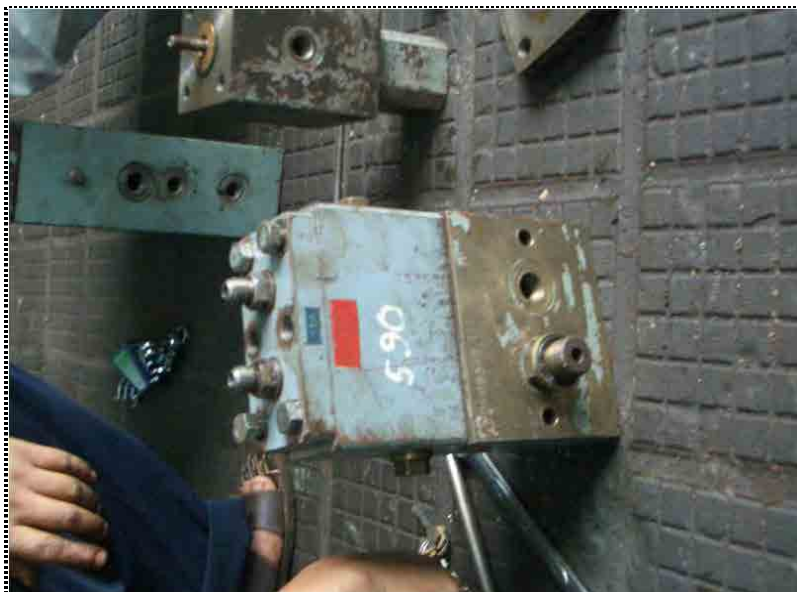
Typical Photo of Disassembled Distributing  
Valve No. 550

Due to galling and sticking problem  
of distributing valve rod, this valve is  
removed from the panel for repair

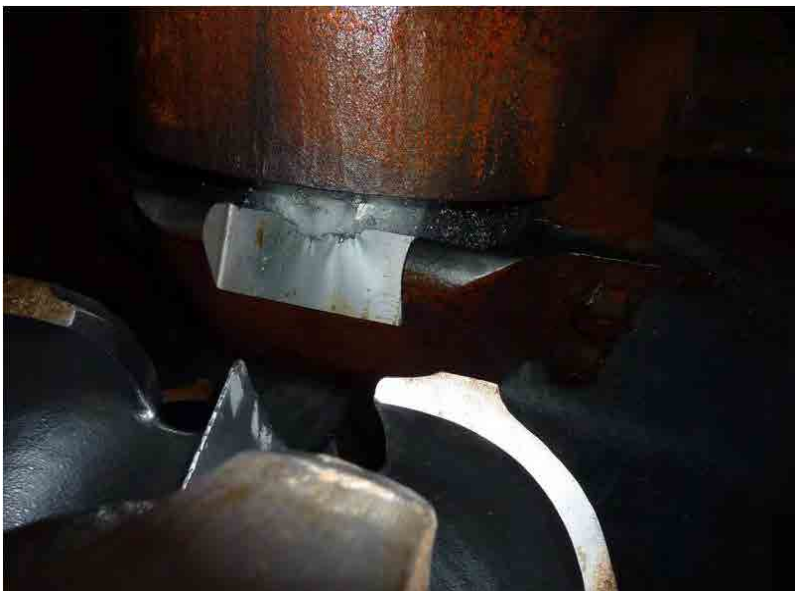
- 4) Typical photo shows the cavitation pitting and erosion around the middle of the deflector leading edge on Unit No. 5A (Upper), which will cause further rapid pitting of the deflector and

Unit No. 5 A Upper Deflector

Deflector machined surface edge is damaged by cavitation pitting and erosion.

shall be replaced with new one.

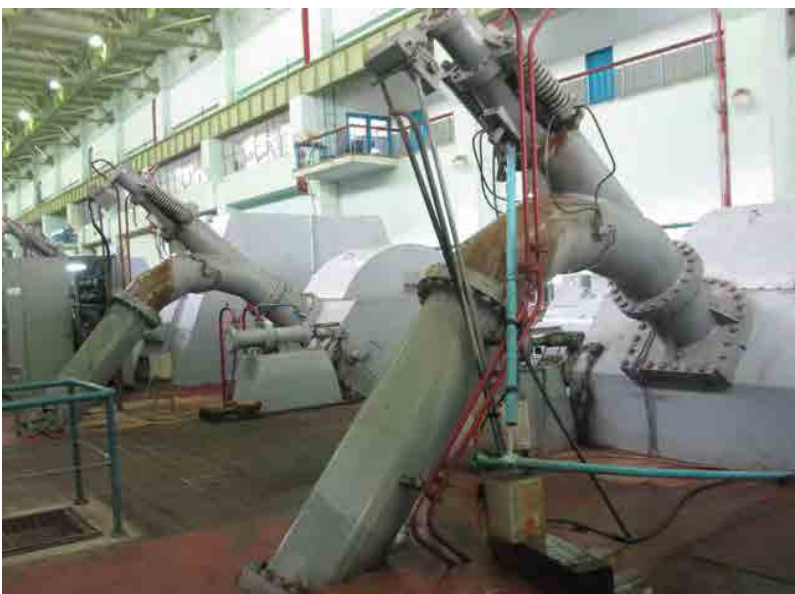
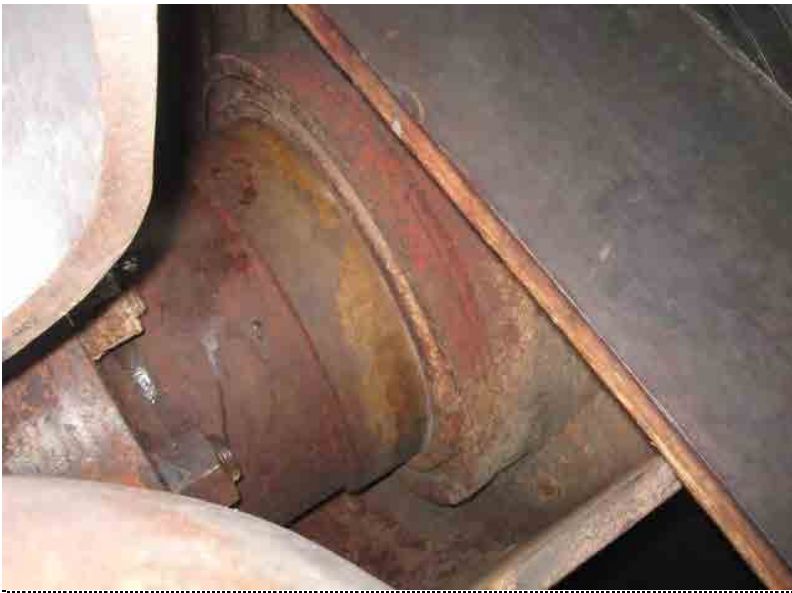
Water Leakage from 5B Needle Shaft Seal

Back side: 5B ( Front Side 6A) water leakage from needle shaft seal

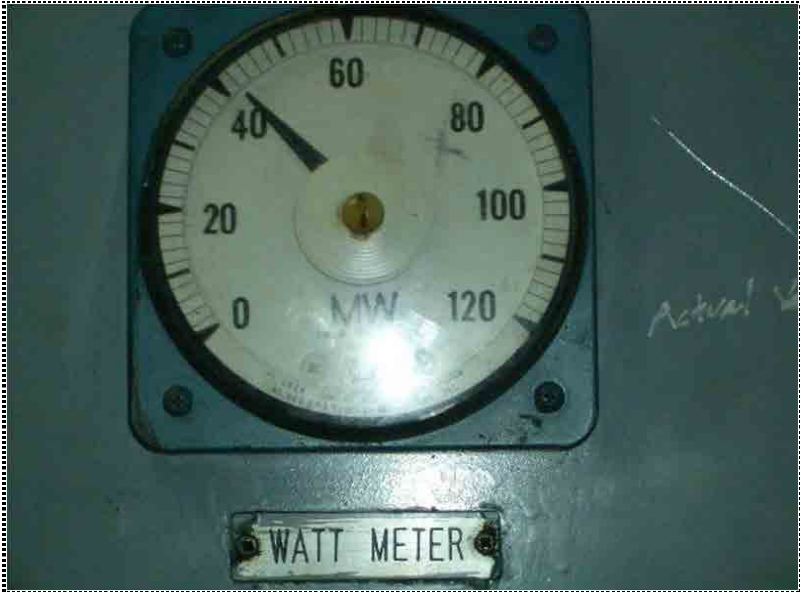
Typical Photo of Glass Damaged Indicator

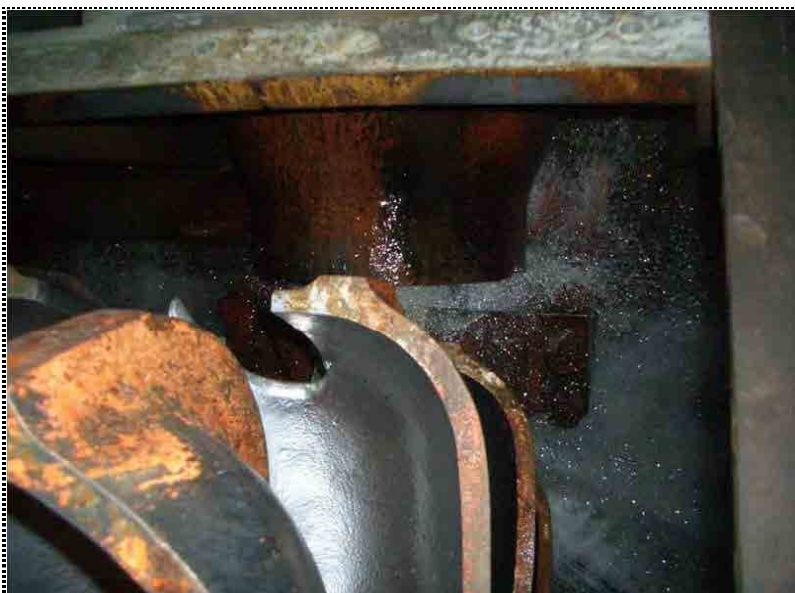
Unit No. 6 A Upper Needle Cavitation

Around the needle tip, heavy cavitation pitting and erosion is observed. Due to this damage, penstock water can not be sealed at the needle fully closed position.

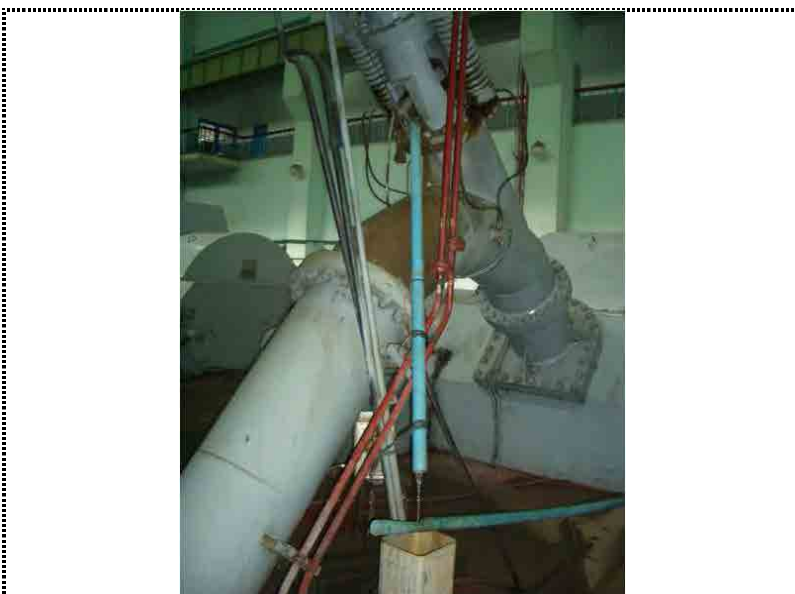
Unit No. 6 B Upper Needle Cavitation

Due to heavy water leakage from the needle nozzle, details of cavitation pitting and erosion cannot be inspected.

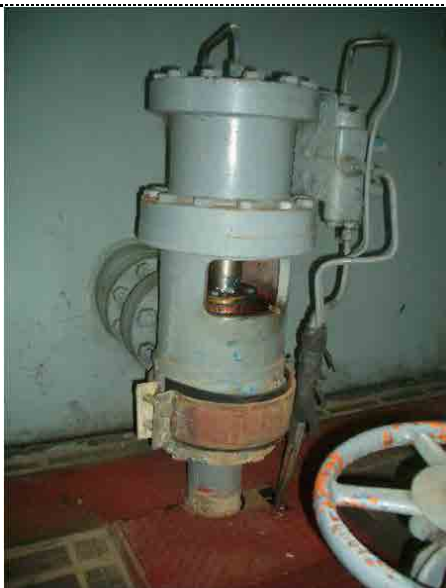
Water Leakage from Needle Shaft on No. 6 A

Water leakage is observed on No. 6 A needle shaft area.

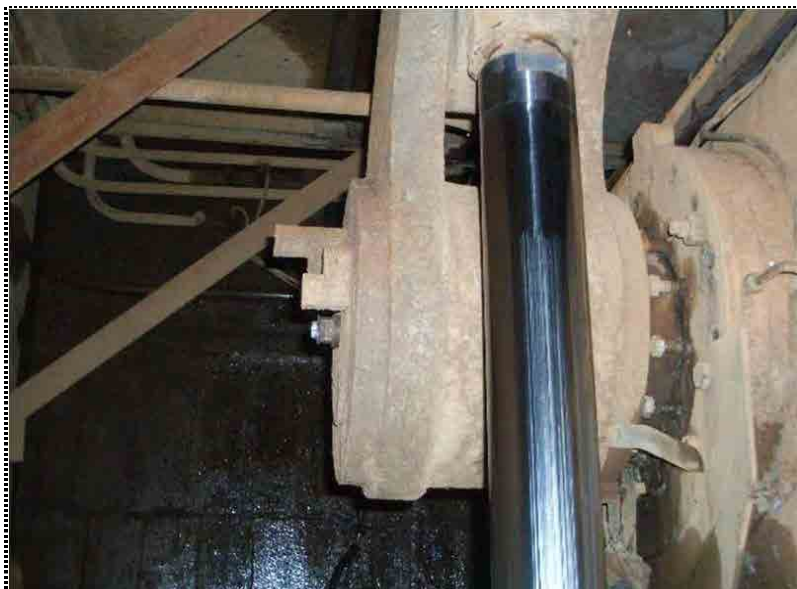
- 4) Water leakage from the jet brake valve body on Unit No. 6 is observed. This jet brake shall be replaced with new one.

Leakage from Jet Brake Body

Leaking portion is temporary sealed with steel plate and rubber sheet.

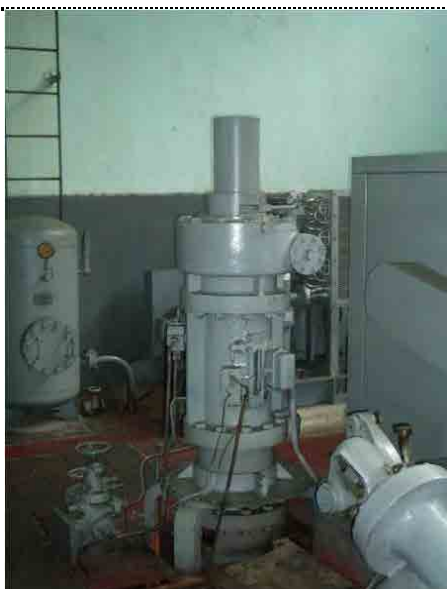
This water leak is by the damage of  
the seal elements provided at the stem.

Also, servomotor body is exposed to muddy  
silt water.

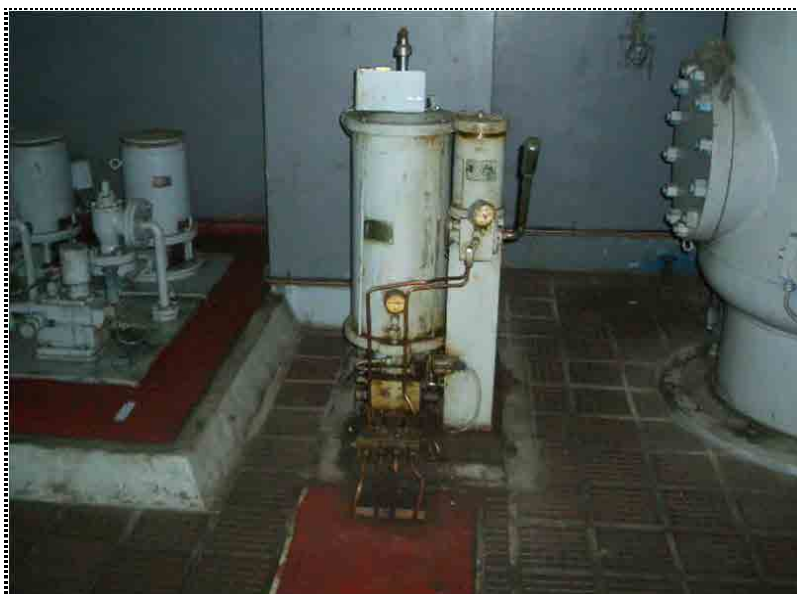
Existing Cooling Water Supply Pump and Motor for Unit No. 2

The existing pump has leakage problem and the motor is damaged.

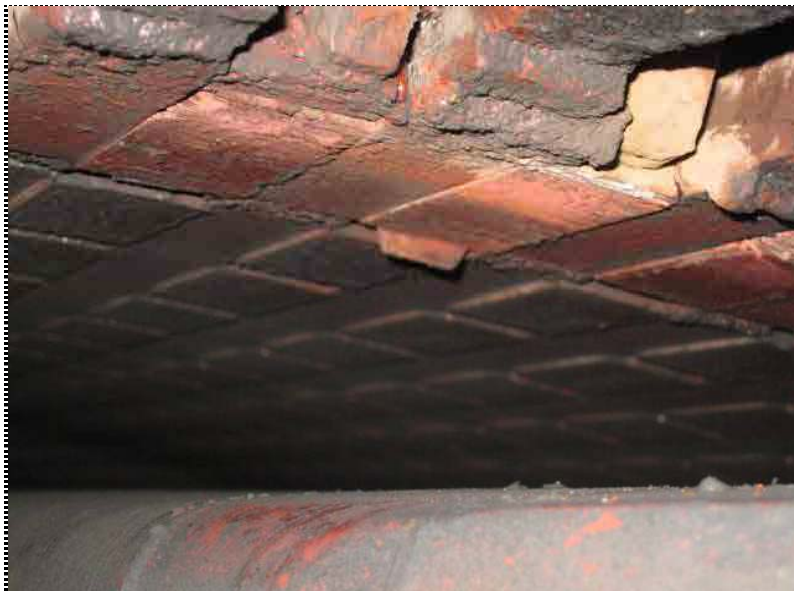
Stator Core

Red rust on Split of Core

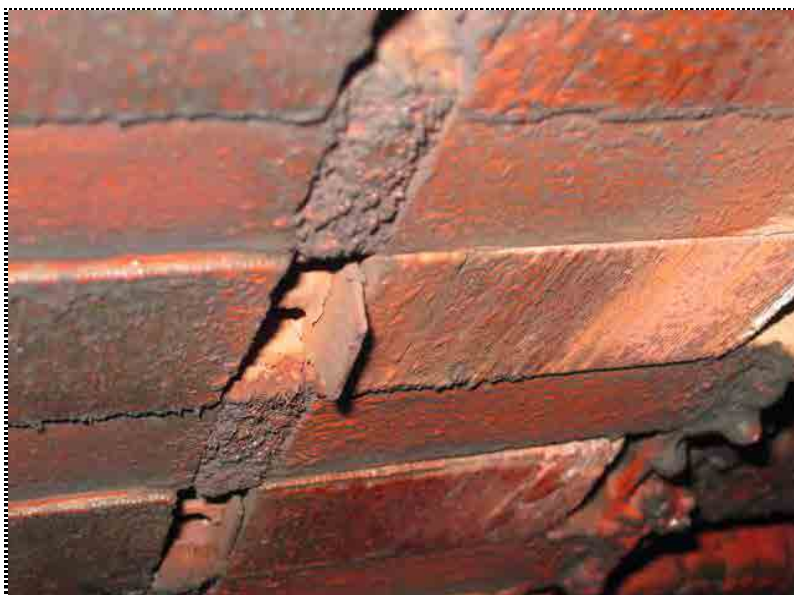
Stator Core

Defect on Air Duct of Core

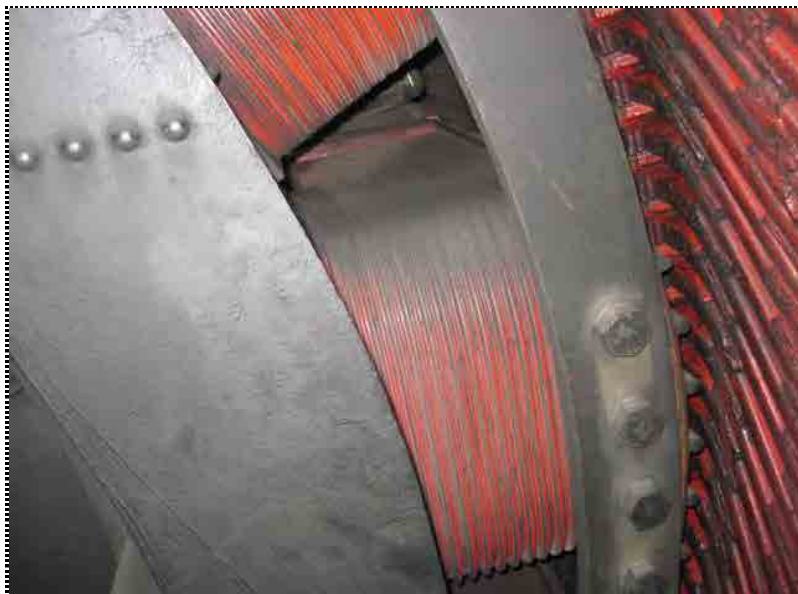
Stator Core

Defect on Air Duct of Core

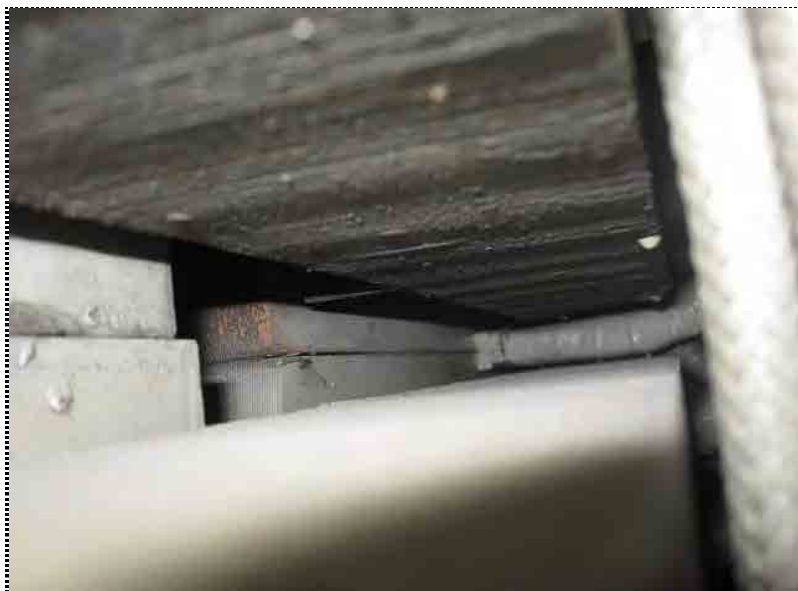
Stator Core

Red rust

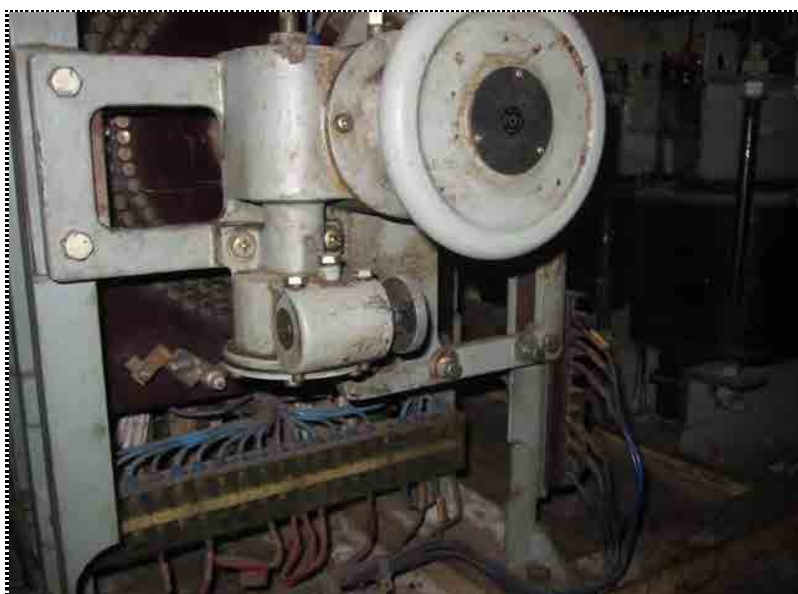
Excitation System

Damaged part (Thyristor)

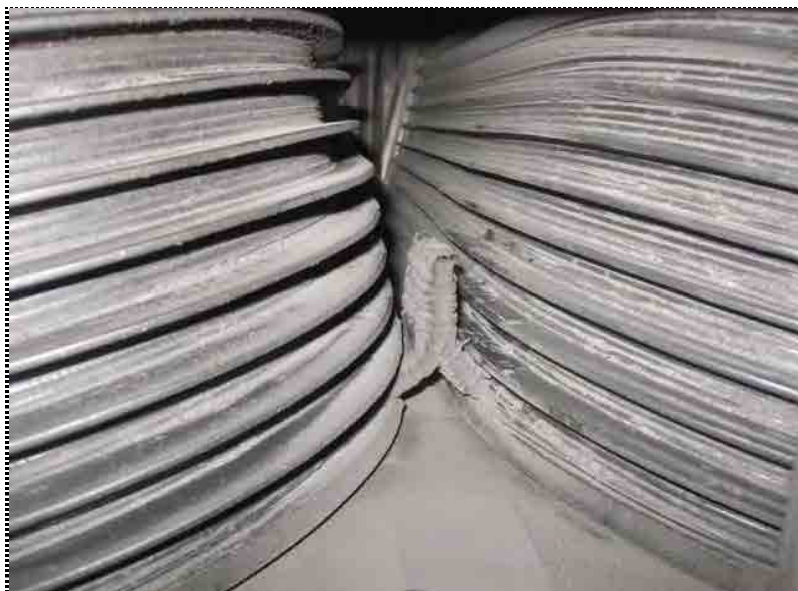
Air Cooler

The track of water leakage

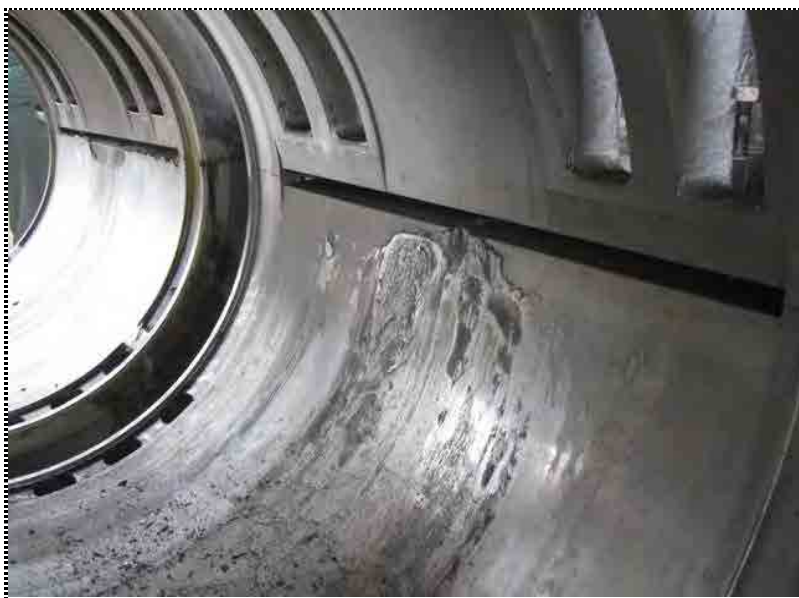
Guide Bearing

Damaged Bearing (1)

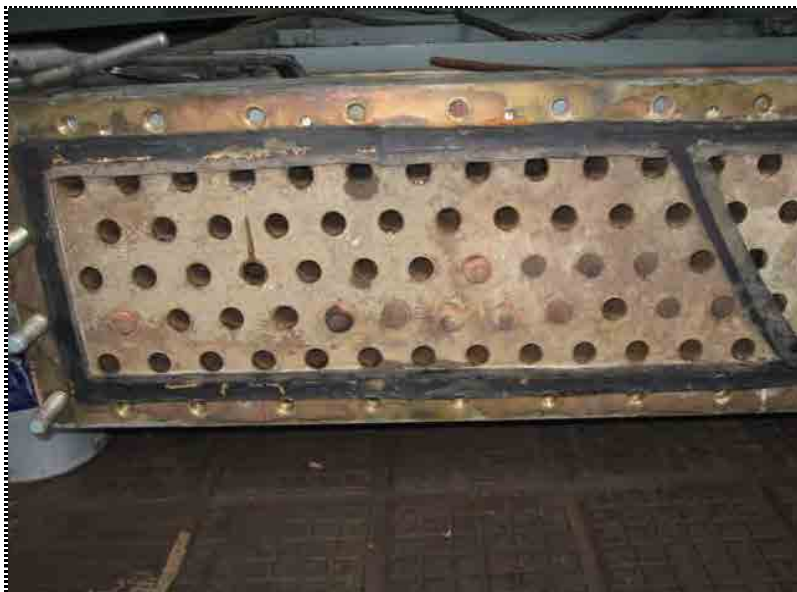
Generator Air Cooler

Damaged air cooler (1)

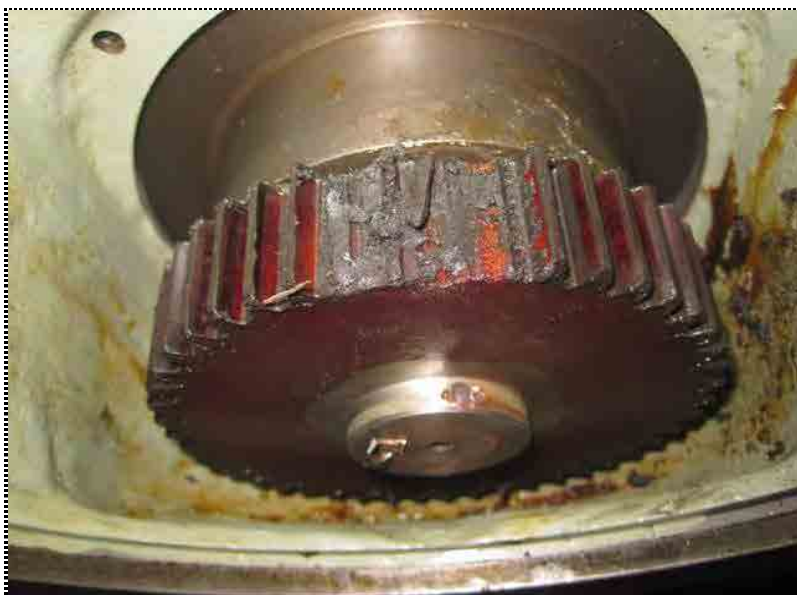
Speed detector for generator

Damaged gear (1)
