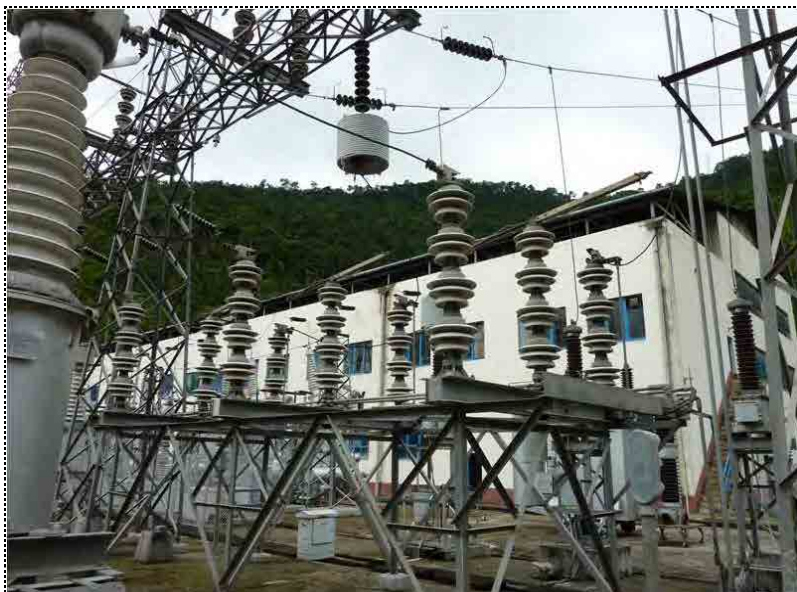
No 509

Oil leakage was repaired

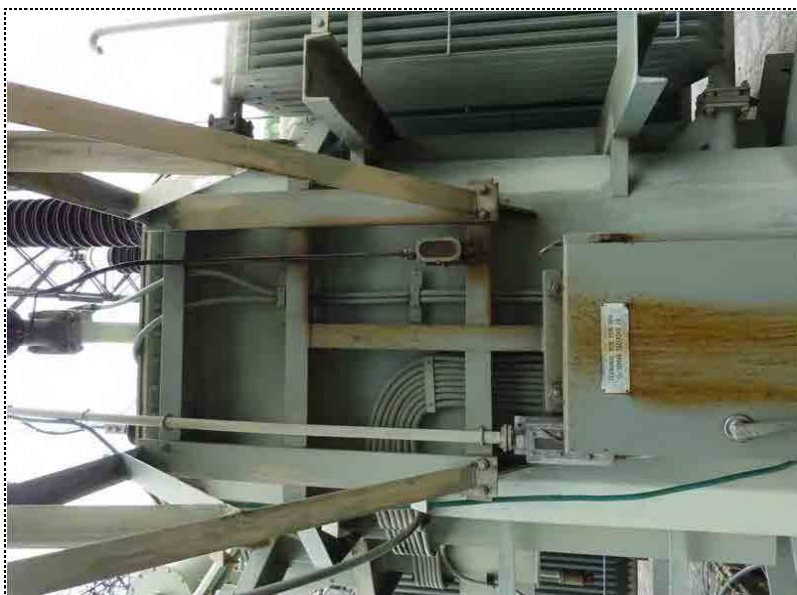
No 708

Oil was leaked from the buchholtz relay.

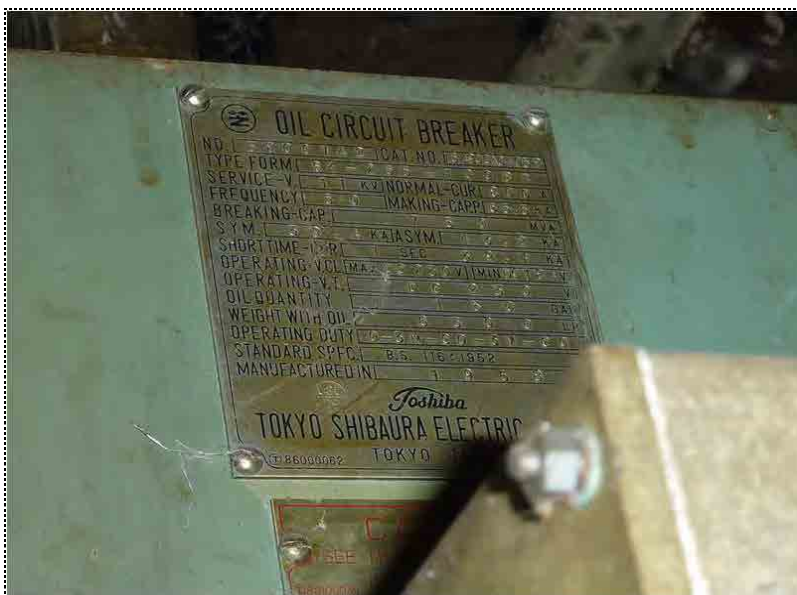
No 902

Oil was leaked from the arc-suppression tank.

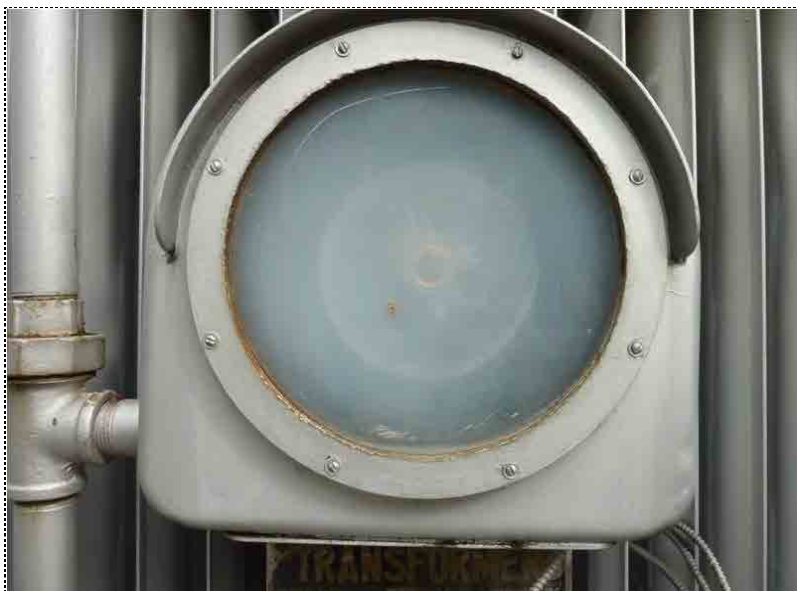
No 907

Oil has been leaked from joint parts.

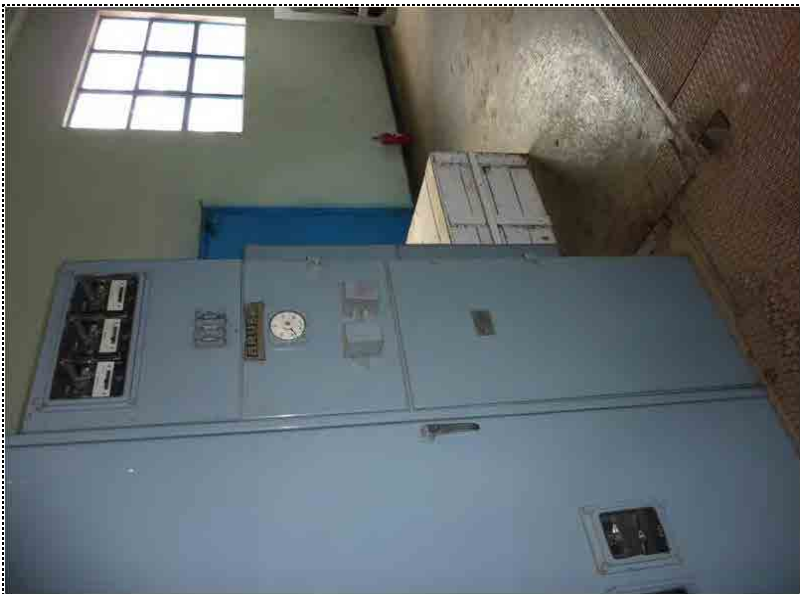
No 912

The heavy oil leakage was confirmed

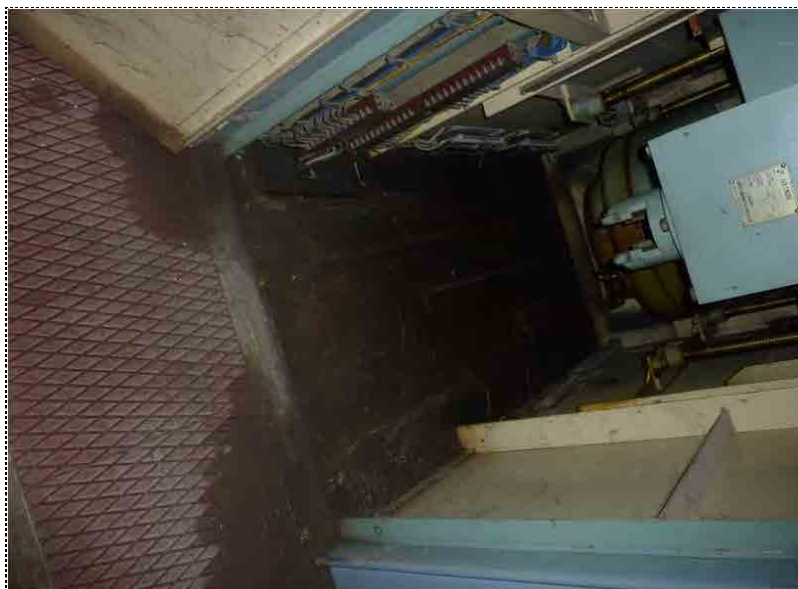
The oil leakage was confirmed.

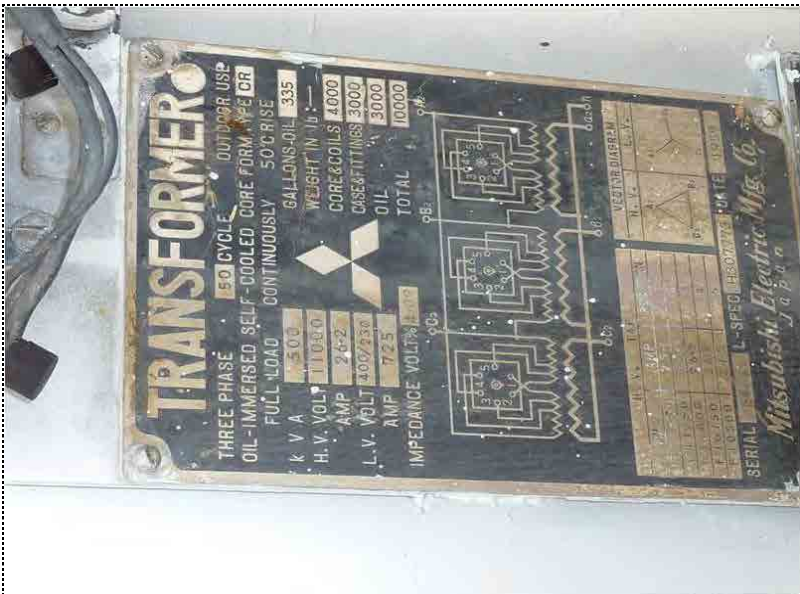
No 927

The oil leakage was confirmed at No.2 House Transformer.

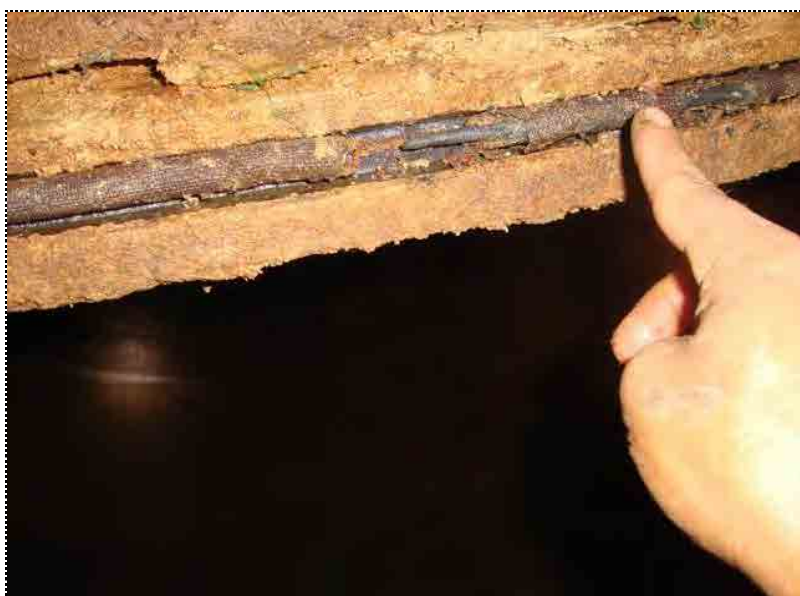
No 3

Items		Results	Photo No.
1	Water leakage	ND	-
2	Difference between packing and pipe (packing condition)	ND	-
3	Designed drawing	○	-
4	Past repair record	When the inside of LPPL No.1 was painted from 8 August 2010 to 22 January 2011, the painting works could not be conducted due to water leakage from valve packing of the butterfly valve for LPPL No.1 at first. Therefore, the six (6) turbine-generators were stopped and drainage works of No.2 poundage was done for one day. After that, its sealing works were carried out. Although the painting works were started under the above conditions, the sealing material was broken in the middle of them. After that, damaged valve packing has not been repaired. According to the photo taken in 8 August 2010, the damaged condition was confirmed.	1-3
5	Others	Outside condition is no problem.	-

Situation of damaged packing
(view from the upstream)

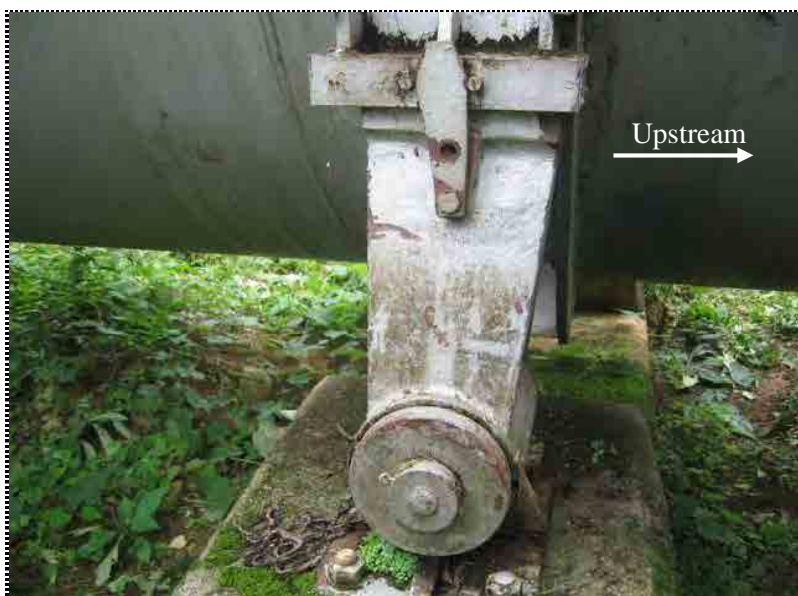
No 5

Items	Results	Photo No.
1 Rocker support No.	S3	4
2 Right side condition	None	-
3 Left side condition	Movement to the upstream	5
4 Past repair record	None	-
5 Others	When the inside of LPPL No.1 was painted from 8 August 2010 to 22 January 2011, maintenance staffs tried to repair the damaged rocker support by a jack and a chain block. However, it has not been completed yet. Measurement for the repair	-

Situation of damaged rocker support "S3"
This is the left side of rocker support,
which is moved to the upstream.
(view from the left side)

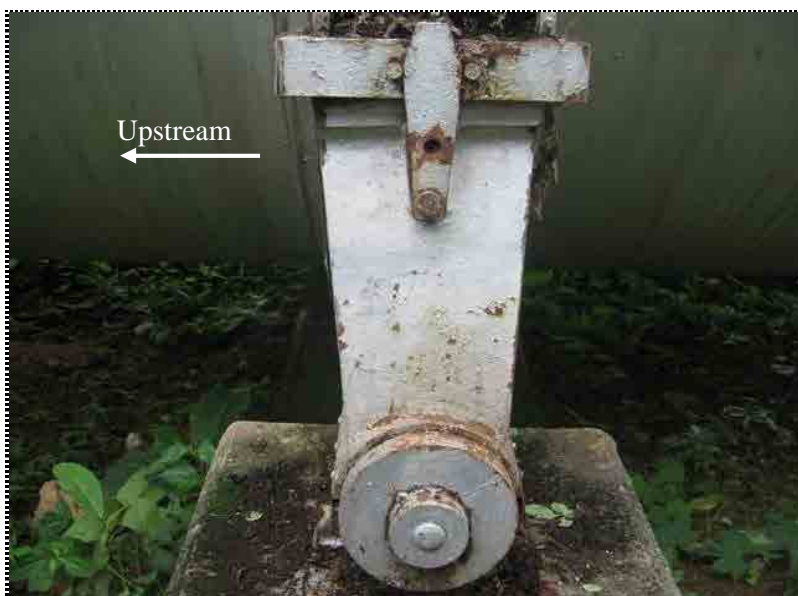
No 6

Items	Results	Photo No.
1 Rocker support No.	S4	-
2 Right side condition	Movement to the upstream	6
3 Left side condition	Movement to the downstream	7
4 Past repair record	None	-

Situation of damaged rocker support "S4"
This is the right side of rocker support,
which is moved to the upstream.
(view from the right side)

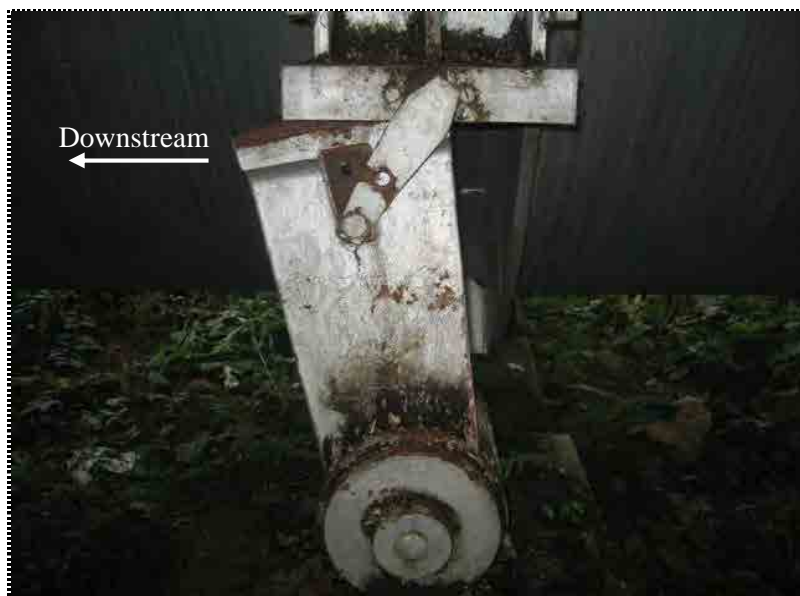
No 7

Situation of damaged rocker support "S4"
This is the left side of rocker support,
which is moved to the downstream.
(view from the left side)

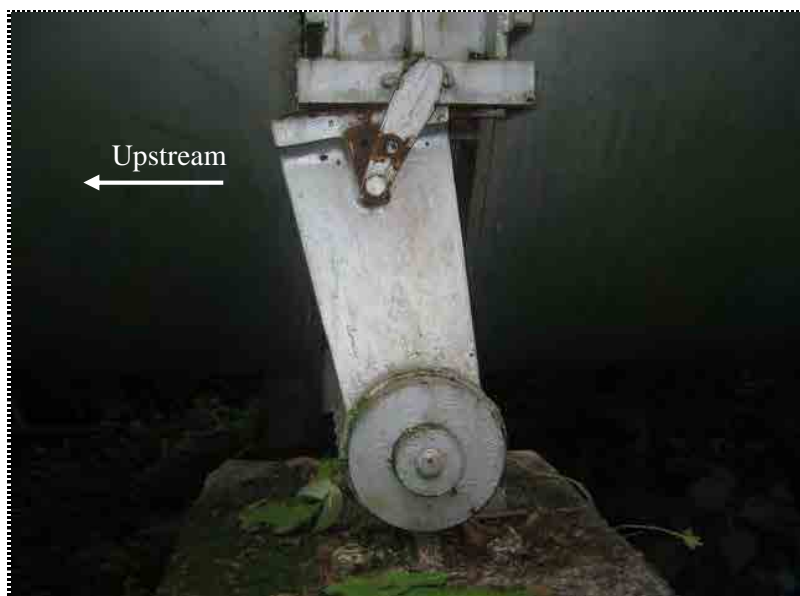
No 8

5	Others	Measurement for the repair	-
Items		Results	Photo No.
1	Rocker support No.	S5	-
2	Right side condition	Movement to the upstream	8
3	Left side condition	Movement to the upstream	9
4	Past repair record	None	-
5	Others	Measurement for the repair	-

Situation of damaged rocker support "S5"
This is the right side of rocker support,
which is moved to the upstream.
(view from the right side)

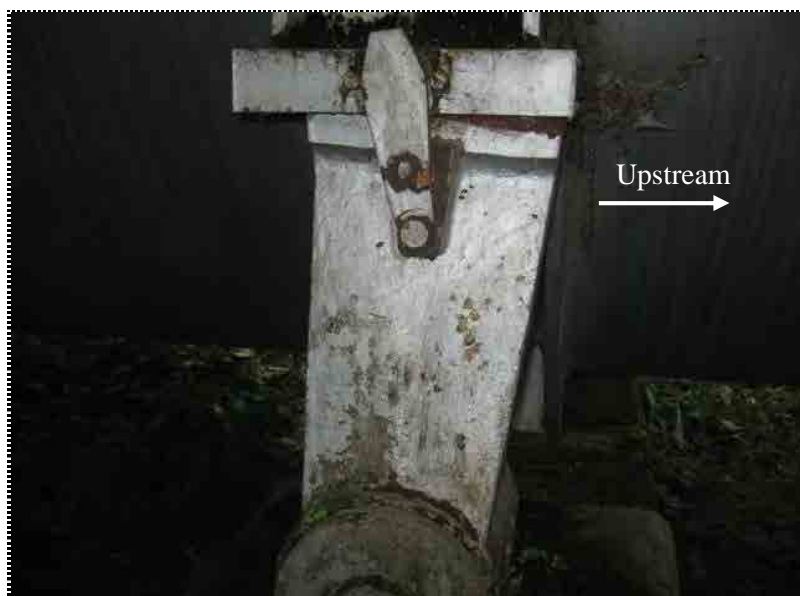
No 9

Situation of damaged rocker support "S5"
This is the left side of rocker support,
which is moved to the upstream.
(view from the left side)

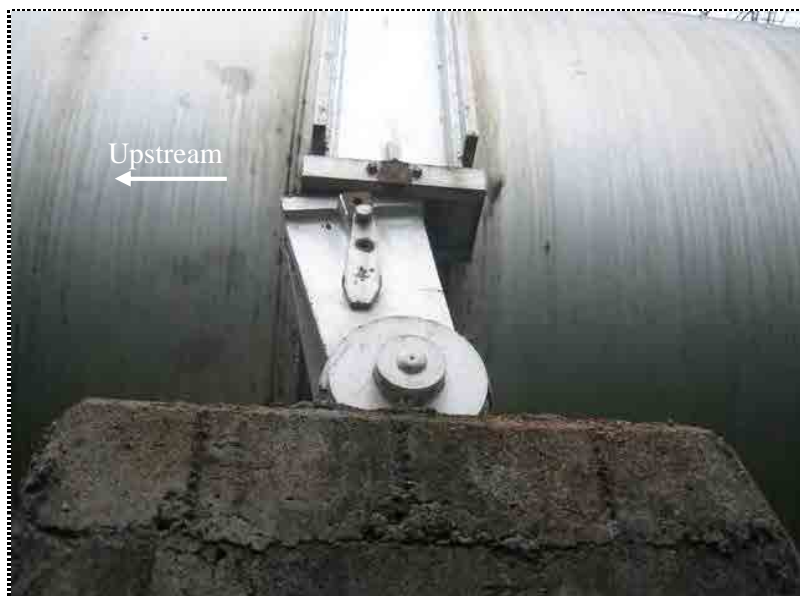
No 10

Items		Results	Photo No.
1	Rocker support No.	S49	-
2	Right side condition	Movement to the upstream	10
3	Left side condition	Movement to the upstream	11
4	Past repair record	None	-
5	Others	The upstream rocker support of S48 is structural steel type. Measurement for the repair	12

Situation of damaged rocker support "S49"

This is the right side of rocker support, which is moved to the upstream.
(view from the right side)

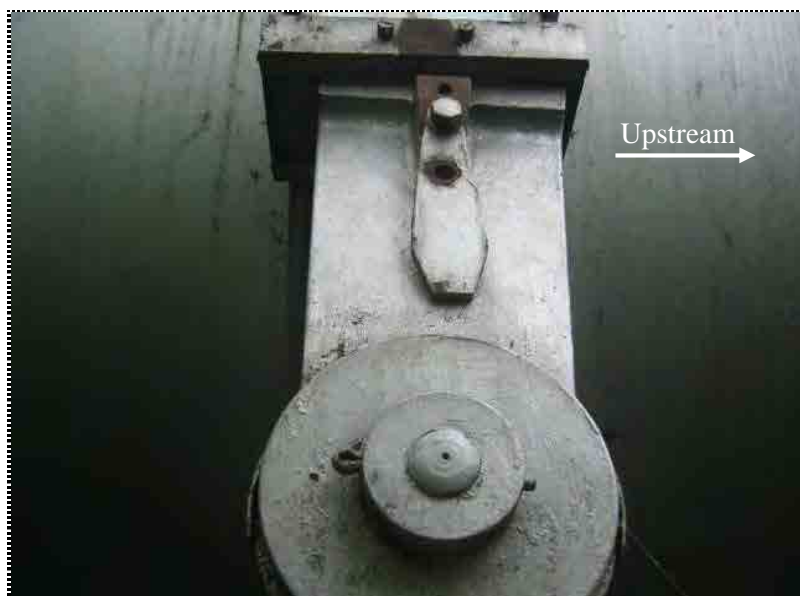
No 11

Situation of damaged rocker support "S49"

This is the left side of rocker support, which is moved to the upstream.
(view from the left side)

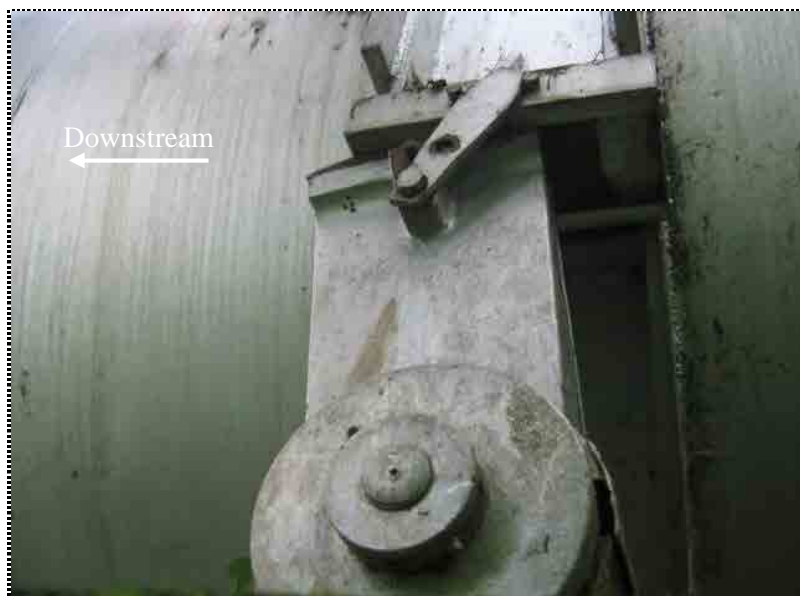
No 13

Items		Results	Photo No.
1	Rocker support No.	S50	-
2	Right side condition	None	-
3	Left side condition	Movement to the downstream	13
4	Past repair record	None	-
5	Others	Measurement for the repair	-

Situation of damaged rocker support "S50"

This is the left side of rocker support, which is moved to the downstream.
(view from the left side)

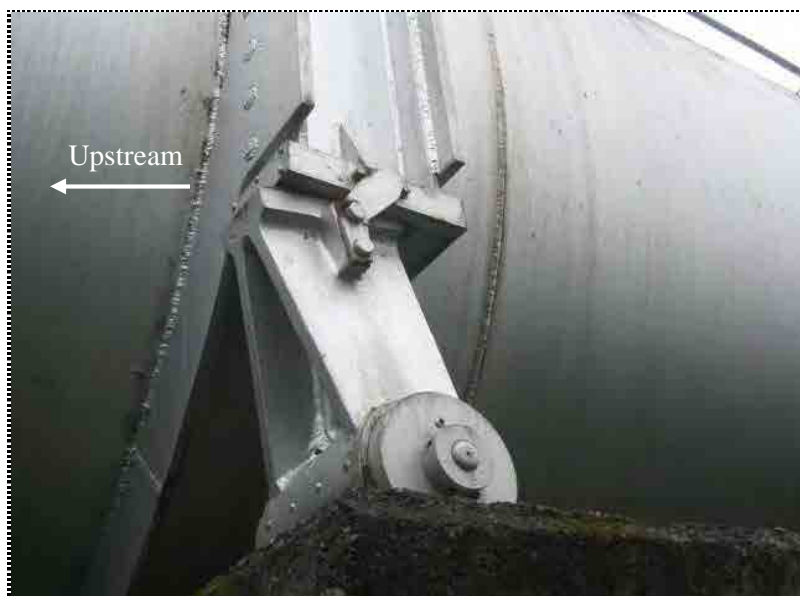
No 14

Items		Results	Photo No.
1	Rocker support No.	S51	-
2	Right side condition	Movement to the upstream	14
3	Left side condition	Movement to the upstream	15
4	Past repair record	None	-
5	Others	Measurement for the repair	-

Situation of damaged rocker support "S51"

This is the right side of rocker support, which is moved to the upstream.
(view from the right side)

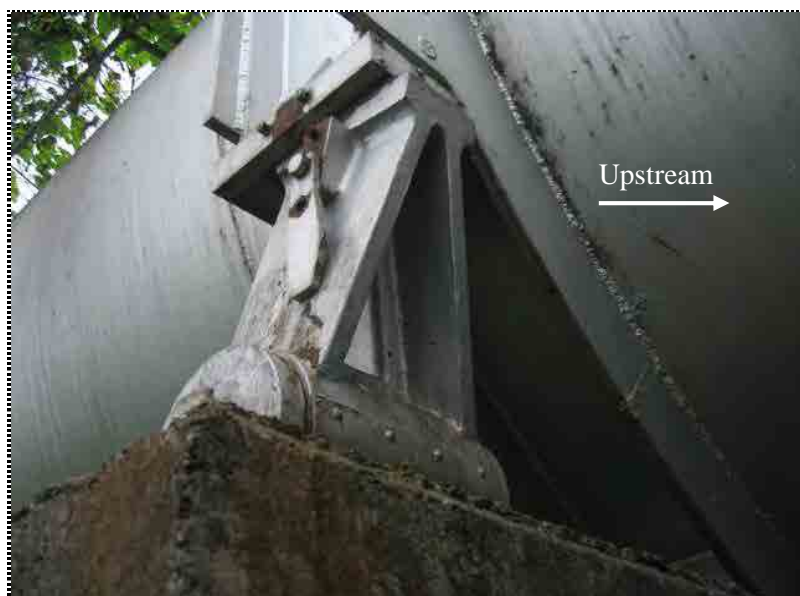
No 15

Situation of damaged rocker support "S51"

This is the left side of rocker support, which is moved to the upstream.
(view from the left side)

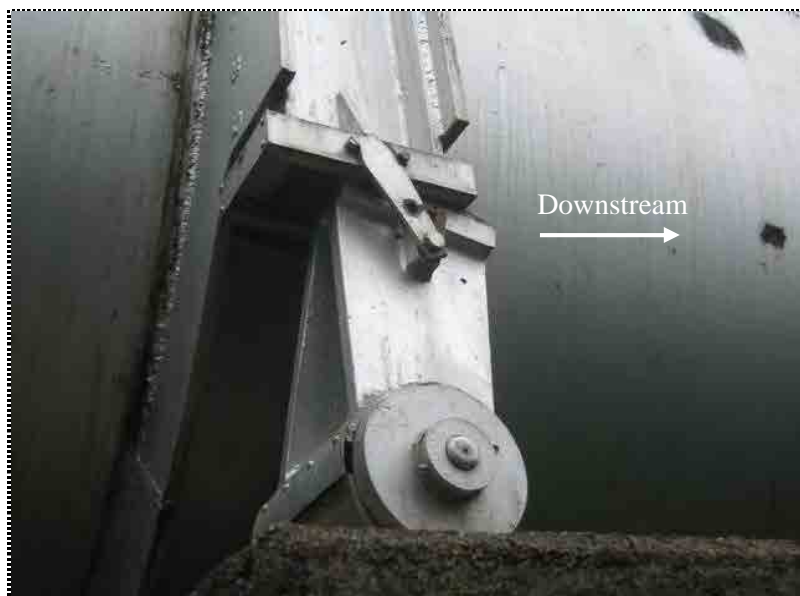
No 16

Items		Results	Photo No.
1	Rocker support No.	S52	-
2	Right side condition	Movement to the downstream	16
3	Left side condition	Movement to the downstream	17

Situation of damaged rocker support "S52"

This is the right side of rocker support, which is moved to the downstream.
(view from the right side)

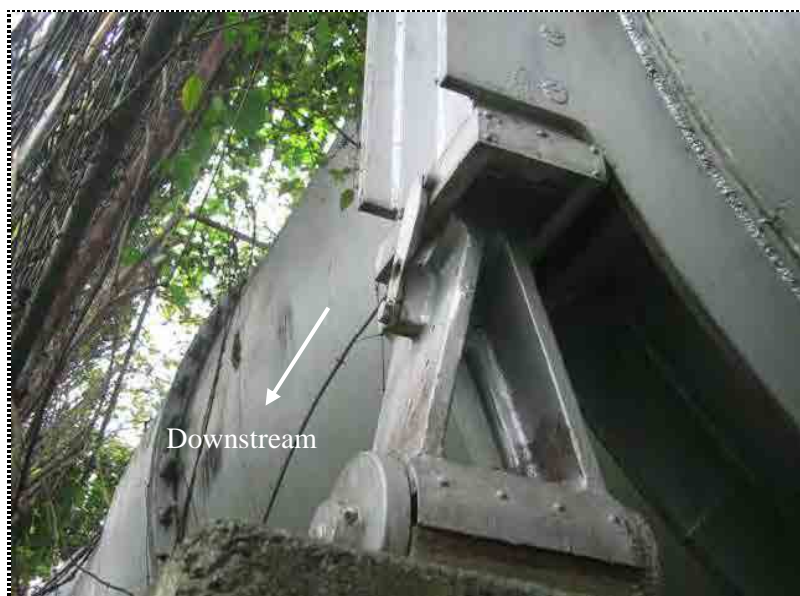
No 17

Situation of damaged rocker support "S52"

This is the left side of rocker support, which is moved to the downstream.
(view from the left side)

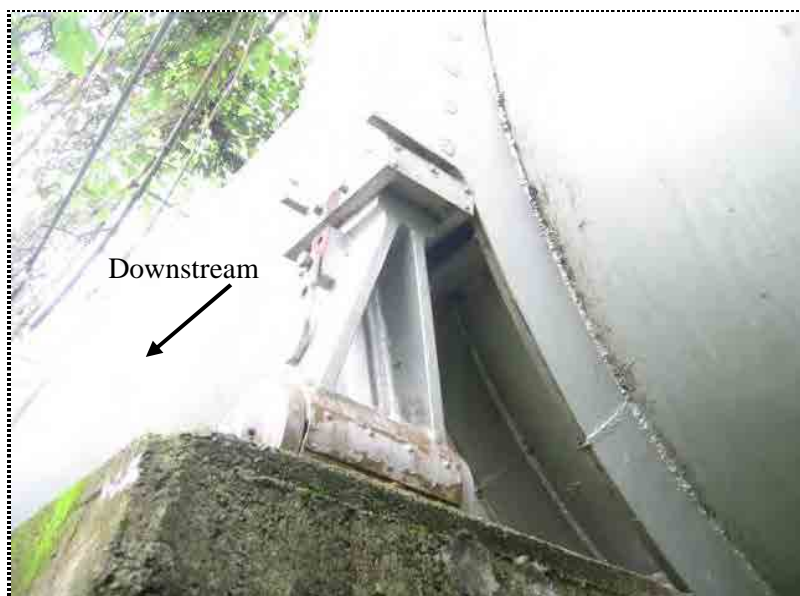
No 18

Items		Results	Photo No.
1	Rocker support No.	S53	-
2	Right side condition	None	-
3	Left side condition	Movement to the downstream	18
4	Past repair record	None	-
5	Others	Measurement for the repair	-

Situation of damaged rocker support "S53"

This is the left side of rocker support, which is moved to the downstream.
(view from the left side)

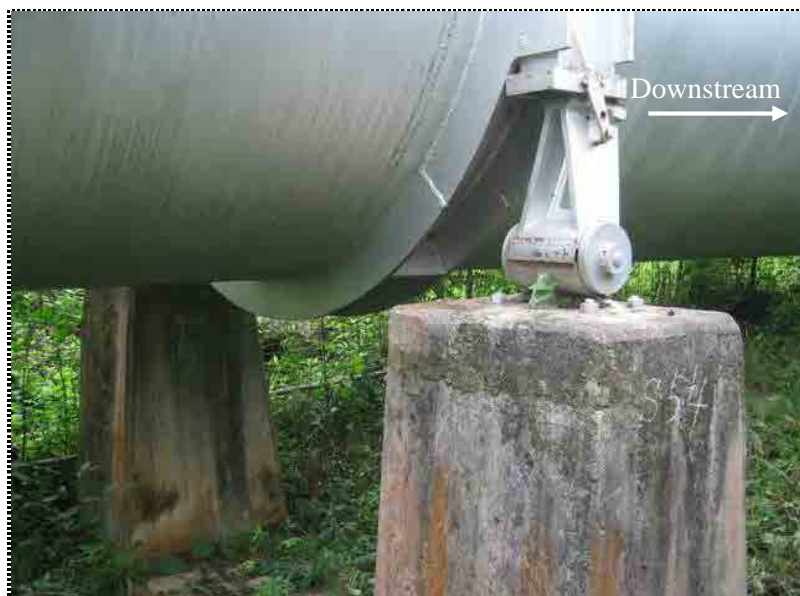
No 19

Items		Results	Photo No.
1	Rocker support No.	S54	-
2	Right side condition	Movement to the downstream	19
3	Left side condition	None	-
4	Past repair record	None	-
5	Others	Measurement for the repair	-

Situation of damaged rocker support "S54"

This is the right side of rocker support, which is moved to the downstream.
(view from the right side)

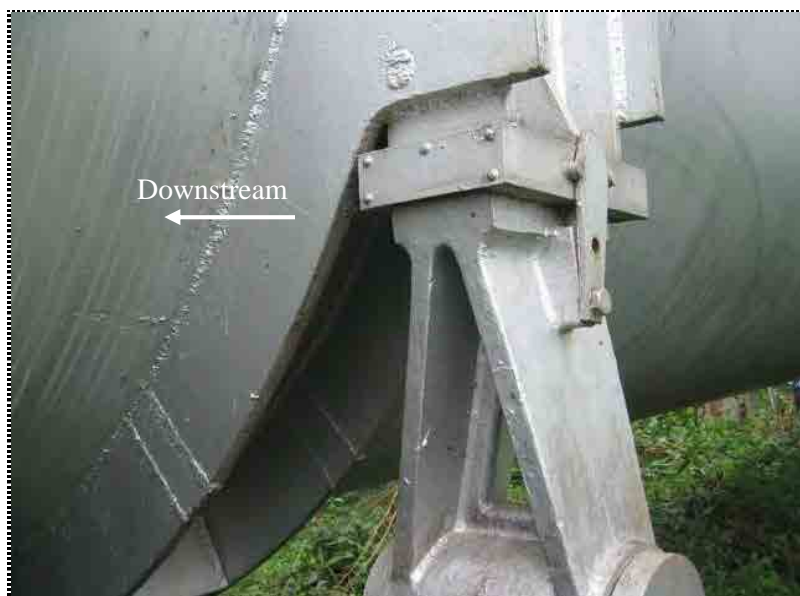
No 20

Items		Results	Photo No.
1	Rocker support No.	S55	-
2	Right side condition	None	-
3	Left side condition	Movement to the downstream	20
4	Past repair record	None	-
5	Others	Measurement for the repair	21

Situation of damaged rocker support "S55"

This is the left side of rocker support, which is moved to the downstream.
(view from the left side)

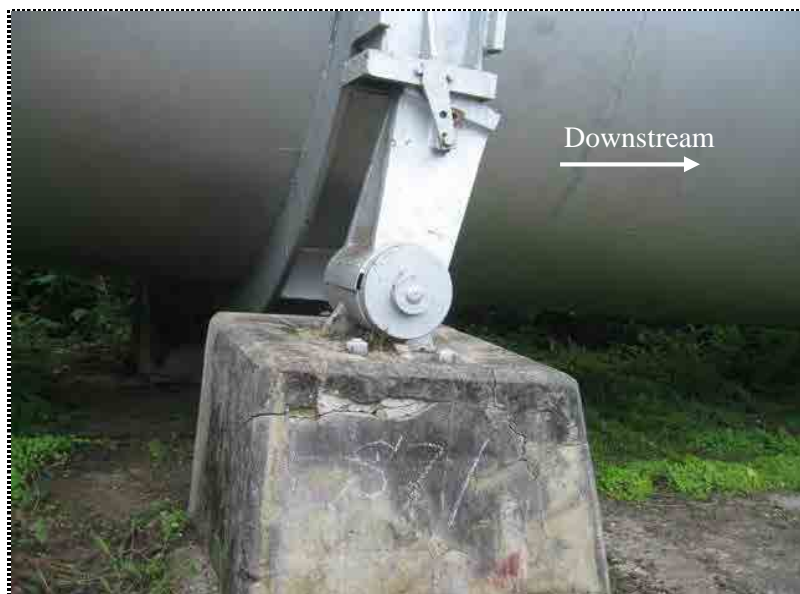
No 22

Items		Results	Photo No.
1	Rocker support No.	S71	-
2	Right side condition	Movement to the downstream	22
3	Left side condition	Ditto	23
4	Past repair record	According to the JICA Expert report in 2000, it has been reported that only right side of rocker support was damaged.	-
5	Other	Base concrete of right side of rocker support has some cracks, which go on from anchor plate to downstream surface. According to its drawing, the cracks are located in the	24&25

Situation of damaged rocker support "S71"

This is the right side of rocker support, which is moved to the downstream.
(view from the right side)

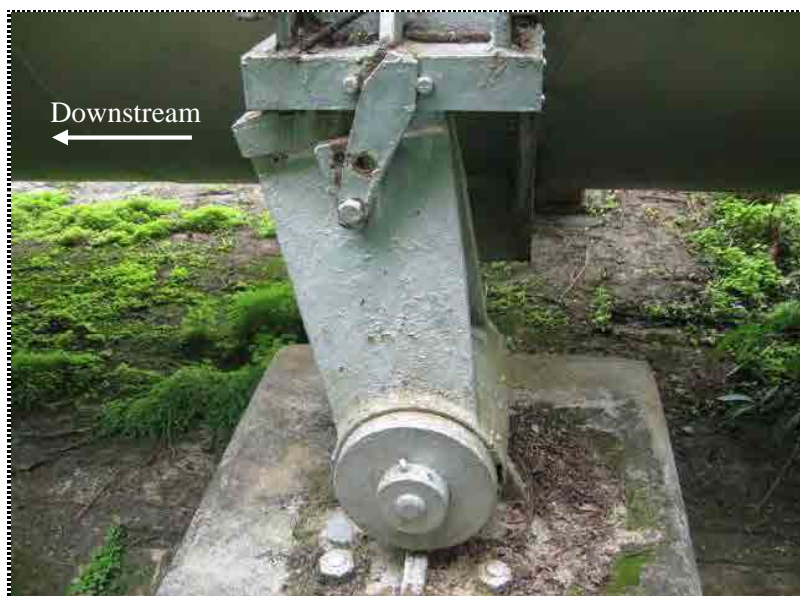
No 23

Situation of damaged rocker support "S71"

This is the left side of rocker support, which is moved to the downstream.
(view from the left side)

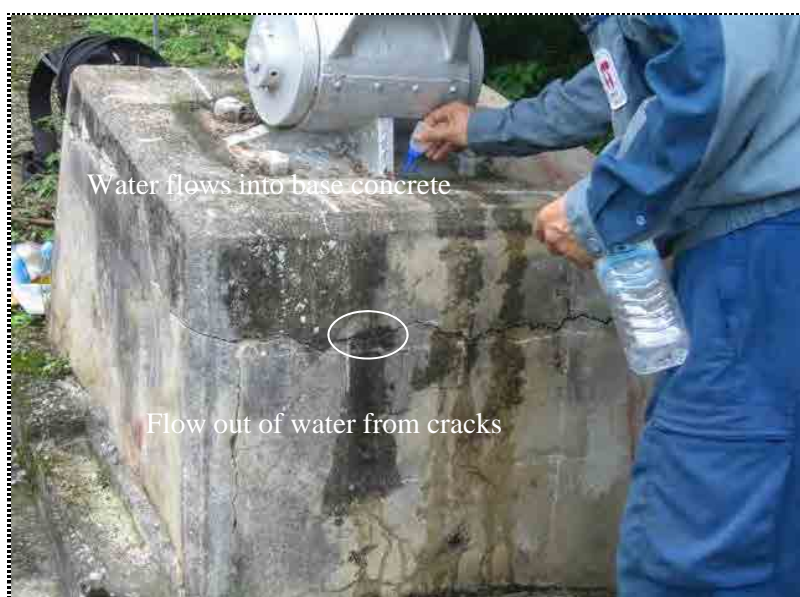
No 24

Base concrete of right side of rocker support has some cracks, which go on from anchor block to downstream surface.
(view from the downstream)

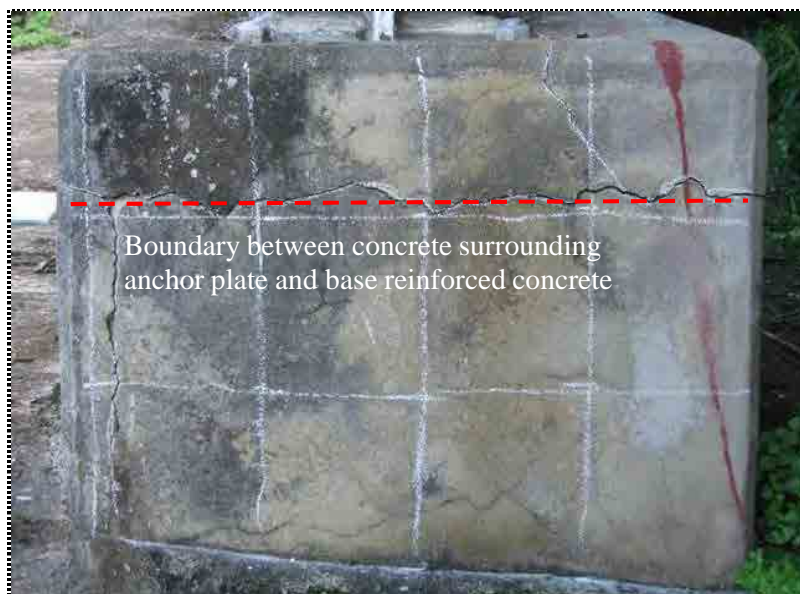
No 25

joint between concrete surrounding base plate and base reinforced concrete.	
		Measurement for the repair	
Items		Results	Photo No.
1	Rocker support No.	S72	-
2	Right side condition	None	-
3	Left side condition	Movement to the downstream	26
4	Past repair record	None	-
5	Others	Measurement for the repair	-

According to its drawing, the cracks are located in the joint between concrete surrounding base plate and base reinforced concrete
(view from the left side)

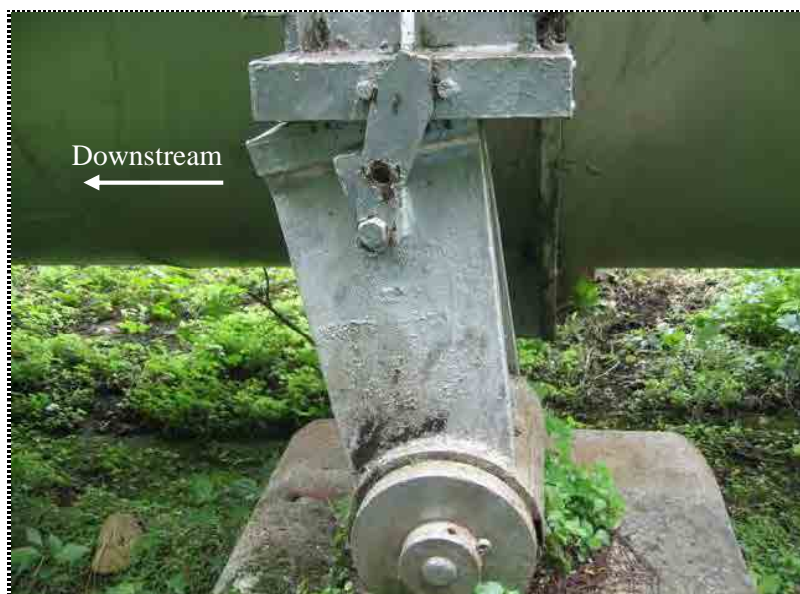
No 26

Situation of damaged rocker support "S72"
This is the left side of rocker support, which is moved to the downstream.
(view from the left side)

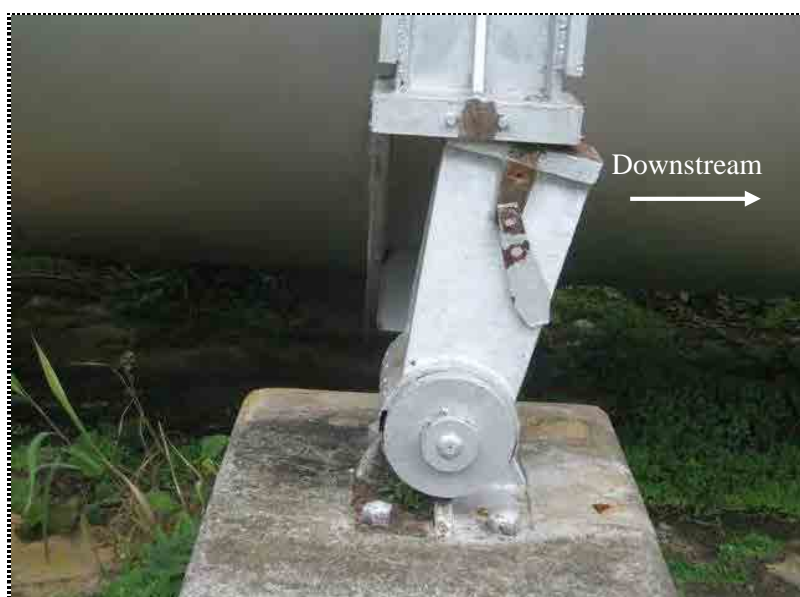
No 27

Items		Results	Photo No.
1	Rocker support No.	S74	-
2	Right side condition	Movement to the downstream	27
3	Left side condition	None	-
4	Past repair record	None	-
5	Others	Measurement for the repair	-

Situation of damaged rocker support "S74"
This is the right side of rocker support, which is moved to the downstream.
(view from the right side)

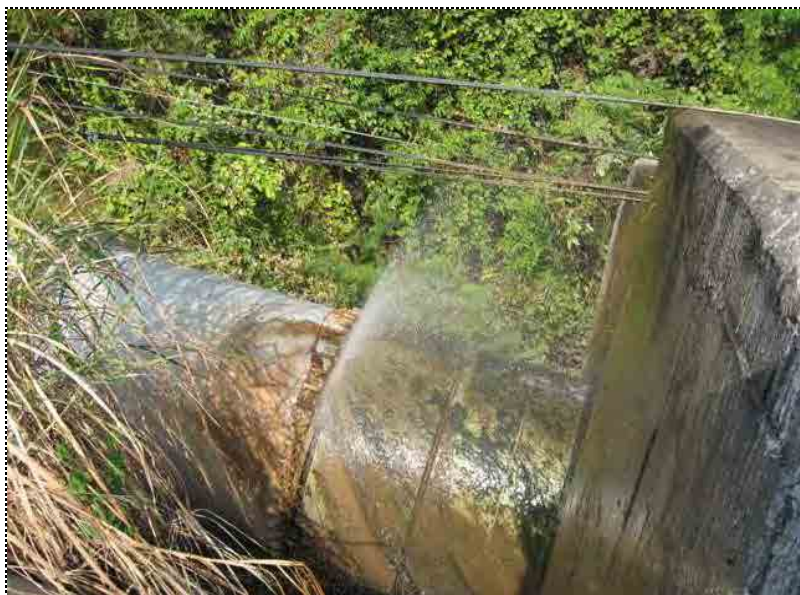
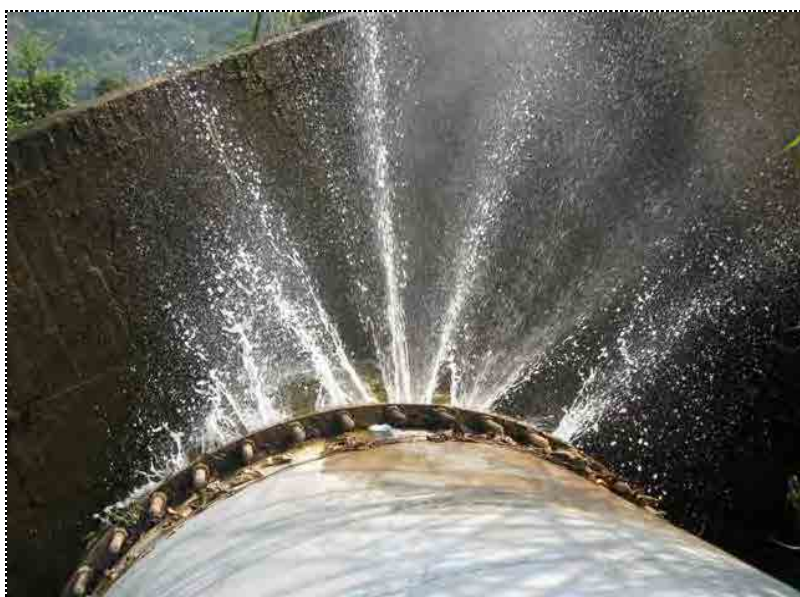
Items		Results	Photo No.
1	Water leakage	○	28
2	Difference between upper pipe and lower pipe (thickness of packing)	No measurement	-
3	Past repair record	Damaged packing was removed and replaced with new one twice in the past fifteen (15) years according to repair record. 1) 15 April 2006 2) 10-12 April 2010 According to the photo before repair in 10-12 April 2010, the water leakage was heavy.	29&30
3	Past repair record	Damaged packing was removed and replaced with new one in 5&6 April, 2000	-
4	Others	According to the present condition of photo, since there are some gaps in the joint.	-

According to the photo before repair in
10-12 April 2010, the water leakage was
heavy.
(view from the right side)

Situation of water leakage from the top of
the expansion joint
(view from the upstream)

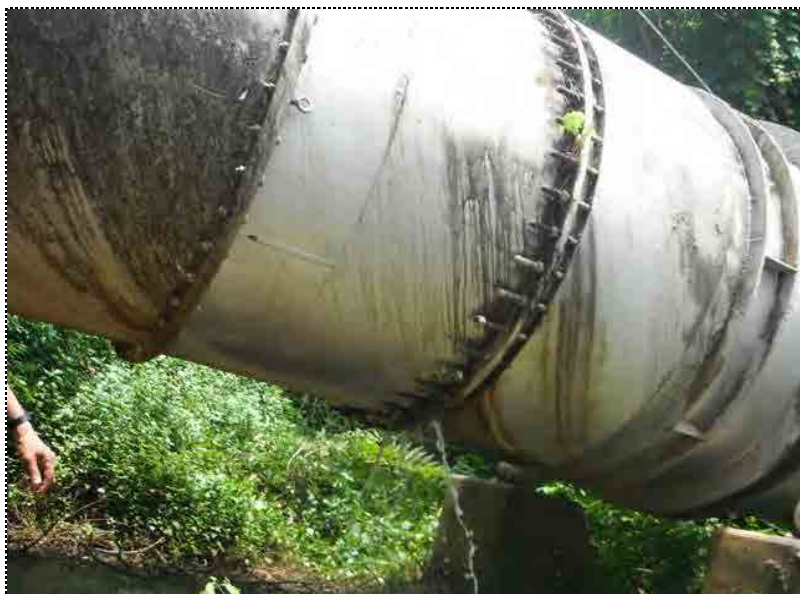
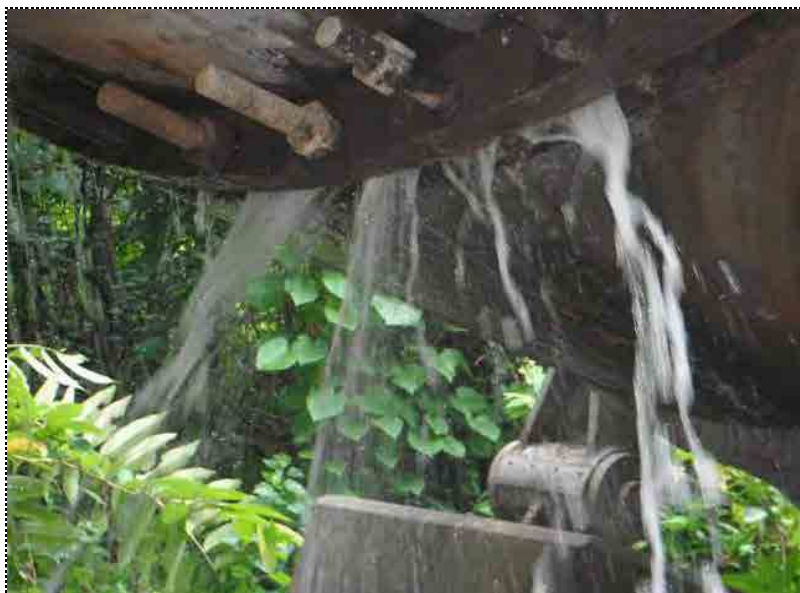
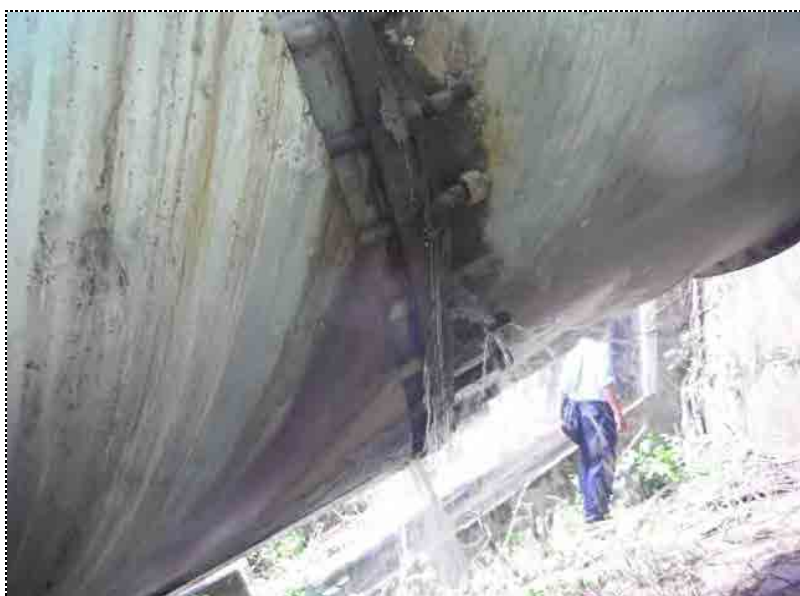
Items		Results	Photo No.
1	Water leakage	×	31-33
2	Difference between upper pipe and lower pipe (thickness of packing)	No measurement	-
3	Past repair record	Damaged packing was removed and replaced with new one in 5&6 April, 2000.	-

According to the JICA Expert report in 2000, it has been reported that a quantity of water leakage is 1.2 L/min.	
4	Others	According to the present condition of photo, there is water leakage in the bottom of the expansion joint.	-

Situation of water leakage from the bottom of the expansion joint
(view from the upstream of the right side)

Situation of water leakage from the bottom of the expansion joint
(view from the downstream of the left side)

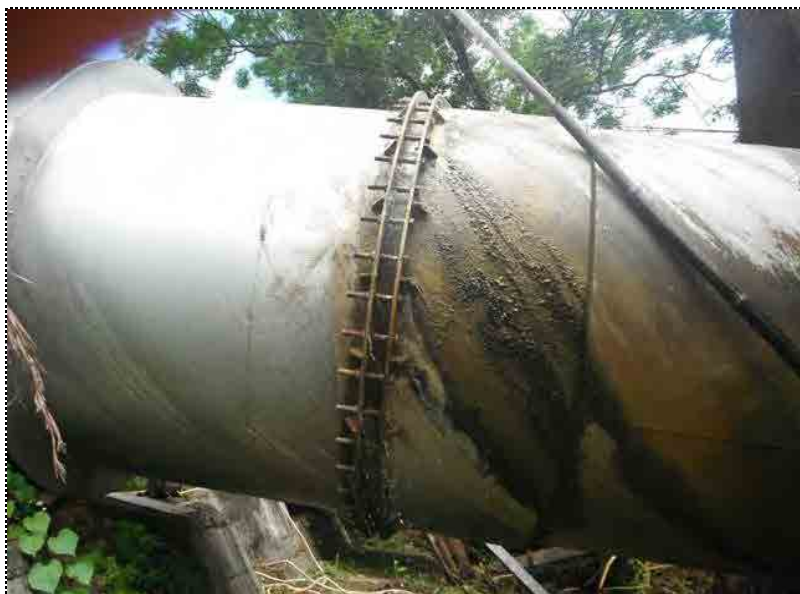
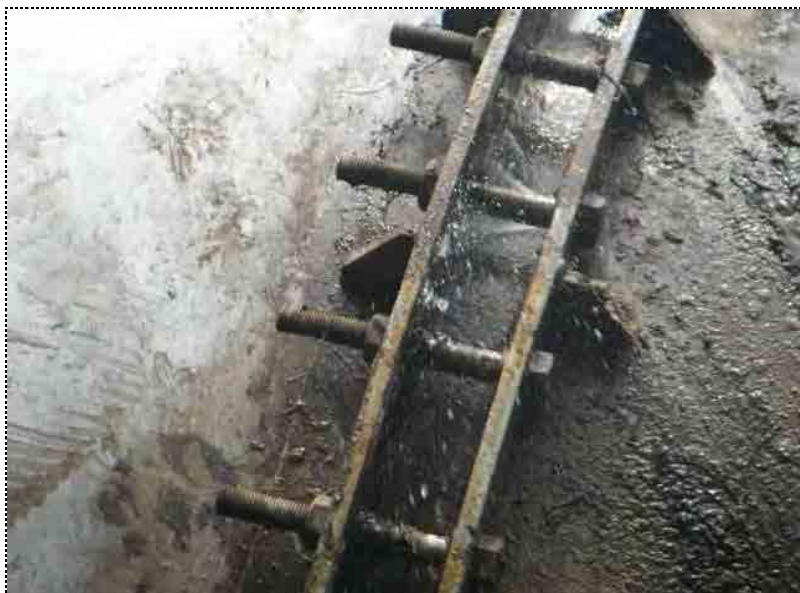
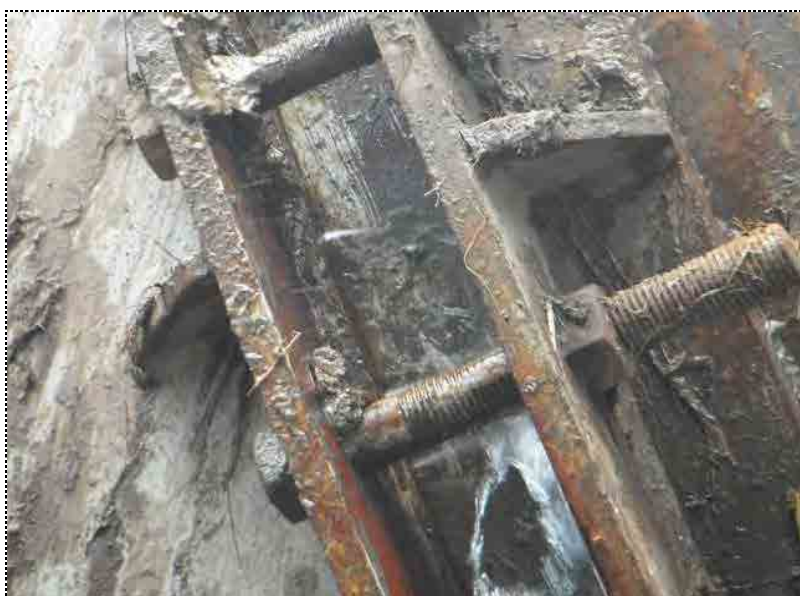
Items	Results	Photo No.
1 Water leakage	△	34-36
2 Difference between upper pipe and lower pipe (thickness of packing)	No measurement	-
3 Past repair record	None	-
4 Others	Since there is water leakage in the both sides of the	-

expansion joint according to the present condition by photo, it is necessary to confirm the detail conditions in the rainy season.	
--	--	--	--

Situation of water leakage from the right of the expansion joint
(view from the right side)

Situation of water leakage from the left of the expansion joint
(view from the left side)

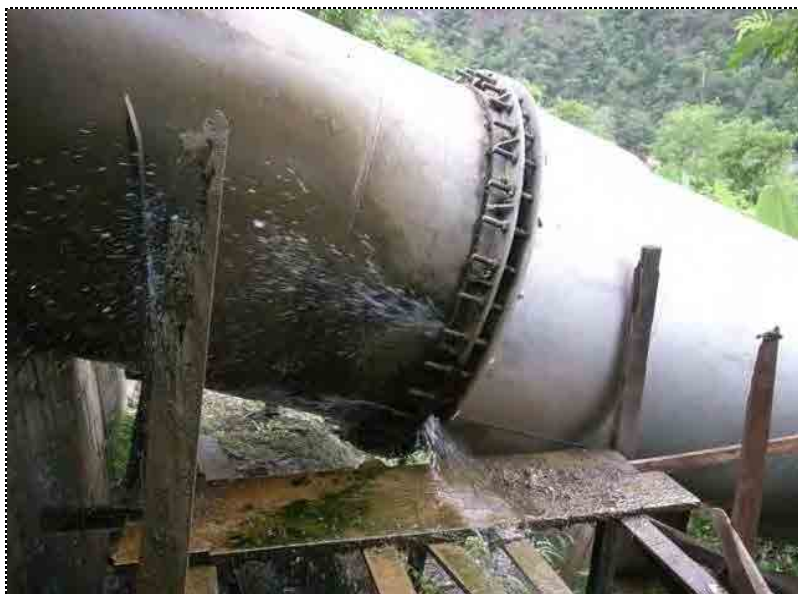
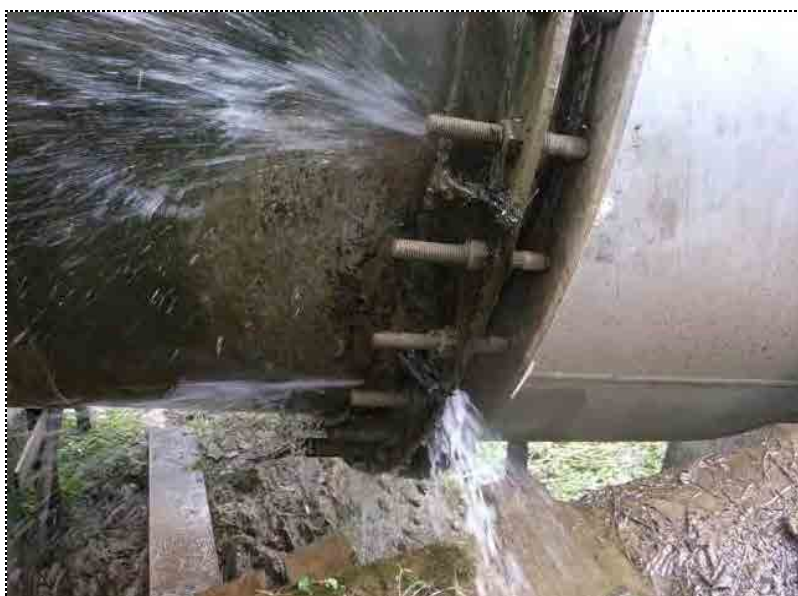
Items	Results	Photo No.
1 Water leakage	×	37&38
2 Difference between upper pipe and lower pipe (thickness of packing)	×	39
3 Past repair record	Damaged packing was removed and replaced with new one four (4) times in the past fifteen (15) years 1) 13&14 June, 1998 2) 13&14 August 2005 3) 27 August 2006 4) 10 September 2011 According to the photo before repair in 10 September 2011, the water leakage was heavier than the present.	42
4 Others	Measurement for the rehabilitation planning Under base concrete of No.7 anchor block (Unit No.5 & 6) of penstock pipe line No.2, which is located in the upstream of the expansion joint, is eroded by continuous the water leakage.	40&41

Situation of water leakage from the expansion
joint
(view from the right side)

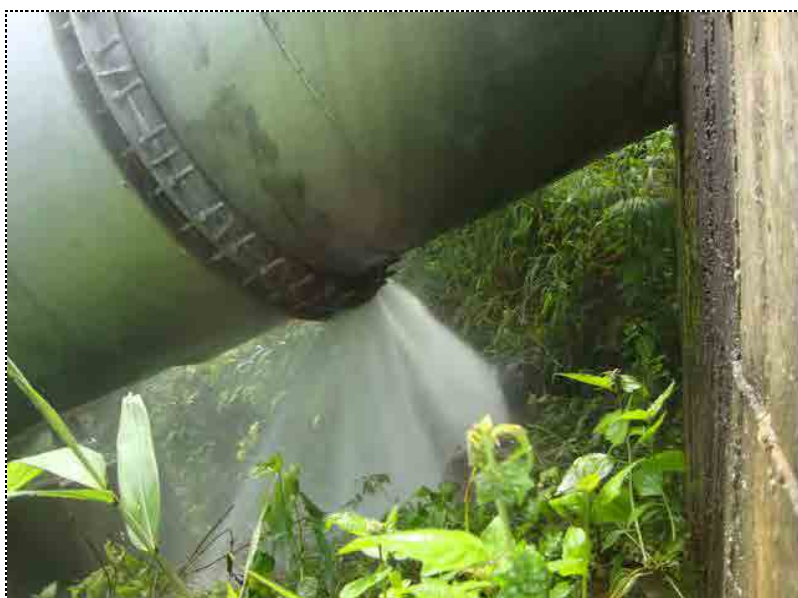
No 42

According to the photo before repair in
10 September 2011, the water leakage was
so heavy.
(view from the left side)
