スリランカ国  
全国重要橋梁実態及び  
維持管理に係る情報収集・確認調査

ファイナル レポート（付属資料）

### 3.1 架け替え選定対象橋梁 79 橋の橋梁台帳 (現地調査結果)

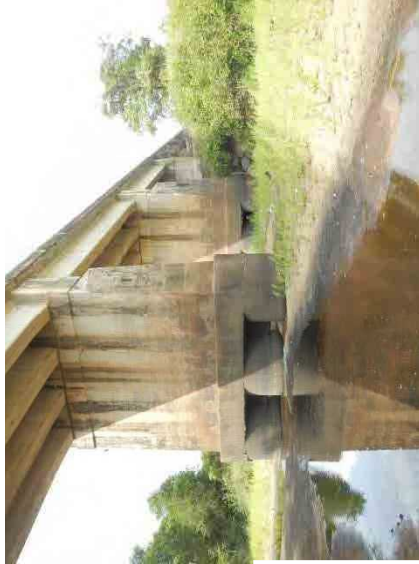
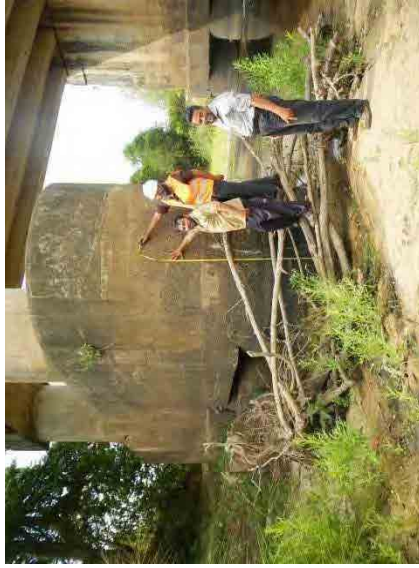
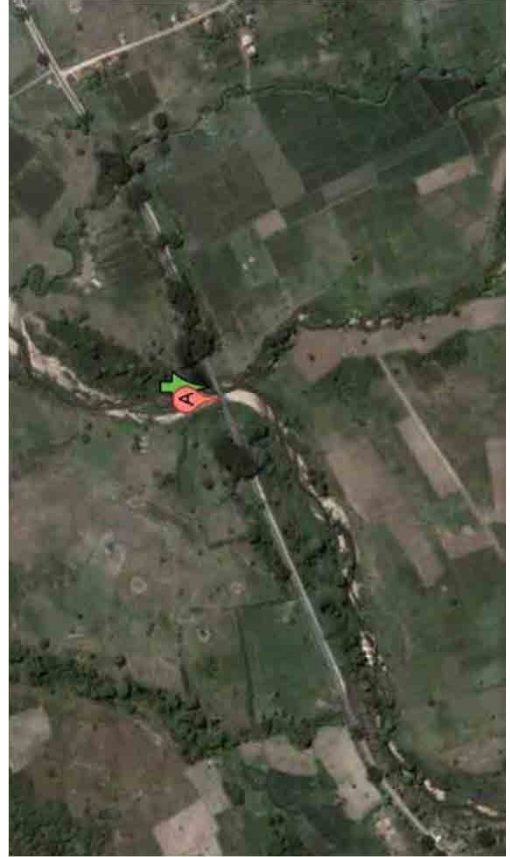
Curb-to-Curb of 4.20m wide is insufficient for 2-lane traffic of Class A Road. A1 Abutment and P6 to P8 Piers were damaged seriously.

- Substructure Critical RATE 4

Piles of piers have been exposed and damaged seriously.

- Pile Caps that widths are exactly same as the diameter of Piles have been damaged seriously.  
Abandoned old substructures remain under the existing bridge.

(Reconstruction at L-Side of the existing bridge)  
Eliminated by LOT size

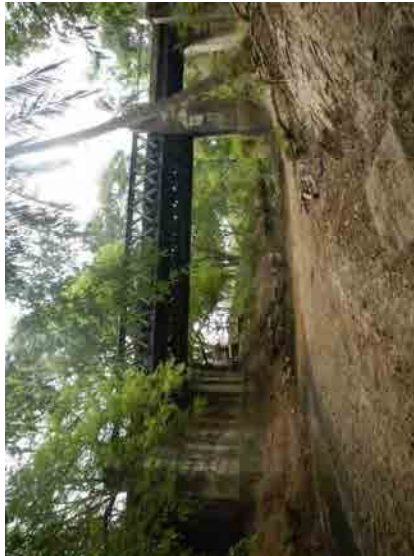
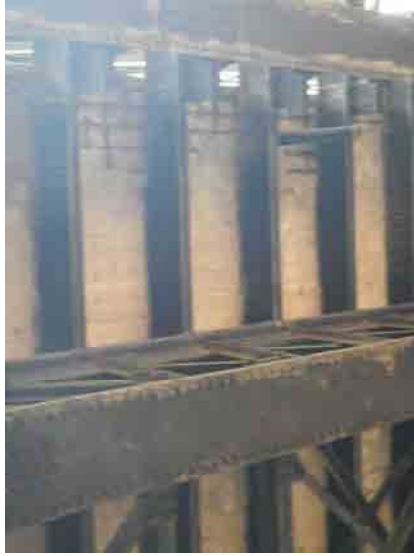
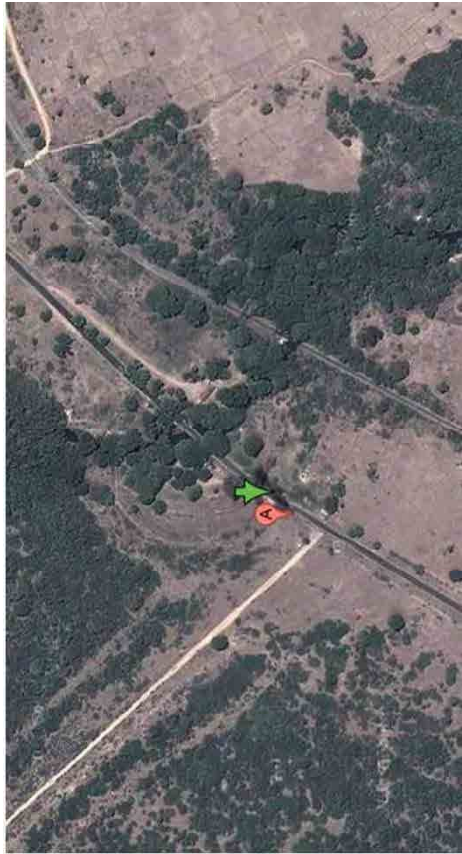
Curb-to-Curb of 6.60m wide is sufficient for the time being for 2-lane traffic.

- Superstructure RATE 3
- Steel members corroded
- Re-bar of RC Slab rusted
- Substructure RATE 2
- Fair
- Others

(Reconstruction of 2-lane bridge on the existing alignment)  
Eliminated by LOT size

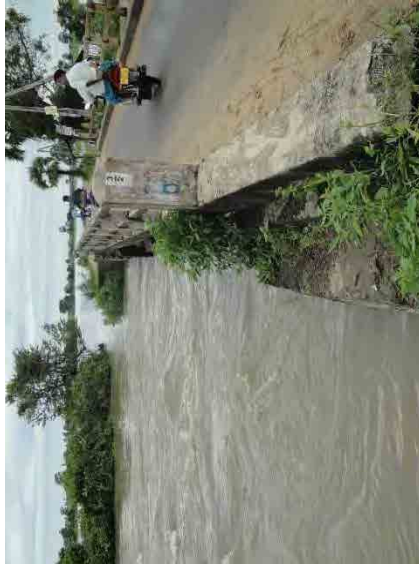
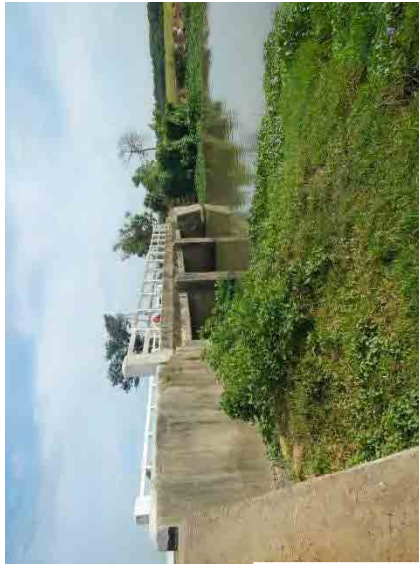
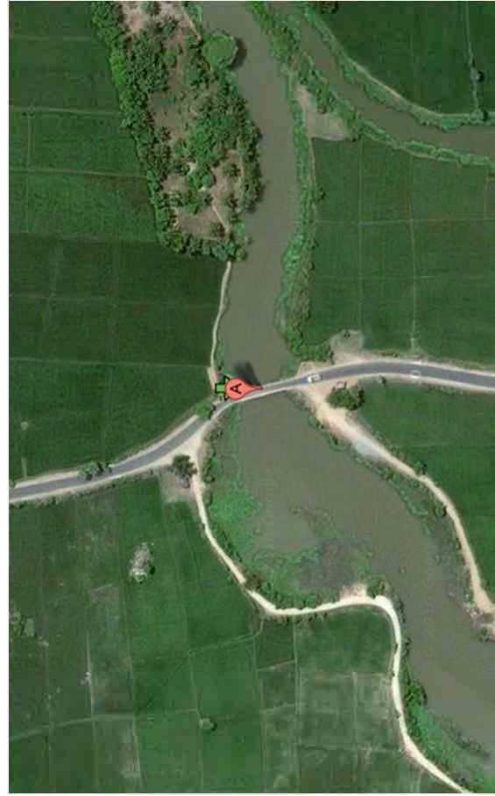
Curb-to-Curb of 4.17m wide is insufficient for 2-lane traffic of Class B Road.

- Substructure Critical RATE 4

- Others A Pile Bent type Pier was constructed in front of damaged A 2 Abutment.

The right bank of the river at L-side of A1 Abutment was scoured seriously because of insufficient bridge opening for floods..

(Reconstruction at R-side of the existing bridge)  
Eliminated by LOT size

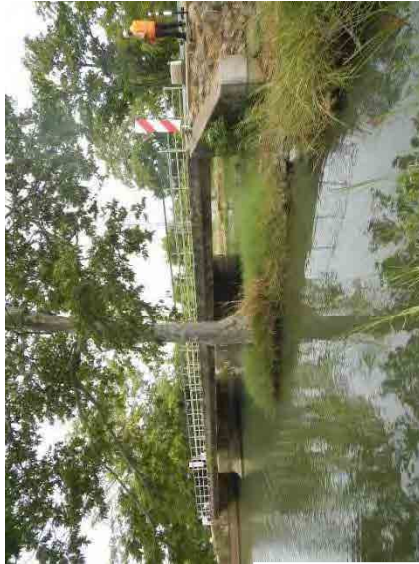
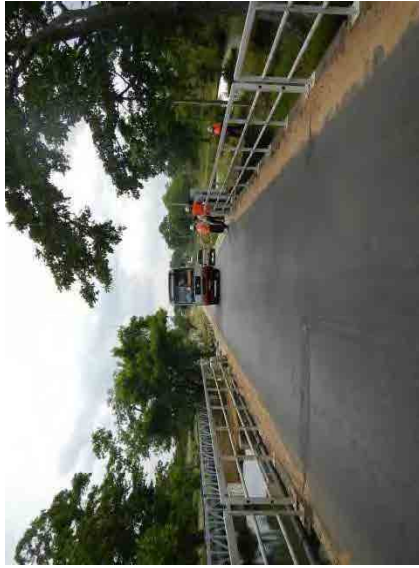
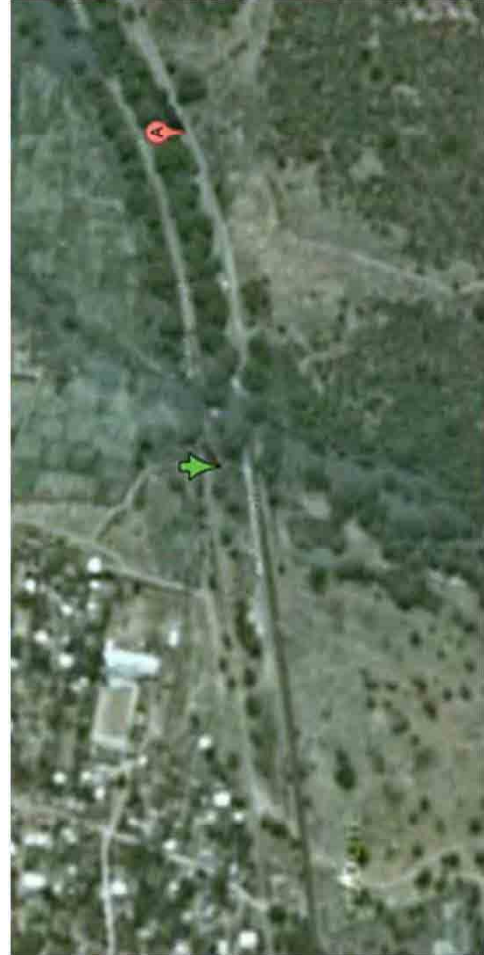
Curb-to-Curb of 5.42m wide is insufficient for 2-lane traffic of Class A Road.

Insufficient bridge elevation and opening for floods

- Superstructure RATE 2
- Fair
- Main girders rusted
- Substructure RATE 1
- Good
- Others

**Reconstruction is not recommended.**

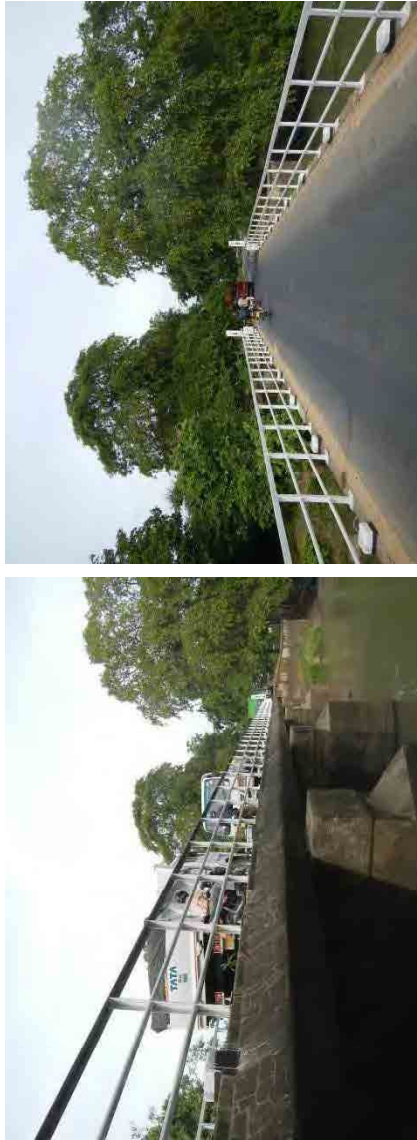
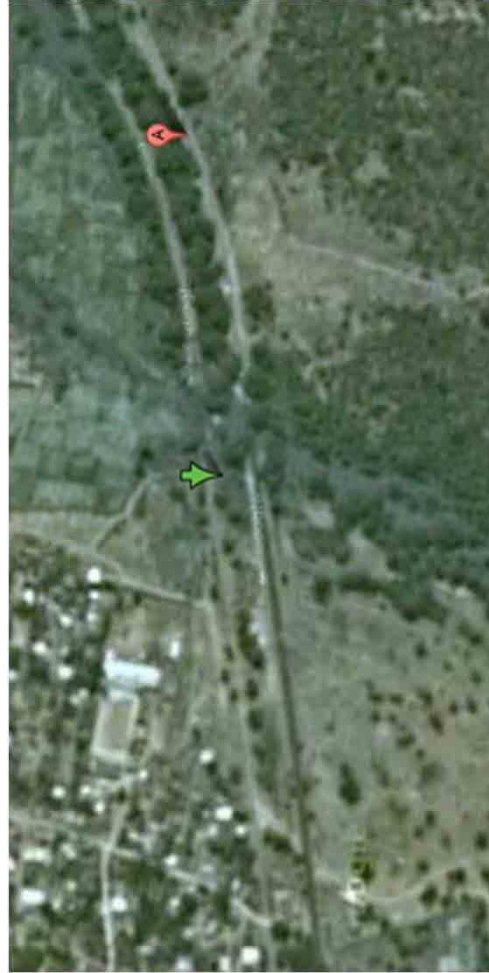
Curb-to-Curb of 5.15m wide is insufficient for 2-lane traffic of Class A Road.  
Insufficient bridge elevation and opening for floods

- Superstructure  
Fair  
Main girders rusted  
RATE 2
- Substructure  
Good  
RATE 1
- Others

**Reconstruction is not recommended because of Environmental problem.**

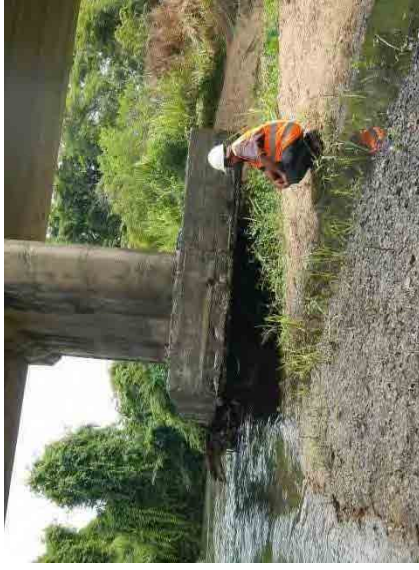
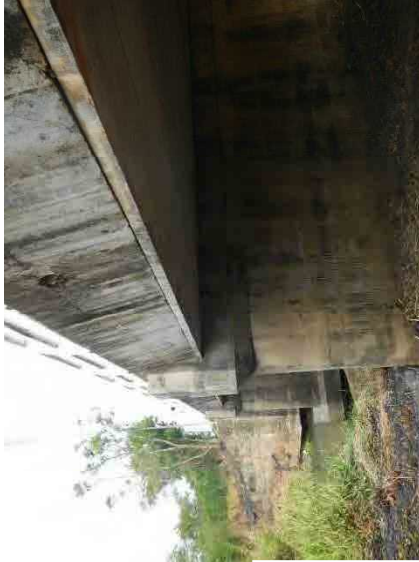
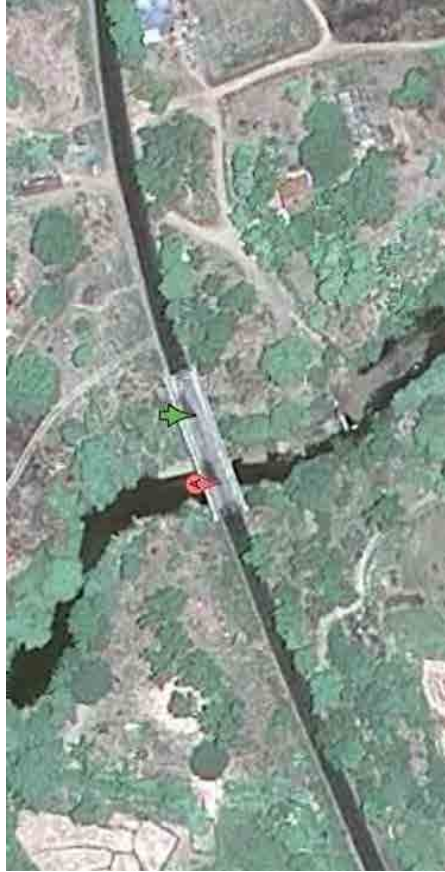
- Superstructure Good RATE 1
- Substructure RATE 3
- Pile Caps of A1 Abutment and P1 Pier were scoured out by floods.
- Pile Heads of A1 Abutment and P1 Pier have been exposed.
- Others

(Reconstruction at R-side of the existing bridge)  
Eliminated by LOT size

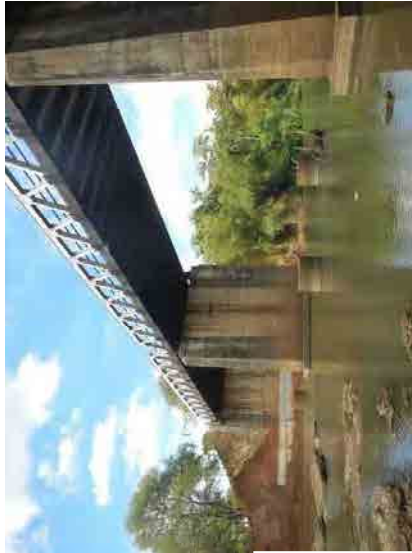
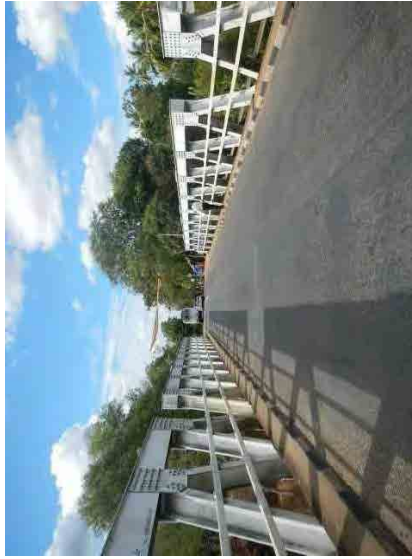
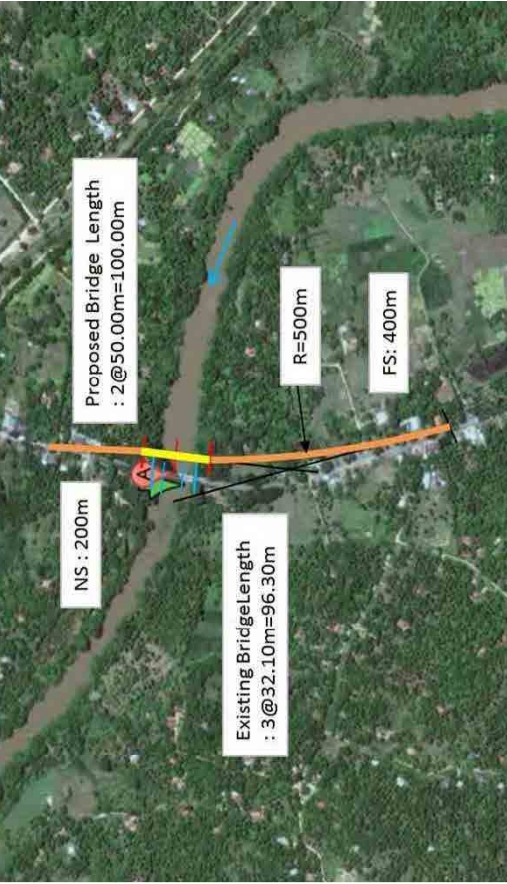
Curb-to-Curb of 6.80m wide is sufficient for the time being for 2-lane traffic of Class A Road.

- Superstructure Fair RATE 2
  - Substructure Good RATE 1
  - Others
- Bridge members have been rusted without proper maintenance works.

**Additional 2-lane bridge at R-side of the existing bridge**

- Bridge Length: 2@50.0 =100m
- Approach Length: NS: 200m FS: 400m
- Superstructure: Steel I-Girder
- Substructure: Wall Type Abutment Wall Type Pier
- Foundation: Spread Foundation
- Resettlement: Less than 20 households

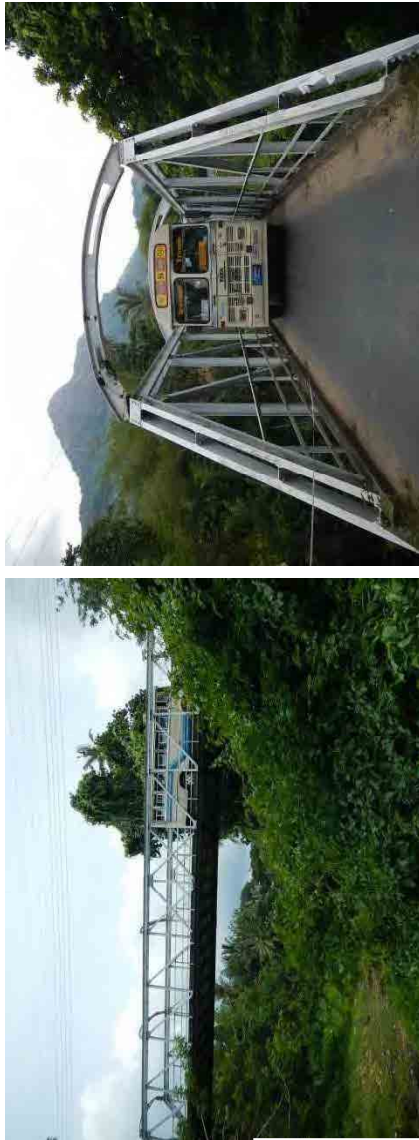
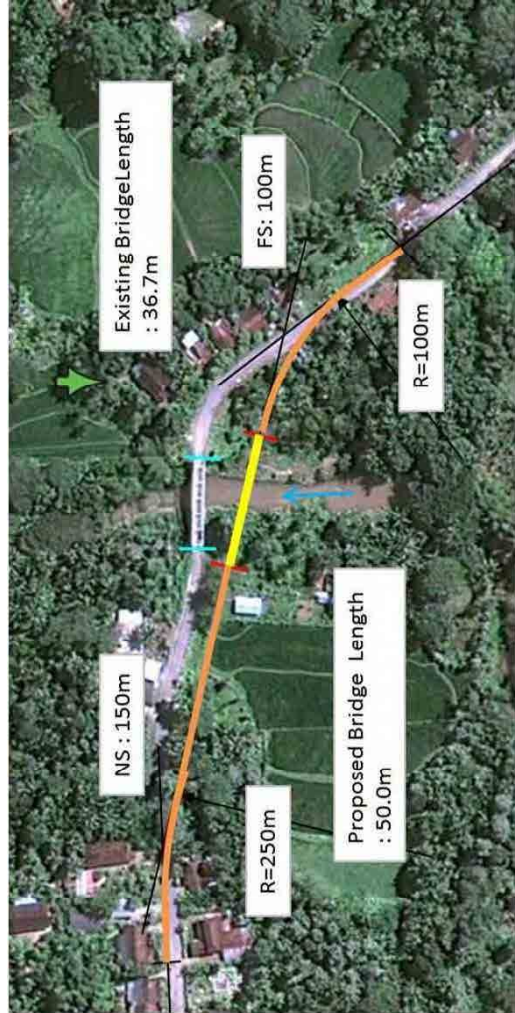
[BRIDGE ]  
Insufficient horizontal and vertical clearances for the traffic of Class B Road

- Superstructure Fair RATE 2

- Others  
Stonemasonry Retaining Wall at R-side of NS Approach is damaged.

**Reconstruction at R-side of the existing bridge**

Bridge Length: 1@50.0 =50m

Approach Length: NS: 150m FS: 100m

Superstructure: Steel I-Girder

Substructure: Wall Type Abutment Wall Type Pier

Foundation: Cast-in-place concrete pile foundation

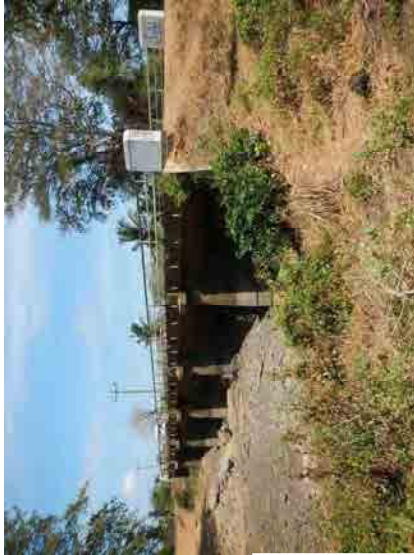
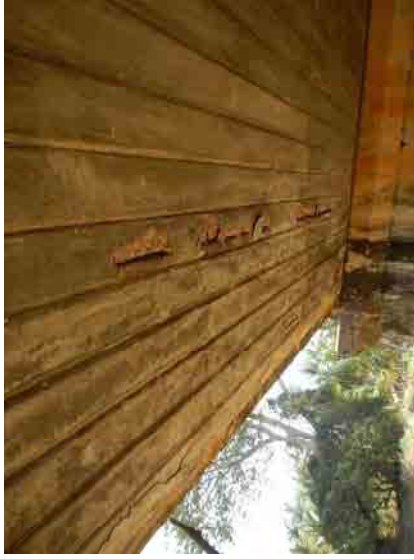
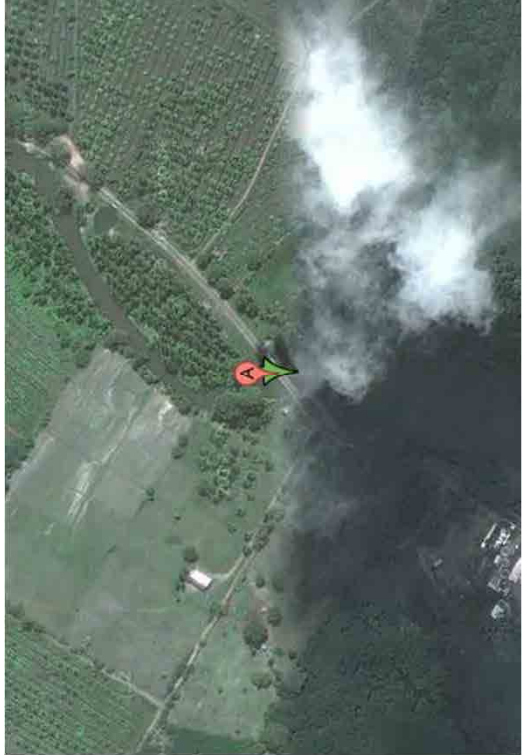
[BRIDGE ]  
Curb-to-Curb of 4.00m wide is insufficient for the existing traffic.

- [ SOUNDNESS ]\*\*
- Superstructure Re-bar of girders corroded. RATE 3
  - Substructure Fair RATE 2
  - Others

< PROPOSAL >  
**Reconstruction is not recommended because of Environmental problem.**

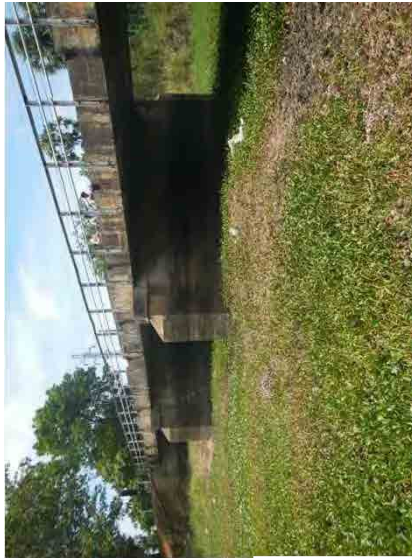
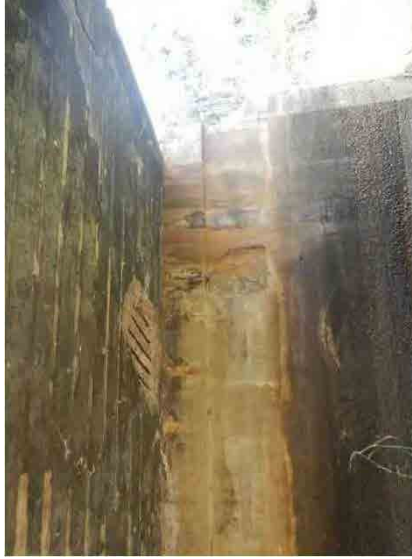
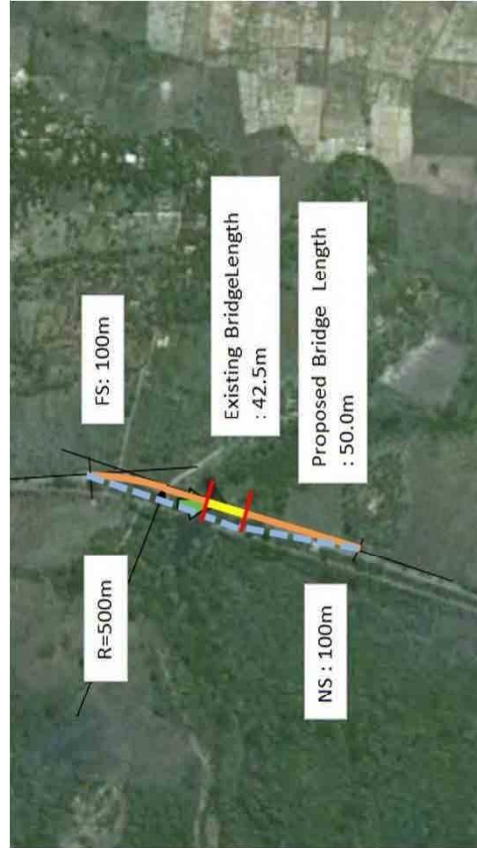
- Superstructure Poor RATE 3
- R-Bars of C Slab corroded
- Substructure Fair RATE 2
- Others

- Bridge Length: 1@50.0 = 50m
- Approach Length: NS: 100m FS: 100m
- Superstructure: Steel I-Girder
- Substructure: Wall Type Abutment Wall Type Pier
- Foundation: Cast-in-place concrete pile foundation
- Resettlement: No
